The Basko Grand Mall and Adjacent Hotel

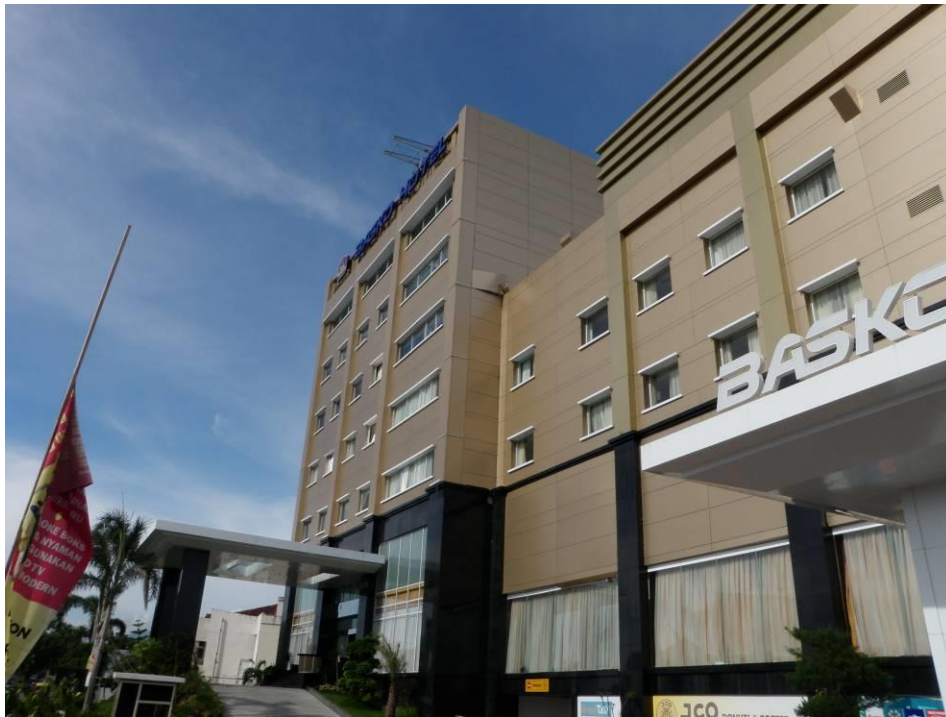
The picture below shows the front view of the hotel with the mall on the right. Notice that much of the front façade and structural system suffered very little damage in the earthquake.

Figure 1: Exterior View of the Basko Mall and the Adjacent Hotel Showing Little Apparent Damage

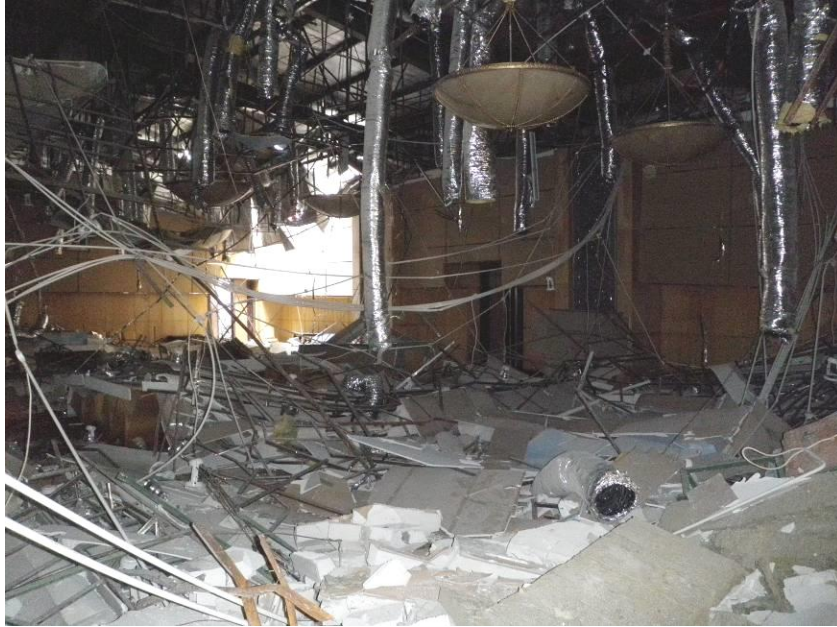
In spite of these first impressions, the entire facility is closed for business and will be closed for quite some time. The reason is partly because some infill walls suffered out-of-plane failure, but primarily because of major damage to non-structural components. The following photographs show major damage in the second-floor ballroom and the main corridor on the fourth floor.

Figure 2: Second-Floor Ballroom in the Hotel with Collapsed Ceiling

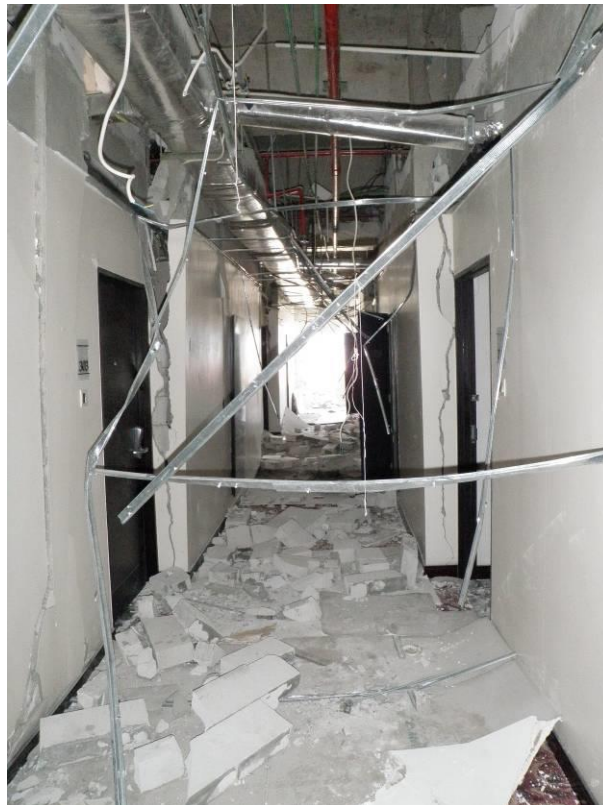
Figure 3: Fourth-Floor Hotel Corridor Showing Major Non-Structural Component Damage
