Oxfam GB

Haiti Earthquake Response

Arup Assignment Report

May 2010

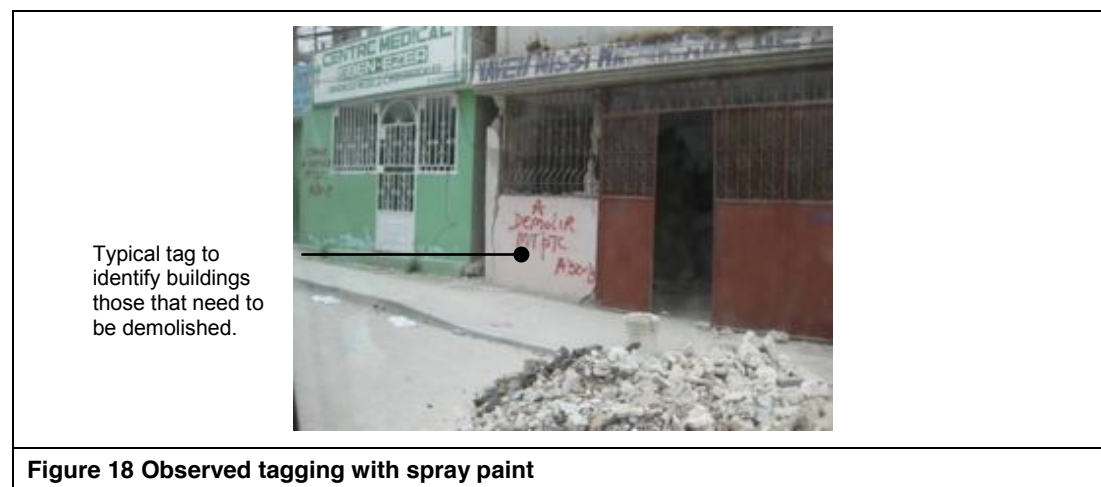
Figure 18 Observed tagging with spray paint

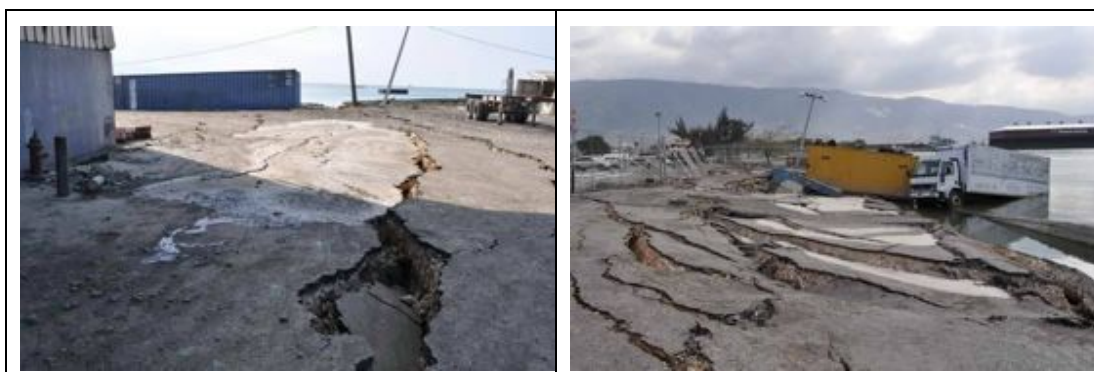
Figure 30 Sand boils due to liquefaction at the port facilities possibly leading to marine slope failures with sinking of land.

This is the loss of strength in saturated sand deposits due to cyclic loading. It can cause both significant settlement and lateral movement of foundations. The key here is to identify the location of liquefiable deposits and either avoid those areas, improve the density of the ground or provide suitable deep foundations to a competent stratum below.

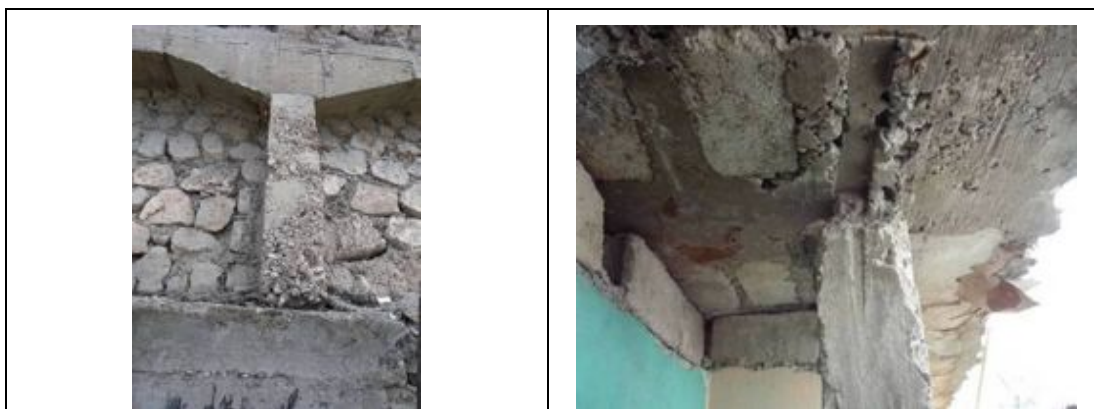
Placement of concrete is quite a skill and it is often done very poorly. Unfortunately this is the case in Haiti too. Leaking formwork, sloppy mixes (to get the concrete to flow) and no compaction and vibration of the concrete typically result in poor quality concrete as shown in Figure 57.

Figure 57 Example of poorly graded and poorly compacted concrete

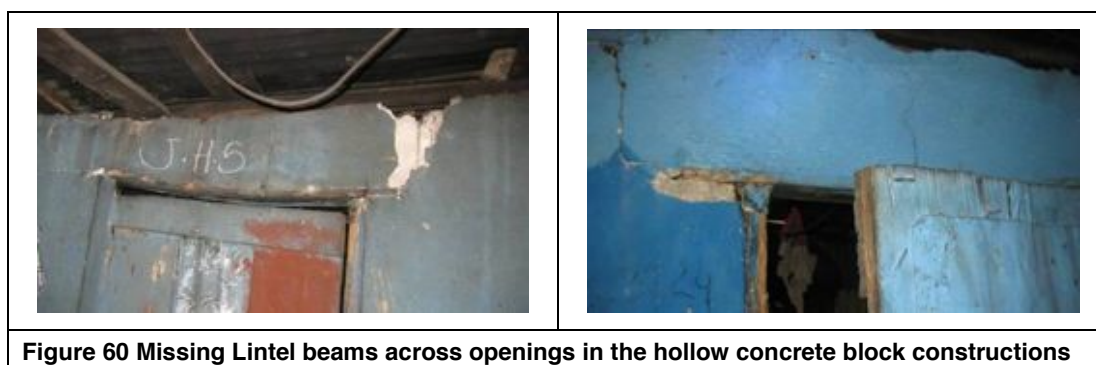
Figure 60 Missing Lintel beams across openings in the hollow concrete block constructions

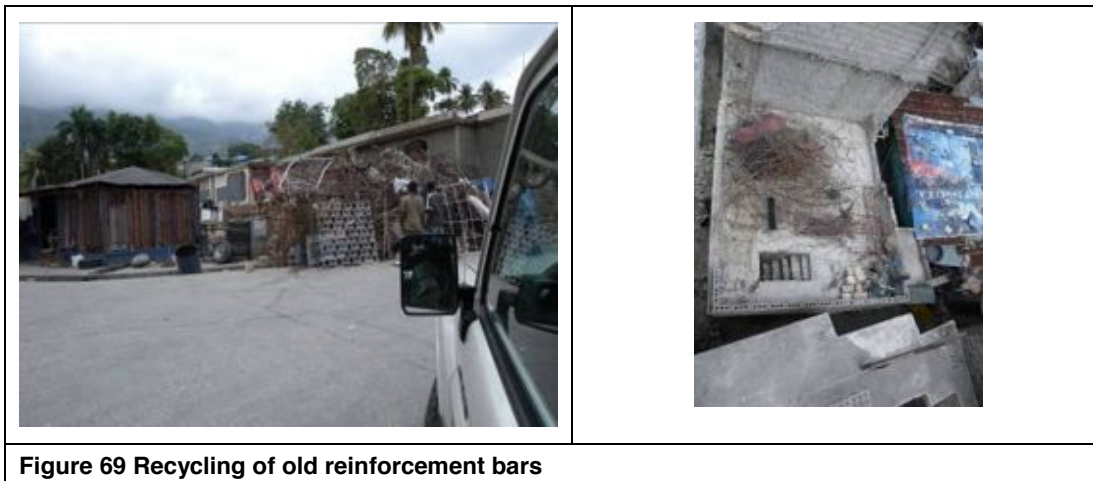
Figure 69 Recycling of old reinforcement bars

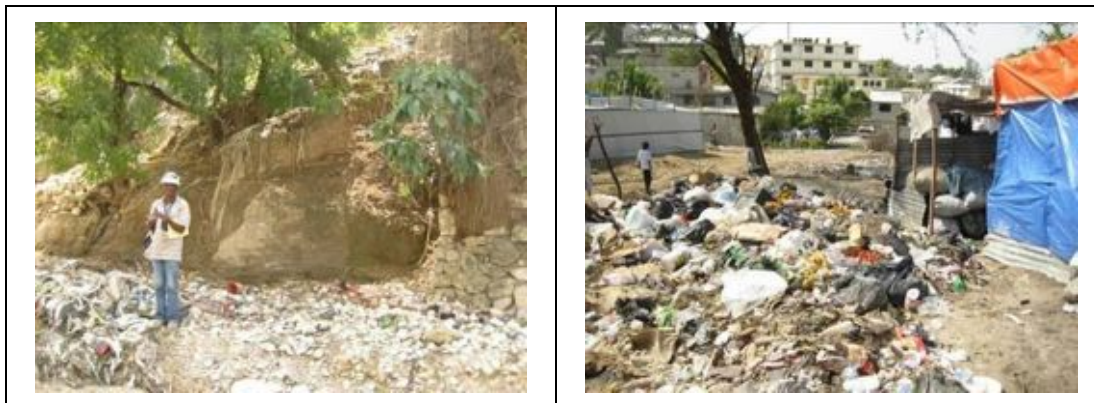
Figure 84 Typically natural water courses have been used for dumping household waste.

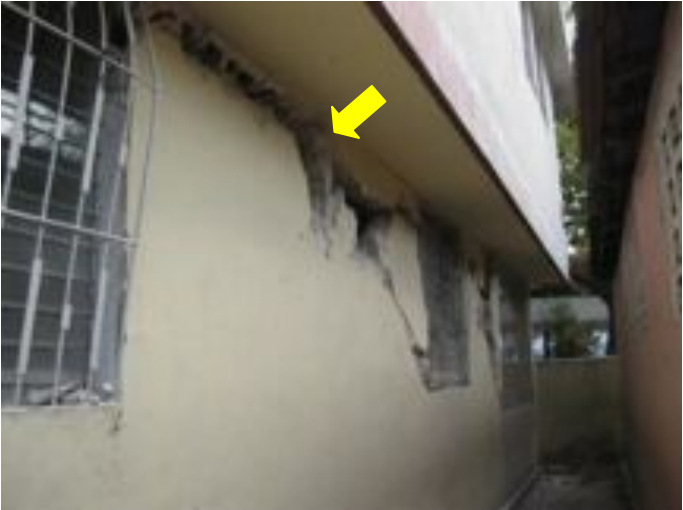
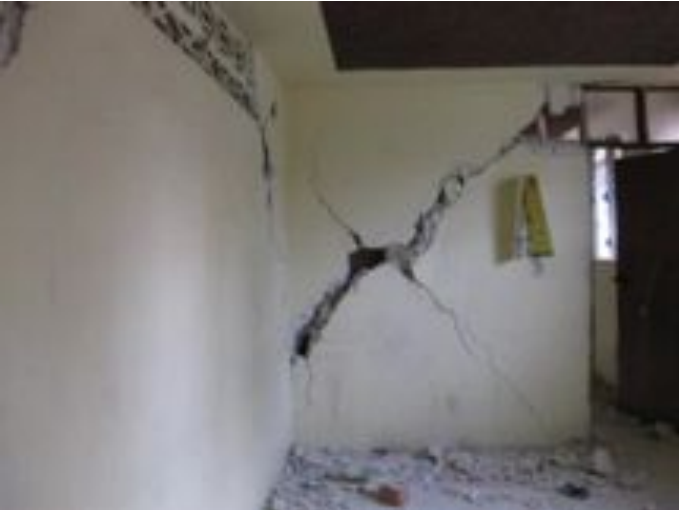
<p>2 storey house on left and 1 storey house on right. Lower storey of the 2 storey house is compromised. Concret column failure is evident</p>	<p>Severe cracking of internal partitions of 2 storey house at ground floor level.</p>

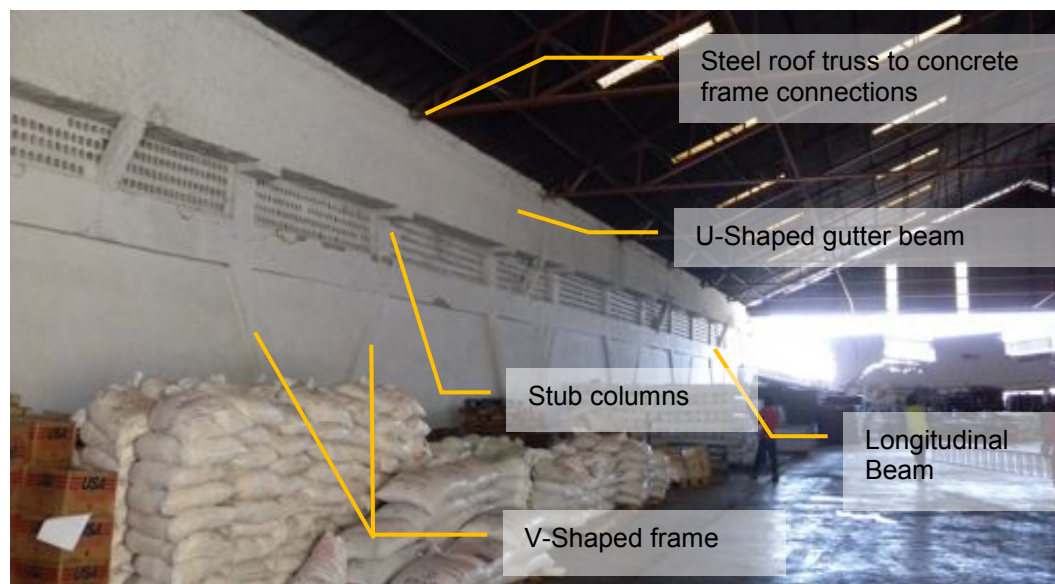
V-Shaped concrete piers running along the side of the warehouse with B3. Note the collapse at the rear of the warehouse.

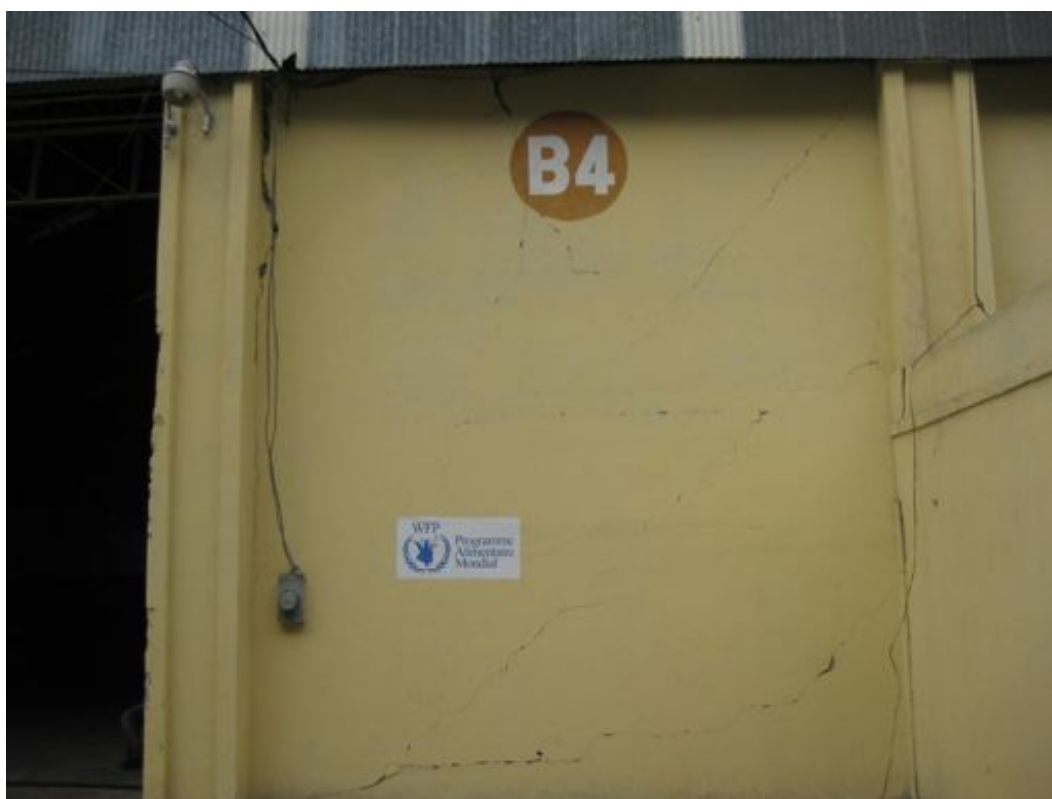
Figure 8 In plane cracking of masonry walls to the sides of the main warehouse loading entrance.

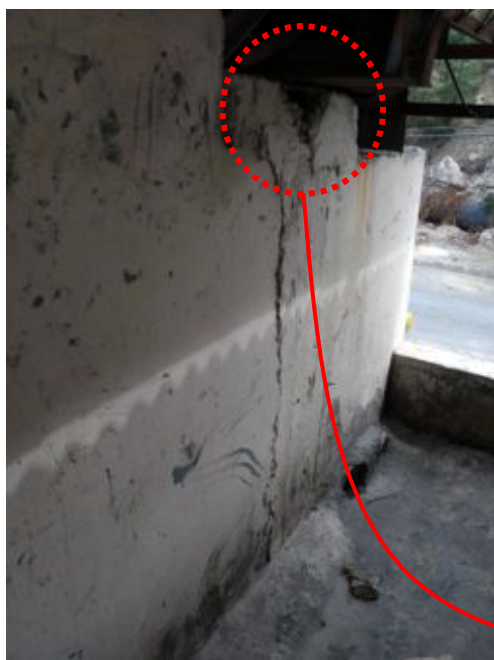
Column rebar have been tack welded to angles which in turn have been tack welded to steel base plate connecting to the steel roof trusses. Poor quality detailing and workmanship

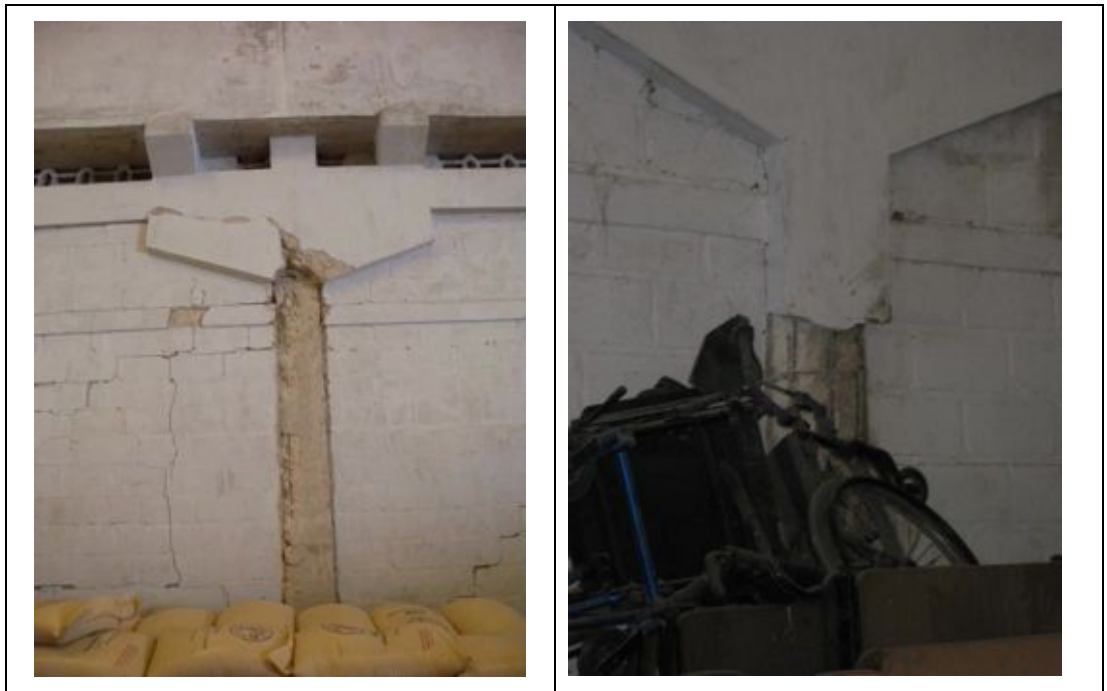
Figure 14 Damage to concrete columns appears to be limited to the cover. Damage to column head / around interface to gutter beam is apparent too.

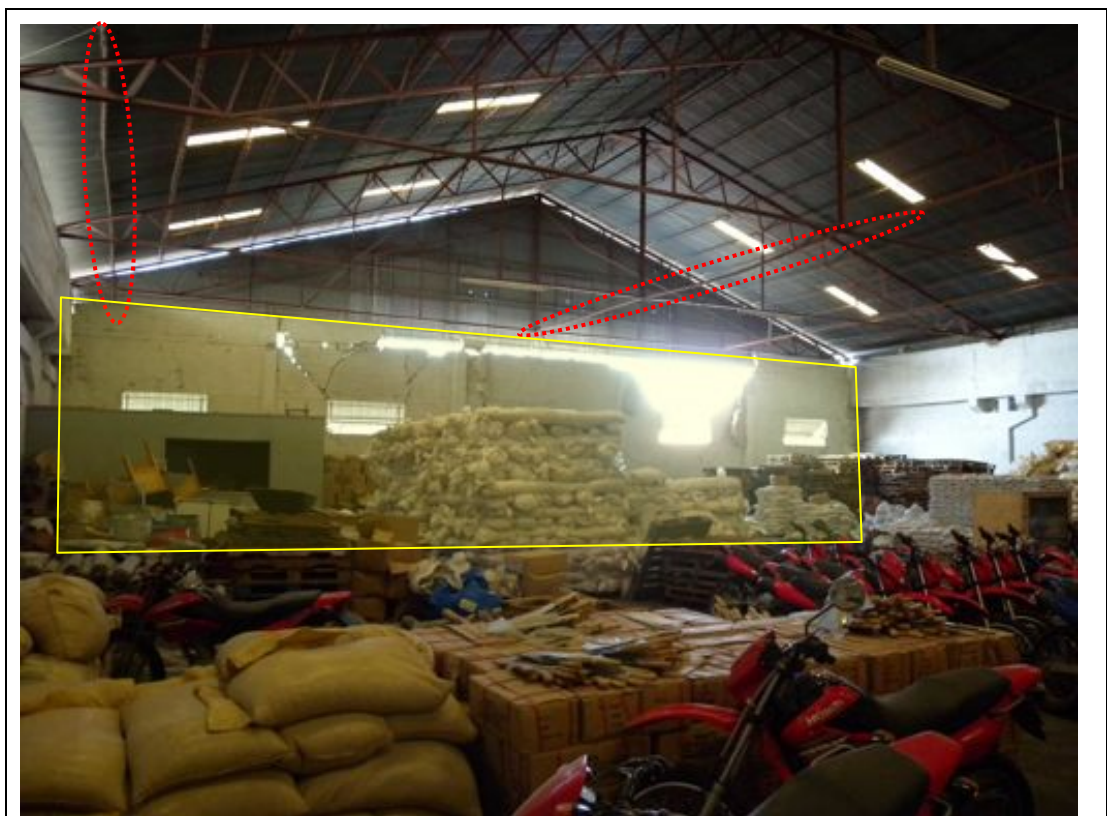
Figure 15 Partially collapsed rear warehouse portion – note that the warehouse is still being used extensively.

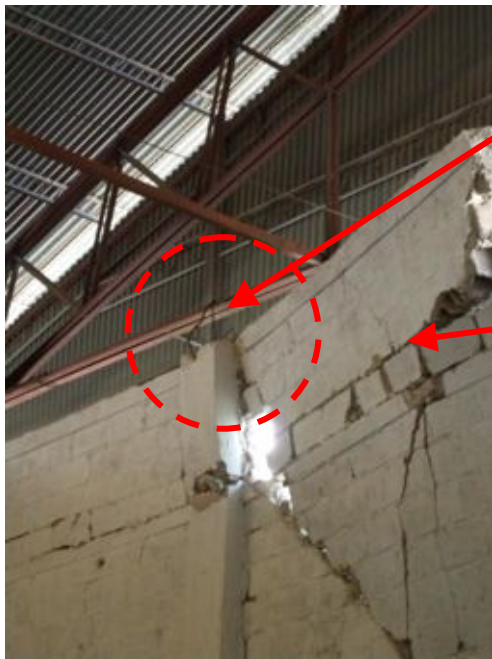
Figure 16 Close up view of nearly collapsed rear warehouse portion. Note how the wall column reinforcement bars have been crudely hooked over the truss bottom chord, nearly pulling the roof down.
