# Geotechnical Aspects of the M = 8.8 February 27, 2010 Chile Earthquake

*Jonathan Bray, UC Berkeley; David Frost, Georgia Tech;  
Ramon Verdugo, Universidad de Chile; Christian Ledezma, Pontificia  
Universidad Catolica de Chile; & Terry Eldridge, Golder Assoc.*

# M = 8.8 Chile Earthquake

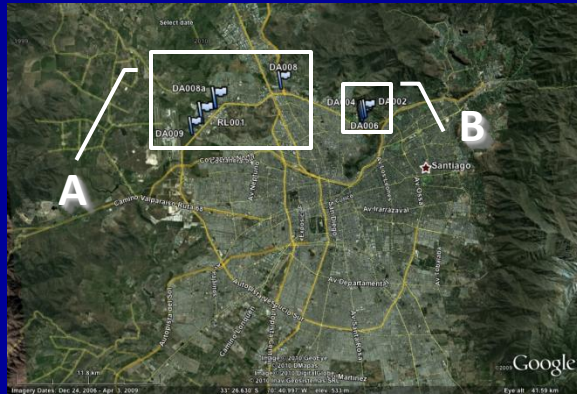
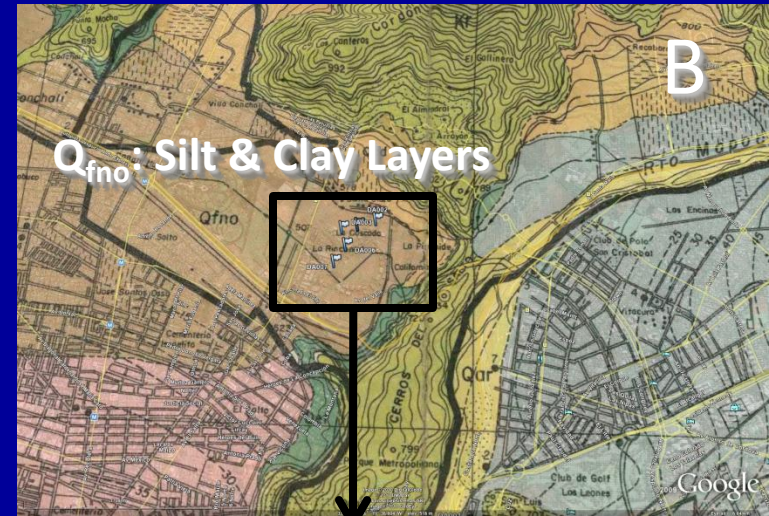
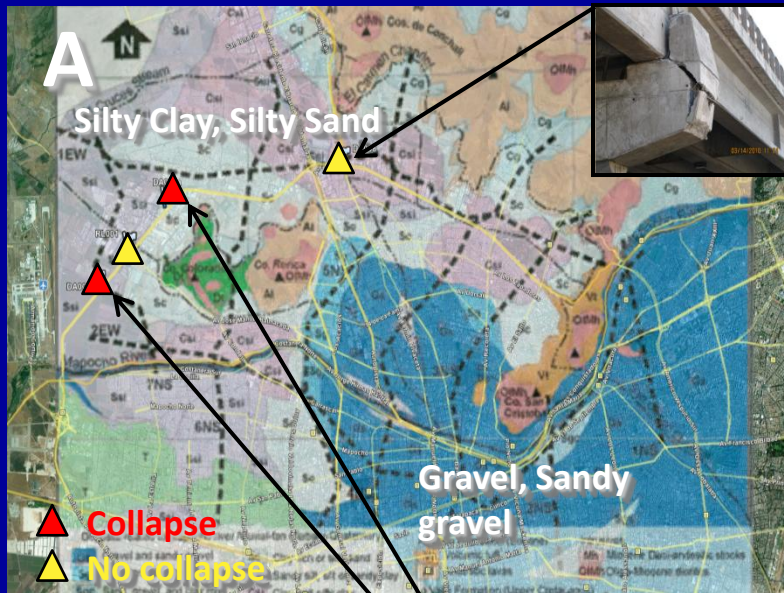
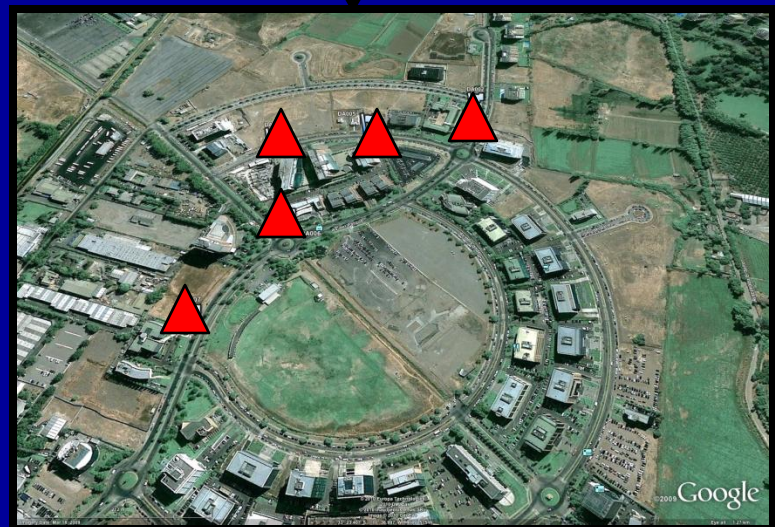
# Site Effects: Vespucio Norte & Ciudad Empresarial

Localized Damage – Site Effects?

H/V peaks: 0.5-2sec (Bonnefoy et al, 2008)  
Damage to 5 to 20-story buildings

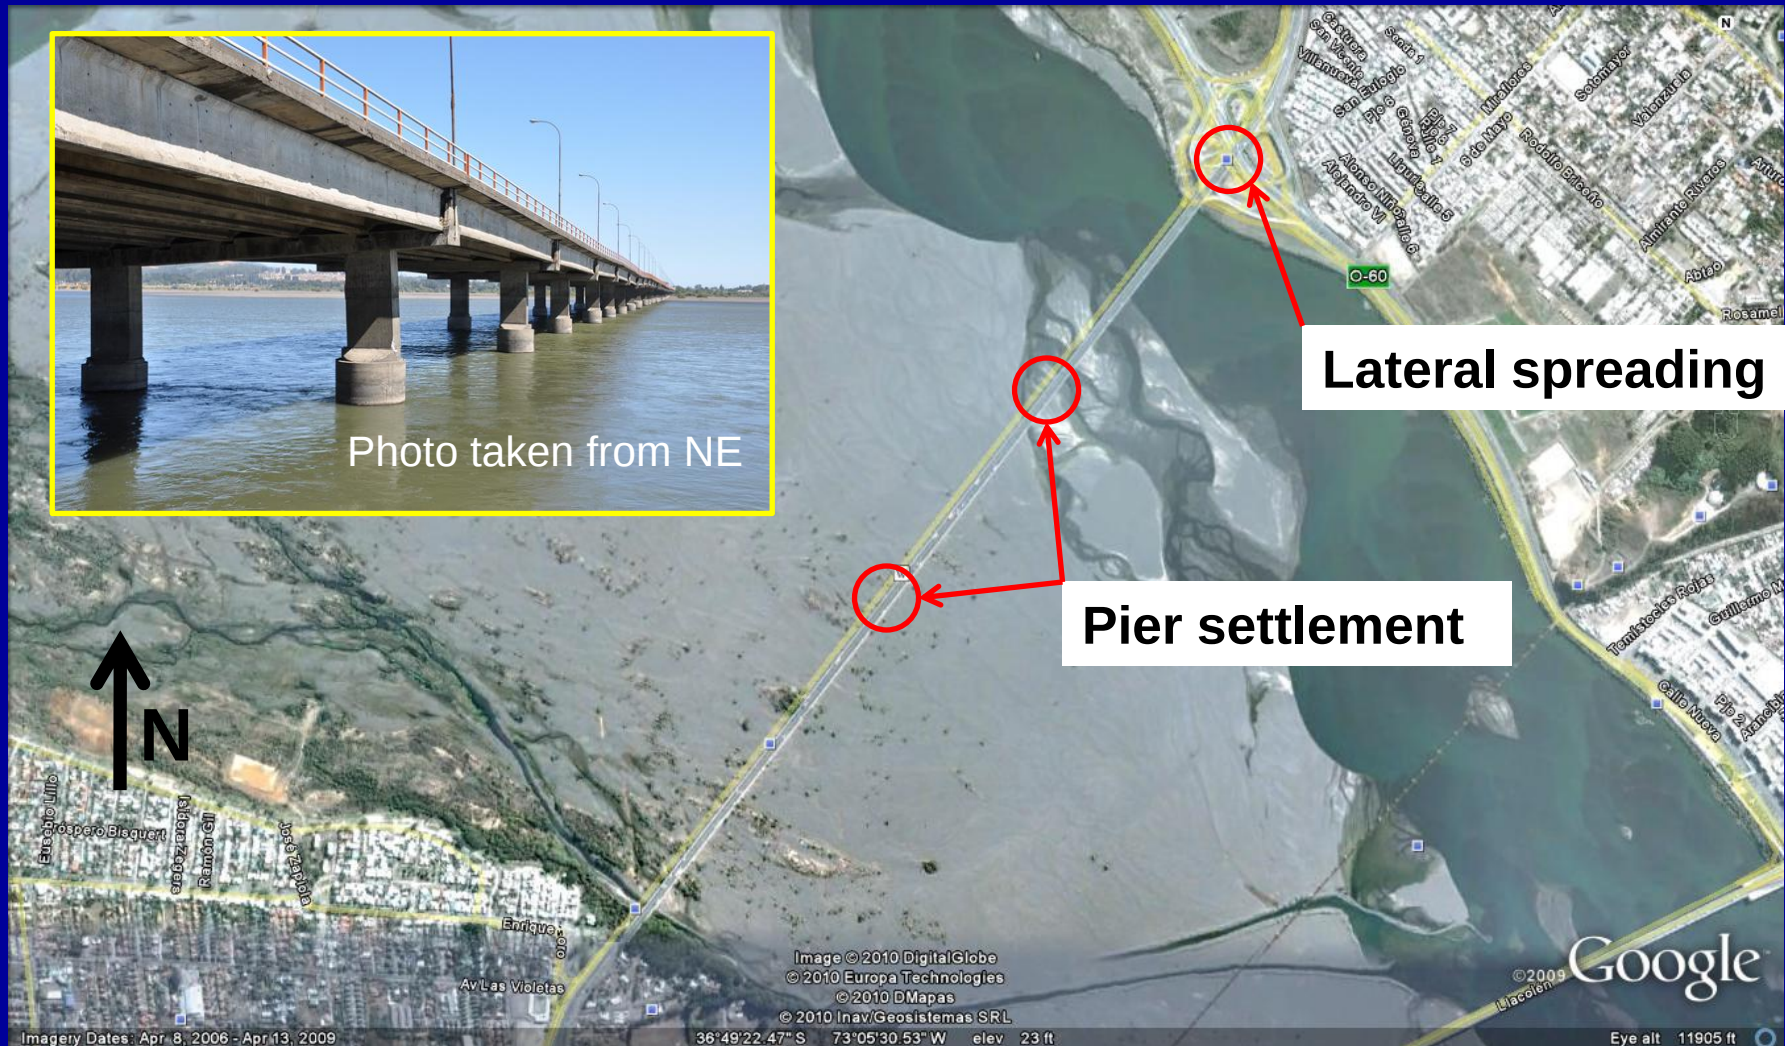
# Juan Pablo II Bridge, Concepción

Bent damage due to lateral spreading on NE approach  
Liquefaction-induced pier settlements along bridge span

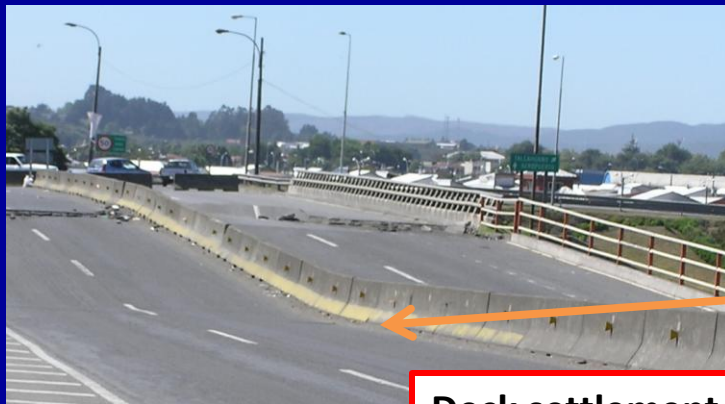
Lateral spreading and bridge bent damage on NE approach

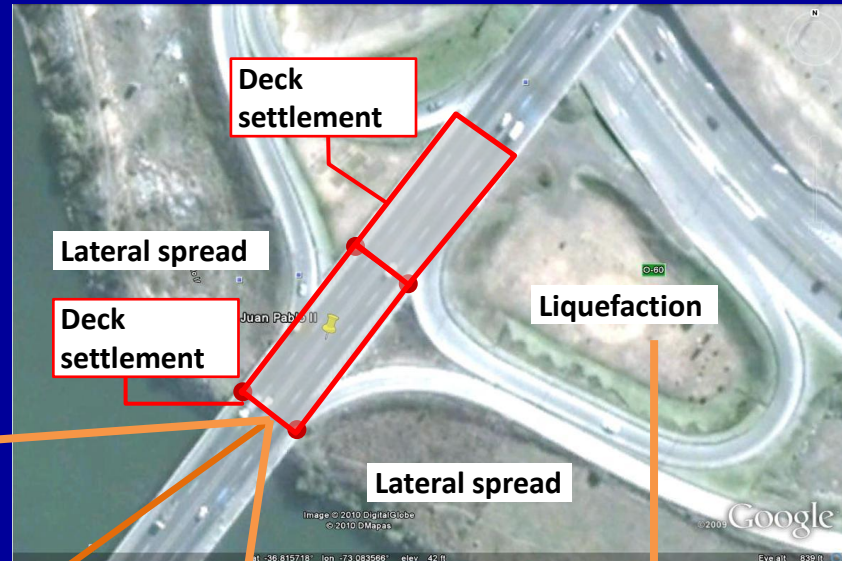
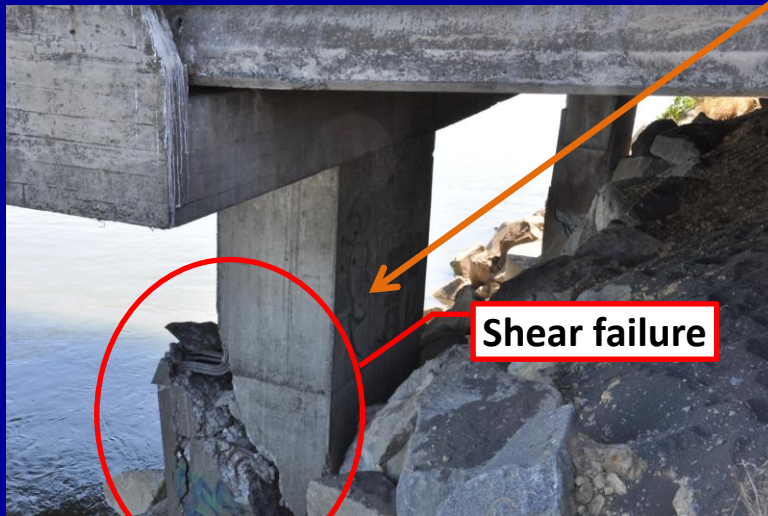
Deck settlement

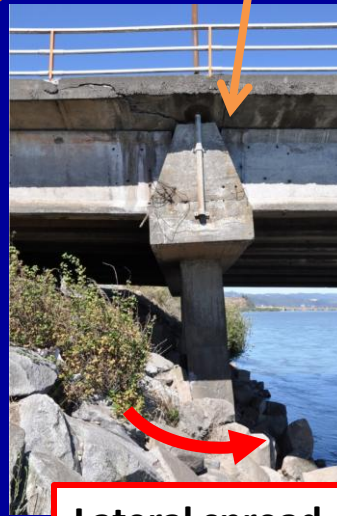
Shear failure

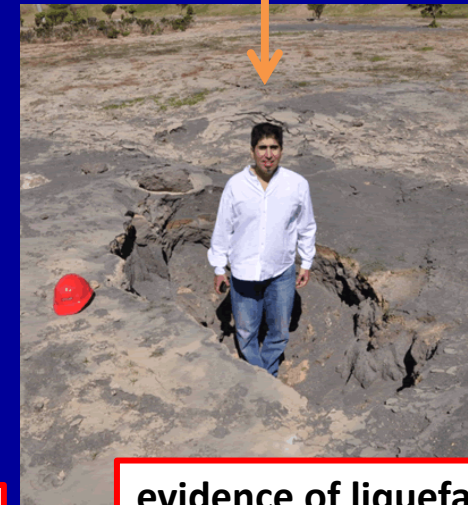
Lateral spread

evidence of liquefaction

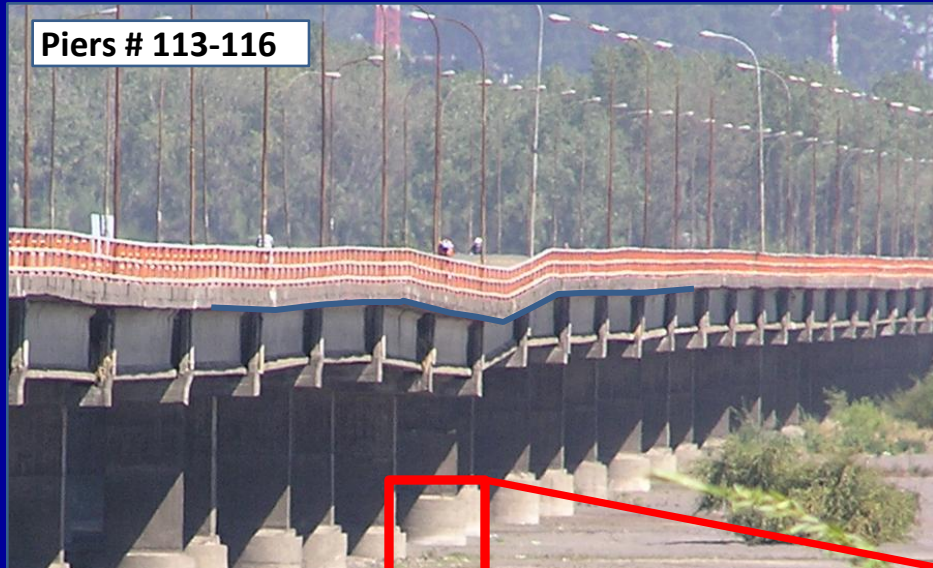
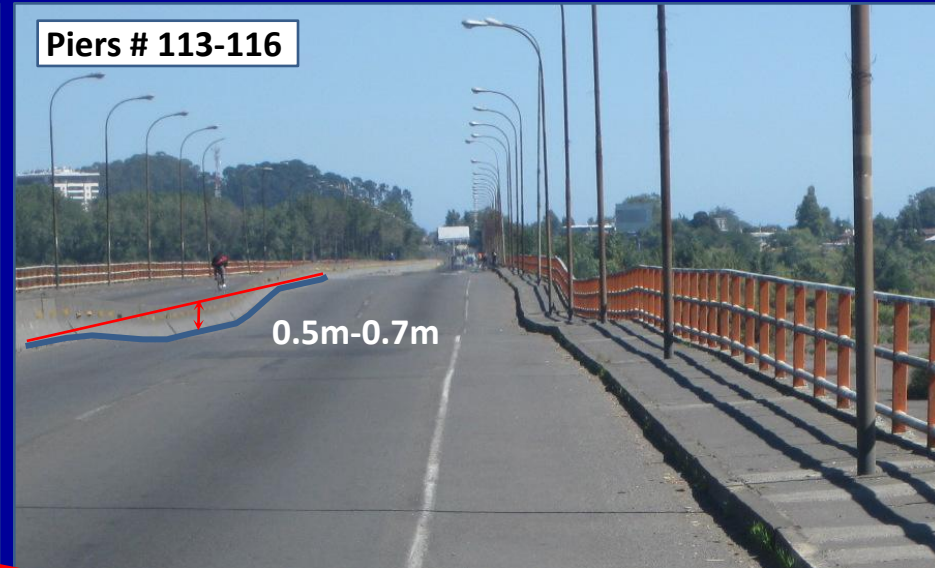
## Liquefaction-induced pier settlements along bridge span

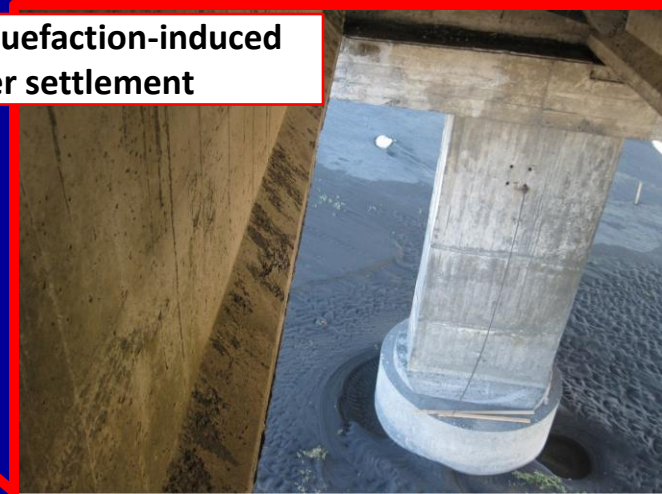
### Liquefaction-induced pier settlement

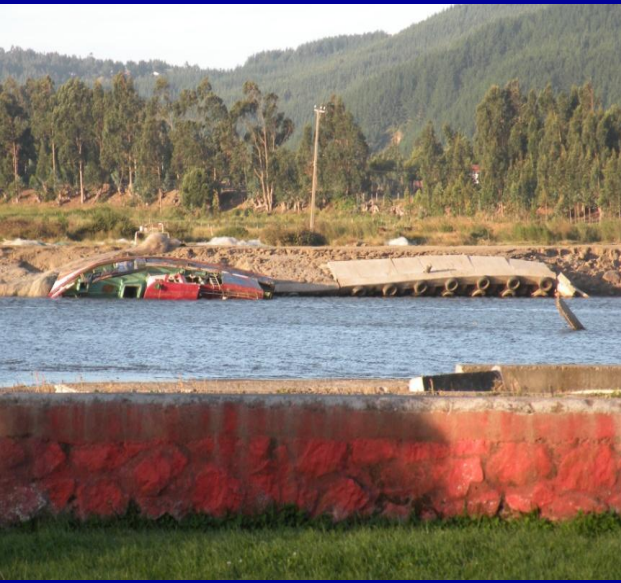
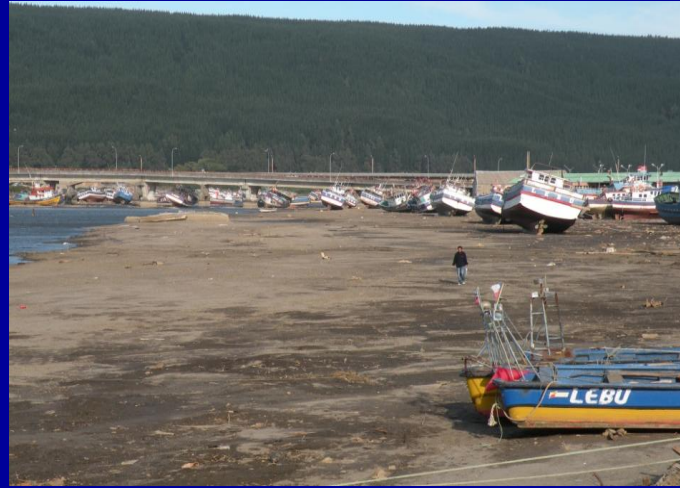
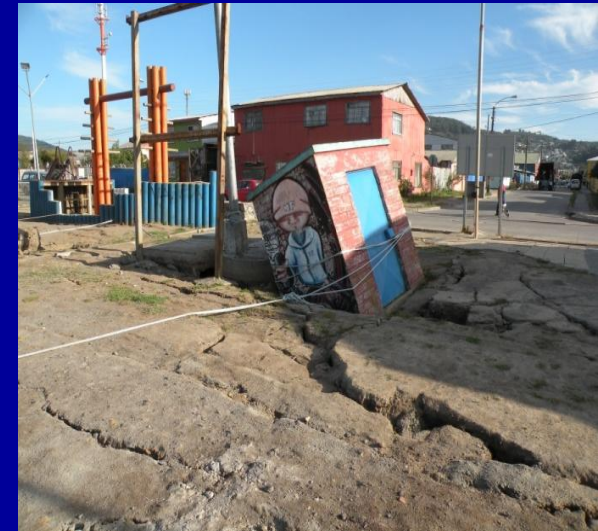
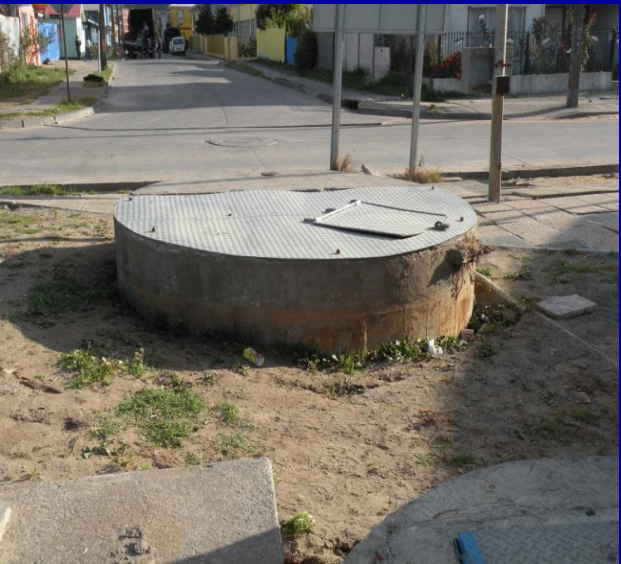
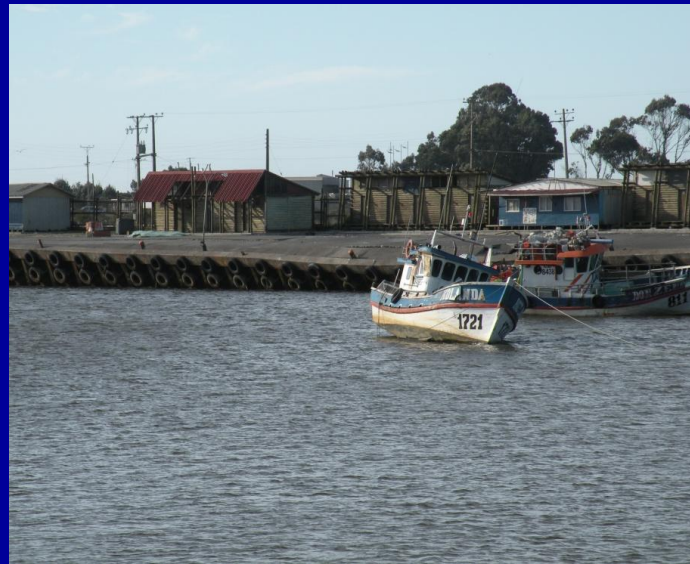
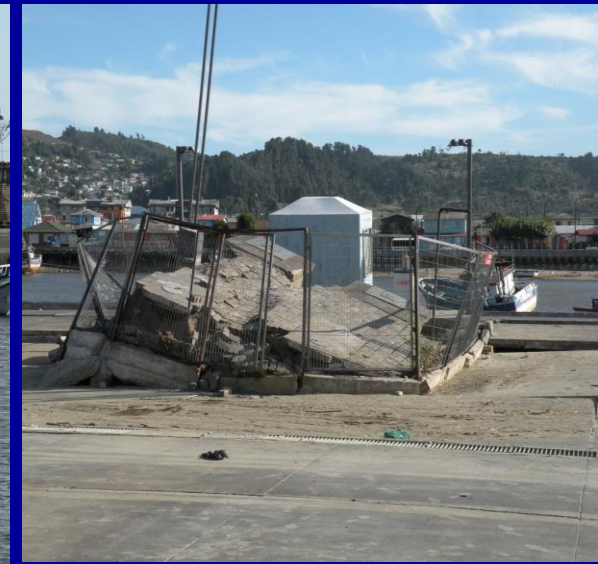
# Lebu (Fishing Port & Village)

Uplift (~2m), quay wall failure, liquefaction – fishing industry devastated

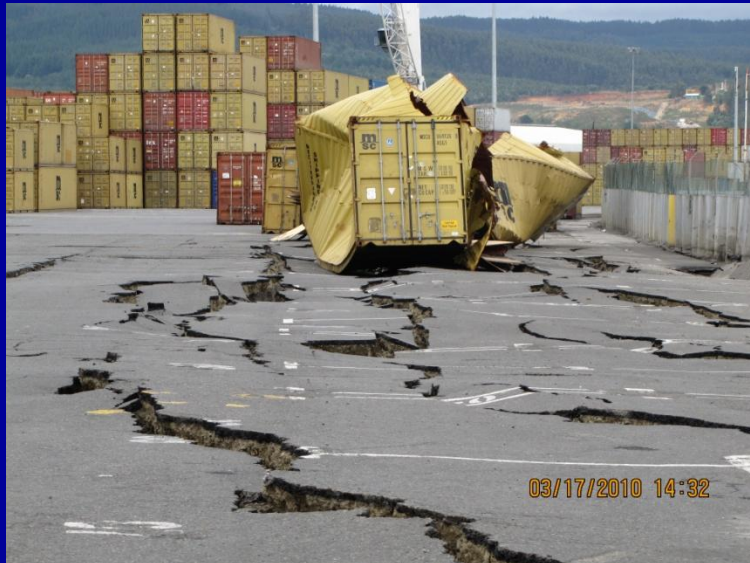
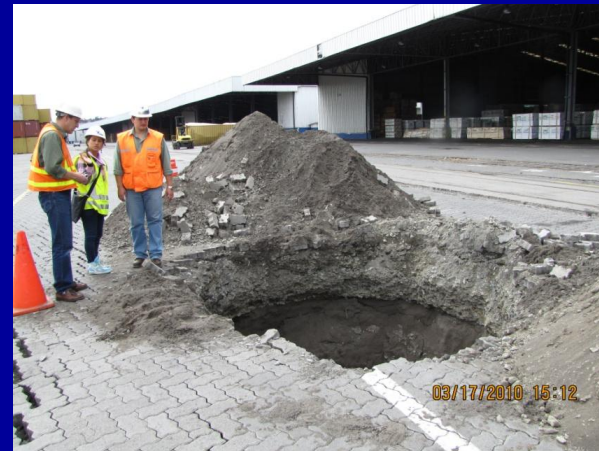
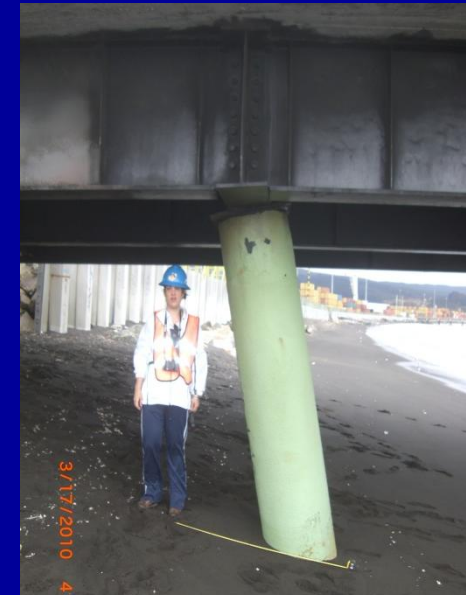
Coronel : a) Lateral Spreading/Settlement, b) Sediment Ejecta/Sinkholes, & c) Pile Damage

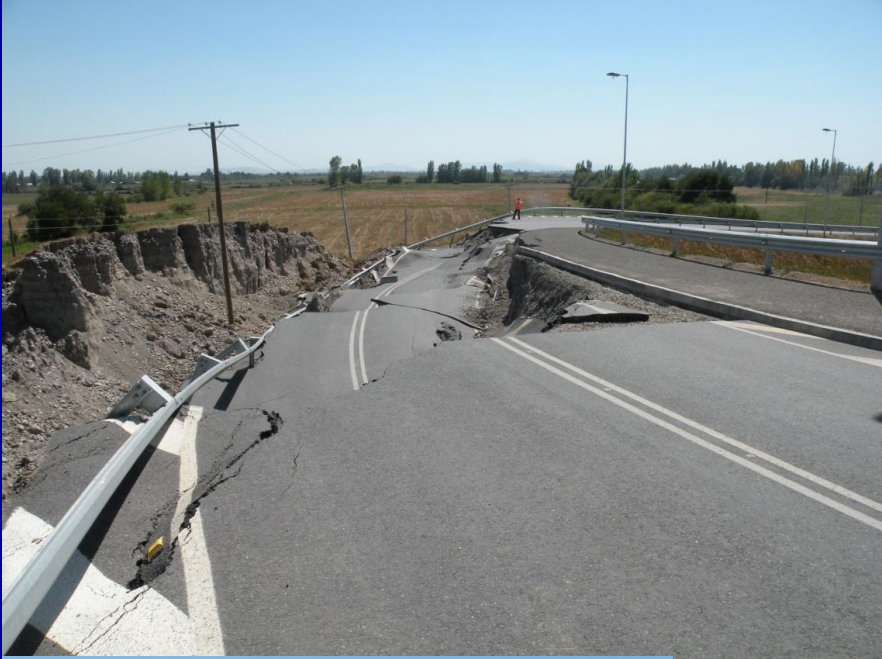
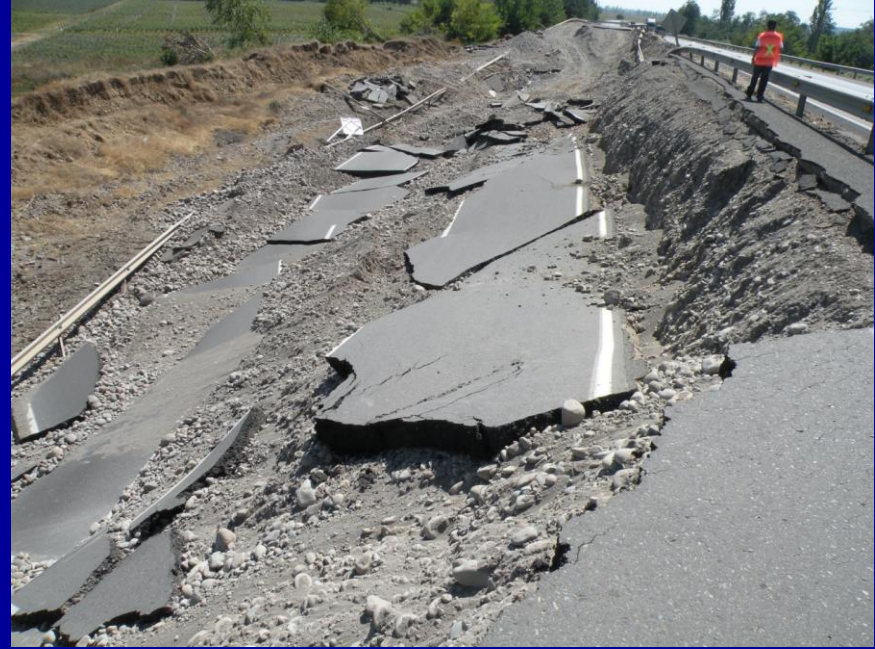
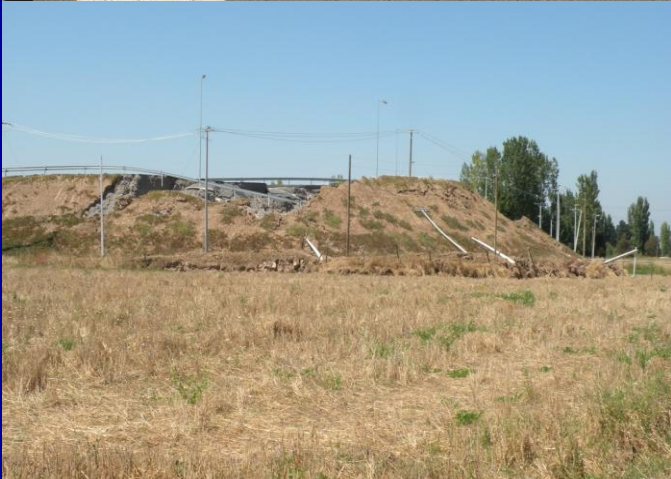
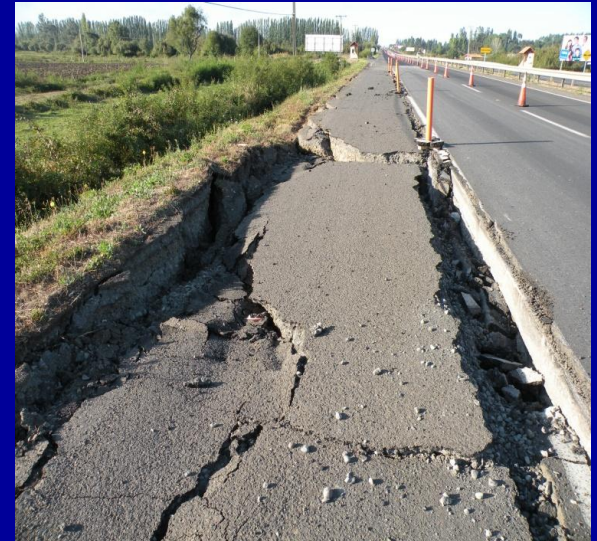
# Embankment Failures along Highway 5

Possible liquefaction of thin seams in foundation soils led to translational failures of highway embankments

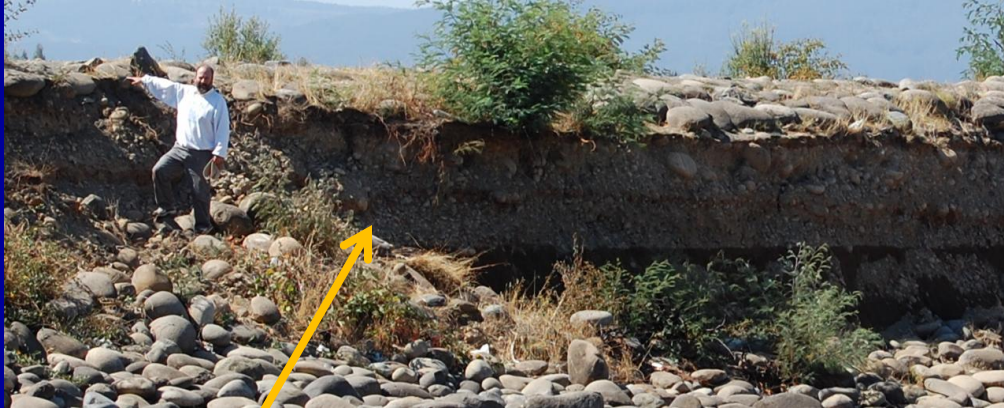
## Coihueco Zoned Earth Dam Upstream Slope Failure

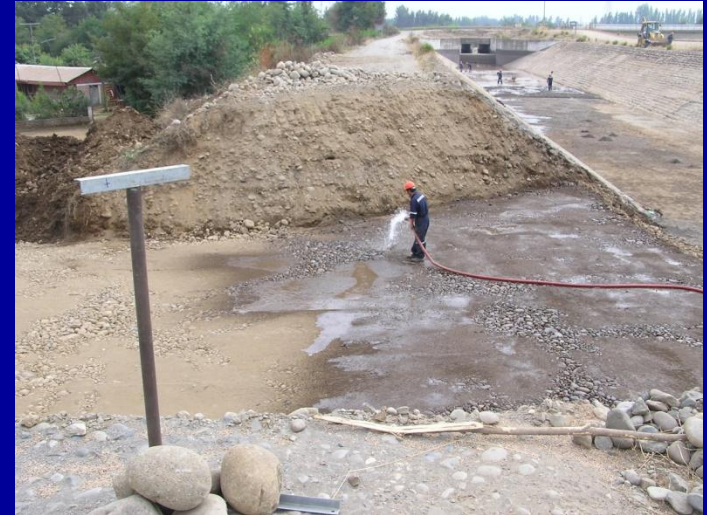
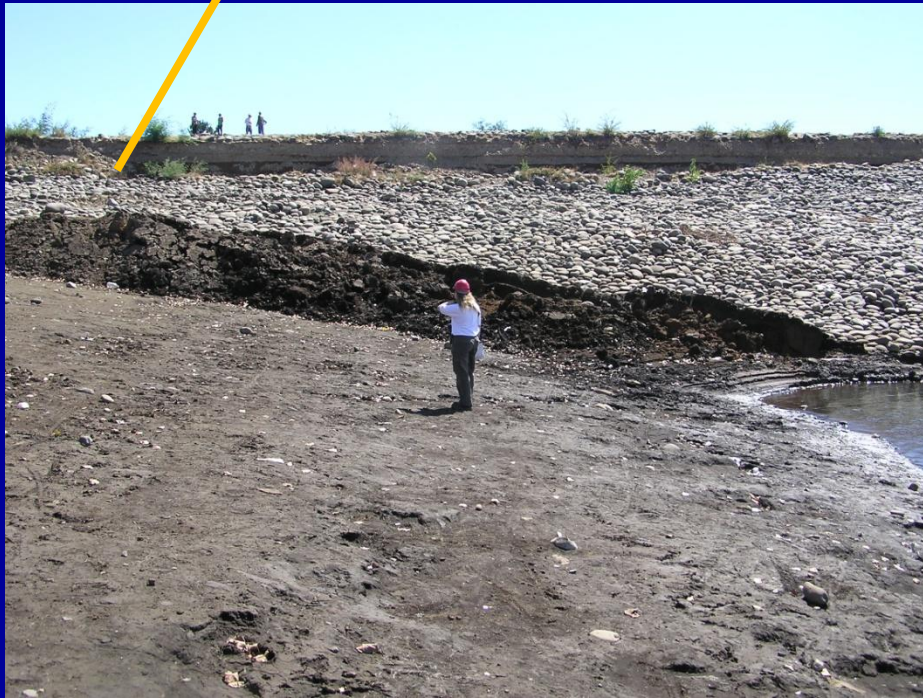
## Levee Breach

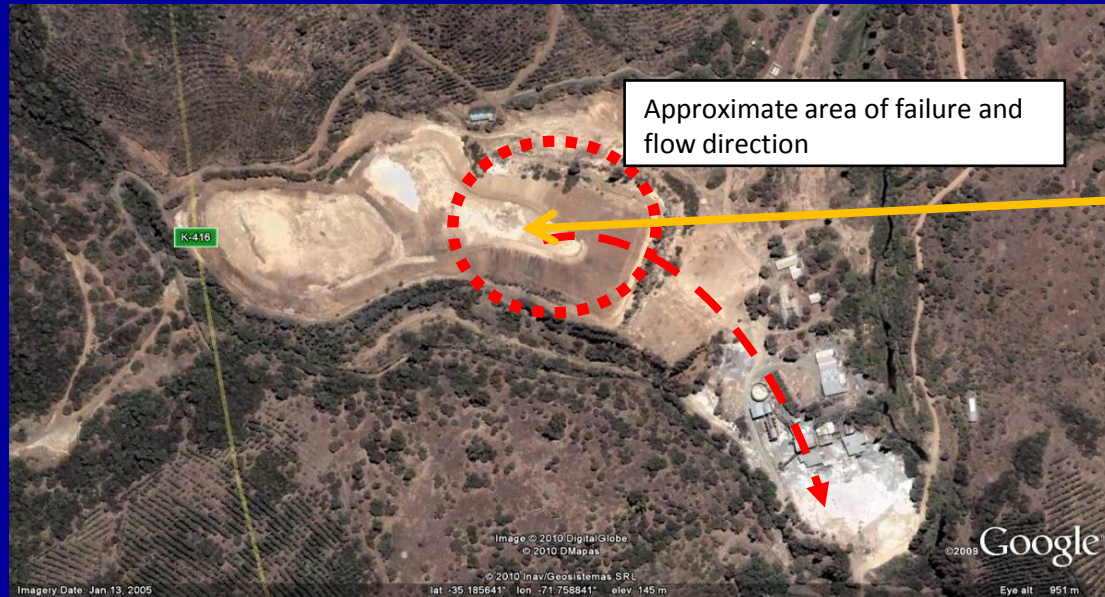
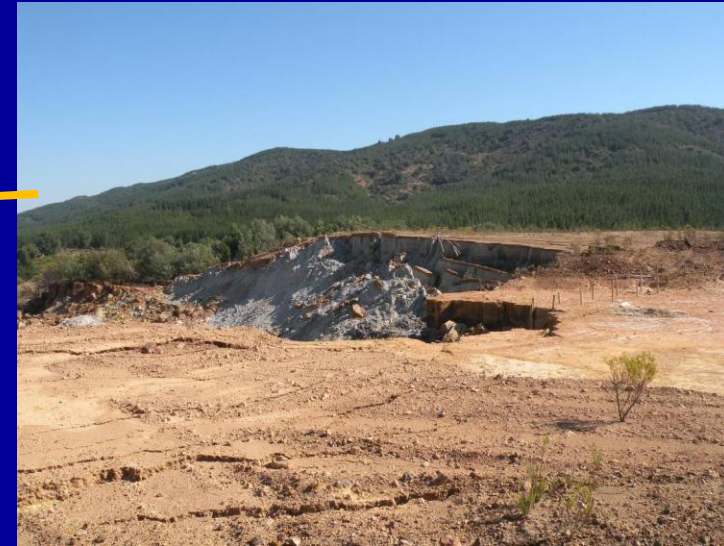
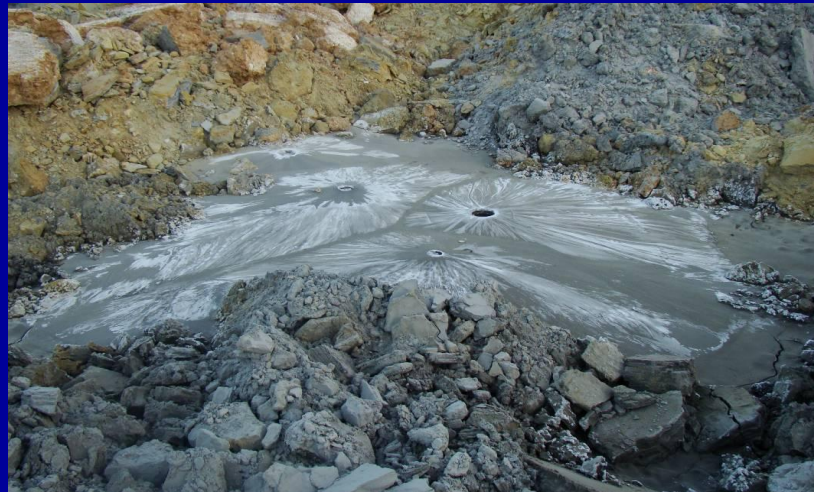
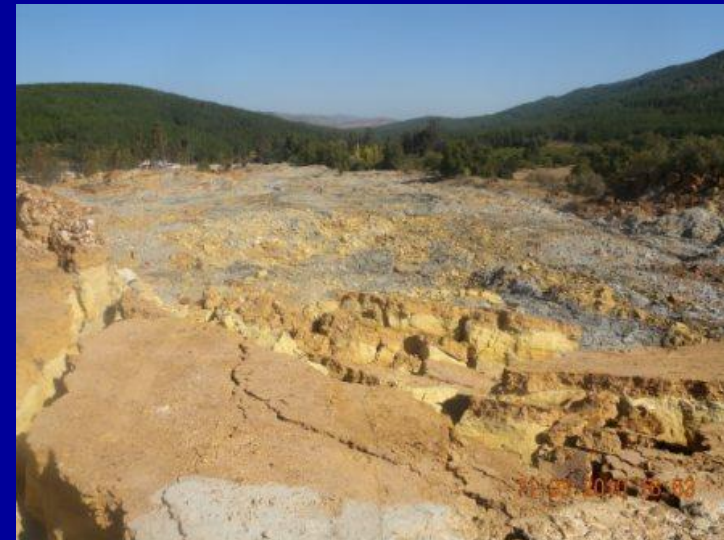
## Las Palmas Tailings Dam Failure
