CHILE RECOVERS FROM 2010 M8.8 EARTHQUAKE

MRP Engineering Bulletin

February 2011

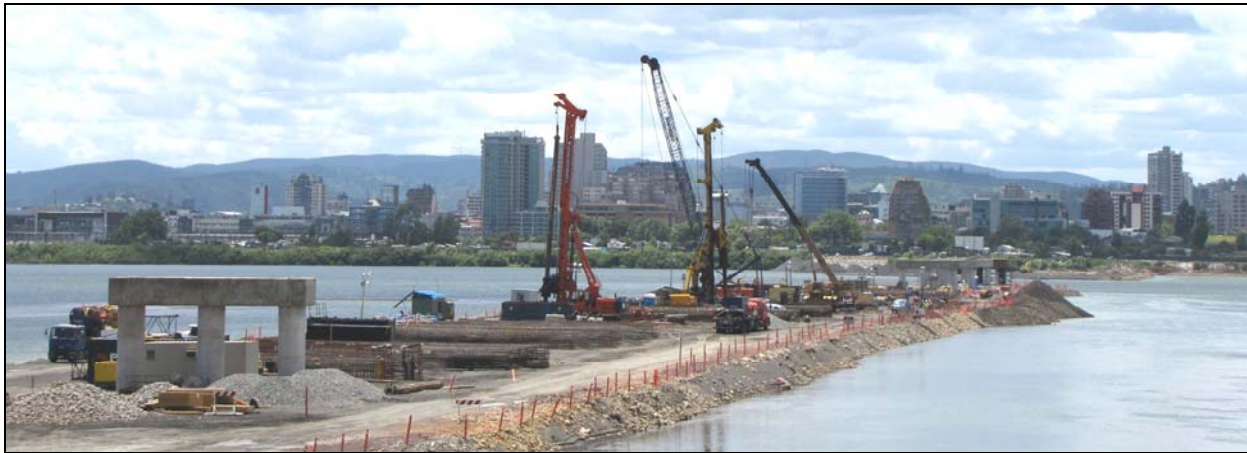
December 2010: Construction is in progress on a new highway bridge over the Bío-Bío River in Concepción. This crossing will replace a bridge damaged by the earthquake. The city skyline (background) includes a number of vacant residential towers.

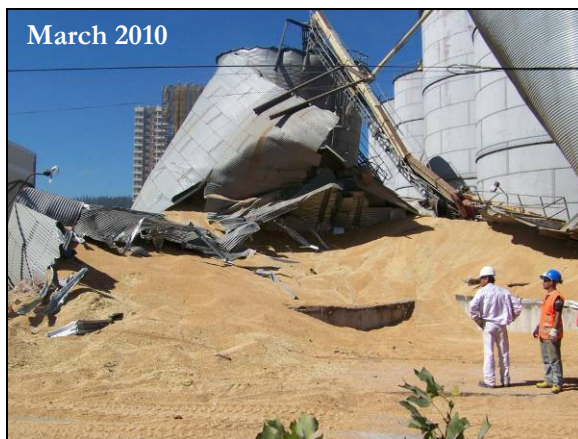
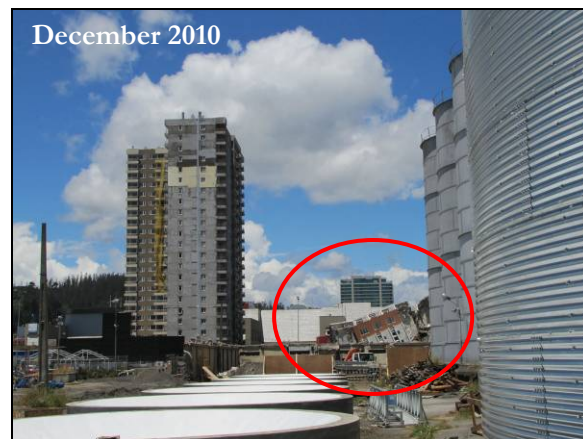
Concepción City Center: Collapsed grain bins have been removed but not yet replaced as shown in these two images taken in March and December of 2010. The 20-story residential tower in the background remains vacant. The right photograph includes the toppled Rio Alto tower (in the circle) which is still under investigation.

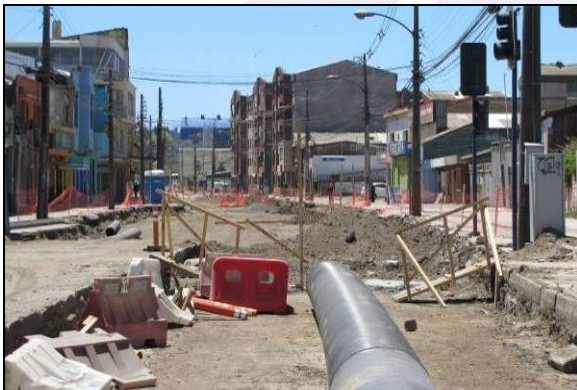
Street and utility reconstruction in Talcahuano city center is evident throughout the low-lying areas of this community.

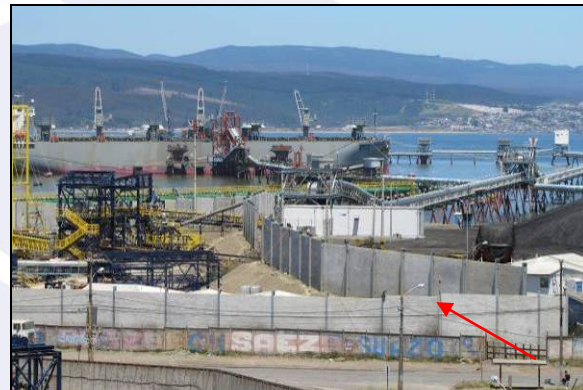
Low-lying areas of Port of Coronel (south of Concepción) are surrounded by newly constructed flood walls.

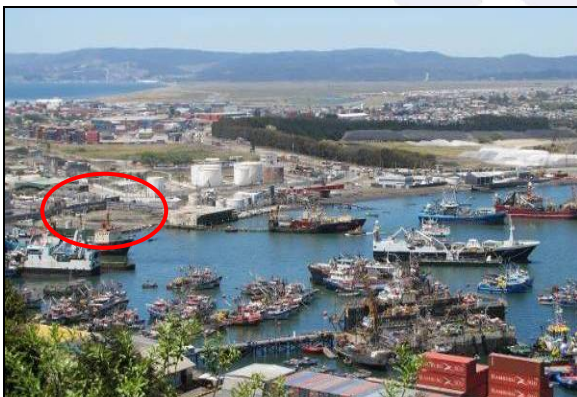
San Vicente Bay's industrial zone is recovering. A fish-processing plant (circled area) has been demolished.

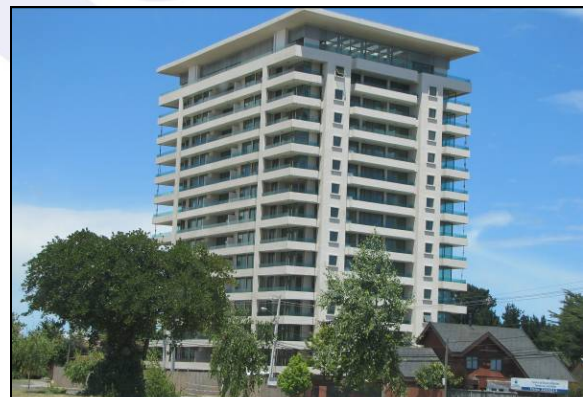
Damaged condominium tower in San Pedro still stands vacant. Corner balconies remain shored up.

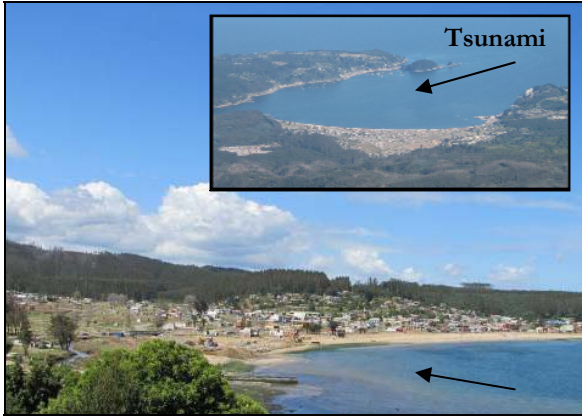
Panoramic view of the Dichato waterfront community devastated by the tsunamis that followed the earthquake

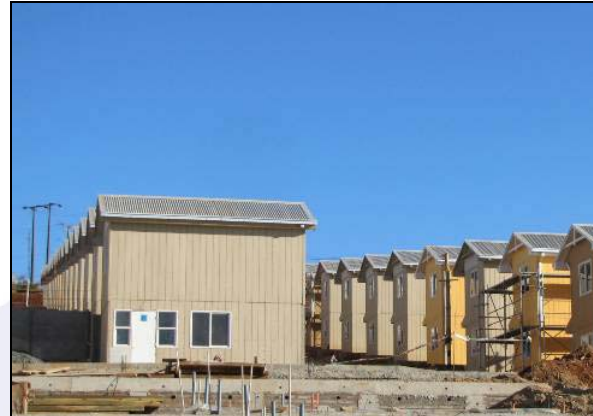
Fast-track community of wood-framed housing for residents displaced by tsunamis

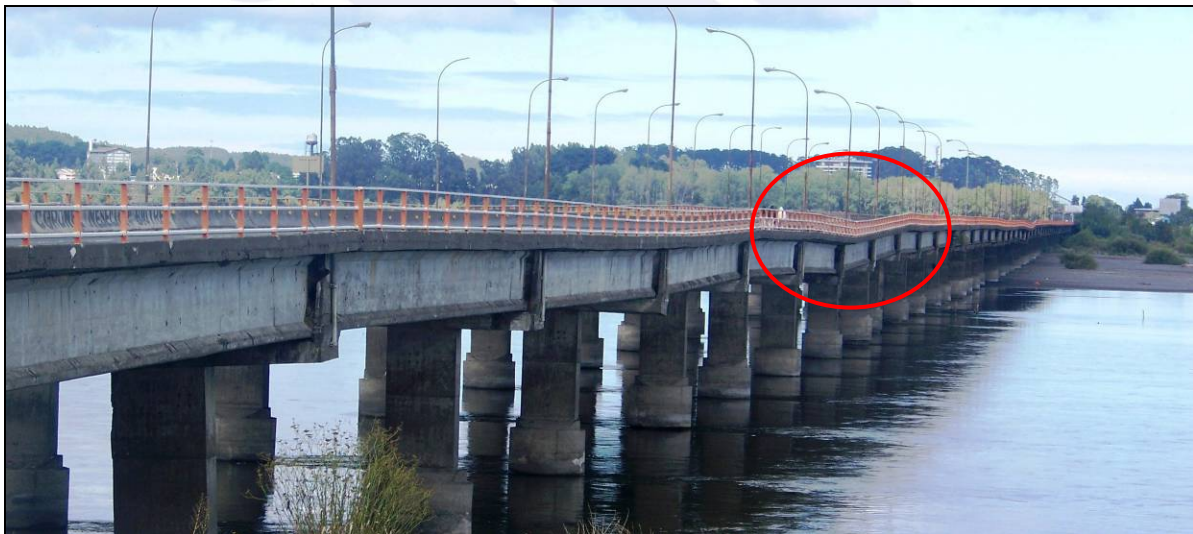
Juan Pablo II Bridge damaged in the February earthquake was restored to service in October 2010. This photo from March 2010 illustrates some of the bridge foundation damage as evidenced by the sagging roadway.

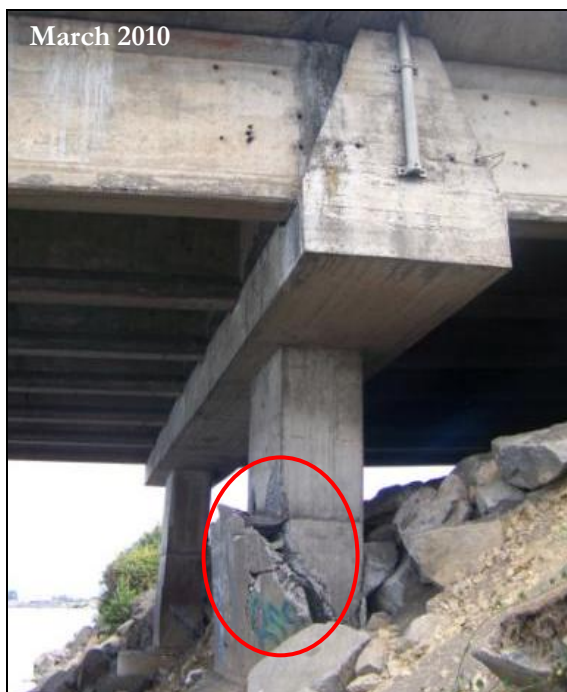
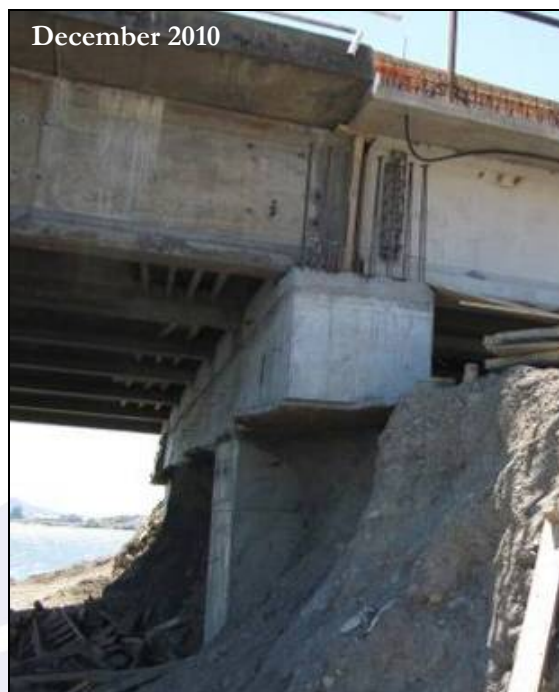
The photo on the left shows Juan Pablo II Bridge fractured column caused by soil liquefaction and lateral spreading along the Bío-Bío riverbank. The photo on the right depicts the new bridge girder and columns.
