27 February 2010 M_w 8.8 Maule Earthquake

Discussion on Pre 1985 and Post 1996 Reinforced Concrete Buildings in Viña del Mar

Alvaro Celestino
EERI Recon Team Member (Concrete Buildings sub-team)
Degenkolb Engineers

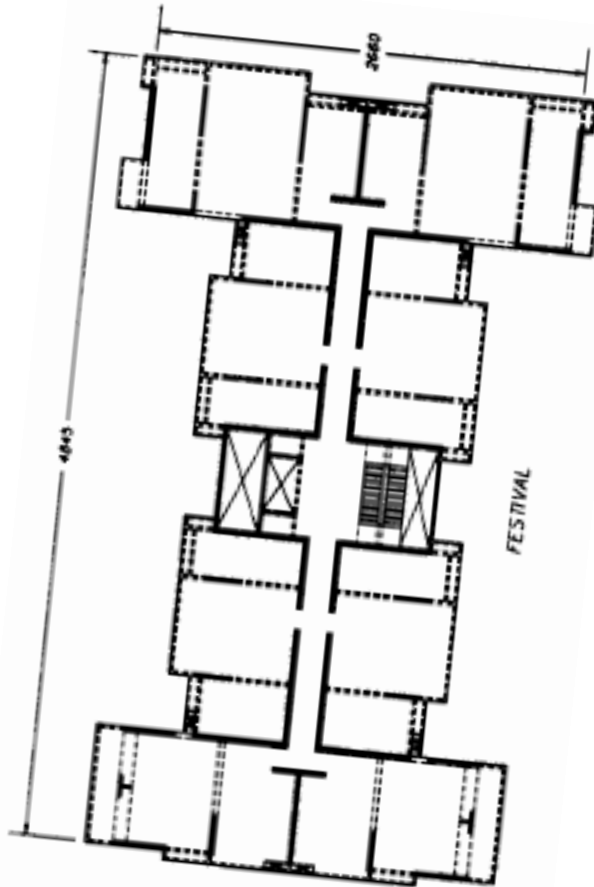
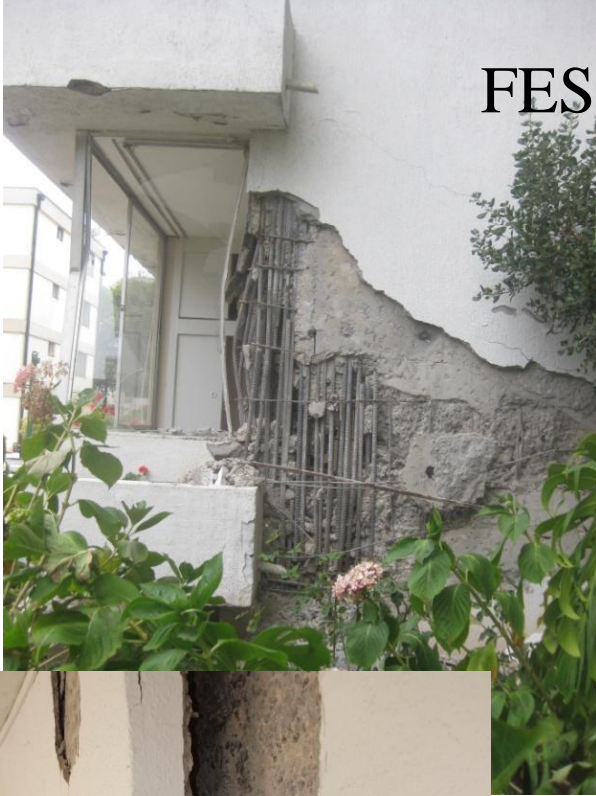
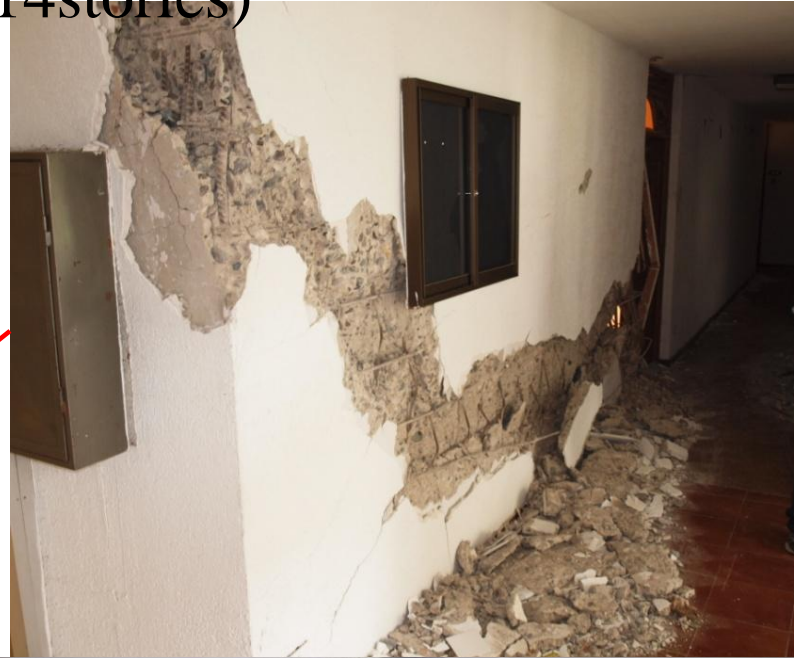
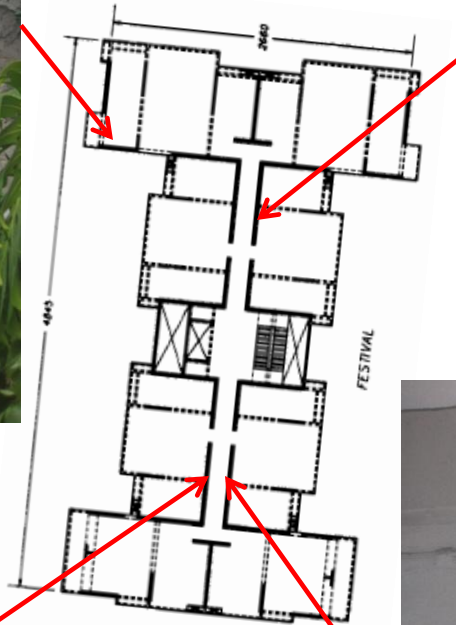
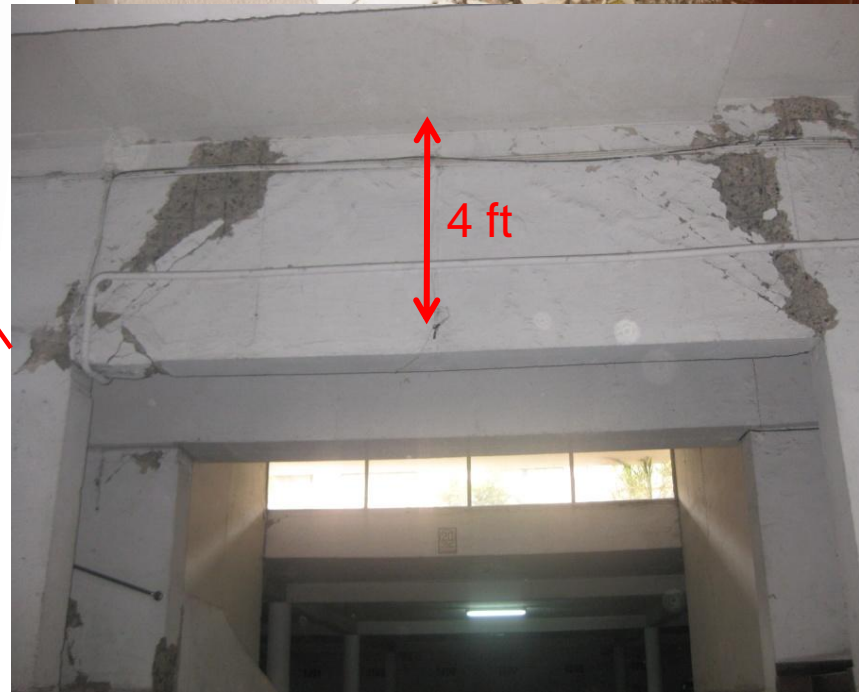
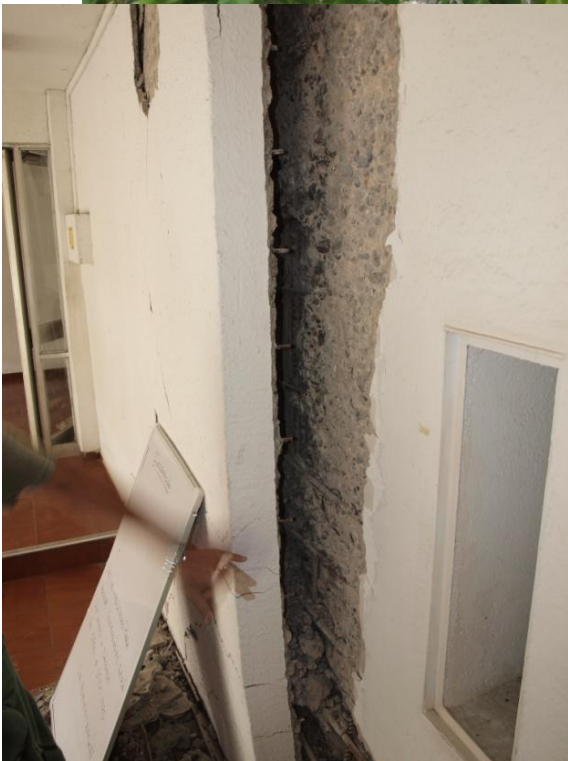
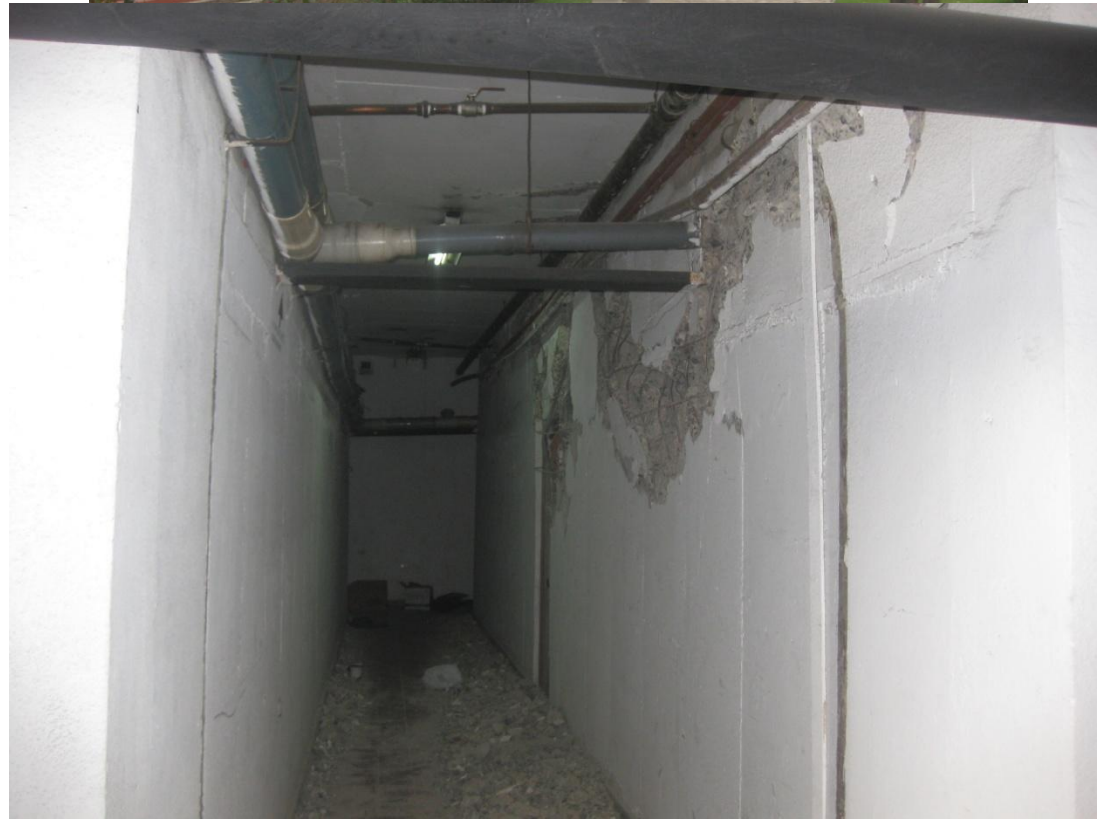
FESTIVAL (1979 – 14stories)

1985 Damage: Diagonal cracking in N-S walls on 1st, 2nd floors.

Damage 2010: Severe crushing, rebar buckling, rebar fracture on N-S and E-W walls

Retrofit Scheme: damaged walls sandwiched with 4" thk. (N) R.C. walls.

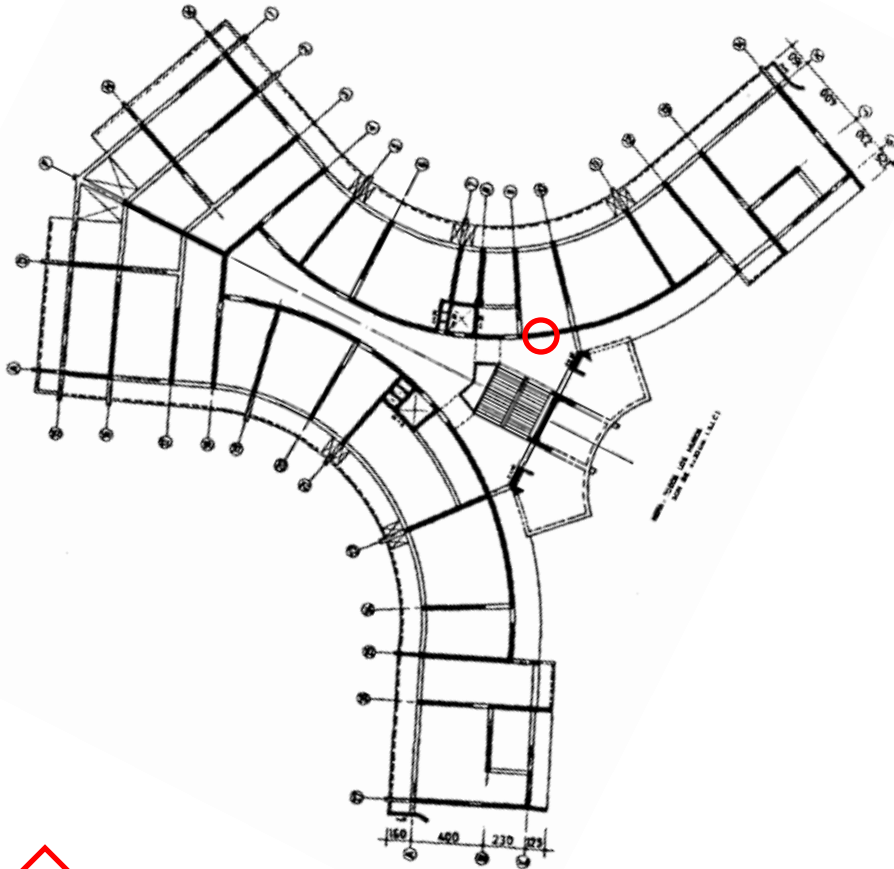
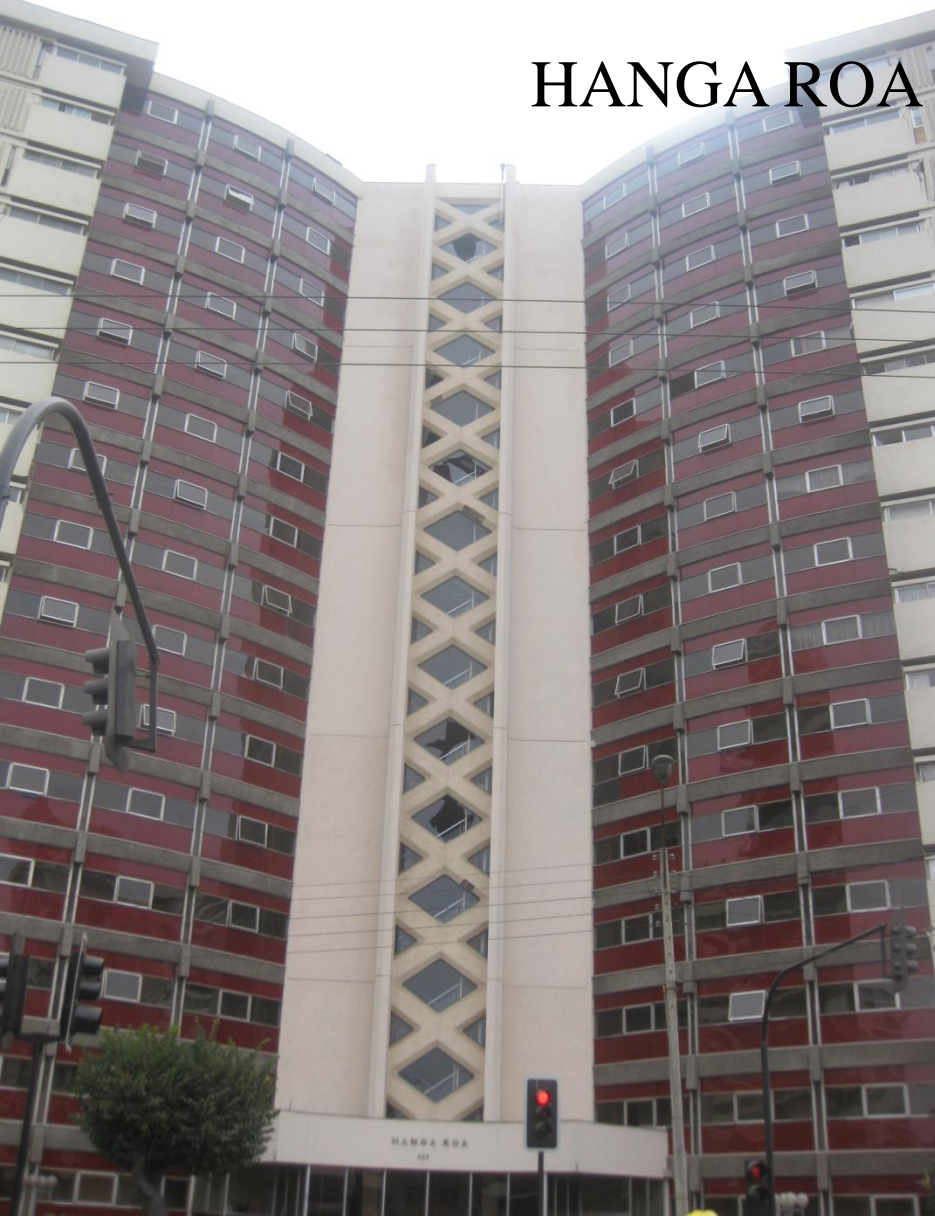
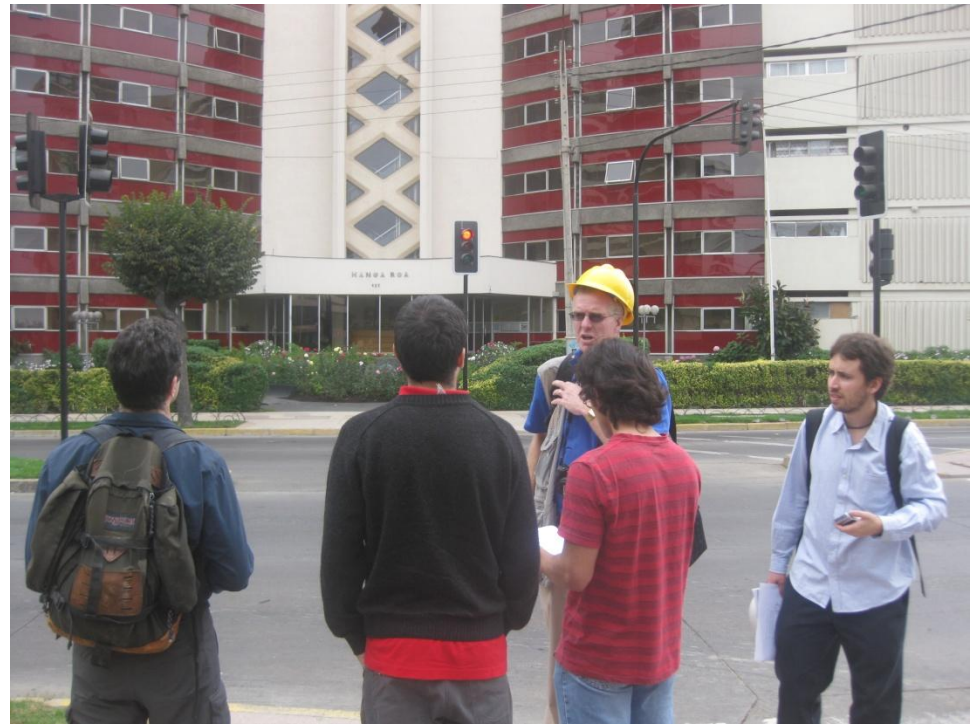
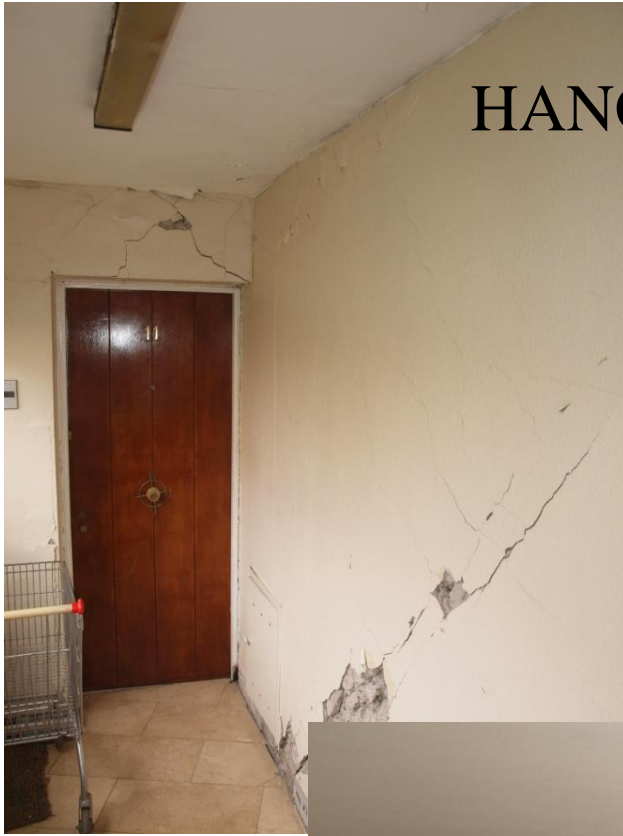
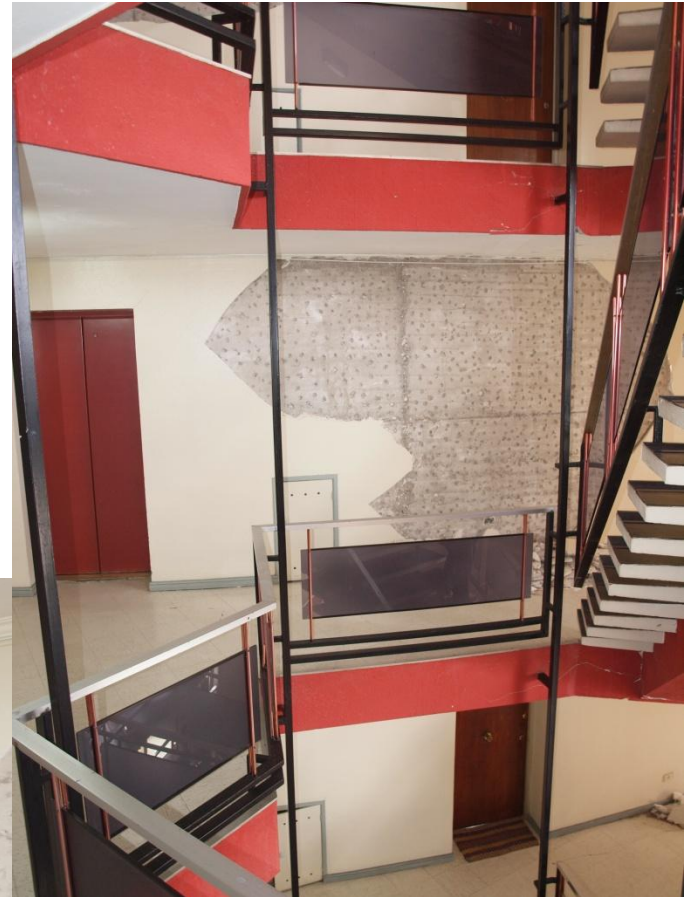
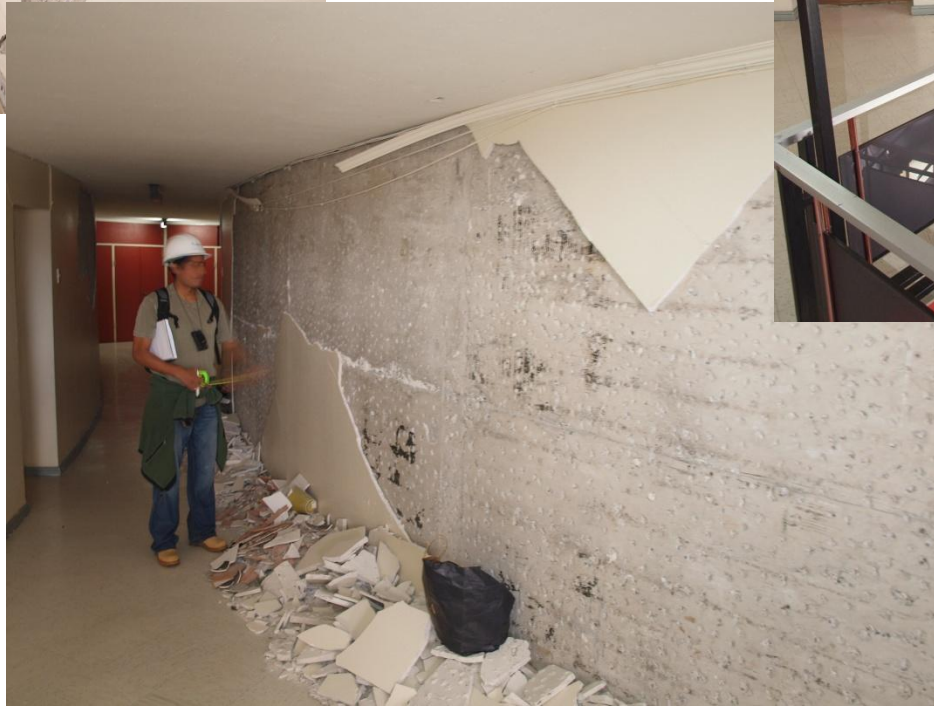
HANGA ROA (1970 – 15stories)

1985 Damage: 1-foot wide full-height vertical crack in one shear wall.

Damage 2010: Diagonal cracking, minor plaster spalling

Retrofit Scheme: possibly (N) thicker wall was poured.

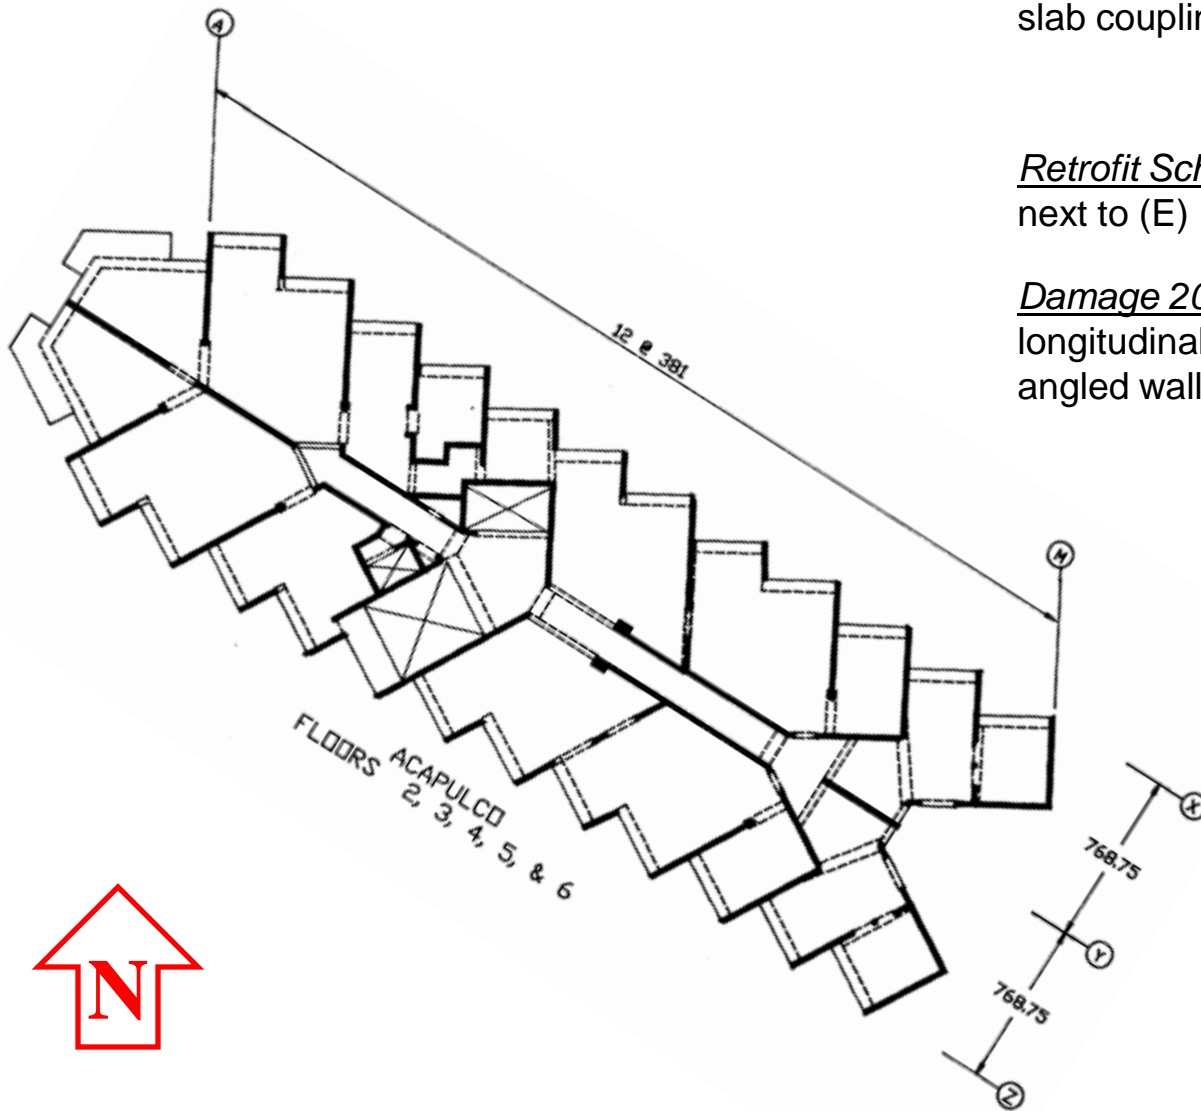
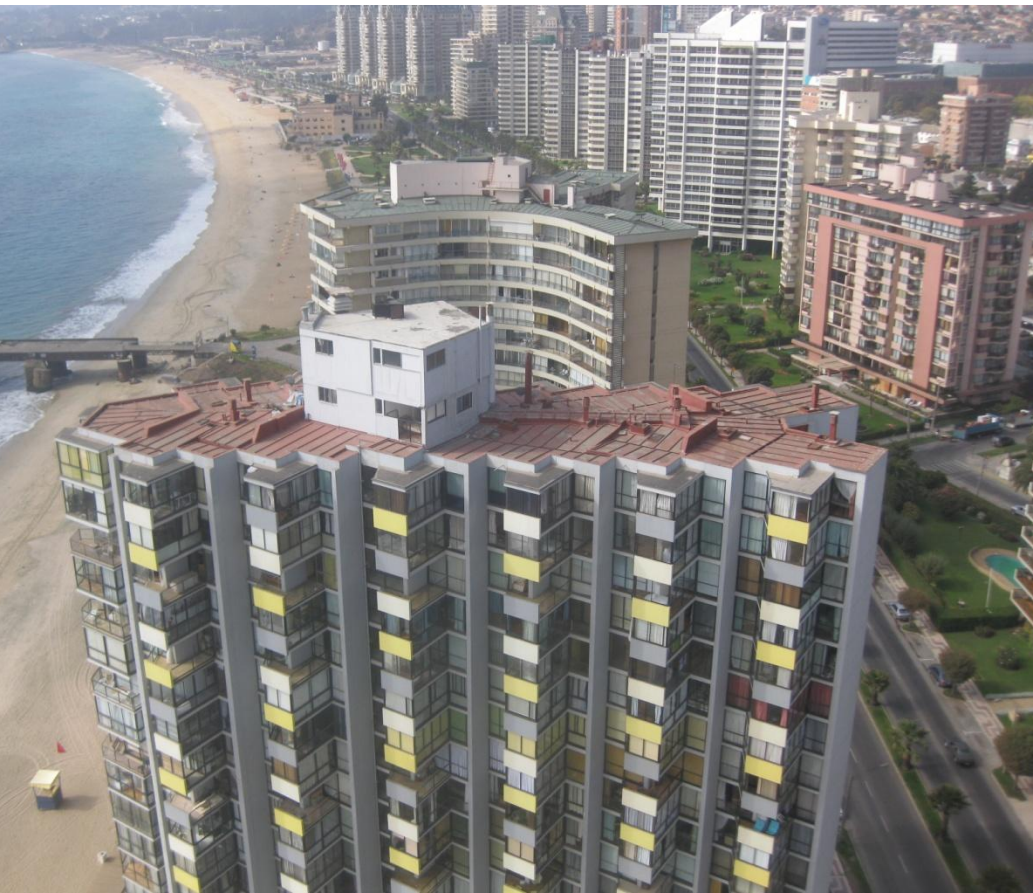
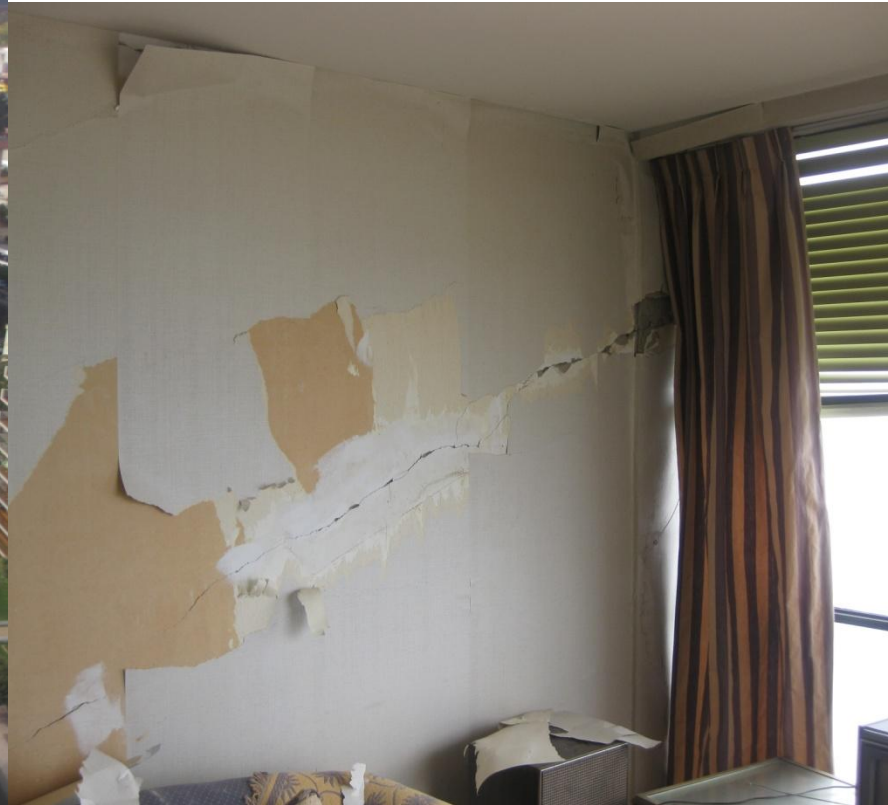
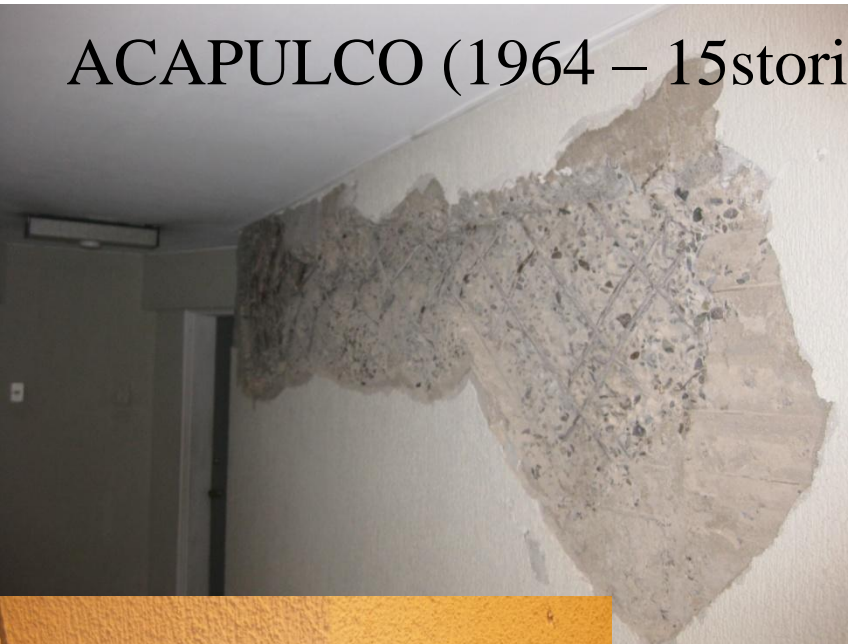
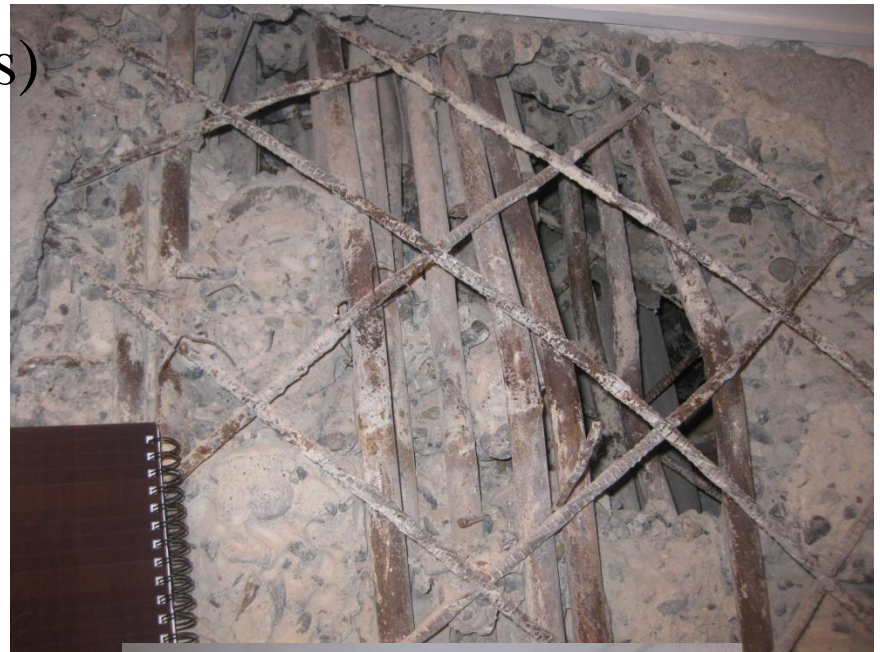
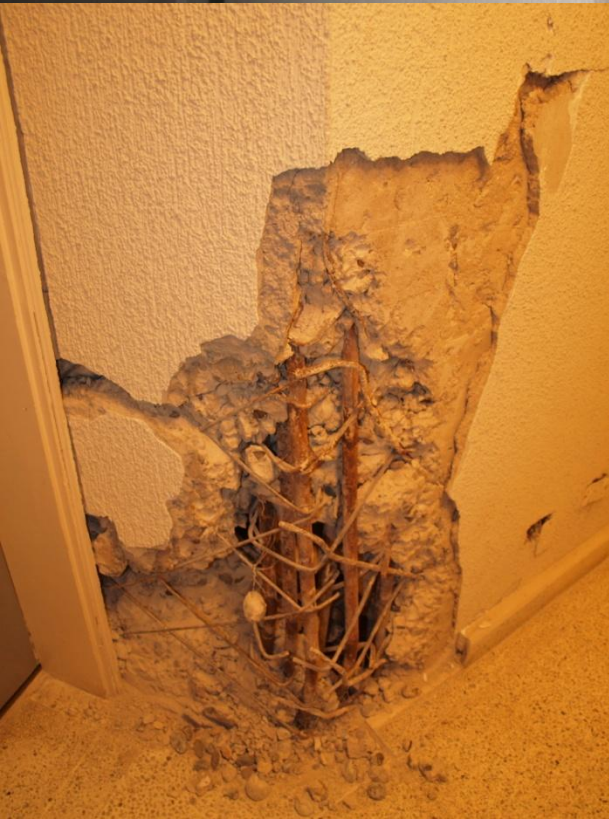
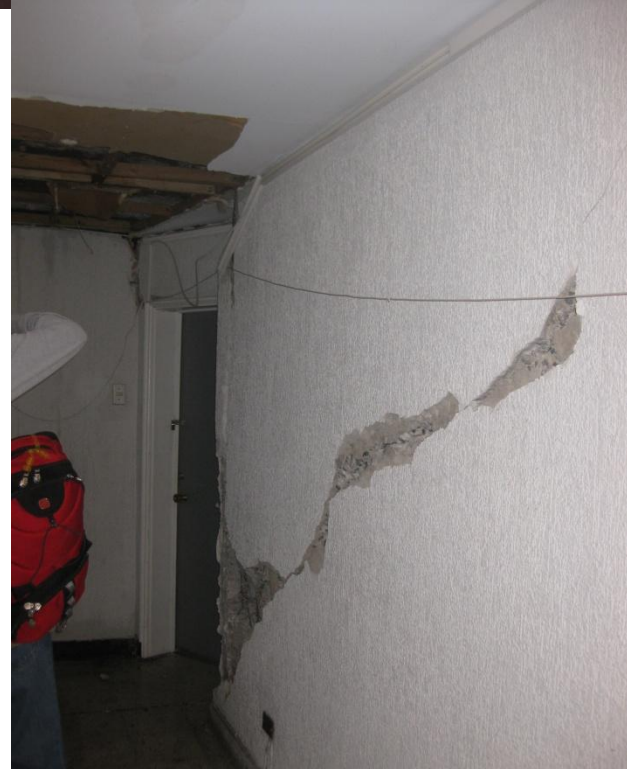
ACAPULCO (1964 – 15stories)

1985 Damage: shear walls angled from corridor crushed at boundaries; slab coupling; slip at construction joints

Damage 2010: Severe crushing/buckling at longitudinal shear walls. Diagonal cracks in angled walls.

Retrofit Scheme: (N) walls were poured next to (E) in some locations.

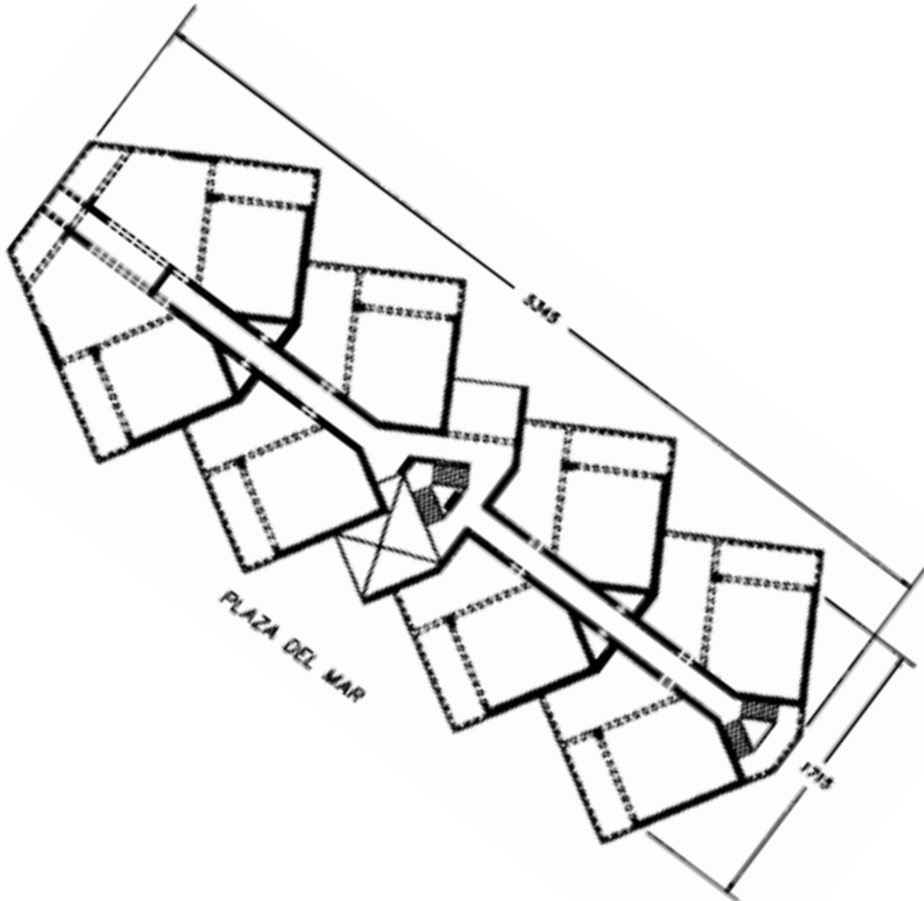
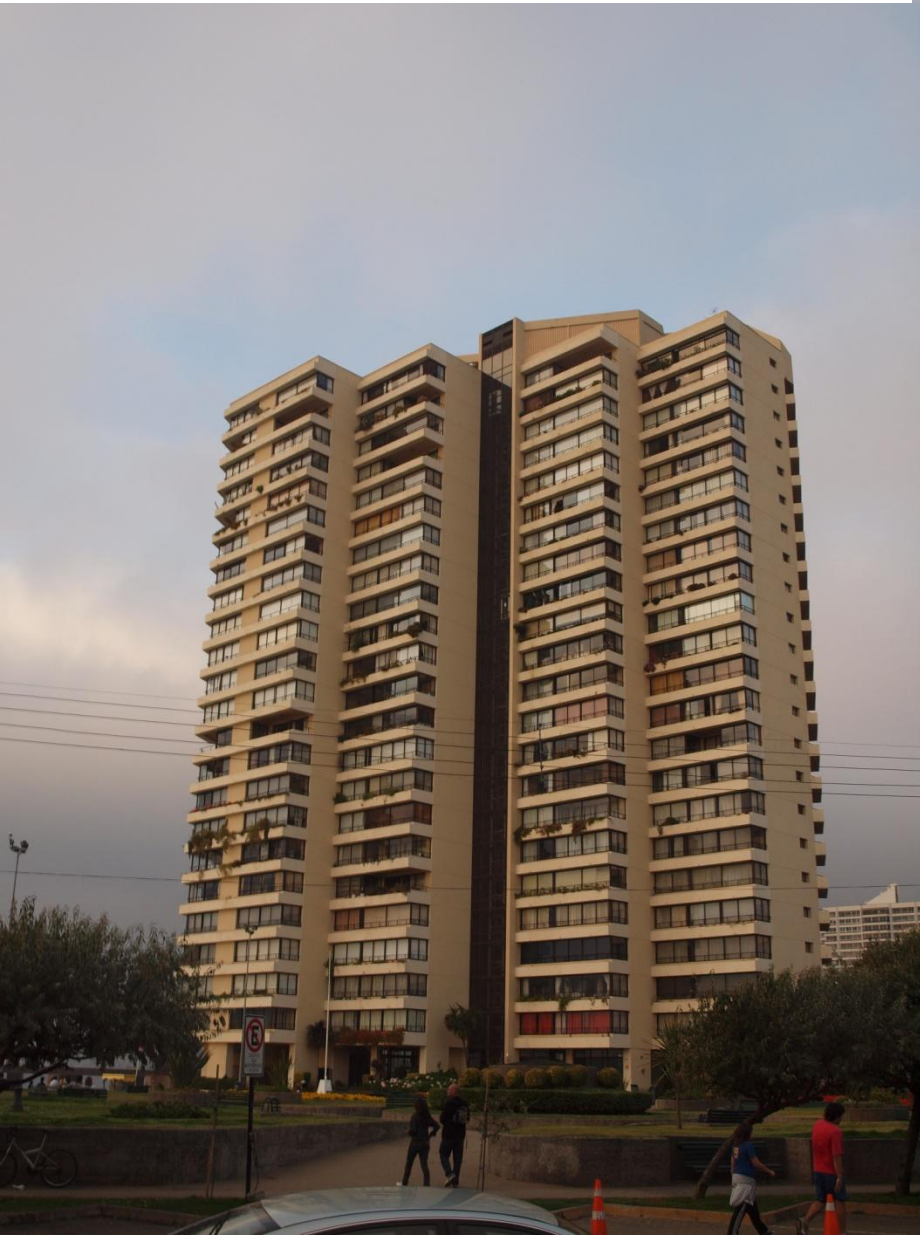
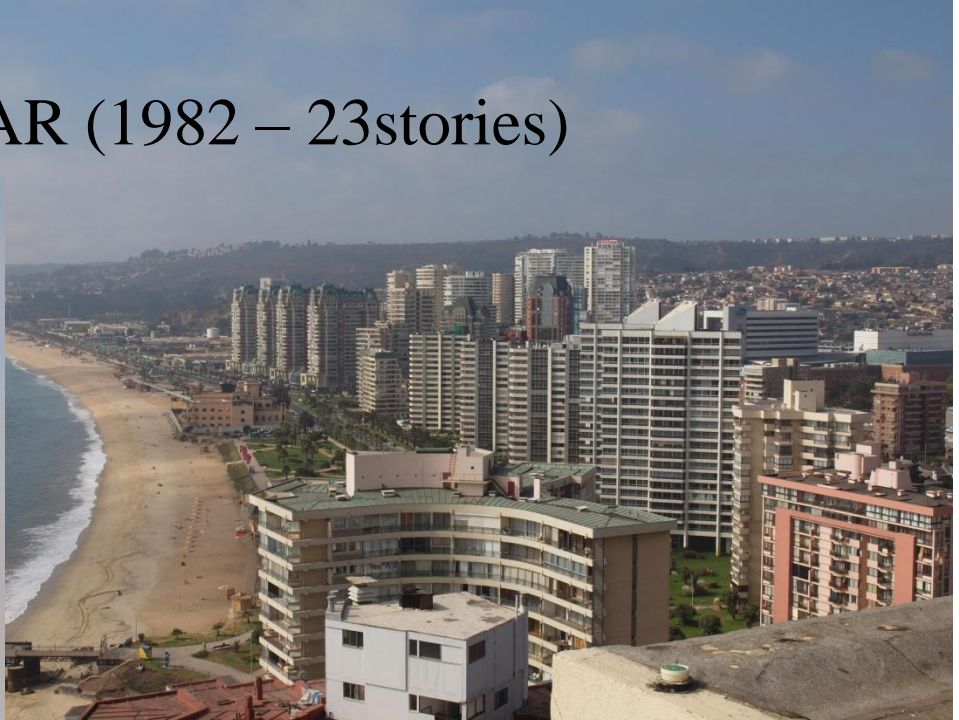
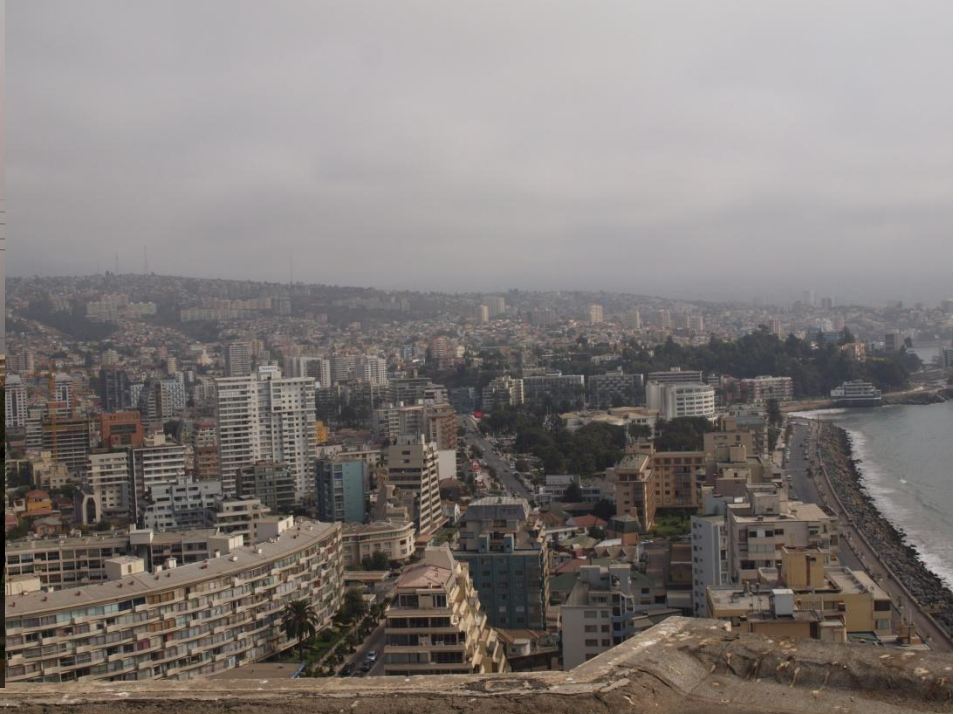
PLAZA DEL MAR (1982 – 23stories)

1985 Damage: minor diagonal cracking in shear walls at ground floor. Cracked lintels.

Damage 2010: minor

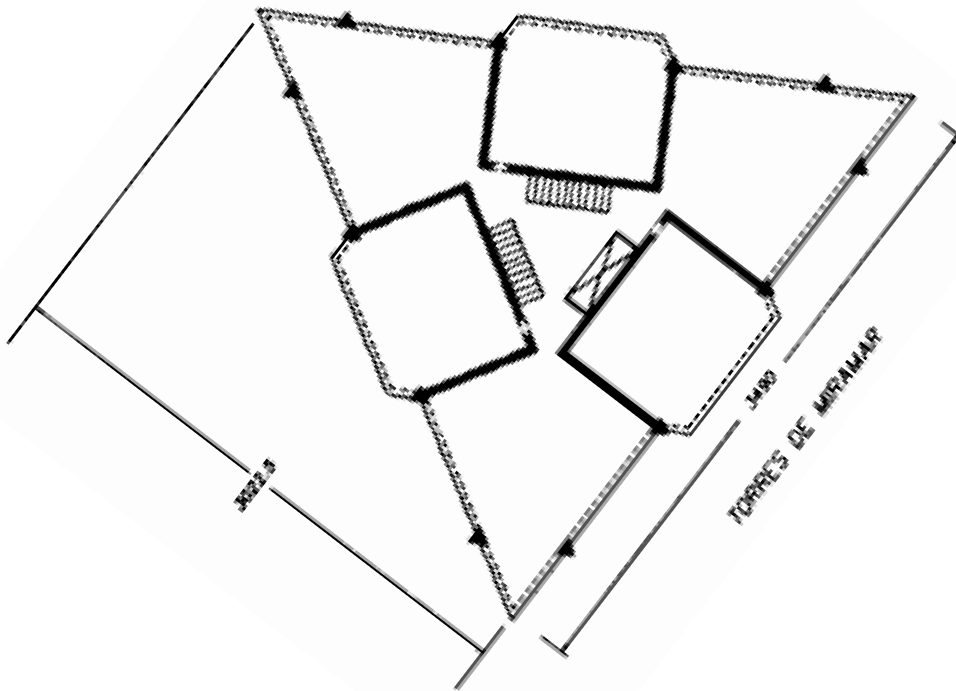
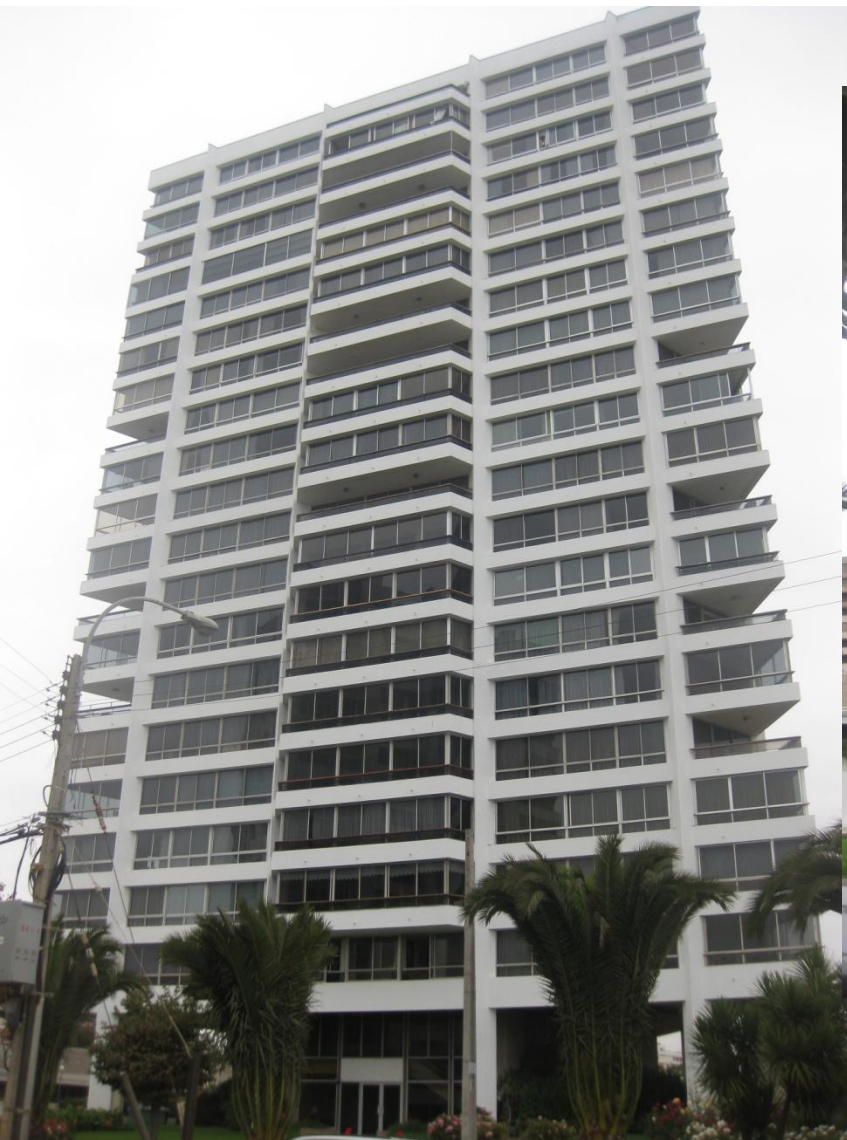
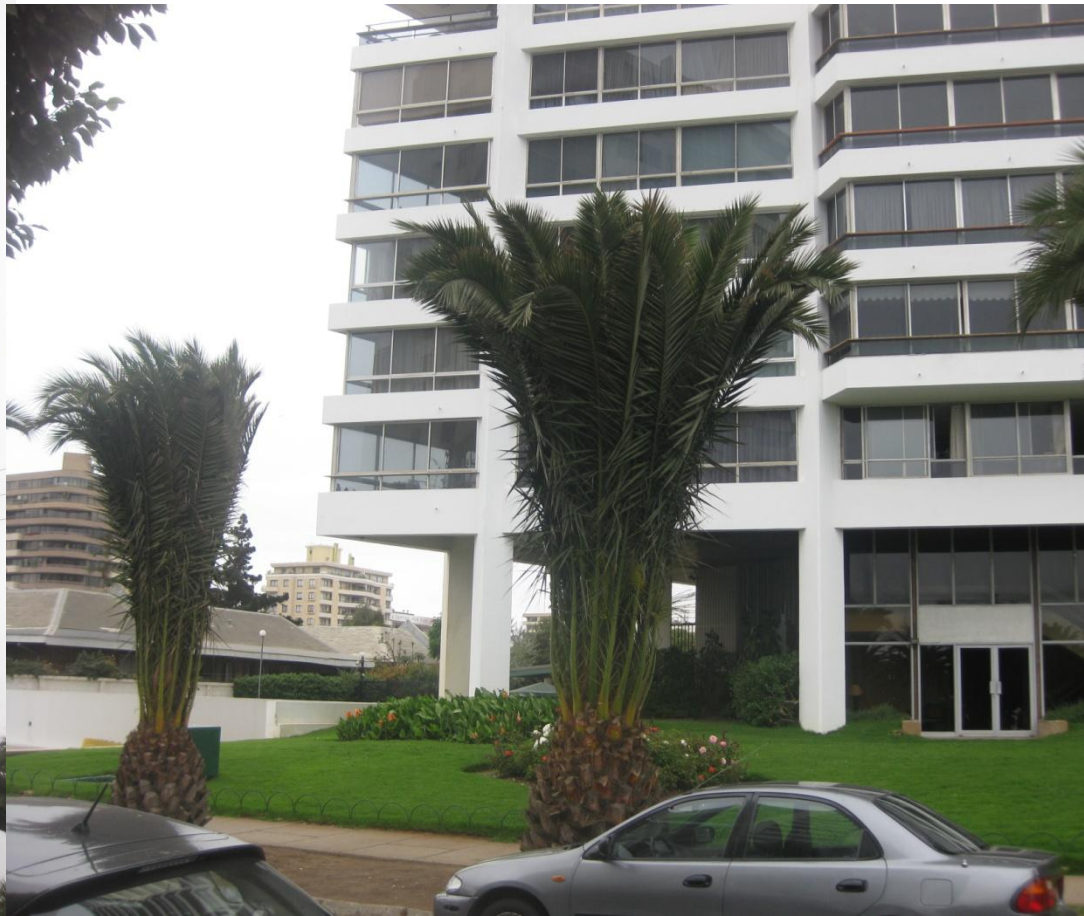
MIRAMAR (1975 – 21stories)

1985 Damage: none/minor; signs of foundation rocking were reported.

Damage 2010: none/minor
