## 2010 Chile Earthquake: Masonry and Historic Buildings

Joe Maffei March 2010

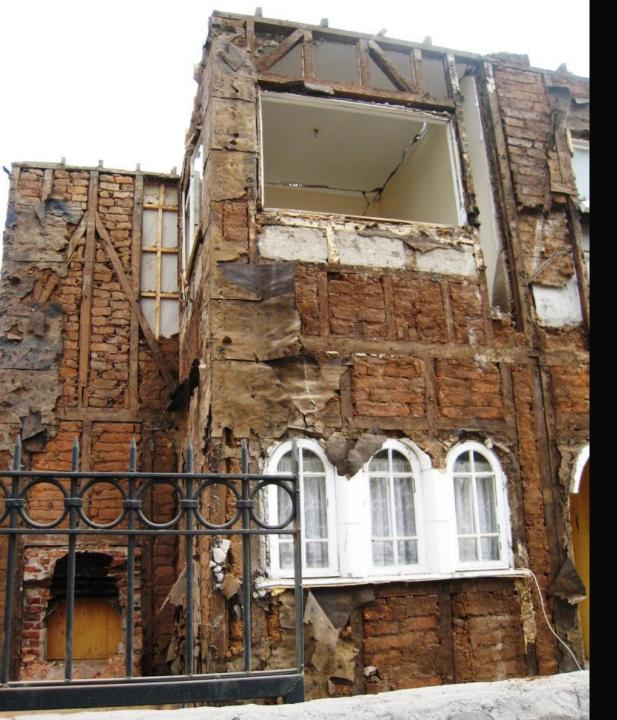
Viña del Mar

Timber framing with adobe brick infill. Damaged by loss of brick, being repaired.

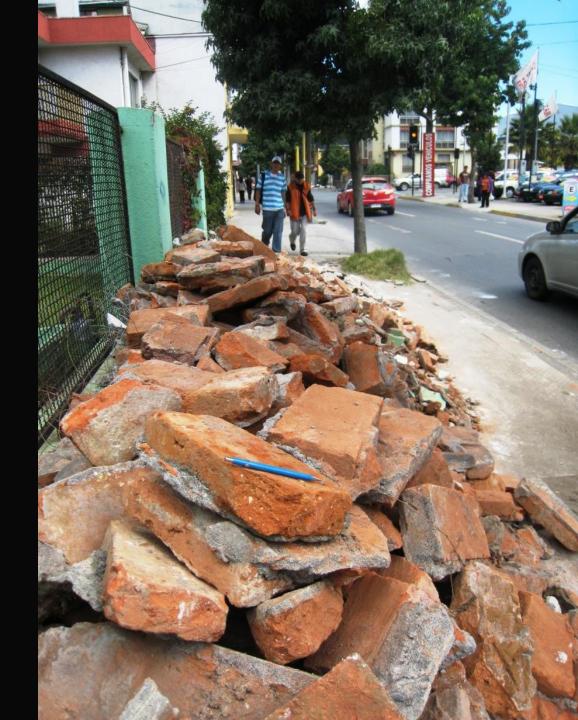
## Typcial older clay brick

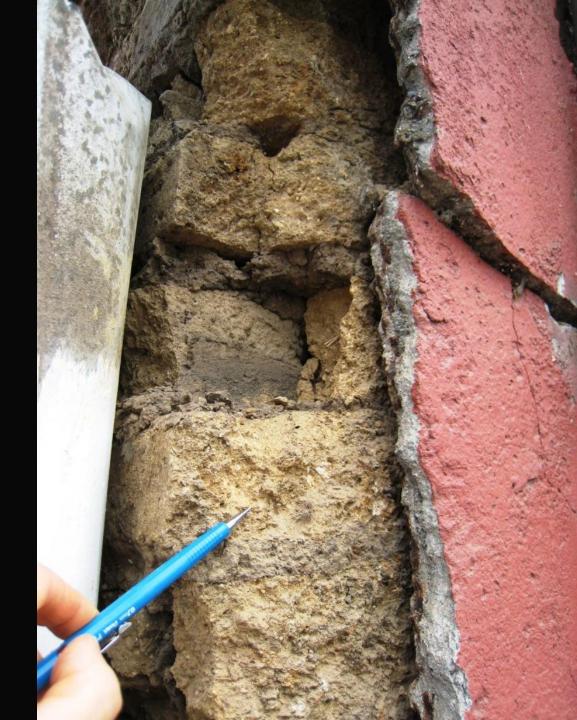
#### Adobe brick

Cracks through brick units, rather than along mortar joints

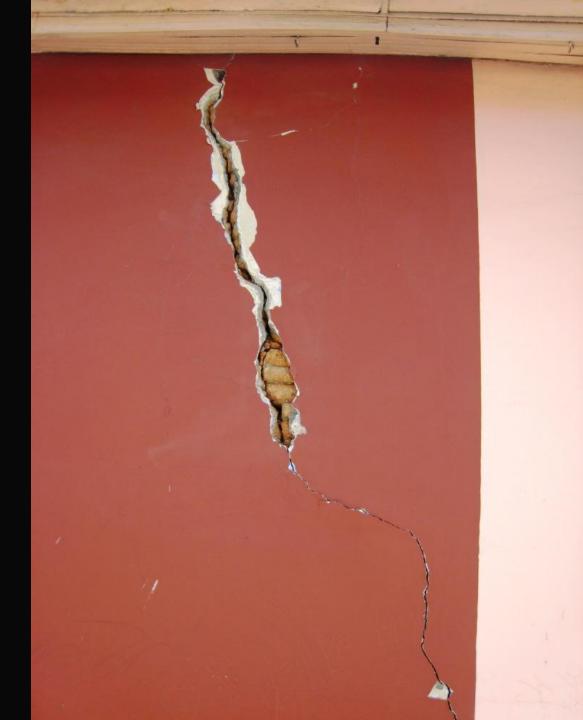
Viña del Mar

Concrete moment frame with brick infill, which contains an additional vertical "confining" concrete section

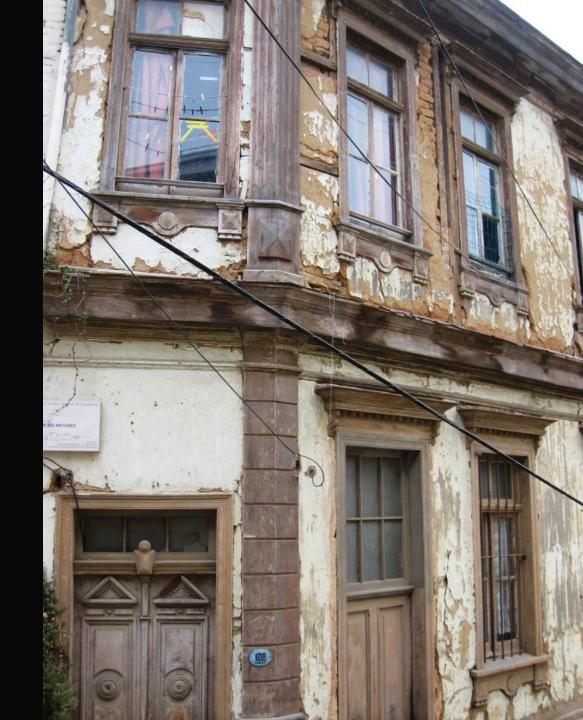
Valparaiso

#### Timber framing with adobe brick infill.

Masonry covered by plaster or corrugated metal

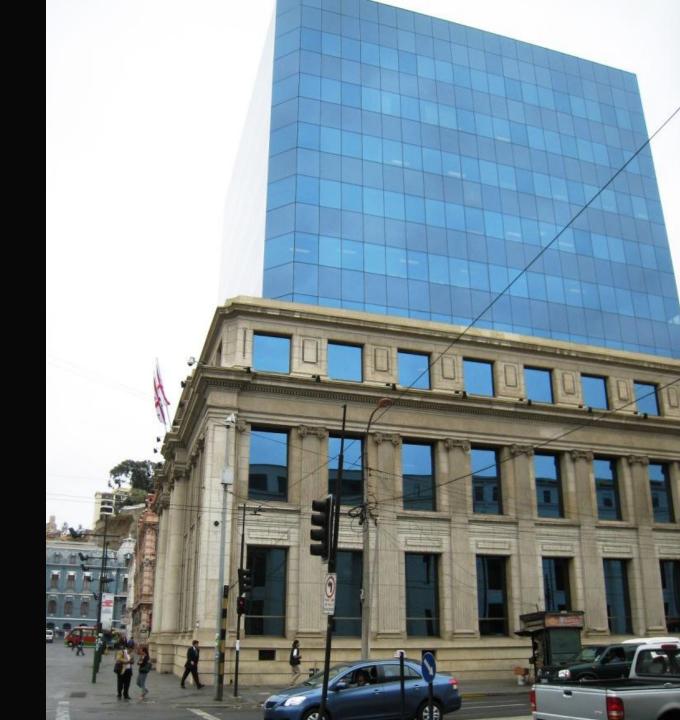
Valparaiso

Historic preservation of exterior façade only

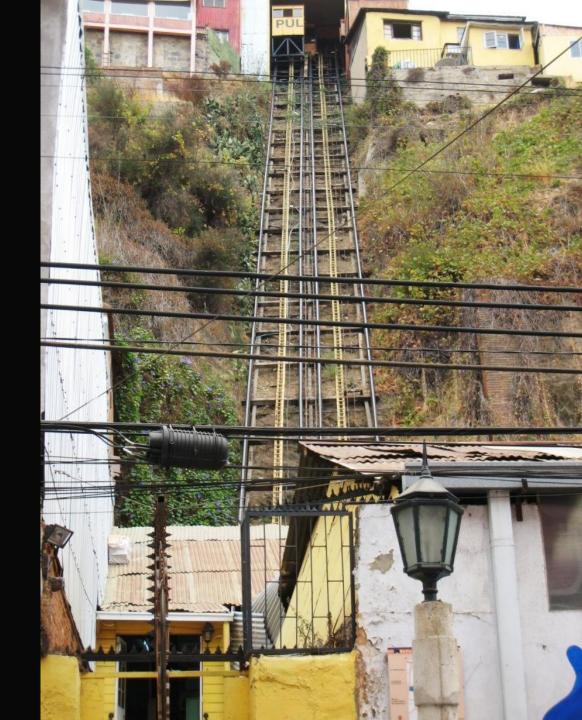
Historic *acensore* in Valparaiso. All were reported as being fully operational.

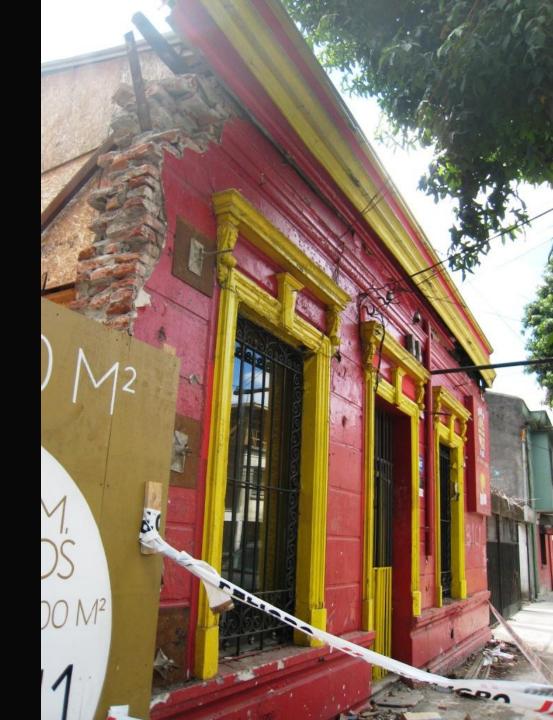
Older masonry buildings with moderate damage are likely to be demolished
