Tuned mass damper

Parque Araucano building, Santiago

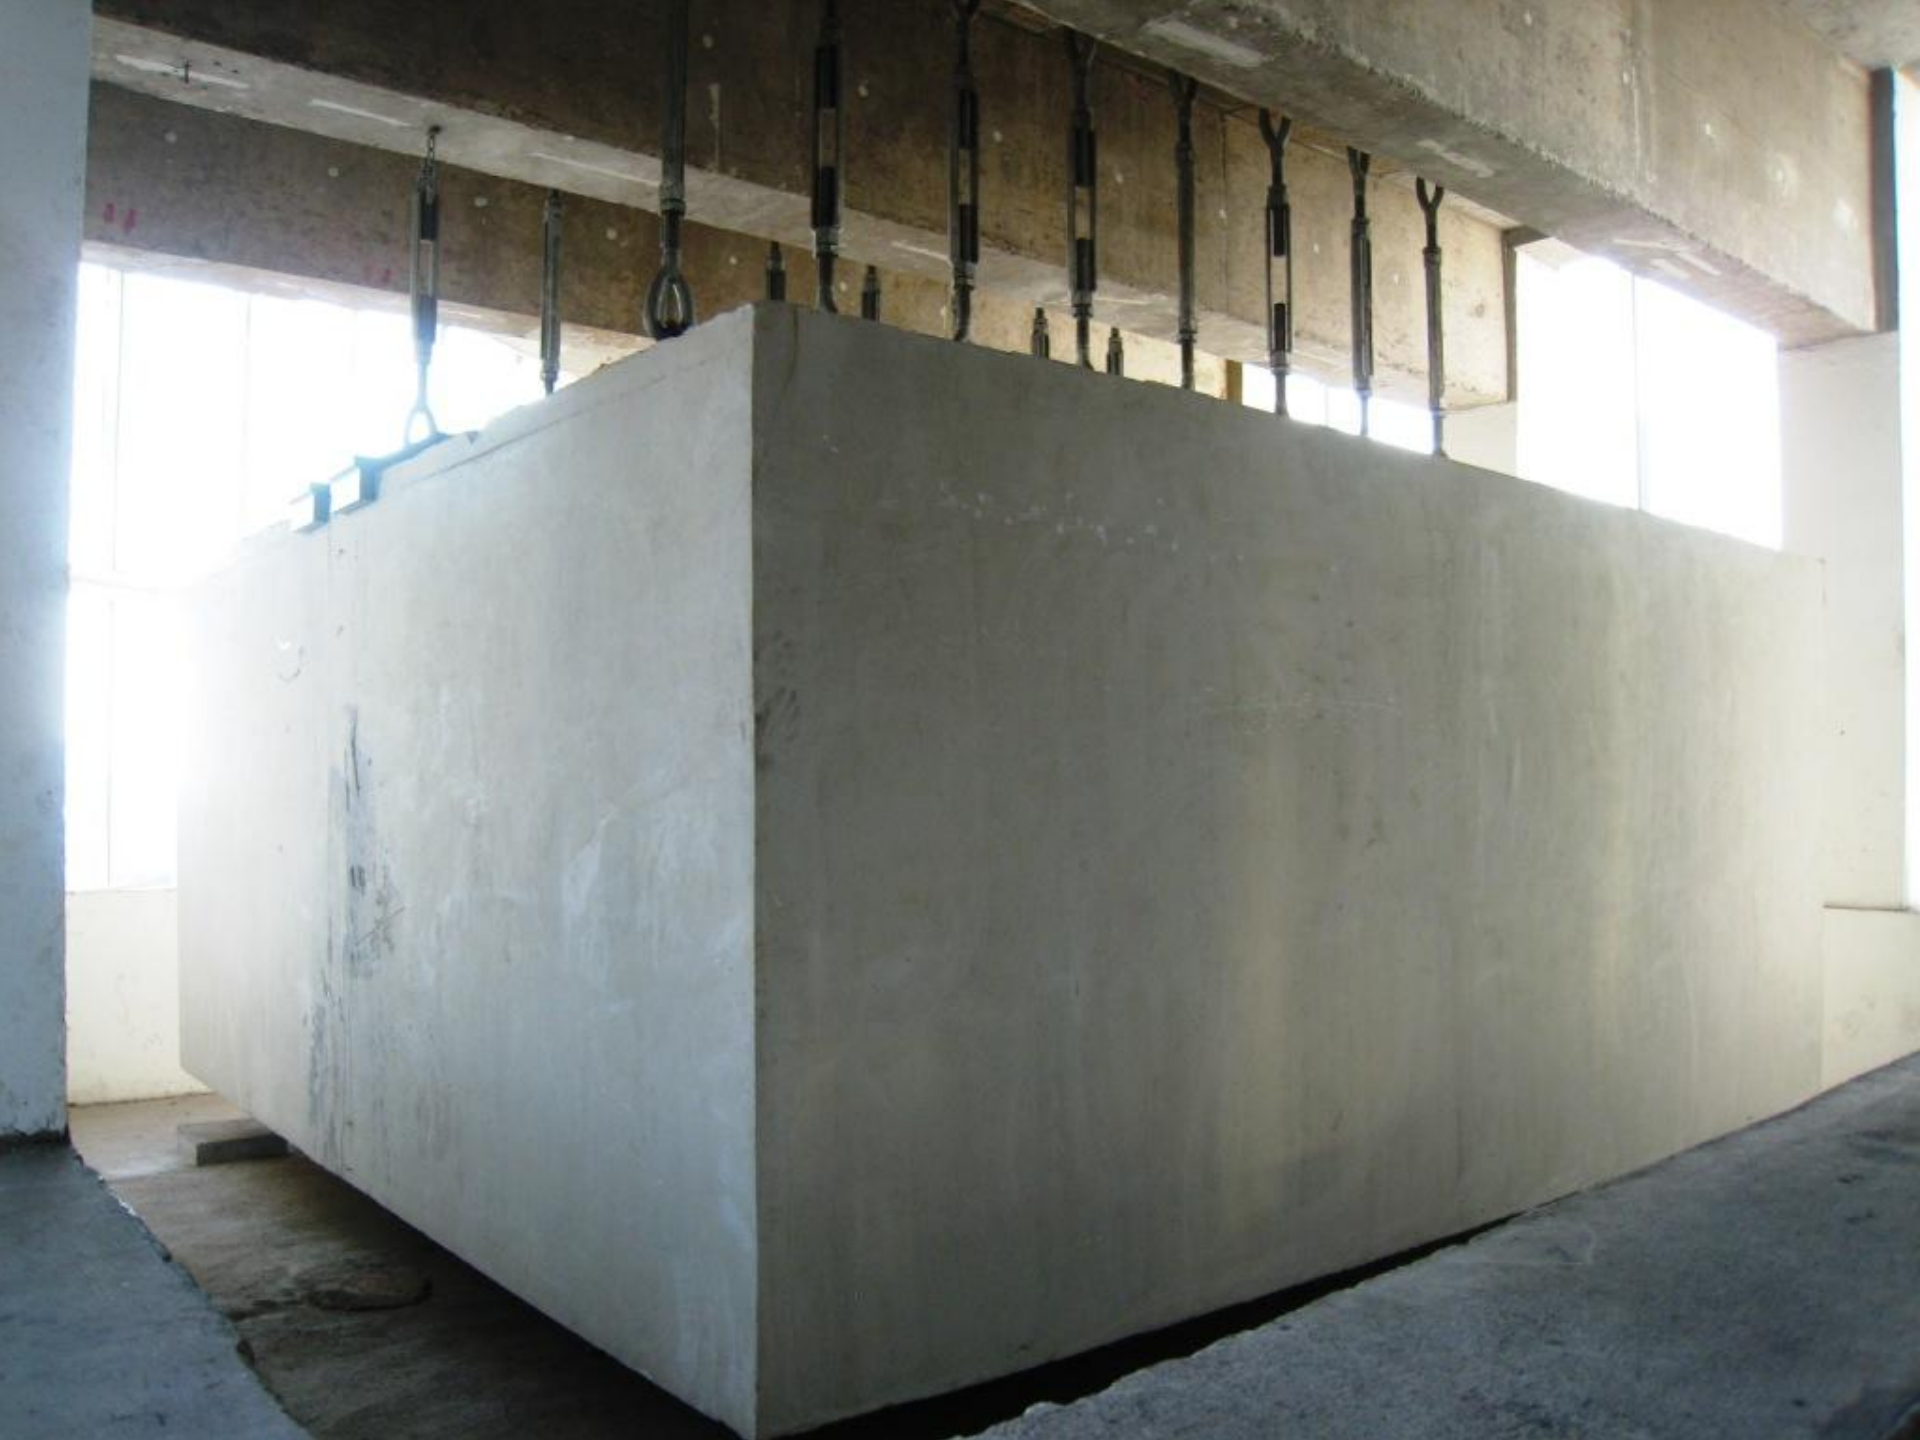
Building remained fully operational.

Only damage observed at roof level mechanical floor was electrical panel separated approximately 7 cm from wall
