**EARTHQUAKE ENGINEERING RESEARCH INSTITUTE**

## **Brief Report on Earthquake Reconnaissance after the M 8.8 February 27<sup>th</sup> 2010 Maule, Chile Earthquake**

**Team Focus:**           Nonstructural Components  
(particular emphasis on hospitals)

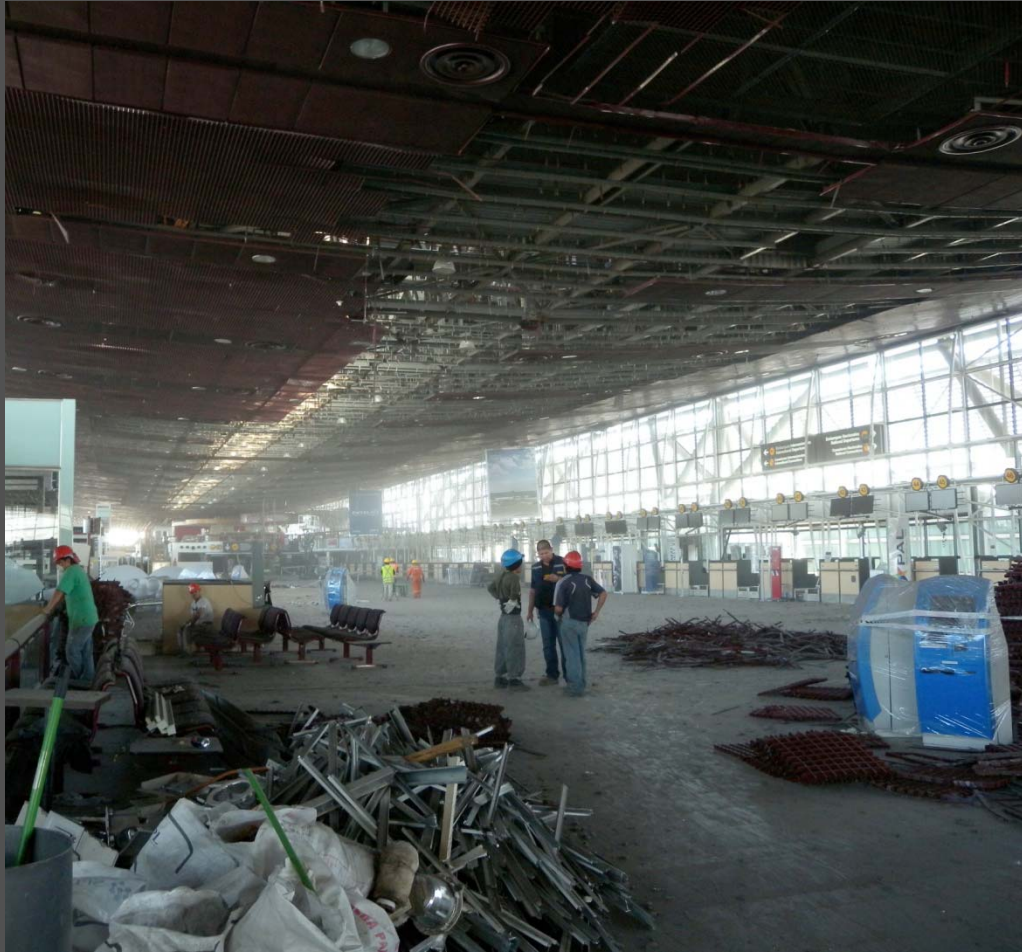
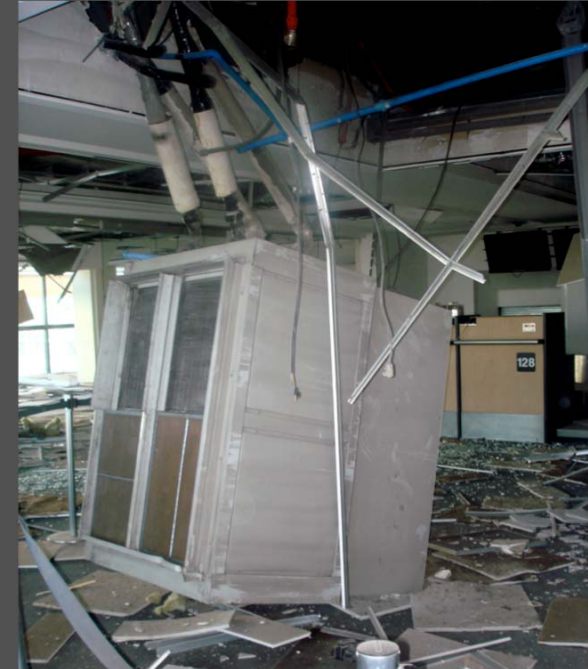
## Airport terminal at Santiago shut down mainly due to nonstructural damage

Many suspended air handling units like this fell to the ground

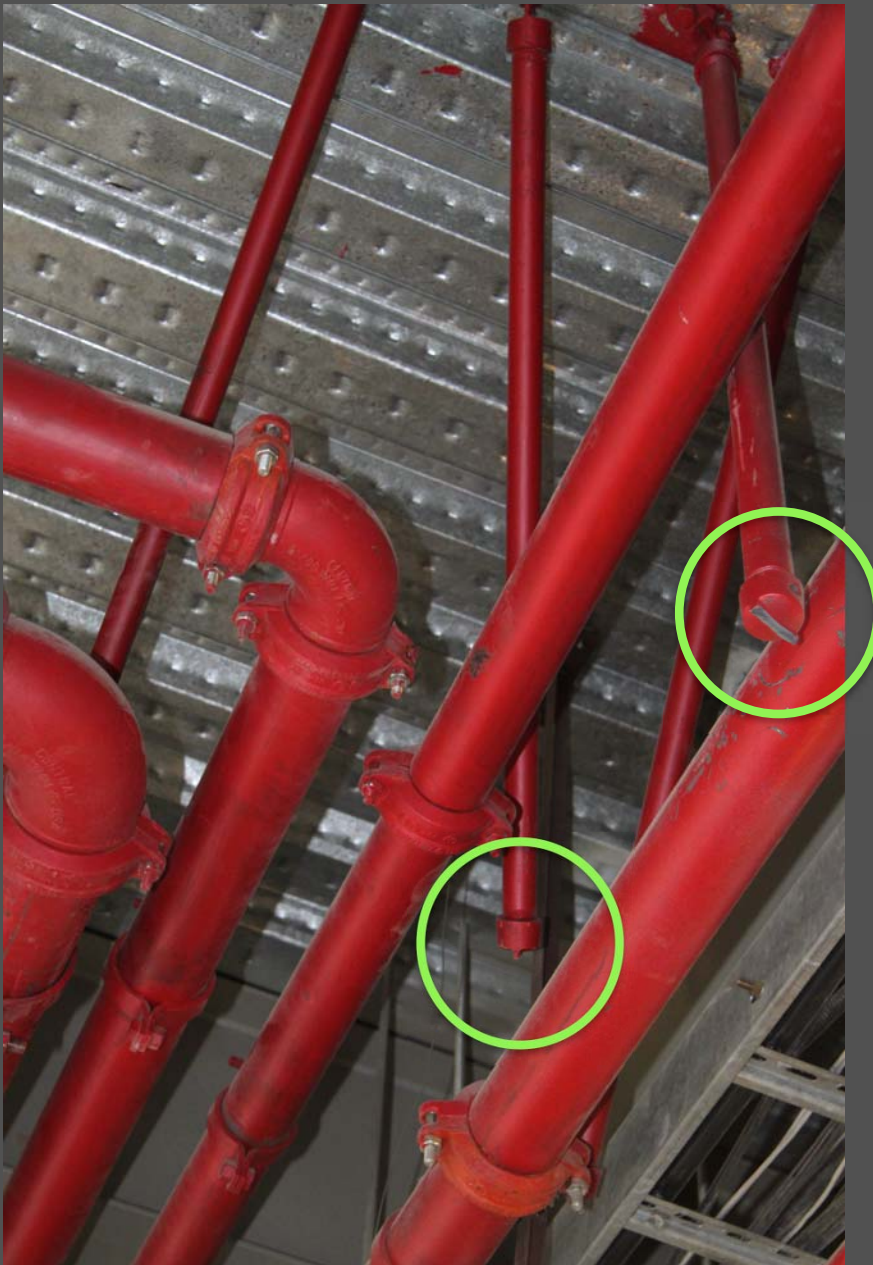
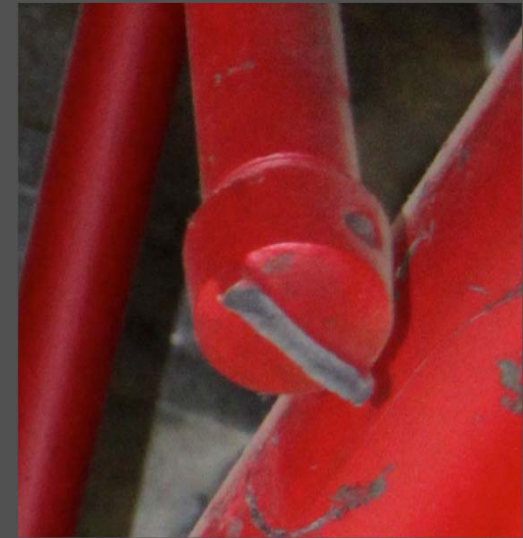
## Sheared off sprinkler braces at the Santiago Airport

Closeup view

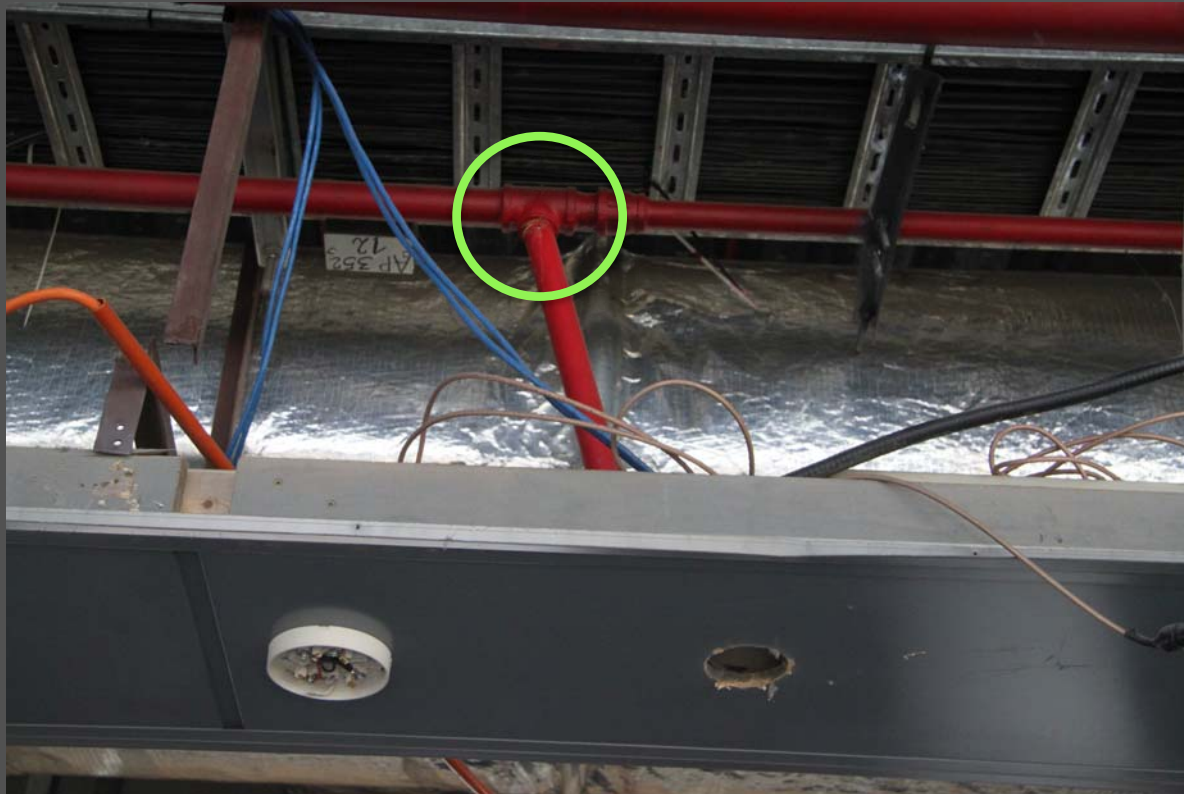
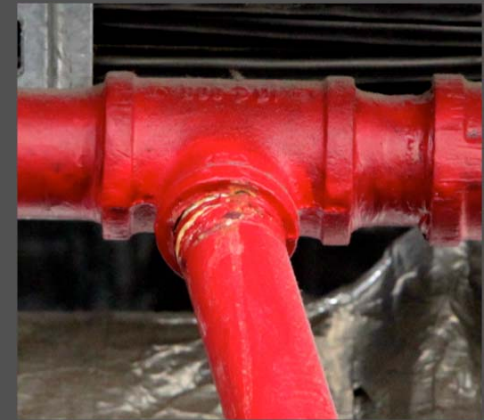
## Broken sprinkler piping at the Santiago Airport

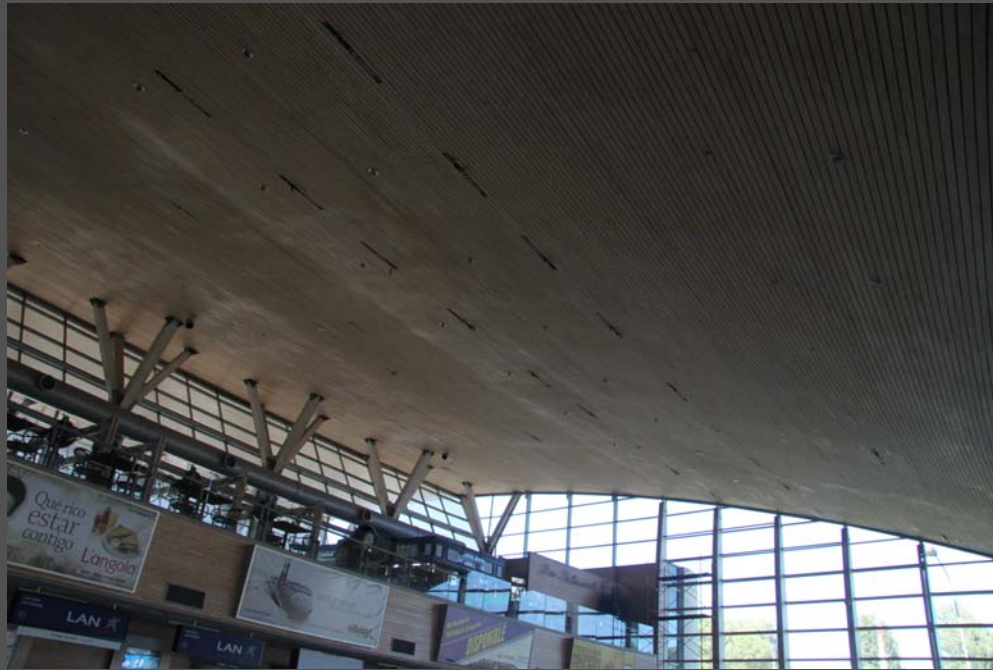
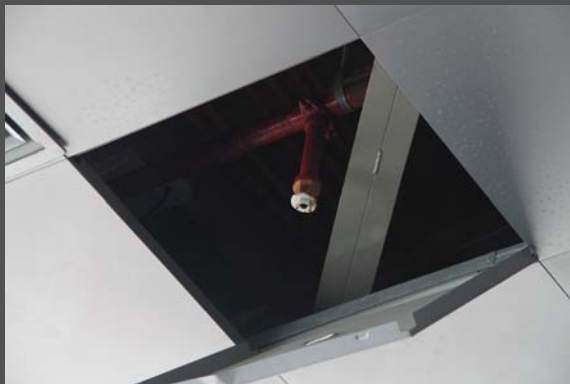
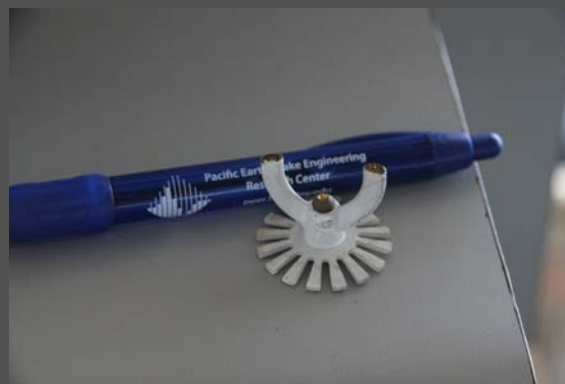
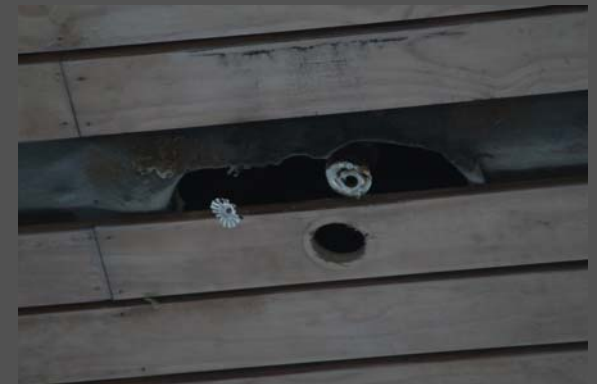
## Water damage from broken sprinklers at the Concepción Airport

Closeup view of some sprinkler heads sheared off

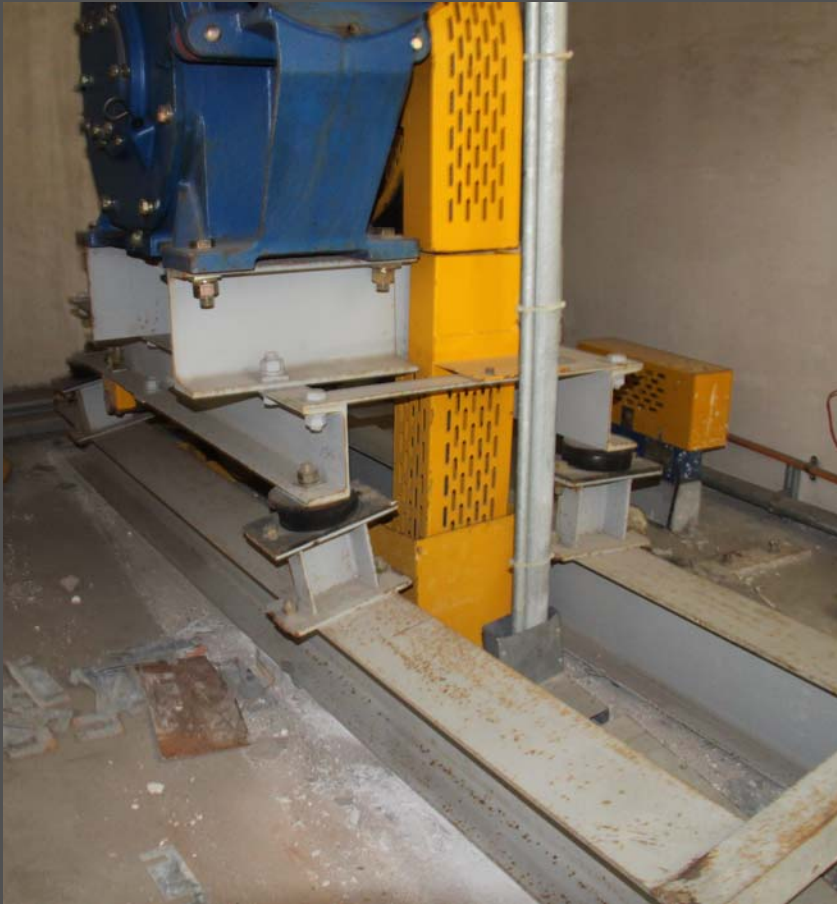
Nearly overturned elevator machine

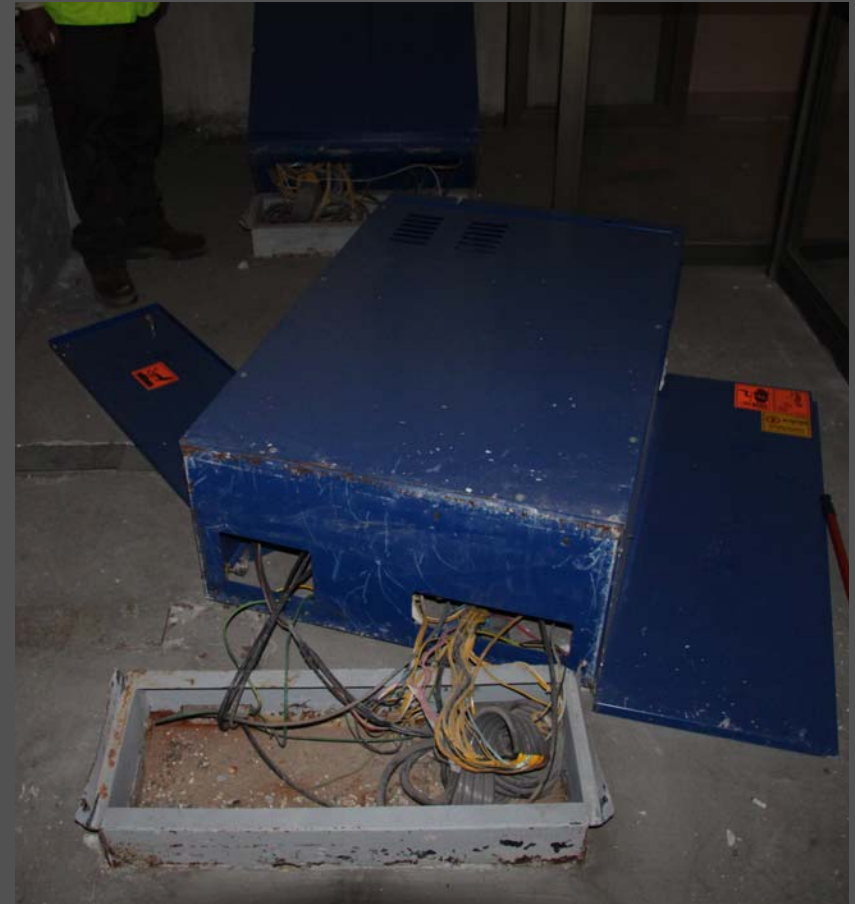
Overturned switch control panel

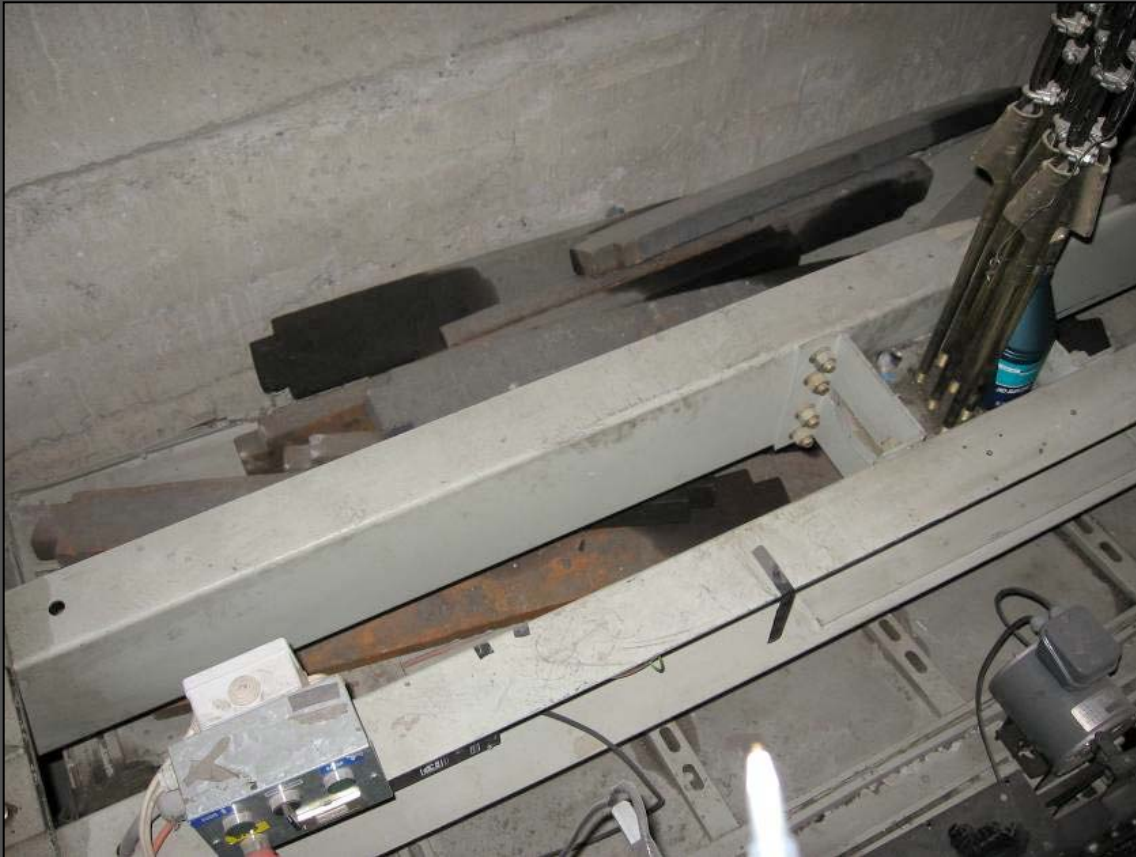
Derailed and disassembled counterweight

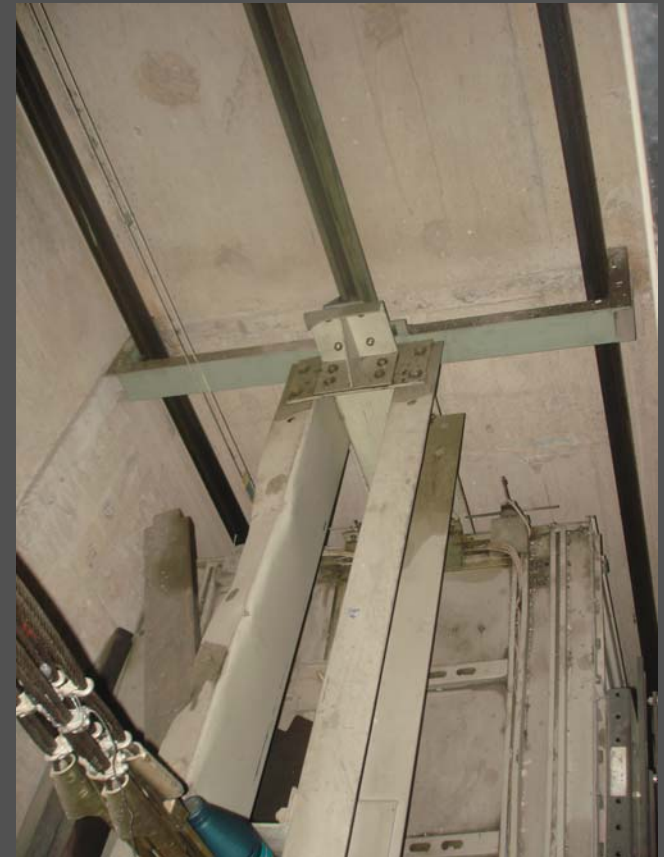
Elevator cabin hit by derailed counterweight

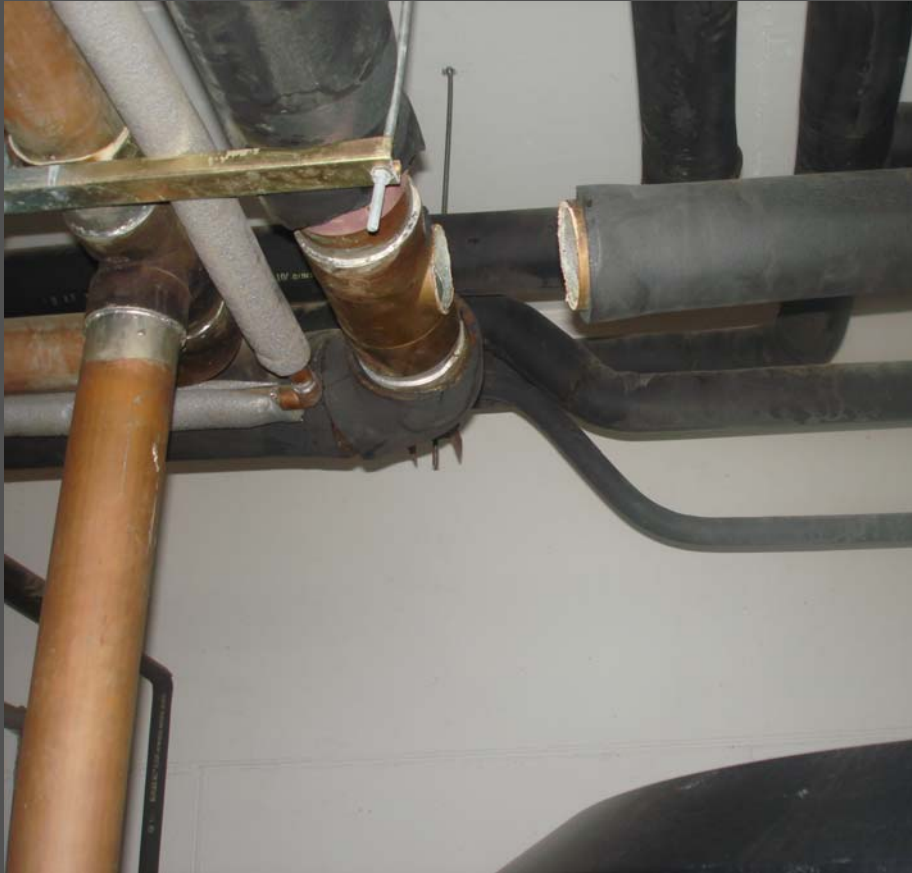
Broken copper water pipe of hot water

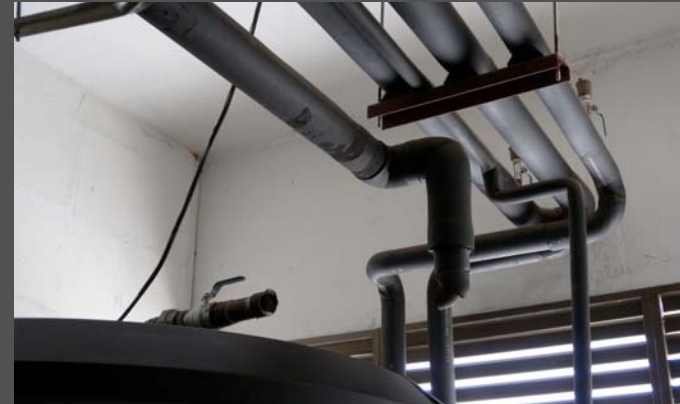
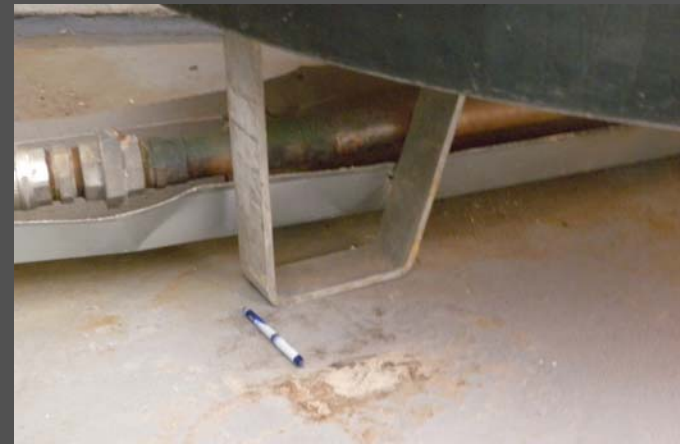
Evidence of sliding of an unanchored boiler

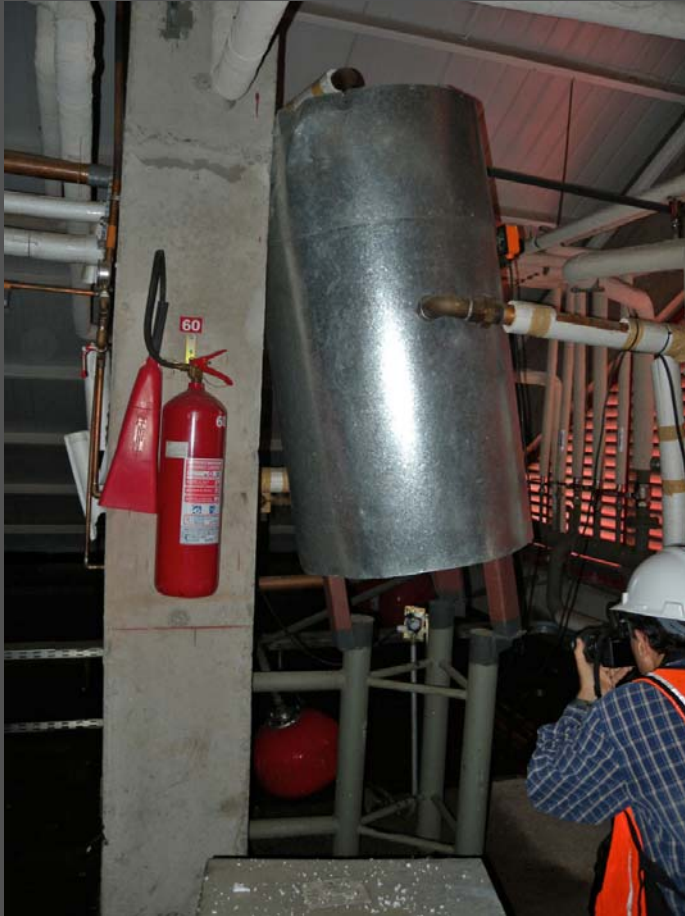
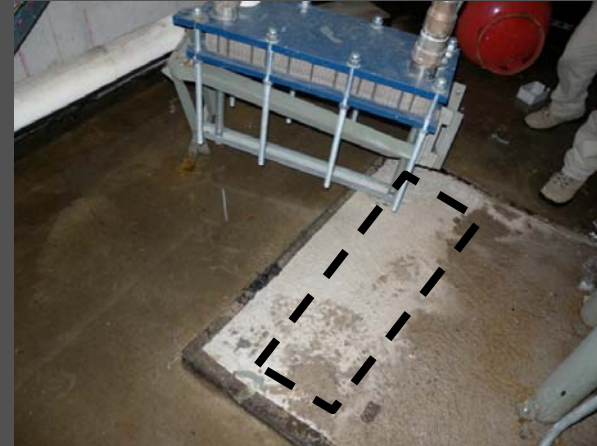
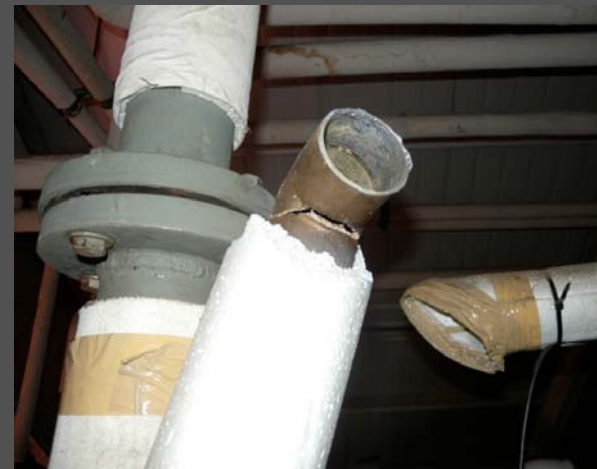
## Example of broken water pipes in San Carlos Hospital

Broken copper water pipe of hot water caused by lack of lateral bracing of the boiler

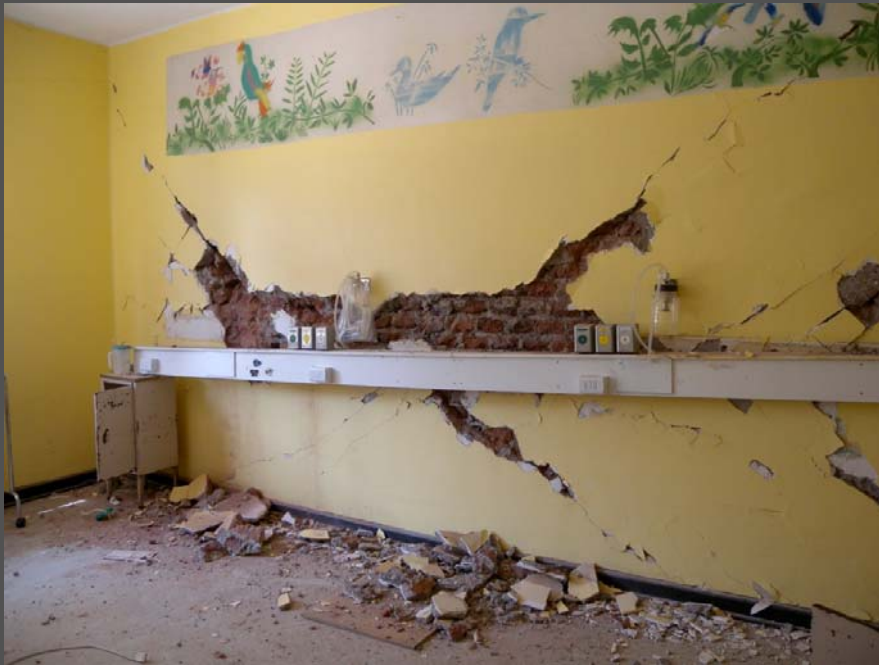
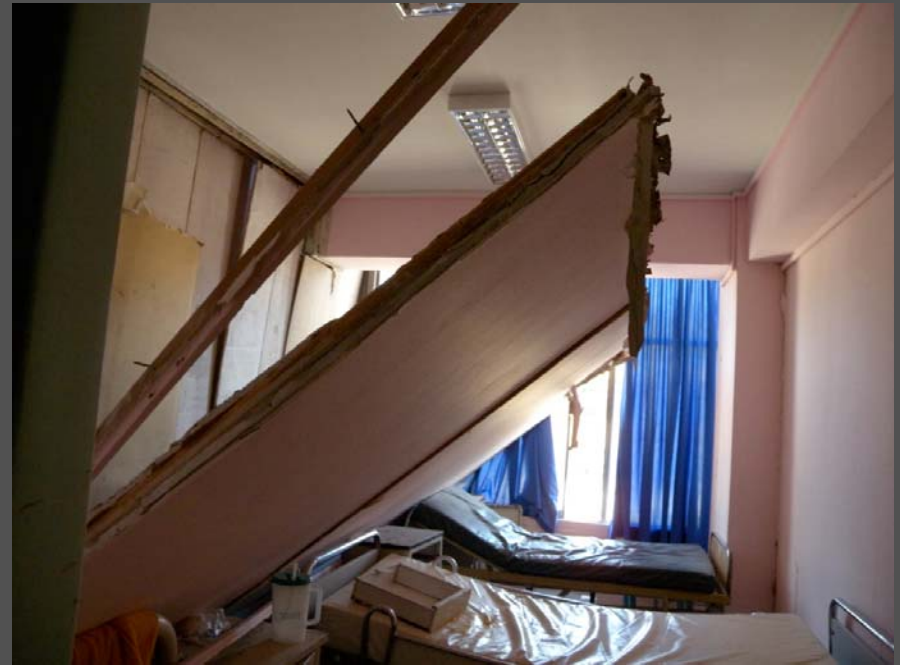
## Felix Bulne Hospital in Santiago shut down primarily due to nonstructural damage

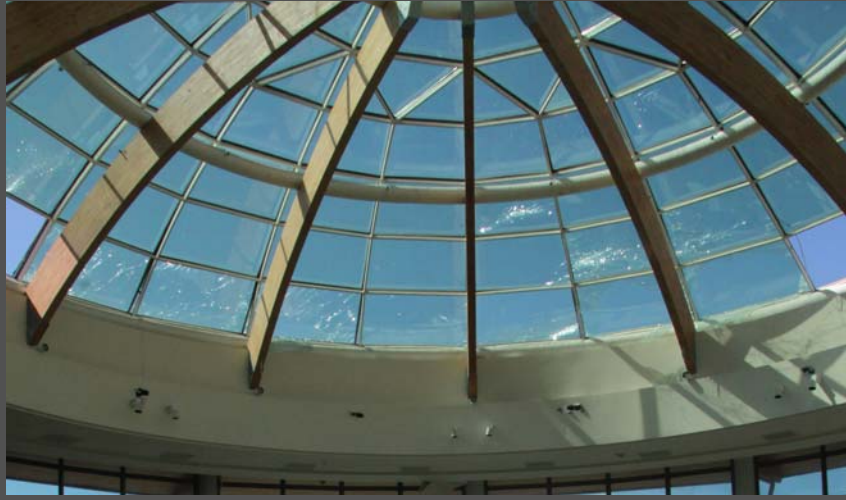
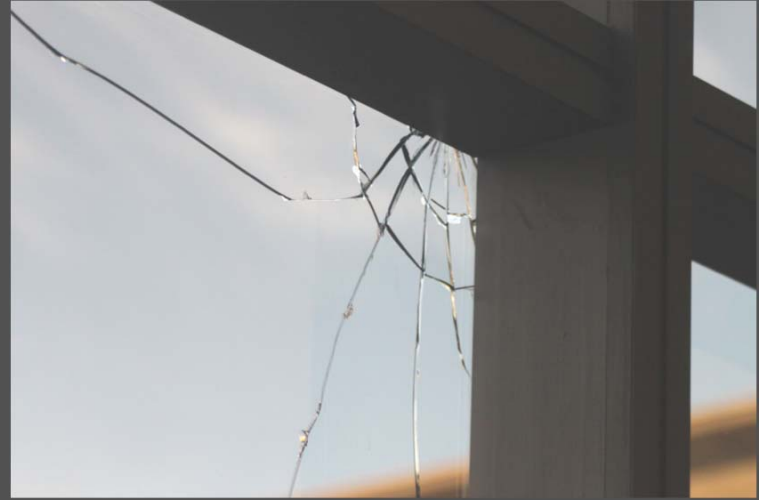
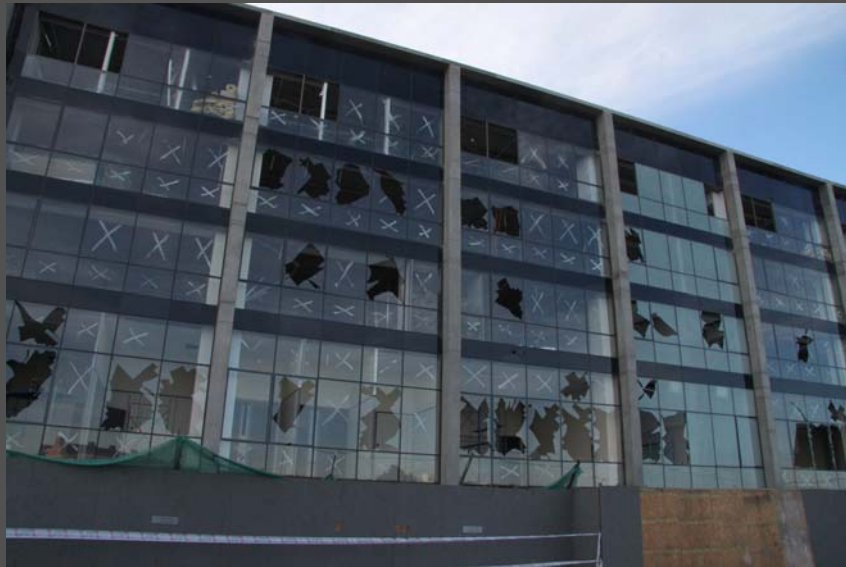
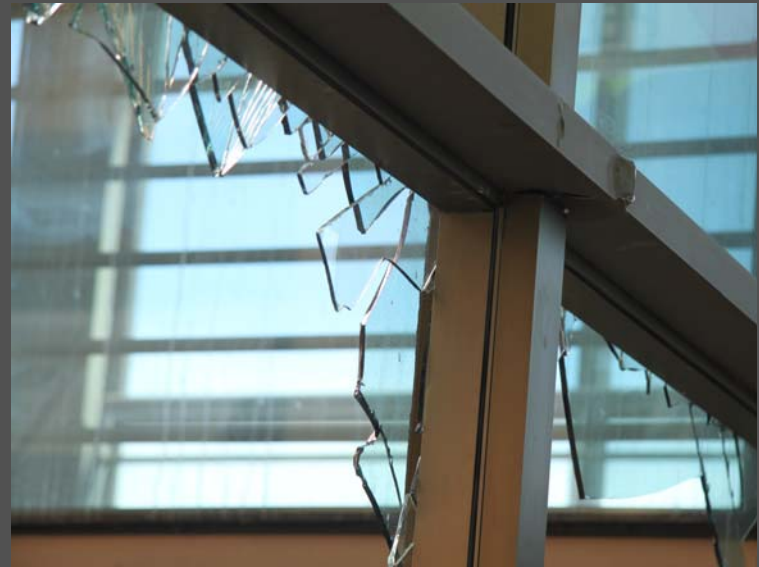
Glazing damage was frequently observed in residential buildings, hospitals and commercial buildings

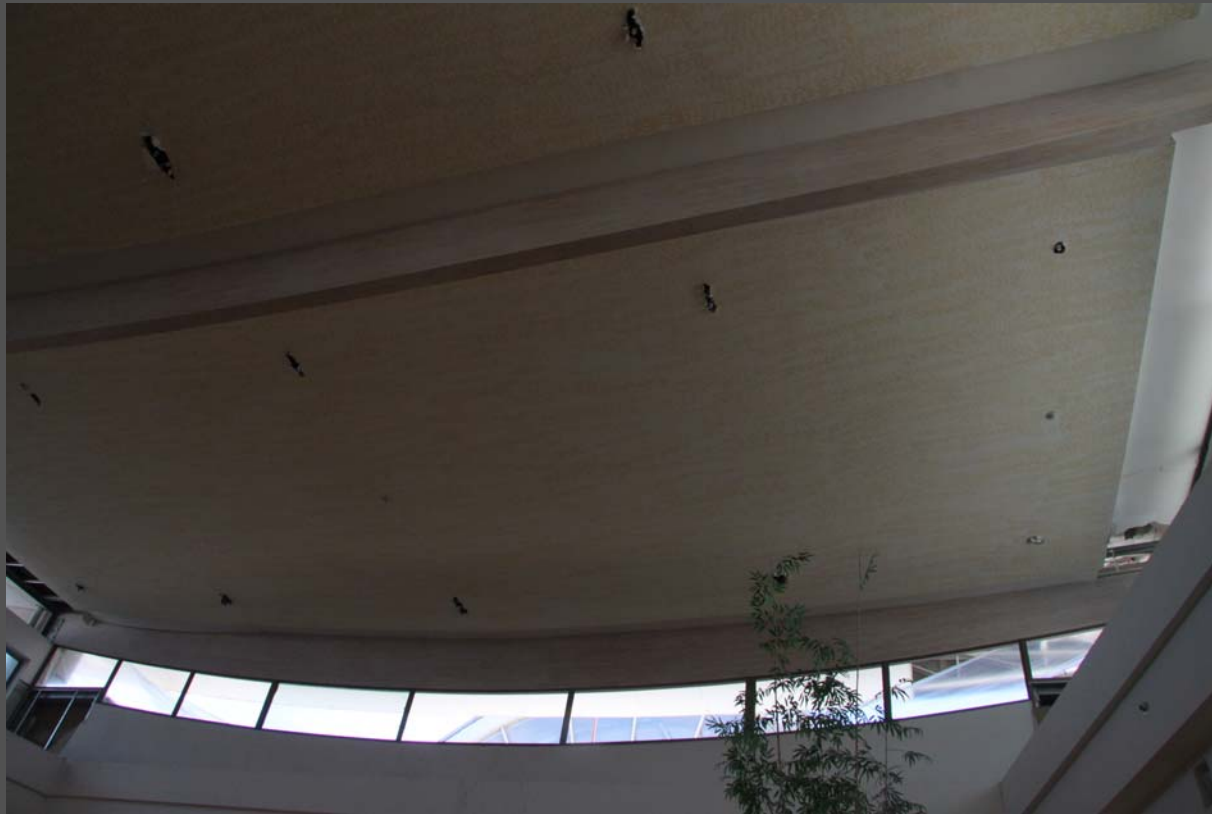
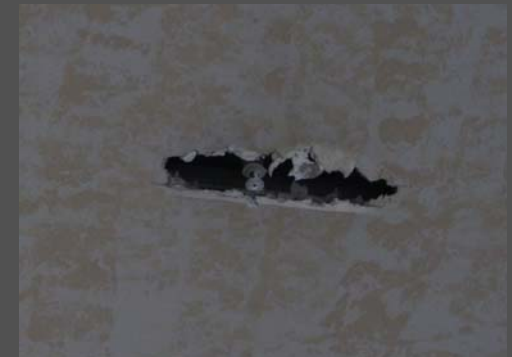
## Ceiling-sprinkler head dynamic interaction at the Mall Plaza in Concepción

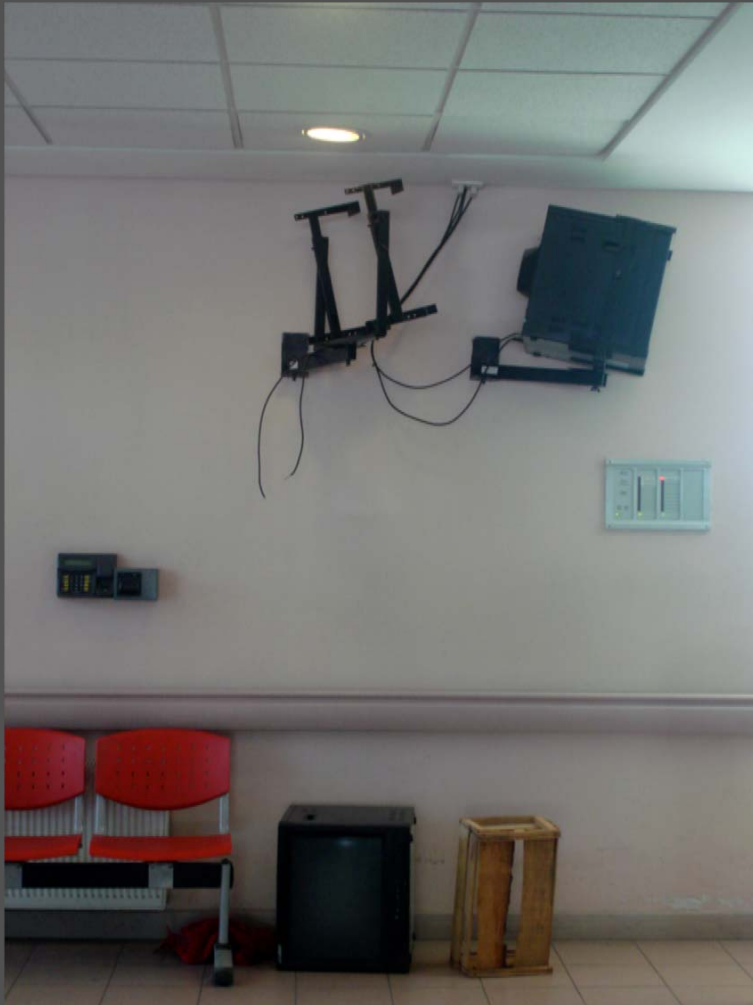
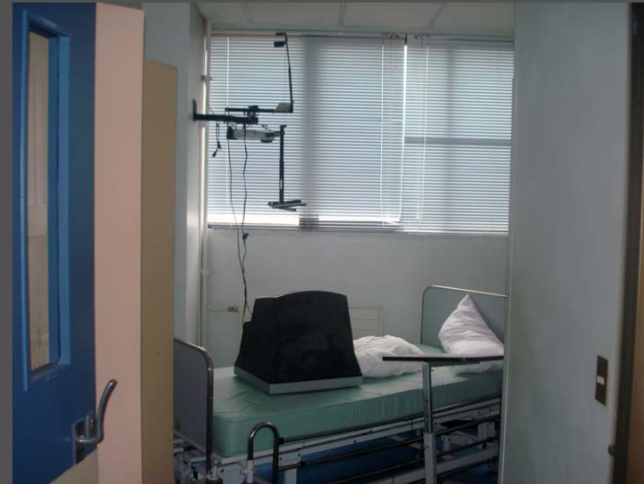
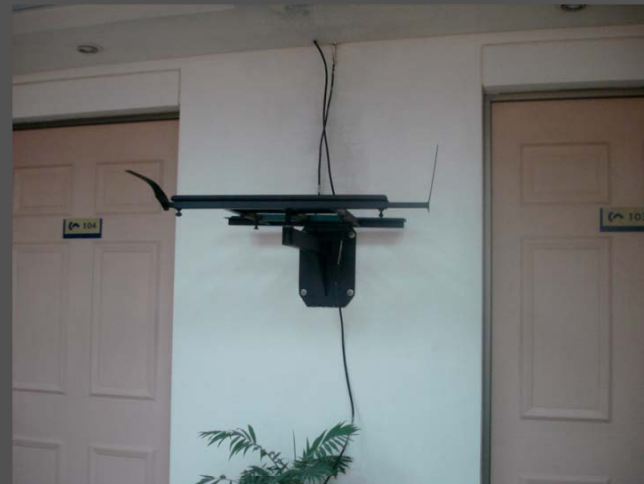
## Damage to wall-mounted monitors at Talcahuano and San Carlos Hospitals

Wall-mounted monitors at this hospital fell from their brackets

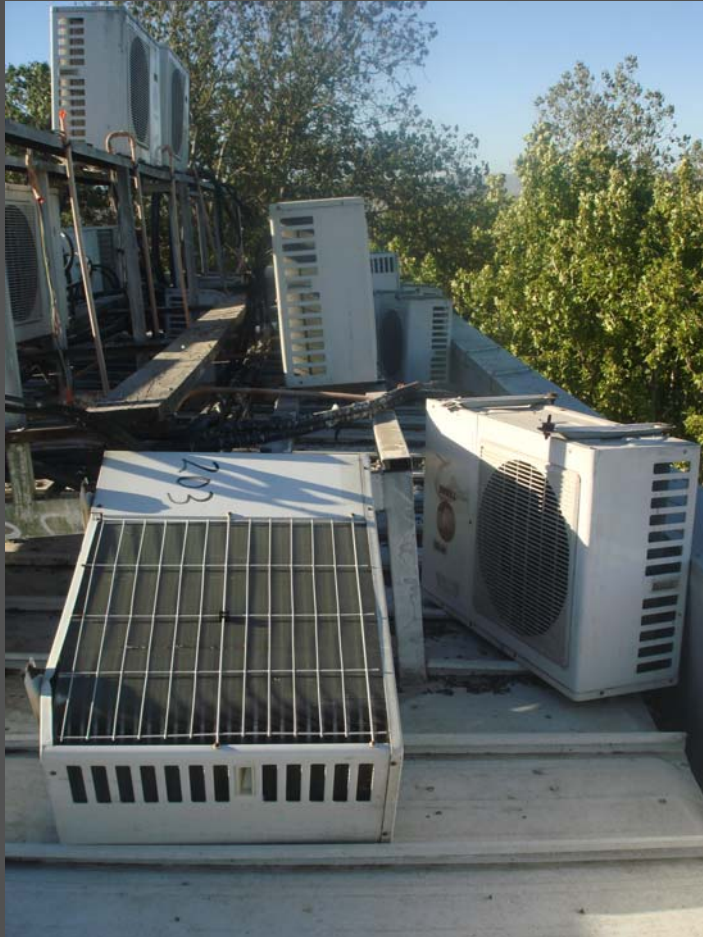
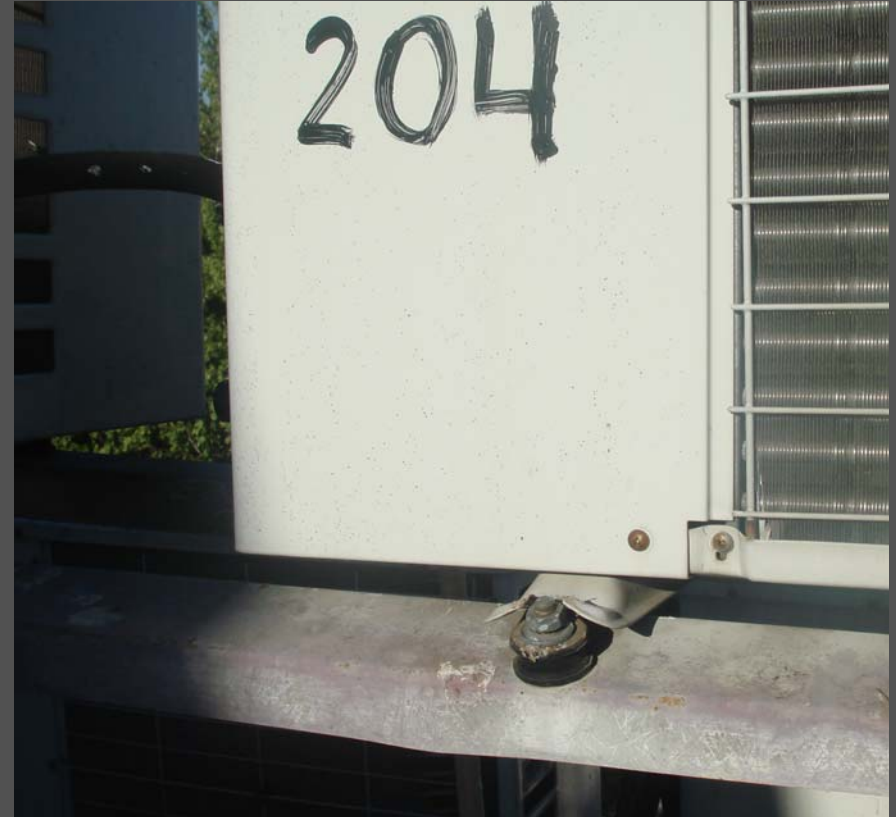
## Roof-mounted small AC units at the Clínica del Maule in Talca

75% of these roof-mounted small AC units overturned

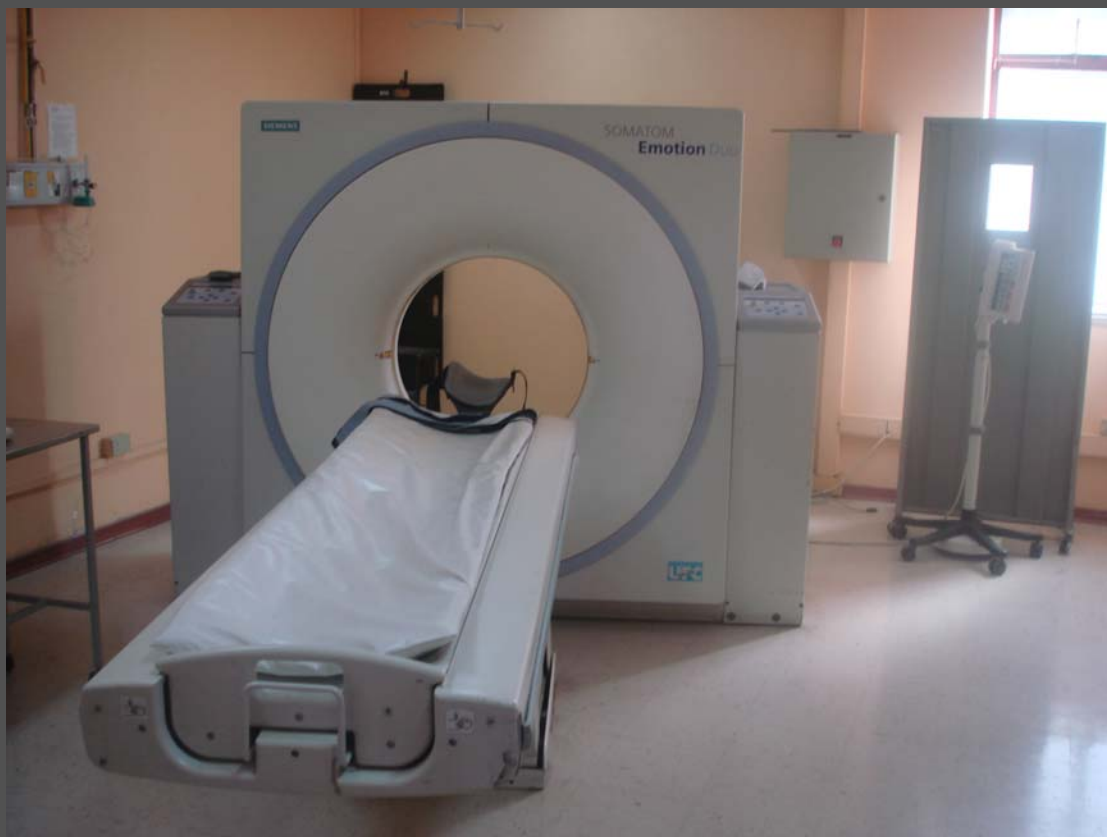
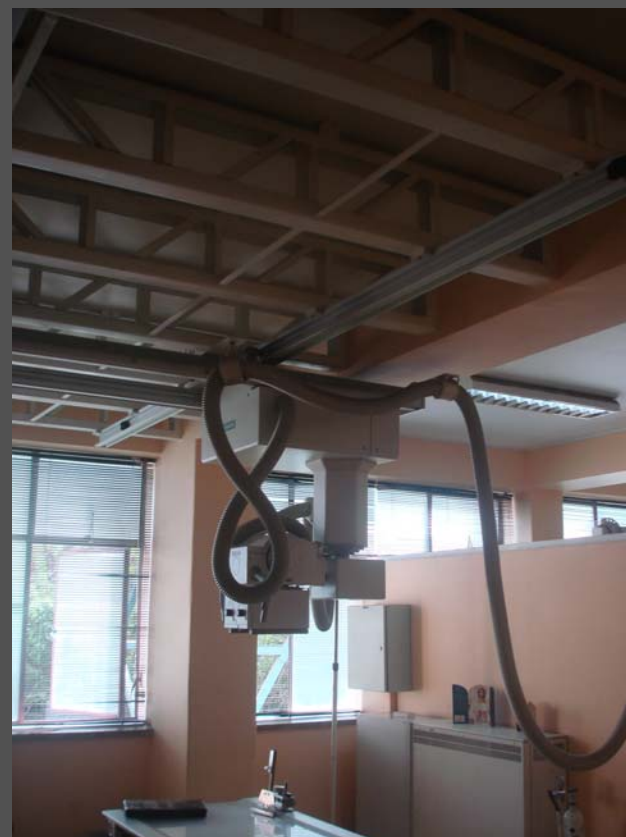
## Examples of well anchored hospital equipment that performed well At Santiago General Hospital
