# Tsunami Effects of the February 27, 2010 Chile Earthquake

March 20, 2010

EERI Survey Debrief

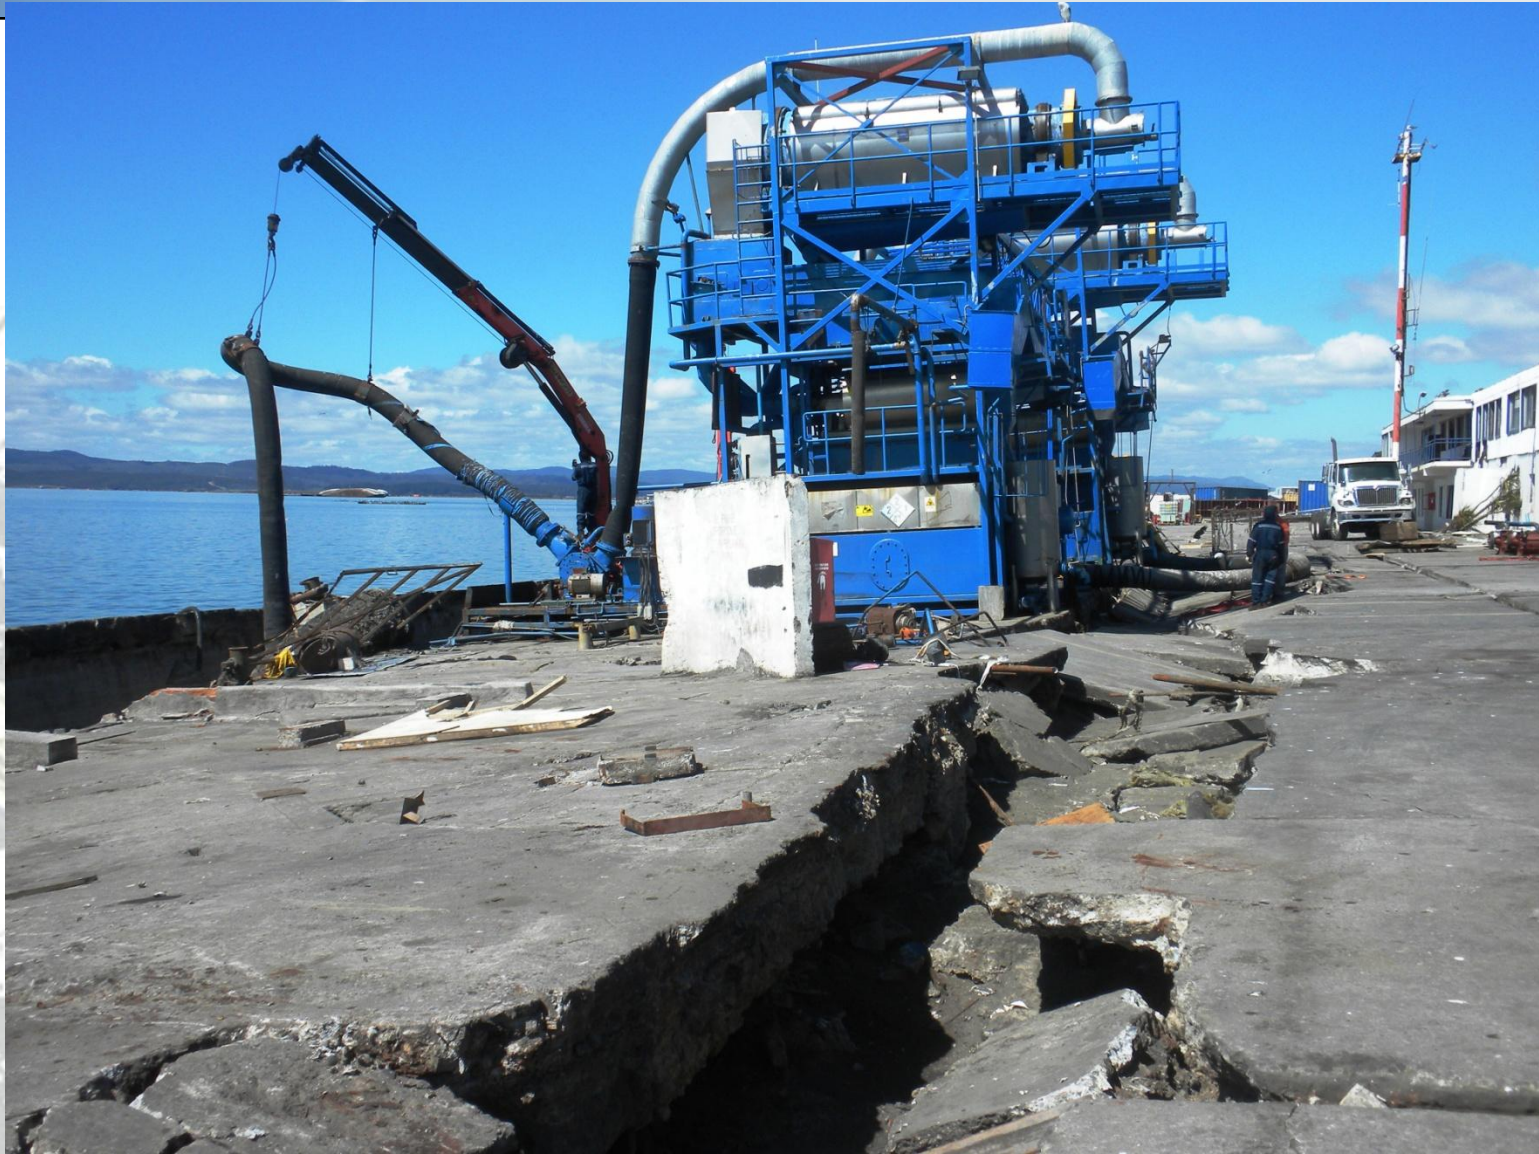
## Fish pumping Station, Talcahuano

# Scour and Fluidization

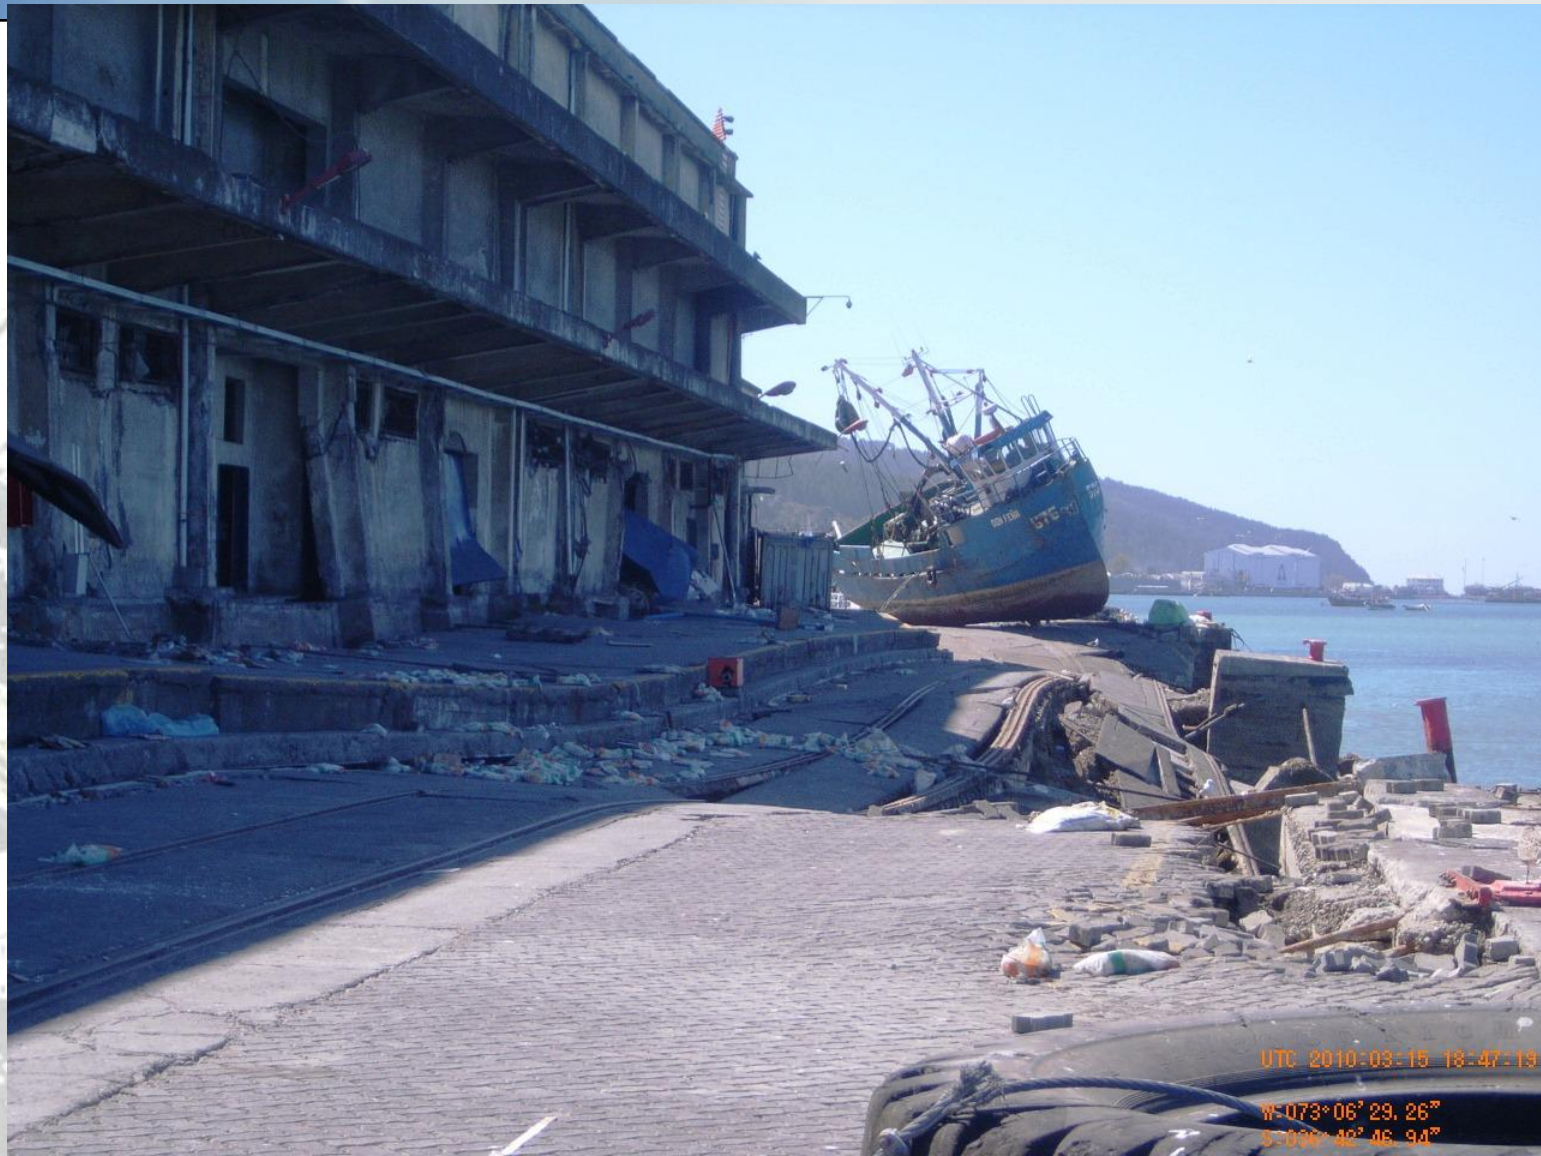
## Warehouse and pier, Talcahuano

# Scour and Fluidization

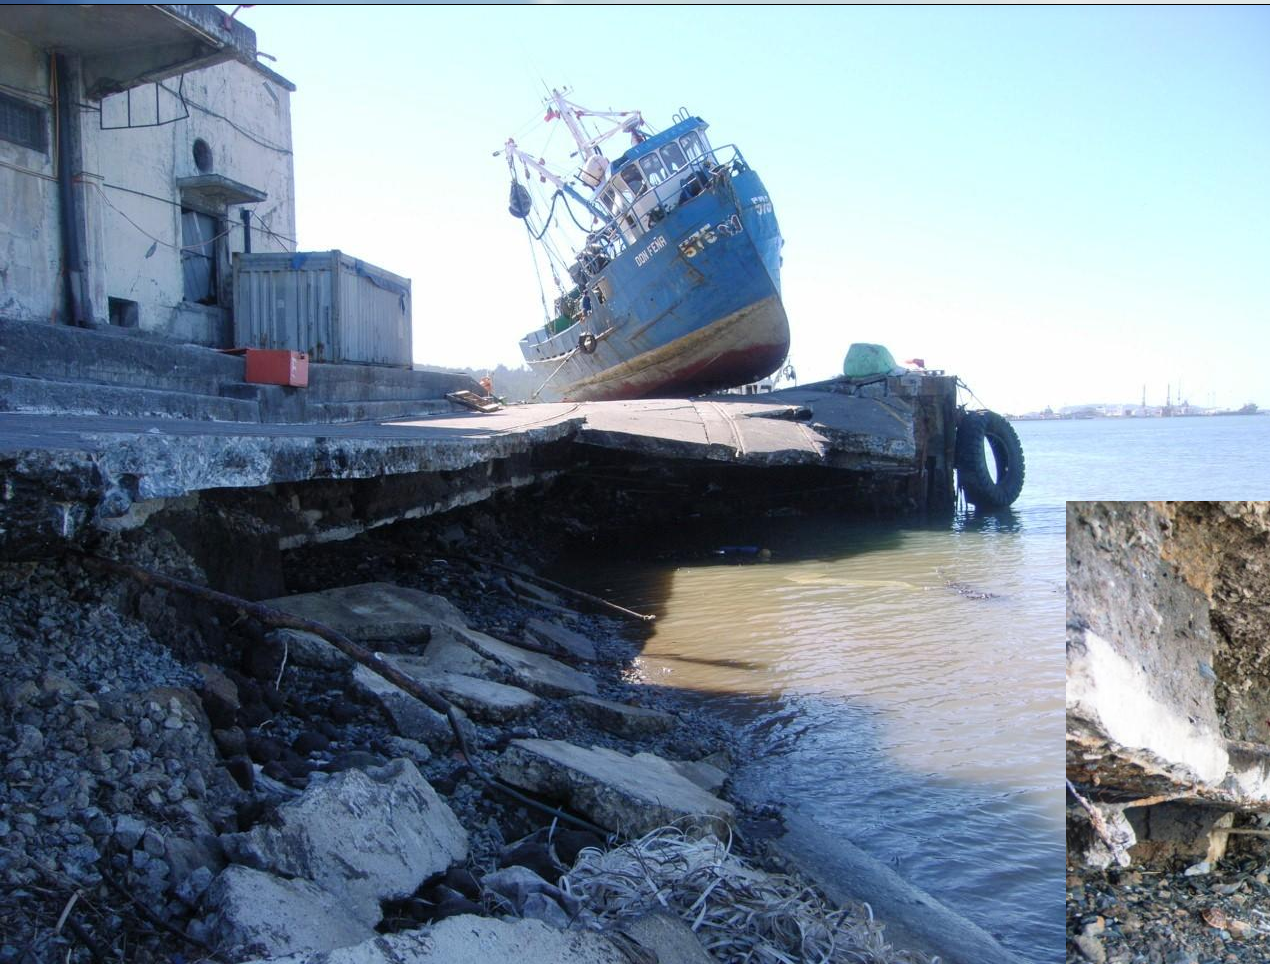
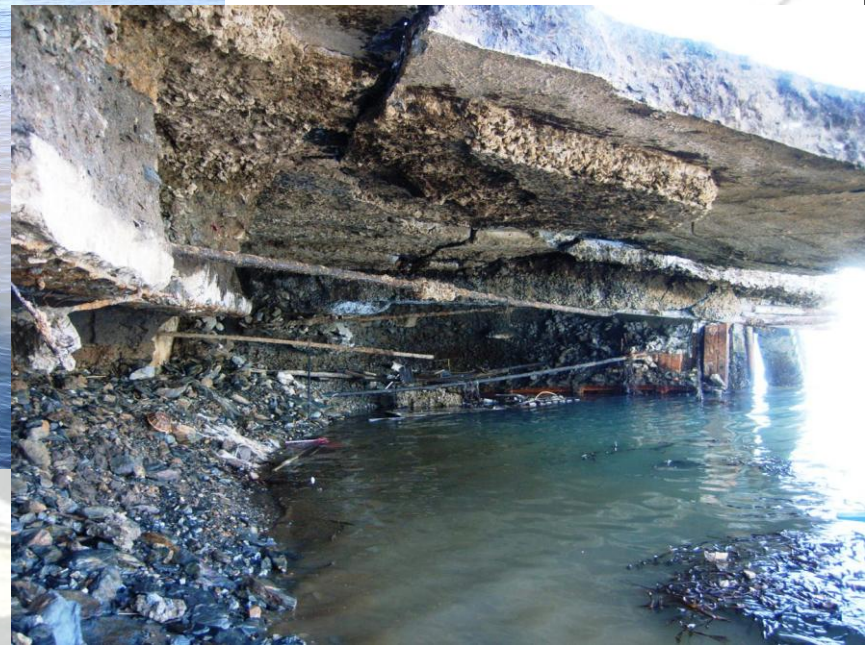
## Warehouse and pier, Talcahuano

# Scour and Fluidization

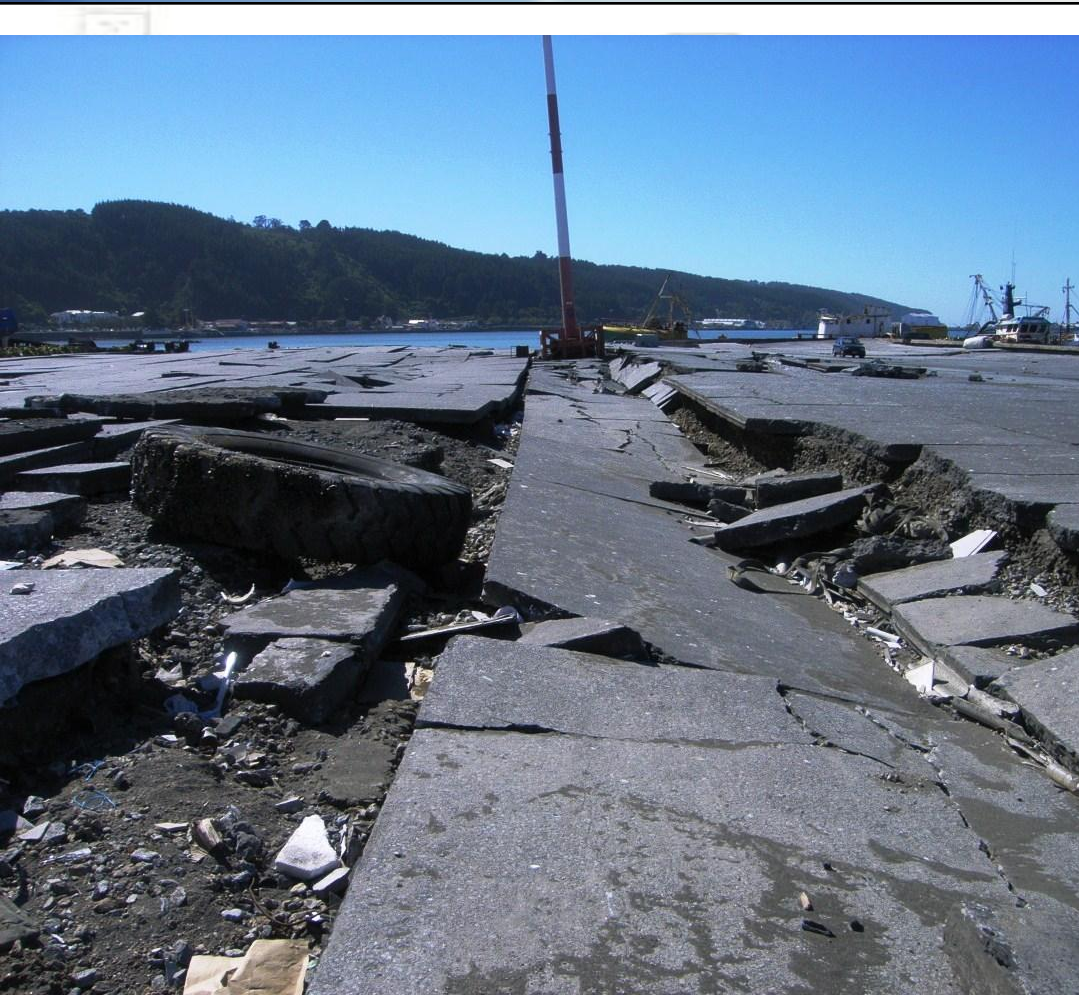
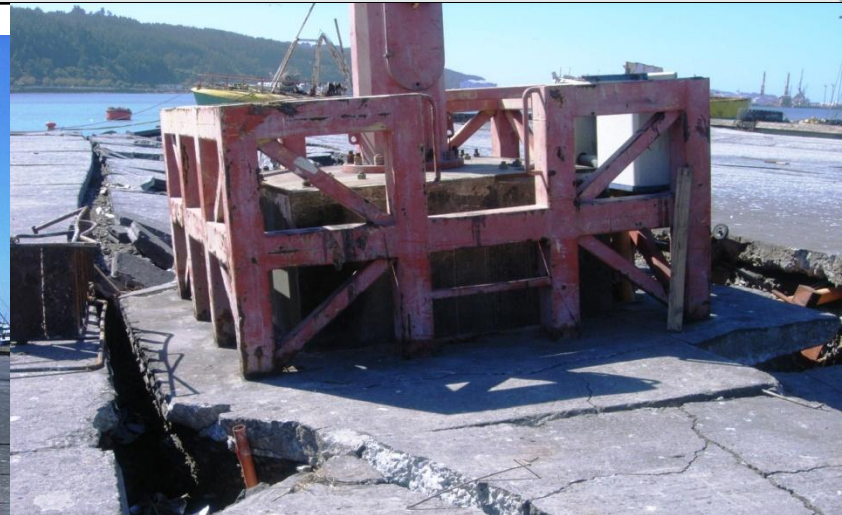
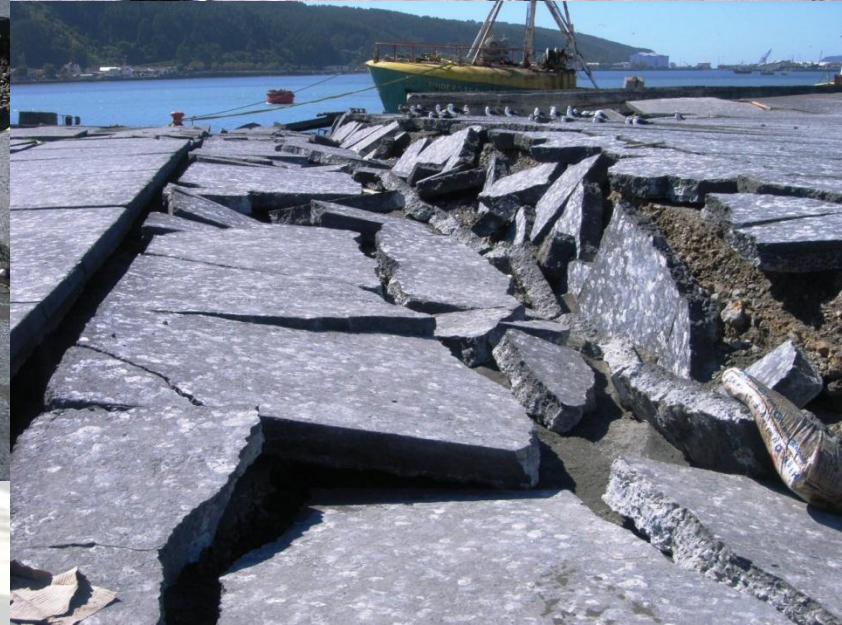
## Warehouse and pier, Talcahuano

# Scour and Fluidization

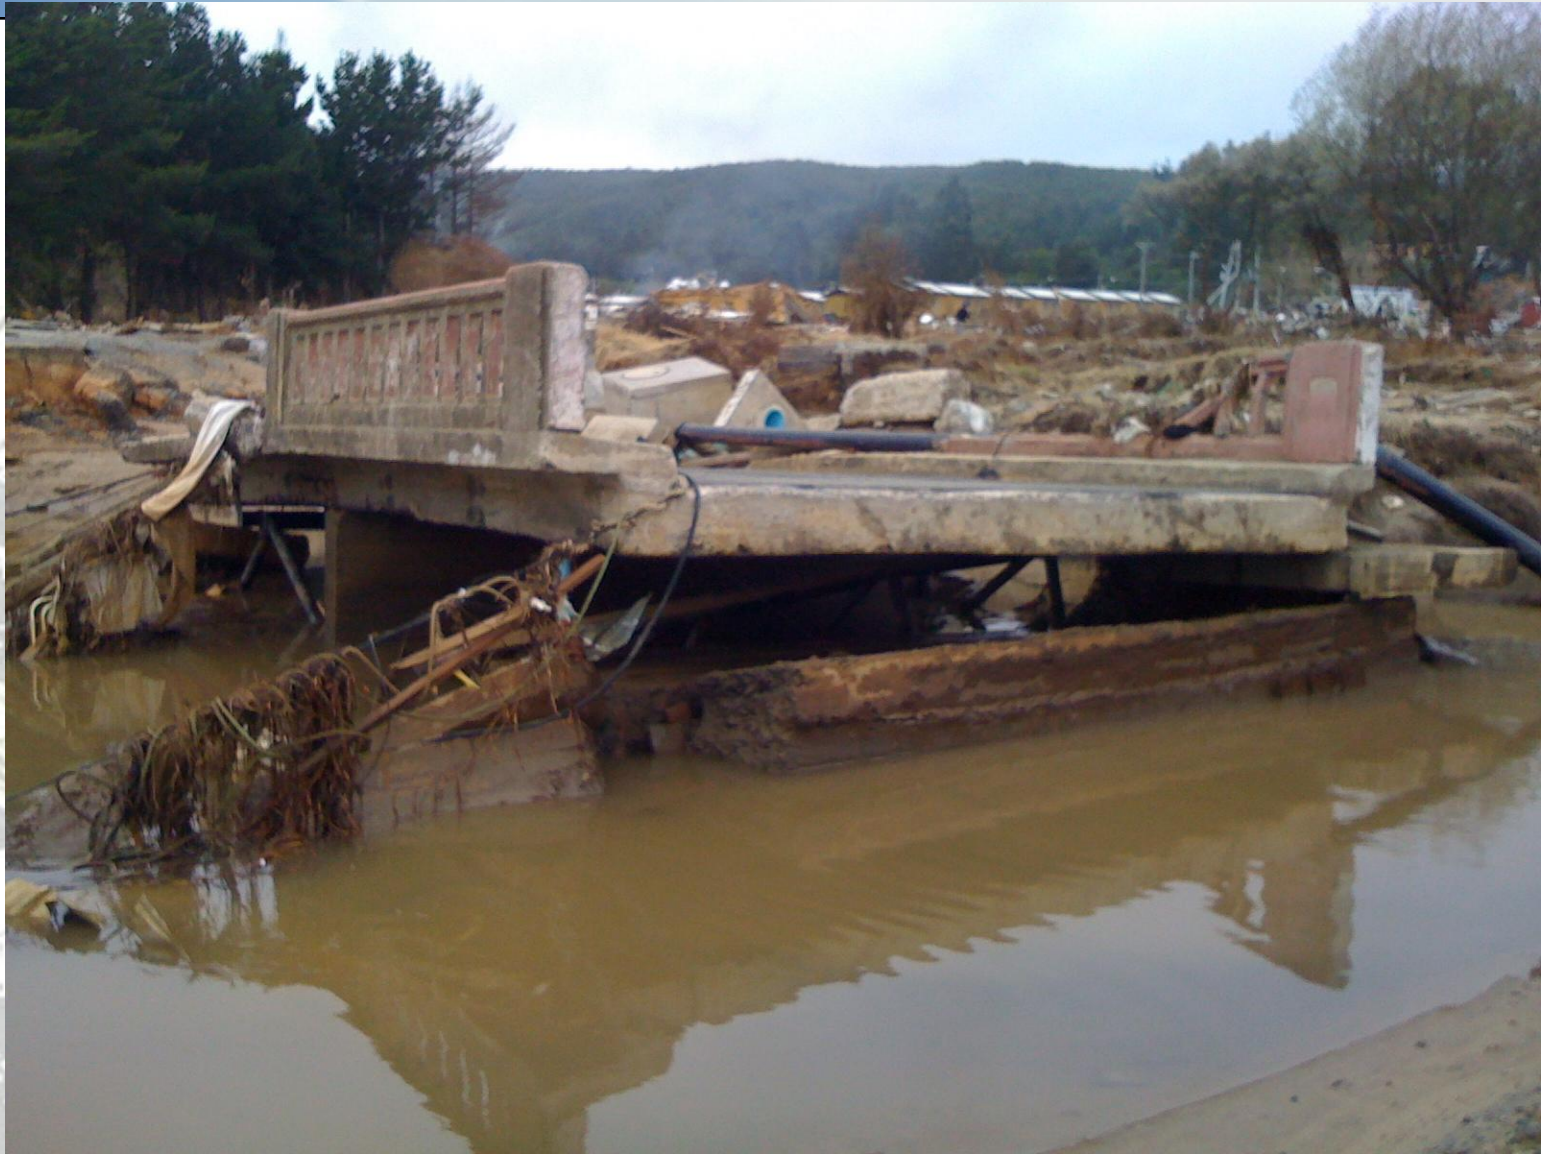
# Scour Damage

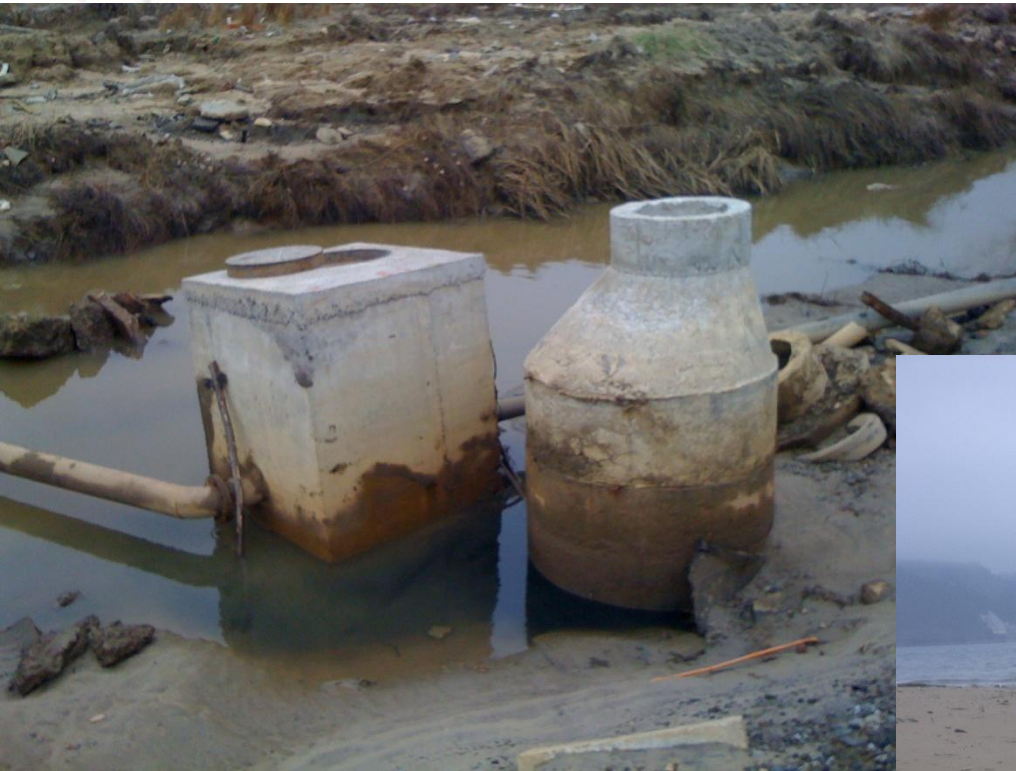
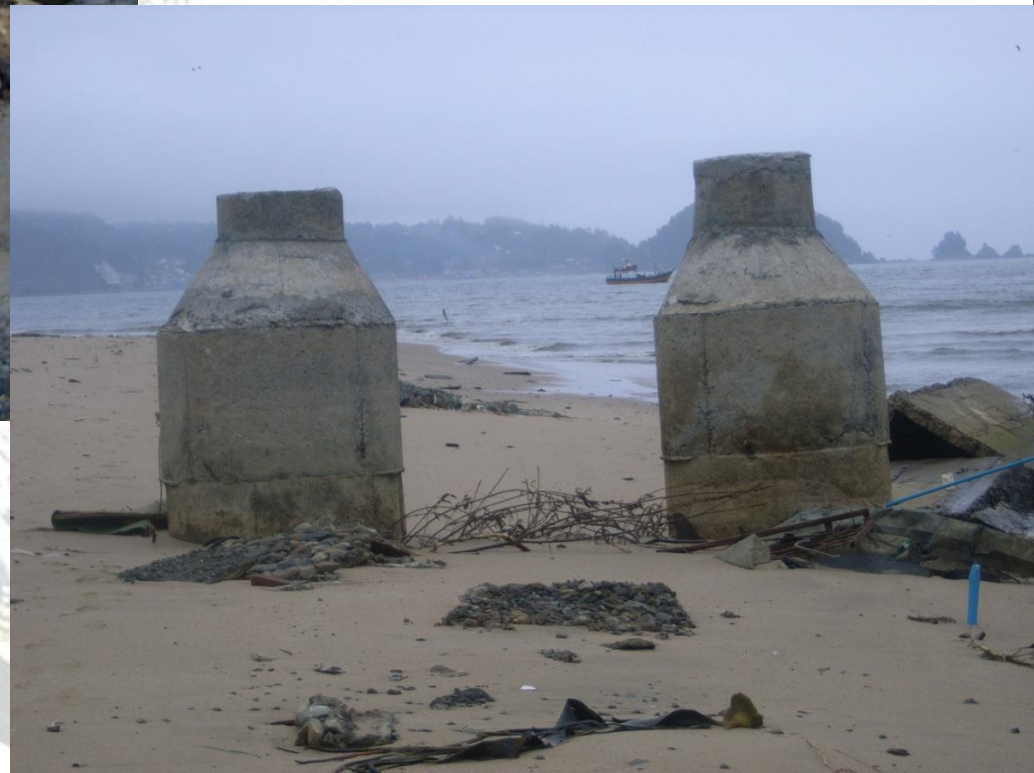
# Scour Damage

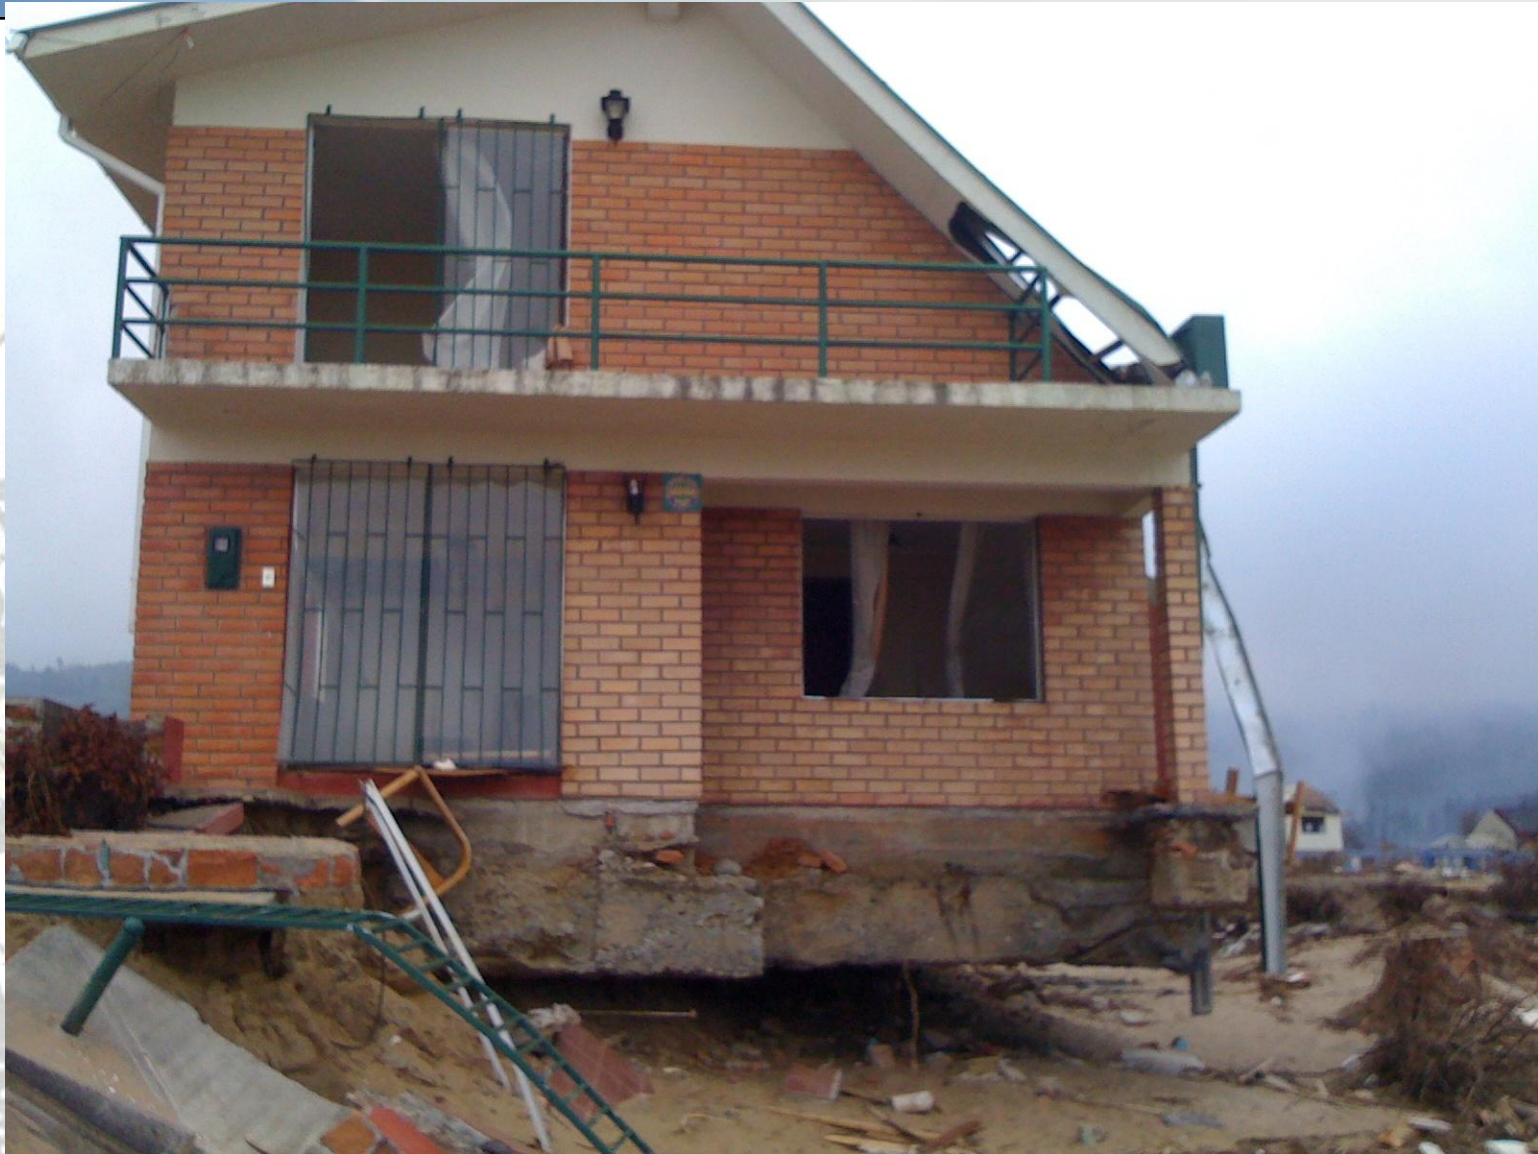
# Scour Damage

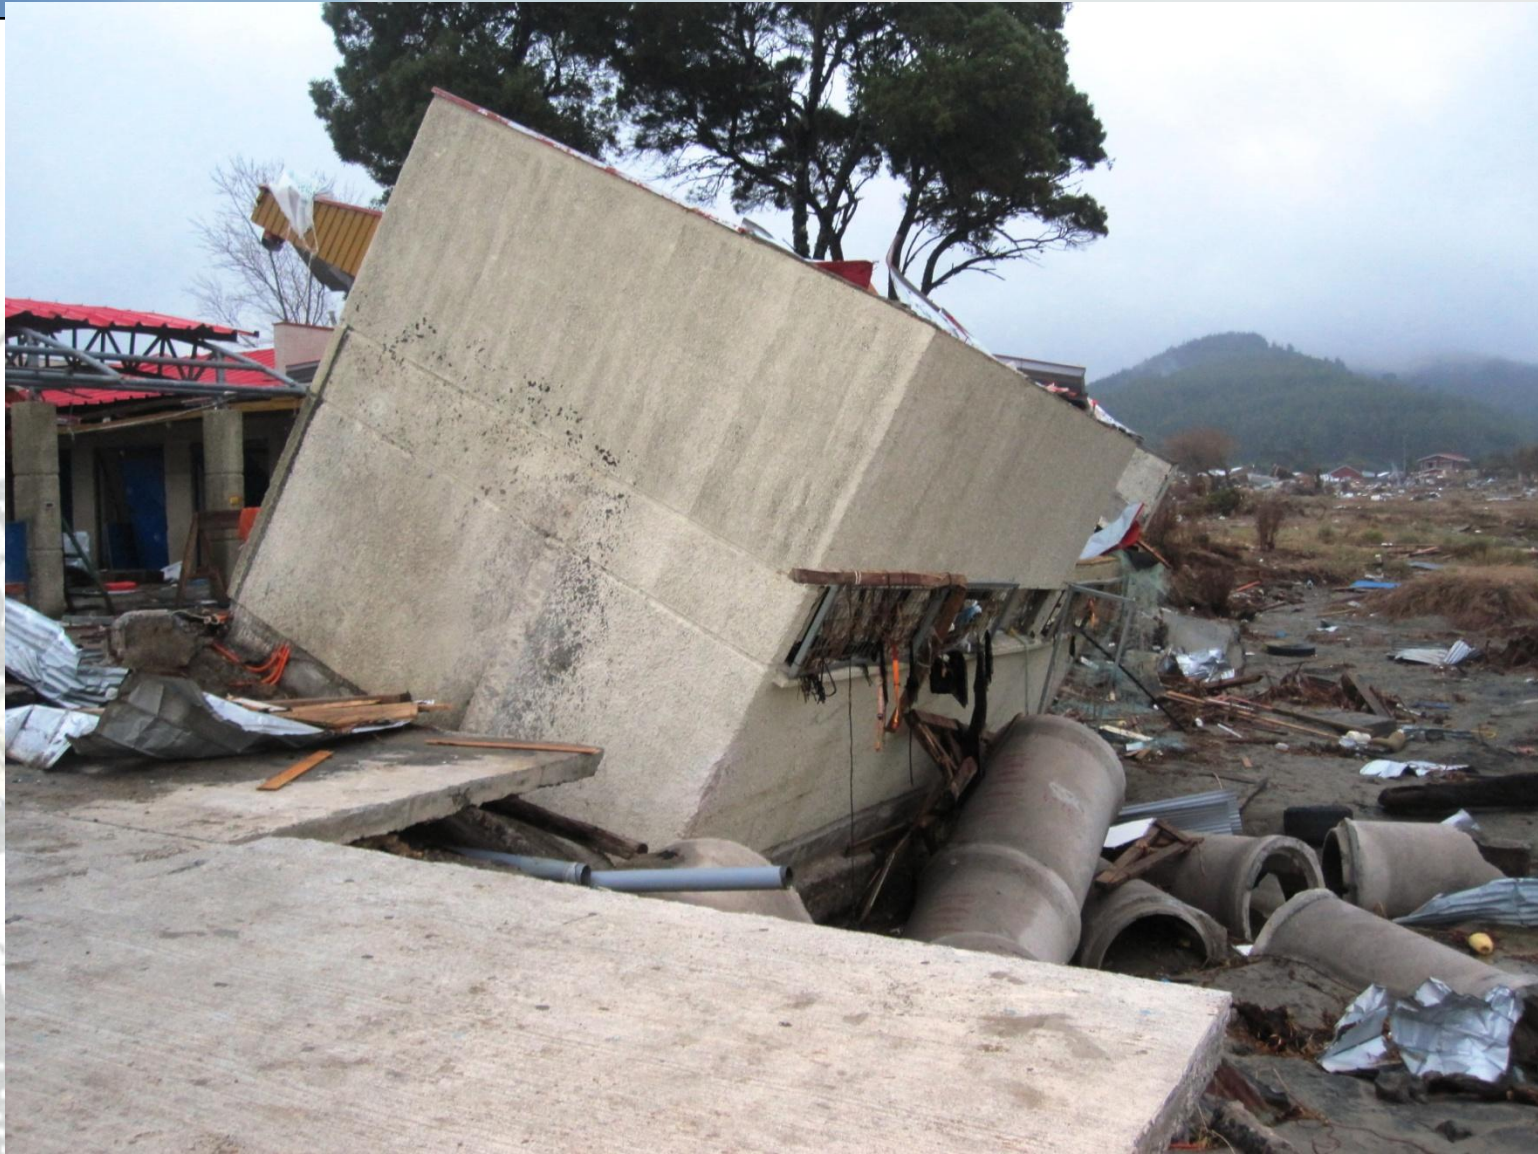
# Scour Damage

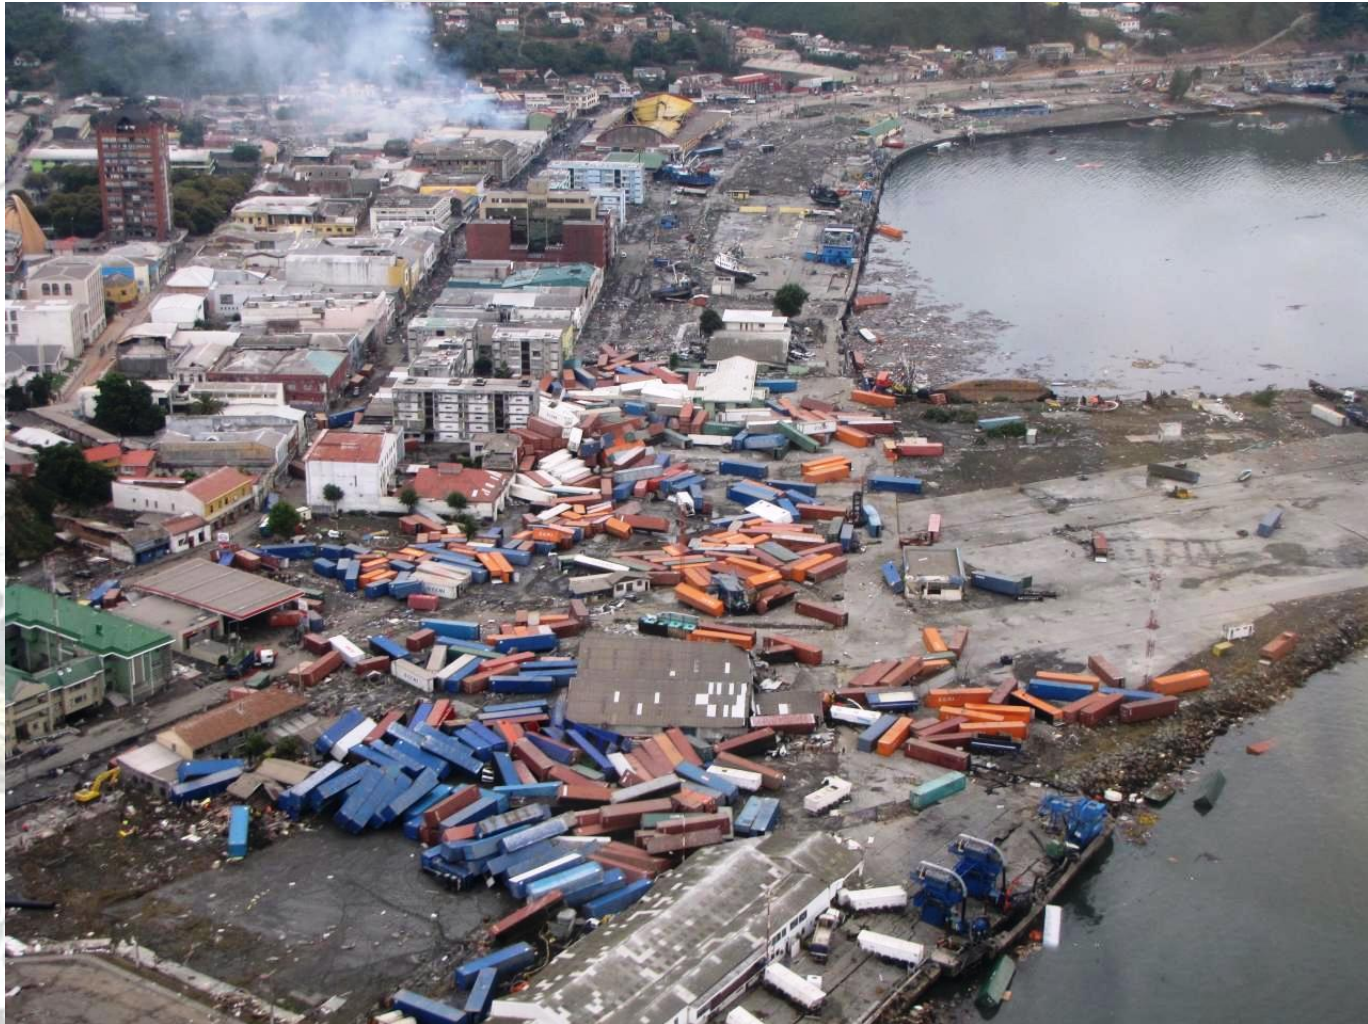
# Debris Impact

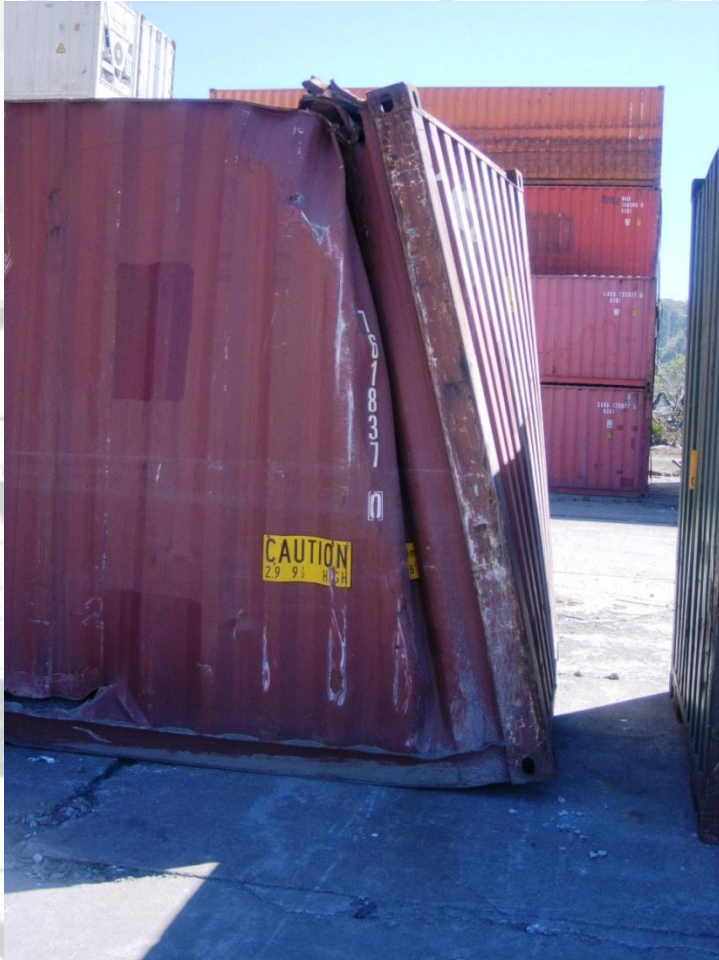
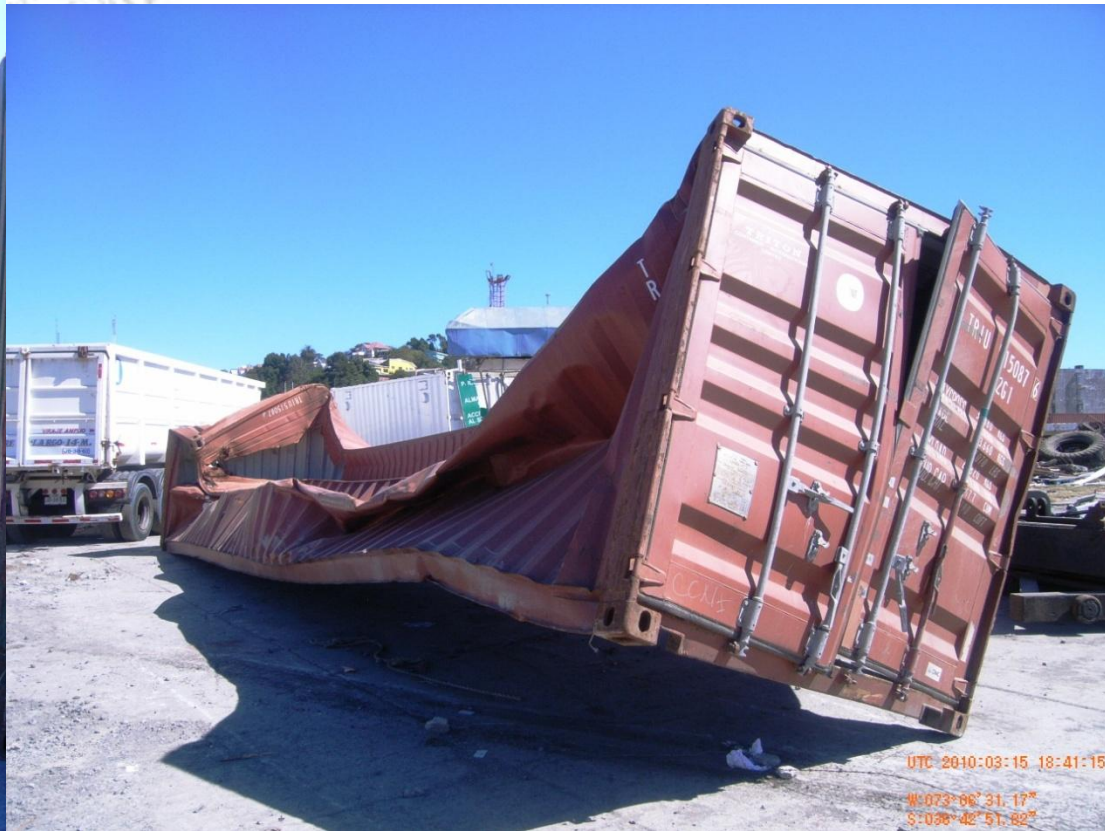
# Debris Impact

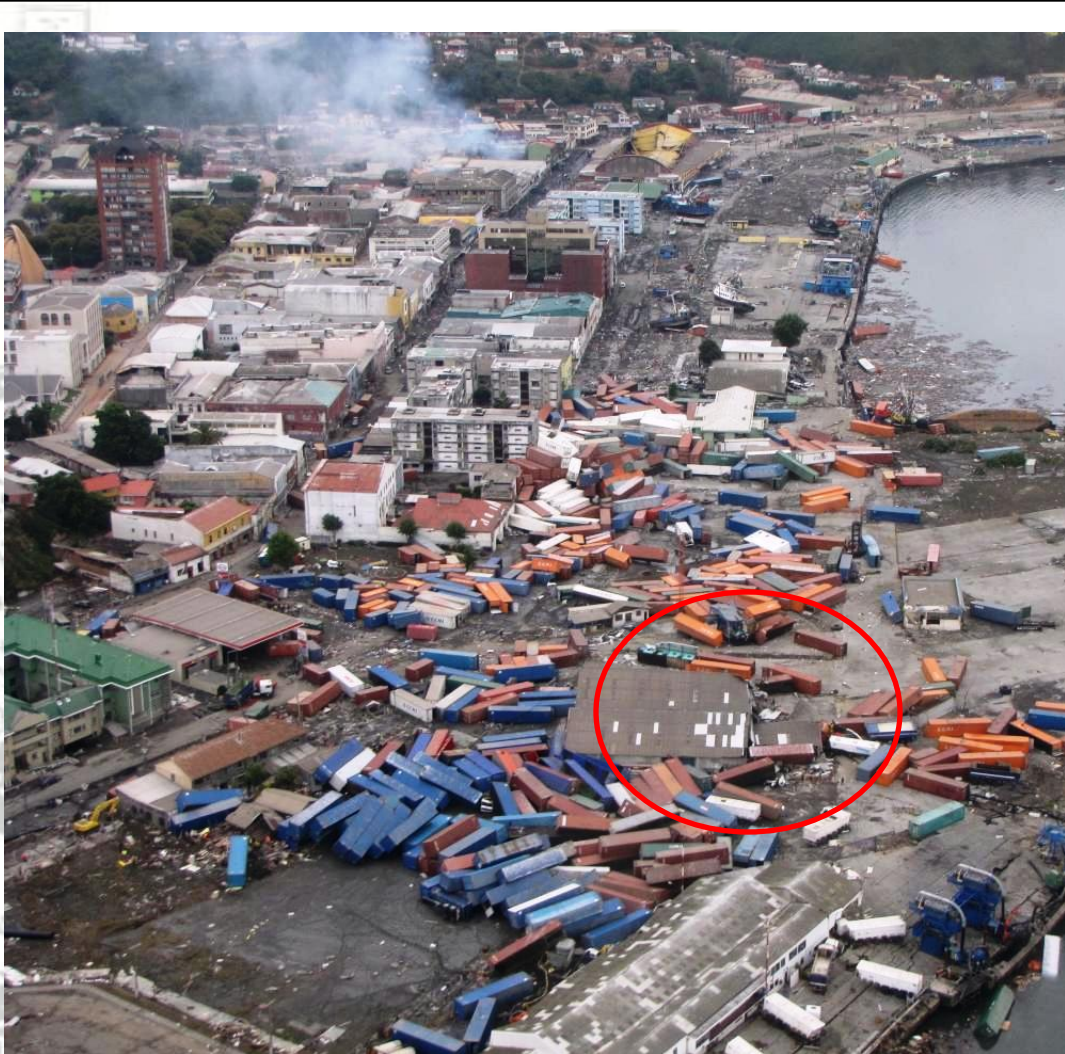
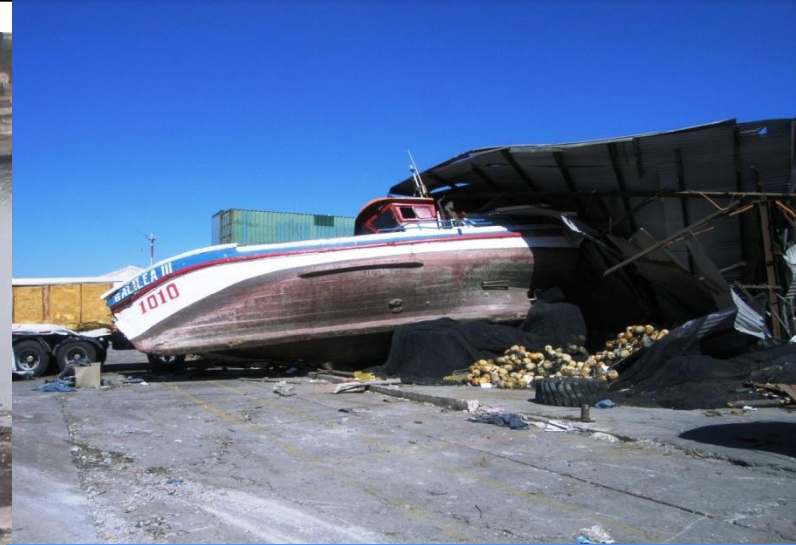
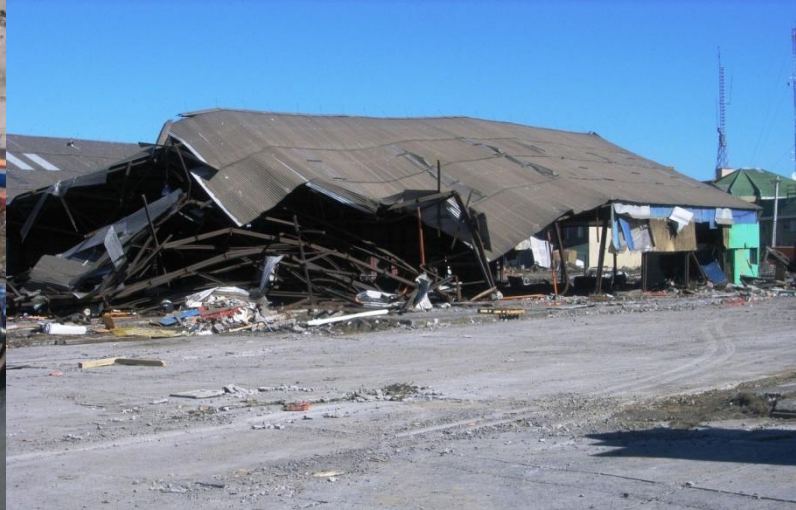
# Debris Impact

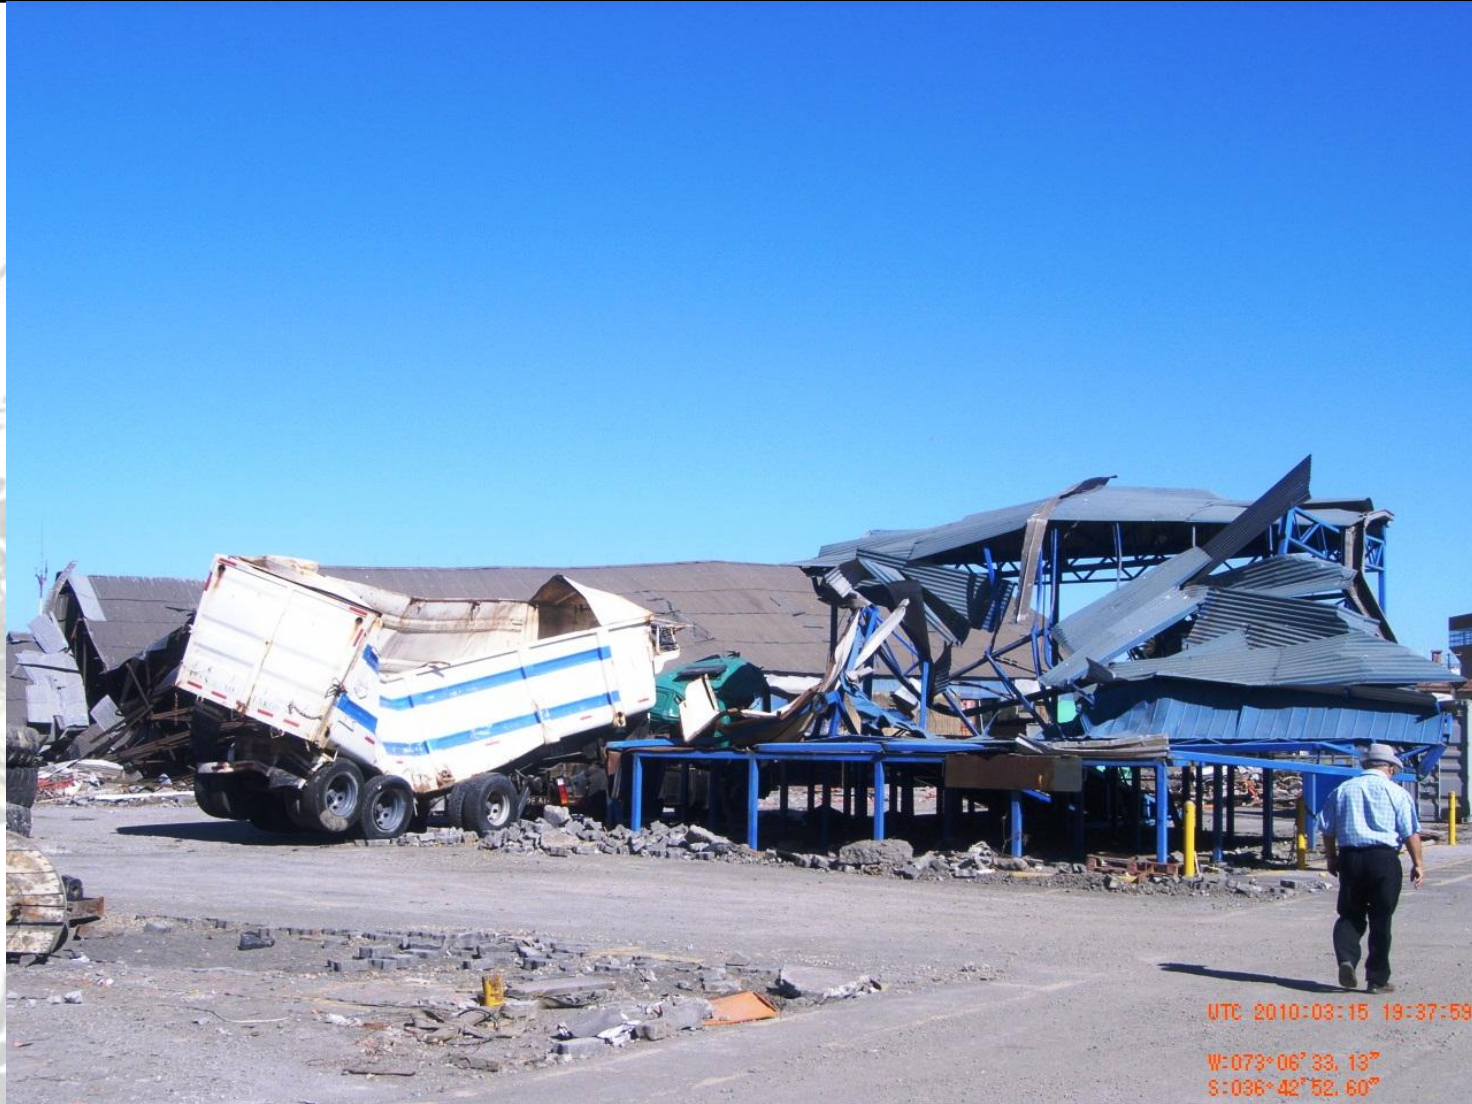
# Debris Impact
