# Masonry Investigation

EERI Investigative Team

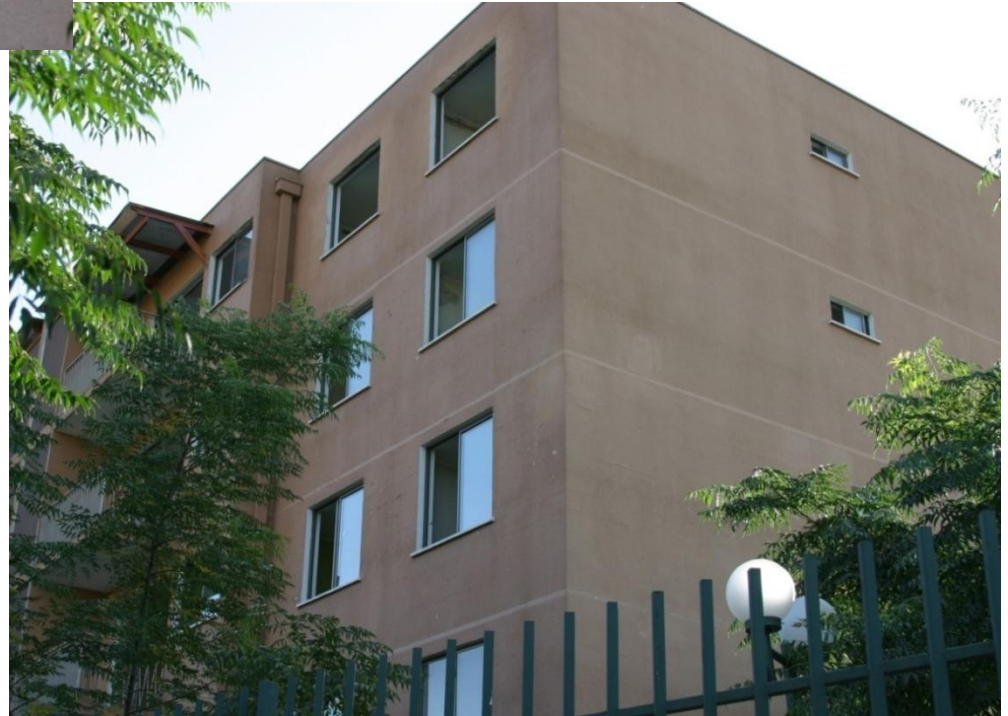
- This building could be mistaken for reinforced concrete due to “repello” or cementitious stucco on the structure. We know it is masonry due to the stair step shear crack between piers.
- Over 20 apartment complexes had no visible damage
- Performed very well

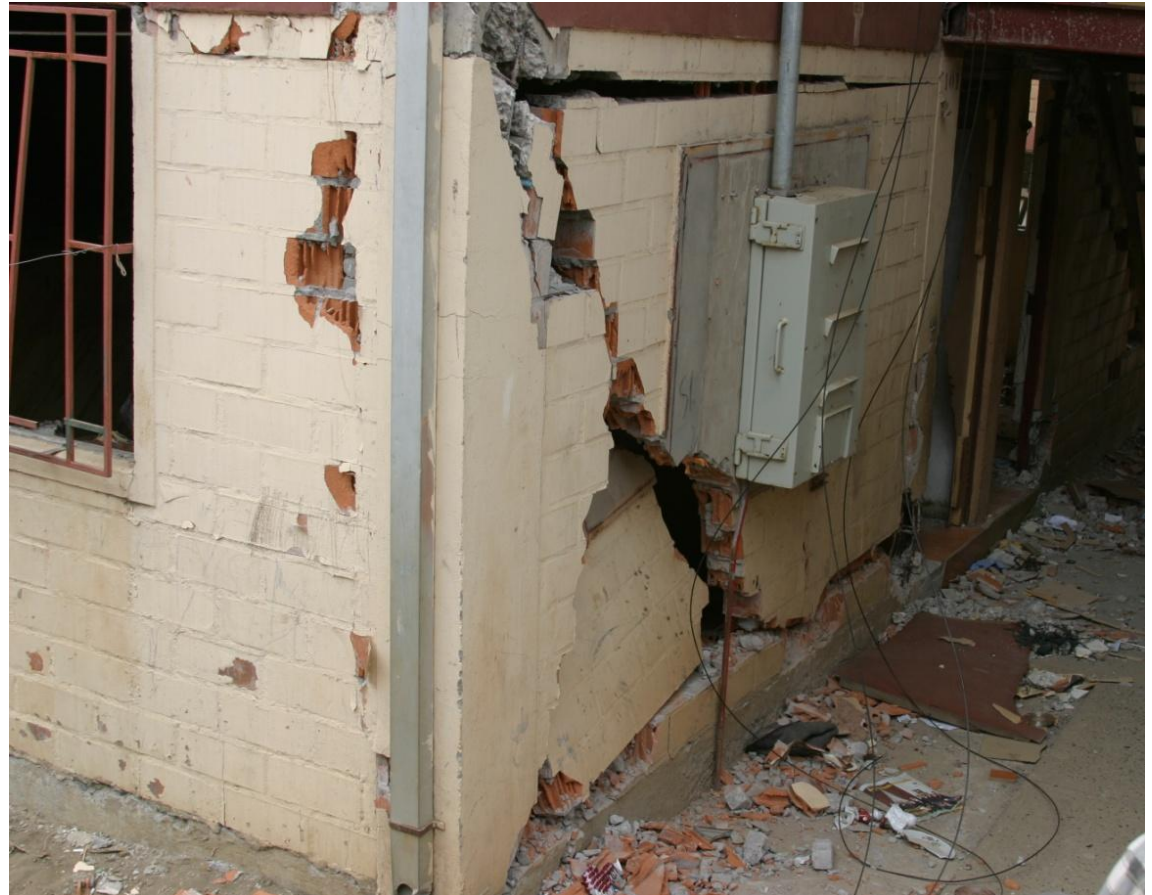
# Constitución Apartments – Rengifo 705

- In-plane shear failure of masonry visible in several buildings
- Damage concentrated in lower levels where shear is highest

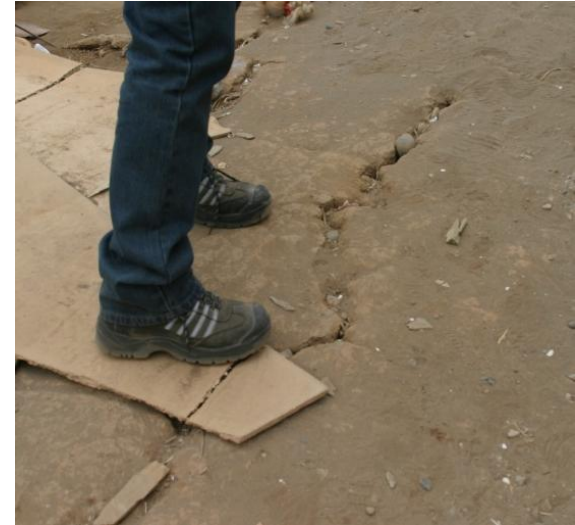
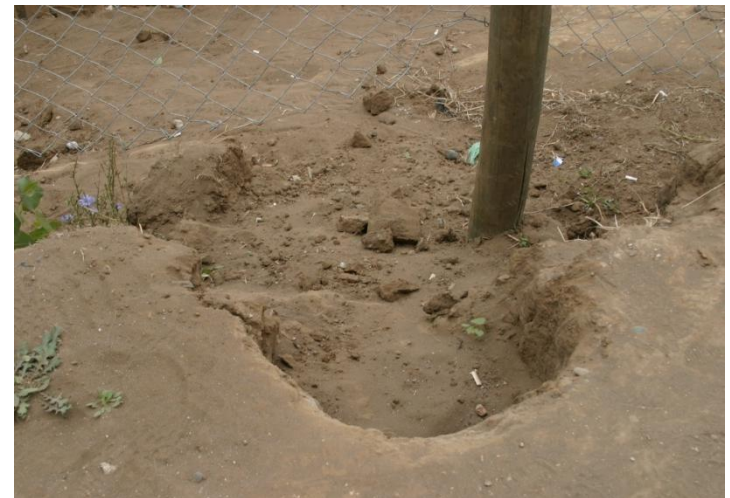
# Local Soil Issues – Rengifo 705

- Evidence of lateral spreading
- Soil cracking
- Soil movement towards steep slope approximately 20 ft from home.
- Highest level of damage in buildings located near the slope.

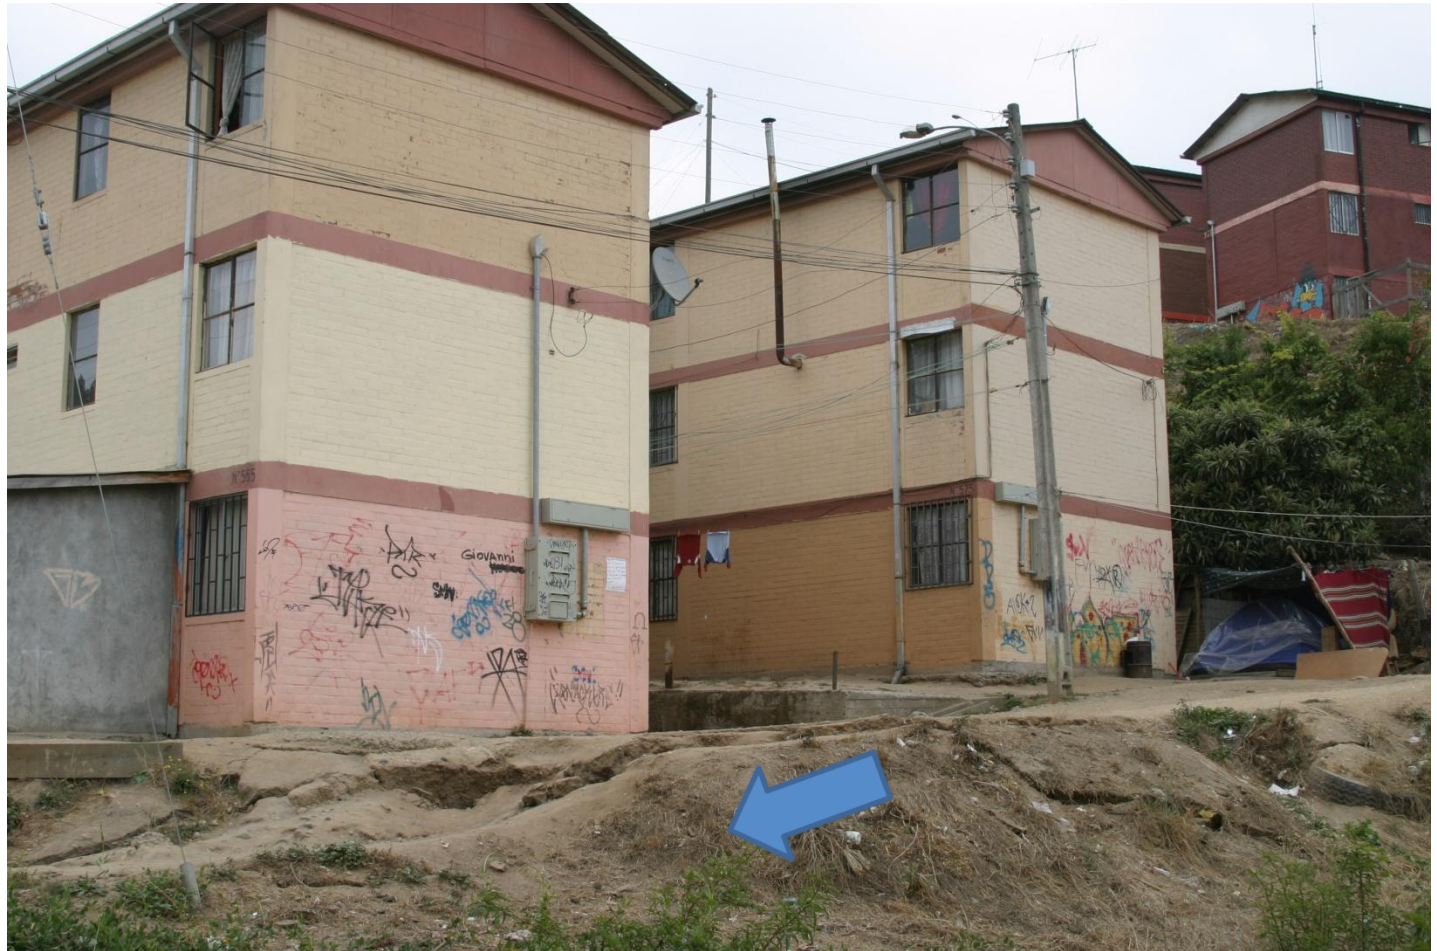
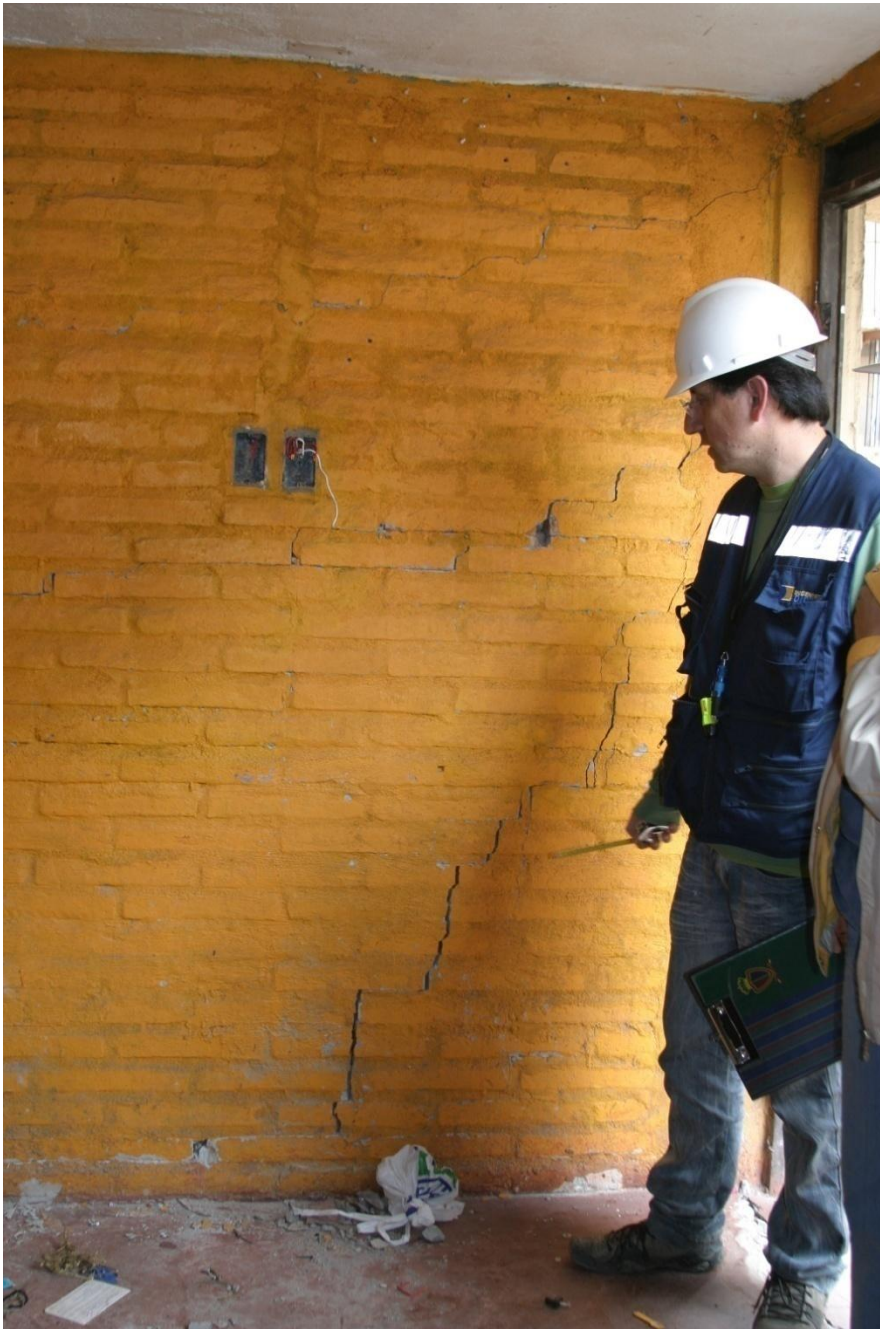
# Constitución Apartments – Mesa Seco

- Soil moving downhill

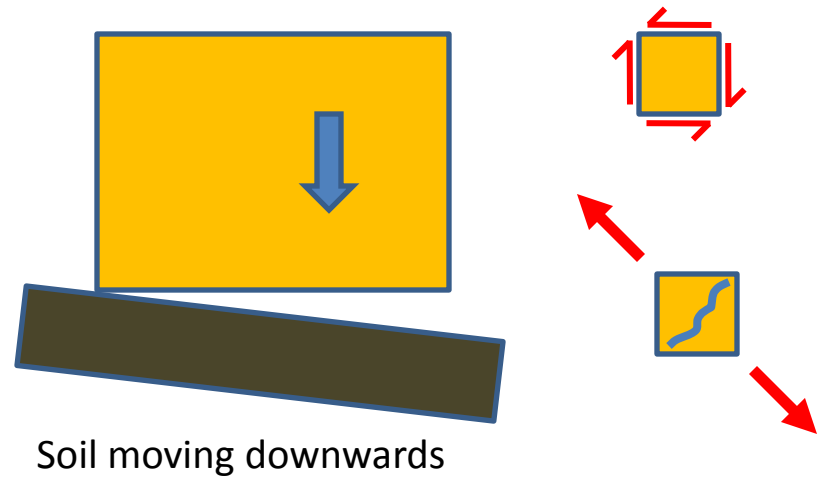
# Mesa Seco

- Shear cracks in one direction
- Earthquake would cause shear cracks in two directions
- Free-body diagram explains everything

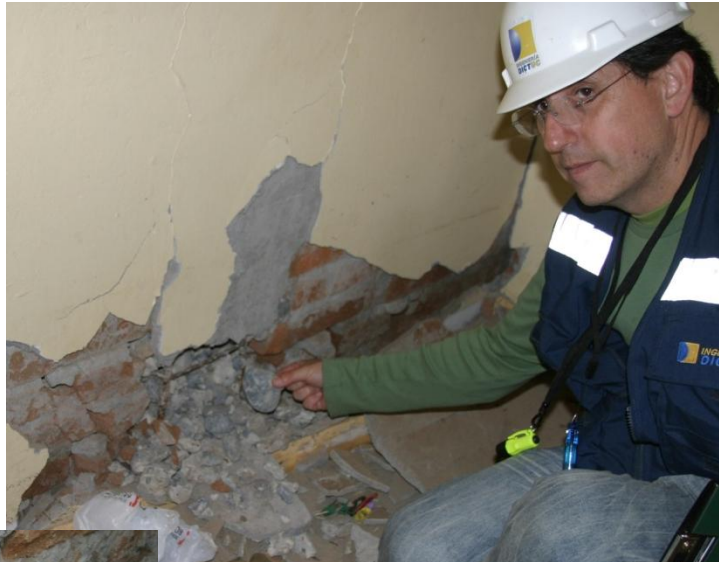
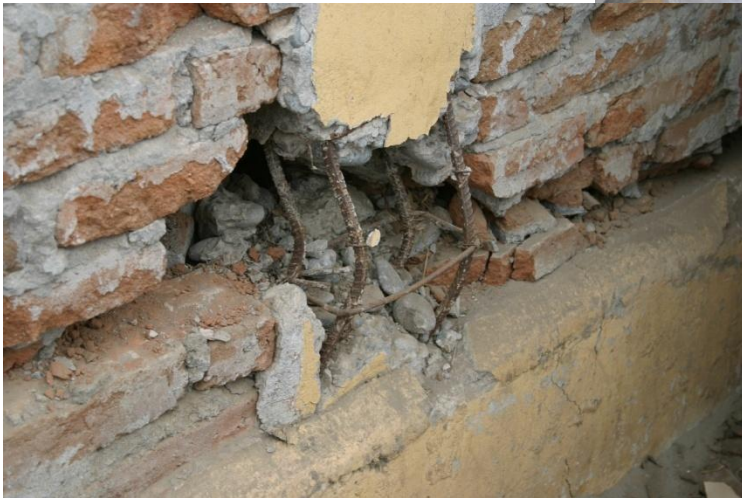
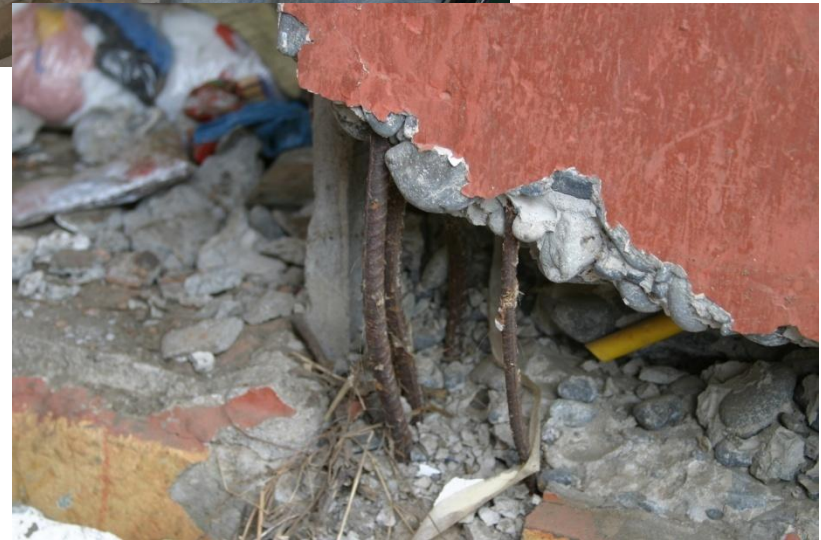
# Poor construction - O'Higgins 859

- Aggregate size too large
- Lack of confinement
- Different bar sizes

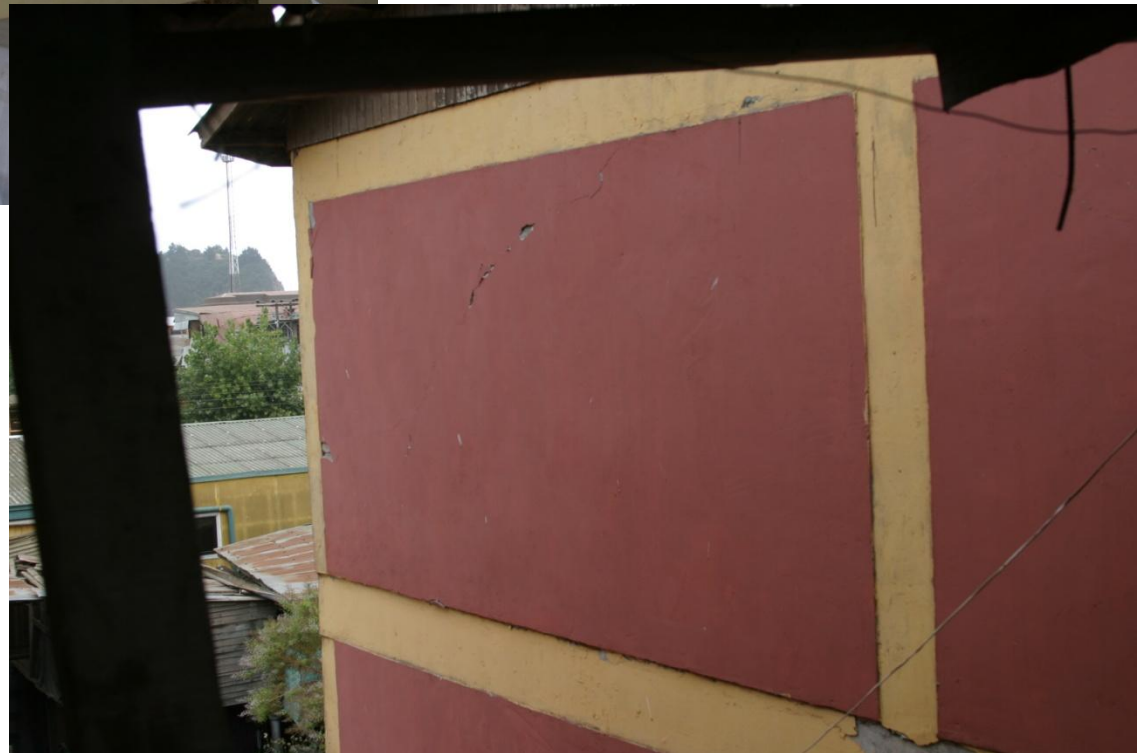
Diagonal cracks in  
fourth floor on  
inside and outside  
of structure

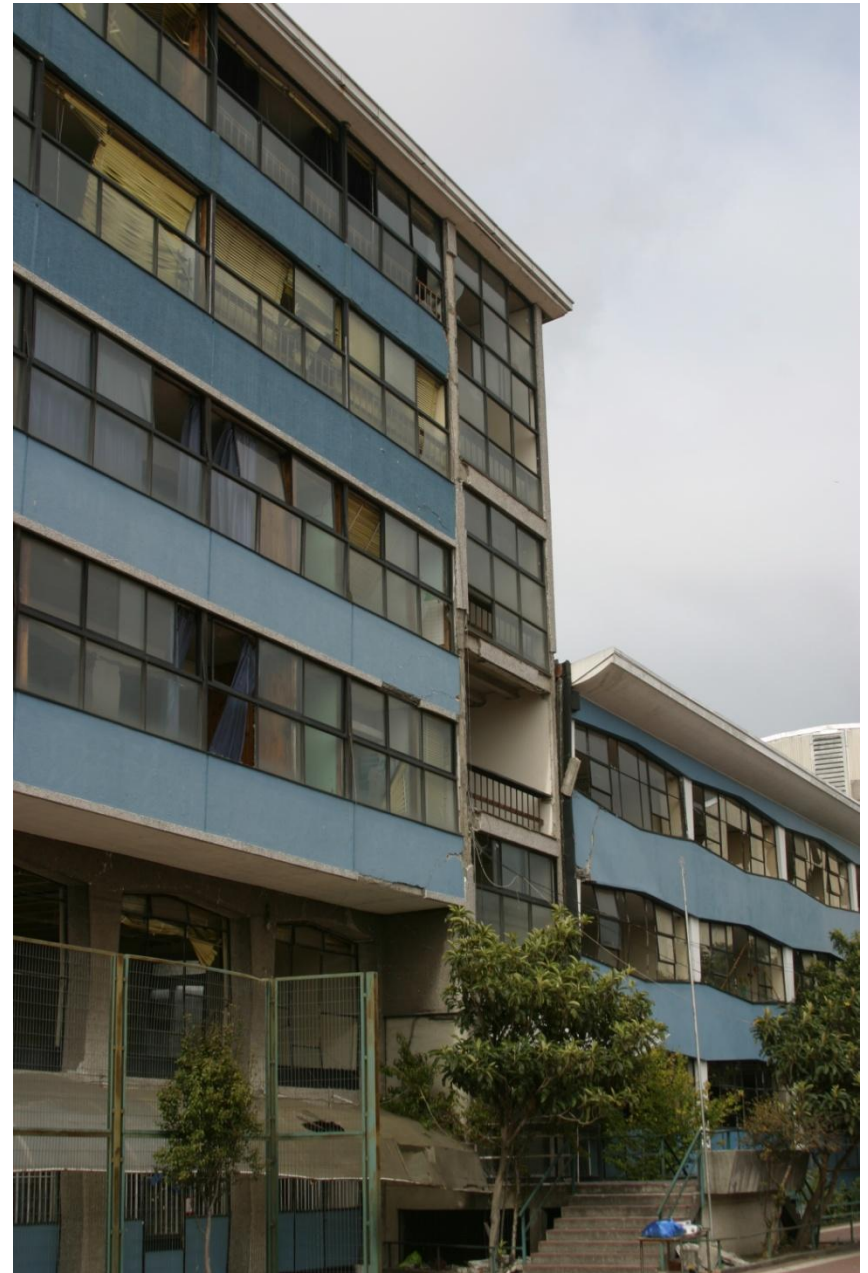
School building that  
is out of service due  
to shear cracks

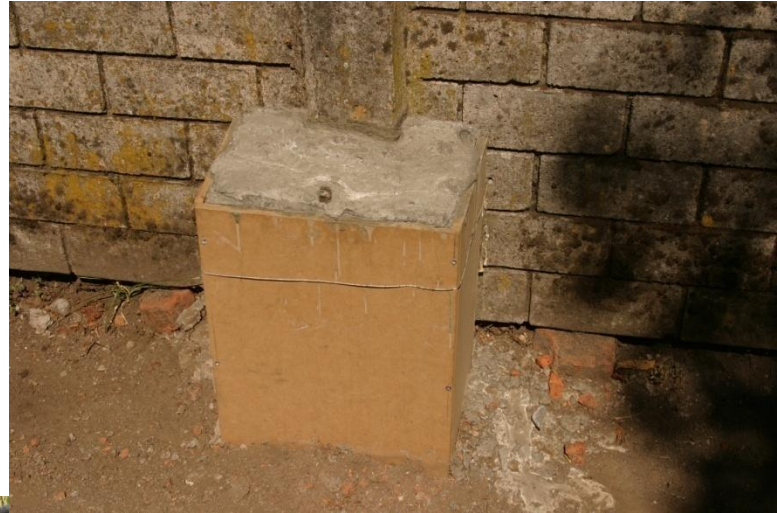
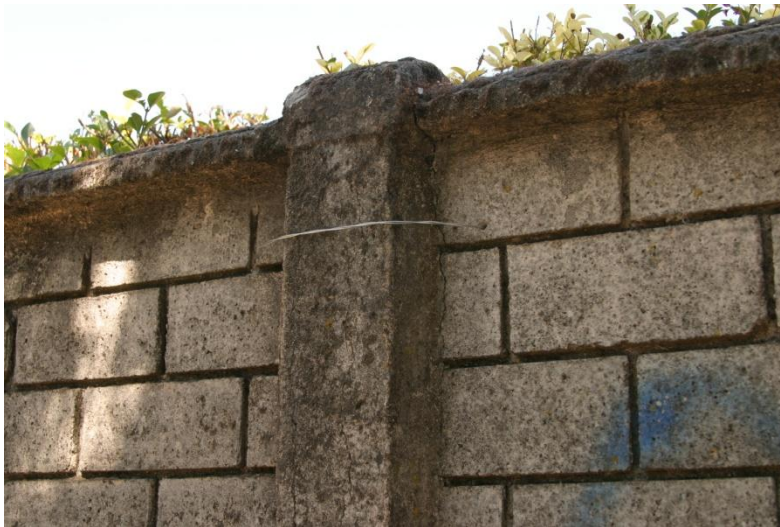
# Confined Masonry Fence (2)

- Enlarging section at base
- Attempt to tie back top of column

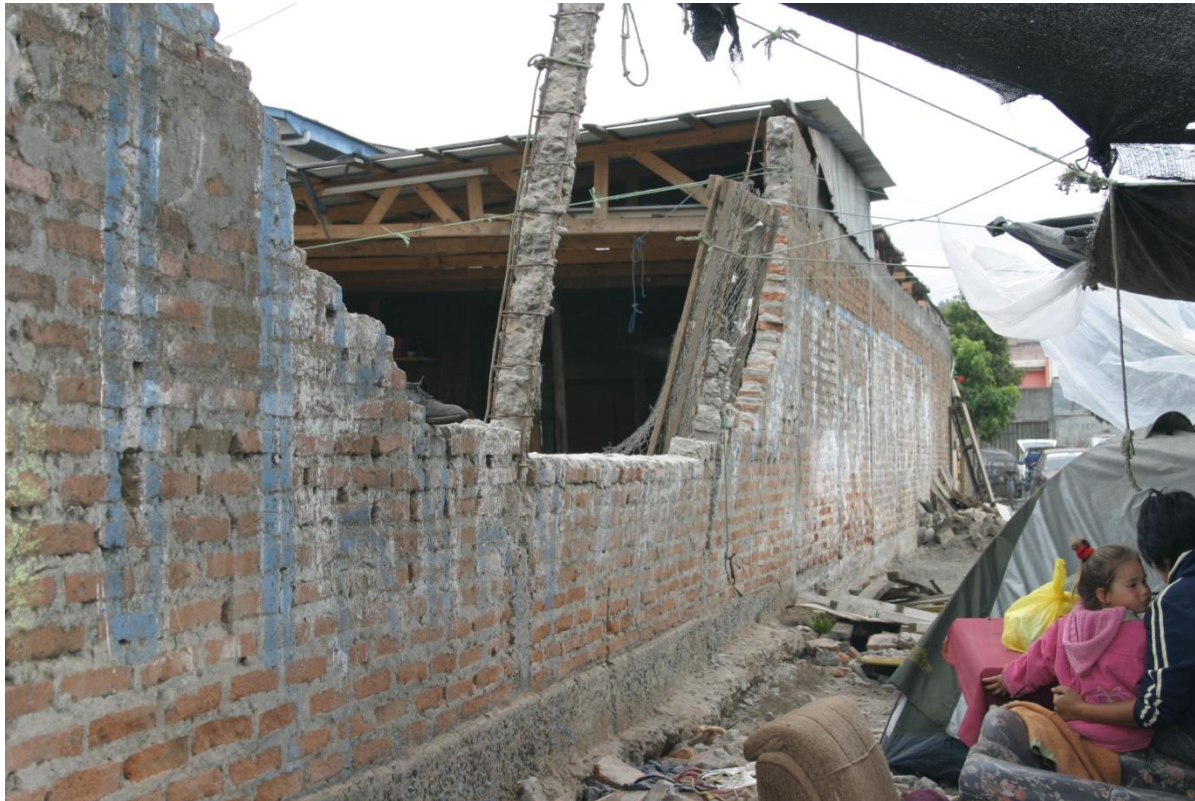
# Confined Masonry Fence

- Different than fence in previous two slides. This one had out-of-plane failure and the concrete column is the only section that remained.

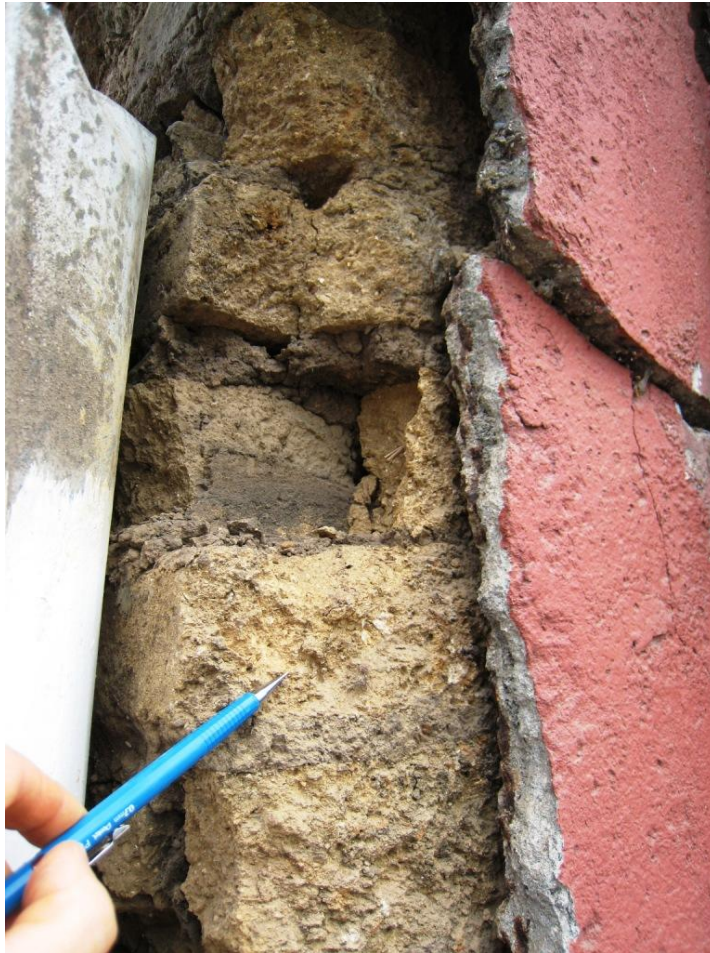
Often is lower quality.

Can see straw in some units.

Column in masonry wall  
has no vertical steel

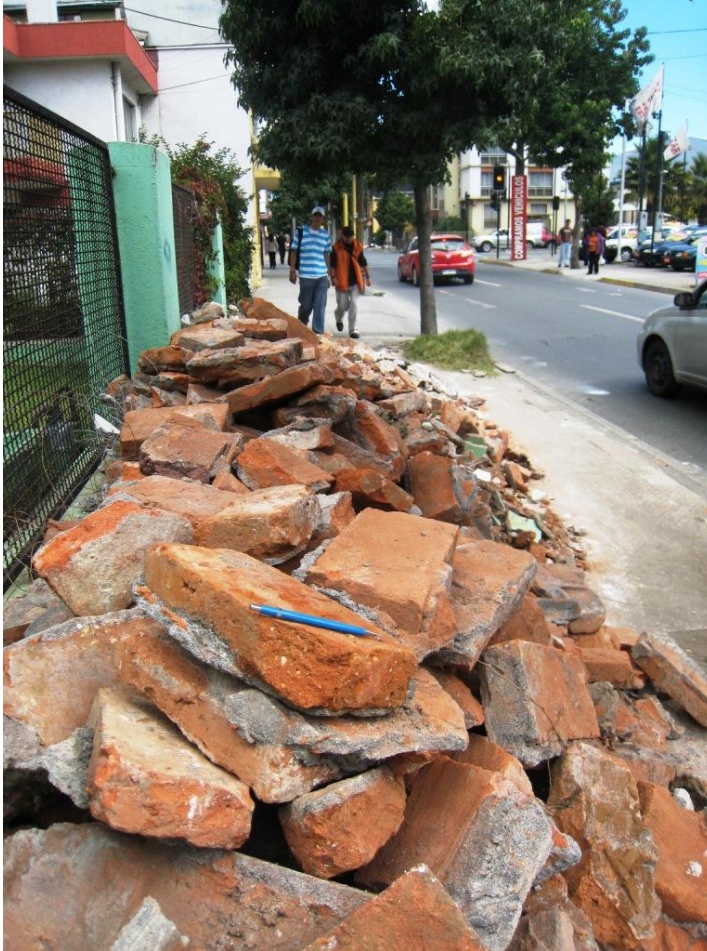
Unreinforced  
masonry  
failures were  
very common

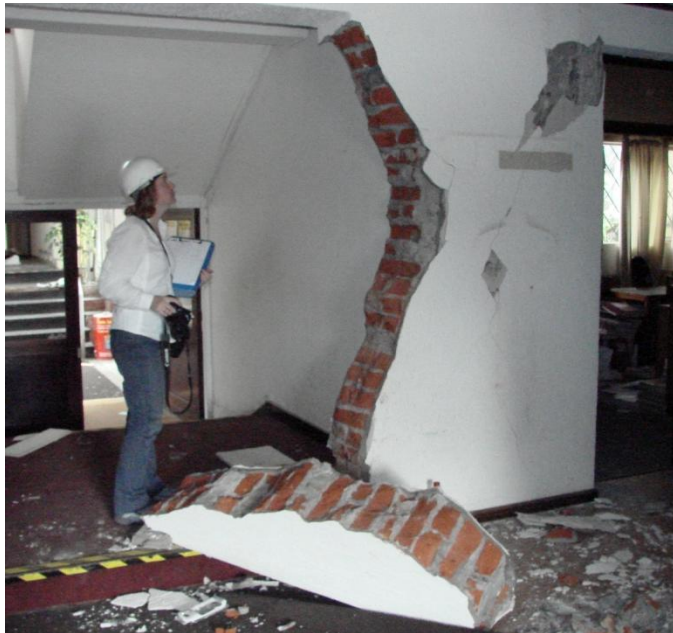
# 250 Sargento Aldea

- Diagonal cracking in piers

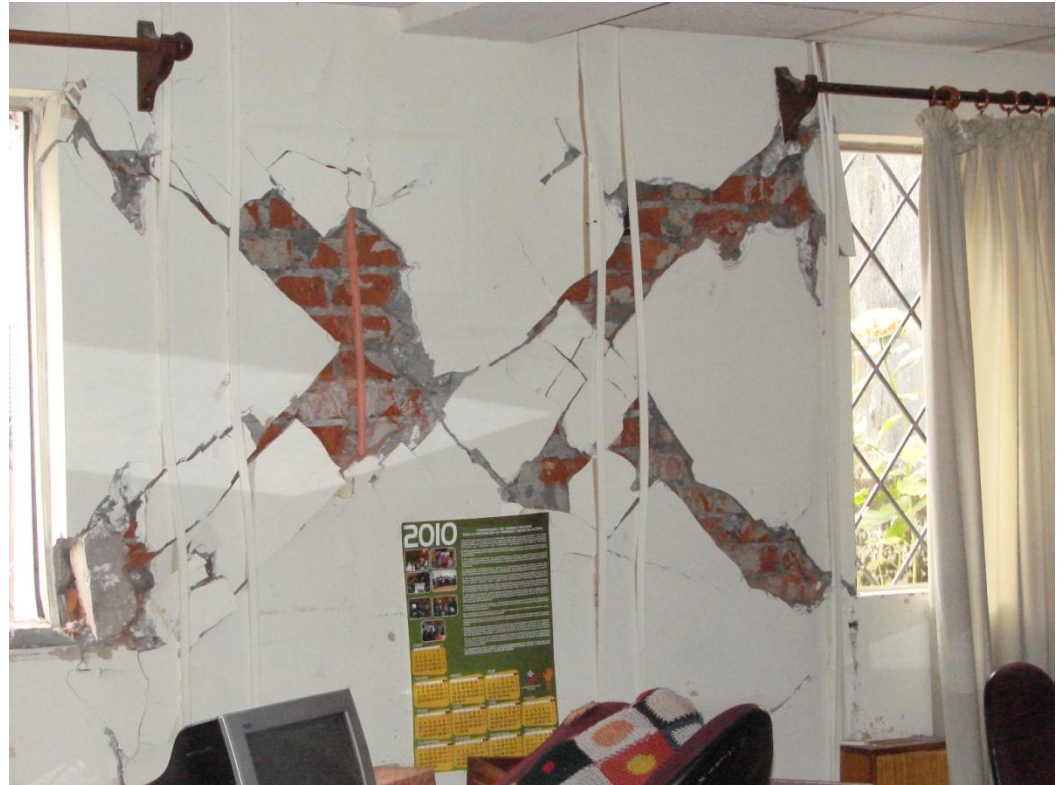
- Diagonal cracking in shear wall between window openings

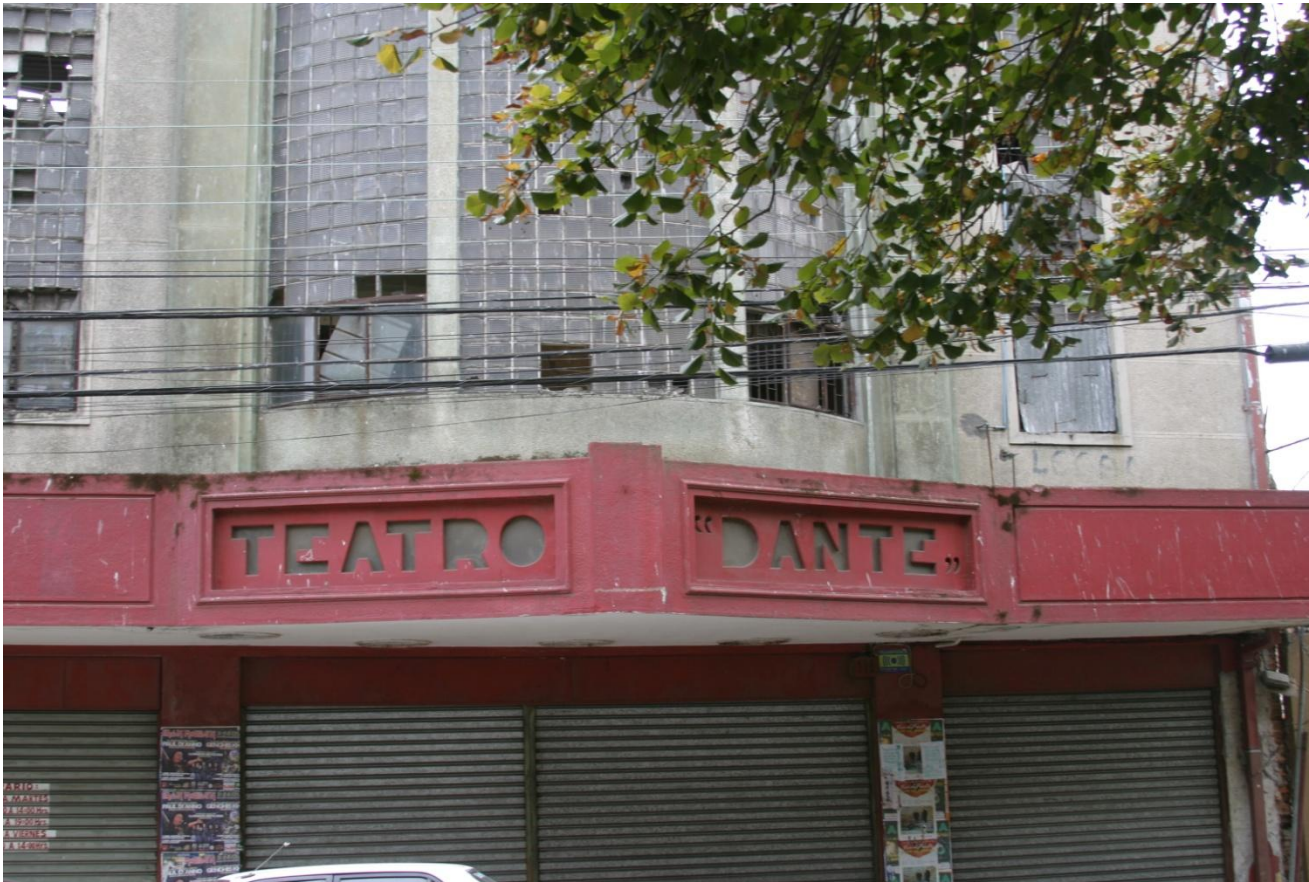
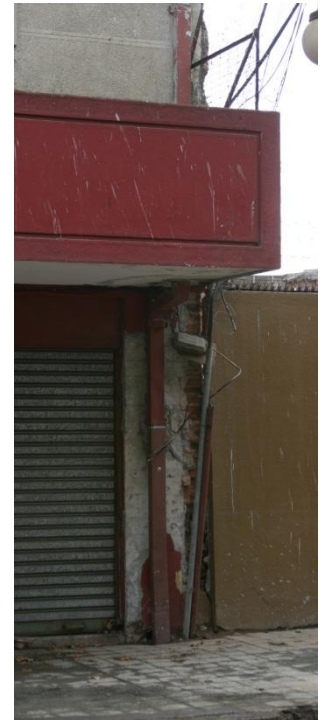
# Dante Theater

- Cracked windows
- Loss of cementitious coating
- Problems at connection
- Out of plane failure in side wall

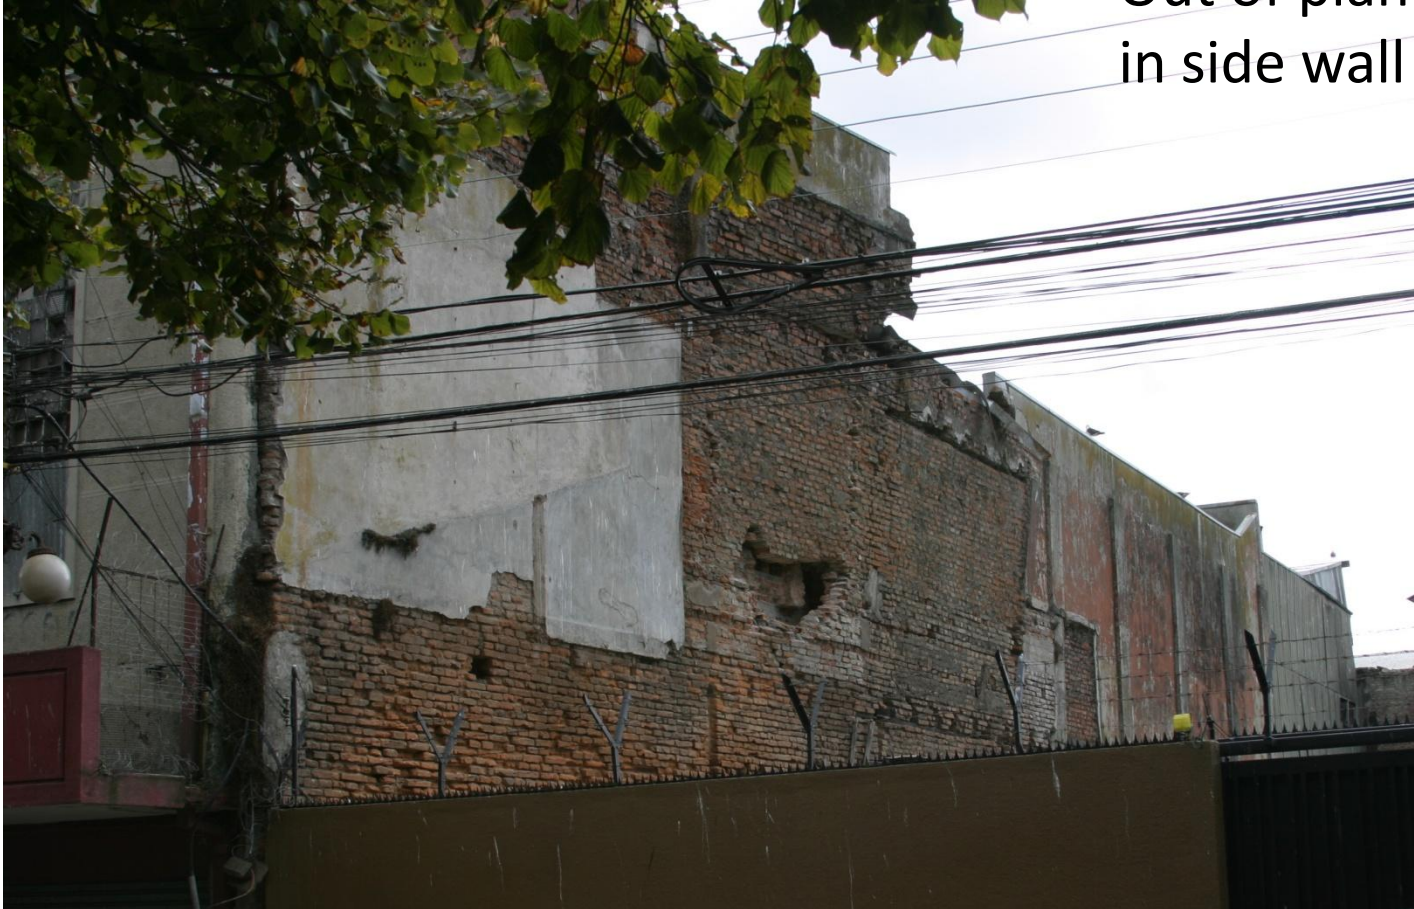
# Dante Theater (2)

- Out of plane failure in side wall

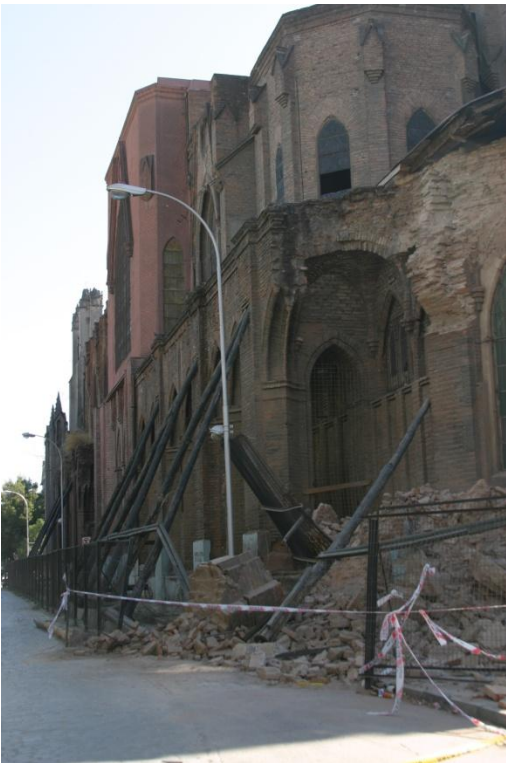
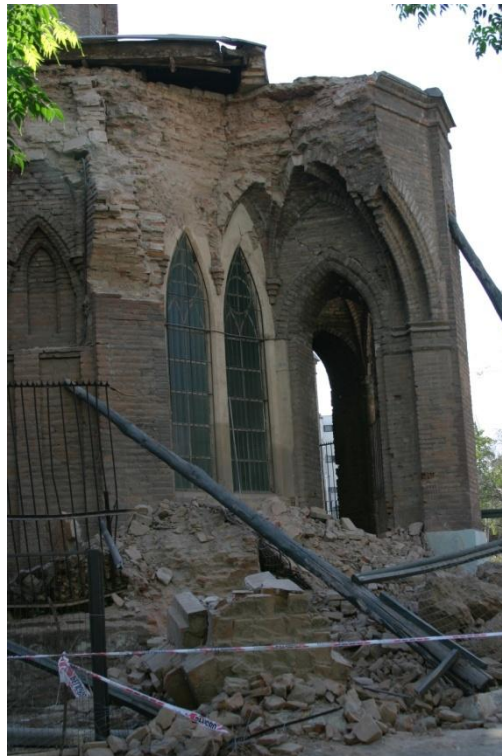
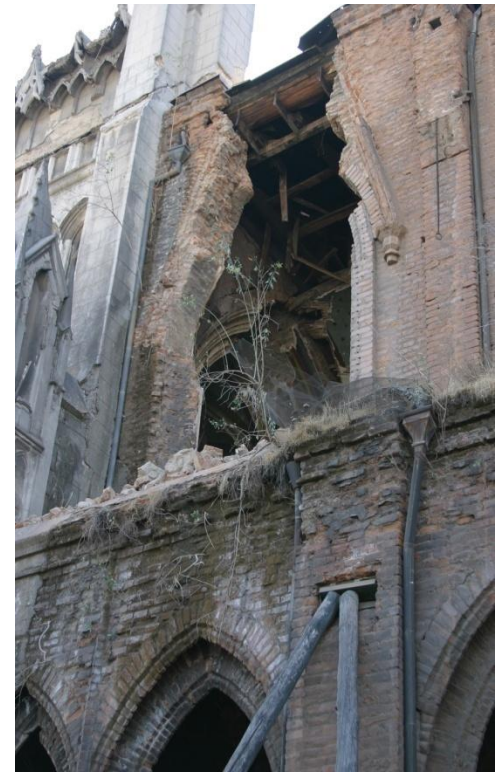
# Basilica de El Salvador

- Exterior arch was lost
- Out-of-plane failure of gothic arch section

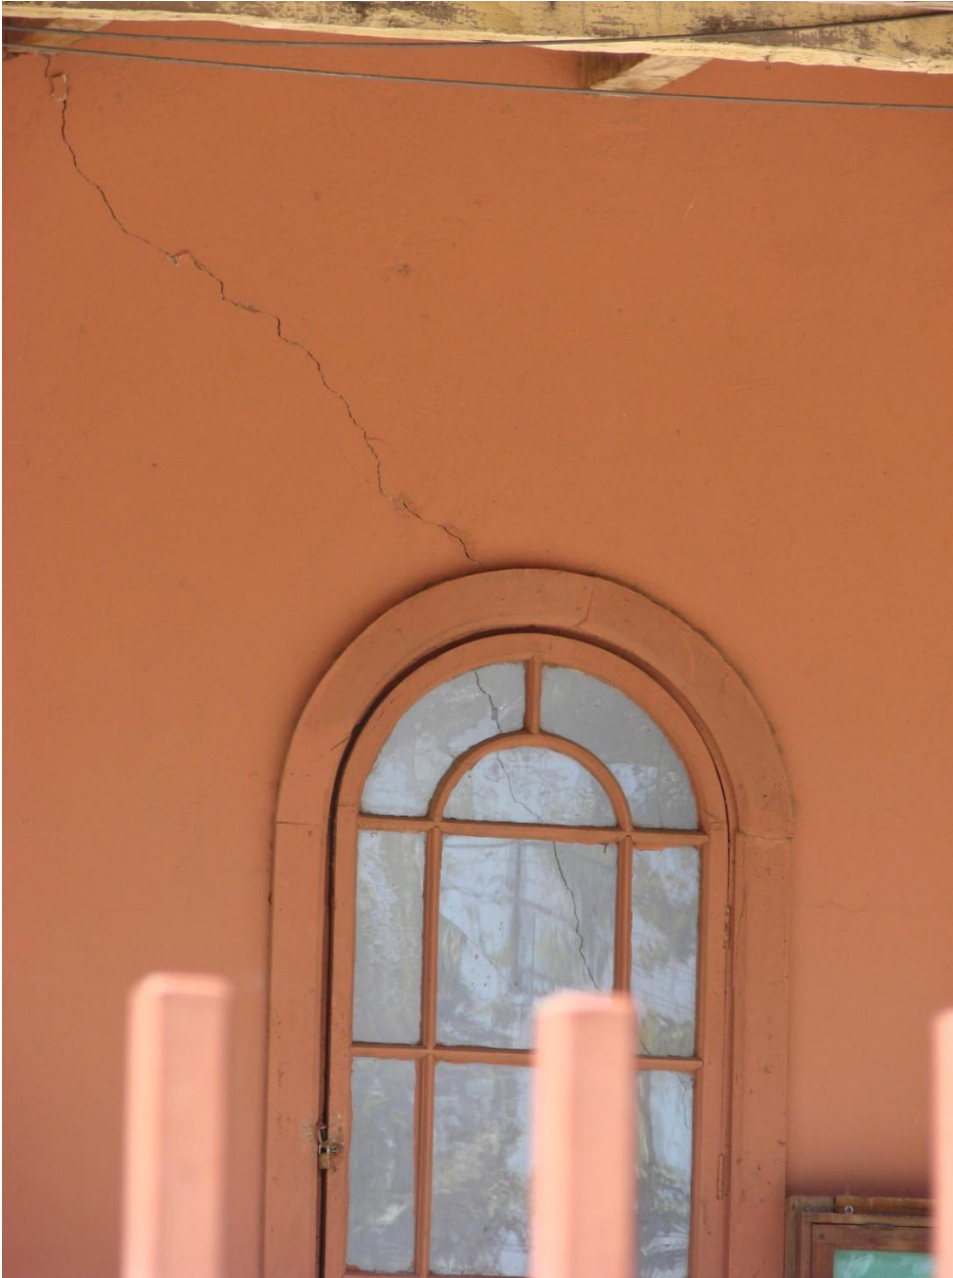
# Chillán

- Diagonal crack
- Window effect?
