EERI/PEER/FHWA Bridge Team Report

Performance of Highway and Railway
Structures during the February 27,
2010 Maule Chile Earthquake

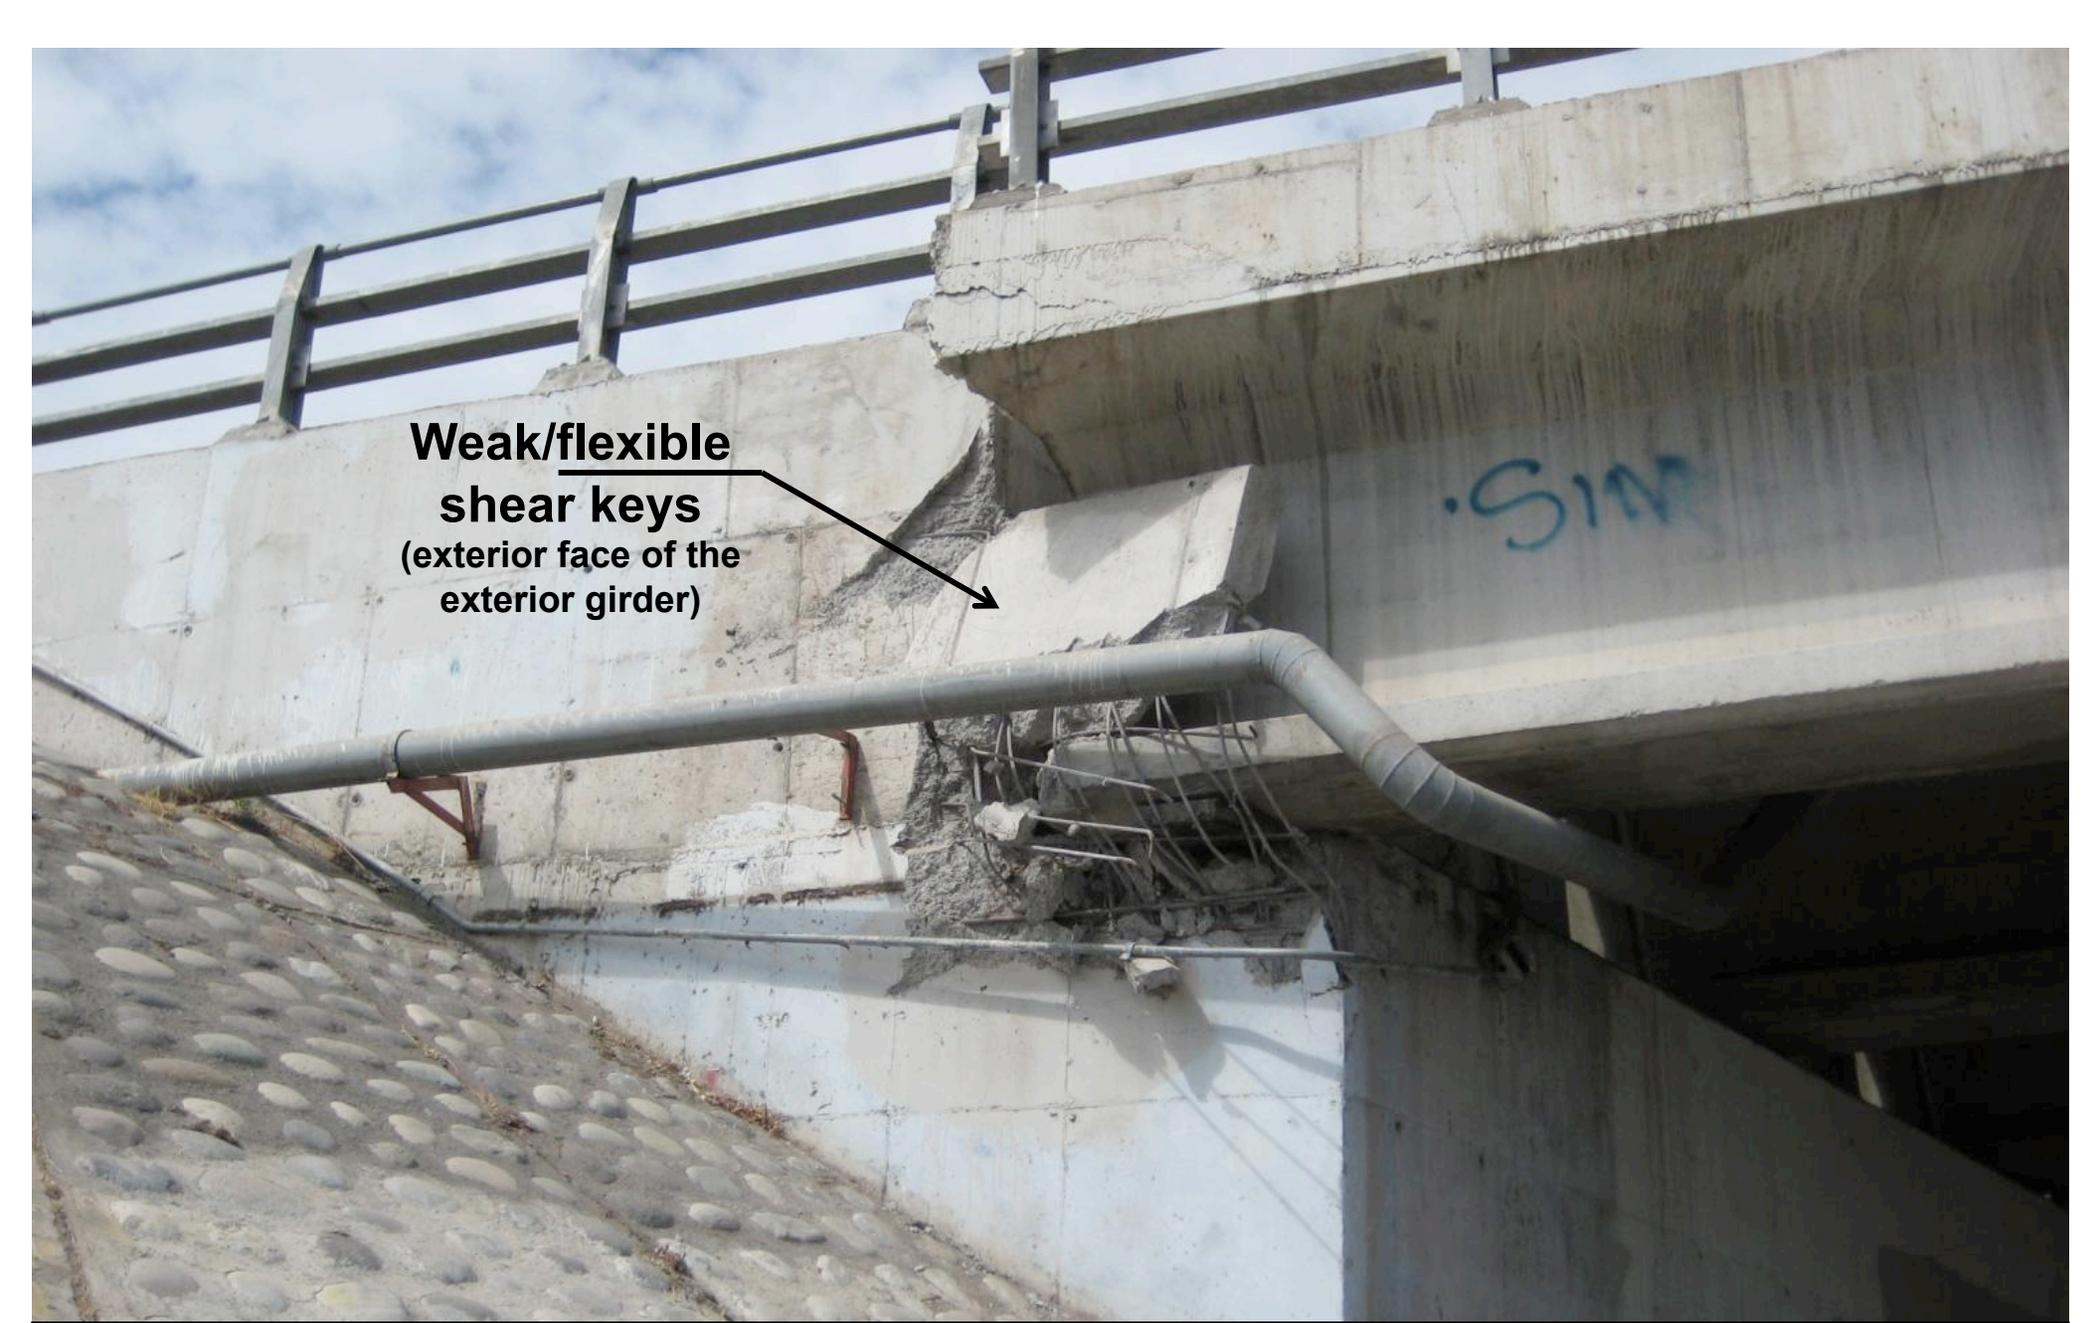
**Weak/flexible
shear keys**
(exterior face of the
exterior girder)

In most of the damaged OC's the entire deck twisted or rotated about a vertical axis representing center of stiffness (see next slide). In these OC's shear keys were weak, flexible and heavily damaged. They were constructed at the exterior face of the exterior girders over the abutments and interior bent (6 shear keys n total).

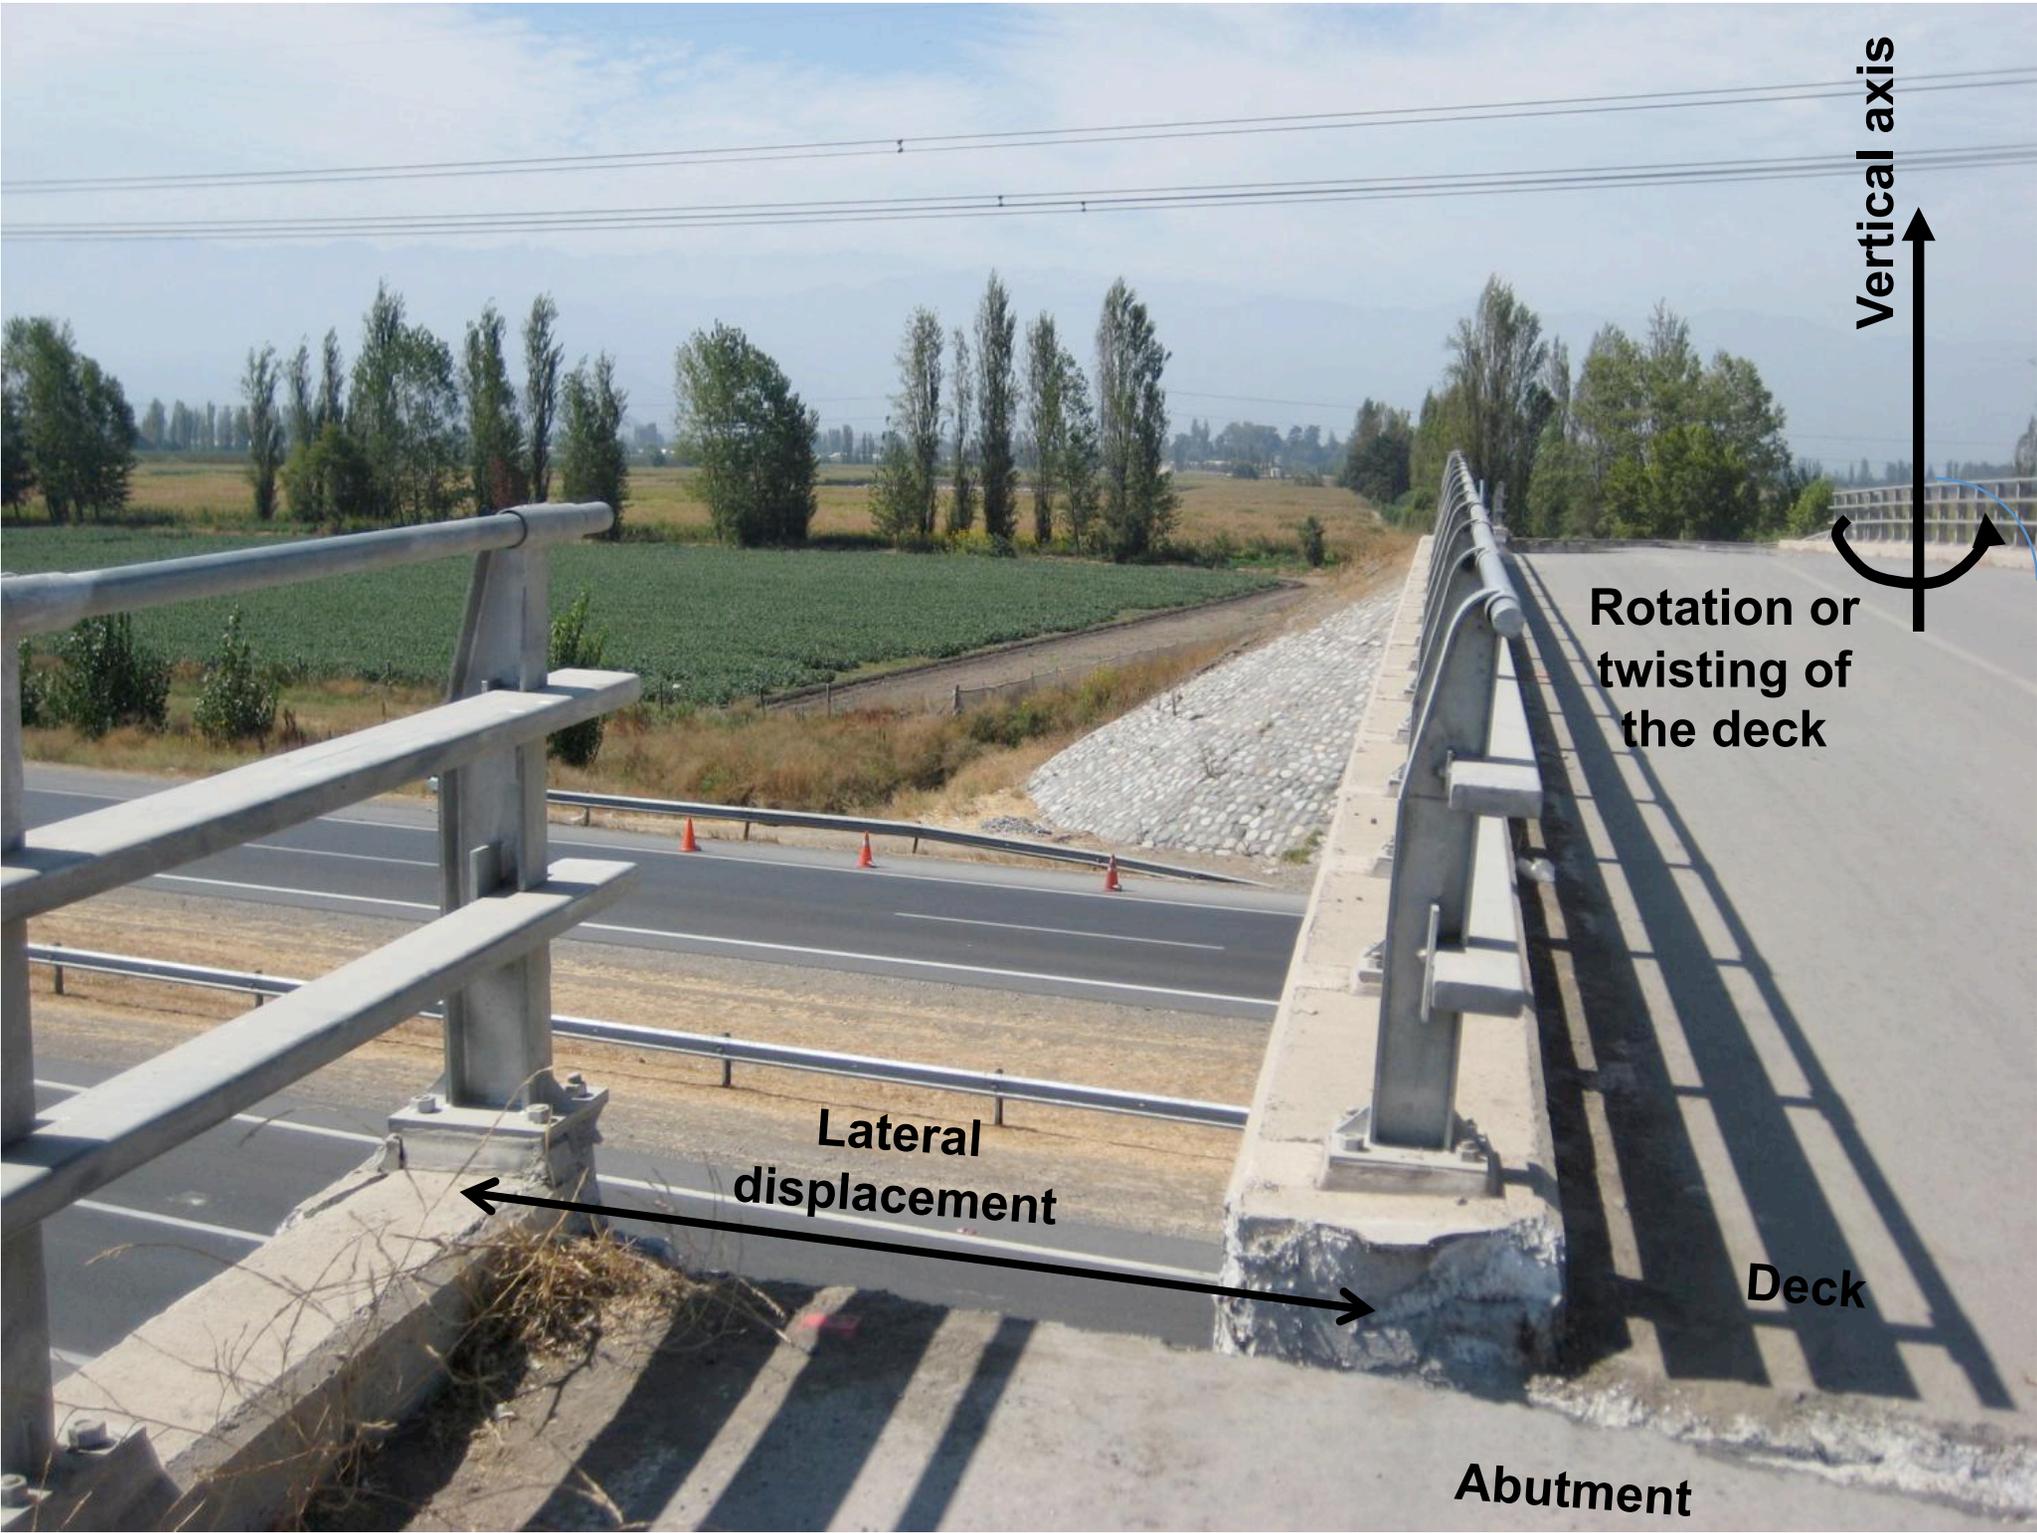
Rotation or twisting of the deck

Lateral displacement

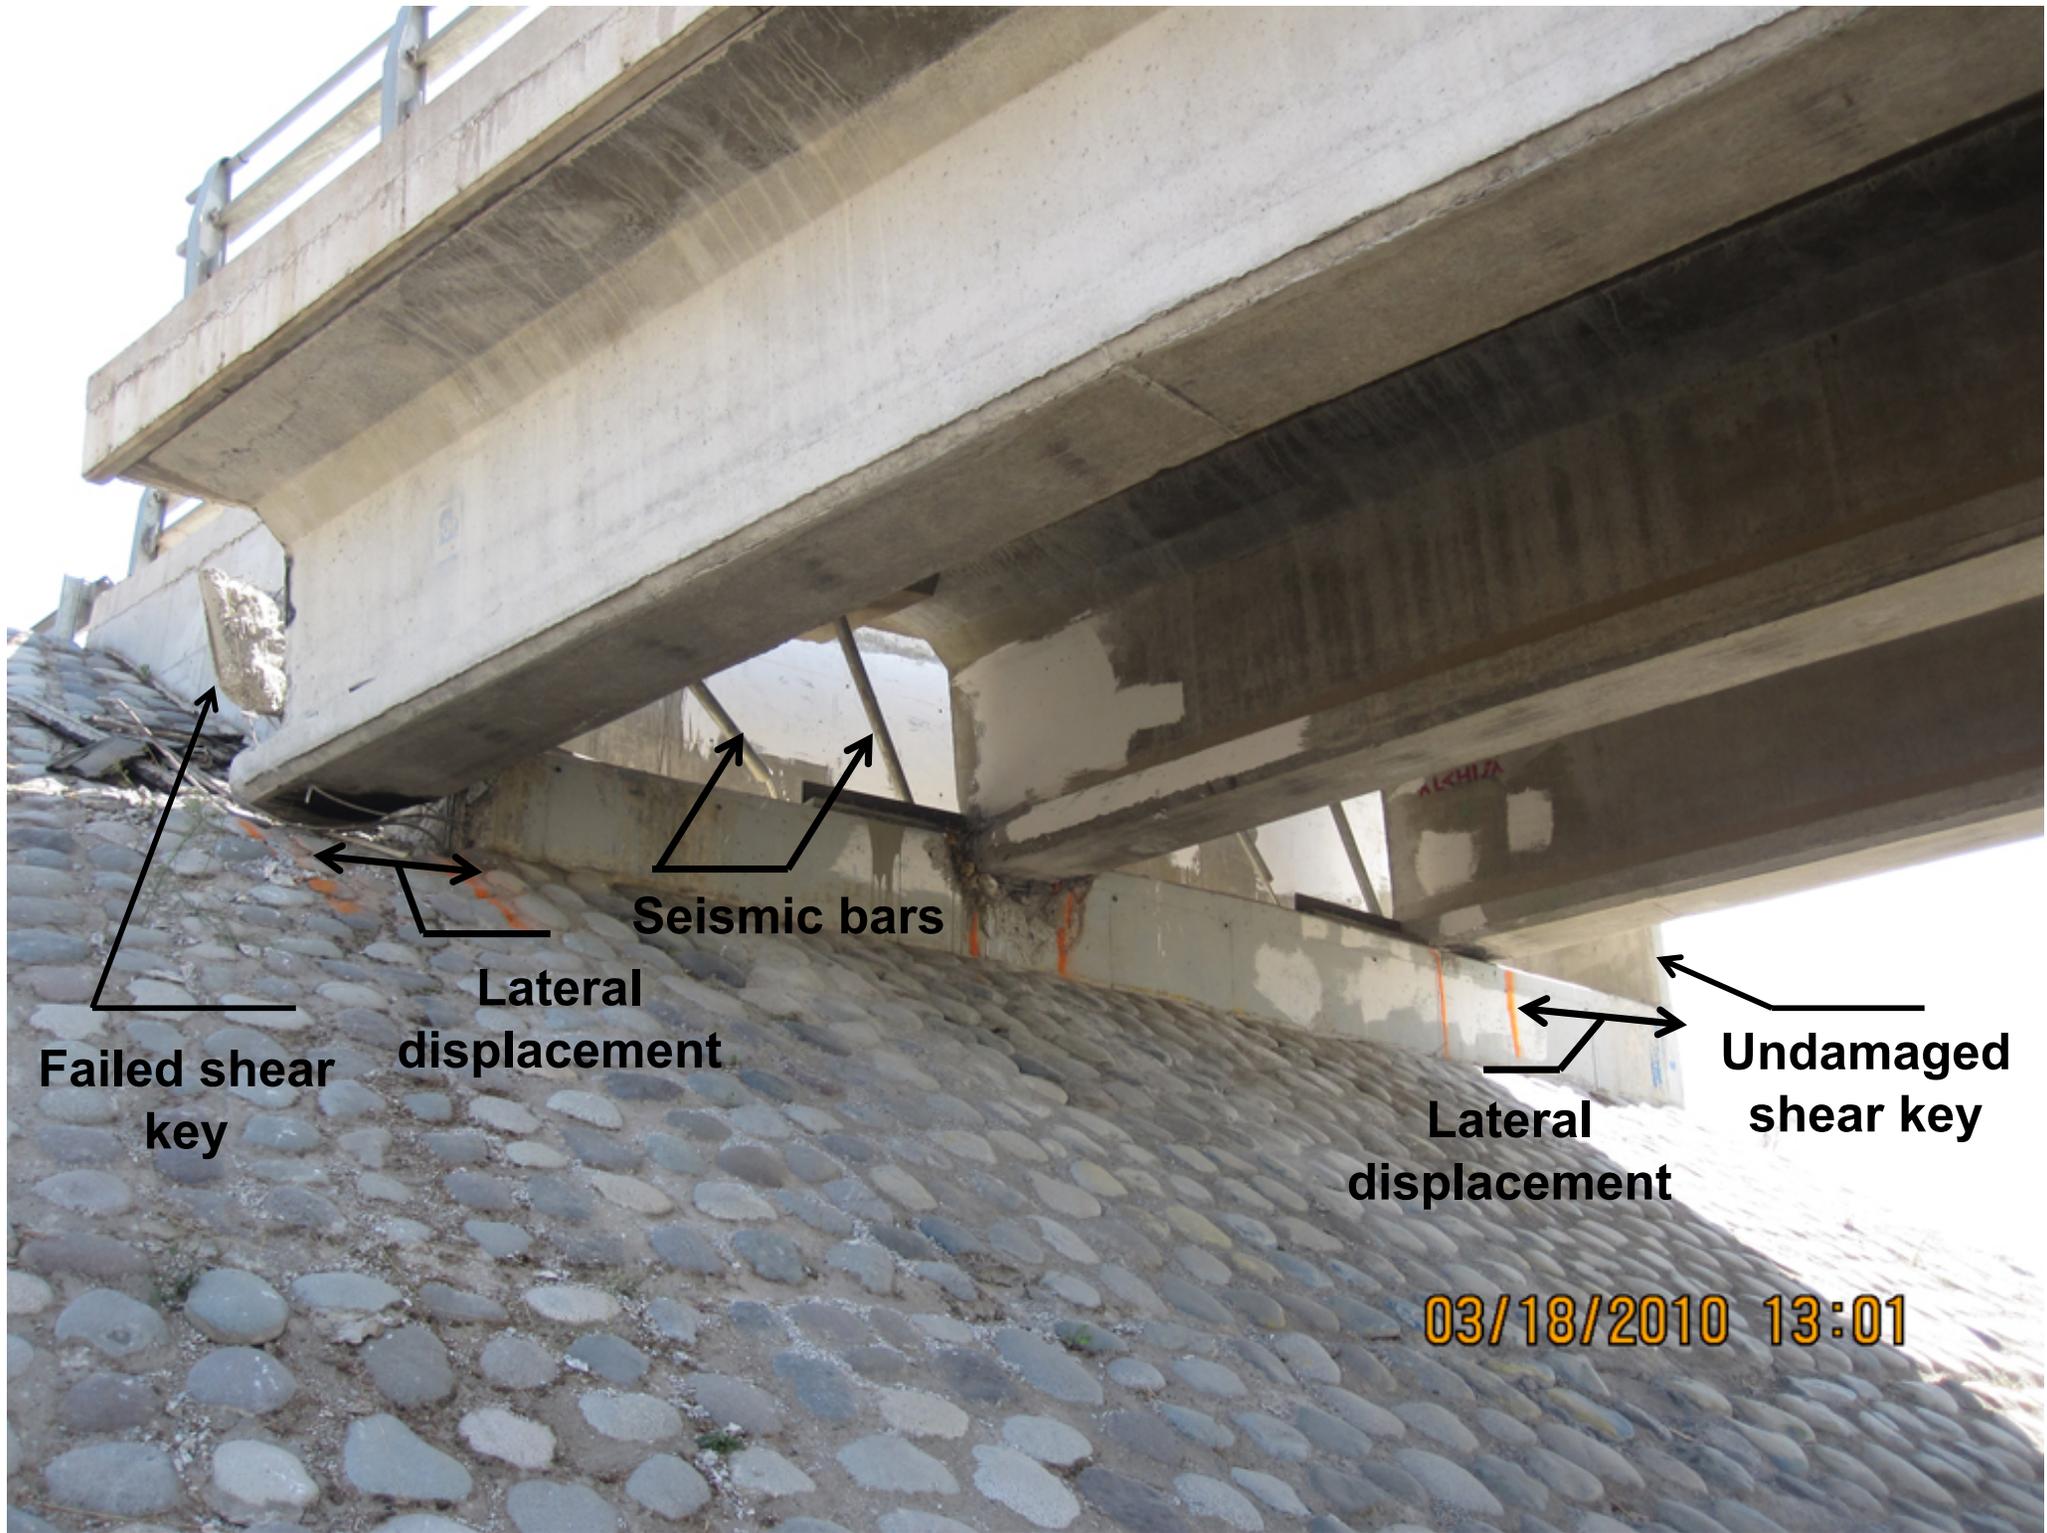
Failed shear key

Seismic bars

Undamaged shear key

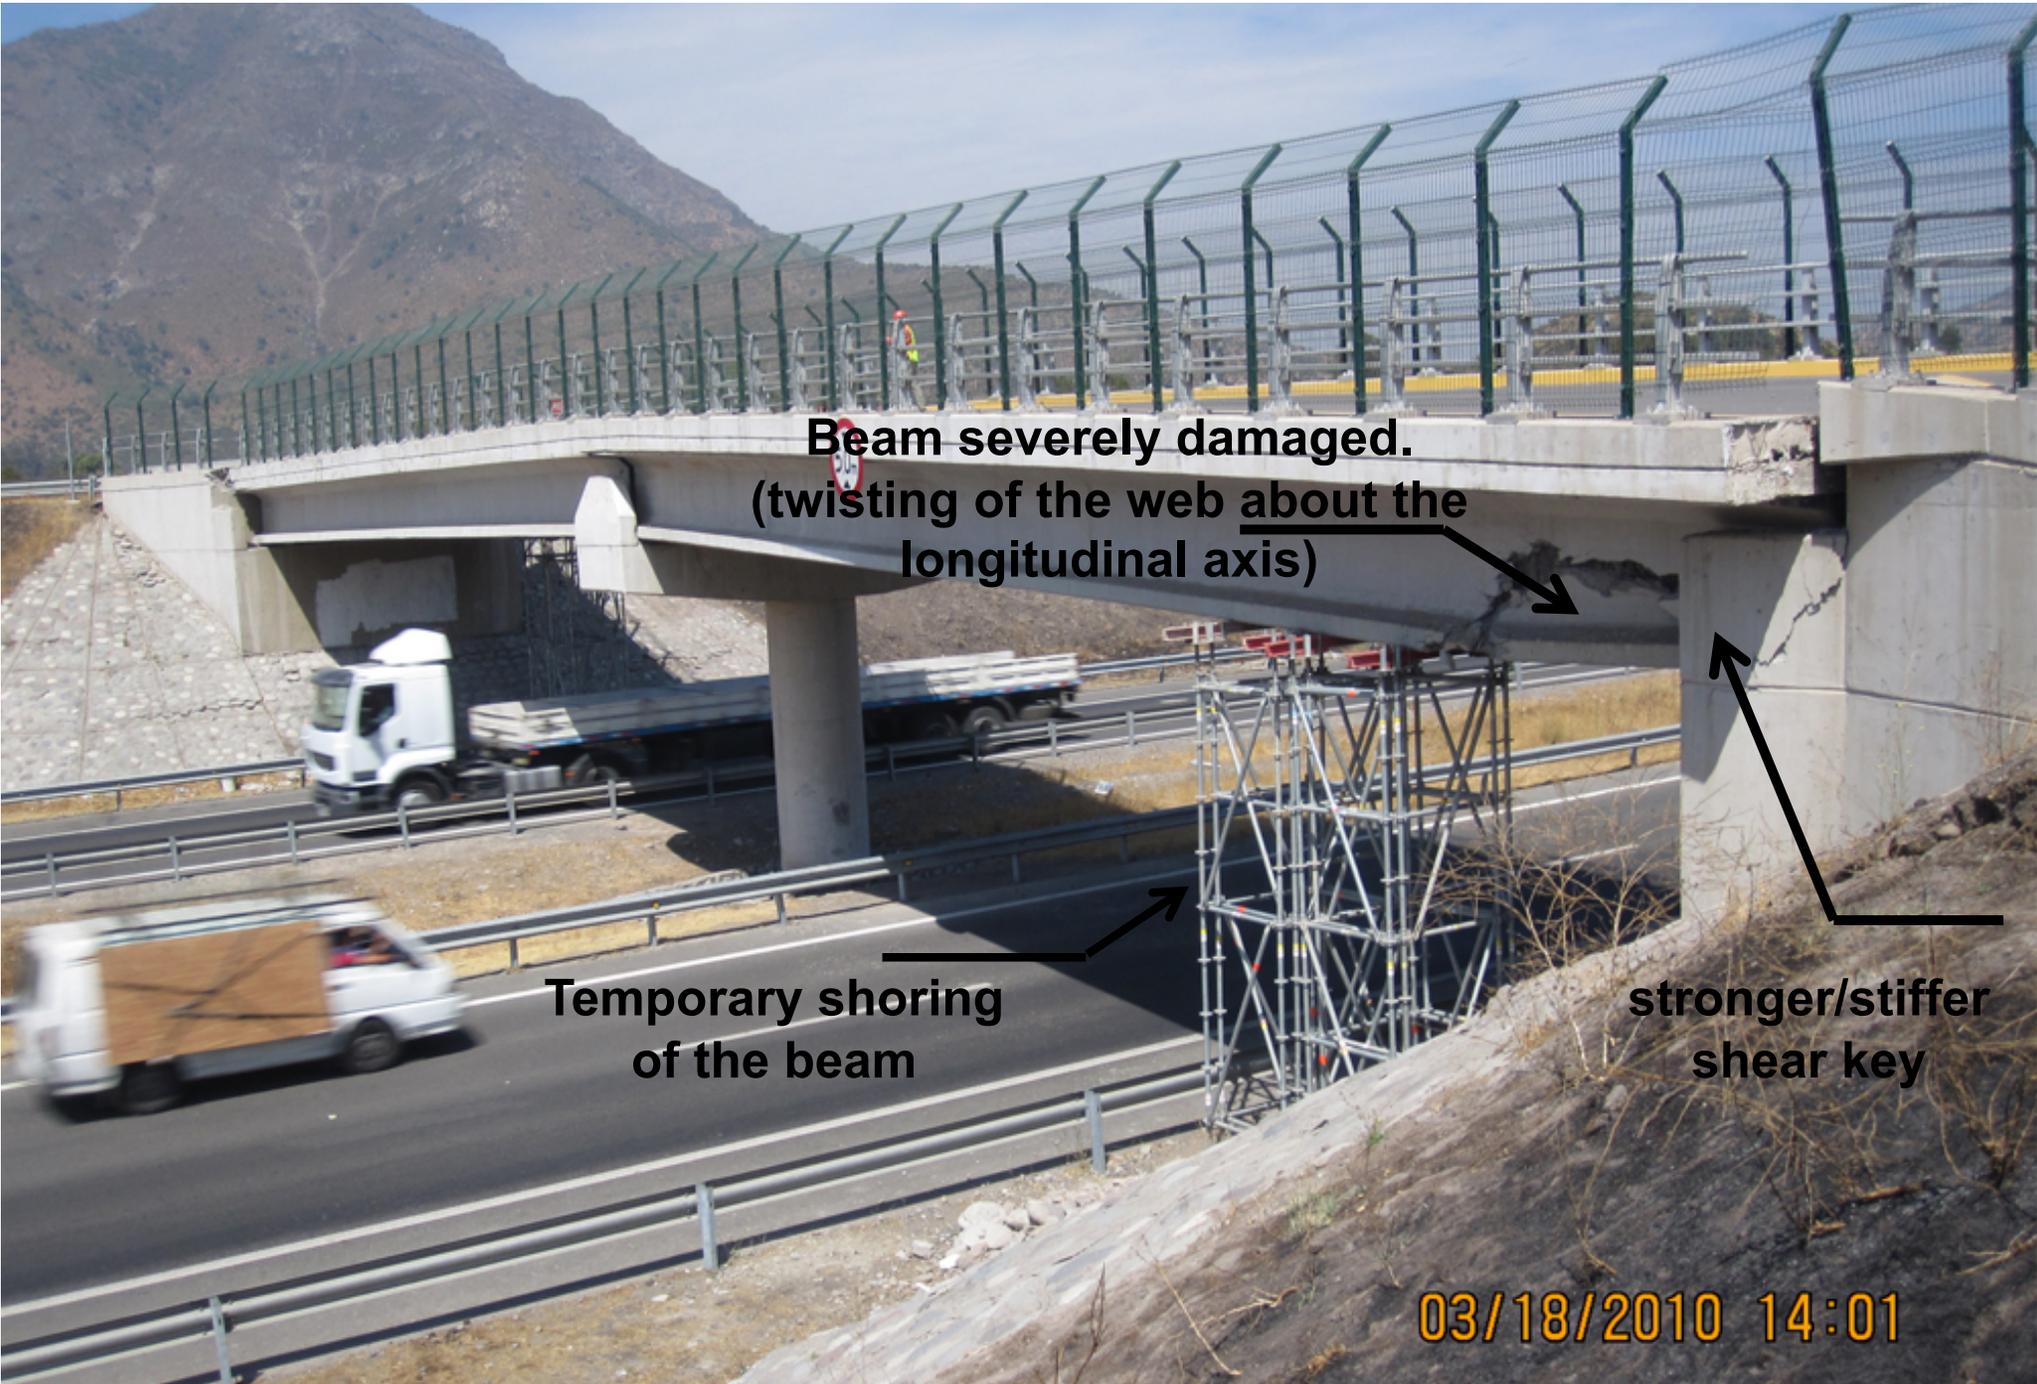
**Beam severely damaged.
(twisting of the web about the longitudinal axis)**

**Temporary shoring
of the beam**

**stronger/stiffer
shear key**

Exterior beams were heavily damaged in some O/C's with stronger and stiffer shear keys and without end diaphragms

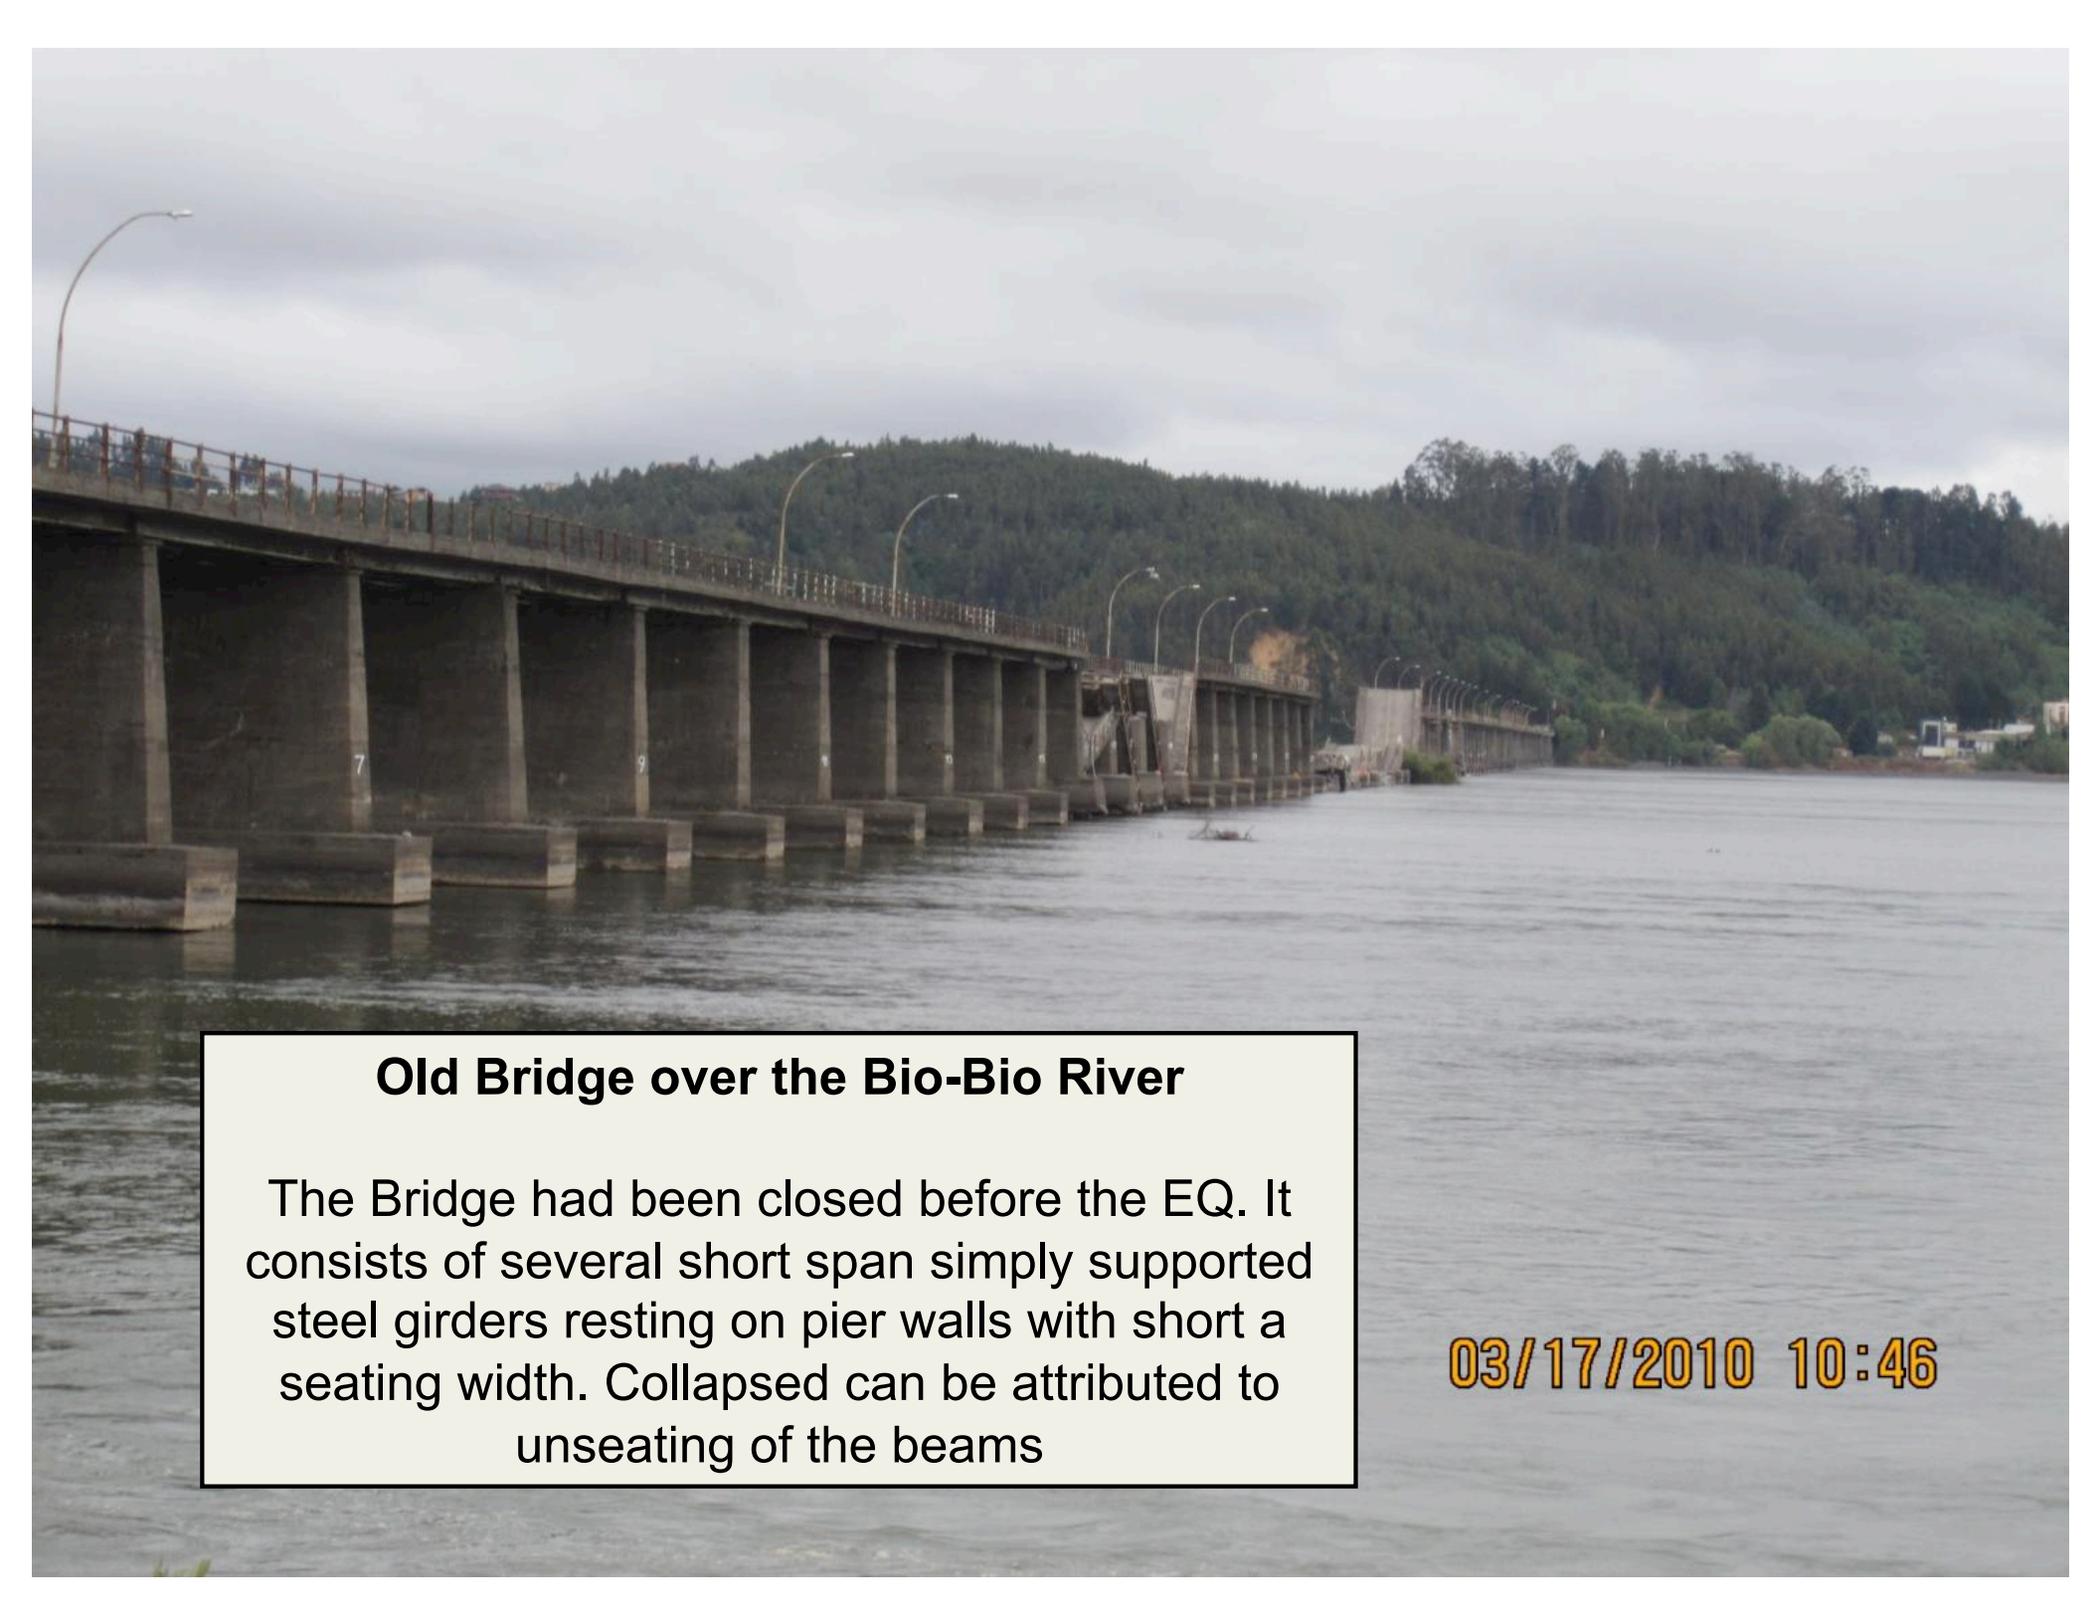
Old Bridge over the Bio-Bio River

The Bridge had been closed before the EQ. It consists of several short span simply supported steel girders resting on pier walls with short a seating width. Collapsed can be attributed to unseating of the beams

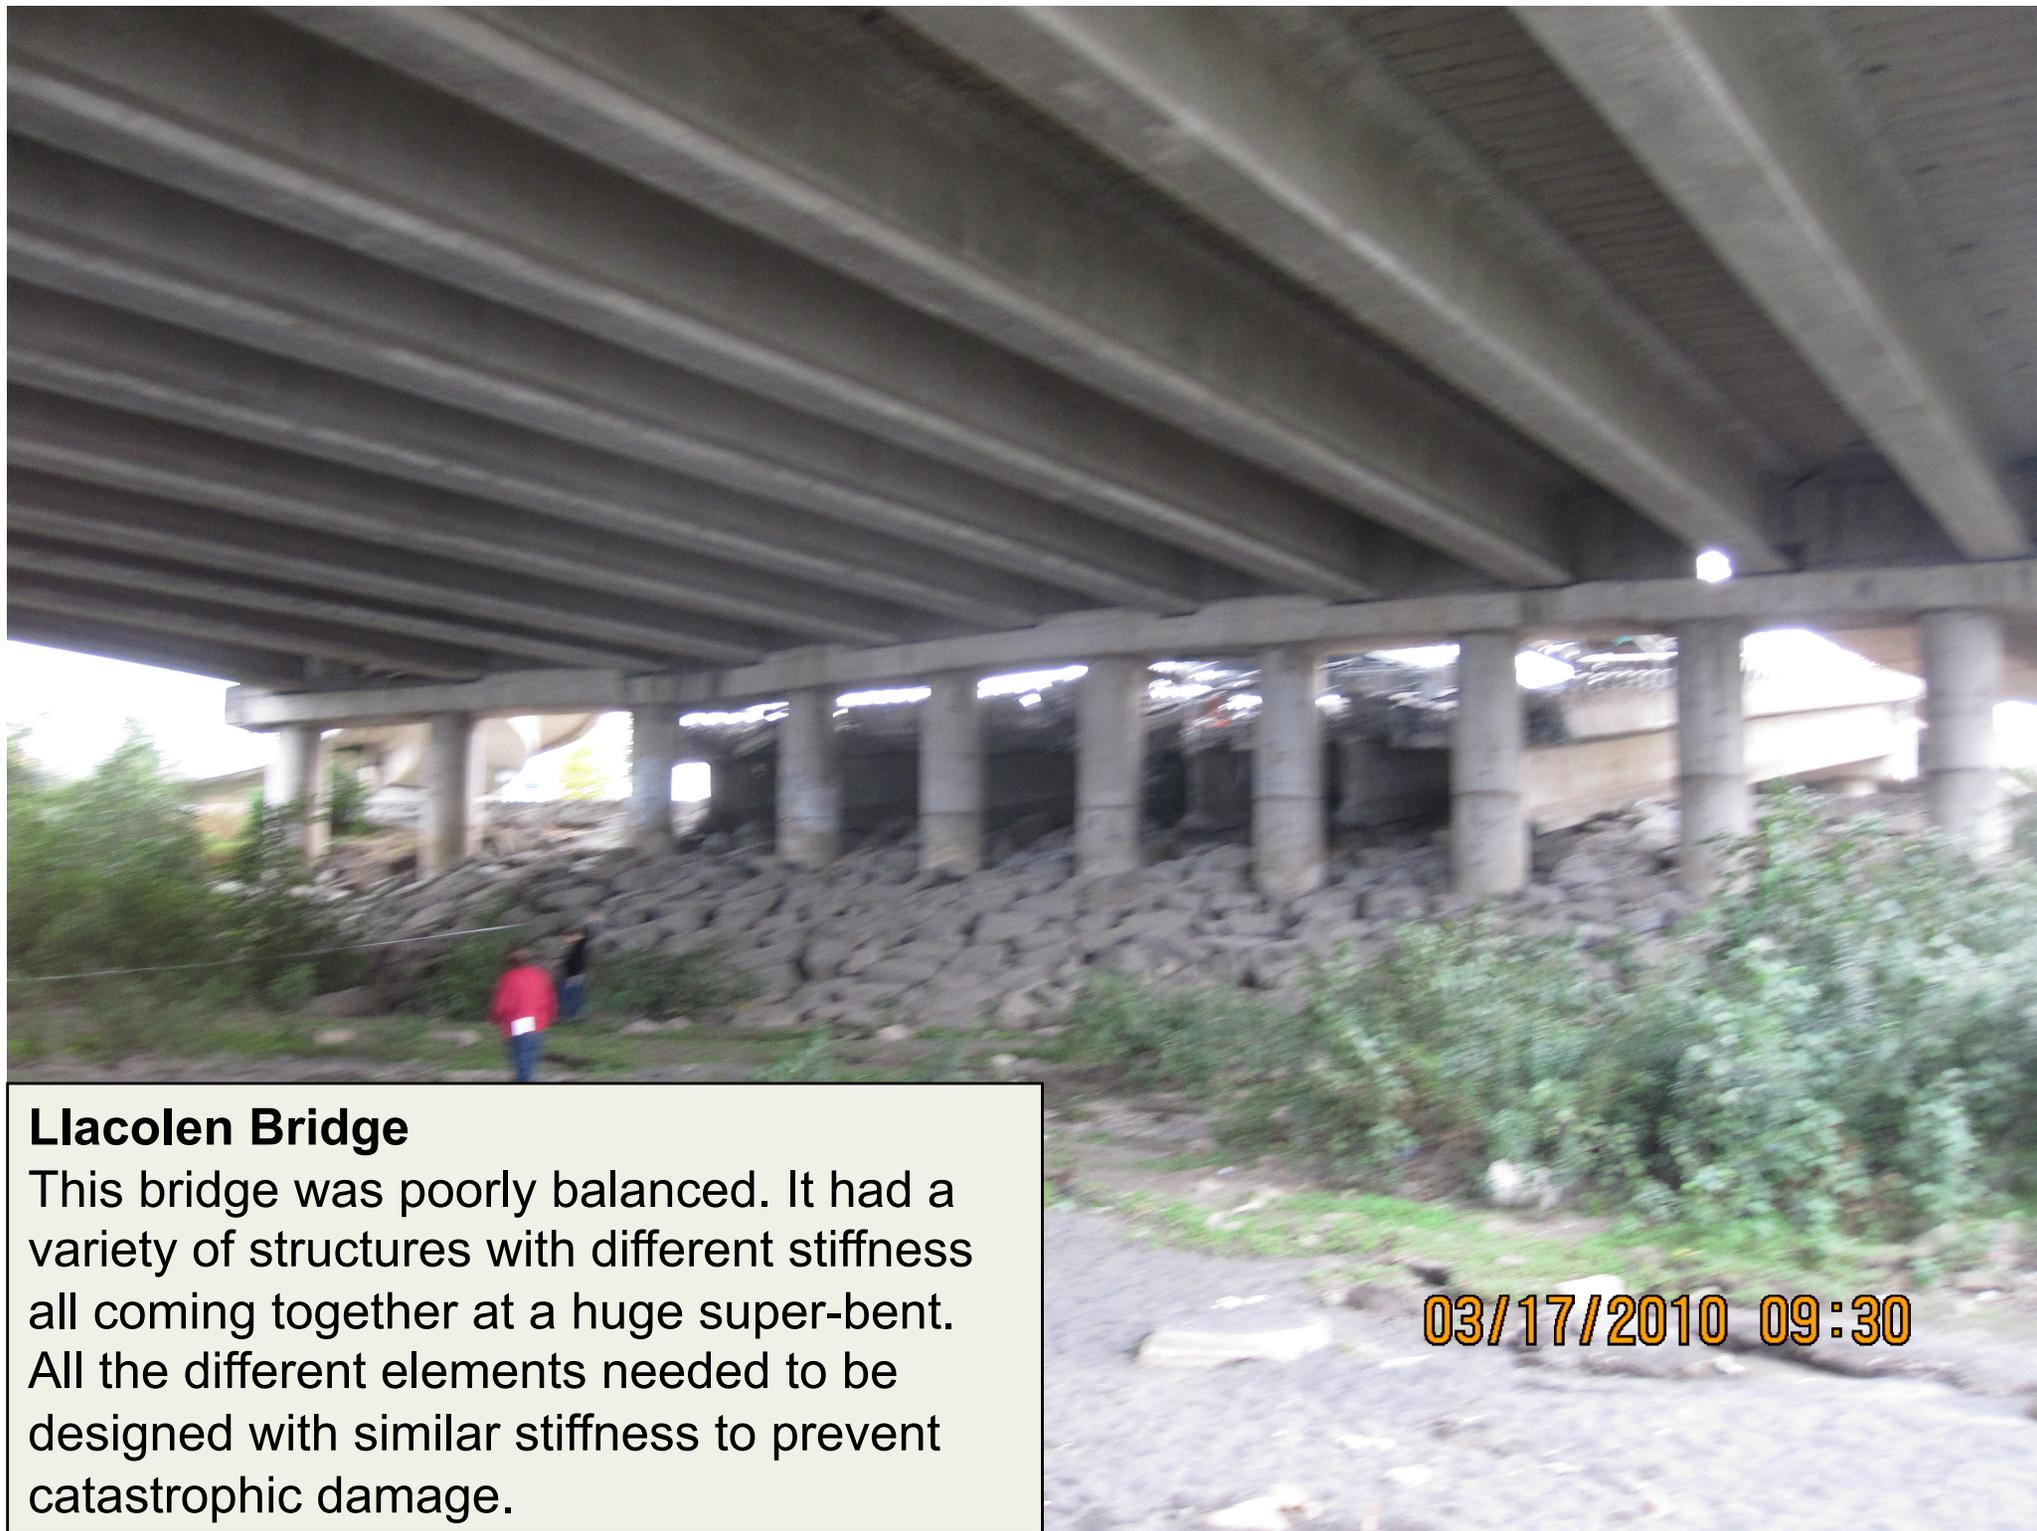
Llacolen Bridge

This bridge was poorly balanced. It had a variety of structures with different stiffness all coming together at a huge super-bent. All the different elements needed to be designed with similar stiffness to prevent catastrophic damage.

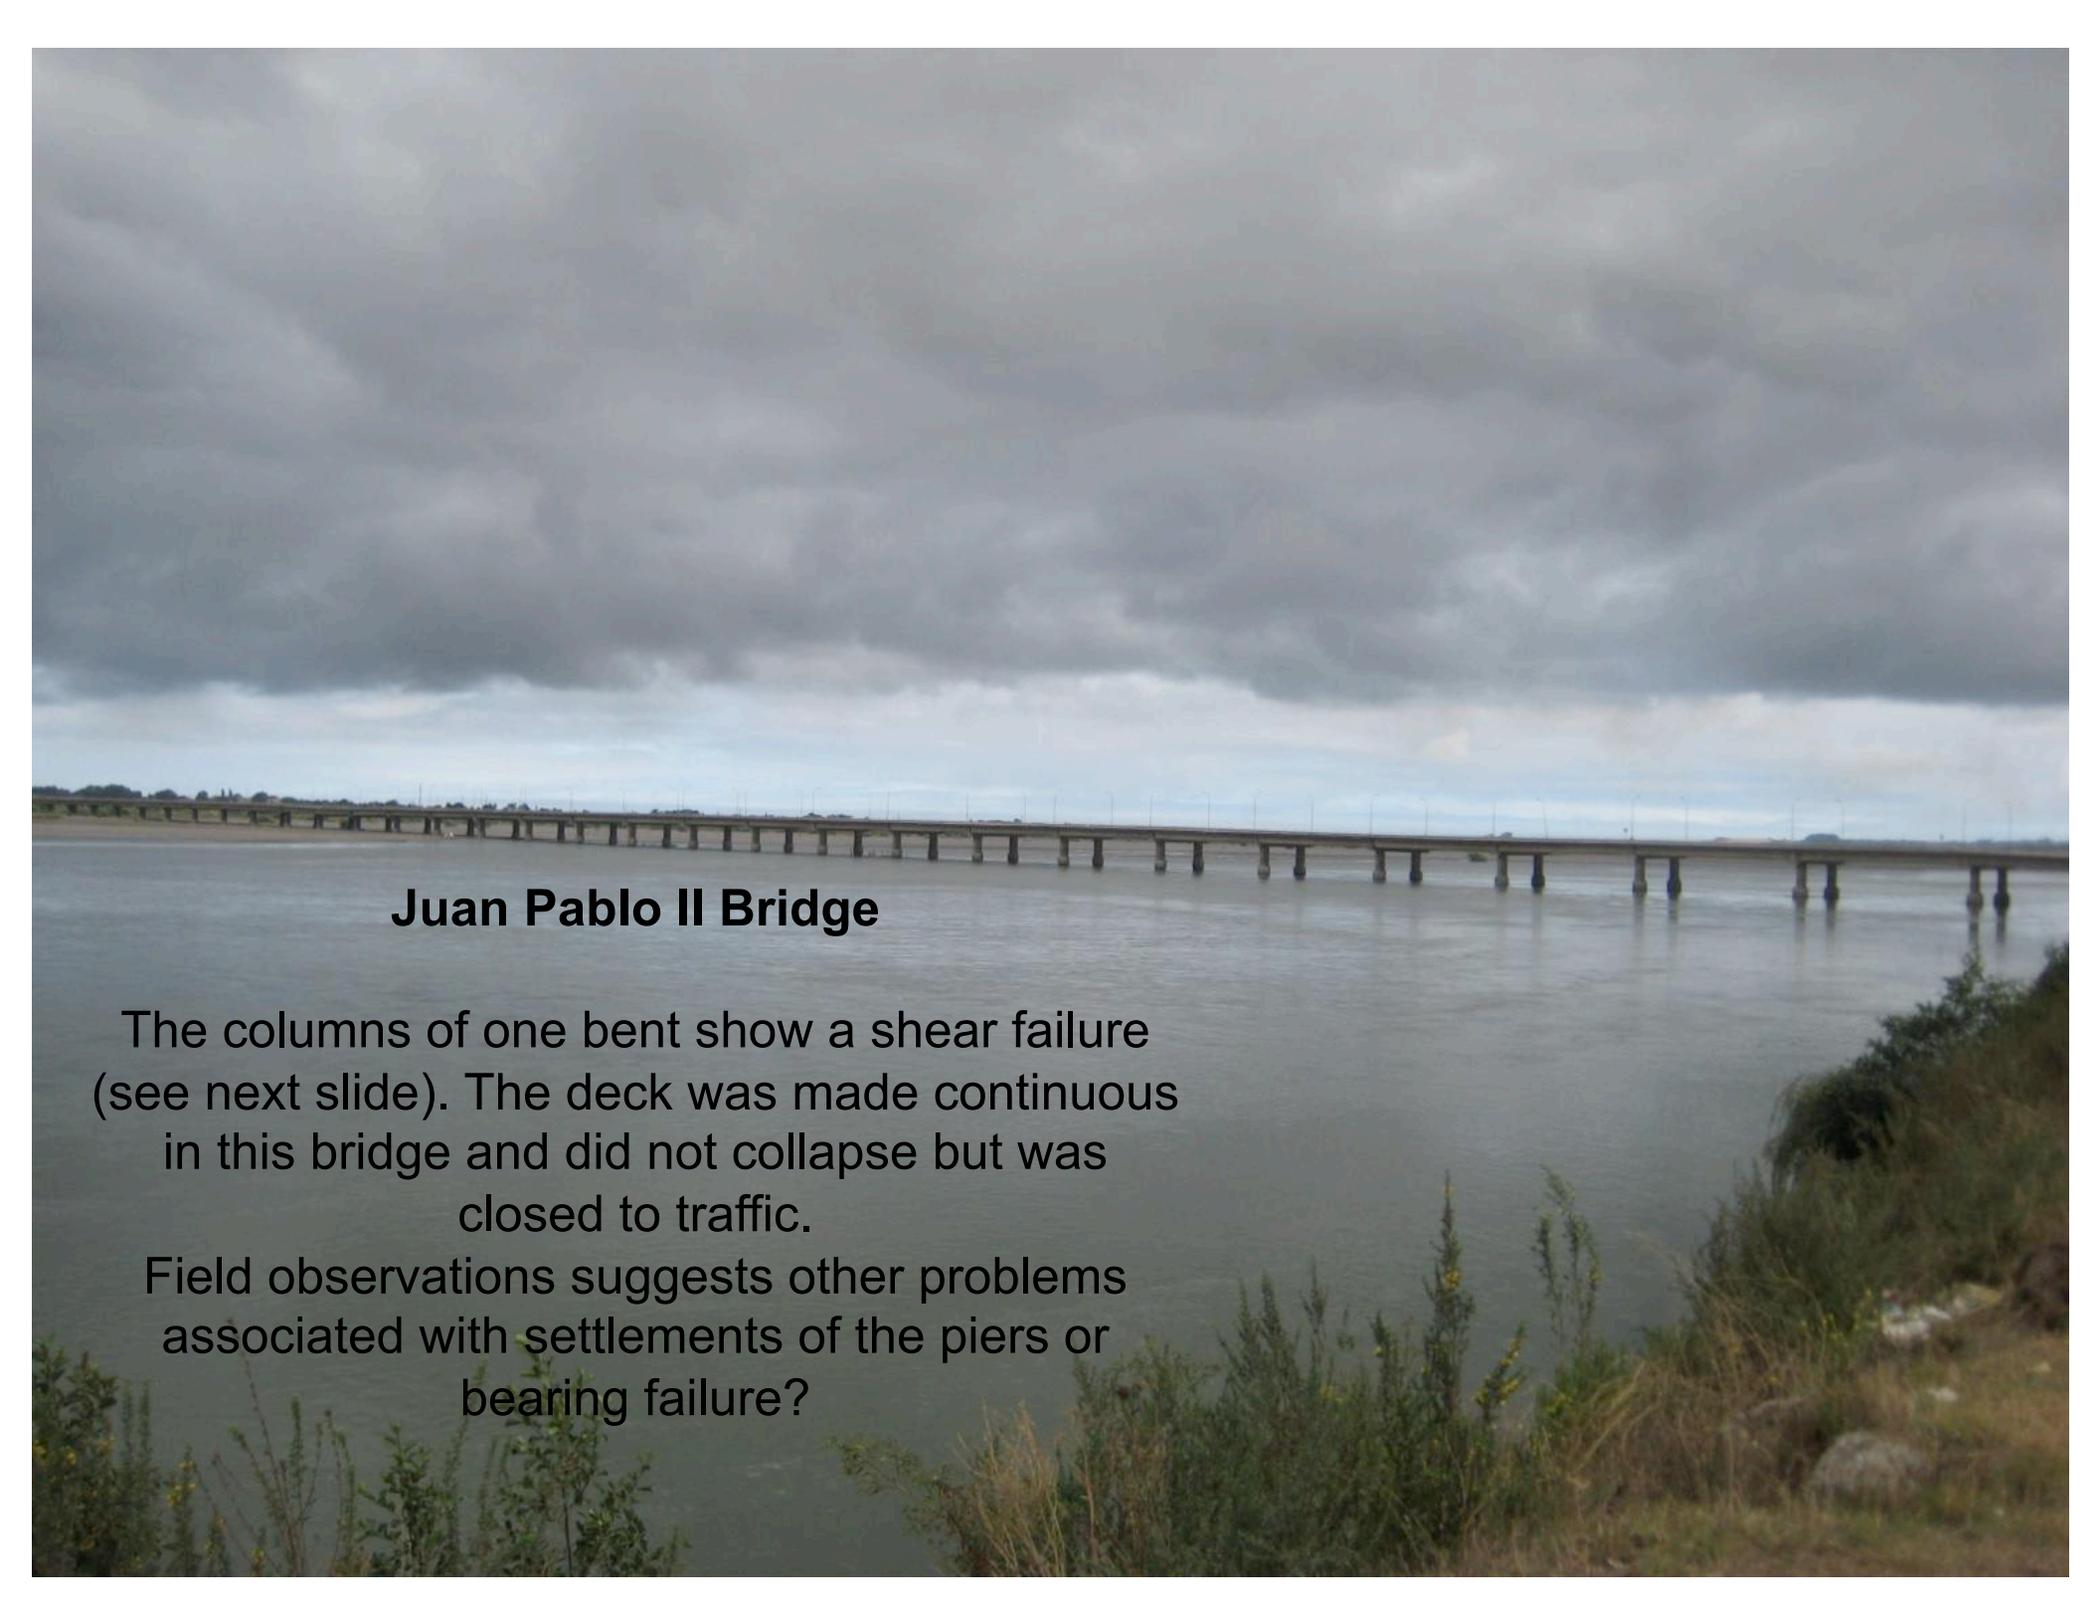
Juan Pablo II Bridge

The columns of one bent show a shear failure (see next slide). The deck was made continuous in this bridge and did not collapse but was closed to traffic.

Field observations suggests other problems associated with settlements of the piers or bearing failure?
