EERI/PEER/FHWA Bridge Team Report

Performance of Highway and Railway
Structures during the February 27,
2010 Maule Chile Earthquake

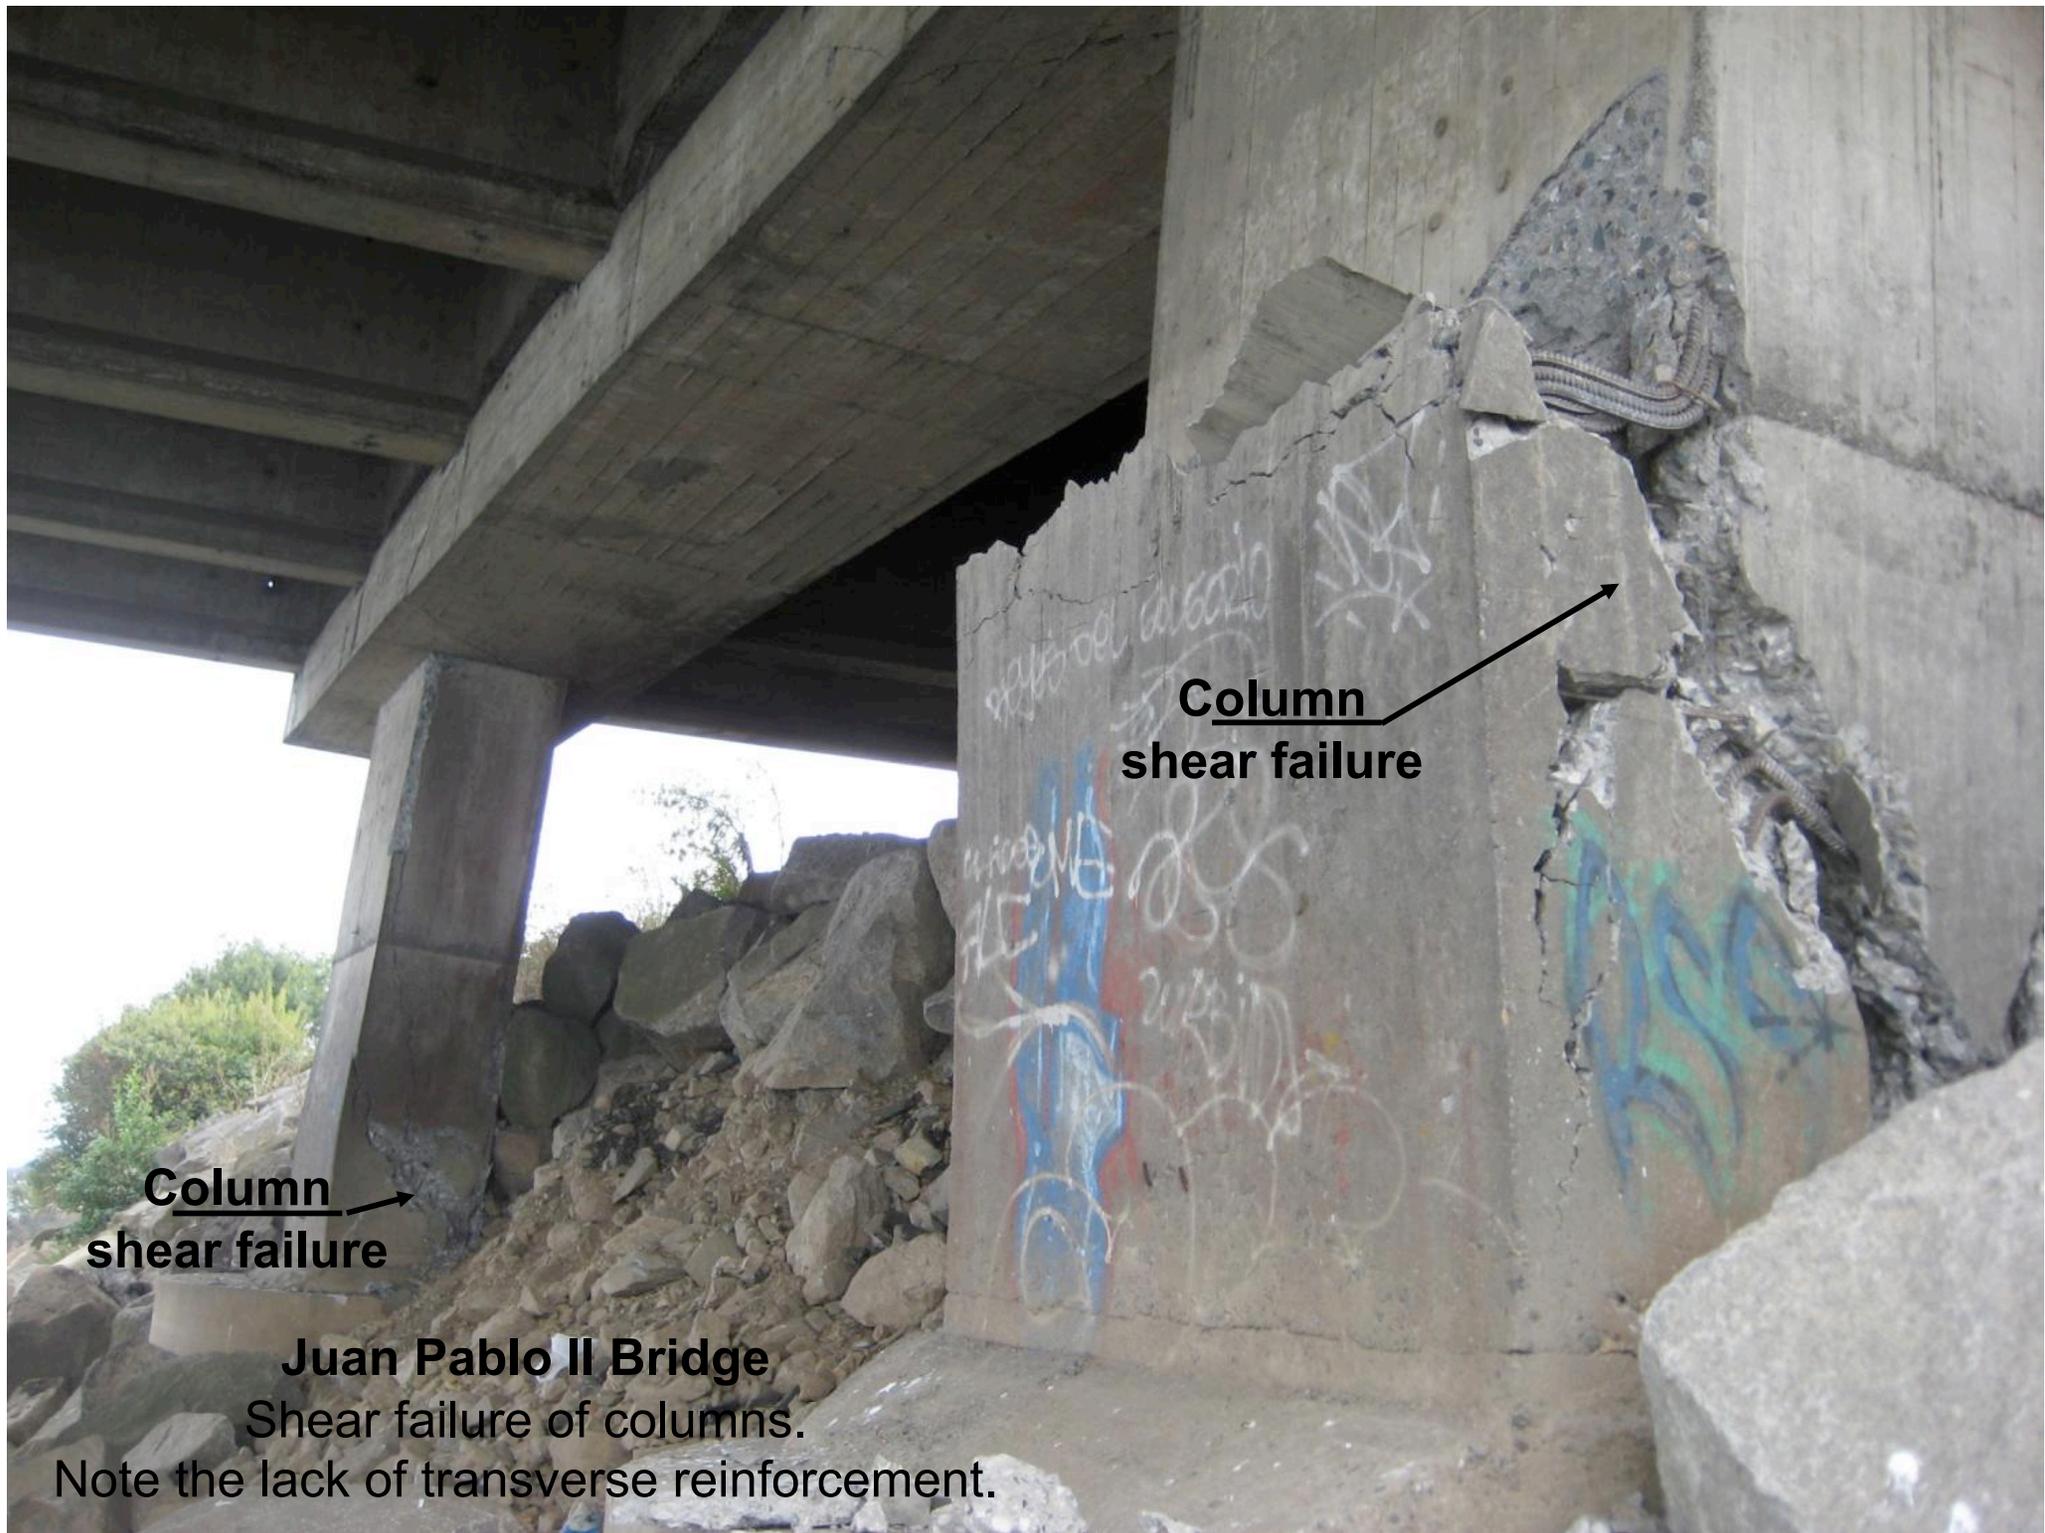
Juan Pablo II Bridge

**Column
shear failure**

Shear failure of columns.

Note the lack of transverse reinforcement.

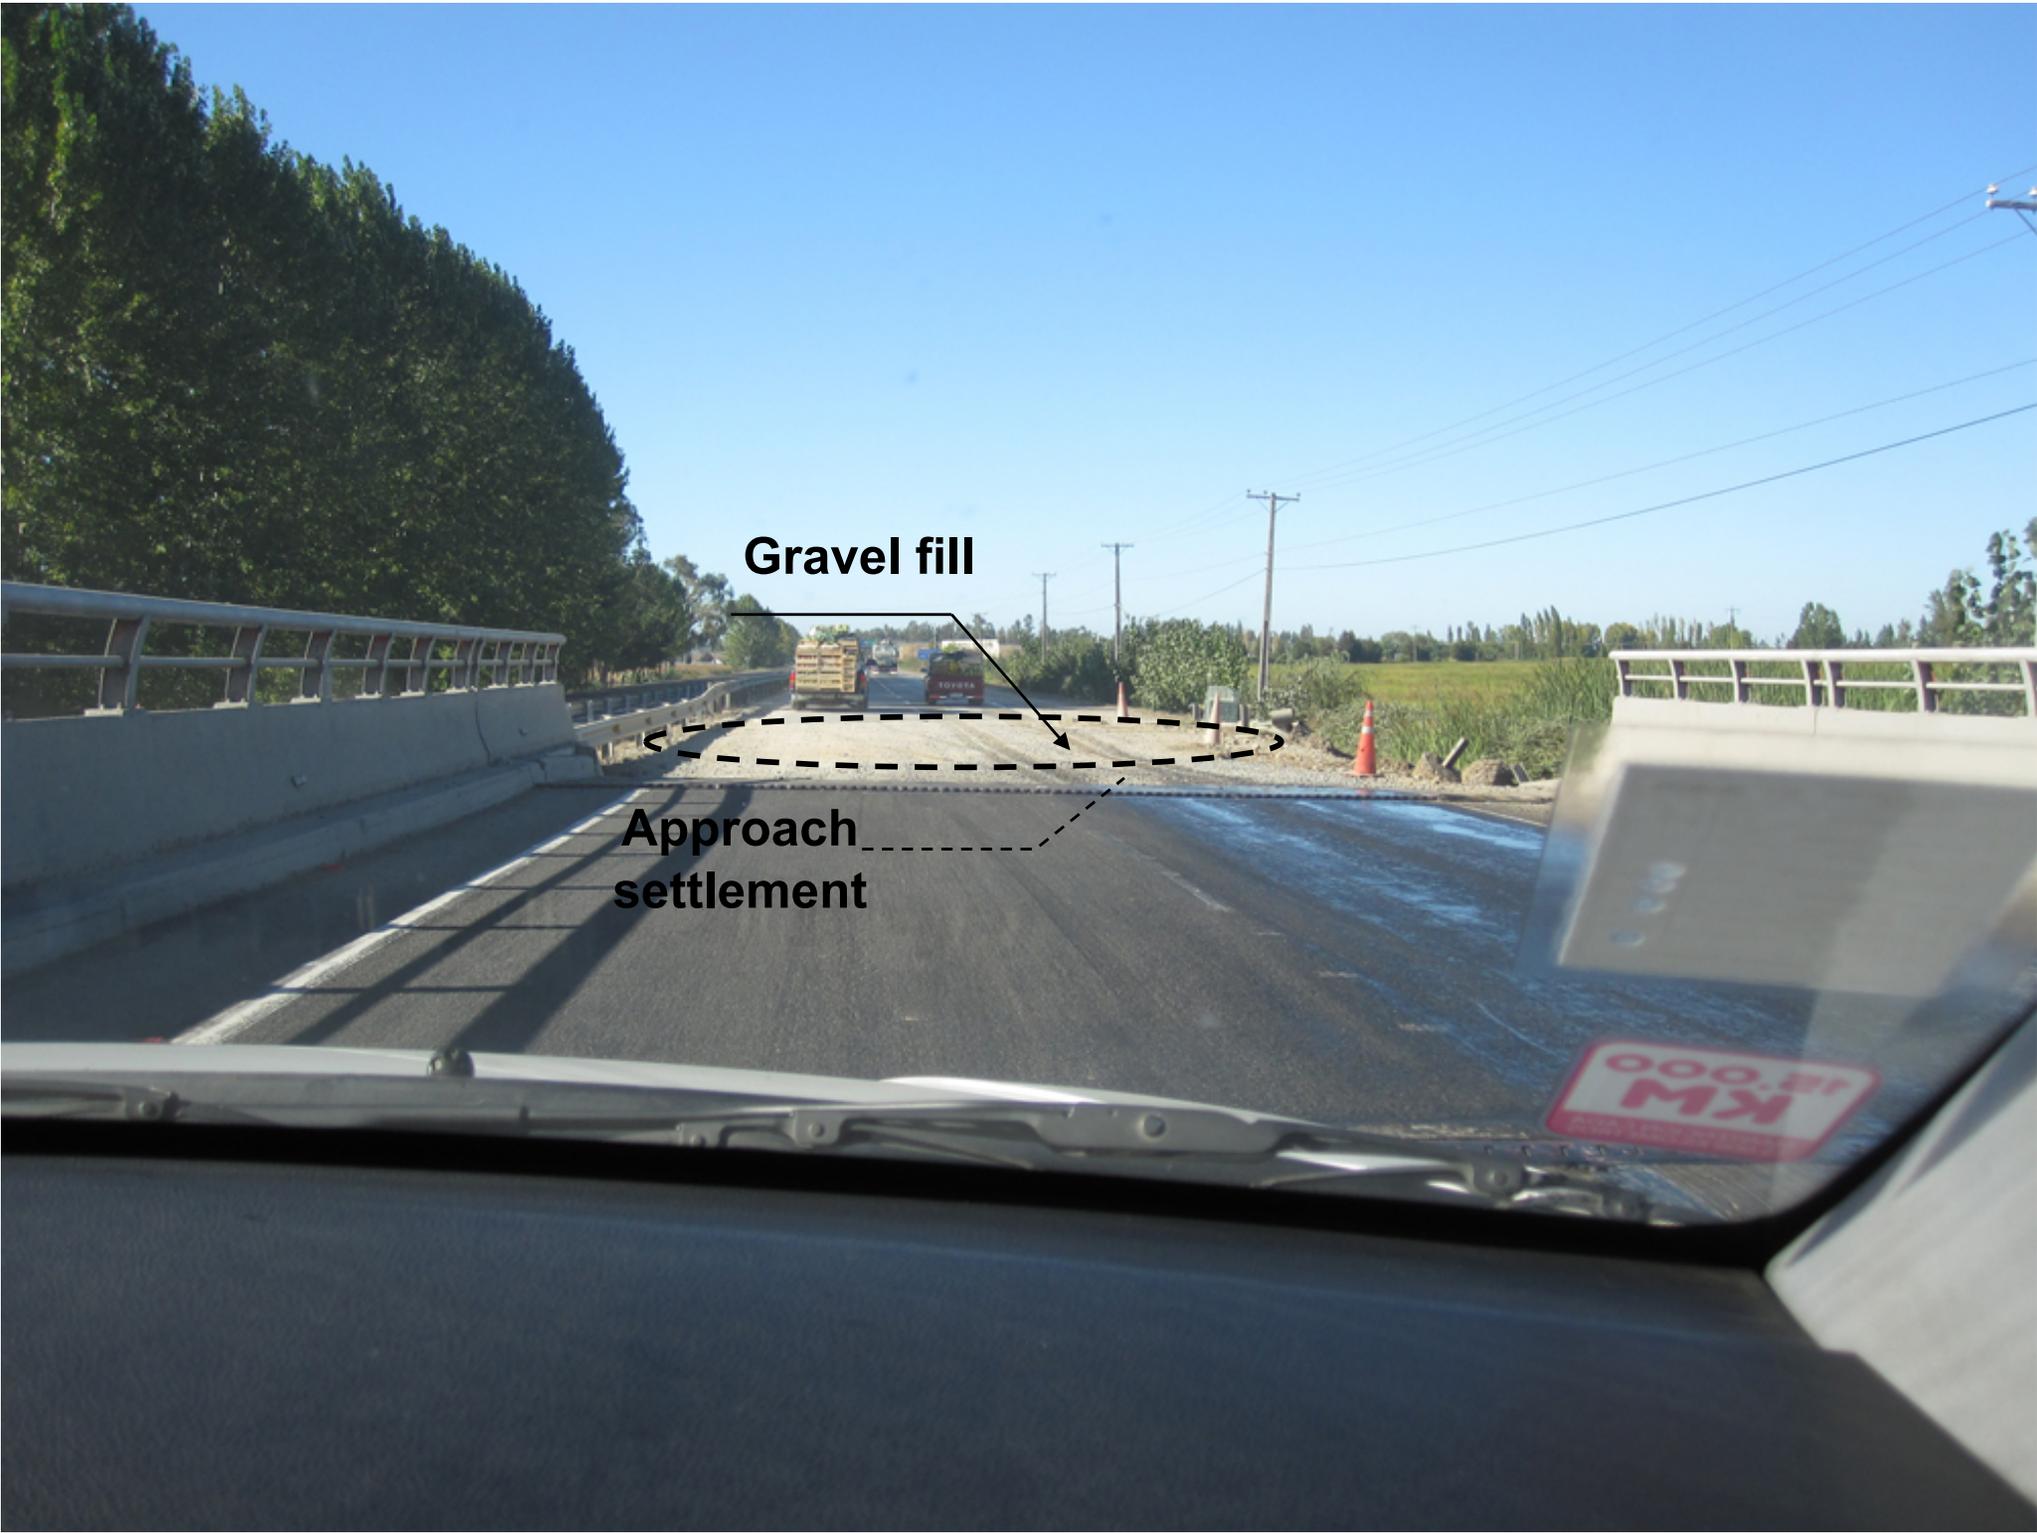
**KM
18,000**

Gravel fill

**Approach
settlement**

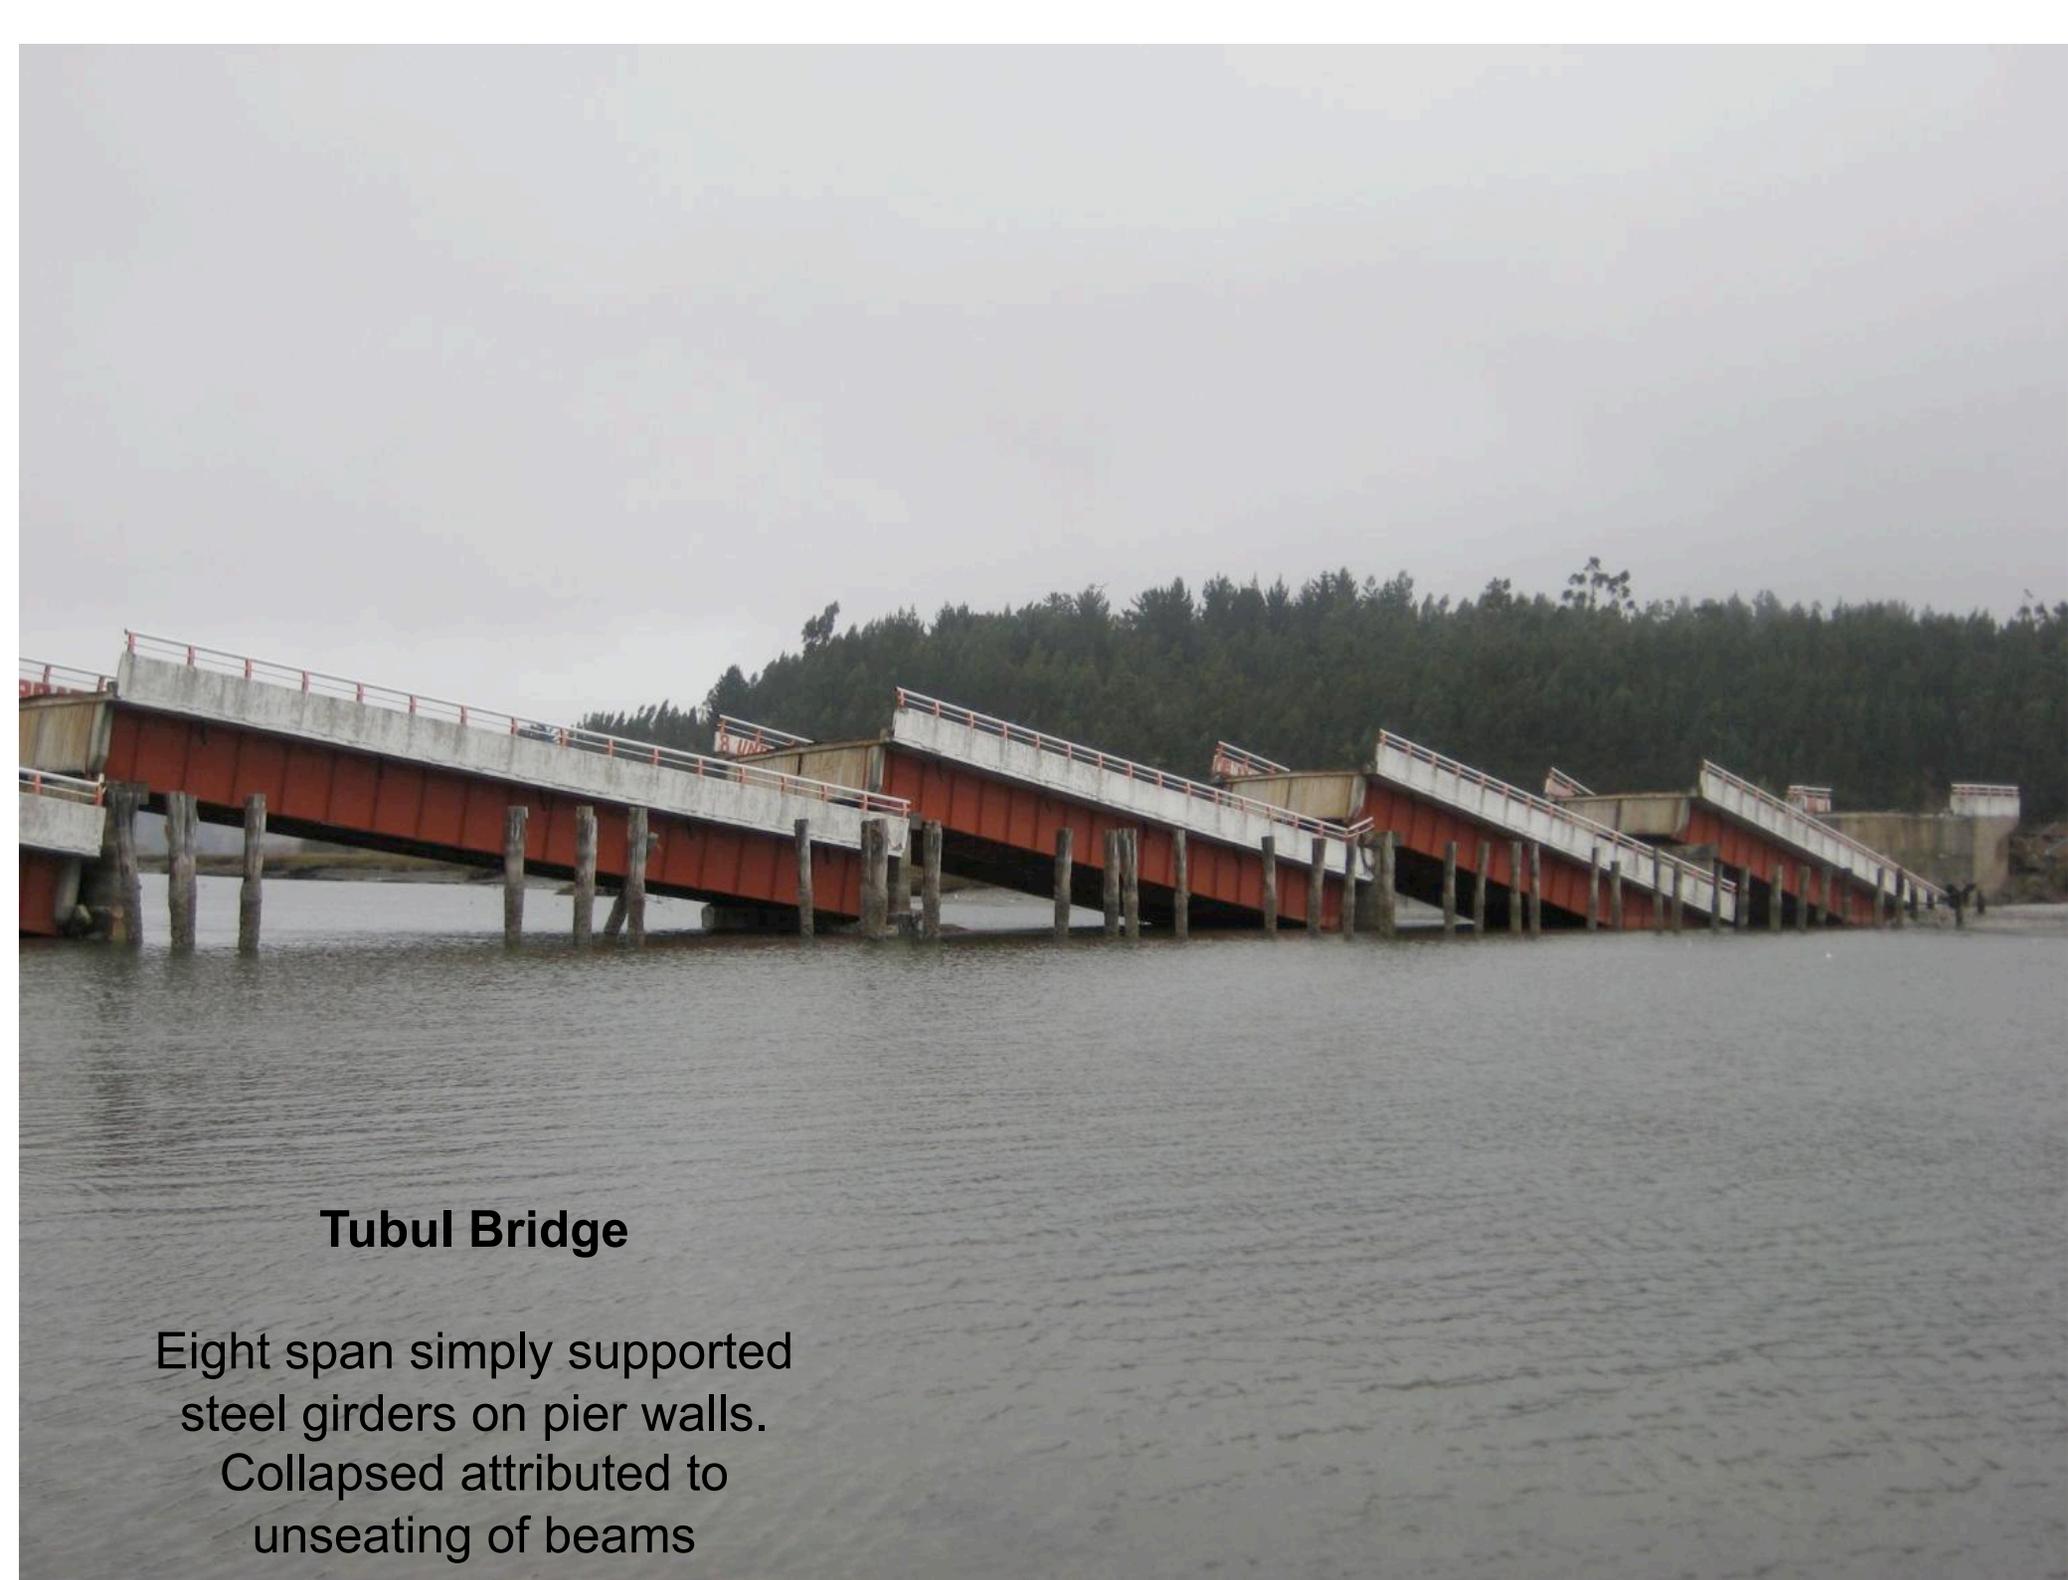
Tubul Bridge

Eight span simply supported
steel girders on pier walls.
Collapsed attributed to
unseating of beams

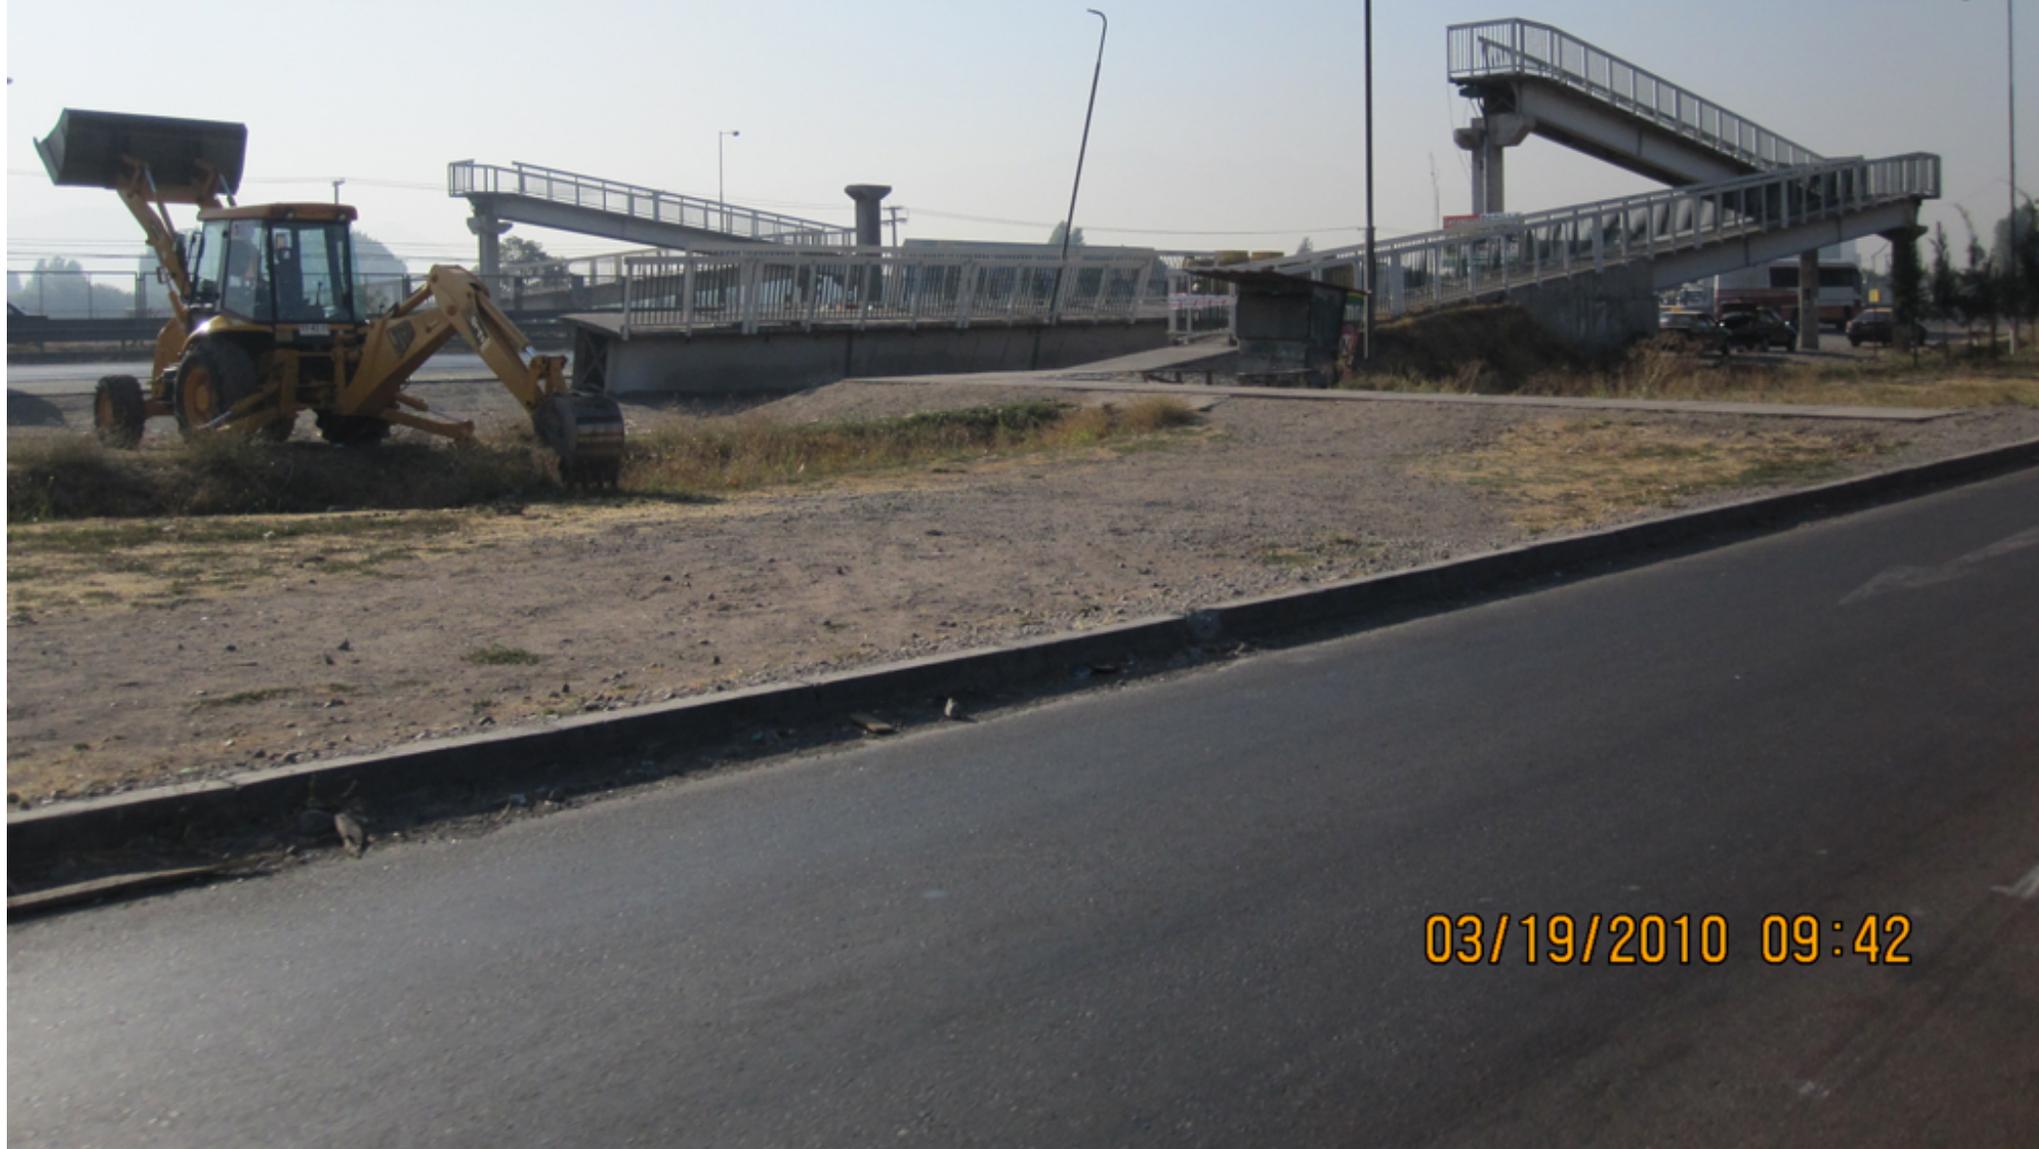
Pedestrian OC.

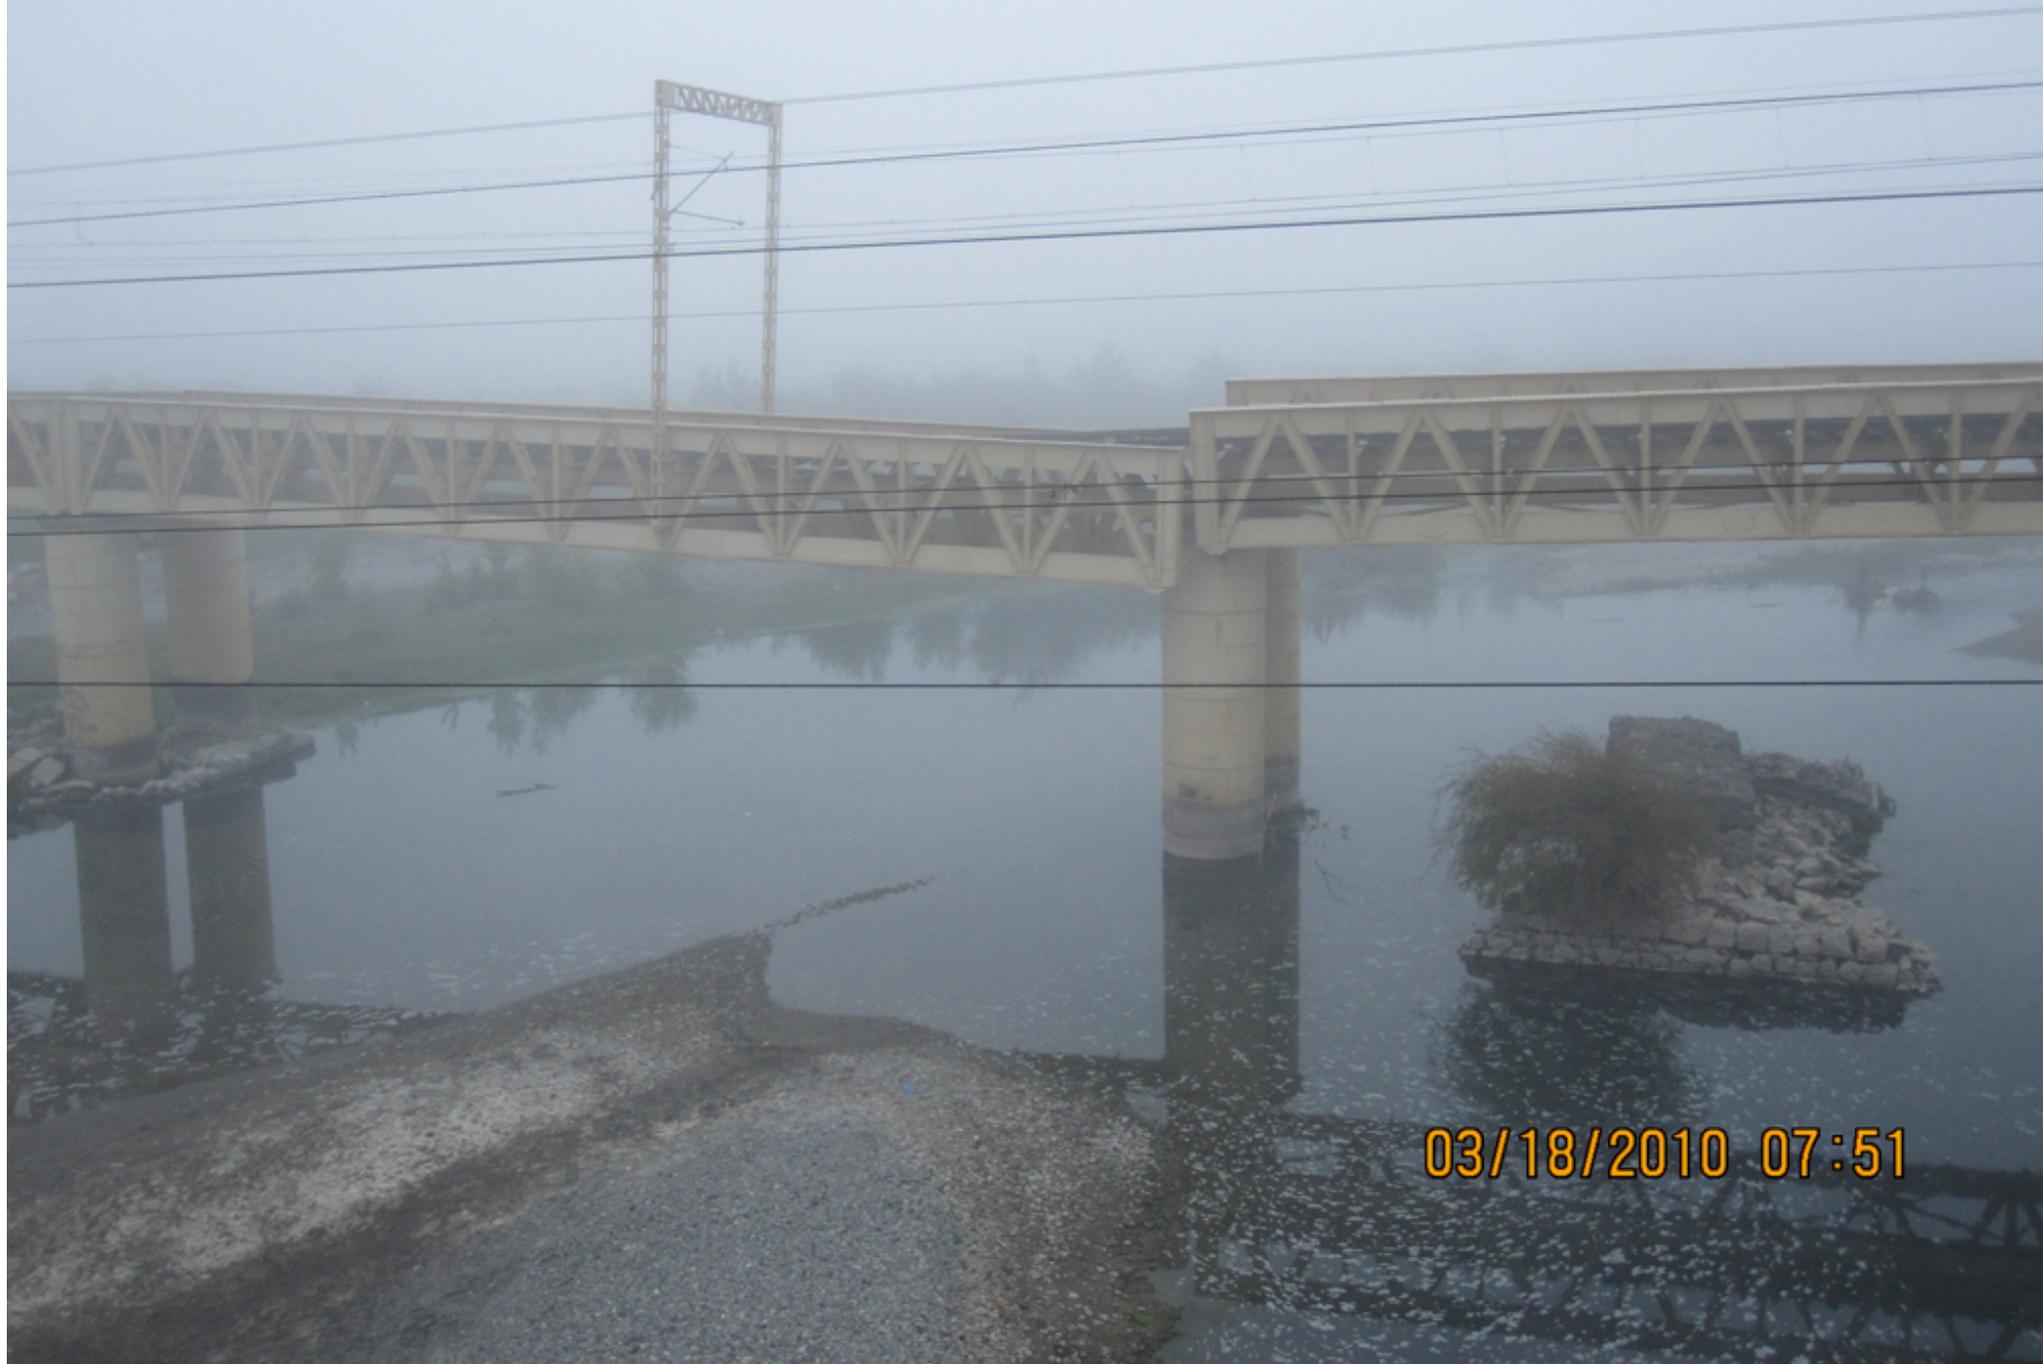
Railroad bridge with unseated span, parallel to Route 5 near Longavi.
