The 2011 Off the Pacific Coast of Tohoku Earthquake
- Quick Investigation Report on Earthquake Damage on Buildings -

Professor Masato Motosaka, Tohoku University
(Translation by Shunsuke Otani, University of Tokyo)

March 12, Saturday, Preliminary Investigation

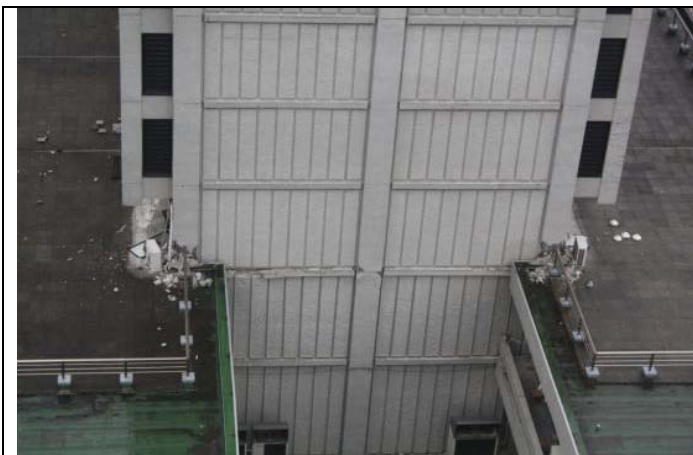
The damage of the east end walls is shown in Photos 1 and 2. The base of the third story columns in the east and west end walls suffered heavy damage due to high axial forces caused by the overturning moment. Non-full web steel element was exposed and buckled in a steel encased reinforced concrete column, and longitudinal reinforcement was either fractured or buckled (Photo 3). After the failure at column bases, the rocking vibration of the building must have occurred. Exposed longitudinal reinforcement at the base of damaged columns revealed new fracture by this earthquake and old fracture of rusted reinforcement by the previous earthquake.

Photo 1: Damage of end walls from roof of the adjacent building

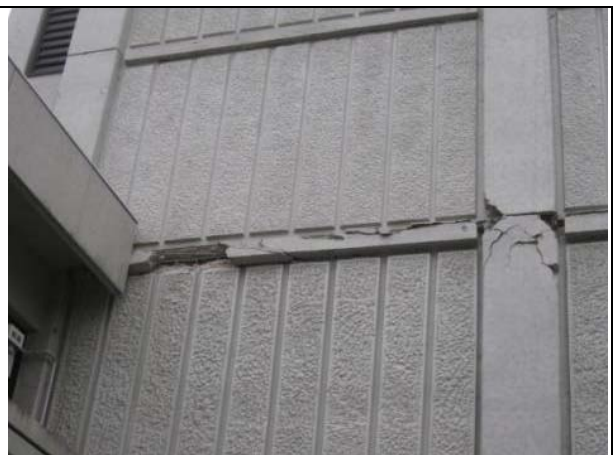
Photo 2: Damage of end walls from the ground

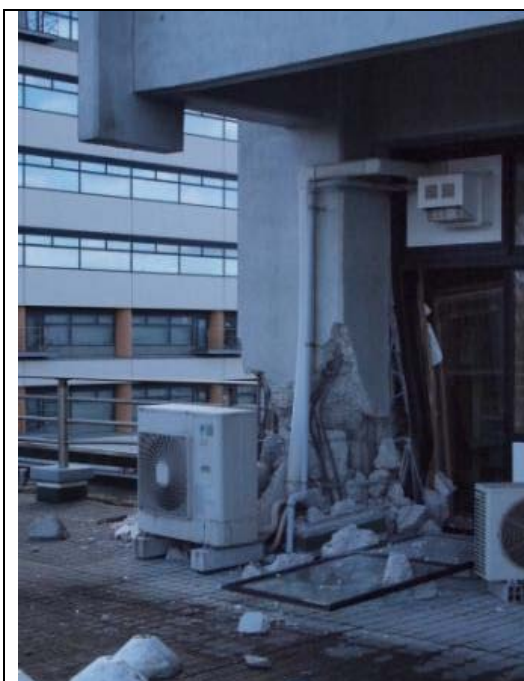
Photo 3: Damage of north-east corner column

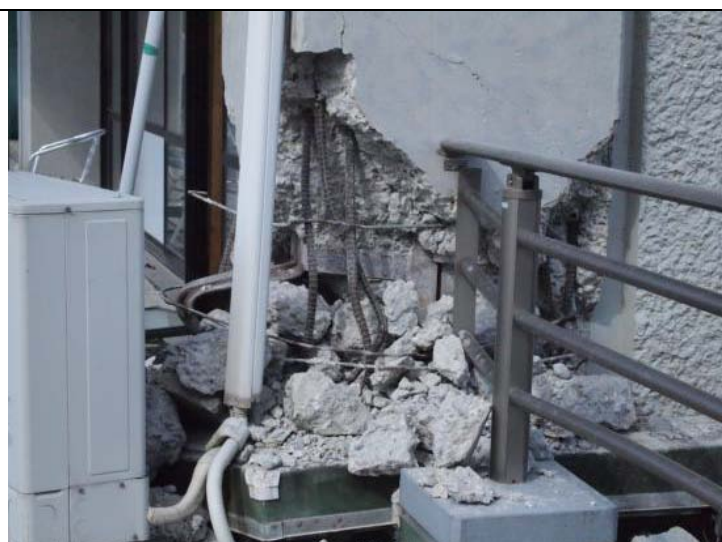
Photo 4: Damage of south-east corner column

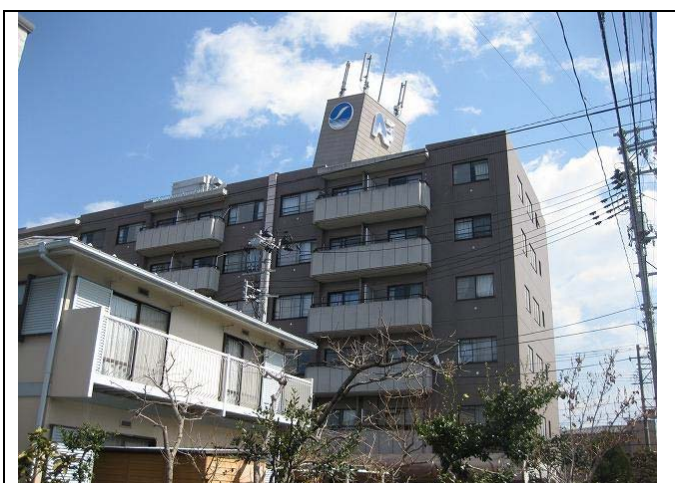
The information of building damage was obtained at the disaster headquarter of Wakabayashi Municipal Office. The penthouse of a six-story reinforced concrete building tilted in Narita-machi (Photo 5); the building did not show any other damage.

Photo 5: A tilted penthouse of a six-story reinforced concrete condominium building

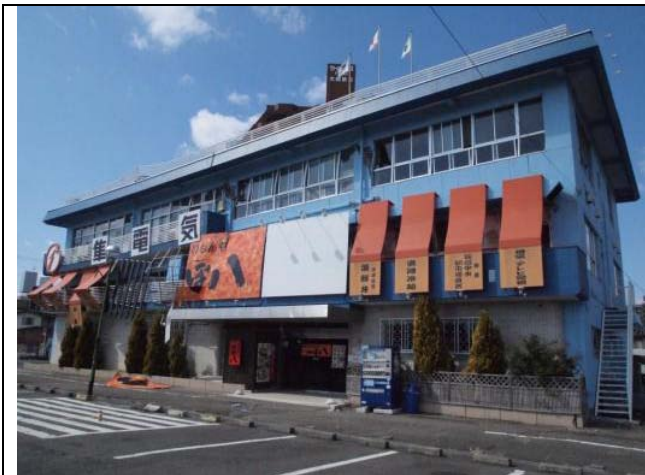
Three-story reinforced concrete building collapsed in the second story in Yamato-machi 5-chome (Photos

6 and 7), probably caused by torsional oscillation.

Photo 6: Collapse in the second story of a three-story reinforced concrete building in Yamato-machi 5-chome.

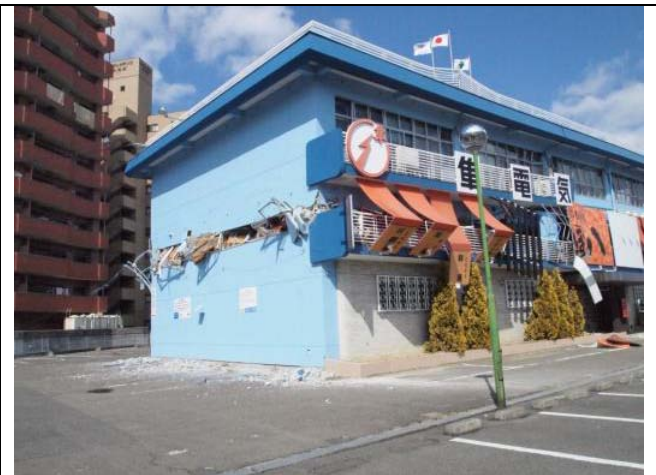
Photo 7: Collapse in the second story

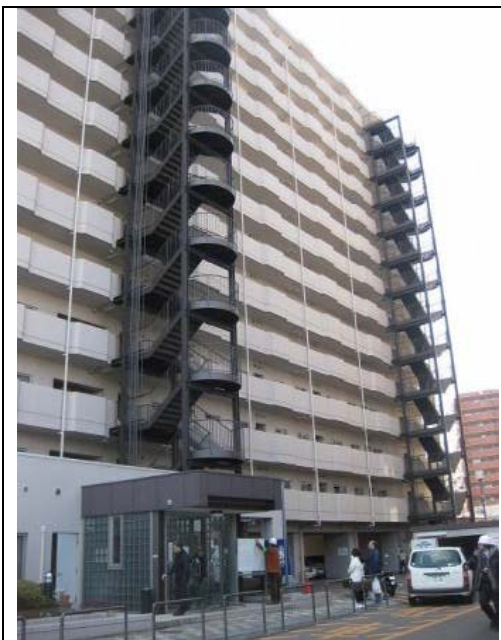
X-shaped shear cracks were observed in non-structural walls facing the hall way from second to nine stories in a fourteen-story reinforced concrete condominium building sold in 1981, Yamato-machi 5-chome (Photo 8); no such damage was observed in the first story (pilotti: soft first-story) and 13 and 14th stories. Doors are not located in the non-structural walls and could be opened.

Photo 8 (a) A 14-story reinforced concrete building

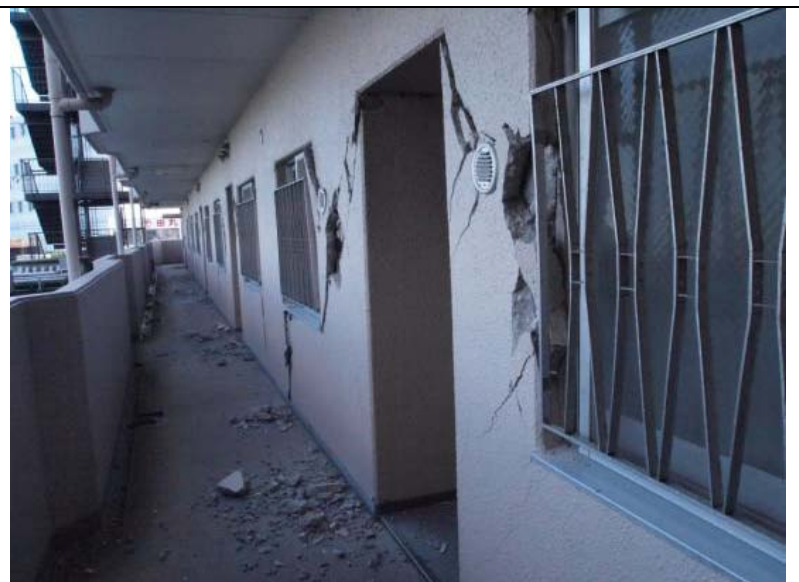
Photo 8 (b): Damage of non-structural walls in the hall way

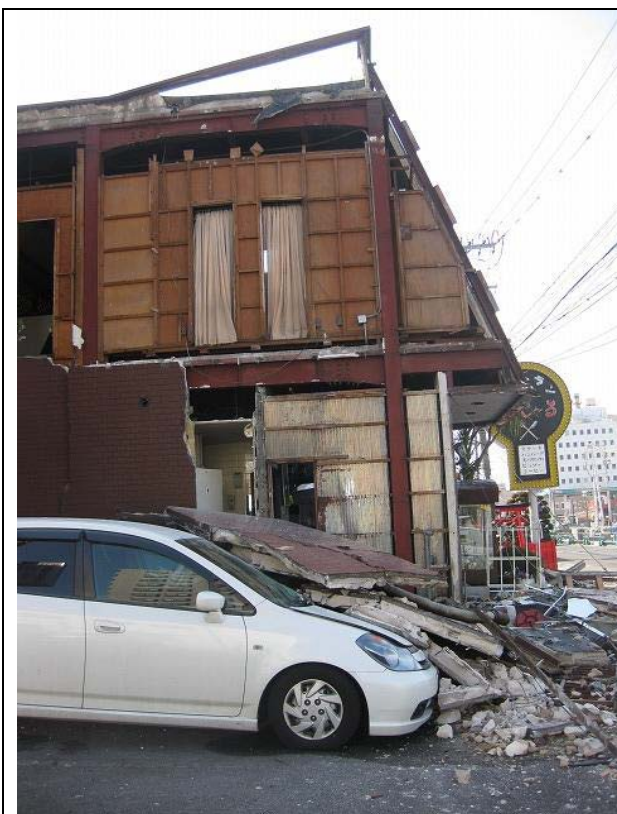
Along the Shinterakouji in Yamato-machi 5-chome, exterior wall finishing fell from a two-story steel construction (Photo 9) and roofing materials fell from a two-story steel building (Photo 10); poor detailing of connection between the finishing and structural members (Photo 11).

Photo 9: Exterior finishing fell from a two-story steel building

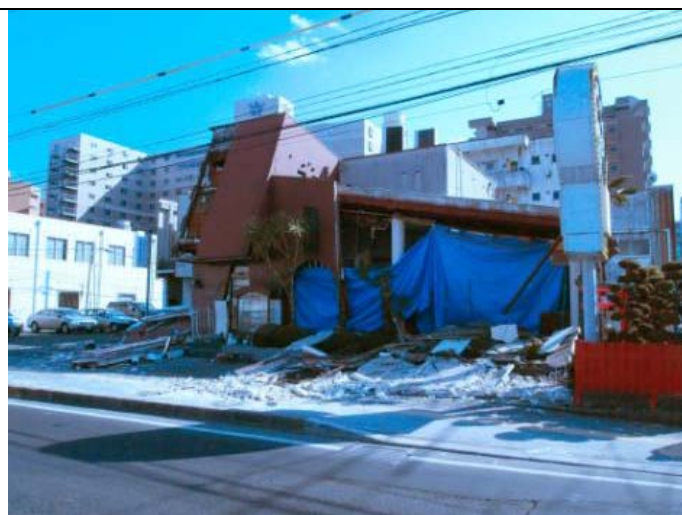
Photo 10: Fall of roofing materials from a two-story steel building

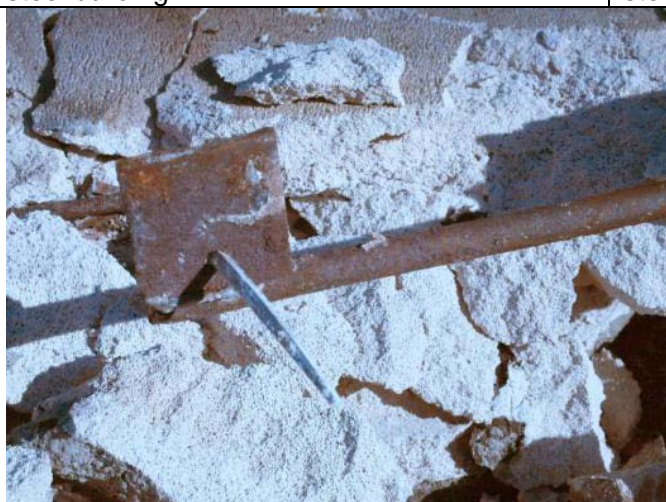
Photo 11: Detail of fastener (anchor) of fallen ALC exterior wall

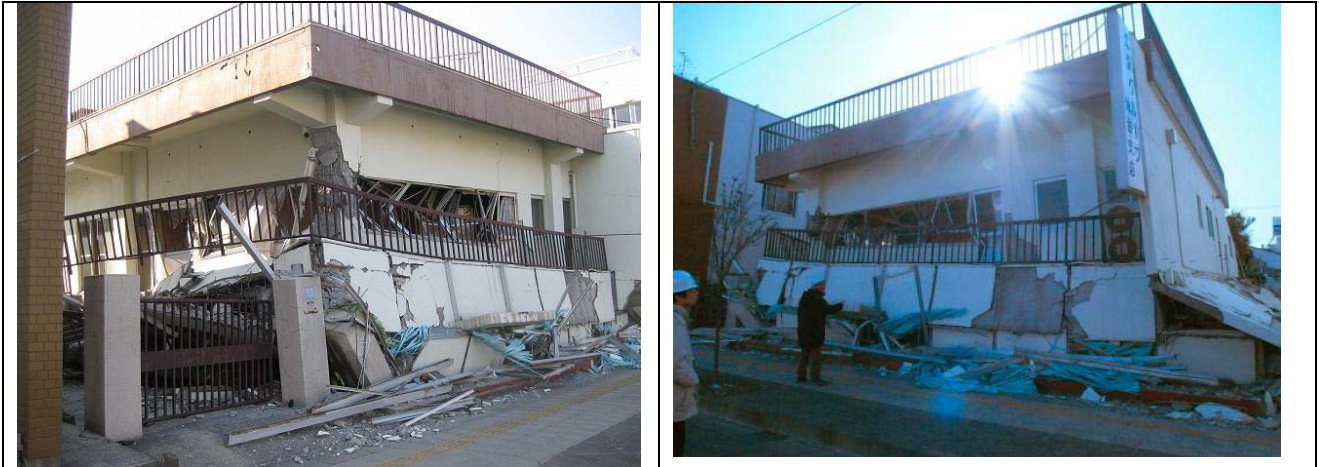
The first-story of a two-story reinforced concrete building collapsed in Oroshim-machi 2-chome (Photo

12); the first story is box wall construction, and the second-story is moment-resisting frame construction. The first story failed in the weak (out of plane) direction of the walls, and second-story columns failed in shear.

Photo 12: Collapse of a two-story reinforced concrete building in Oroshi-machi 2-chome, Wakabayashi-ku

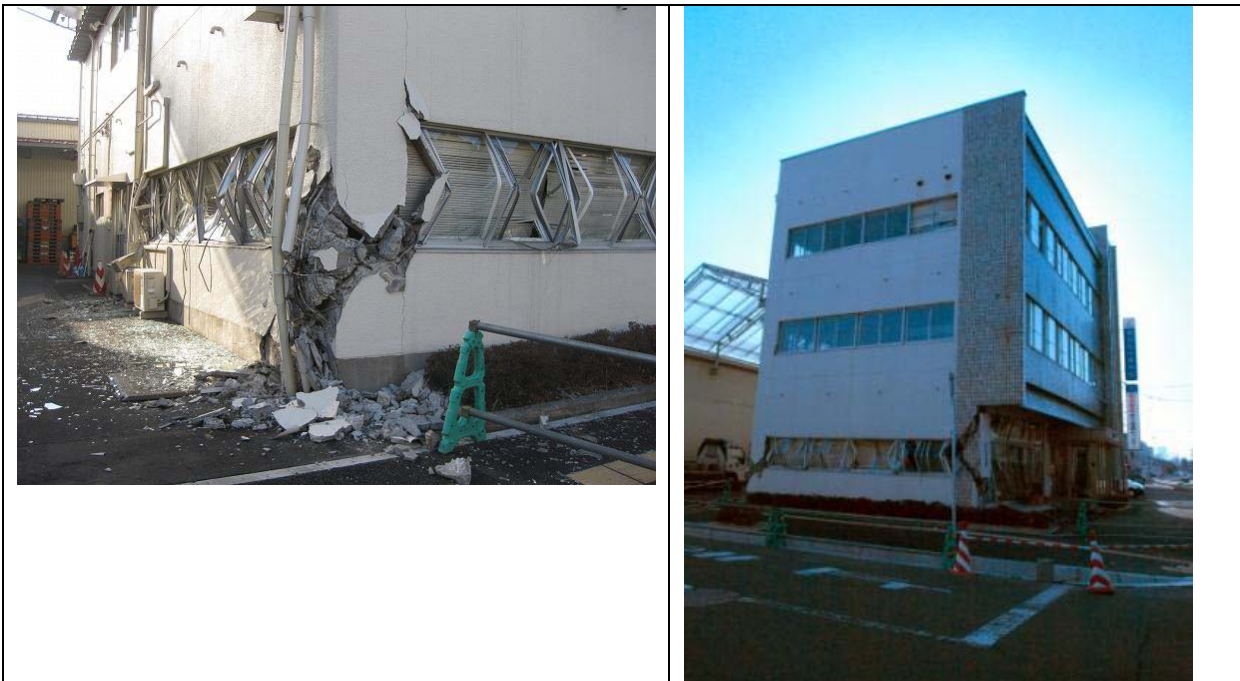
A part of the first story of a three-story reinforced concrete building collapsed in Oroshi-machi 3-chome (Photo 13); the diameter of plain longitudinal reinforcement was 19 mm, and tie reinforcement of diameter 9 mm at 250 mm on centers. The core of the building suffered slight damage, but the building was twisted by eccentricity and exterior columns failed in shear.

Photo 13: Collapse of a three-story reinforced concrete building in Oroshi-machi 3-chome, Wakabayashi-ku

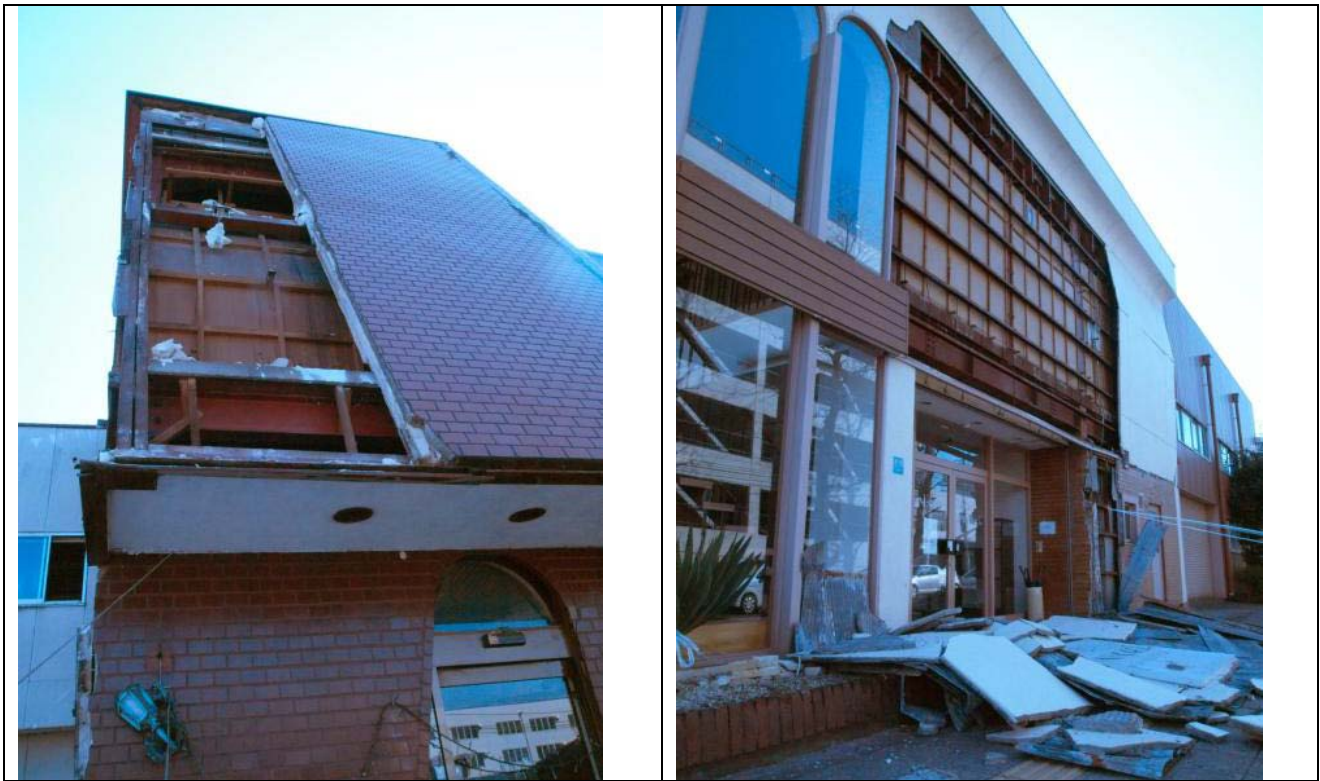
Many exterior curtain walls were observed to fall in Oroshi-machi (Photo 14). Concrete block fences were overturned in many locations (Photo 15).

Photo 14: Fall of exterior curtain walls in steel construction

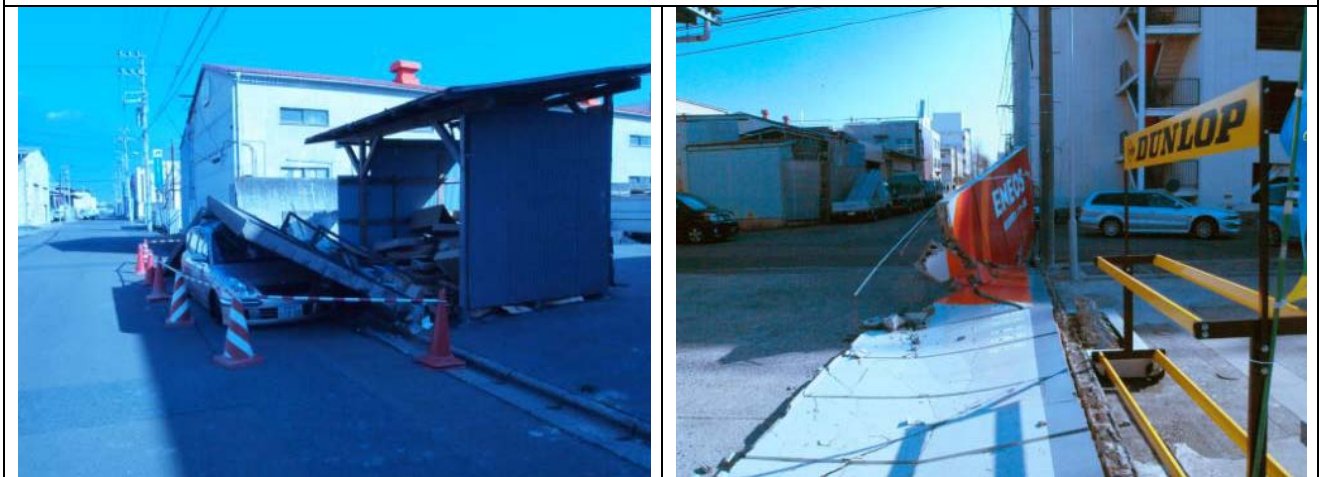
Photo 15: Overturned concrete block fences in Oroshi-machi, Wakabayashi-ku

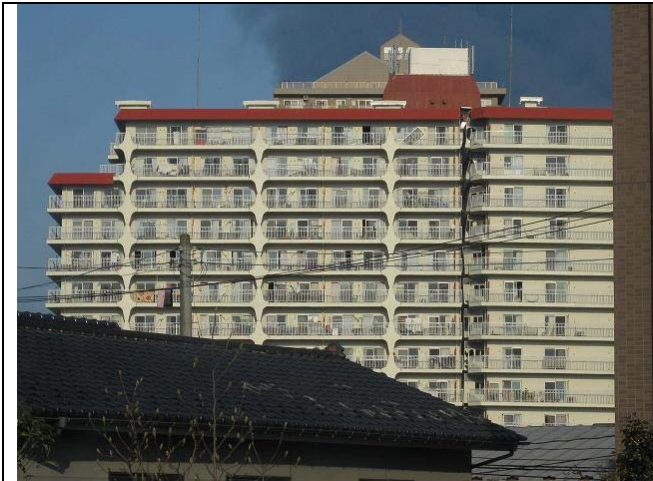
This high-rise condominium buildings suffered damage in pile foundation during the 1978 Miyagi-ken Oki Earthquake. There are two buildings. A building located normal to Route 45, suffered slight structural damage although non-structural partitions failed in shear; no tilting was observed in this building. A building facing to Route 45 showed tilting in the short direction (confirmed on March 12) although the

damage in the upper stories appeared light; non-structural exterior walls showed shear cracking in the longitudinal direction; the tilting rotation was observed in the short direction and the residual lateral displacement at the 14-th floor was estimated to be 400 mm by visual observation. The first floor indicating inclination; the pile might be damaged. The investigation team told the occupants that further detailed investigation might be necessary. The occupants by their own method monitored the separation of the expansion joints, and the tilting is reported to increase (March 15). The damage in piles is suspected.

Photo 16: Condominium buildings in Takasago, Miyagino-ku

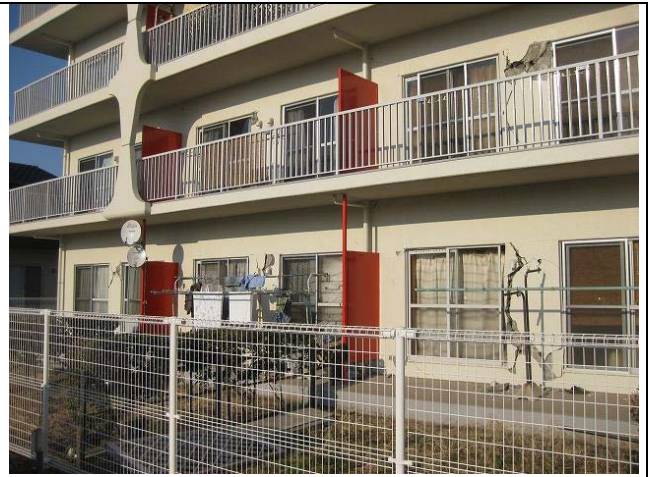
Photo 17: Shear failure of non-structural exterior walls

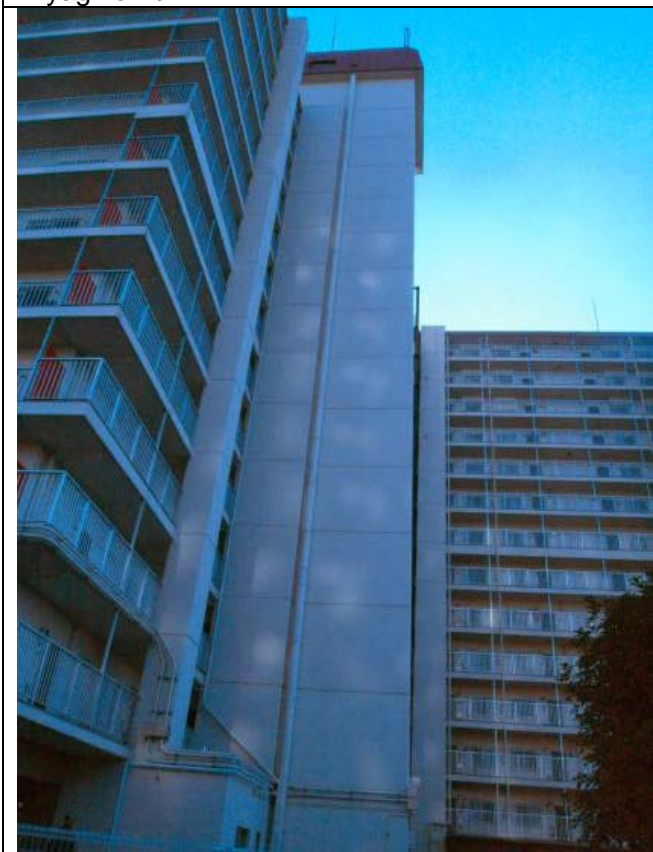
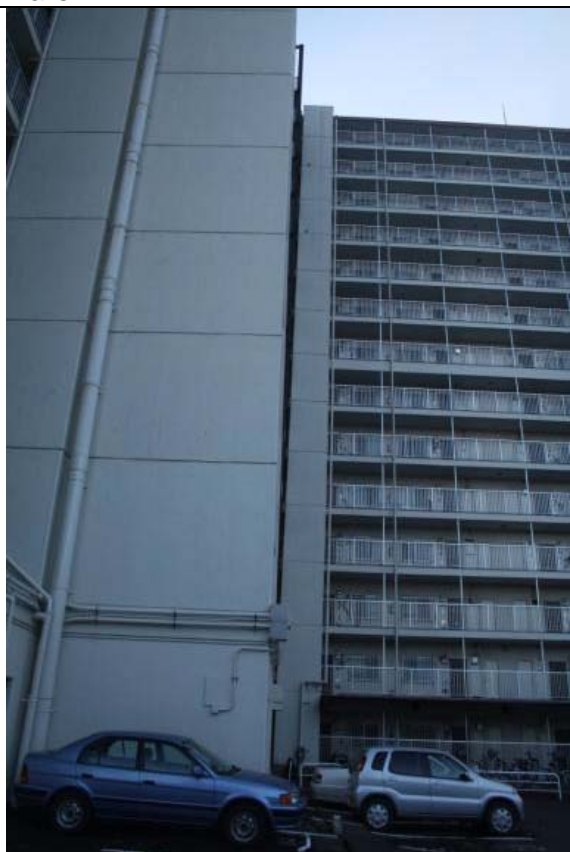
Photo 18: Expansion joint between two buildings (left on March 12, and right on March 16)

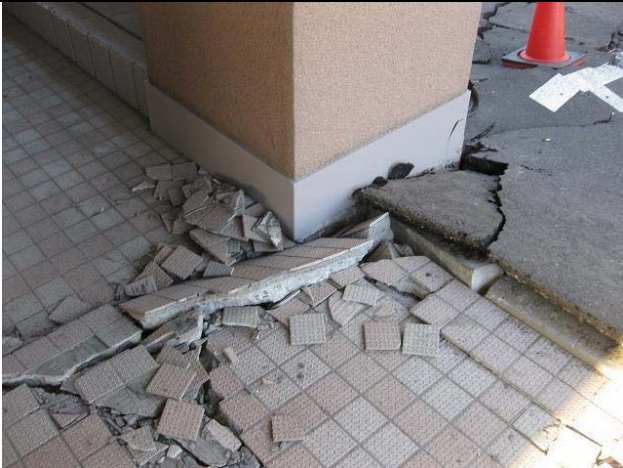
Photo 19: Damage at the base of a first-story column

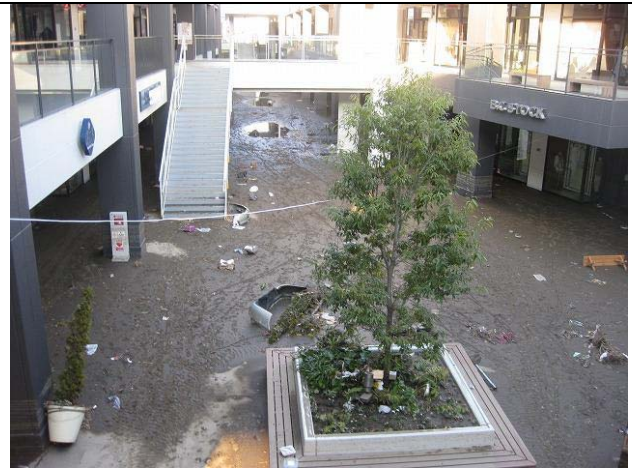
Tsunami water reached 1.0 m high in a large shopping mall, Mitsui Outlet. Some cars were floated and moved in the parking area by the tsunami wave. However, water did not go into shops. No vibration damage is observed in the buildings (Photos 20 and 21).

Photo 21: Damage of the Mitsui Outlet Mall building by the tsunami (Second floor deck)

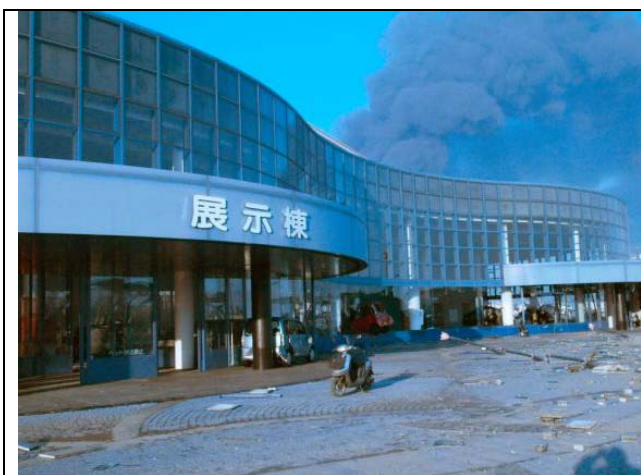
Some cars were floated and moved into the exhibition hall of Miyagi Yume Messe, and broke exterior glasses (Photos 22 and 23). No damage of the building was observed caused by the vibration of the earthquake.

Photo 22: Damage of Miyagi Yume Messe by tsunami

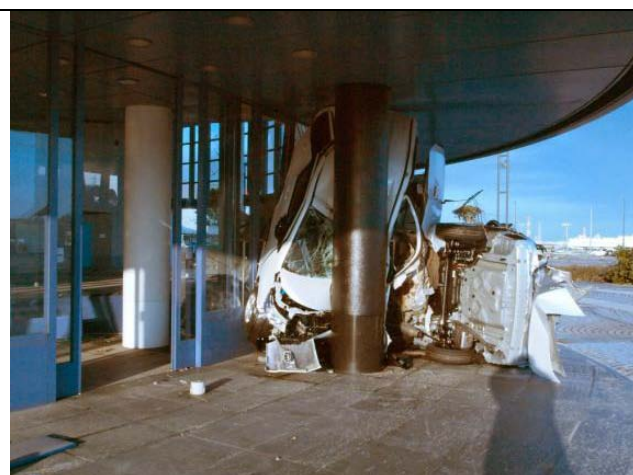
Photo 23: Cars were carried into the exhibition building by tsunami wave

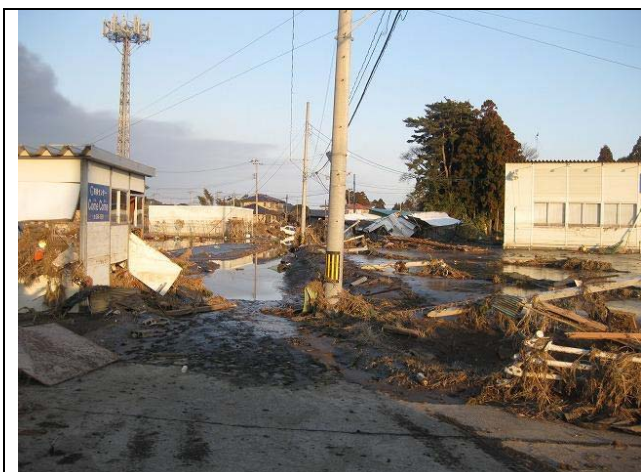
It was not possible to visit residential areas of Gamoh area due to heavy damage by tsunami (Photo 24).

Photo 24: Damage of Gamoh residential area due to tsunamis

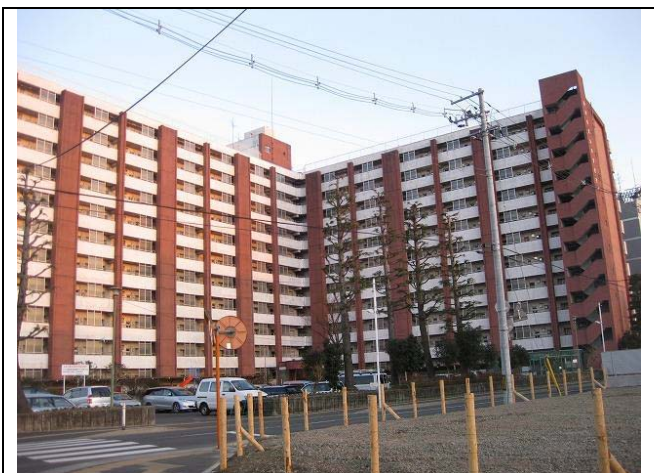
A 11-story reinforced concrete condominium building, which tilted attributable to the damage in piles after the 1978 Miyagi-ken Oki Earthquake, suffered no damage. The 11-story reinforced concrete building normal to the longitudinal building showed the trace of rocking motion, and cracking was observed in the ground along the base, no residual displacement was observed at the expansion joint; no inclination of the building was detected (Photo 25). The damage in piles appeared slight if any.

Photo 25: Kohriyama Municipal Apartment Building
in Nagamachi, Taihaku-ku

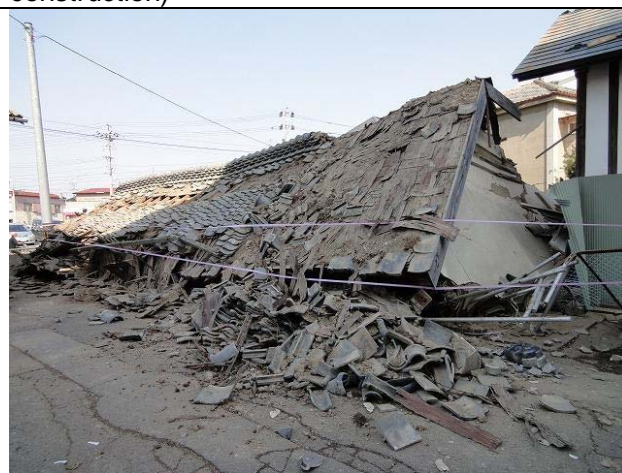
Fig. 7: Collapse of a Godown, adjacent to Ohsaki City Municipal Building

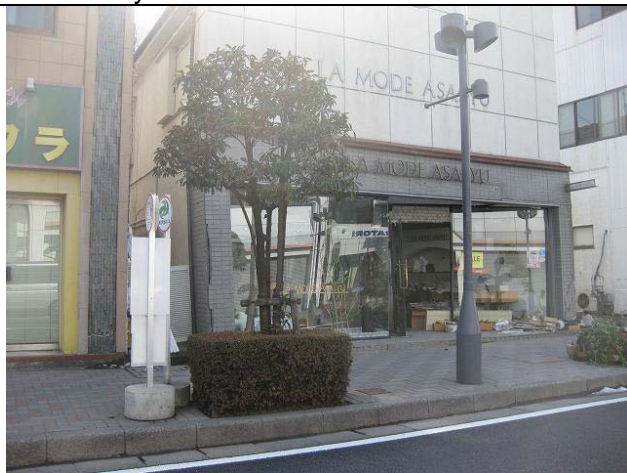
Photo 8: A tilted two-story house for combined use for shop and residence

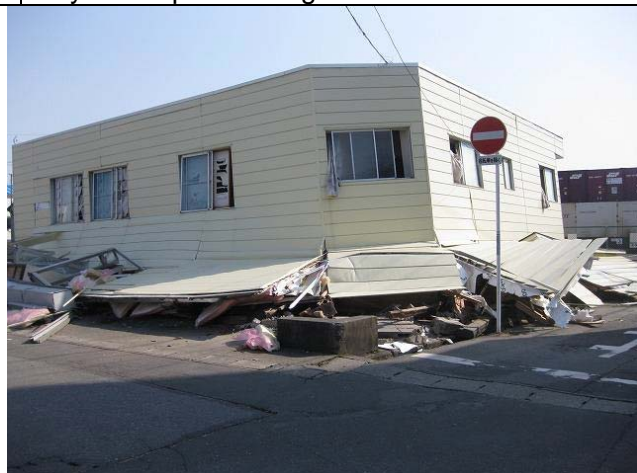
Photo 9: Collapse of a two-story house for combined use for shop and residence

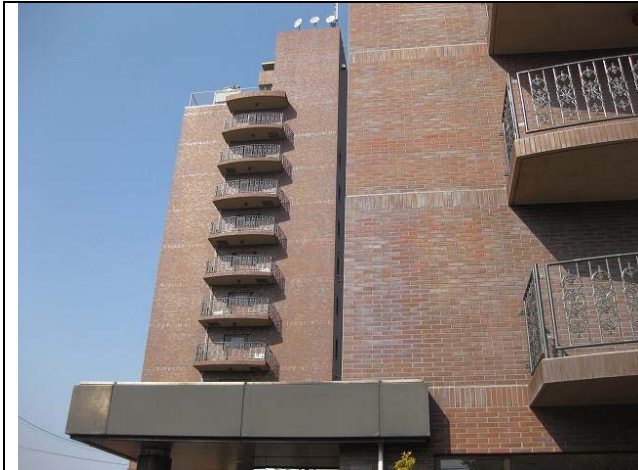
There is a 11-story reinforced concrete hotel in front of Furukawa Station. No structural damage in the super structure is observed, but the tilting of the building is observed probably due to ground movement (Photos 10 and 11).

Photo 10: Tilting of a 11-story reinforced concrete hotel building

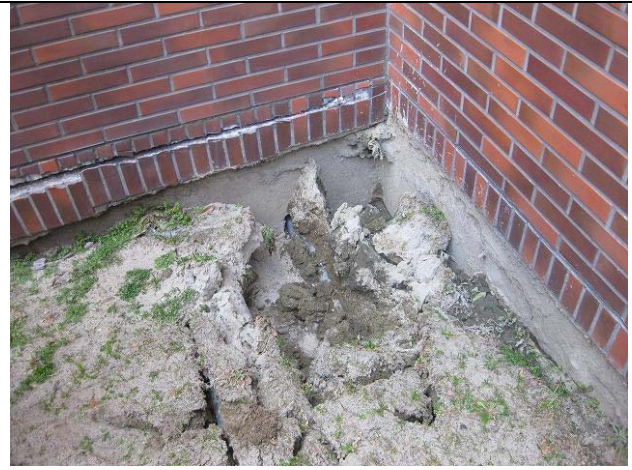
Photo 11: Boundary of foundation and ground at the base of the 11-story reinforced concrete hotel building

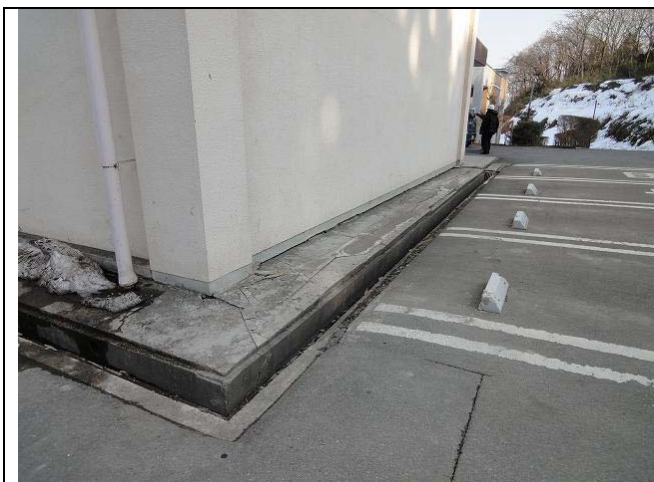
Damage of roof tiles was observed in a very limited number of houses, but not serious damage, In the Iwadeyama High School, ground fissure was observed along the scarcement of f the building (Photo 12), but no serious structural damage was detected.

Photo 12: Ground cracking along the periphery of the building	
---	--

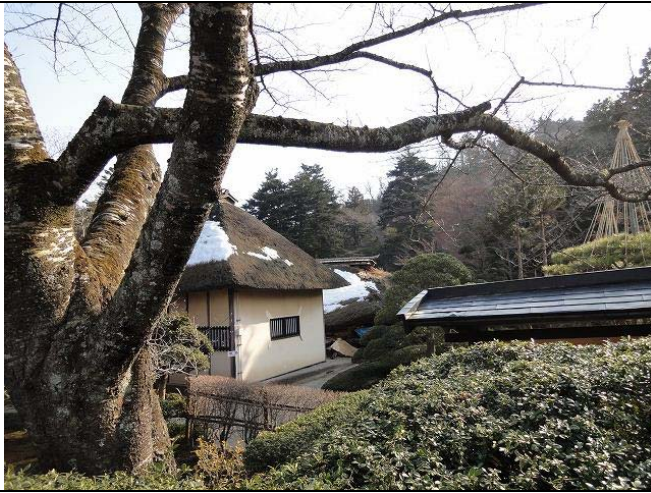
The Yuhbi-kan, a traditional farm house with thatch roof, collapsed completely in Iwade-district of Ohsaki City.

Photo 13: Collapse of the Yuhbi-kan in the back of the picture	
--	--

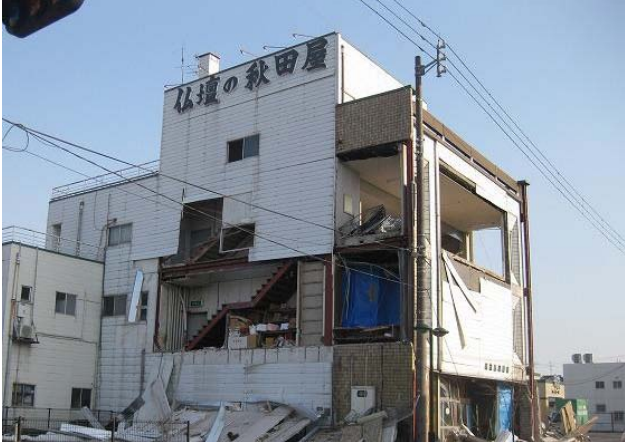
No structural damage was observed from Kaminome Elementary School to National Route 457. In the urban area of Kami-machi Nakaniida District, many external non-structural walls fell from a three-story steel commercial building.

Photo 15: Fall of external non-structural walls from a three-story steel commercial building
