Tohoku Chapter, Architectural Institute of Japan  
Reconnaissance Report (11) on Building Damage in Kurihara City  
The 2011 off the Pacific Coast of Tohoku Earthquake  
Released on March 28, 2011

Professor Masato Motosaka, Graduate School of Engineering,  
Tohoku University  
(Translated by Shunsuke Otani, University of Tokyo)

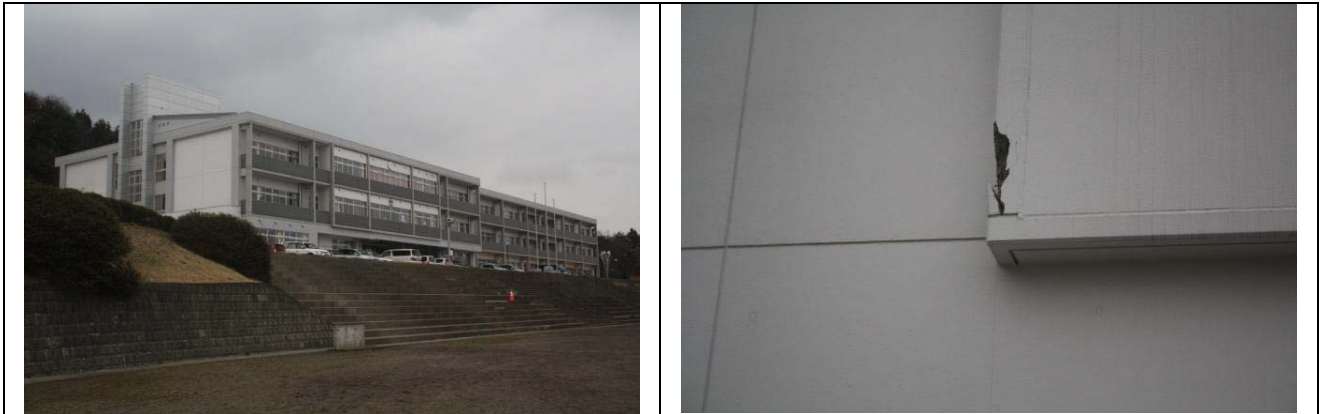
Photo 2: Tsukidate Junior High School Building with minor non-structural damage

Two buildings near the K-NET Tsukidate station were selected for the damage investigation; Kurihara City Municipal Tsukidate Junior High School (new construction, Photo 2) and Kurihara City Municipal Tsukidate Gymnasium Center Building (Photo 3), the latter suffered non-structural damage during the 2008 Iwate-Miyagi Inland Earthquake. No damage was observed in both buildings.

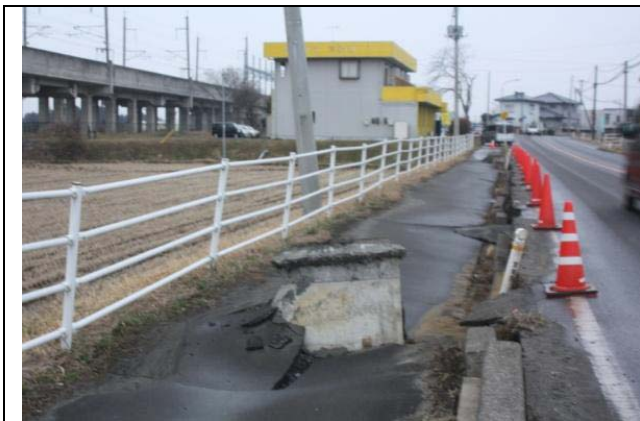
Soil liquefaction phenomena were observed on the road to National Route 398 in Shiwahime District; i.e., a man hole was lifted (Photo 4). Fall of masonry walls along the plot periphery was seen in several locations (Photo 5). Concrete block walls did not fall, but heavy masonry walls fell down (Photo 6). When the investigator asked an old man at a parking lot near Shiwahime Municipal Branch how he compared the intensities of ground motion of the 2011 Tohoku earthquake and the 1978 Miyagi-ken Oki Earthquake, he said “the ground motion intensity of this earthquake was larger and the duration was longer. Compared with the 2008 Iwate-Miyagi Inland Earthquake, the ground motion intensity of this earthquake was larger.”

Photo 4: Lifting of a man hole due to soil liquefaction near Shiwahime

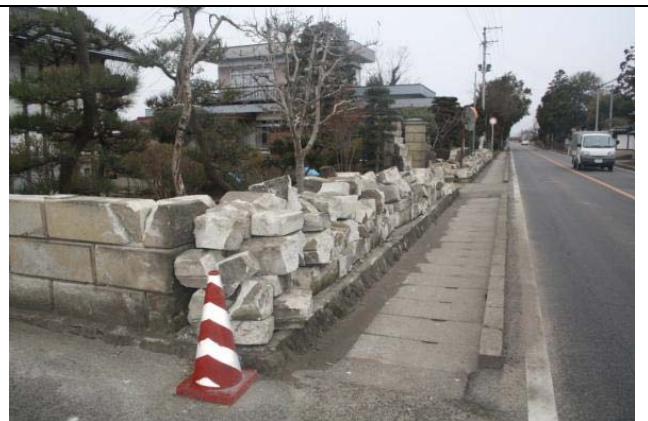
Photo 5: Fall of masonry walls

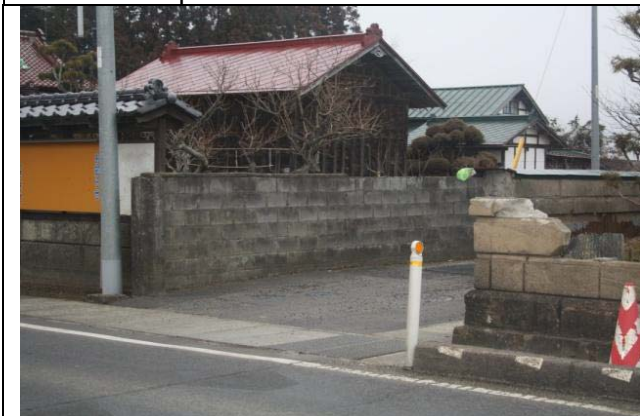
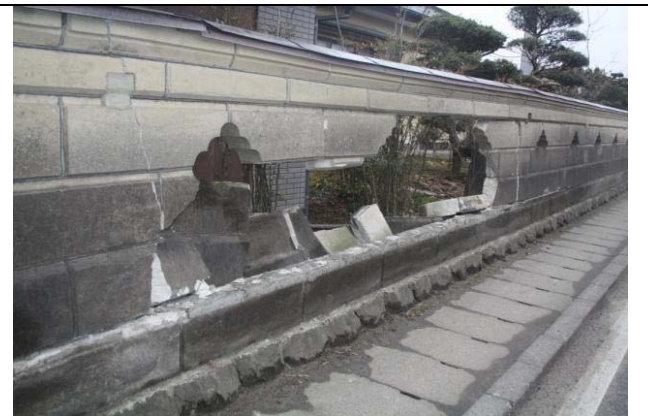
Photo 6: Undamaged concrete block walls and damaged masonry walls

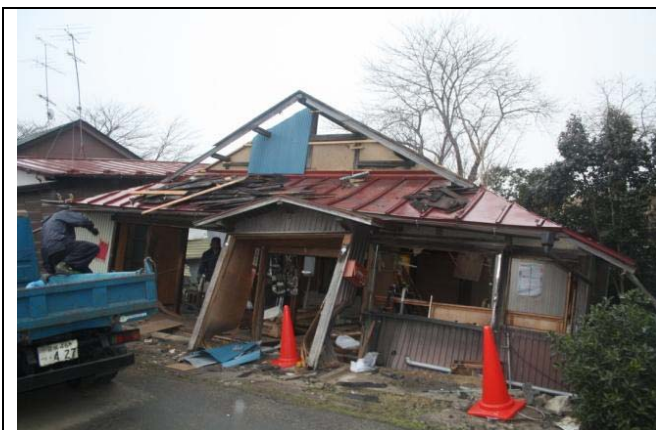
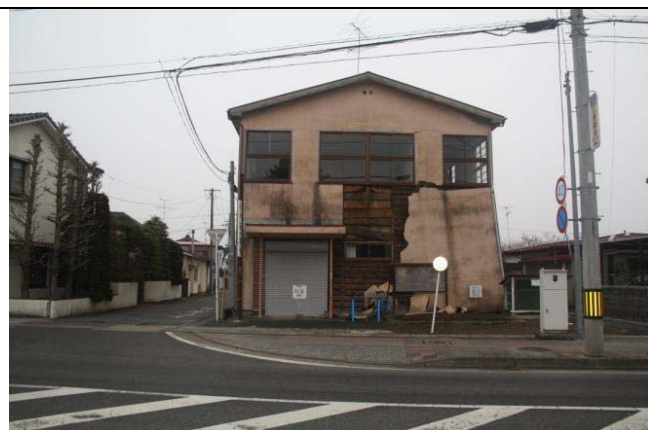
Along the Hazama River in Wakayanagi-machi, the damage of old timber houses was observed (Photo 7)

Photo 7: Damage of houses in urban area of Wakayanagi-machi

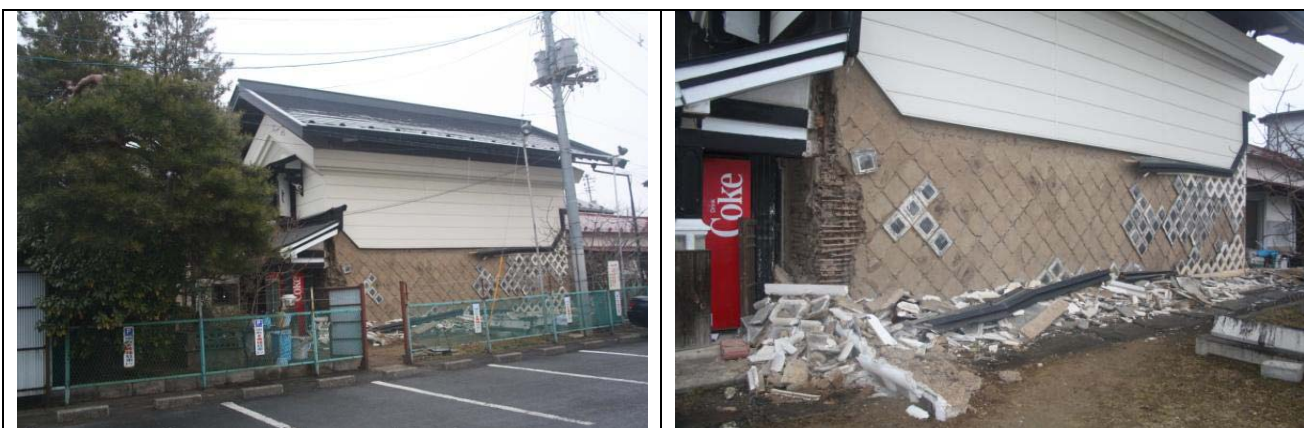
Mud exterior finishing fell from old traditional ware houses (Photo 8)

Photo 8: Fall of exterior mud finishing of traditional ware house walls

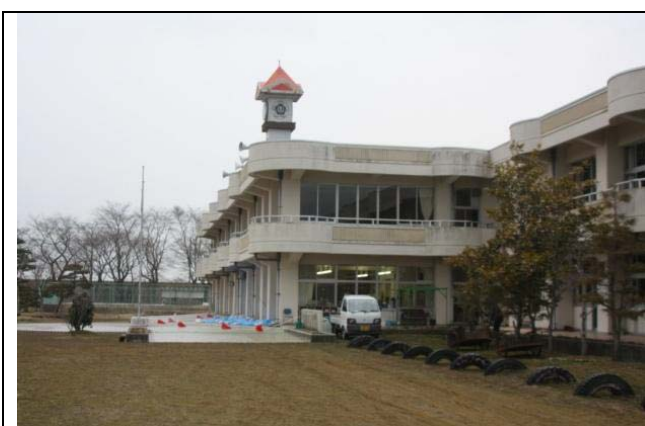
Photo 9: Overall view of Kurihara City Municipal Wakayanagi Elementary School

No damage was observed in the two story reinforced concrete Kurihara City Municipal Wakayanagi Elementary School Building, supported by pile foundation. Due to the soil settlement, 20 cm deep opening was observed (Photos 9 and 10). A statute fell down (Photo 11). The school master said “the large motion was felt in the east-west direction. The length of piles was told to be 30 m.” The gateposts of the Kanro-ji temple fell to the west near the school (Photo 12), and a large masonry lantern fell in a similar manner. The dominant frequency of the (H/V) ratio of horizontal to vertical spectra of micro tremor measurements at the Wakayanagi Elementary School after the 2008 Iwate-Miyagi Inland Earthquake was observed to be 0.8 Hz. In the neighborhood of the school, utility poles were tilted (Photo 13), cracking on the road, severe tilting of a timber house (Photo 14) in the second story were observed,

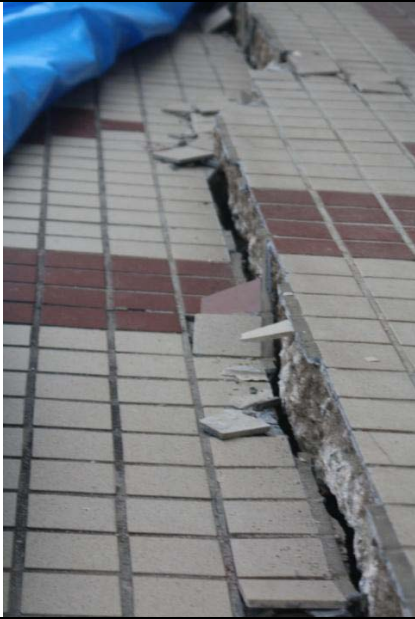
Photo 10: Ground settlement at the elementary school

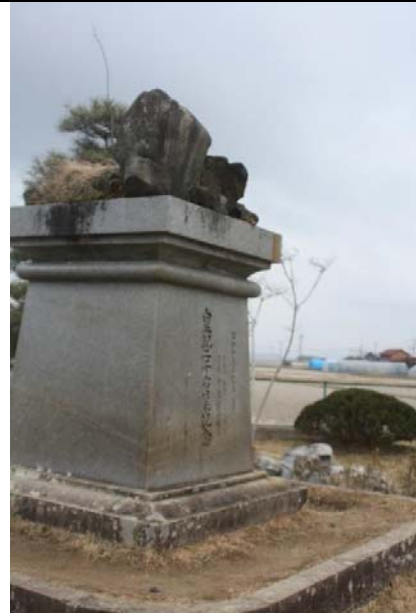
Photo 11: Fall of a statute

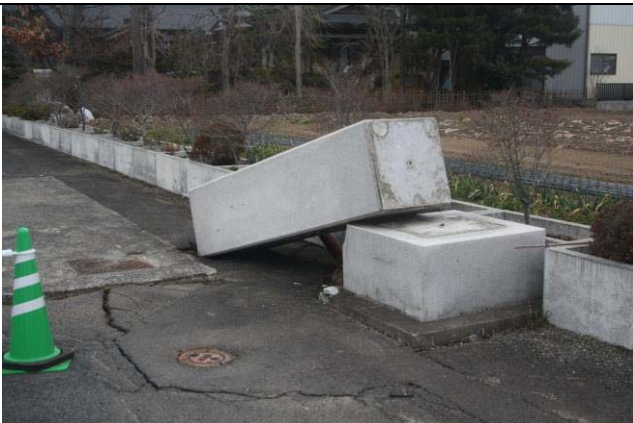
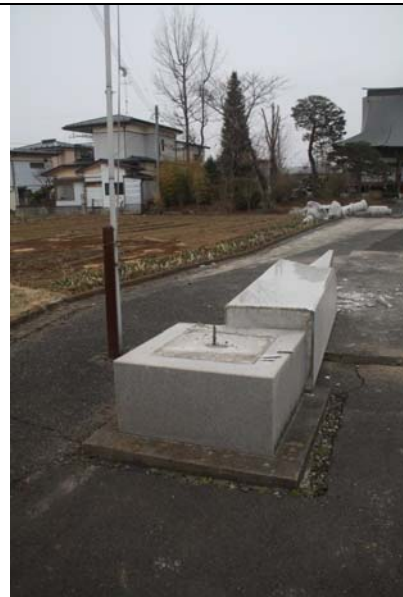
Photo 12: Fall down of two gateposts of the Kanro-ji temple to west

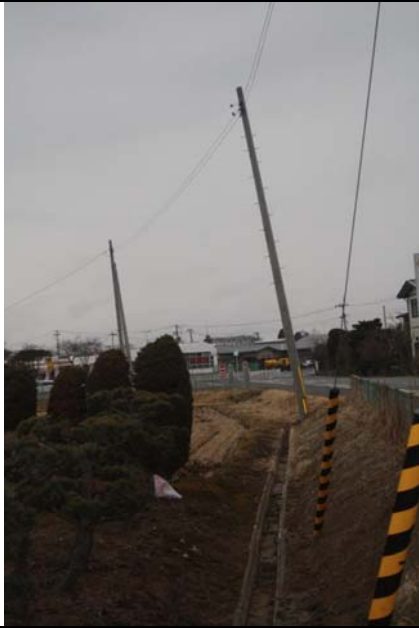
Photo 13: Tilting of utility poles

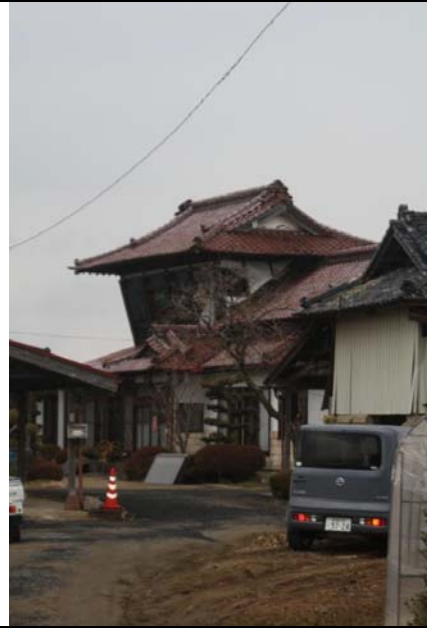
Photo 14: Tiling of the second story of a timber house
