Tohoku Chapter, Architectural Institute of Japan
Reconnaissance Report (12) on Tsunami
The 2011 off the Pacific Coast of Tohoku Earthquake
Released on April 3, 2011

Disaster Committee, Tohoku Chapter
Dr. Reiji Tanaka, Professor
Mr. Ryota Yamaya, Guest Researcher,
Tohoku Institute of Technology
(Translated by Shunsuke Otani, University of Tokyo)

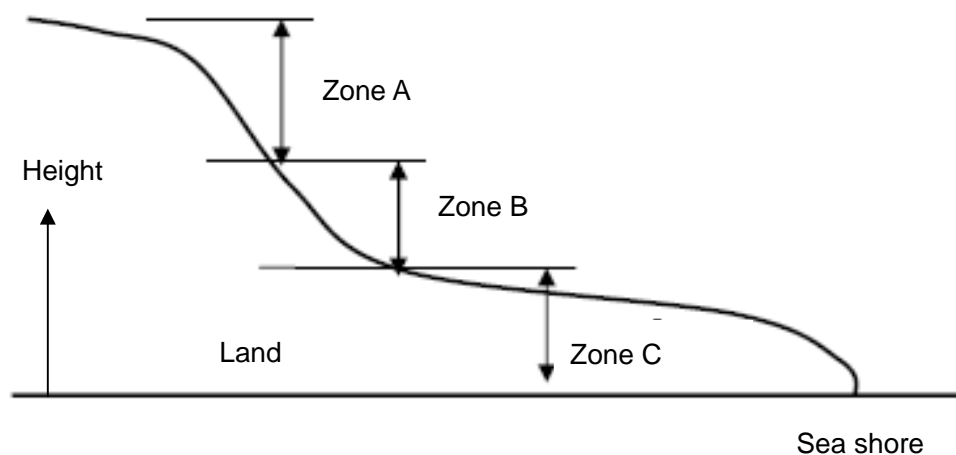
Fig. 1 : Tsunami Damage Zones

In Motoyoshi-machi and Ohya Coast, those houses on the hill did not suffer damage, whereas many houses suffered heavy damage in the tsunami attack zone. The areas of different degrees of damage may be classified into three zones depending on the height of the construction sites (Fig. 1).

Zone A: Houses on the hill, no damage from tsunami nor by ground shaking;

Zone B: Houses where tsunami wave reached as high as 1 to 3 m, but some did and others did not suffer damage from tsunami wave; and

Zone C: Houses could not resist tsunami wave attacks and were completely destructed and washed away.

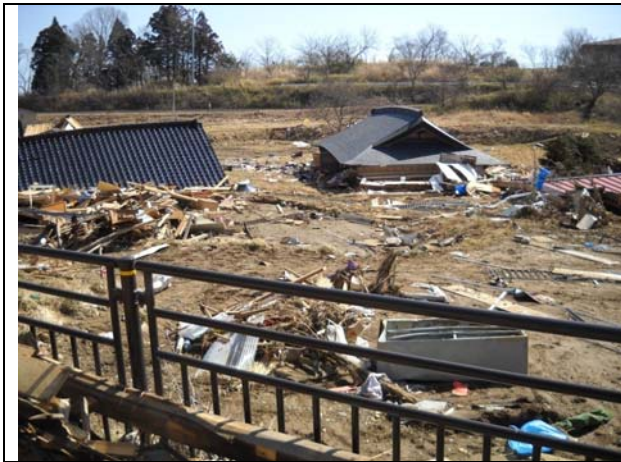
In the area of lower height, the flown out garbage fill the ground. Broken and wrecked houses were also flown out (Photos 6 and 7). Houses on the hill were not touched on the Ohtani Coast.

Photo 6: Houses were flown out.

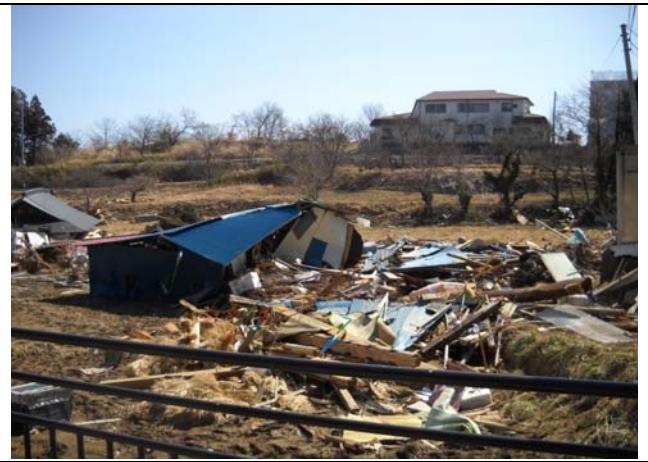
Photo 7: Broken houses in the low land and an untouched house on the hill.

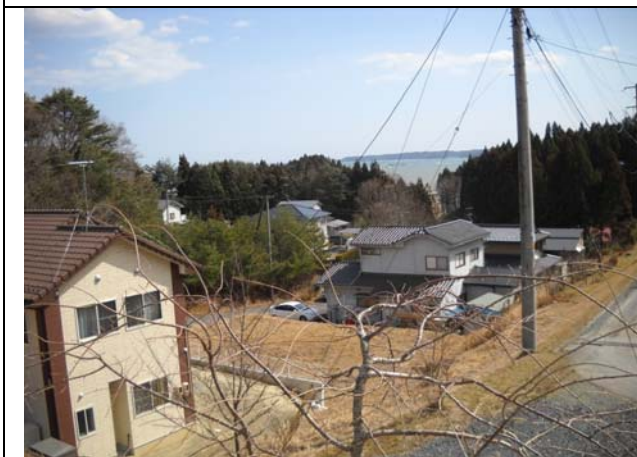
Photo 8: Untouched houses on the hill at the Ohtani Coast (1).

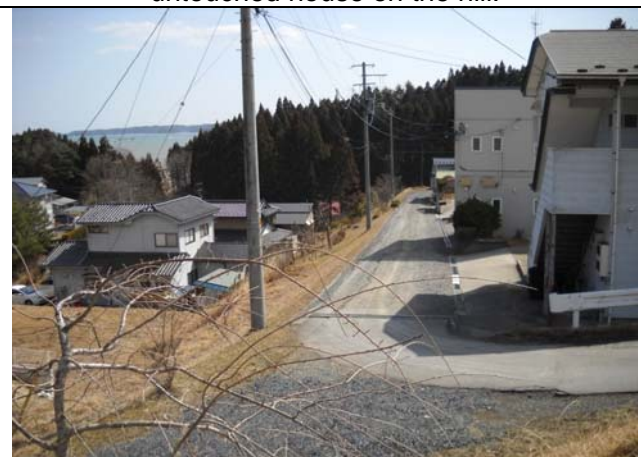
Photo 9: Untouched houses on the hill at the Ohtani Coast (2)

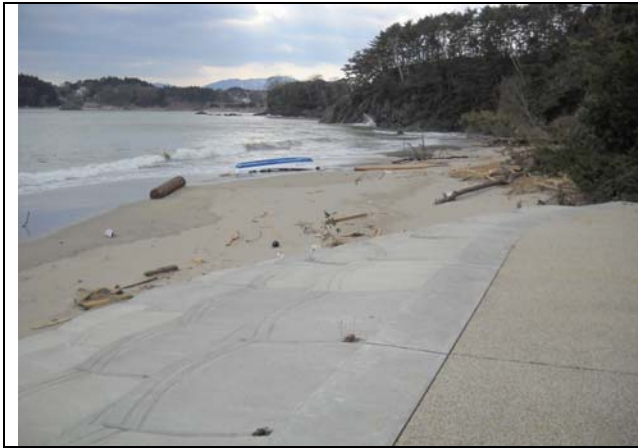
Photo 10: View of the sea near the Ohtani Coast.

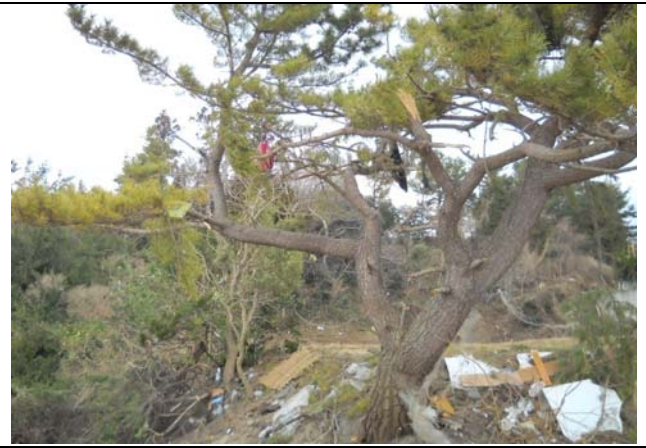
Photo 11: Flown out objects in the forest.

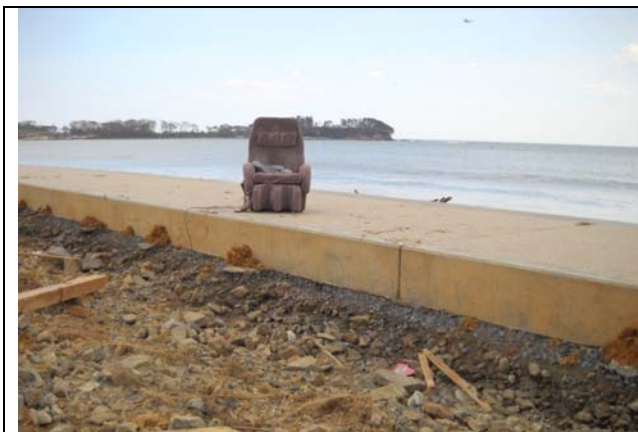
Photo 12: A chair on the breakwater bank.

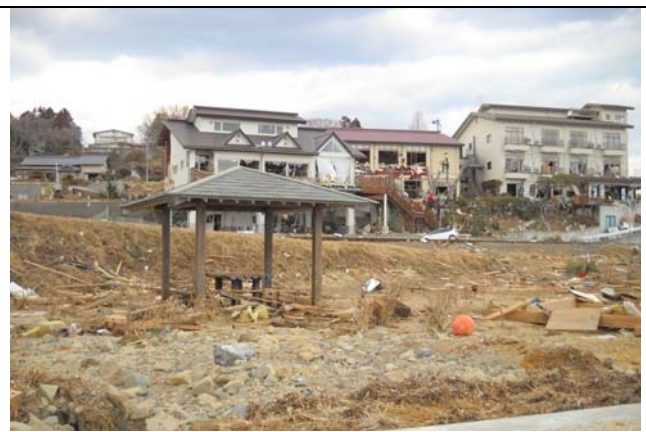
A sofa was found on the breakwater bank (Photo 12). A view from the water break bank to the hill in the Ohtani Coast (Photo 13), in which an arbor is shown supported by four thin timber columns in the low land. The arbor was not damaged. A thin structural member did not attract wave pressure of the tsunami. The dimensions of the column was 200mm square.

Photo 13: A view from the breakwater bank

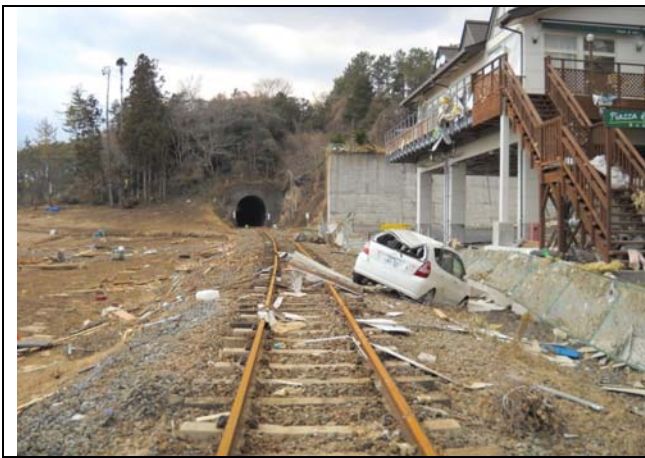
A train runs on the hill (2.5 m high) behind the arbor shown in Photo 13. An automobile was flown out across the rail road (Photo 14); a tunnel in the photo was not damaged. The view from the tunnel to the opposite side is shown in Photo 15. A railway bridge collapsed, and in this area. A three-story hotel building on the hill behind the arbor in Photo 13 is shown in Photo 16; the second floor veranda is supported by three columns in the front, and the windows in the second story were broken. A view of the hotel from the hill side is shown in Photo 17. The second and third stories are of steel construction. From the damage in the second story, the tsunami wave height must have reached approximately 20.5 m (see Fig. 2). There was a concrete block warehouse at 10 m from the sea level (Photo 18); the building was undamaged. There was a timber house next to the concrete block warehouse, but the house was washed away leaving only the foundation (Photo 19). As can be seen in Photo 19, there is a reinforced concrete retaining wall near the concrete block warehouse. There is a two-story reinforced concrete old-age home

Photo 14: A view toward a tunnel.

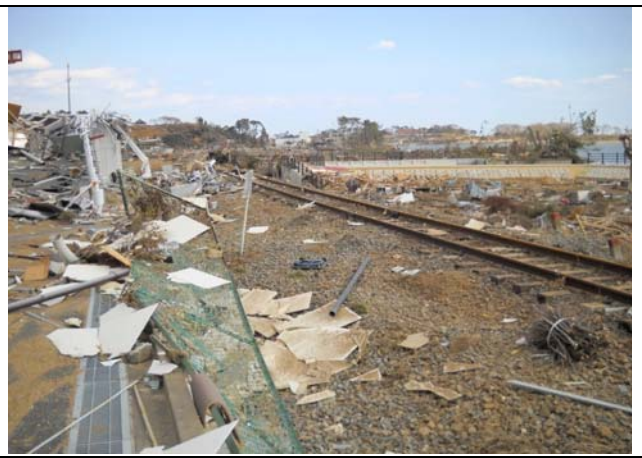
Photo 15: A view from the tunnel side.

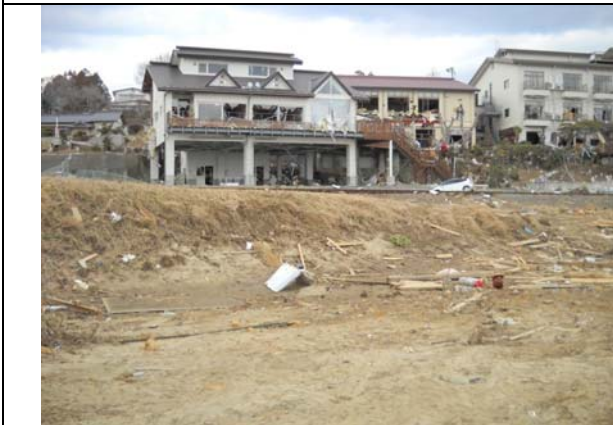
Photo 16: A view of a hotel building from the coast.

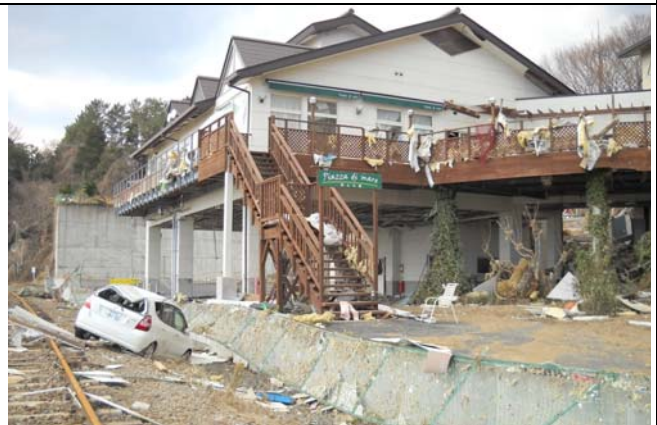
Photo 17: A view of the hotel from land side

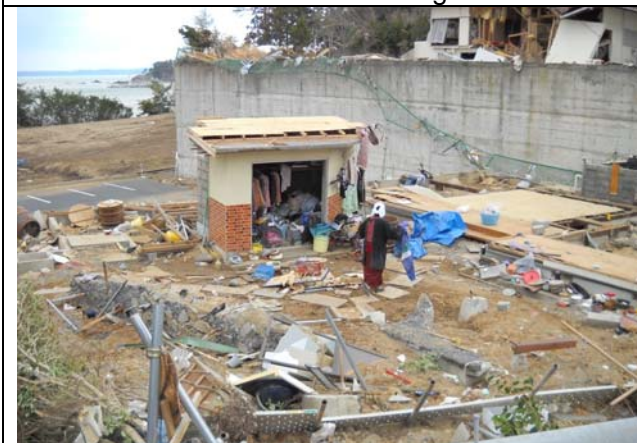
Photo 18: A concrete block warehouse below the hotel building

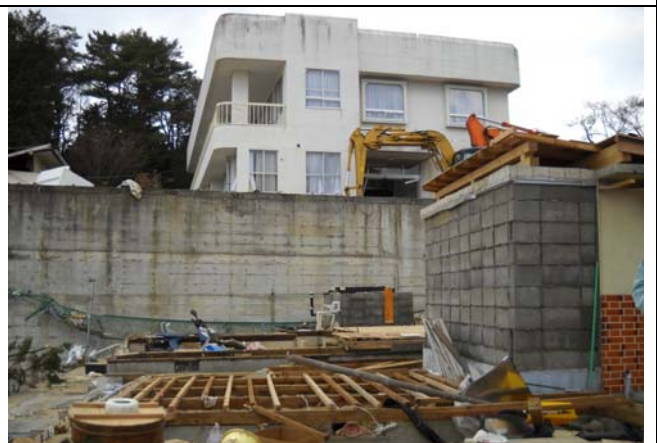
Photo 19: A timber house was washed away leaving the foundation, next to the warehouse.

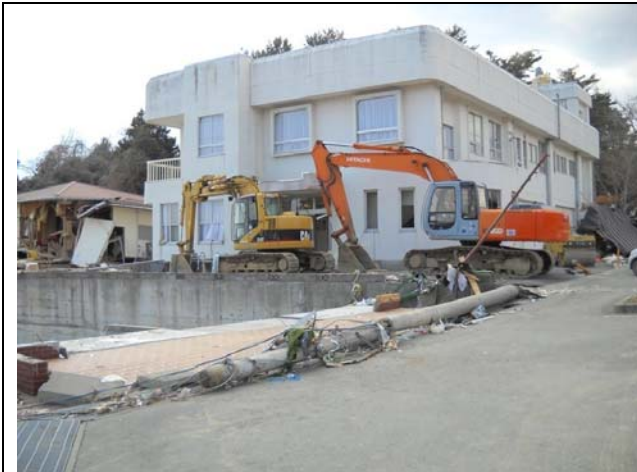
behind the retaining wall (Photo 20). The first story of the old-age home was inundated with tsunami water, but suffered no cracking. The first story of the old-age home is shown in Photo 21.

Photo 20: A two-story reinforced concrete old-age home

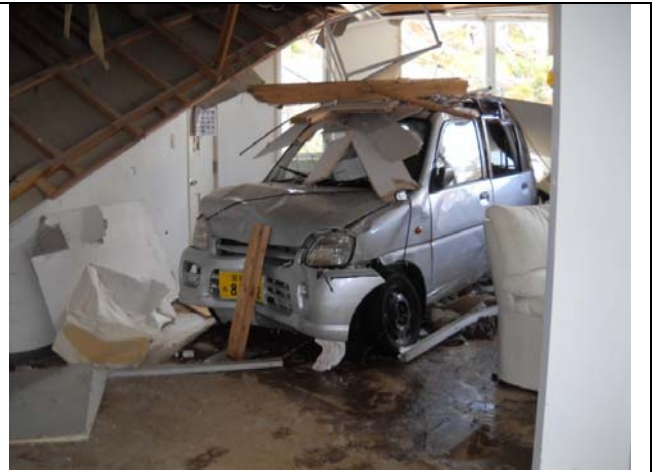
Photo 21: A car was brought into the first story of the old-age home.

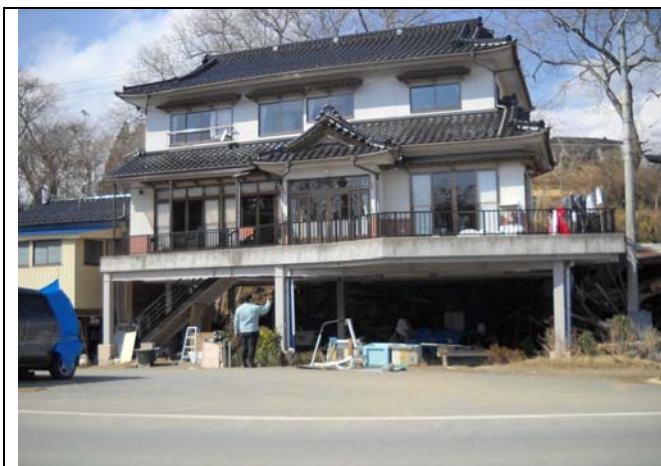
Behind the hotel and the old-age home, and across national route 45 (see Fig. 2), there is a two-story timber house standing on a one-story reinforced concrete elevated foundation (Photo 22); the tsunami wave came to the one-story foundation, but the timber house did not suffer any damage from tsunami wave attacks. The occupants of the house live an ordinary life. An adjacent timber house suffered heavy damage from the tsunami (Photo 23). Building a house on an elevated reinforced concrete foundation is a possible way to avoid tsunami wave attacks.

Photo 22: A timber house on one-story reinforced concrete foundation

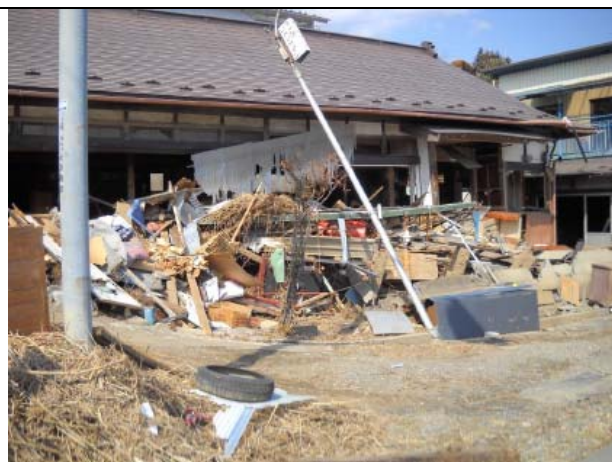
Photo 23: Damaged adjacent timber house
