Tohoku Chapter, Architectural Institute of Japan
Reconnaissance Report (15) on Tsunami Damage in Sendai City
The 2011 off the Pacific Coast of Tohoku Earthquake
Released on April 12, 2011

Disaster Investigation Committee

Dr. Masayuki Hando, Professor, and
Dr. Tomomi Fujita, Research Associate
Sendai National College of Technology
(Translated by Shunsuke Otani, University of Tokyo)

This report introduces the damage survey of Nagamachi, Taihaku-ku (Ward) and Oritate, Aoba-ku of Sendai City carried out by the staff of Sendai Technical college.

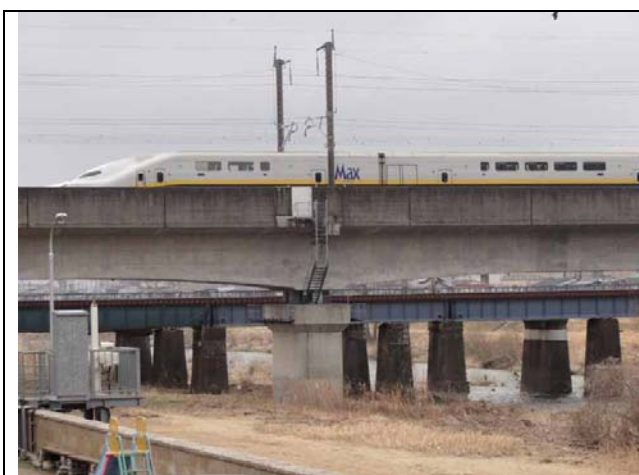
Nagamachi 1-chome, Taihaku-ku

Photo 1: A Shinkansen train stood still on
Hirose-gawa side viaduct

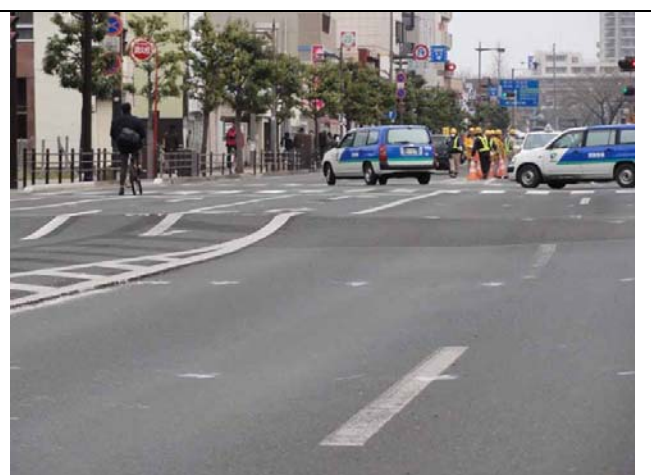
Nagamachi 1-chome, Taihaku-ku

Photo 2: Ground settlement of the old National
Road No. 4.

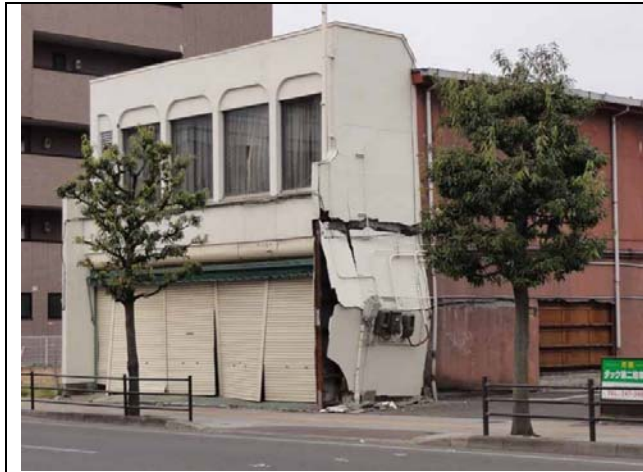
Nagamachi 4-chome, Taihaku-ku

Photo 3: Fall of exterior finishing from a timber house

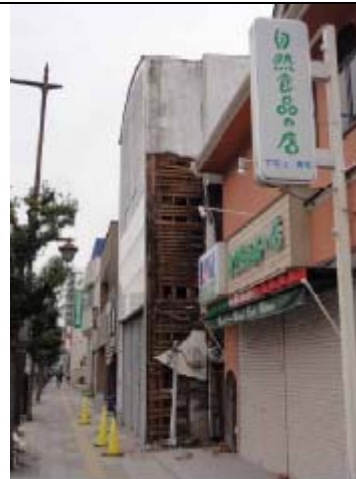
Nagamachi 4-chome, Taihaku-ku

Photo 4: Fall of mortar finishing from a timber house

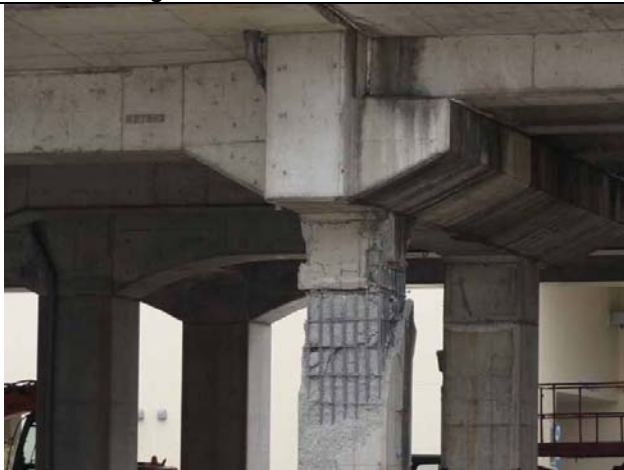
Photo 5: Viaduct of the Shinkansen Line, shear failure penetrated to the concrete core of the pier.
Asuto Nagamachi 2-chome

The damage of the Shinkansen Viaducts, shown in Photos 5 to 8, were re-visited on April 6 (Wed) at

Asuka Nagamachi 2-chome. The repair work was completed by this time.

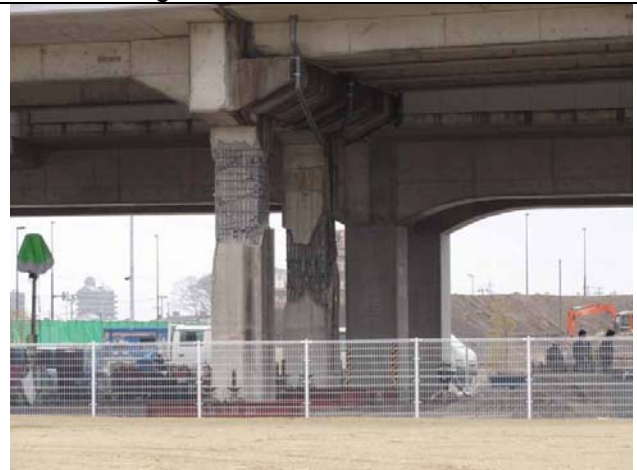
Photo 6: Piers of viaducts for the Shinkansen (built in 1982) and the Tohoku Line (built in 2006)
Asuto Nagamachi 2-chome

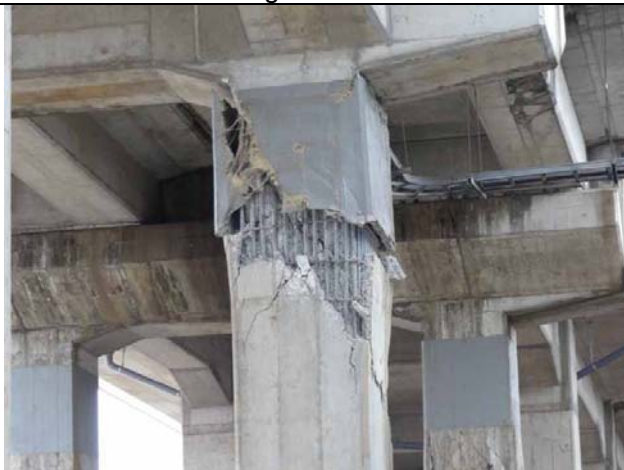
Photo 7: Fracture of retrofit fiber reinforcement sheet of a pier of the Shinkansen Viaduct
Asuto Nagamachi 2-chome, Taihaku-ku

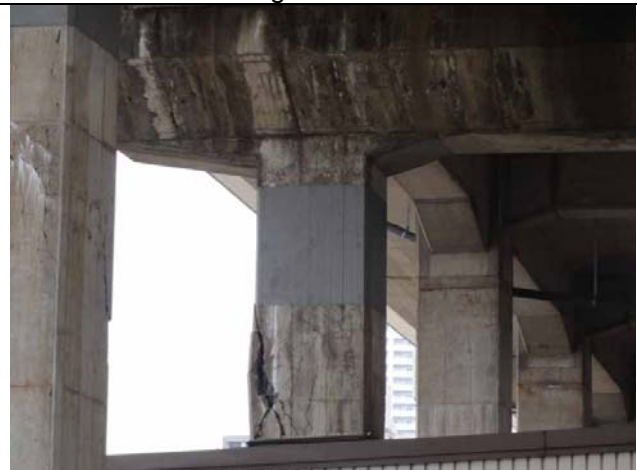
Photo 8: Shear failure of a pier below the fiber reinforcement retrofit of the Shinkansen Viaduct
Asuto Nagamachi 2-chome, Taihaku-ku

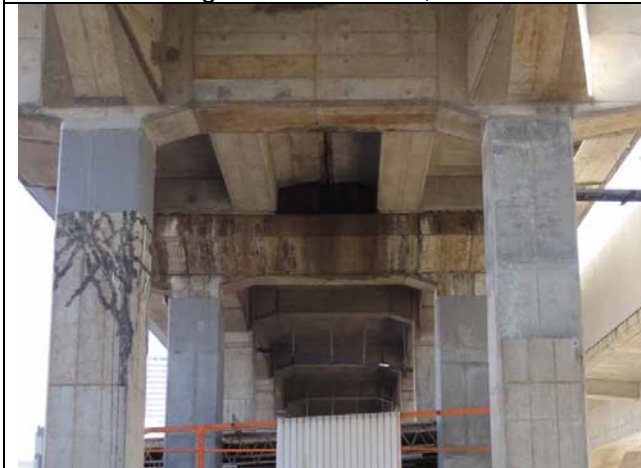
Asuto Nagamachi 2-chome, Taihaku-ku

Photo 11: Shinkansen Viaduct, right pier after the fracture of fiber reinforcement sheet (see Photo 9), and left pier after shear cracking (see Photo 10).

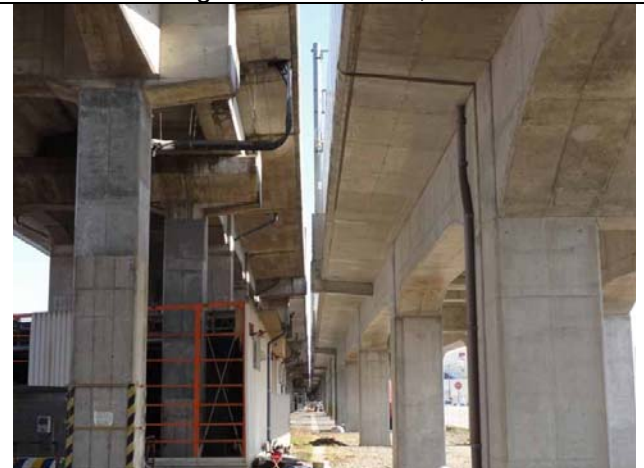
Asuto Nagamachi 2-chome, Taihaku-ku

Photo 12: Left is the Shinaknsen (1982) viaducts and right is the Tohoku Line (2006) viaducts

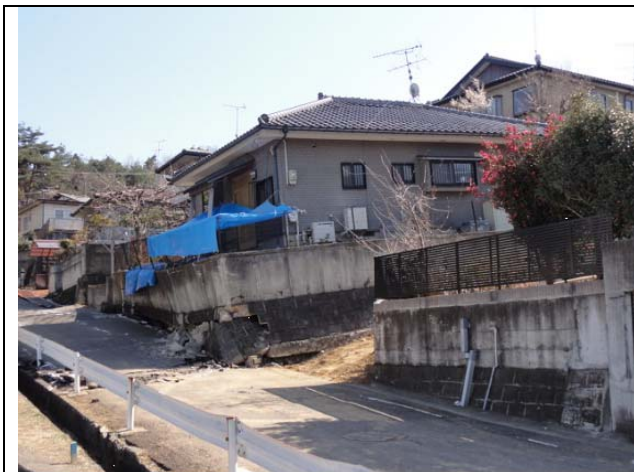
Photo 1: Failure of retaining walls.
Oritate 5-chome, Aoba-ku

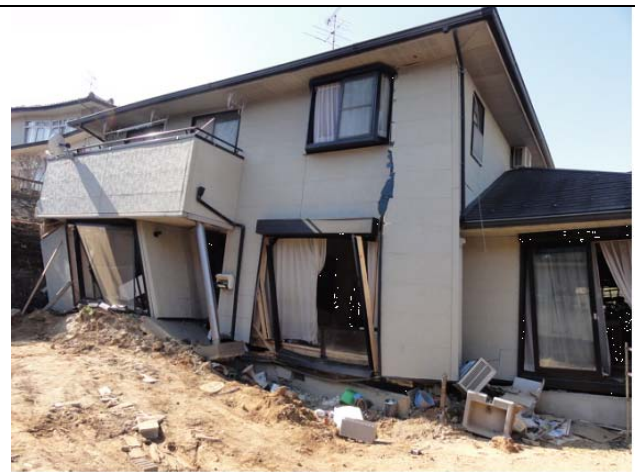
Photo 2: Damage of a house caused by land slide.
Oritate 5-chome, Aoba-ku

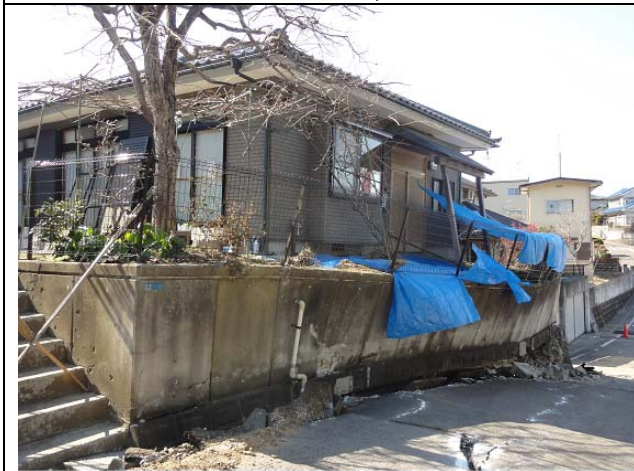
Photo 3: Failure of retaining walls.
Oritate 5-chome, Aoba-ku

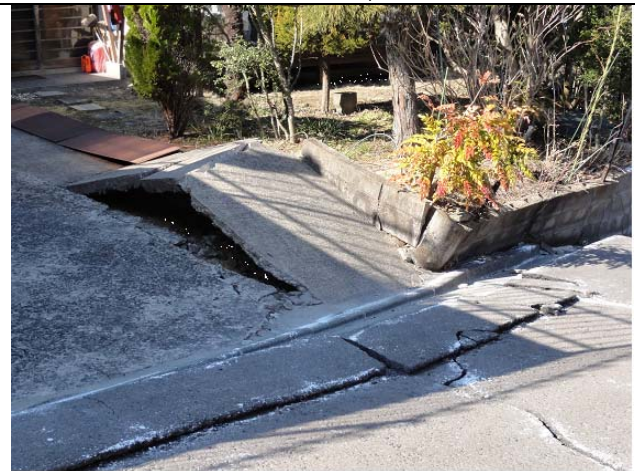
Photo 4: Damage of road surface.
Oritate 5-chome, Aoba-ku

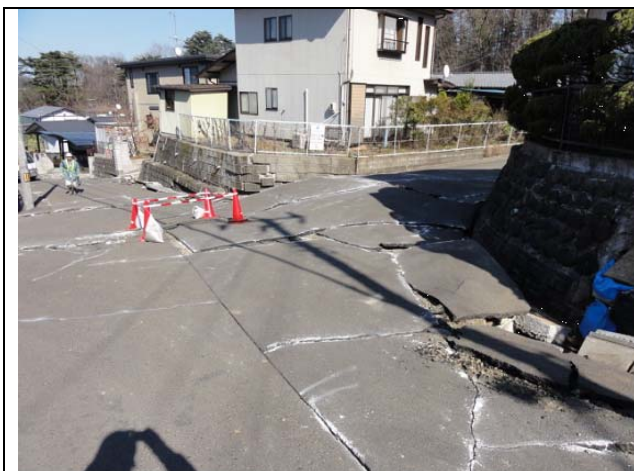
Photo 5: Failure of road surface.
Oritate 5-chome, Aoba-ku

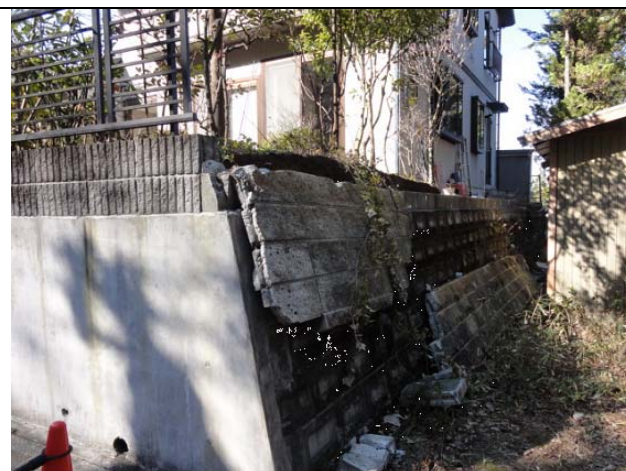
Photo 6: Fall of concrete block walls.
Oritate 5-chome, Aoba-ku

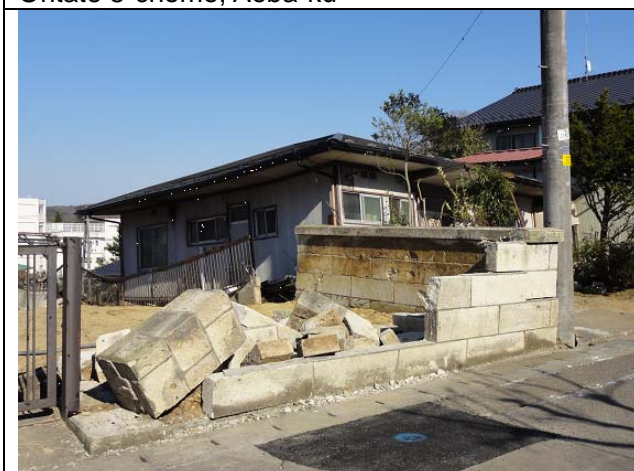
Photo 7: Fall of masonry walls and damage of a house due to land slide
Oritate 5-chome, Aoba-ku

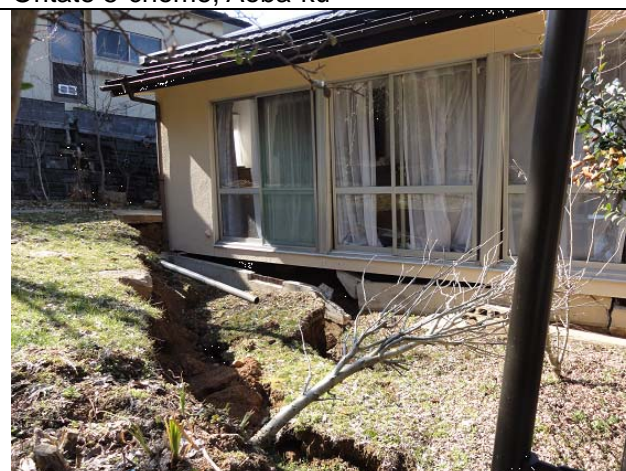
Photo 8: Ground settlement (80 cm).
Oritate 5-chome, Aoba-ku

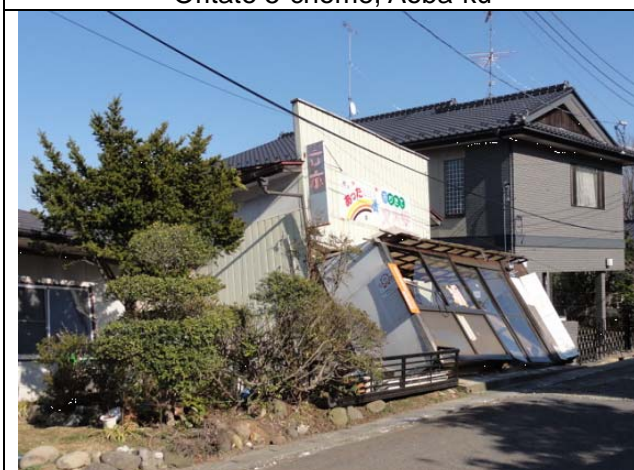
Photo 9: Damage of a house due to land slide.
Oritate 5-chome, Aoba-ku

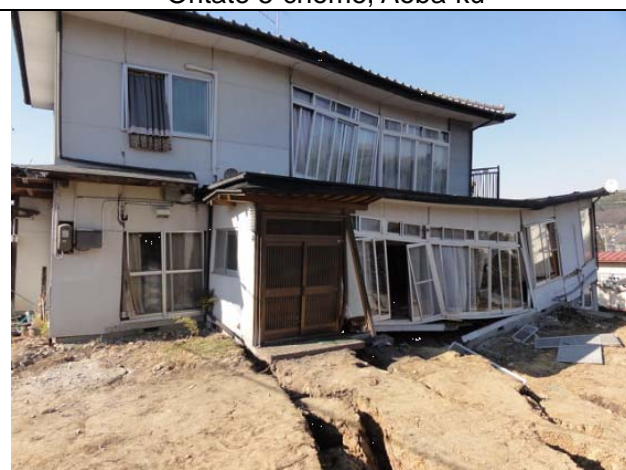
Photo 10: Damage of a house due to land slide
Oritate 5-chome, Aoba-ku

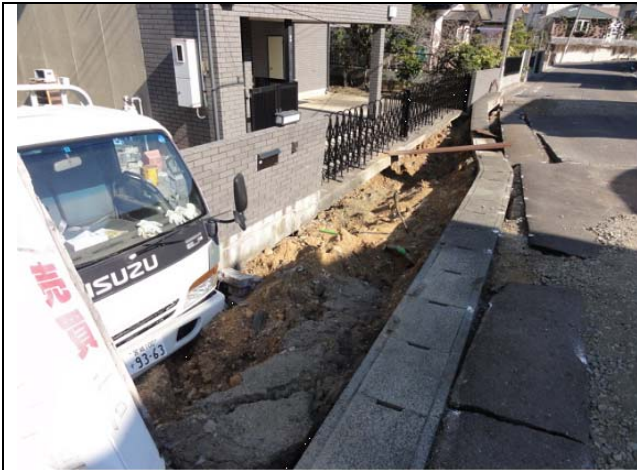
Photo 11: Land slide.
Oritate 5-chome, Aoba-ku

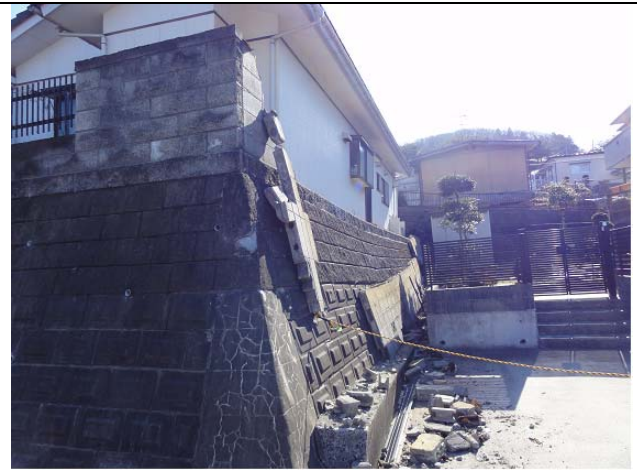
Photo 12: Fall of concrete block walls.
Oritate 5-chome, Aoba-ku

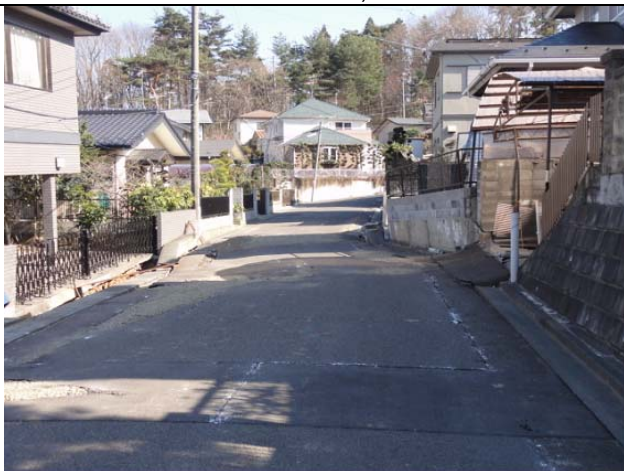
Oritate 5-chome, Aoba-ku

Photo 13: Land slide (previously straight road)

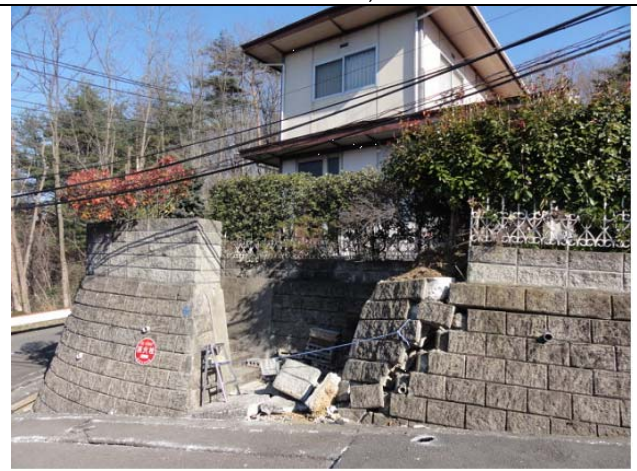
Oritate 5-chome, Aoba-ku

Photo 14: A house of relatively light damage in this area
