Tohoku Chapter, Architectural Institute of Japan  
Reconnaissance Report (16) on Mangoku-ura and Onagawa-cho  
The 2011 off the Pacific Coast of Tohoku Earthquake  
Released on April 15, 2011

Disaster Committee, Tohoku Chapter  
Dr. Reiji Tanaka, Professor  
Mr. Ryota Yamaya, Guest Researcher,  
Tohoku Institute of Technology  
(Translated by Shunsuke Otani, University of Tokyo)

This report describes the earthquake damage in Mangoku-ura (bay) and Onagawa-cho (town) of Miyagi Prefecture. The route maps of survey are shown in Map A for Mangoku-ura and Map B for Onagawa-cho.

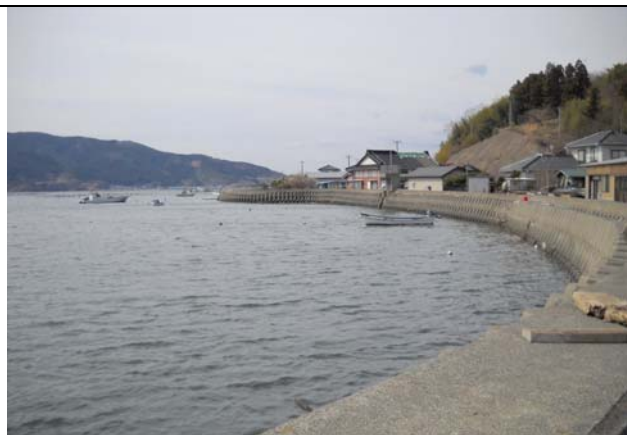
Mangoku-ura is located approximately 6 km to the east of Ishinomaki City, facing a small bay (Photo 1), and east of Onagawa-cho. Tsunami attacked the area, and the third tsunami wave was the highest flowing over a 4-m high breakwater. The damage was very small in this area (Photo 2).

Photo 1: Tsunami wave flowed over 4-m high breakwater.

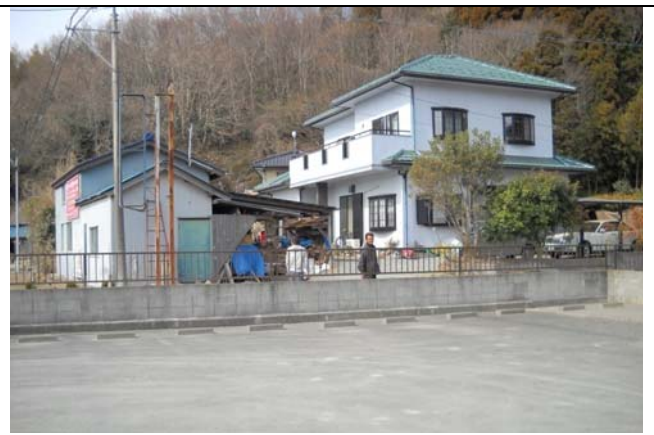
Photo 2: No damage was observed in these timber houses.

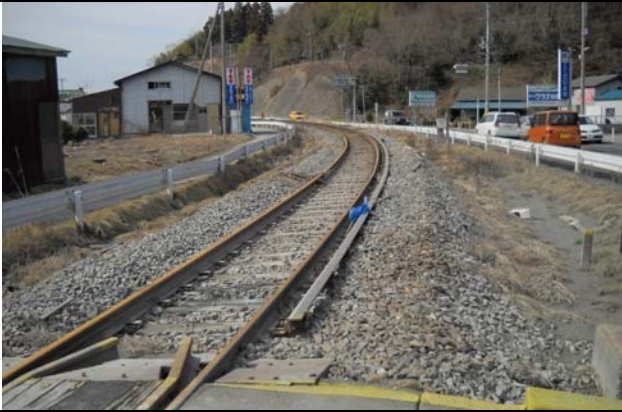
Photo 3: View to west from the Sanriku Railway

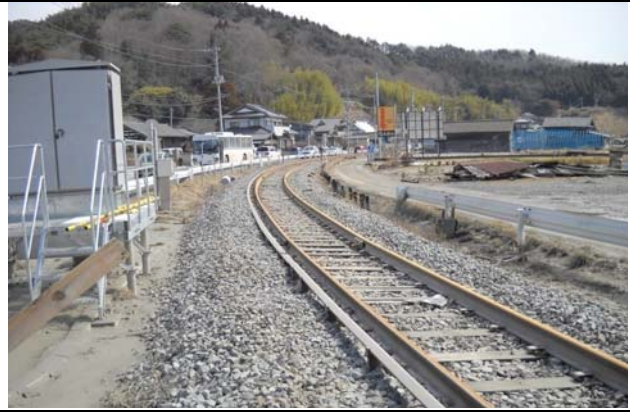
Photo 4: View to east from the Sanriku Railway.

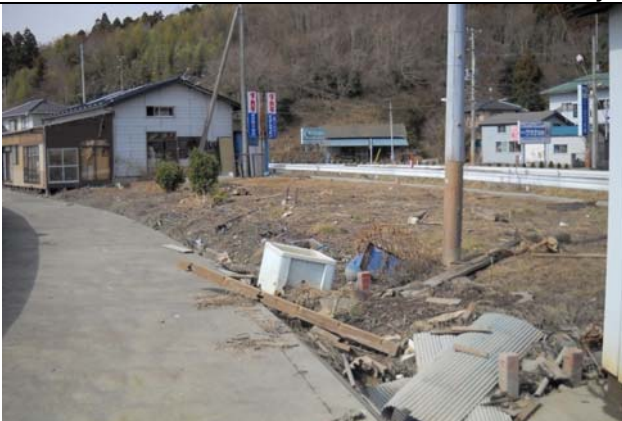
Photo 5: Some washed away items by tsunami near the railway.

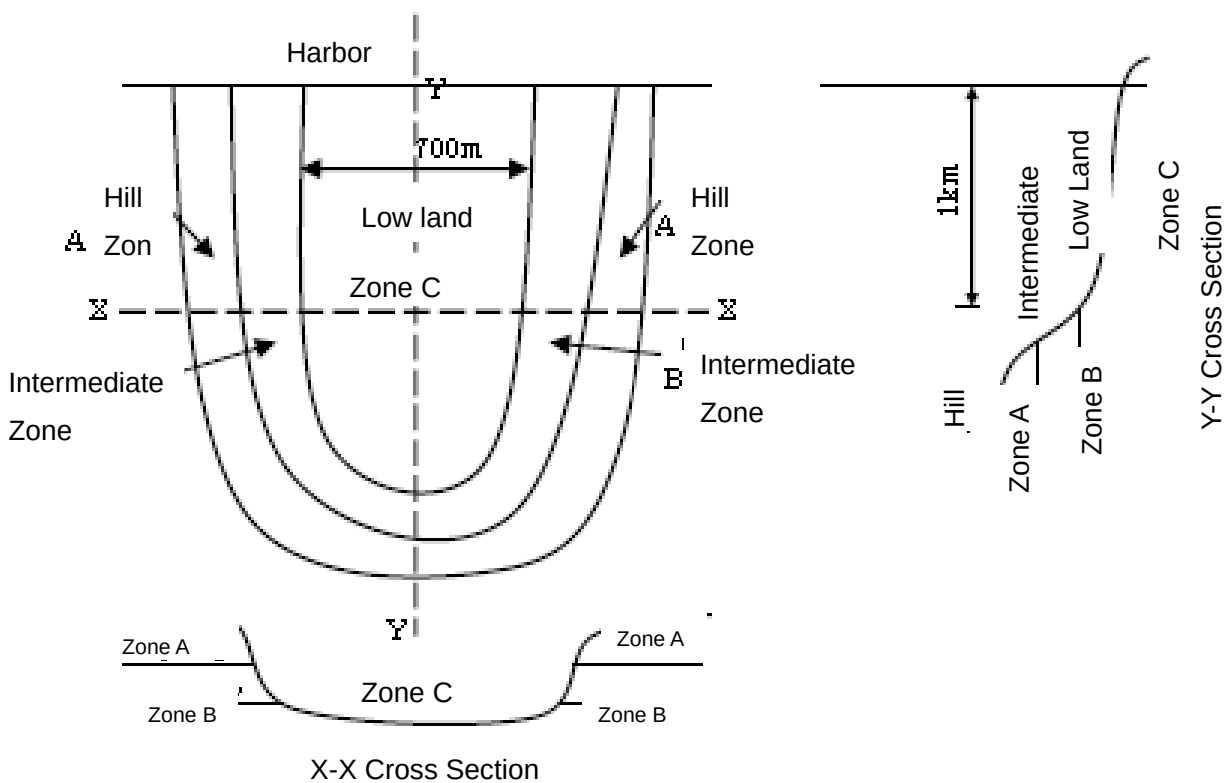
The town is surrounded by hills on three sides and open to the sea only on side (Fig. 1). The X-X cross section forms a U-shape valley; high altitude Zone A and intermediate altitude Zone B surround the low land Zone C in a horseshoe shape. The altitude of Zone C also increases with distance from the shore (see Y-Y cross section).

Fig. 1: Plan view and cross sections of Onagawa-cho (Zones A, B and C)

Zone C (low land): Timber houses were totally destroyed, but those at 1 km from the shore did not suffer damage. Reinforced concrete (RC) and steel buildings were standing.

Zone B (intermediate high land): Lightly damaged and no damaged houses survived tsunami.

Zone C (high land): Most timber houses suffered no damage.

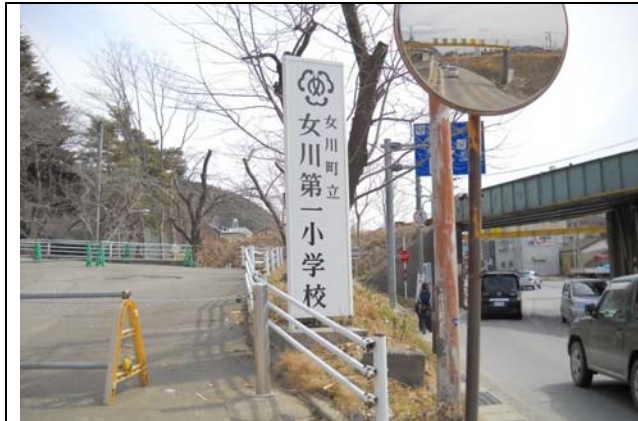
Photo 1: Onagawa Daiichi elementary school

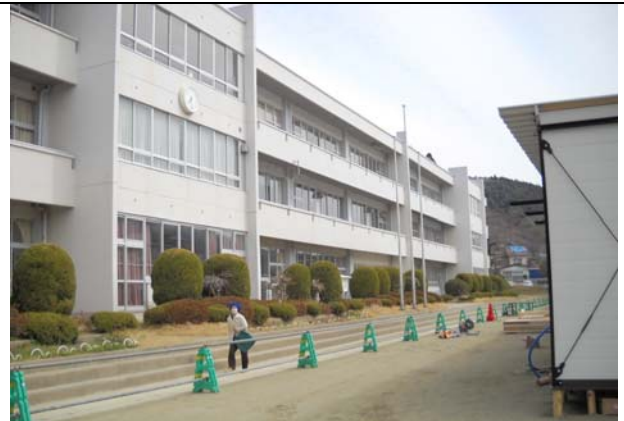
Photo 2: No damage in the school building.

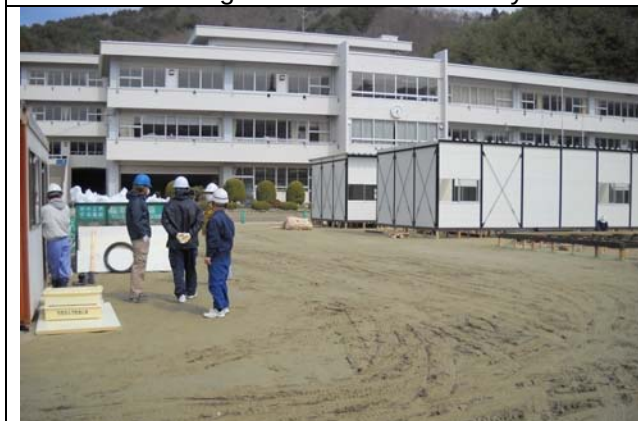
Photo 3: Temporary houses were under construction on the play ground.

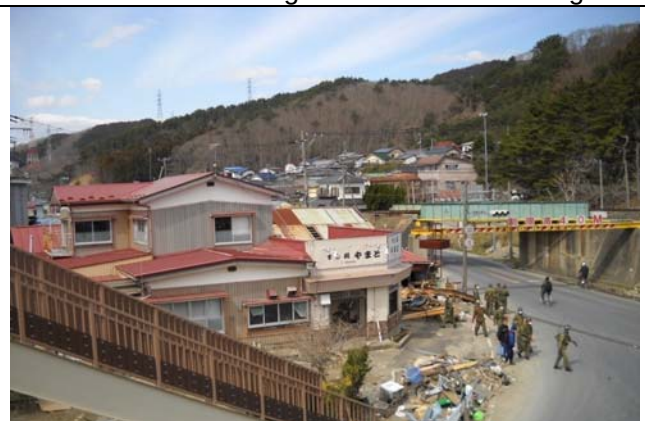
Photo 4: Tsunami wave reached the road beneath the school..

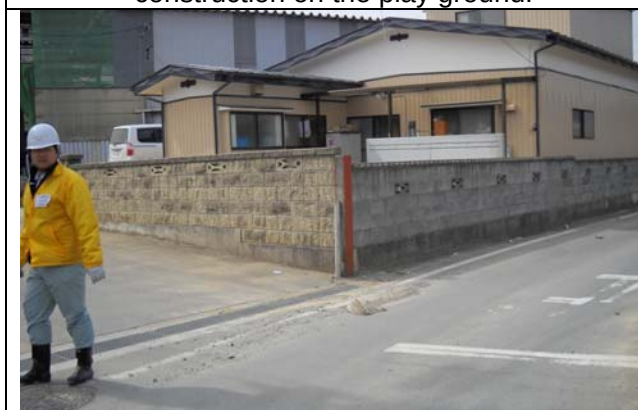
Photo 5: Houses protected by concrete walls suffered no damage.

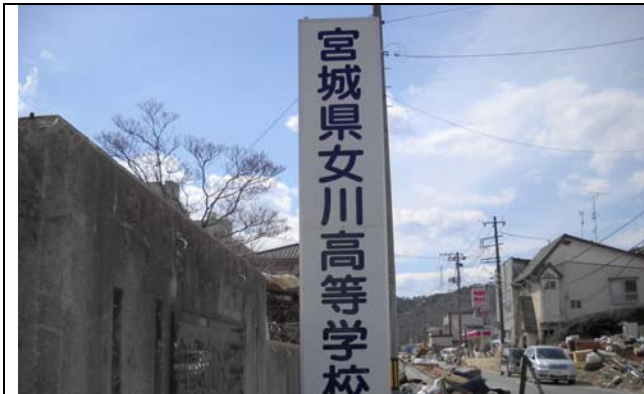
Photo 6: Onagawa High School.

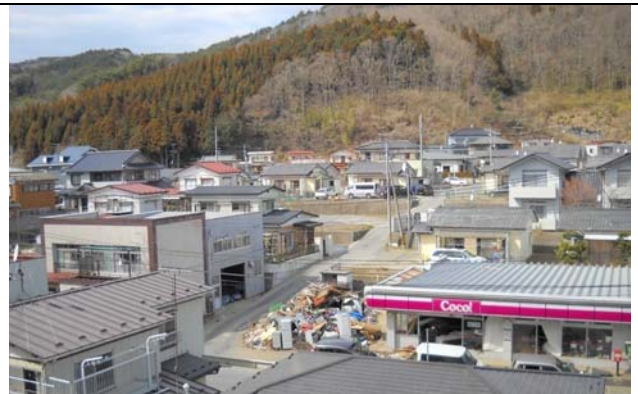
Photo 7: Onagawa High School is located on a hill.

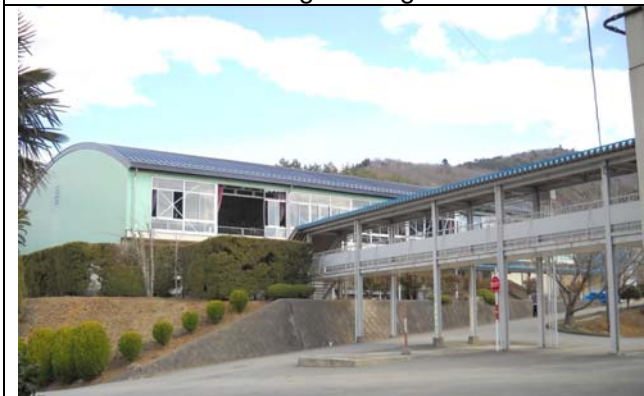
Photo 8: Window glasses were broken in the gymnasium (1).

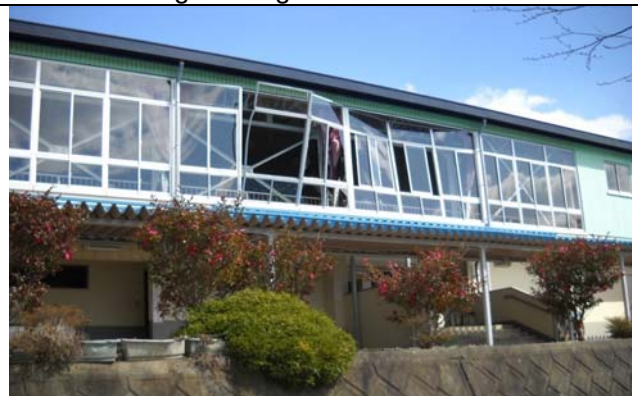
Photo 9: Window glasses were broken in the gymnasium (2).

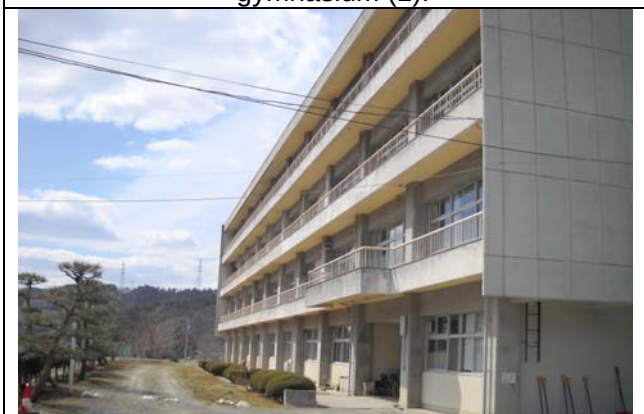
Photo 10: The school building suffered no damage.

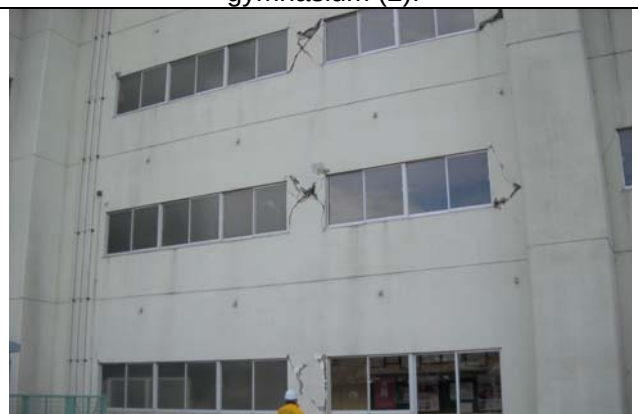
B). Photo 8 shows the gymnasium. Window glasses were broken (Photo 9). Photo 10 shows the school building, and no damage was observed. Photo 11 shows north view; shear cracks were seen on a mullion wall. In only one column with a wing wall suffered a shear crack.

Photo 11: Shear cracks in mullion walls in the north.

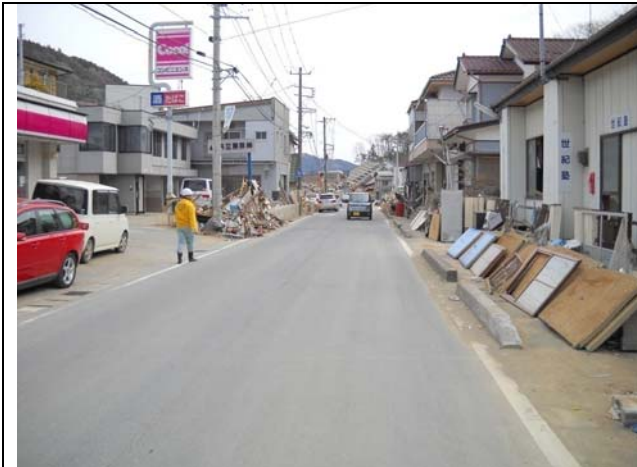
Photo 12: Damage increased with descending height (1)

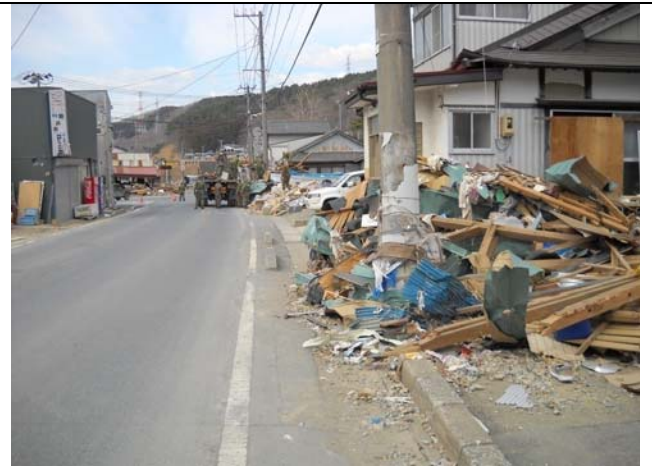
Photo 13: Damage increased with descending height (2)

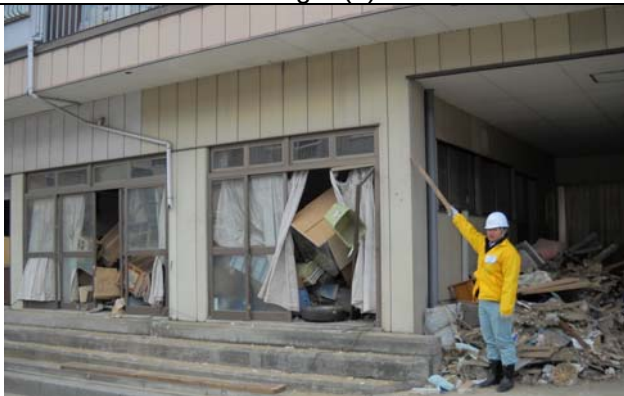
Photo 14: Damage became significant as the tsunami height reached approx. 1.8 m.

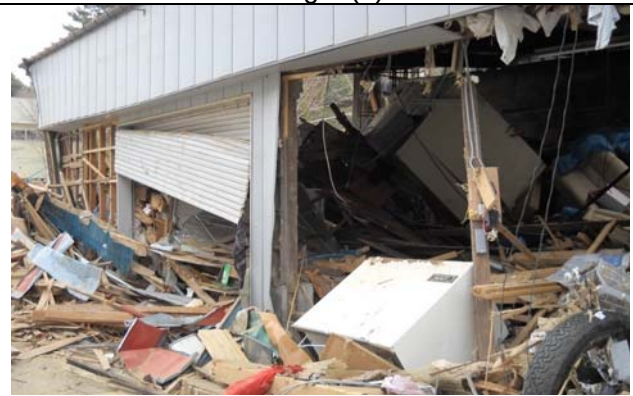
Photo 15: In the area where tsunami wave reached 1.8 m high, the first story was wrecked.

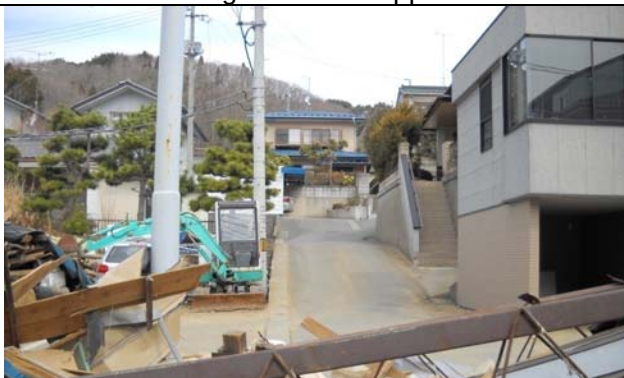
Photo 16: Not much damage in houses on the hill side in Zone B.

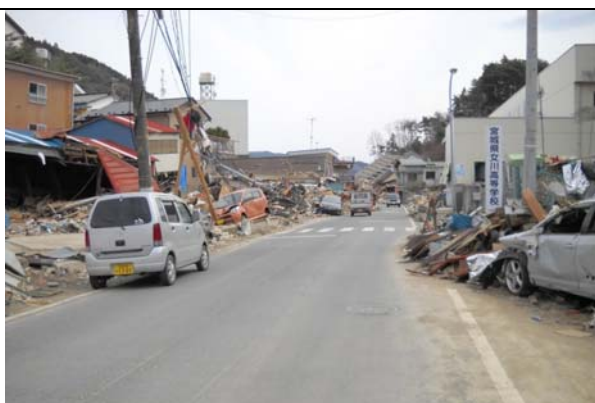
Photo 17: Some houses were standing and others collapsed in Zone B.

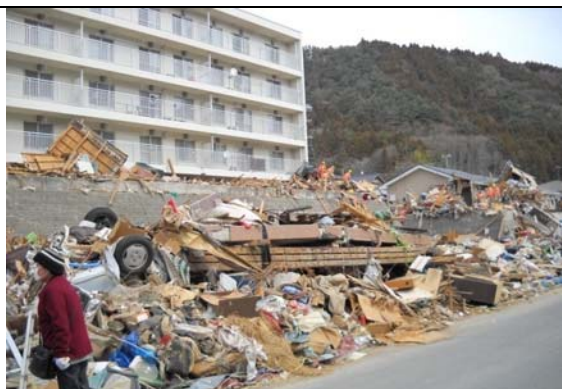
Photo 18: Most timber houses were washed away in Zone C (1).

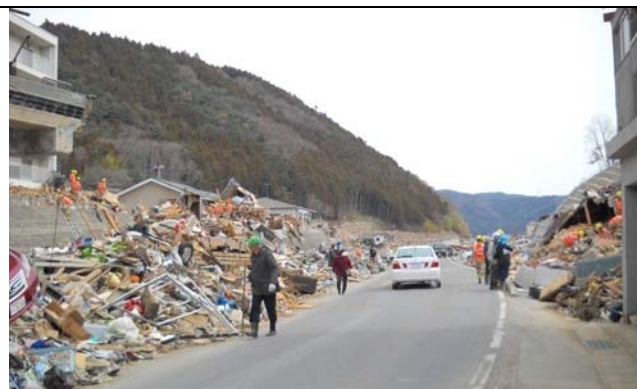
Photo 19: Most timber houses were washed away in Zone C (2).

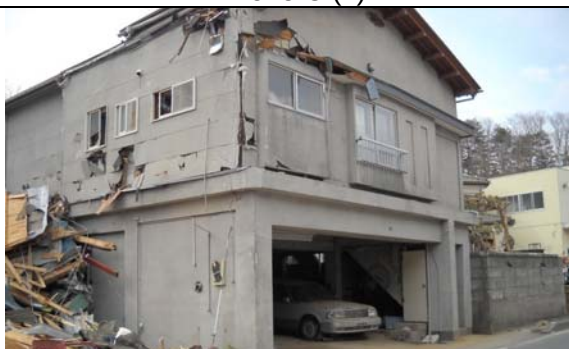
Photo 20: First story RC and second story timber house in Zone C.

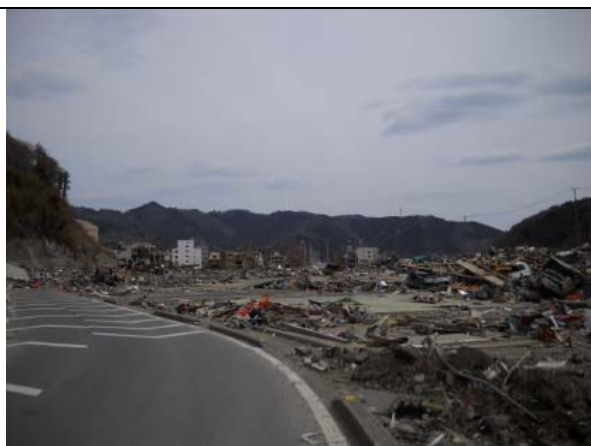
Photo 27: Totally destroyed houses in Zone C (3)

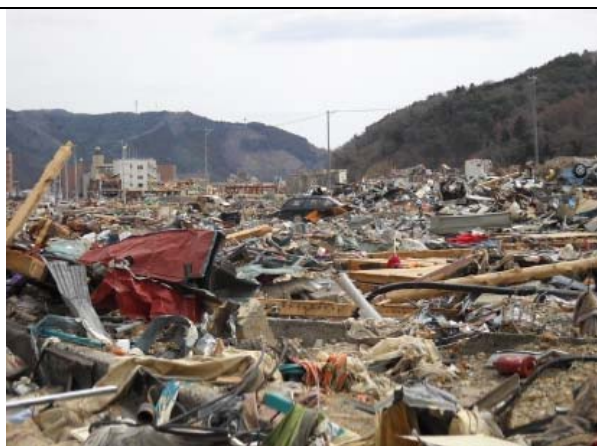
Photo 28: Totally destroyed houses in Zone C (4)

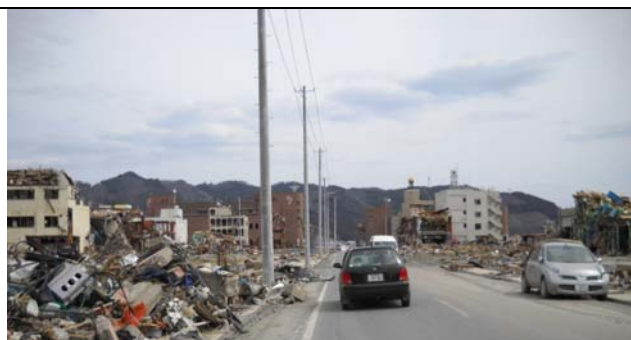
Photo 29: Reinforced concrete and steel structures remained standing near the port.

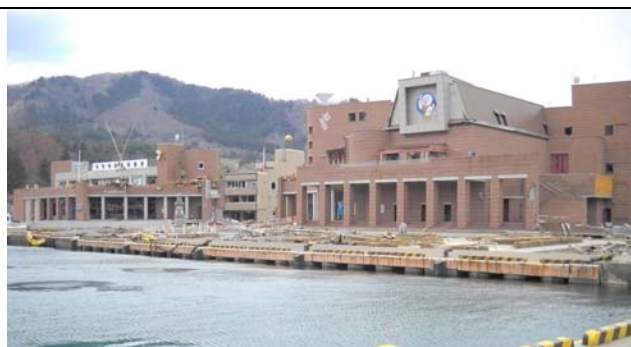
Photo 30 shows the three story reinforced concrete Marinpall Onagawa building (sight-seeing spot), approximately 100 m from the harbor (No. 6 in Map B). Photo 31 shows the sea-side view of the building; the corridor connecting the adjacent buildings was washed away.

Photo 30: Sea-side view of the Marinpall Onagawa building

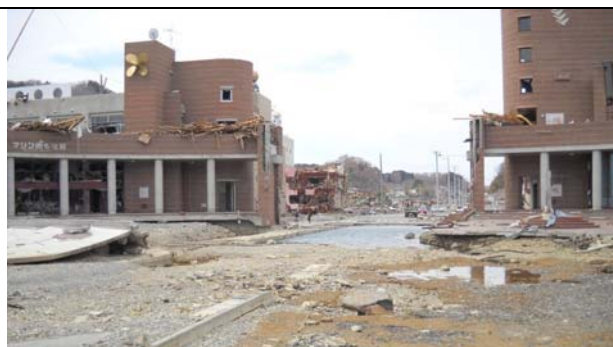
Photo 31: The corridor between the two buildings was washed away.

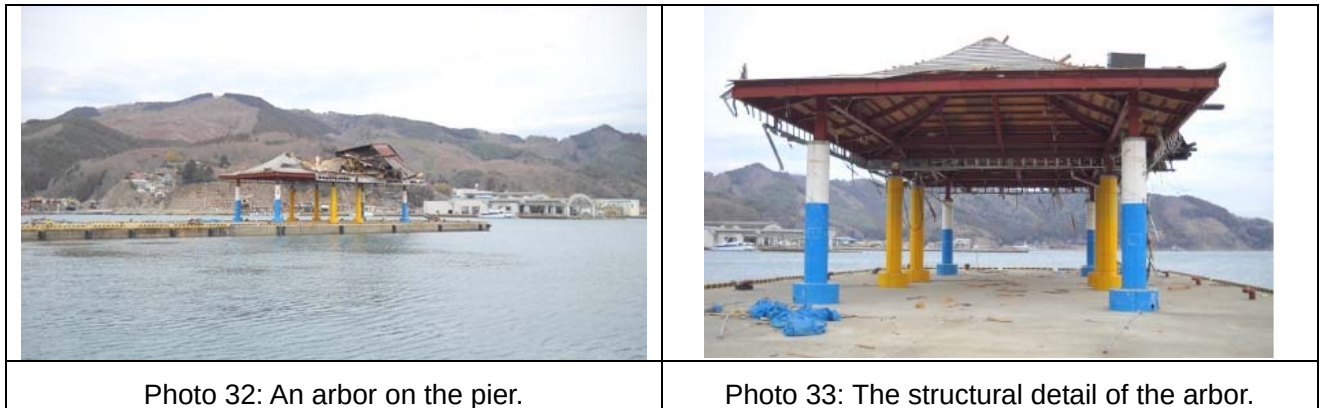
Photo 32 shows a pier sticking out to the shore. A simple steel arbor remained standing on the pier. Photo 33 shows the detail. Tsunami wave must have passed over the arbor, but no damage. This is an example that a structure with thin members can survive tsunami attack.

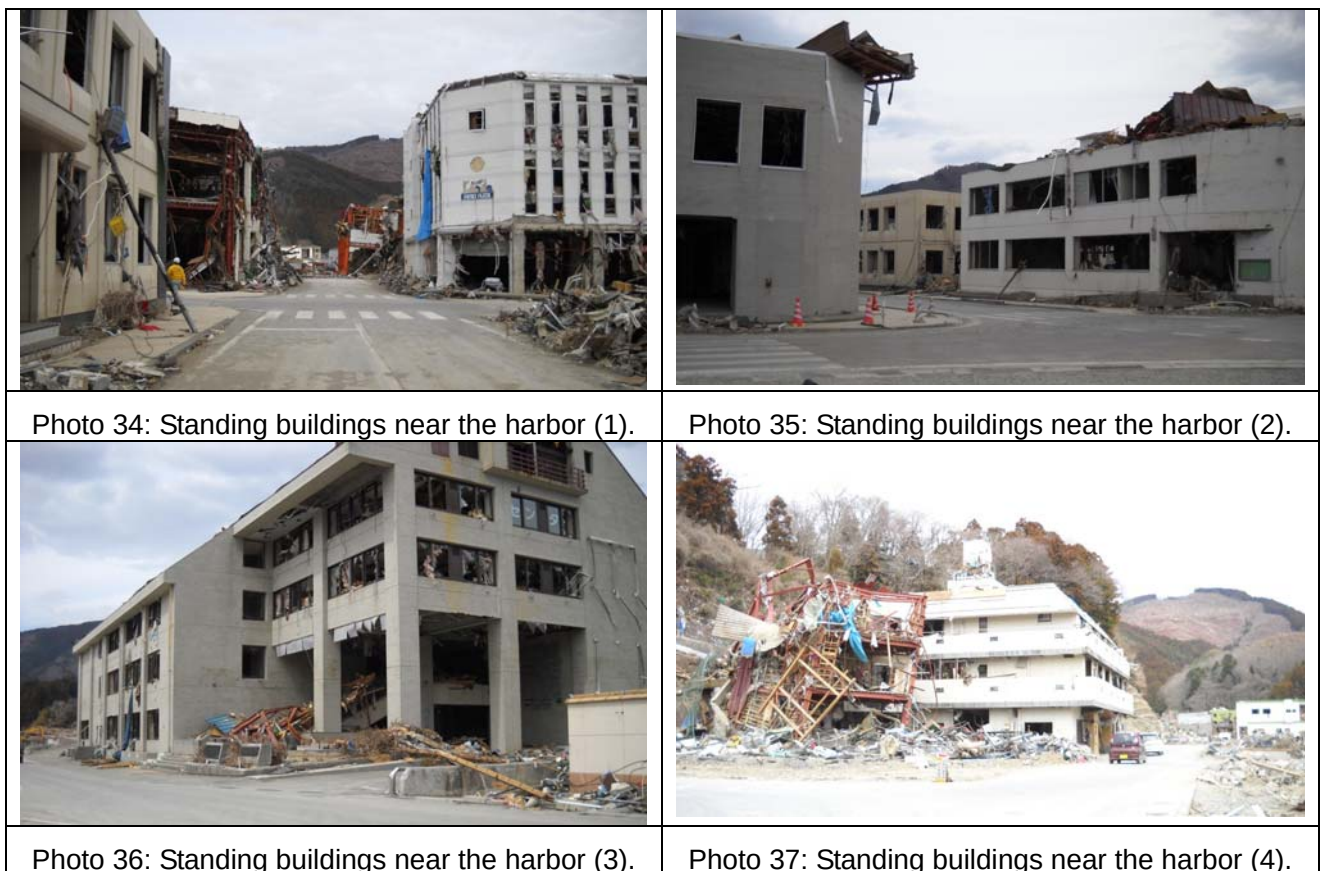
In the neighborhood of the Onagawa Harbor, there remained many reinforced concrete and steel buildings (Photos 34 to 37, No. 7 in Map B).

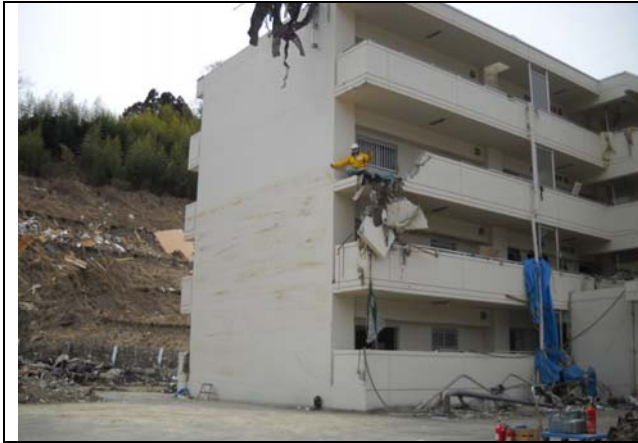
The tsunami wave reached the third floor of the building. The tsunami wave height was estimated to be approx. 8 m on this site. Some rubbish can be seen at the corner of roof; the tsunami height could be higher. Near this building, there was a railway line (Photos 39 and 40, No. 9 in Map B). The rail was completely destroyed.

Photo 38: A four-story RC condominium.

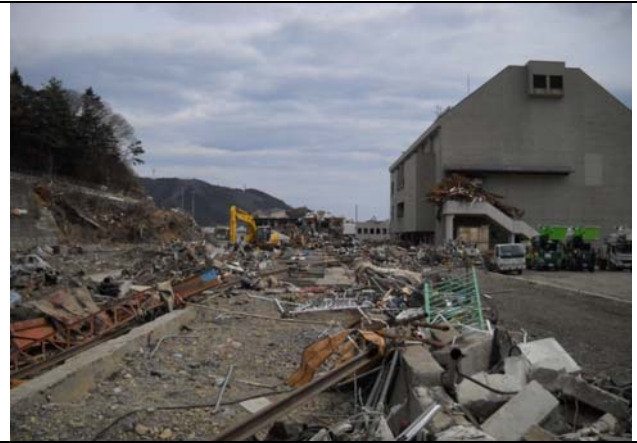
Photo 39: Railway near the condominium

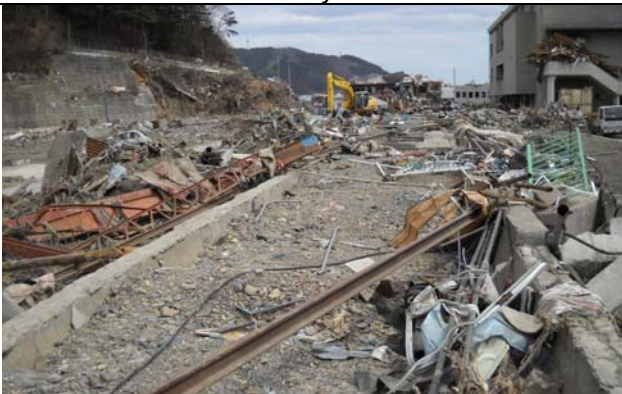
Photo 40: Rail was destroyed.

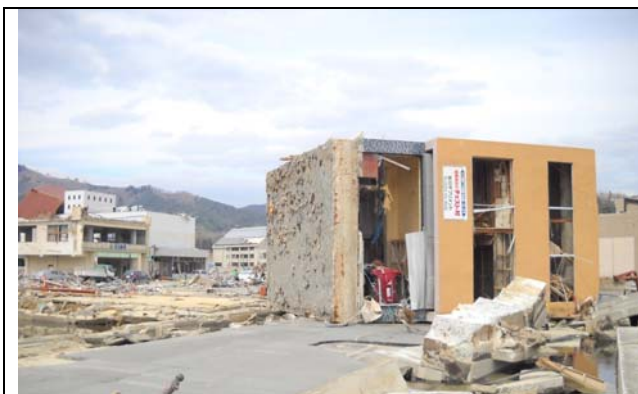
Some reinforced concrete buildings collapsed in this area (No. 7 and 8 in Map B). The collapse was not due to the failure of structural members, but entire buildings were overturned (Photos 41 to 43). The reasons for the collapse needs to be studied.

Photo 41: Overturned RC buildings (1).

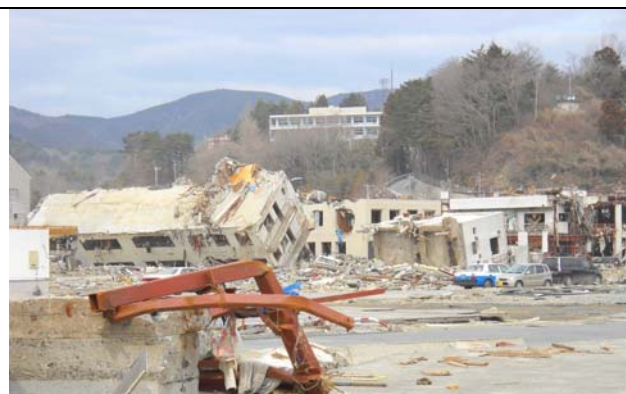
Photo 42: Overturned RC buildings (2).

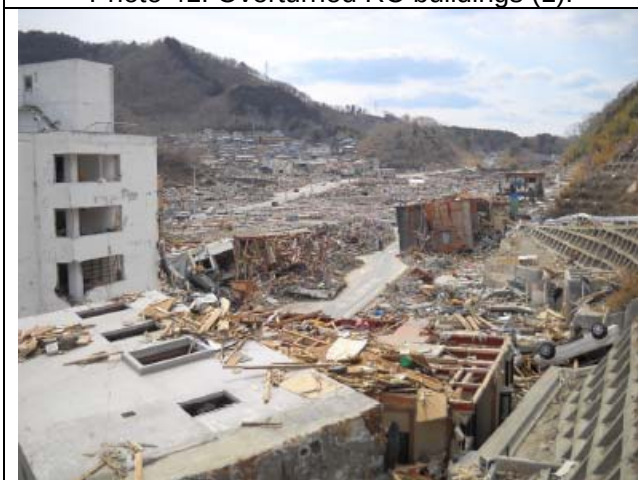
Photo 43: Overturned RC buildings (3).

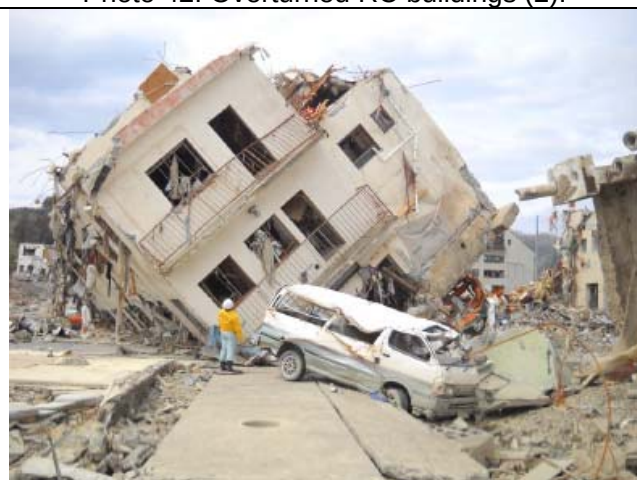
Photo 44: Overturned RC buildings (4).
