Learning from Earthquakes

The Southern Turkey Earthquake of June 27, 1998: A Photo Spread

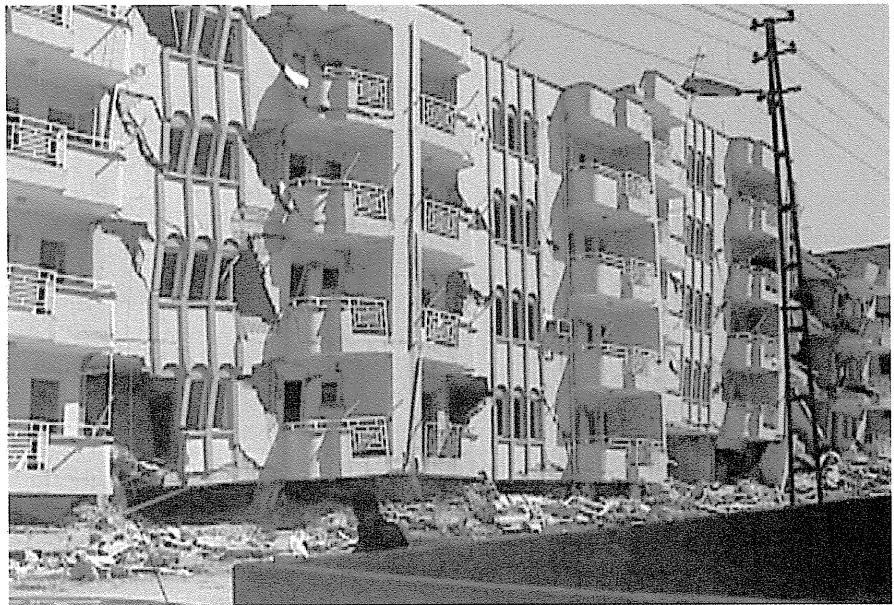
The "ever-present ground story shops compound the issue." (photo: Celebi)

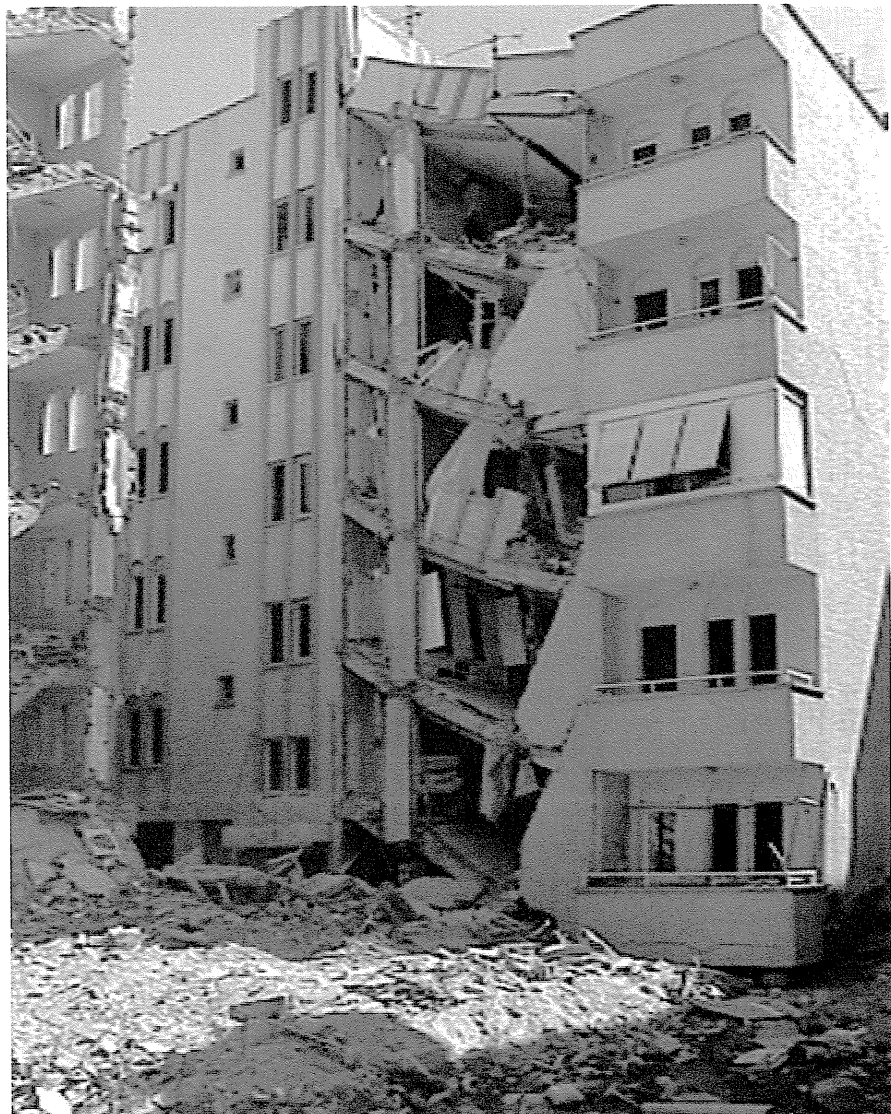
Ceyhan apartment building (photo: Celebi)

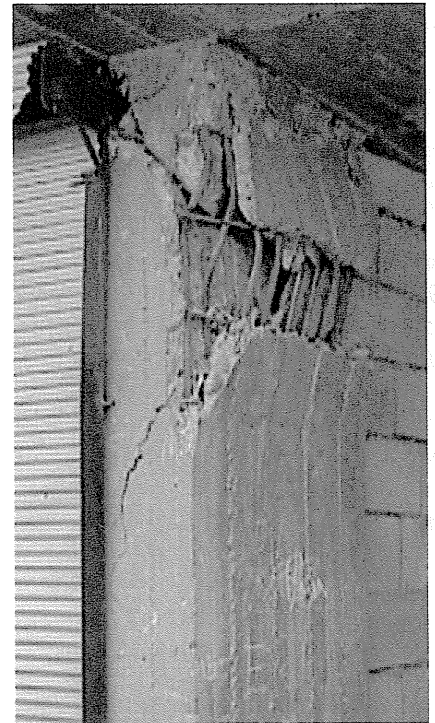
Typical damage (photo: Celebi)

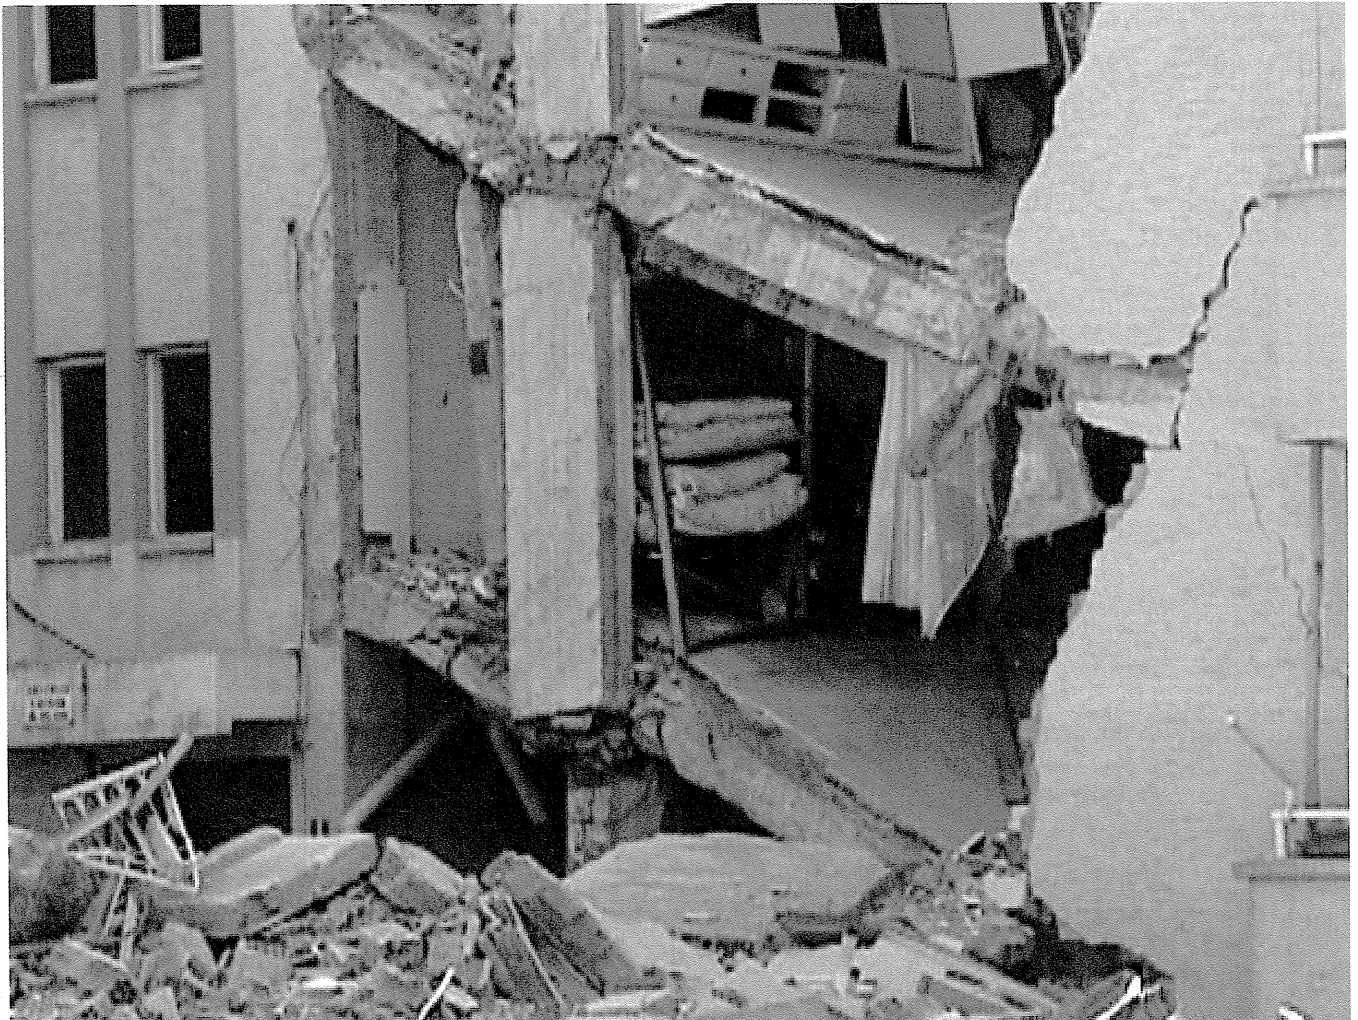
Ceyhan apartment building detail (photo: Celebi)
