## Turkish Earthquakes: Two Reports

### Lessons from the Adana-Ceyhan Quake and the Dinar Aftershock

### The Adana-Ceyhan Earthquake of June 27, 1998

### Dinar Aftershock Tests Retrofitted Buildings

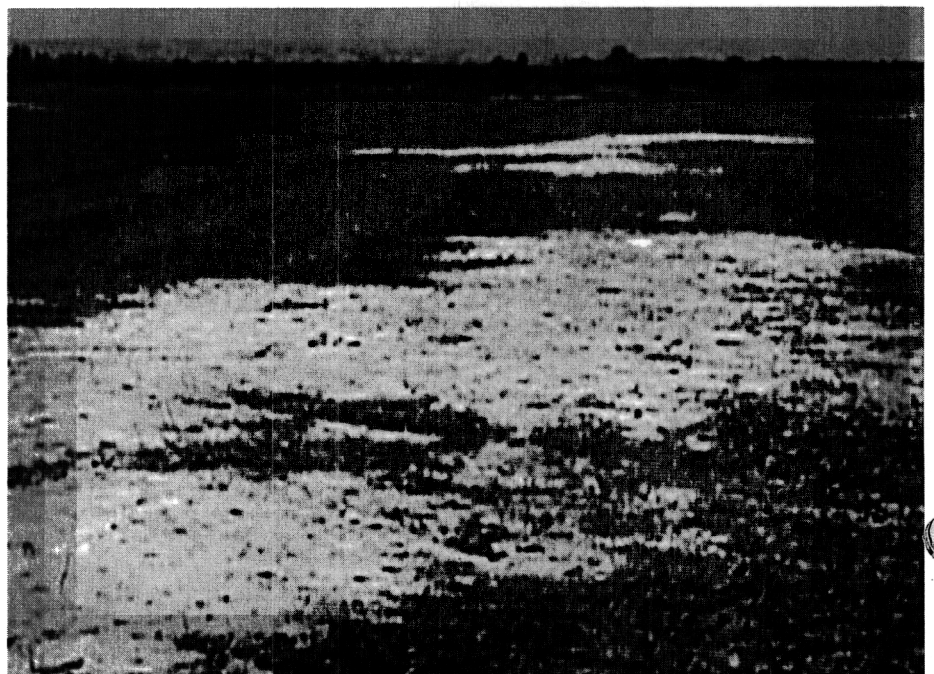
**Figure 3 - Sand boils due to liquefaction in a field near the epicenter.**

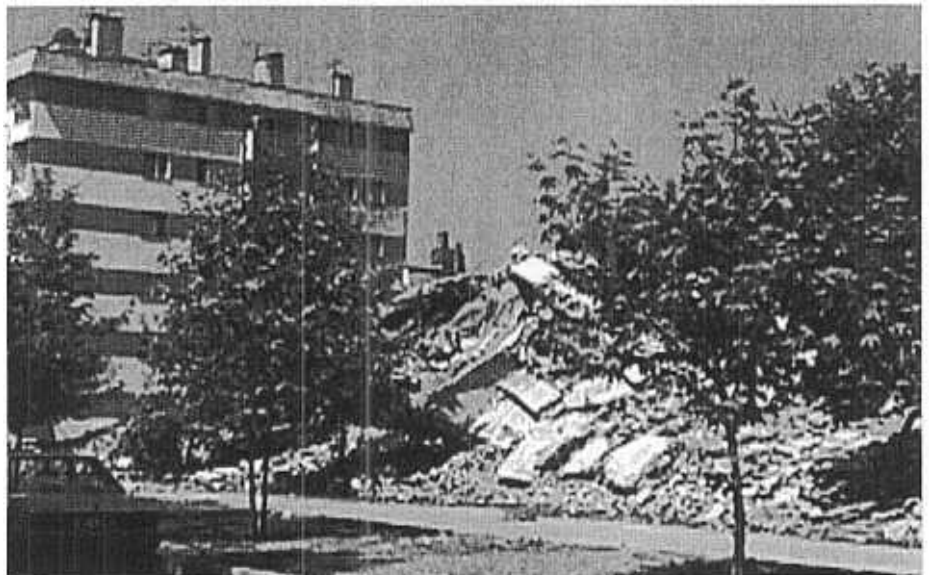
**Figure 5** - Ceyhan: unoccupied new eight-story structure pancaked.

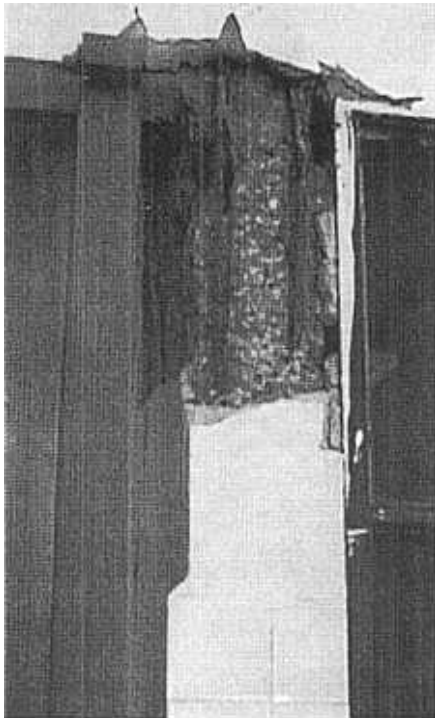
**Figure 6** - Deficient shear reinforcement at top end of column at Çukurova University. Photo: Çelebi

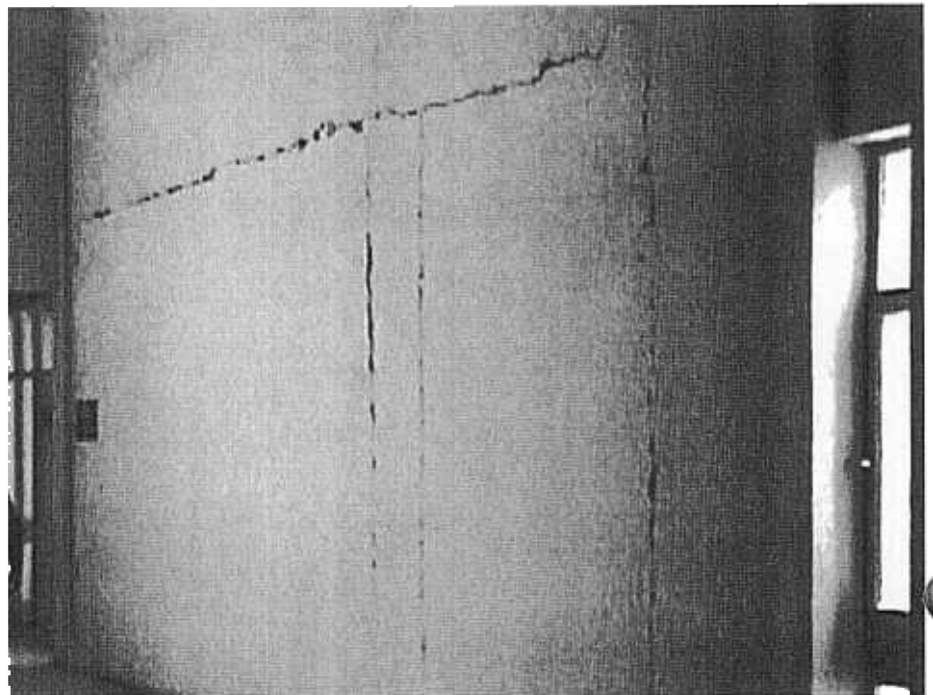
The Çukurova University Medical Facility Hospital Building was seriously damaged. This large complex was shut down immediately after the earthquake, but was reopened within 48 hours following inspections by a group of engineers. There were separation of infill walls from the frame, X-cracks of infill walls, some column damage due to insufficient ties and some due to short-column effect (see Figure 6). Reserve strength in the walls and/or frames with infill walls must have contributed to saving the integrity of the hospital building (see Figure 7).

**Figure 7**— Separation of infill walls at the Çukurova University Medical Facility Hospital Building. Photo: Çelebi

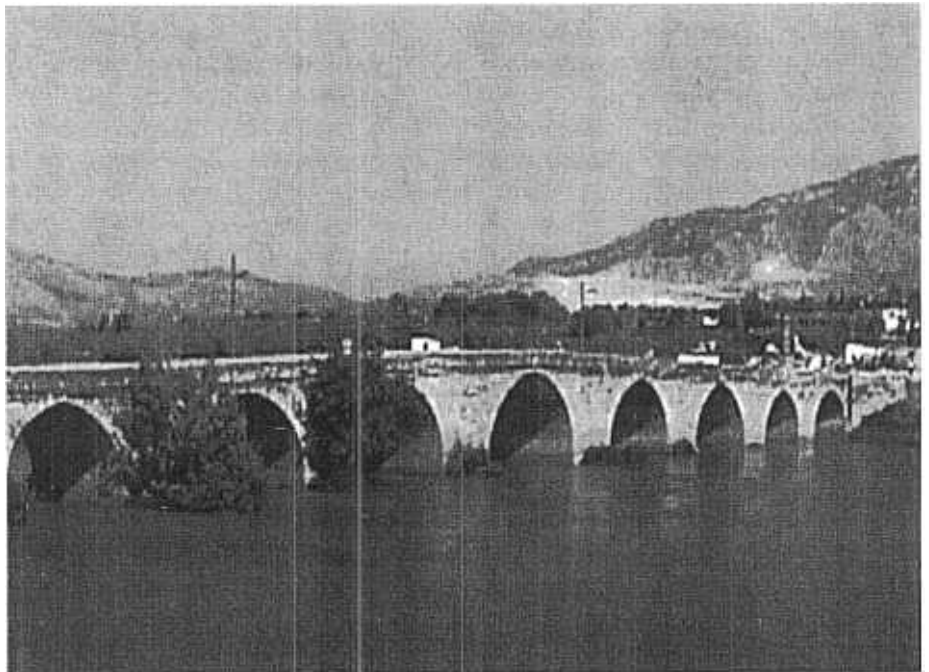
**Bridges and Lifelines:** None of the bridges on the Ceyhan River in Adana was damaged, but the historical Misis bridge in Misis (at the epicentral area) was partially damaged (see Figure 8). All bridges on the Ceyhan River in Adana were intact. There were only minor damages to the overpass bridges along the Cukurova Toll Autobahn.

**Figure 8 – Historical Misis bridge in the epicentral area.**

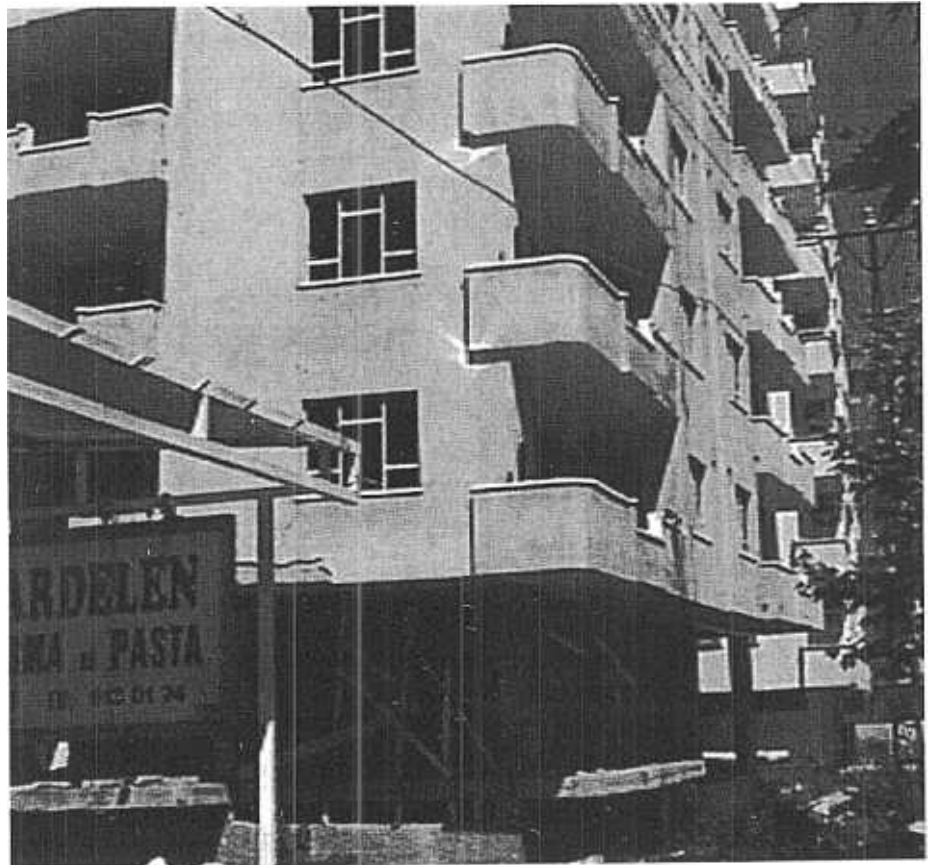
**Figure 9 - Soft first story of new construction resulted in cracks in columns.**

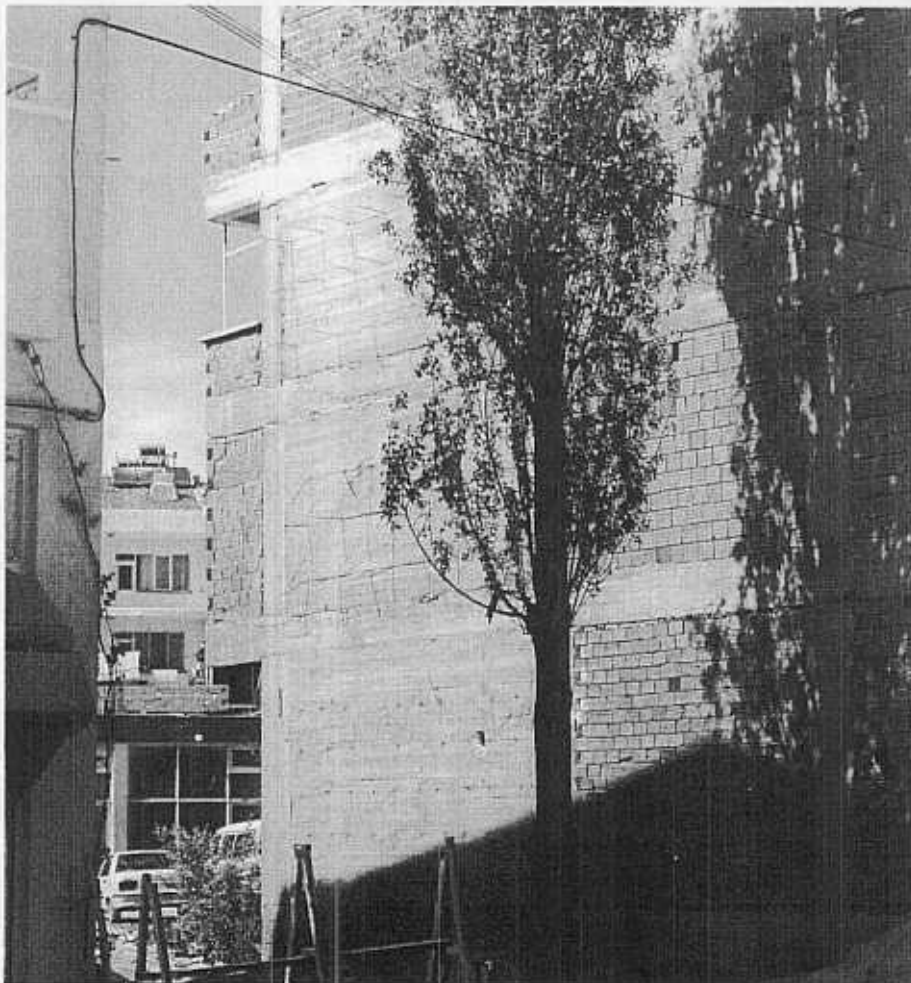
Figure 10 - Reinforced concrete building retrofitted by shear wall insertion.

Reinforced concrete frame buildings strengthened with new shear walls passed the  $M_L = 4.6$  test with flying colors, with one exception (discussed below). Minor cracking at the interface of old and new concrete could be expected, but no yielding or wide cracks were observed.

The diversity of buildings required that individual evaluations be conducted for each one. Careful on-site examinations recorded the location and severity of damage. A capacity control analysis was conducted to determine which spans to reinforce with insertion of shear walls (see Figure 10 for an example), or enlargement of column cross section with the use of jacketing. The design spectrum had a zero period ordinate of 0.2g.

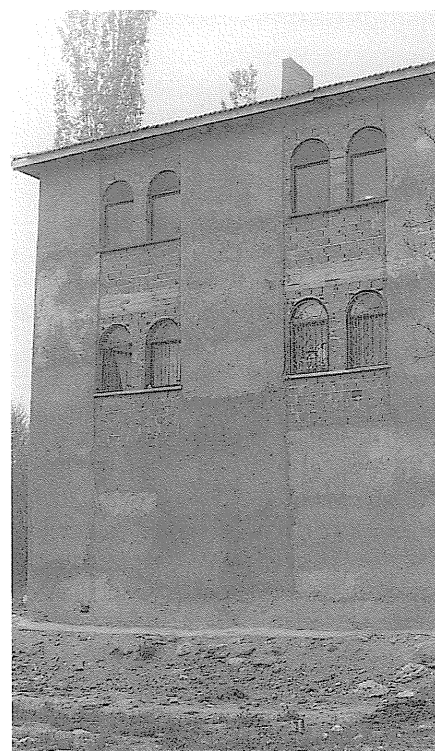
**Figure 12** – Masonry house retrofitted by grout shell on outside walls.

For masonry buildings, an effective retrofit scheme was difficult to develop. The basic technique involved bonding a layer of reinforced grout shell on the outside of walls. The shell was made to function integrally with the wall through studs arranged over a 0.5m square grid. The studs were hooked and welded to the mesh reinforcement on the outside, and tightened with nuts and bearing plates on the inside. Figures 12 and 13 show plain masonry buildings retrofitted in this manner.

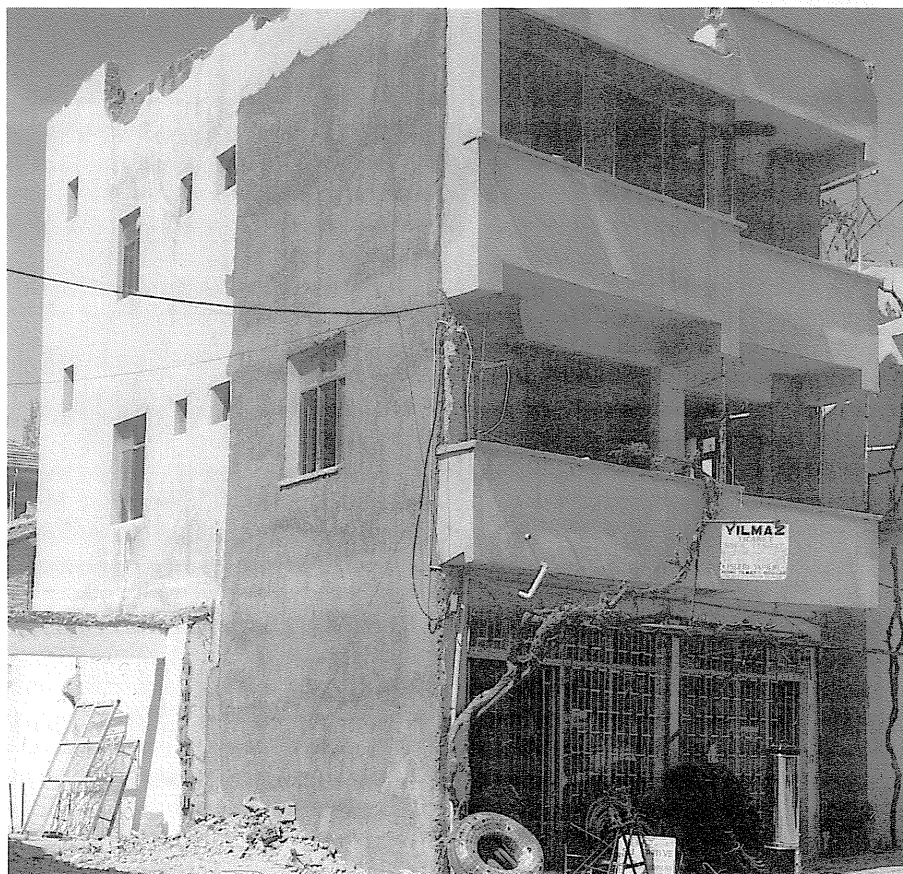
**Figure 13** - Masonry building retrofitted by bonding a layer of R/C grout shell on the outside walls. Pre-existing fourth story removed for weight.
