# Erzincan, Turkey Earthquake of March 13, 1992

This report is a brief summary of the information gathered to date by the EERI reconnaissance team. A complete report of the findings will be published this summer.

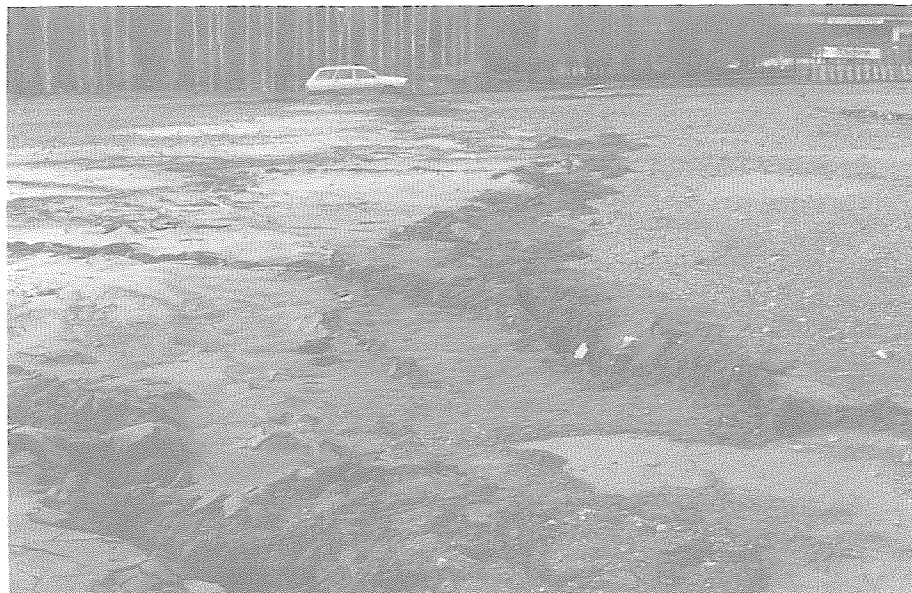
Evidence of surface deformation was discontinuous, indicating that the earthquake was deeper than normal for this setting, consistent with the reported focal depth of 26 km. Figure 2 shows a view of one surface rupture with oblique shears which served as conduits for water erupted due to liquefaction of marsh sediments at three meters depth. Right lateral slip of 10-12 cm was matched by about an equal amount of down-to-the-south slip. Note the undamaged building at the top of the photo.

FIGURE 2 - Surface rupture and oblique shears

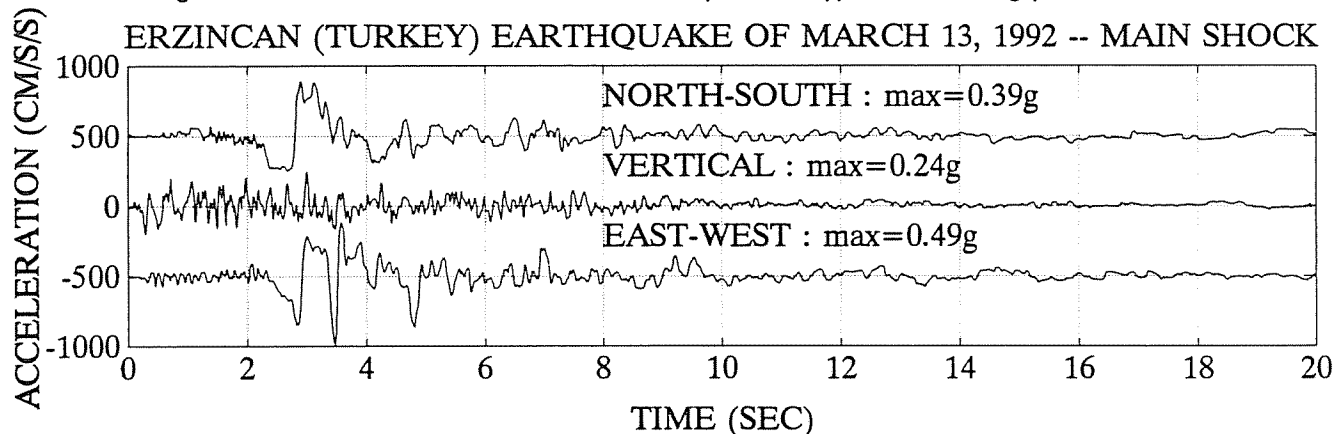
**Strong Motion** - One strong motion instrument is located in Erzincan. The peak ground accelerations recorded by this instrument were 0.40g, north-south, 0.48g east-west, and 0.25g vertical (see Figure 3). The duration of strong shaking lasted approximately 5 to 6 seconds, including a pulse with a duration approaching 1.5 seconds near the start of the record.

FIGURE 3 - Uncorrected strong motion record from city of Erzincan

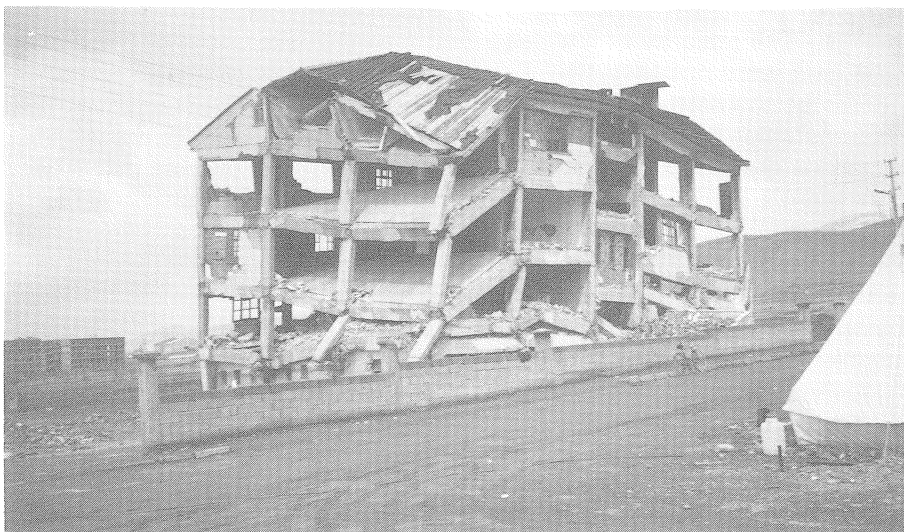
Residential mid-rise buildings typically are three, four and five stories, with a double loaded central corridor. The construction consists of concrete frames with hollow tile infill for the exterior walls and interior partitions. In almost all of these buildings, the hollow tile infills suffered damage, ranging from minor cracking to complete failure of the infill. In almost all cases, the gable portions of the end walls fell out due to inadequate anchorage to the roof framing. In many cases, veneer courses fell out after suffering in-plane cracking. A number of these buildings suffered damage to the concrete frames, usually in the form of spalling of the concrete at the lowest level corner column splice locations. In a large housing complex with over 250 such buildings, approximately 12 buildings lost the first story and 6 collapsed completely. Figure 4 shows a partially collapsed mid-rise residential structure.

FIGURE 4 - Partially collapsed mid-rise residential building

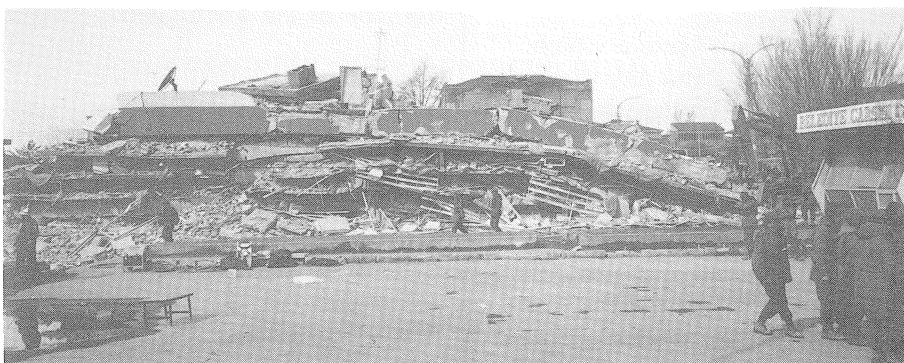
Special use, large, mid-rise structures suffered the most severe damage. The three large hotels in the city, each five stories tall, completely collapsed (see Figure 5). The three hospital complexes also suffered major damage. One six-story wing of the military hospital suffered a short column shear failure of the first story (see Figure 6), the complete collapse of an end stair tower wing, and the racking of an entrance canopy, in a response reminiscent of that of the Olive View Hospital in the 1971 San Fernando earthquake. One wing of the seven-story, Z-shaped Social Security Hospital completely collapsed. A six-story dormitory wing of the State Hospital also collapsed. The main functional buildings at this facility suffered damage severe enough to cause them to be evacuated.

FIGURE 5 - Complete collapse of a five-story, concrete frame hotel building

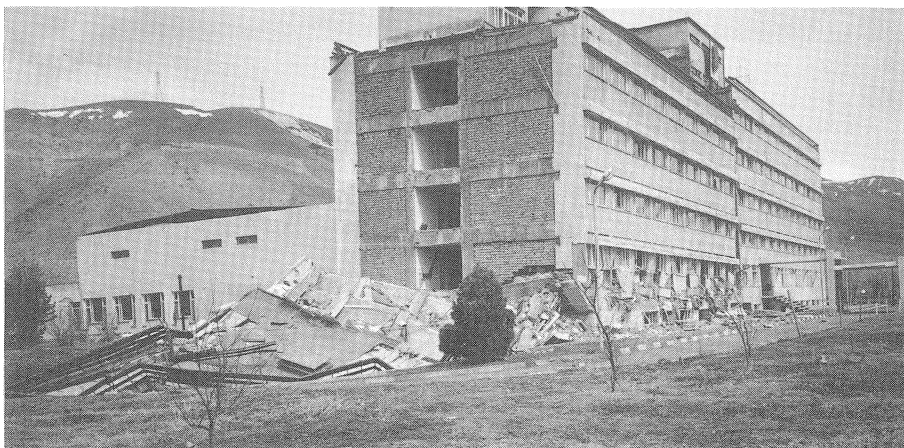
FIGURE 6 - First story short column shear failure at military hospital

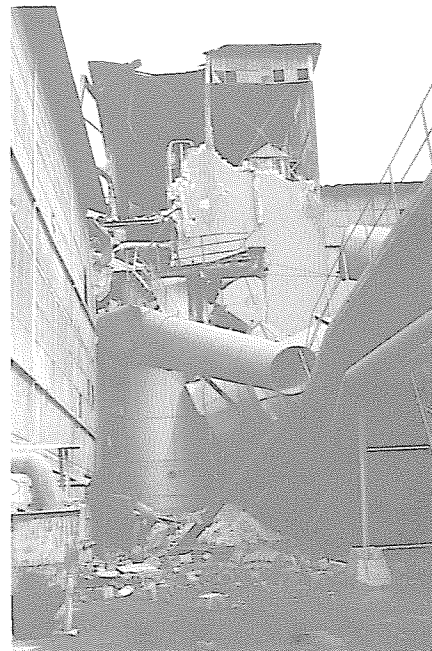
a sugar refinery, a large improperly braced stack collapsed into the main building tearing down a portion of the roof structure (Figure 7). Three large unanchored steel oil storage tanks, the steel framed, brick infill wall buildings, and the two-story masonry buildings at this site were undamaged.

**FIGURE 7** - Collapsed stack at a sugar refinery
