# The Reconstruction of Erzincan, Turkey

*This report was contributed by Mehmet Celebi (EERI 1980).*

### Introduction

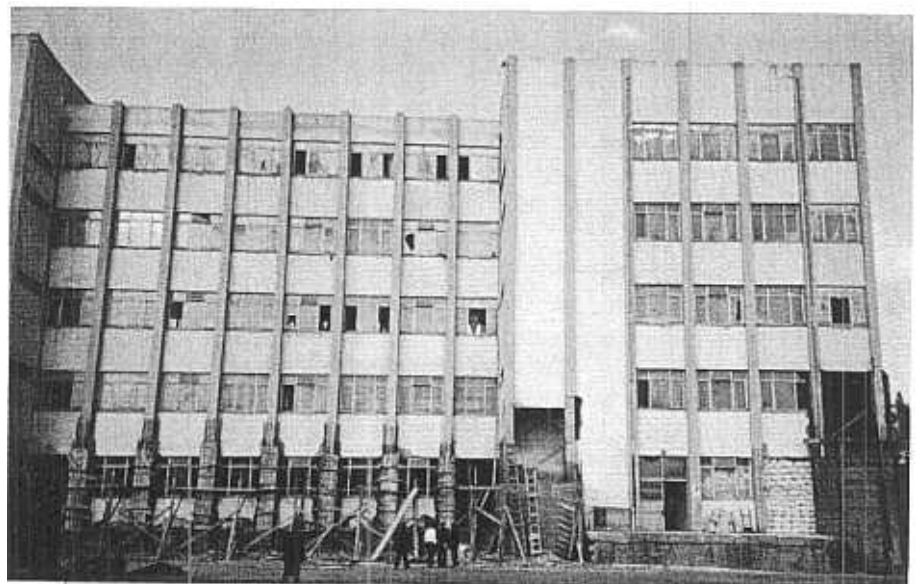
Figure 3 - Unsan Flour Mill during repair and retrofit

Capping reinforced concrete columns is a well known method. In most cases in Erzincan, this method was used in combination with addition of shear walls. Figure 3 shows the repair and strengthening at Unsan Flour Mill. The photograph shows shear walls being added to the corners of the building and columns being capped in the central section of the building.

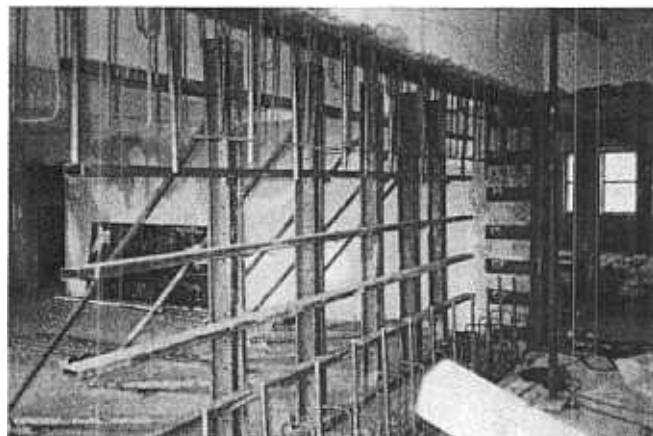
Repair and retrofit of public buildings (schools and government buildings) are being carried out by a new method initiated, designed, and being implemented under the direction of the METU Group. Application of this method is seen in Figures 4-6. The building is strengthened with shear walls cast within a frame of channel members between two columns which, in turn, is attached to the columns by a standardized jacket comprised of four longitudinal corner angles and plate strips between them. The channel at the top of the frame is anchored by a bolt system to the bottom frame channel of the floor above. This is the basic shear transfer mechanism. Once the new shear wall is cast, the columns are considered as not contributing to the lateral force resisting capability. During casting, a "cement board" is used as a vertical form and left in with the concrete. This board is later painted.

Figure 4 - METU method shear wall retrofit

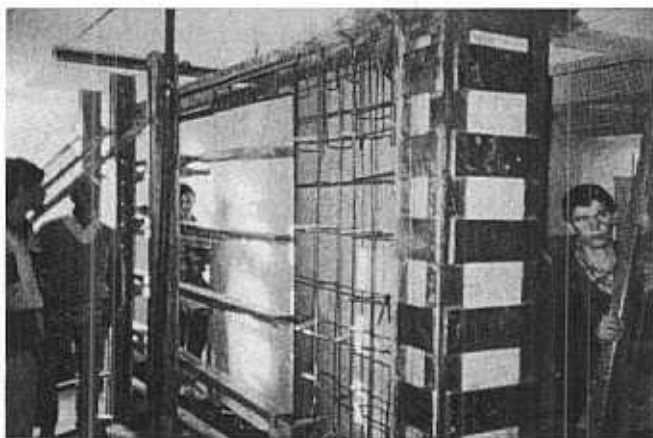
Figure 5 - Rebars in place, form being placed

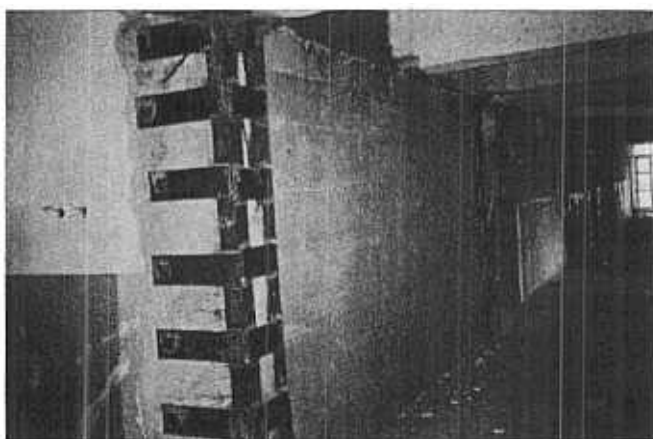
Figure 6 - Finished wall - METU method
