## Learning from Earthquakes

## The Izmit (Kocaeli), Turkey Earthquake of August 17, 1999

On August 20, 1999 an Earthquake Engineering Research Institute team visited the area affected by the Izmit earthquake. The team was composed of T. Leslie Youd, Team Leader, Brigham Young University, Provo, Utah; Mark Aschheim, University of Illinois, Urbana/Champaign; Nesrin Basoz, K2 Technologies/E.W. Blanch, San Jose, California; Polat Gulkan, Middle East Technical University, Ankara, Turkey; Roy A. Imbsen, Imbsen Associates, Sacramento, California; Gayle S. Johnson, EQE International, Oakland, California; Jay Love, Degenkolb Engineers, San Francisco, California; John B. Mander, State University of New York at Buffalo; William Mitchell, Baylor University, Waco, Texas; Halil Sezen, University of California at Berkeley; Mete Sozen, Purdue University, West Lafayette, Indiana; F.H. Swan, Geomatrix Consultants, Oakland, California; and Peter Yanev, EQE International. Contributors to this report were Aschheim, Basoz, Imbsen, Johnson, Mander, Mitchell, Swan, and Youd.

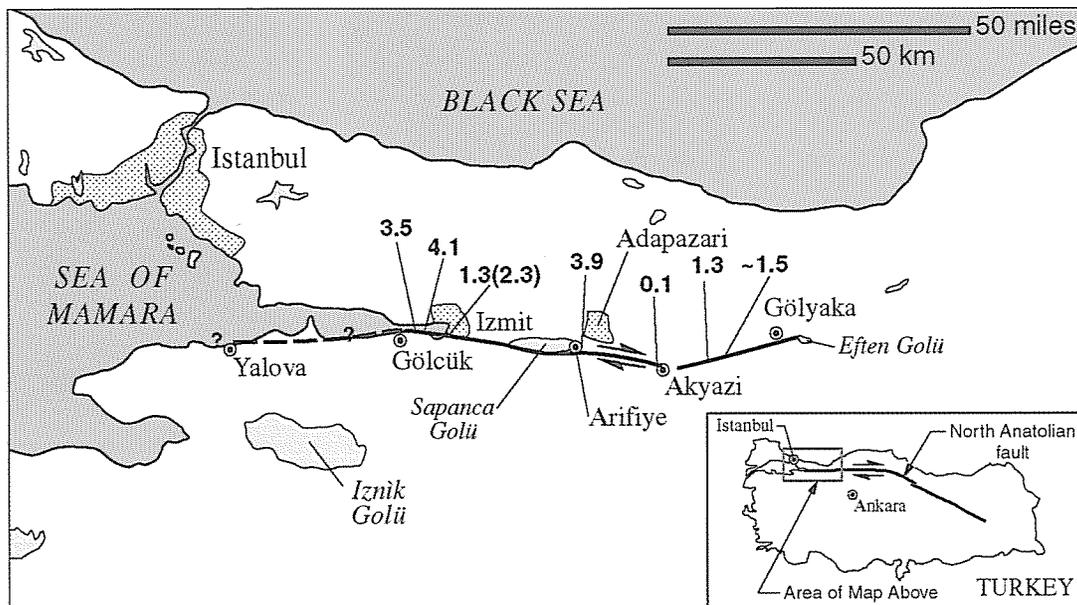
**Figure 1** - Location of the North Anatolian fault (inset) and the fault rupture that generated the August 17, 1999 earthquake. Numbers without parentheses indicate the amount of right-lateral offset in meters; values in parentheses indicate vertical displacement.

The earthquake was generated by rupture along a branch of the North Anatolian fault (Figure 1). The 1300 km-long North Anatolian fault system is one of the most seismically active right-lateral strike-slip faults in the world. Since 1939, there have been

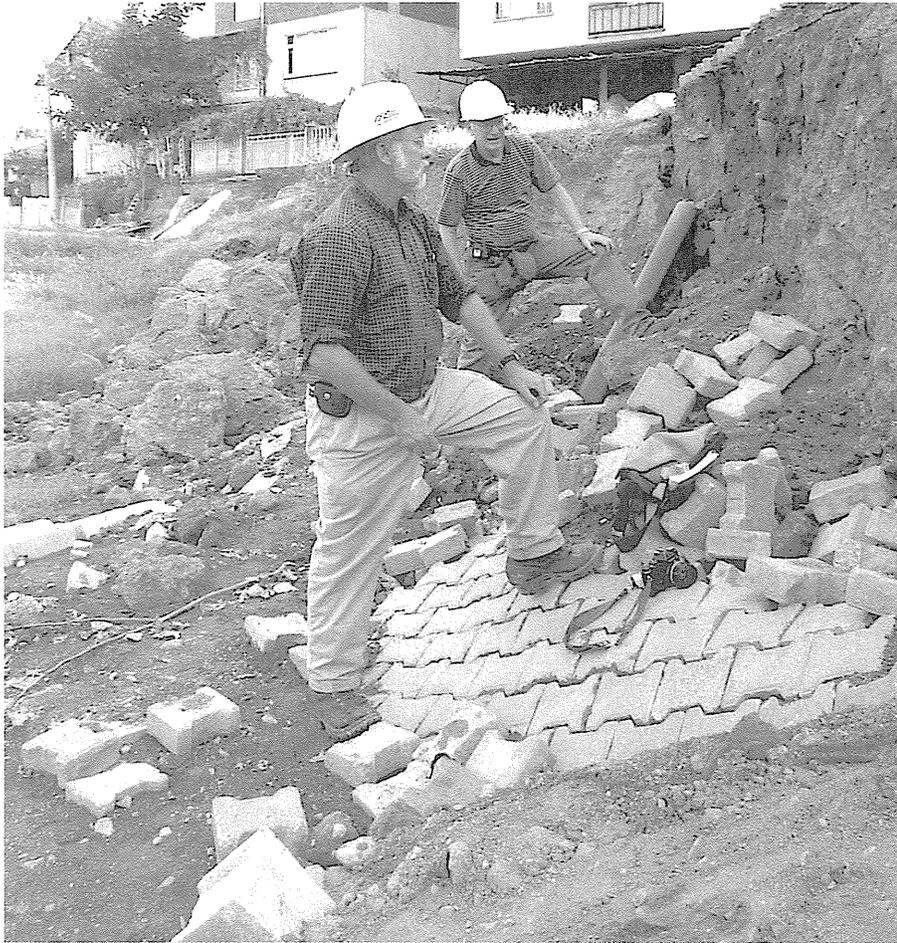
**Figure 2** - Fault scarp east of Golcuk. The vertical displacement is 2.3 m down-to-the north, with 1.3 m of right slip. (Photo: Mark Milstein, Atlantic News Service)

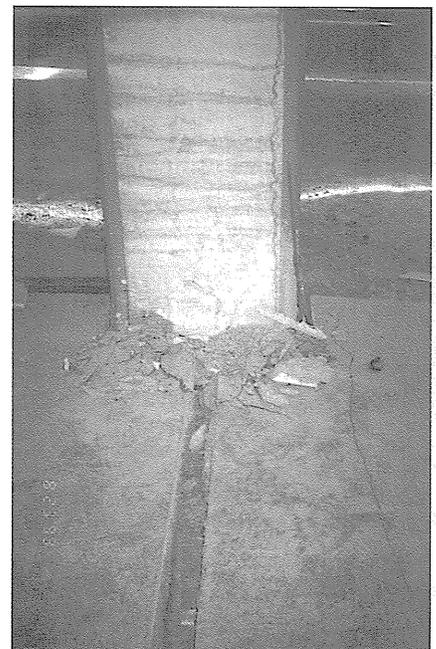
the Ford automobile assembly plant, which is nearly complete but not yet occupied, was deformed by about 0.5 m of right-lateral fault displacement distributed over a 100-m-wide zone. Floor slabs in this code-compliant building were fractured and split apart, and columns were tilted as footings moved with the earth. The tops of columns were pinned to the roof and remained in place. The columns cracked and underwent ductile deformation, but retained ample strength to support the roof structure without danger of collapse (Figure 3). Although substantial repairs will be required, the building deformed without threat to the life safety of occupants. In general, for buildings not directly astride the fault, ground shaking had greater influence on performance than did proximity to the fault.

**Figure 3** - Column pushed through the floor slab and tilted due to 0.5 right-lateral fault displacement. Column underwent ductile deformation without losing significant axial load capacity. (Photo: Youd)

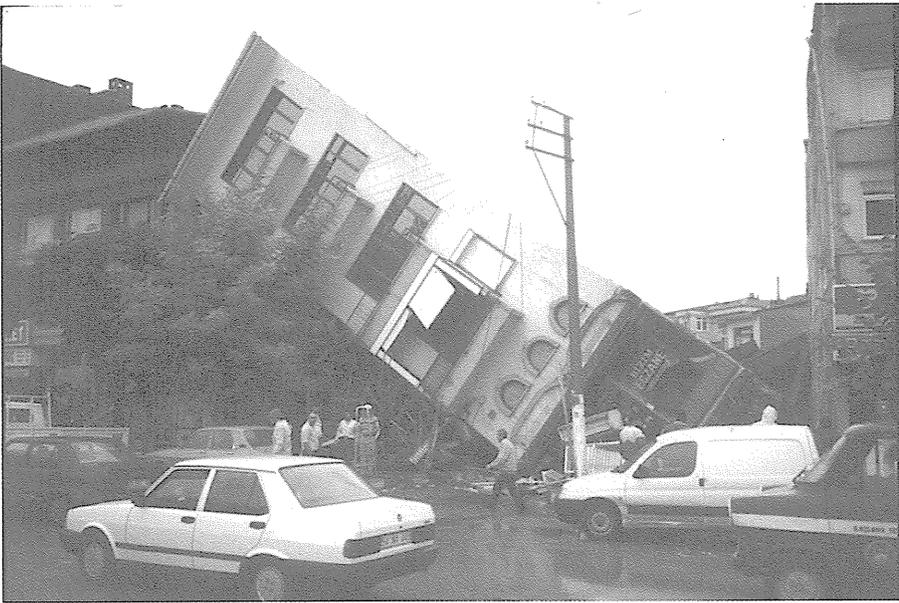
**Figure 4** - Building that toppled due to liquefaction-induced loss of bearing strength beneath shallow mat foundation. (Photo: Youd)

settled, tipped or toppled as liquefaction weakened soils beneath reinforced mat foundations (Figure 4). More than 60 percent of multistory buildings in the severe liquefaction areas suffered partial or total collapse due to structural failure. Follow-up investigations are in progress to determine layer thicknesses, soil properties, and foundation loads. These investigations, which were initiated in response to the EERI investigation, should add a considerable body of case history data to better define loading and soil conditions associated with liquefaction-induced foundation failures.

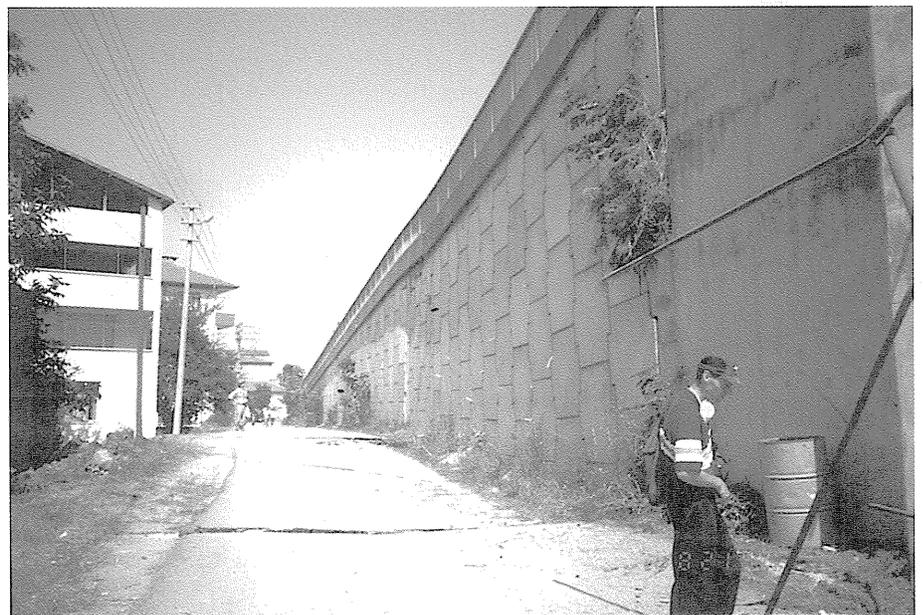
A pair of MSE walls retaining a bridge approach fill were severely tested by the earthquake (Figure 5). The primary fault rupture was only a few meters from the walls and passed beneath the bridge structure, which collapsed. Differential settlement also occurred beneath the walls due to a rigid reinforced concrete box culvert beneath the walls. Shear deformations from the differential settlement propagated upward through the paneled faces, with some panels separating as much as 75 mm, allowing a small amount of fill material to seep through the face.

However, damage to the wall was relatively minor: no straps broke, no facing panels fractured, and there was no immediate threat of wall collapse.

**Figure 5** - Mechanically stabilized earth wall within a few meters of the primary fault rupture. Although subjected to differential settlement, it suffered only minor damage. (Photo: Youd)

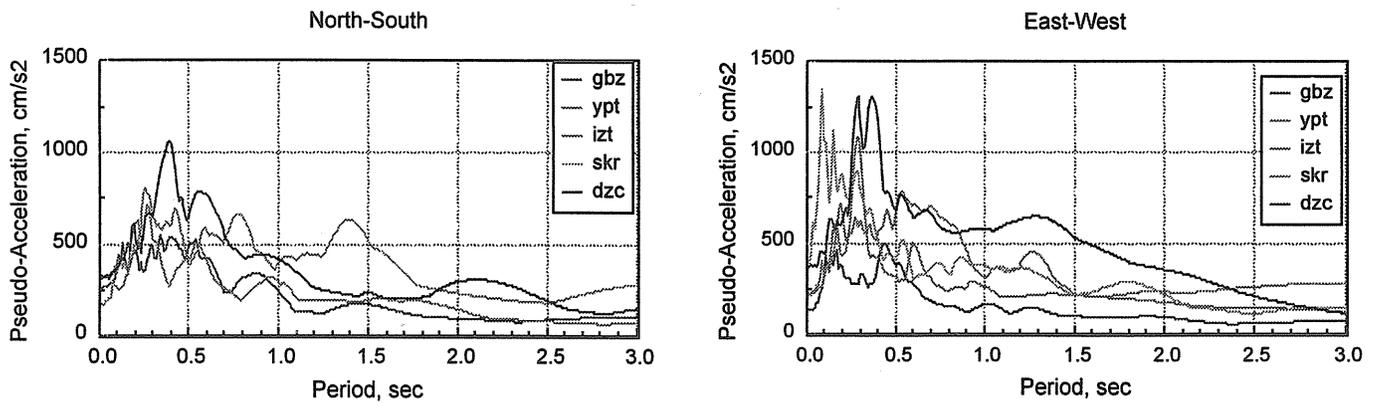
**Figure 6 - Response spectra (5% damped):** a) north-south components, and b) east-west components. The north-south component in Sakarya was not available. (Records provided courtesy of the Earthquake Research Department of the General Directorate of Disaster Affairs and Bogazici University.)

Response spectra are computed for the north-south and east-west components of ground motion for five stations located approximately along the fault: Gebze (GBZ), Yarimca Petrochemical (YPT), Izmit (IZT), Sakarya (SKR) and Duzce (DZC) (Figure 6). Of these, the largest peak ground acceleration was about 0.4g at Sakarya.

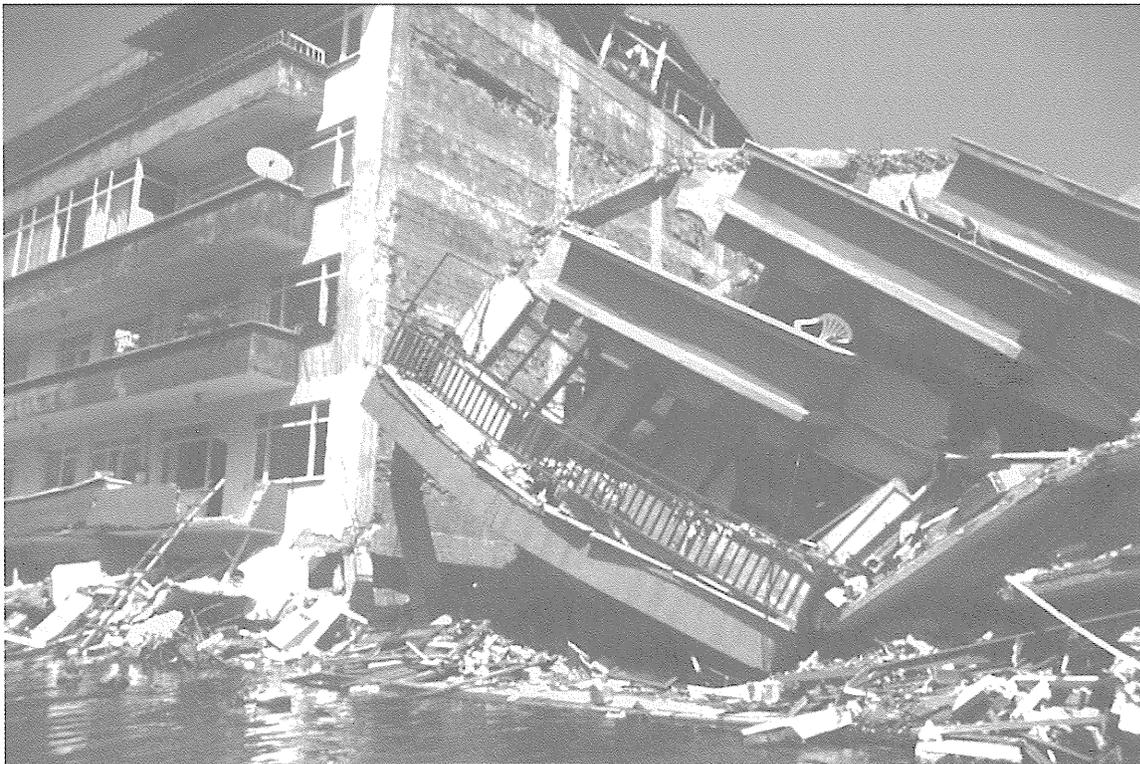
and ground shaking, and in some regions were subjected to ground settlement, liquefaction, or subsidence and sea water inundation (Figure 7). Numerous buildings were located on top of the fault trace, where there were lateral offsets of up to 4 m or vertical offsets of up to 2 m. Some buildings reportedly were "washed" into the Marmara Sea by waves resulting

**Figure 7 - Inundated buildings in Golcuk.** Tectonic displacement along the fault and liquefaction-induced subsidence resulted in extensive areas of flooding along the south shore of Izmit Bay. Note also out-of-plane roof infill, and collapsed building in foreground. (Photo: Aschheim)

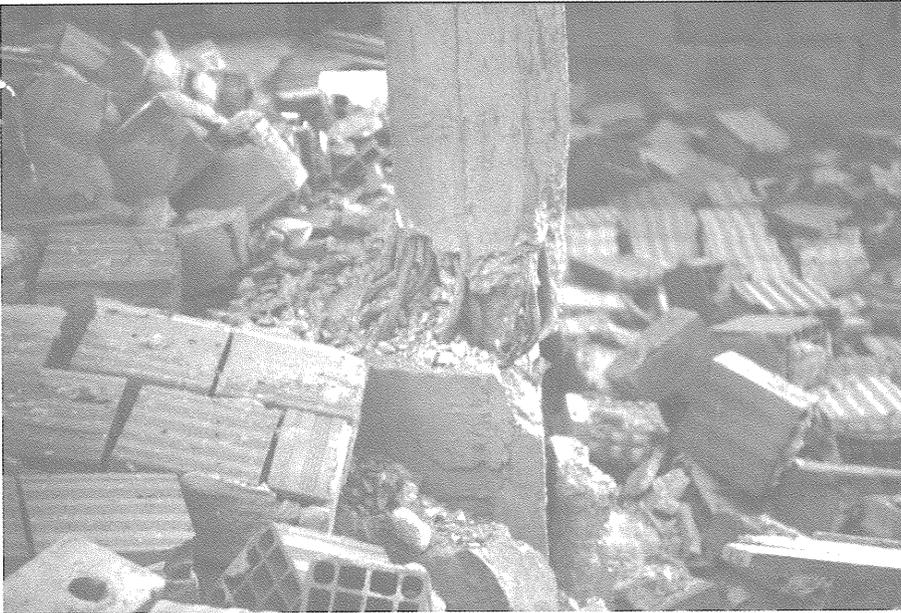
**Figure 8** - Typical weak-axis column hinging.

Flexural hinging at the ends of the columns often led to buckling of longitudinal reinforcement, sometimes resulting in shear failures at the hinges under weak axis bending (Figure 8). Strong-axis demands typically caused flexural hinging at

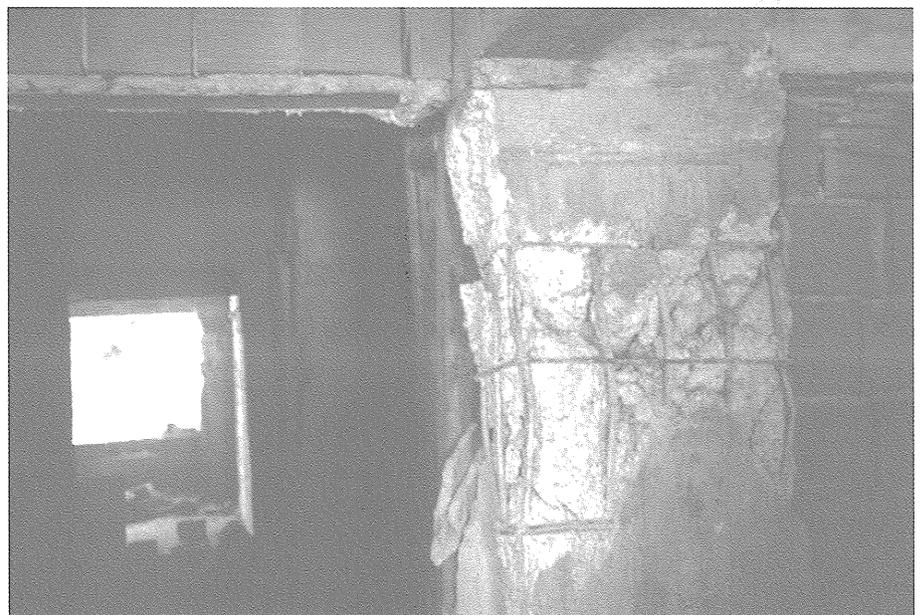
the ends of the columns and buckling of longitudinal reinforcement, or they caused shear failures at the mid-heights of the columns (Figure 9). Columns usually showed indications of large demands in only one principal direction. Soft (or weak) story mechanisms were common. In some cases, column axial forces resulting from overturning moments appeared to contribute to column failures. Loss of joint integrity was infrequent but ap-

**Figure 9** - Typical strong-axis column shear failure.

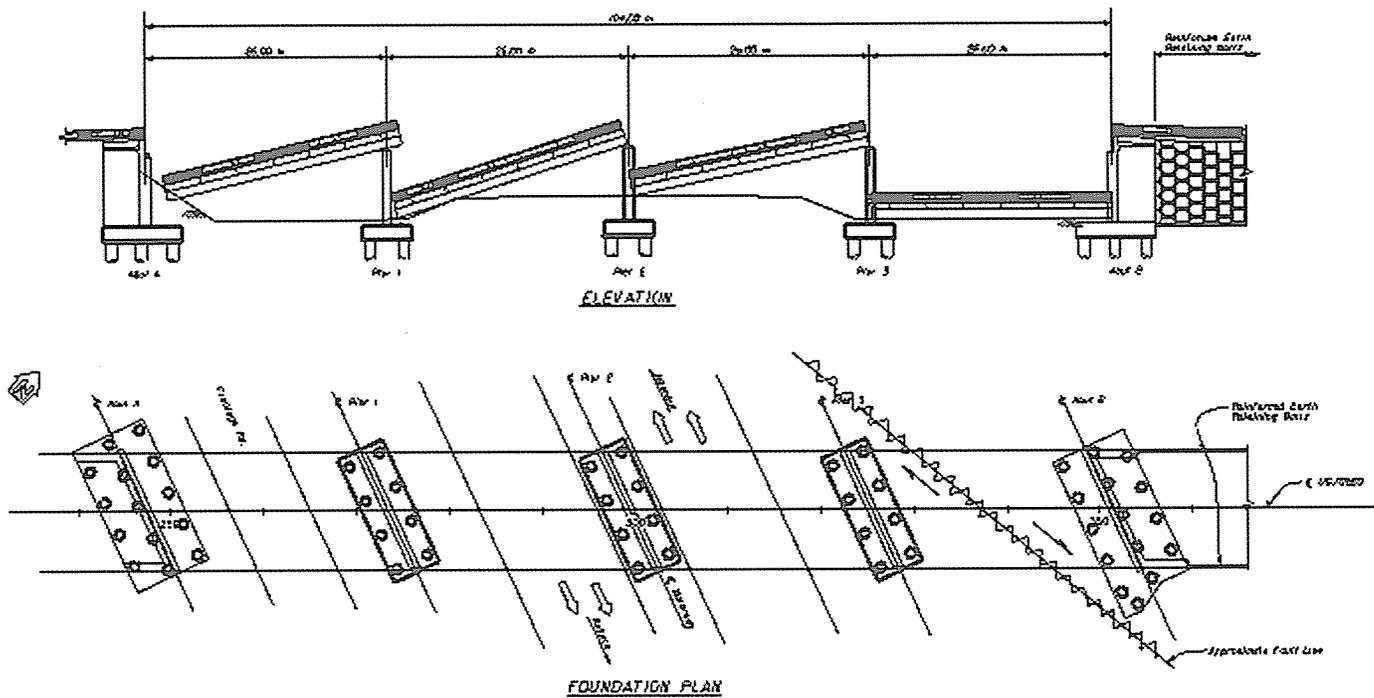
Figure 10 - Plan and elevation of collapsed overpass

The fact that one overpass crossing the E80 at Artifye did collapse was not surprising, as the fault rupture passed directly beneath the bridge (see Figure 10). The fault movement exceeded the

available seat width, causing the span to collapse. In so doing, it dragged the remaining three spans off their seats. One of the spans crushed a passing bus, killing ten people.

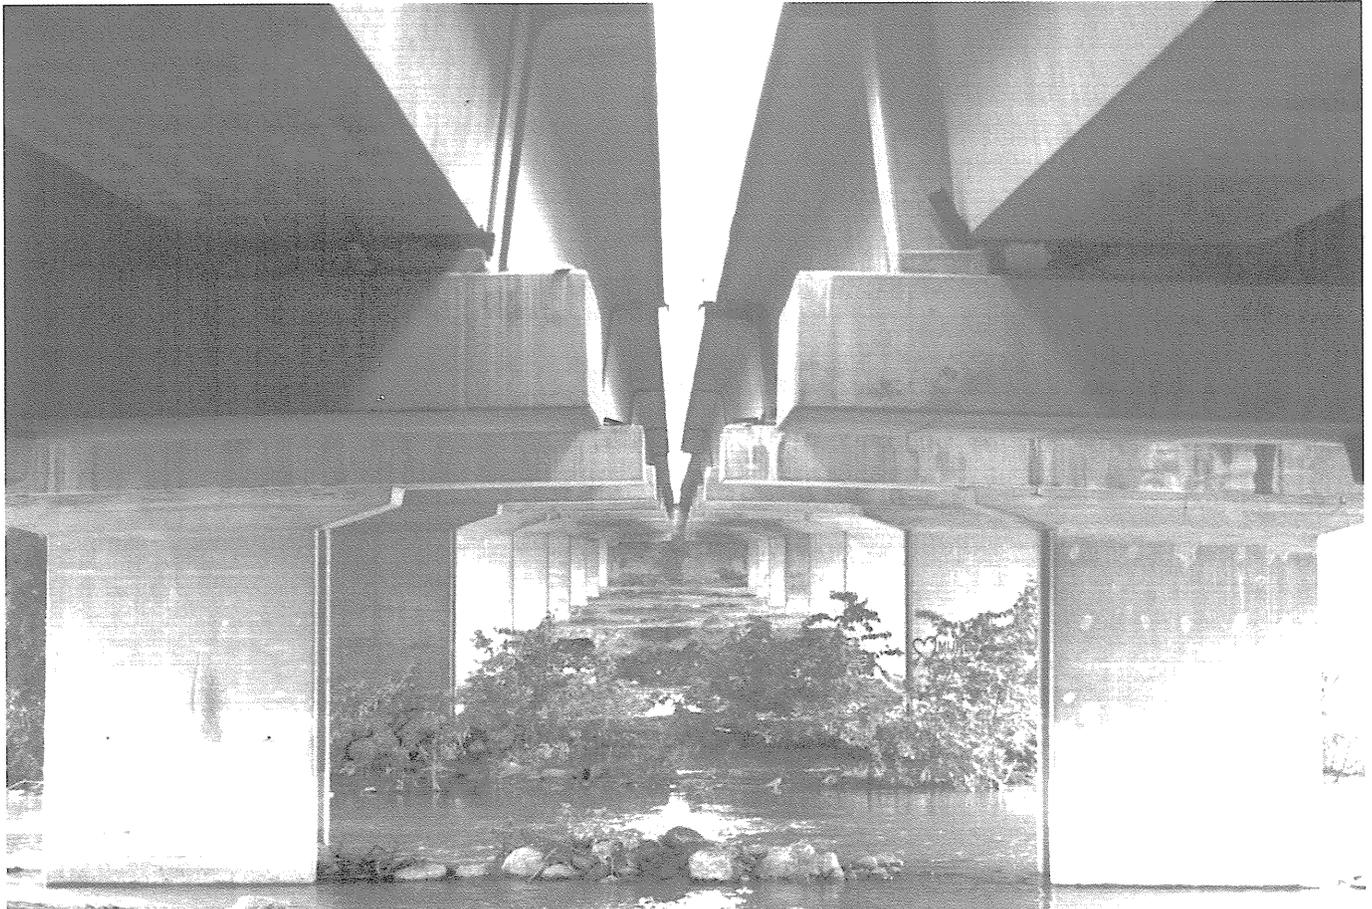
Problems were also encountered with four highway bridges crossing the Sakarya River (Figure 11). Most notable was the bridge carrying the westbound lanes of the E80 motorway. It consists of ten 40-m simply-supported prestressed-concrete trough-shaped girders seated on laminated elastomeric bearing pads. Shear keys are provided at the end of each box to inhibit transverse and longitudinal seismic movements; the elastomeric bearings accommodate thermal movements. The apparent large impulsive fault-normal ground shaking, coupled with vertical accelerations, caused the shear keys to fail in several spans and unseat their bearings. This damage is consistent with what has been observed in pre-

vious earthquakes. The westbound bridge had to be closed for repairs. The eastbound sister bridge sustained less damage to the shear keys and only partial walk-out of the bearing pads; in the absence of complete unseating, the bridge has remained fully operational.

**Figure 11** - The east (left) and westbound bridges over the Sakarya River. Note shifting of the spans and the unseating of the bearings in the westbound bridge. The bearings on the eastbound bridge have partially "walked out," but not unseated. (Photo: Mander)

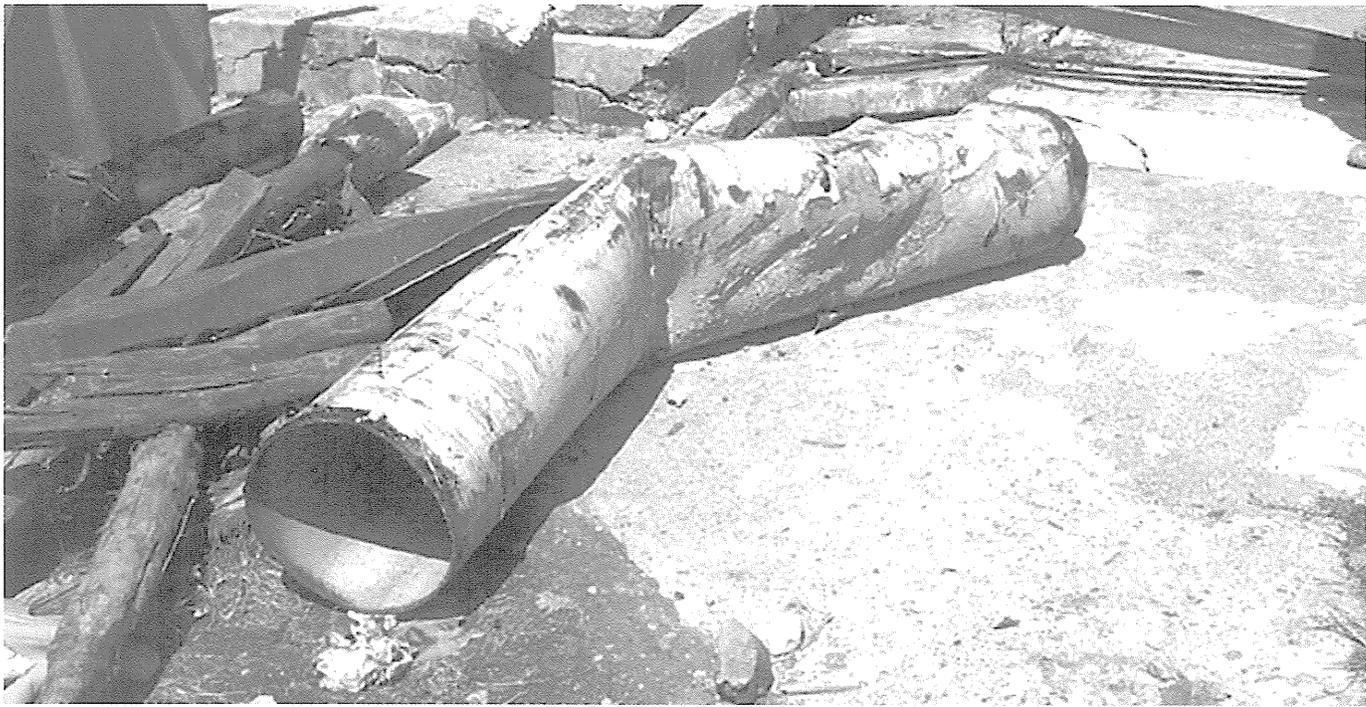
**Figure 12 - Buckled steel pipe at crossing near Arifiye.**

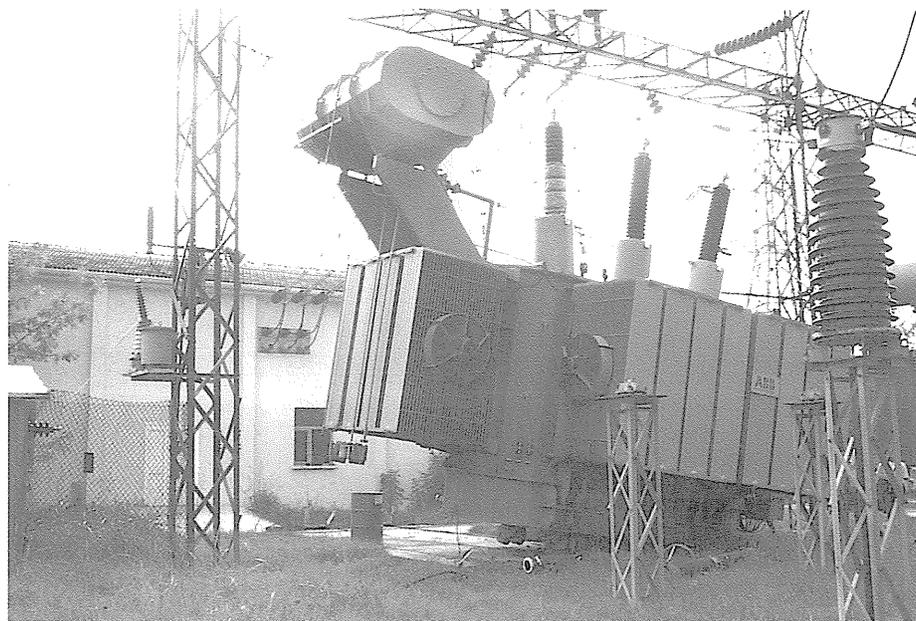
**Electric Power System:** The main power substation in Adapazari sustained damage to its six 380kV transformers, causing a blackout as far as Ankara. Typical damage included tilting of transformers due to support failure (Figure 13) and breakage of porcelain. Control systems were anchored and suffered no damage. The distribution system was somewhat disrupted when buildings collapsed over

**Figure 13- Damage to transformer in Izmit-2 substation. Tilting due to movement of support.**

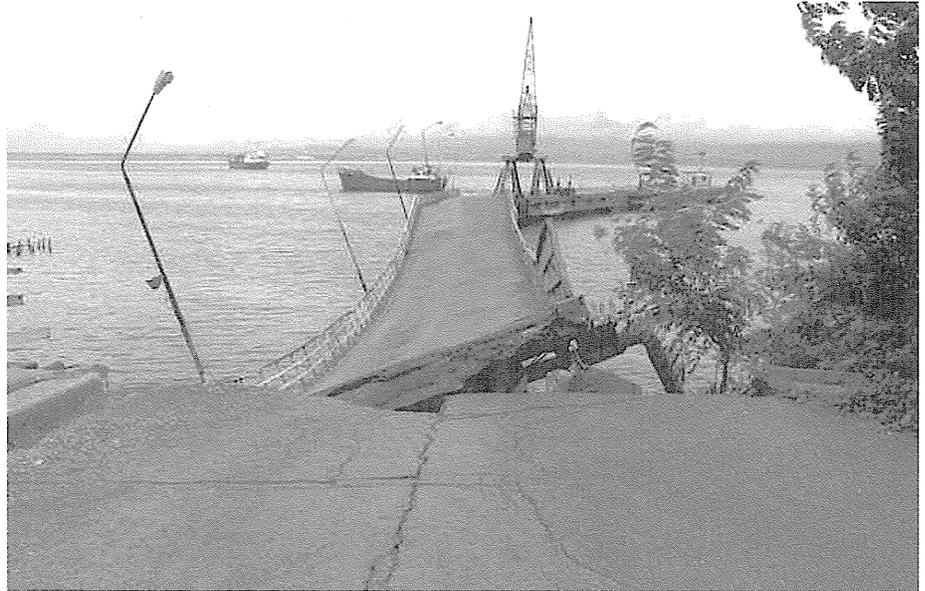
**Ports:** Most of the ports and jetties of industrial facilities along the northern shores of the Izmit Bay sustained damage ranging from minor to extensive (Figure 14). Extensive damage was observed at fault crossings, for example, at the navy base. It included failure of steel piers and piping systems and the collapse of cranes. At the port of Derince, the largest port facility, two of the three main cranes were nonfunctional due to horizontal and vertical movement of the caisson of up to 40 cm. The port continued its operation using mobile cranes. A few jetties at the industrial facilities were functional by the end of the third week. The total estimated loss for port facilities in the region is on the order of \$200 million.

Figure 14 - Private port facility for SEKA paper mill in Izmit. (Photo: Johnson)

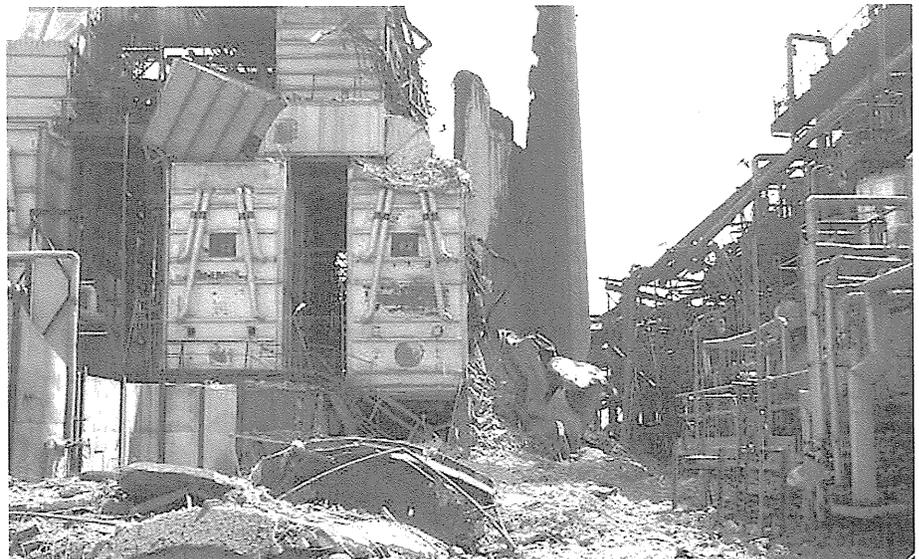
Figure 15 - Collapsed 90-meter reinforced concrete stack at the Tupras refinery caused extensive damage and fires. (Photo: Johnson)

crude unit, when a 90-meter high reinforced concrete heater stack catastrophically collapsed, knocking down equipment and pipeways (Figure 15). Tupras also had a wood cooling tower that completely collapsed, and there was an oil spill at the port.

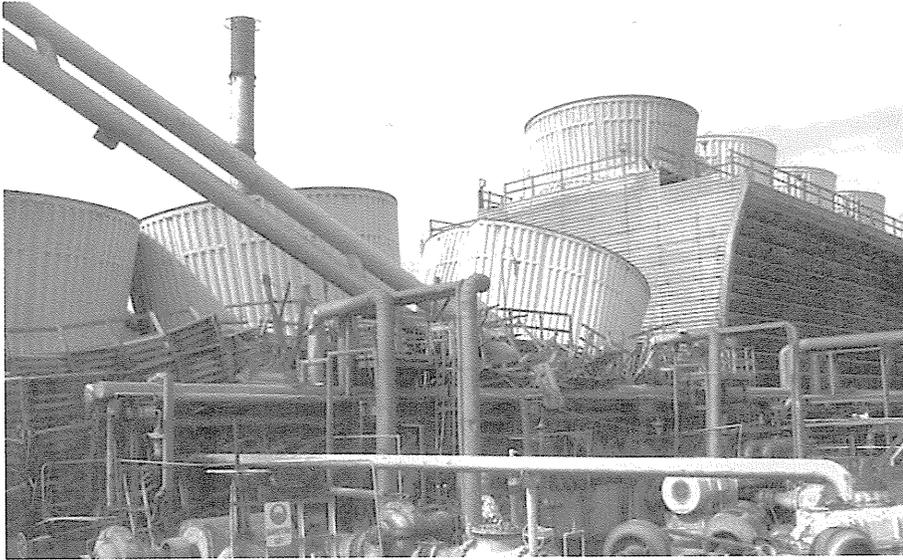
**Figure 16** - Collapsed wooden cooling towers at the Petkim petrochemical plant. Instrument at the site measured peak horizontal acceleration at 0.32g. (Photo: Johnson)

Petkim had extensive damage to the port, complete collapse of the wood cooling towers (Figure 16), and severe damage to concrete cooling towers. Peak horizontal accelerations of 0.32g were recorded on a soil-founded instrument located at this site.

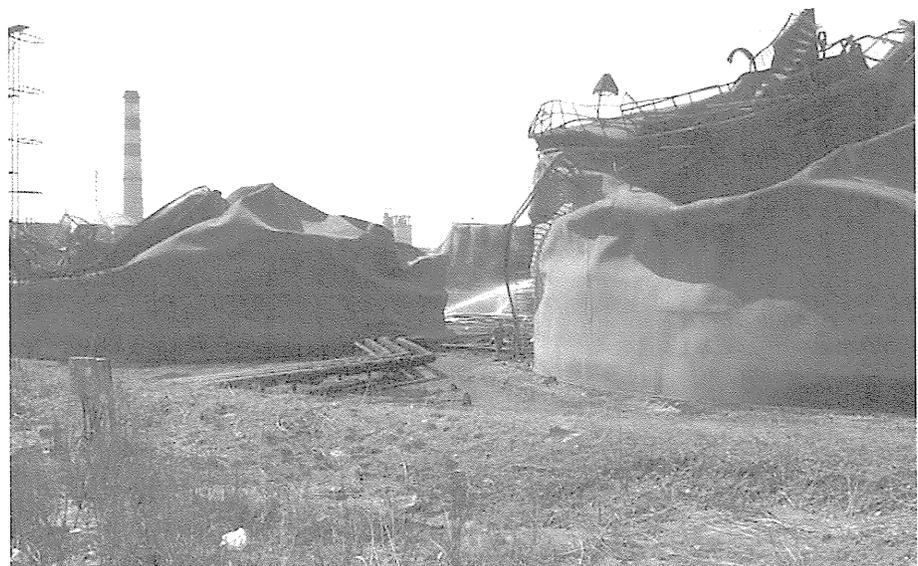
**Petrochemical Industry:** The most widely publicized and spectacular damage occurred at the massive Tupras refinery in Korfez (Figure 17). Several tanks and a cooling tower burned out of control for three days when naphtha spilled from a floating roof tank and ignited; all water was lost to the refinery. A second fire started in a

**Figure 17-** Tanks destroyed by out-of-control fire in the Tupras refinery tank farm. (Photo: G. Johnson)
