Learning from Earthquakes

Preliminary Observations on the Sultandagi, Turkey, Earthquake of February 3, 2002

This report was contributed by the reconnaissance team from the Department of Earthquake Engineering at the Kandilli Observatory and Earthquake Research Institute of Bogazici University, Istanbul, Turkey. The team was in the field the morning of the day after the earthquake, and the field survey continued for two days. The team was comprised of Professor Mustafa Erdik; Research Assistants K. Sesetyan, M. B. Demircioglu, U. Celep, and Y. Biro; and Assistant Professor E. Uckan. The publication and distribution of this report are funded by the National Science Foundation as part of EERI's LFE Program, under Grant #CMS 0131895.

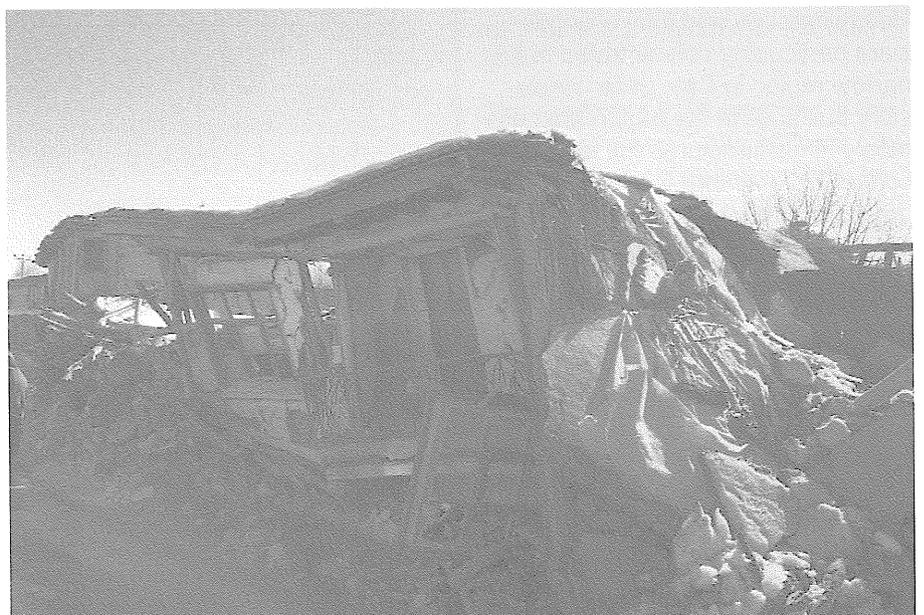
Himis Buildings: Most of the injuries and casualties in the region are associated with the total collapse of himis buildings. They were widely preferred in rural areas three or four decades ago and were traditionally built by their residents without engineering considerations. Thick perimeter walls and heavy roofs are com-

mon features of himis buildings, providing heat insulation. The observed performance indicates the poor strength and brittle behavior of the walls, and the considerable mass of the buildings. Observations suggest that due to the lack of rigid diaphragm action, most of the walls responded individually to the

ground motion. Moreover, observation of collapsed buildings indicates that as a consequence of weak connections between the perimeter walls and orthogonal partition walls, separation occurred there, and most of the thick perimeter walls collapsed in the out-of-plane direction. Figure 5 shows a collapsed himis building in Eber.

Figure 5 - Collapsed himis building in Eber.

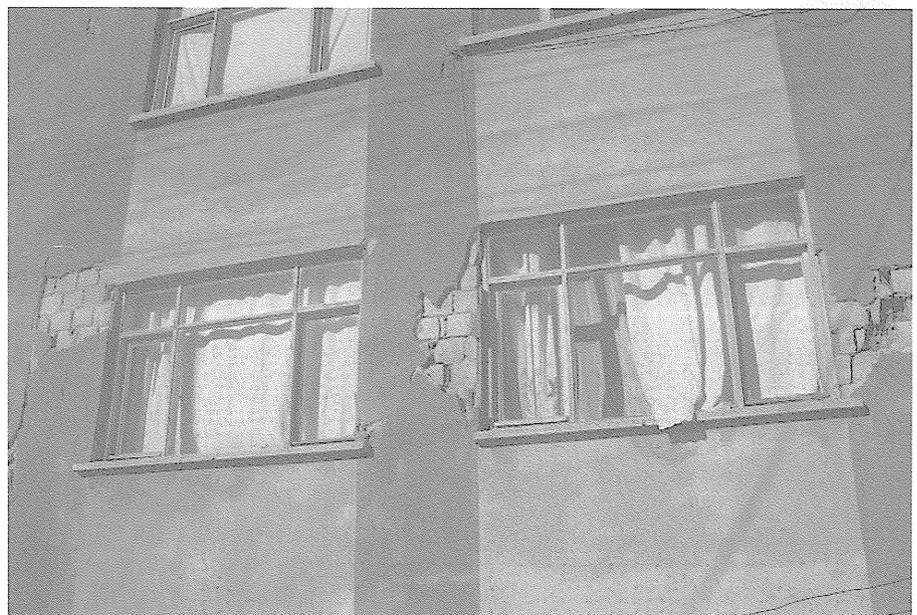
collapse (Figure 6) is the common failure mode for structures built with hollow clay tiles as a consequence of their very limited ductility capacity and poor strength. Wide shear cracks in the walls and evidence of crushing (Figure 7) have commonly

been observed in heavily damaged hollow clay tile buildings. Some of the buildings with fewer than three stories survived the earthquake with minor damage even though they were built with hollow clay tiles.

Figure 7 - Heavily damaged 4-story masonry building in Cay.

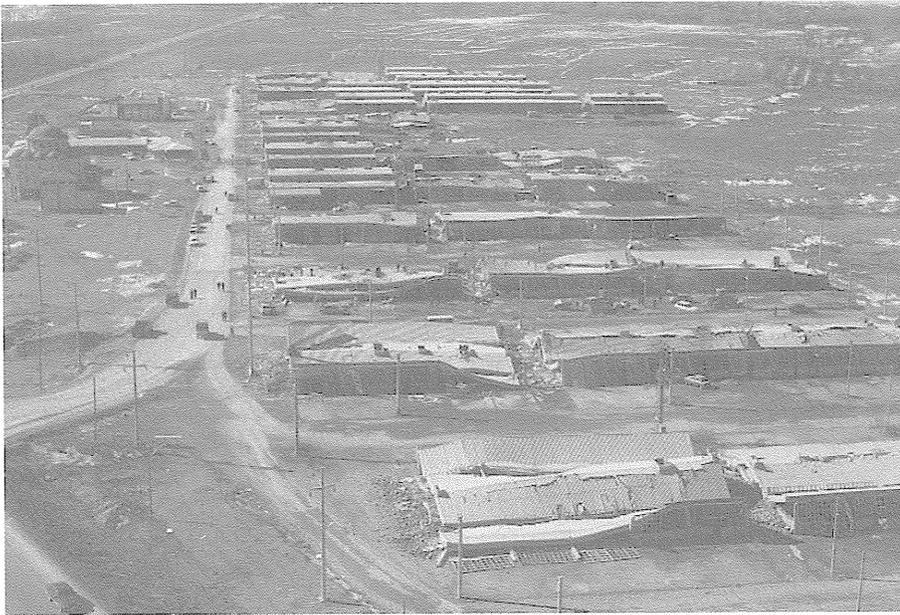
Most of the heavy damage and collapse of reinforced concrete buildings was limited to a narrow region in Cay. Peak ground acceleration (PGA) in Cay, which is approximately 10 km away from the epicenter, was estimated to be approximately 0.20-0.25g. About 30% of the buildings in the Cay commercial blocks collapsed, while those remaining were heavily damaged (Figure 8).

Figure 8 - Cay Commercial Blocks.

The mosque in the commercial blocks also suffered considerable damage (Figure 8 — upper left). This soft-story building is reinforced with plain round bars ($f_y = 220$ MPa, 40 ksi). Full-depth single flexural cracks, 3-4 mm wide, at beams concentrated at column faces suggest some level of beam bar slip (Figure 15). Observed damage indicates that the building responded dominantly in the oblique direction, causing biaxial bending in columns. Most of the bars buckled and cover concrete spalled at column corners. None of the columns exhibited shear-flexure cracks distributed over a constant length; however, one of the columns adjacent to infill walls in the first story failed in shear (Figure 16). It was observed that corner beam-column joints exhib-

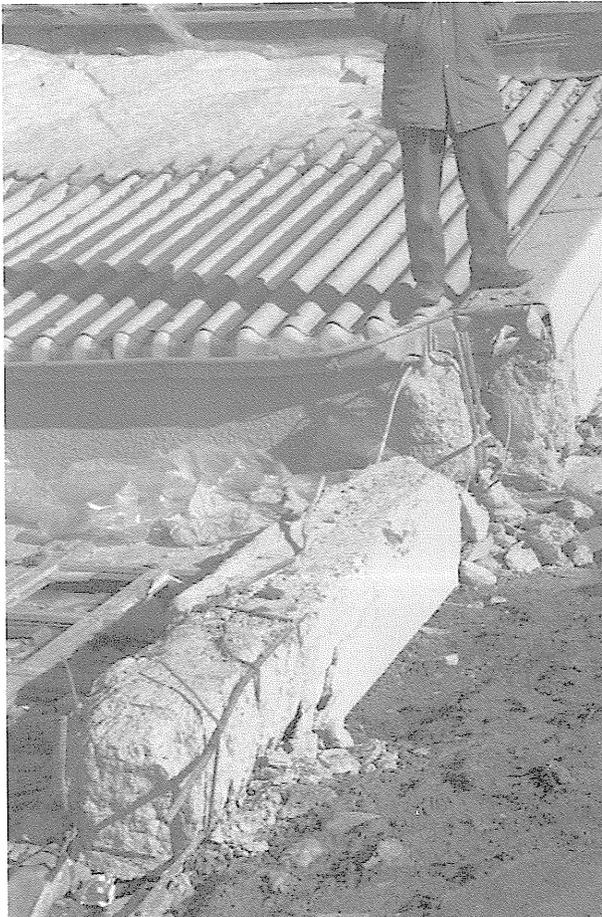
lapsed slab. Some remained vertical, even though the supporting slab collapsed (Figures 9 and 10). Blocks that did not collapse show evidence of wide flexural cracks concentrated at the beam-column joint faces and splitting cracks in the beam-column joints, indicating some level of bar slip.

Figure 9 - Column and slab collapsing in opposite directions.

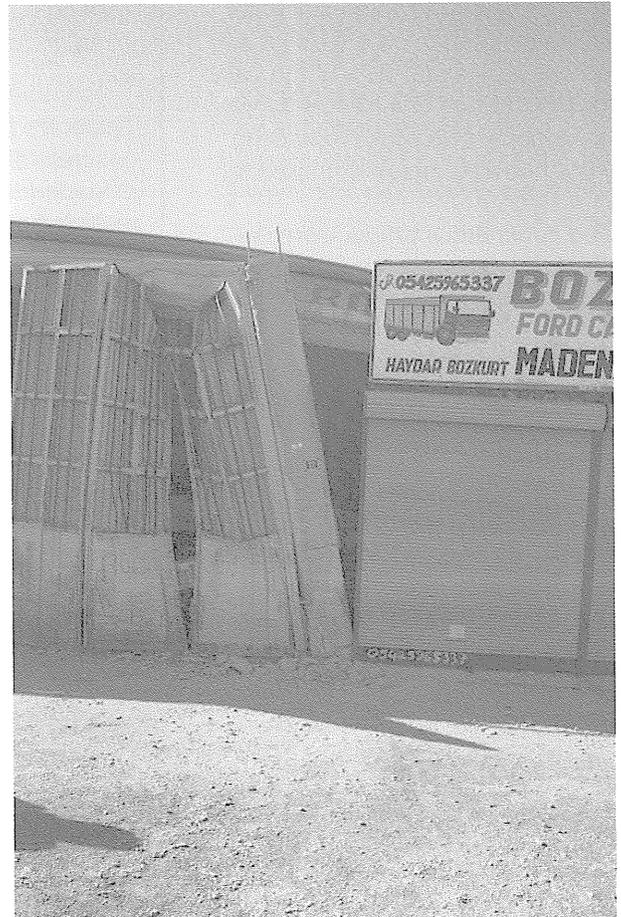
Figure 10 - Collapsed slab due to bond failure of the column bars.

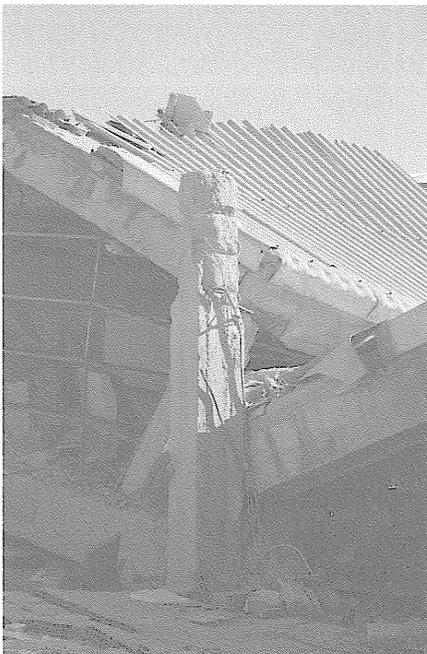
ment spacing of 200 mm is common in most of the columns; most of the transverse reinforcement with 90° hooks opened during the earthquake due to their poor anchorage features, particularly after cover concrete spalling (Figure 11). Exterior beam-column joint failures were also observed in some blocks. Details of the joints suggest that outer column bars buckled and joint cores crushed to some extent due to the lack of joint transverse reinforcement (Figure 12).

Figure 11 - Spacing of transverse reinforcement visible in a column.

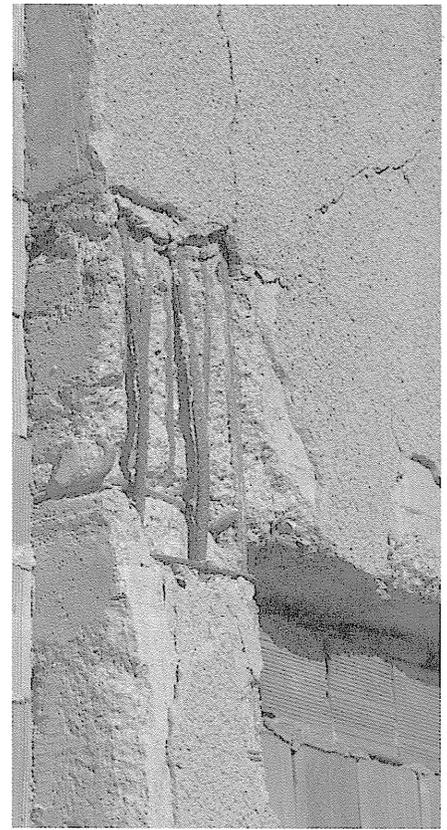
Figure 12 - Exterior beam-column joint damage.

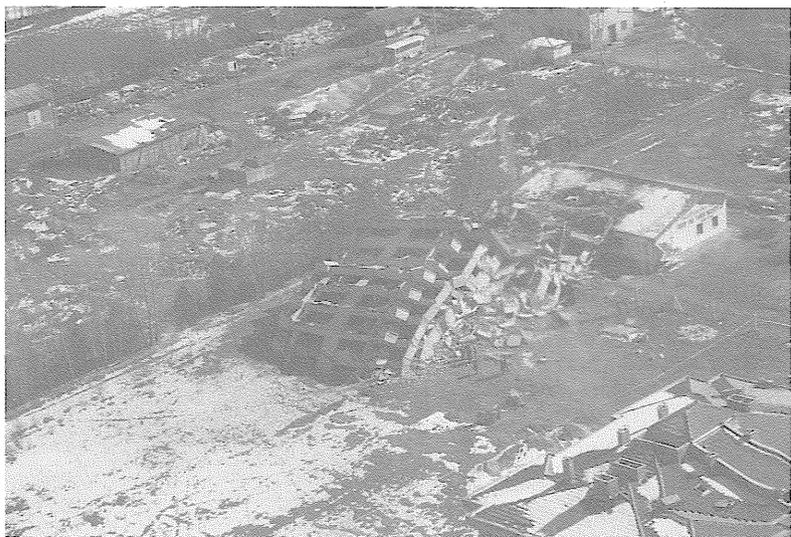
One of three identical eight-story apartment buildings in Cay, close to the commercial blocks, totally collapsed (Figure 13). Observations suggest that loss of column bar anchorage at the foundation level, and probably at the story levels (Figure 14), caused the collapse. Columns showed no evidence of distributed flexural or shear cracks, suggesting the possibility that column bars slipped before the attainment of flexural capacity. Another building lost its first two stories, which collapsed due to inadequate transverse reinforcement details. There are many instances of crushed concrete due to excessive transverse expansion of the core concrete and shear cracks in the weak

Figure 13 - Collapsed and damaged 8-story apartment buildings.

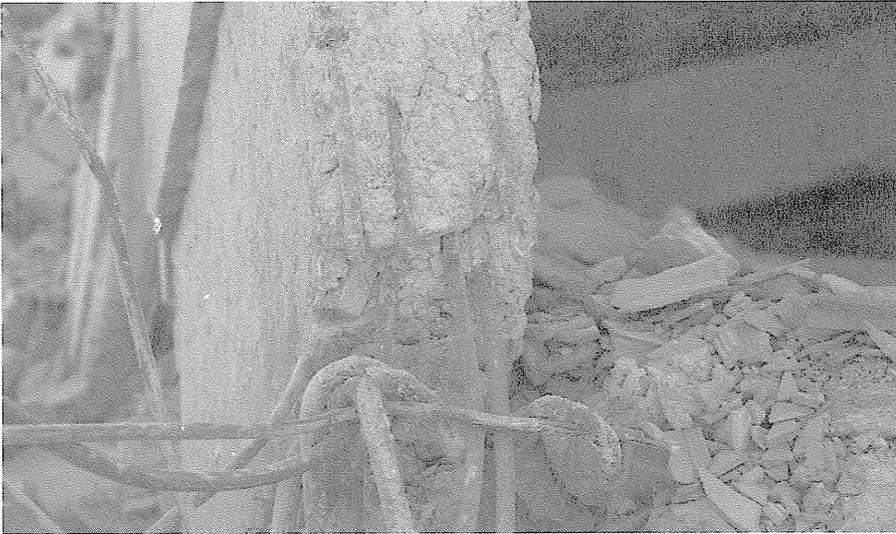
Figure 14 -
Bond failure at column base.

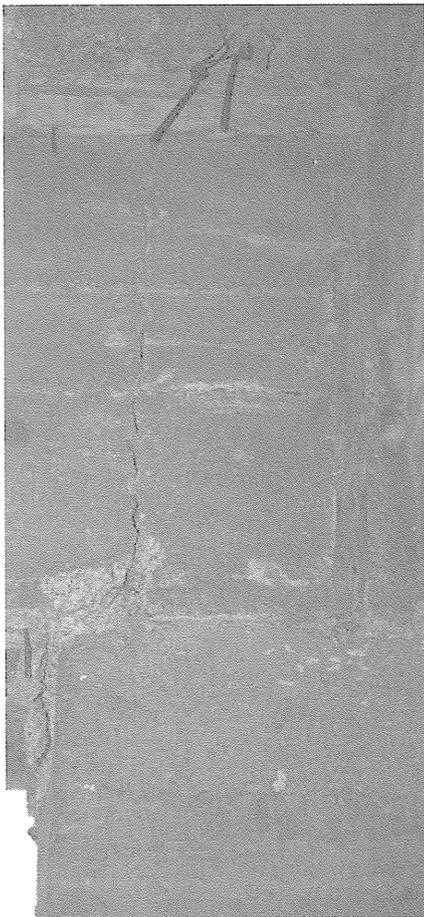
Figure 15 -
Full depth beam flexural crack.

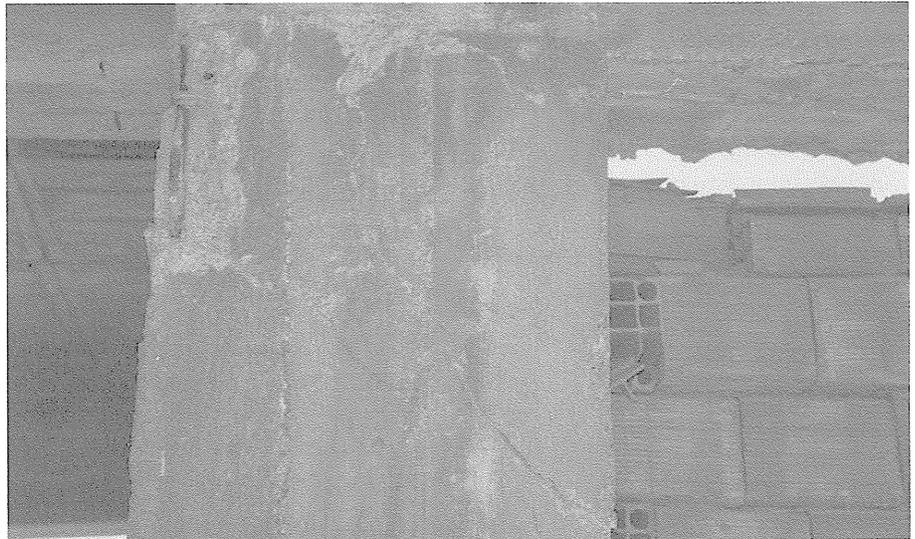
Figure 16 -
Observed column shear failure.

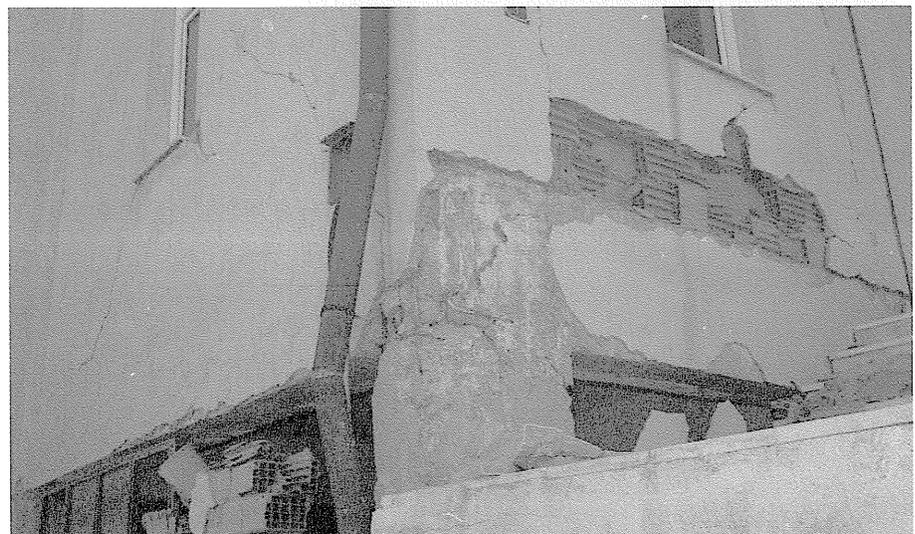
ited beam bar slip, longitudinal column bar buckling, and some level of diagonal tension cracking (Figure 17).

Figure 17 -
Damage at a beam-column joint.
