## MAY 01, 2003 BİNGÖL (TURKEY) EARTHQUAKE

**M.Erdik, M.Demircioğlu, K.Beyen, K.Şeşetyan, N.Aydınoğlu, M.Gul, B.Siyahi, G.Önem, C.Tüzün, A.Salkın and Y.Kaya**

Department of Earthquake Engineering  
Kandilli Observatory and Earthquake Research Institute  
Bogazici University, İstanbul

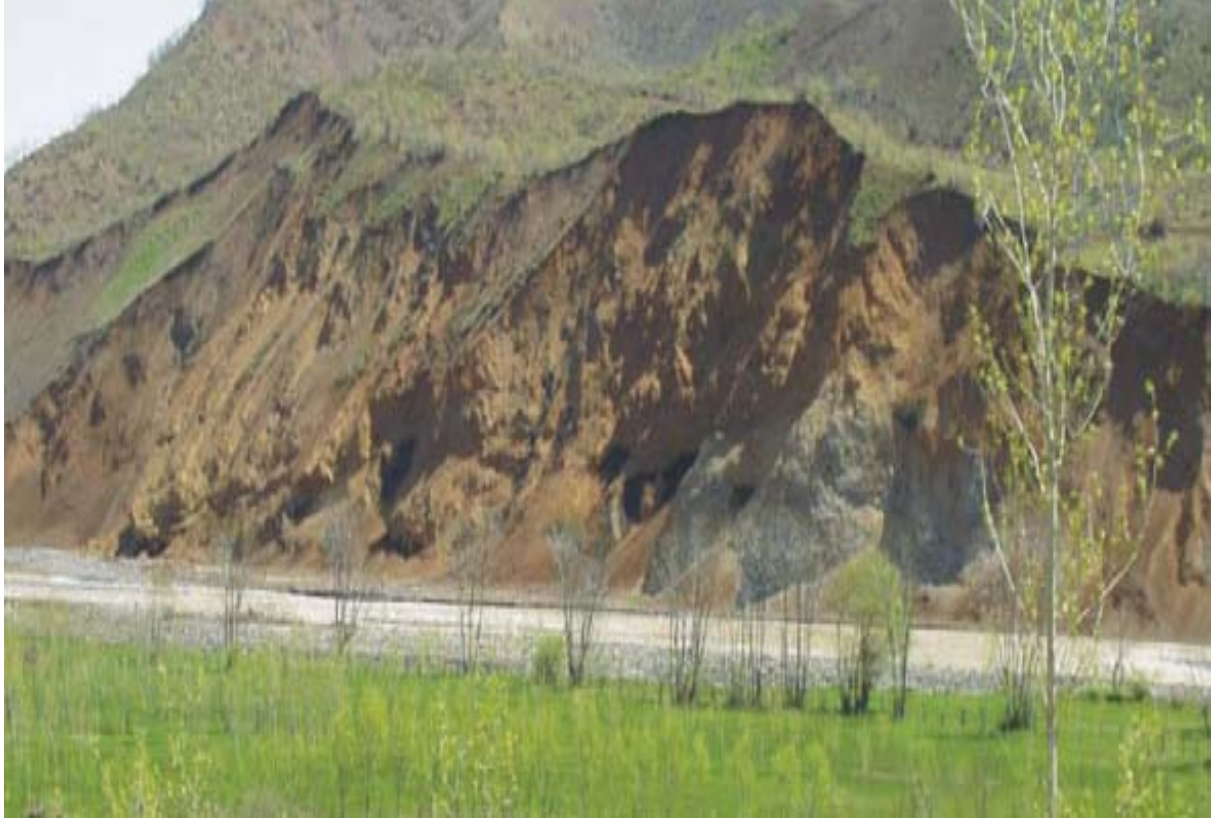
Rock and debris falls, several landslides, surface tension cracks. Landslides contributed to building damage in İpınar, Göltepe ve iekdere villages. Although possibility of liquefaction in the flood plains of Bayram and Gynk rivers exist, no observation of liquefaction has been reported. The old sections of the Bingl city is founded on the Pleistocene alluvial fans of Bingl and Bayram rivers. New parts of the city expands on the alluvial terraces of these rivers. These terraces consist of gravel and silt and in western sections, finer sediments. The pancaked eltiksuyu School is founded on the flood plain of Gynk River.

Figure 26. Debris flow and Landslide along the Gynk River Valley (After Emre et. al, 2003)

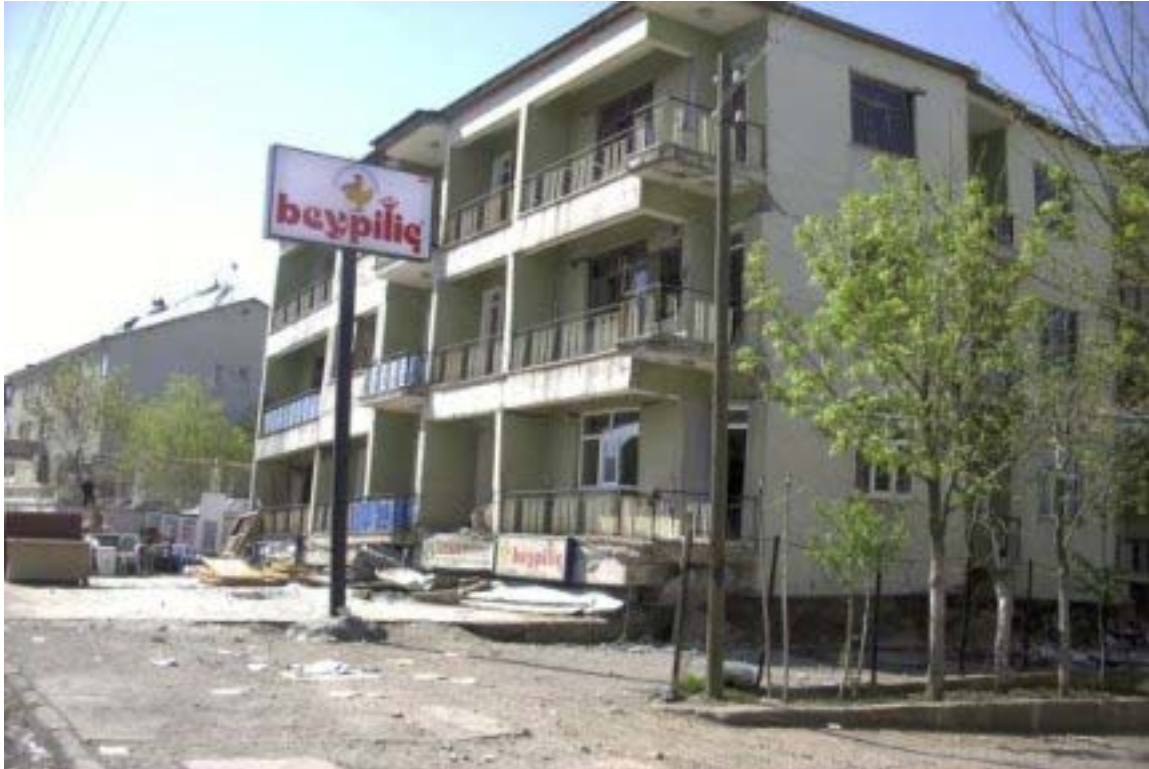
Figure 29. Collapsed 4-storey building due to soft storey.

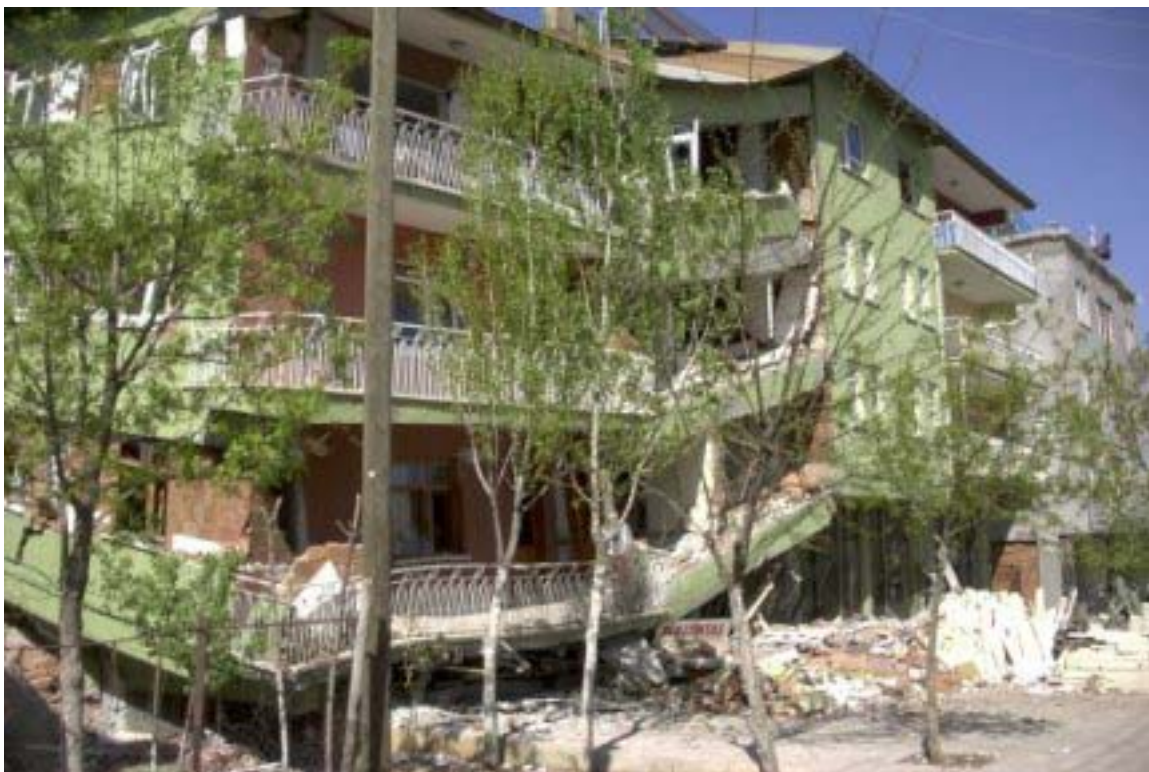
Figure 30. Collapsed 4- storey building due to soft storey

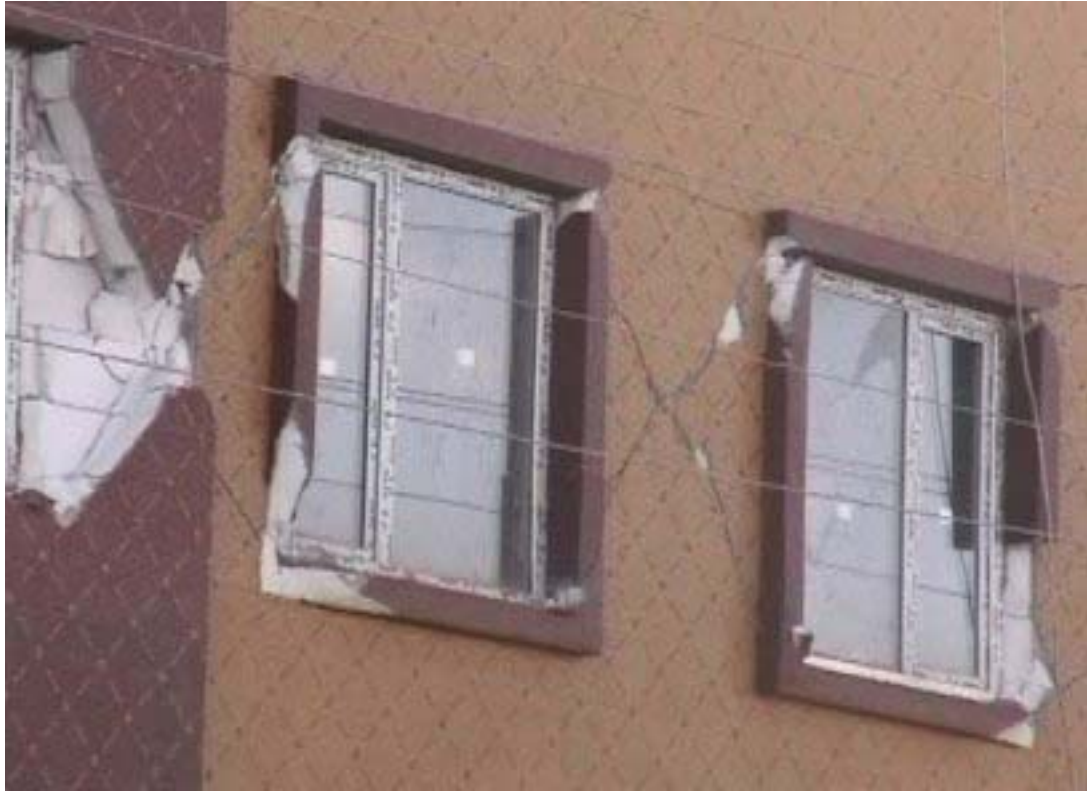
Figure 31. Typical shear crack in infill wall.

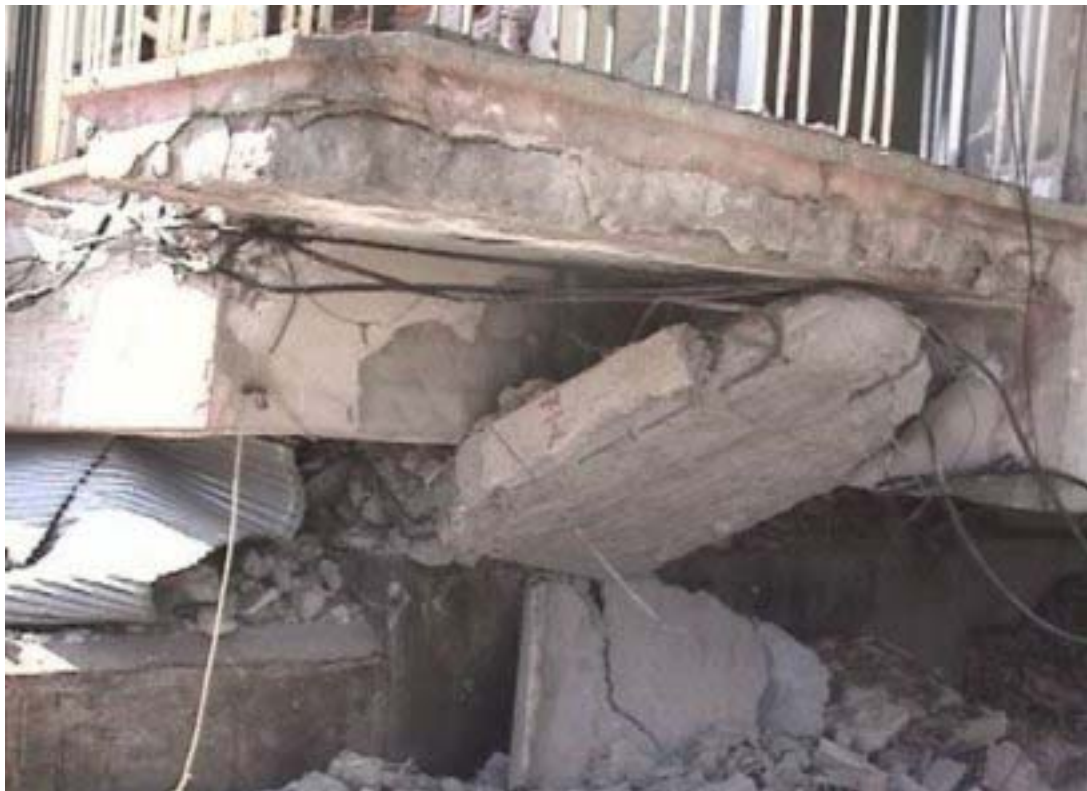
Figure 32. Total column failure at the 1st storey of a building.

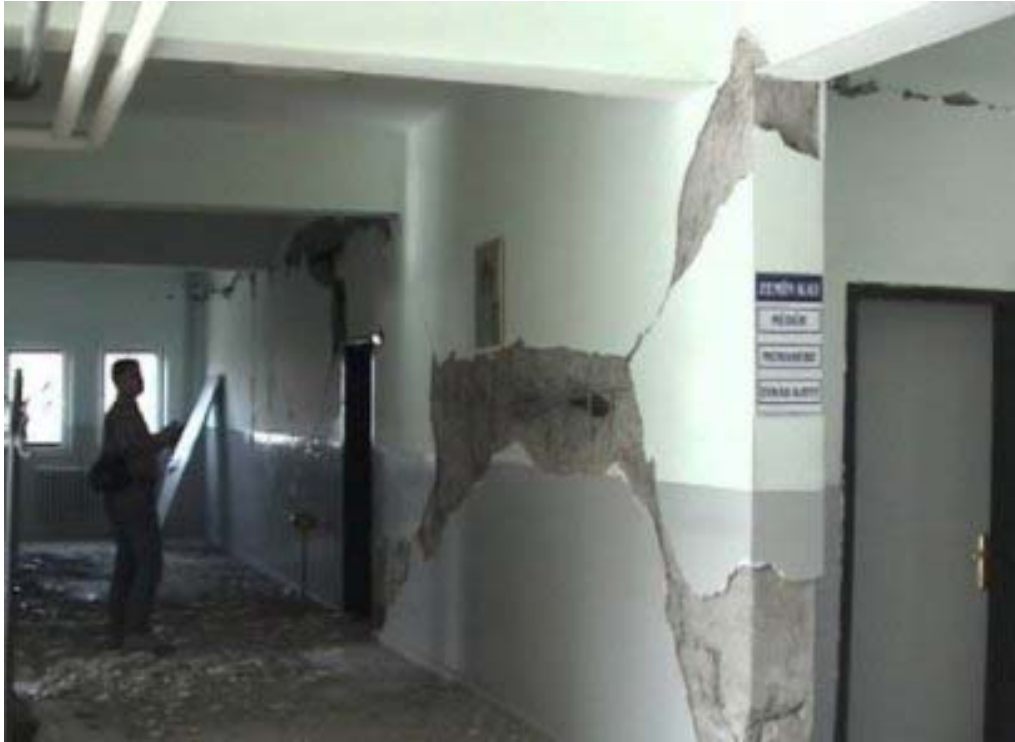
A few number of buildings had shear walls but in some cases due to insufficient transverse reinforcement and poor concrete quality wide shear cracks occurred in the shear walls. ( e.g. Bingöl Lisesi ). On the other hand recently built residential buildings that involve shear walls in their structural system, in Yeni and Yeşilyurt district, performed well during seismic attack.

Figure 33. Observed shear failure at shear wall due to insufficient transverse reinforcement and poor concrete quality.

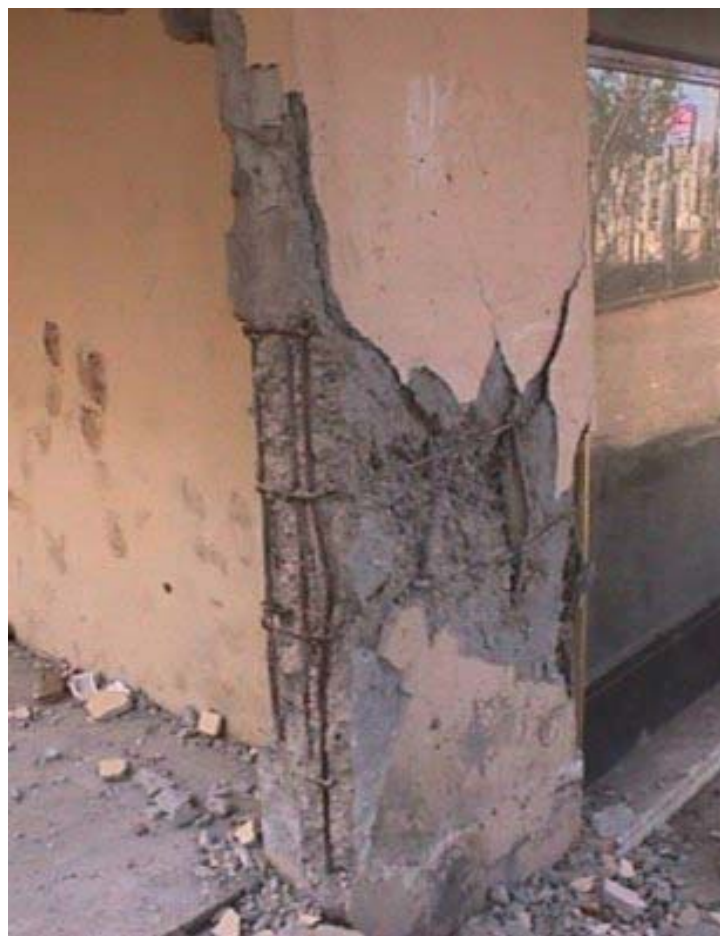
Among the observed damaged buildings the common type of failure was poor detailing at the critical region of the structural elements like insufficient amount of transverse reinforcement at the end region of beams, columns and beam column joints. On the other hand these connections had insufficient lap splice and transverse reinforcement.

Figure 34. Shear failure at column base due to insufficient amount of transverse reinforcement

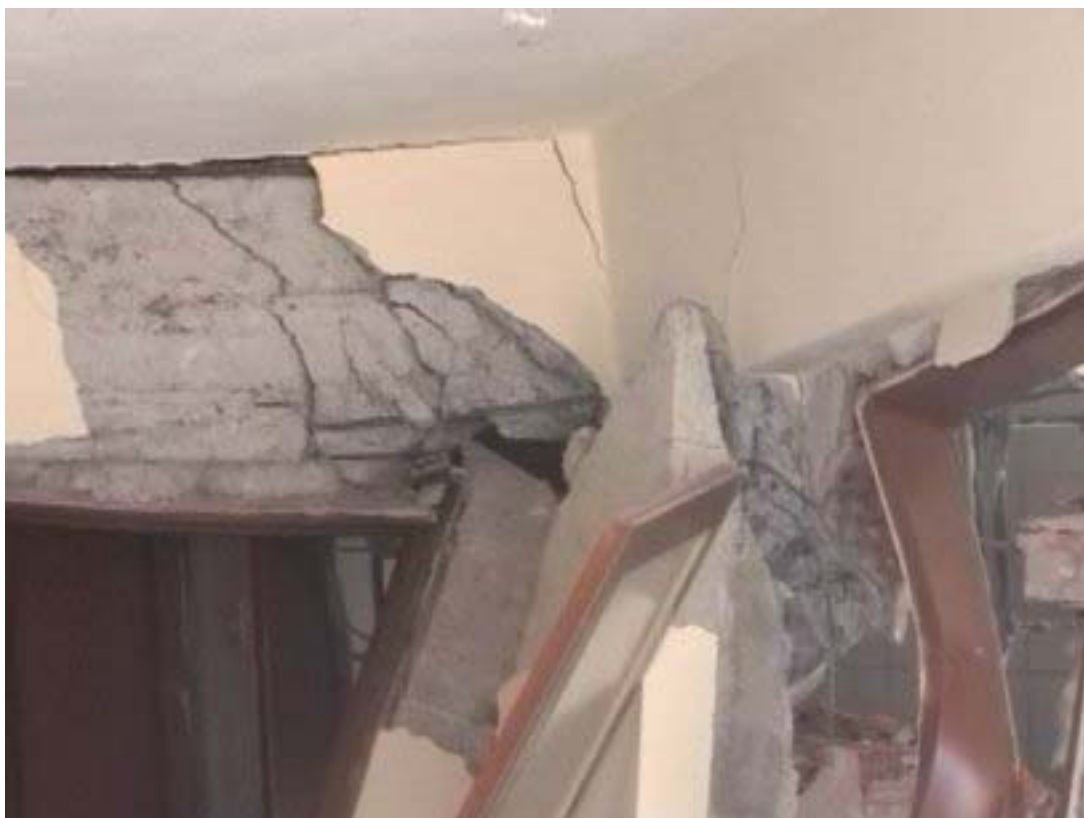
Figure 35. Typical shear crack at beam end

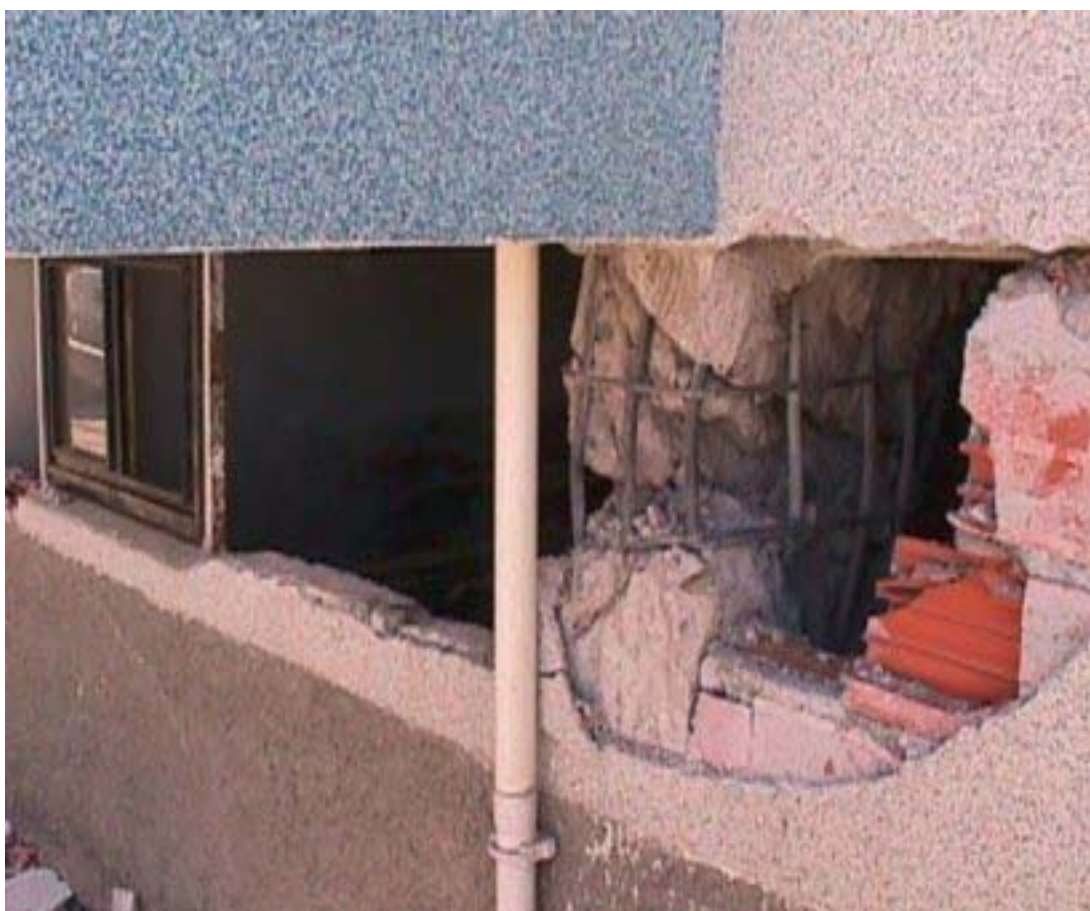
Figure 36. Shear failure at short column.

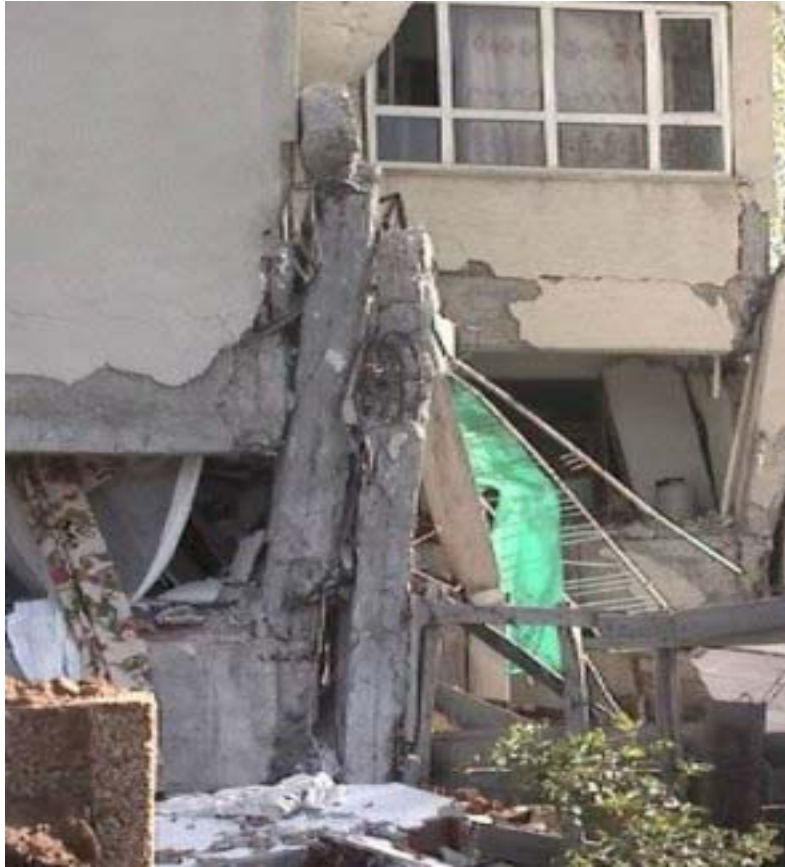
Figure 37. Collapsed first two stories

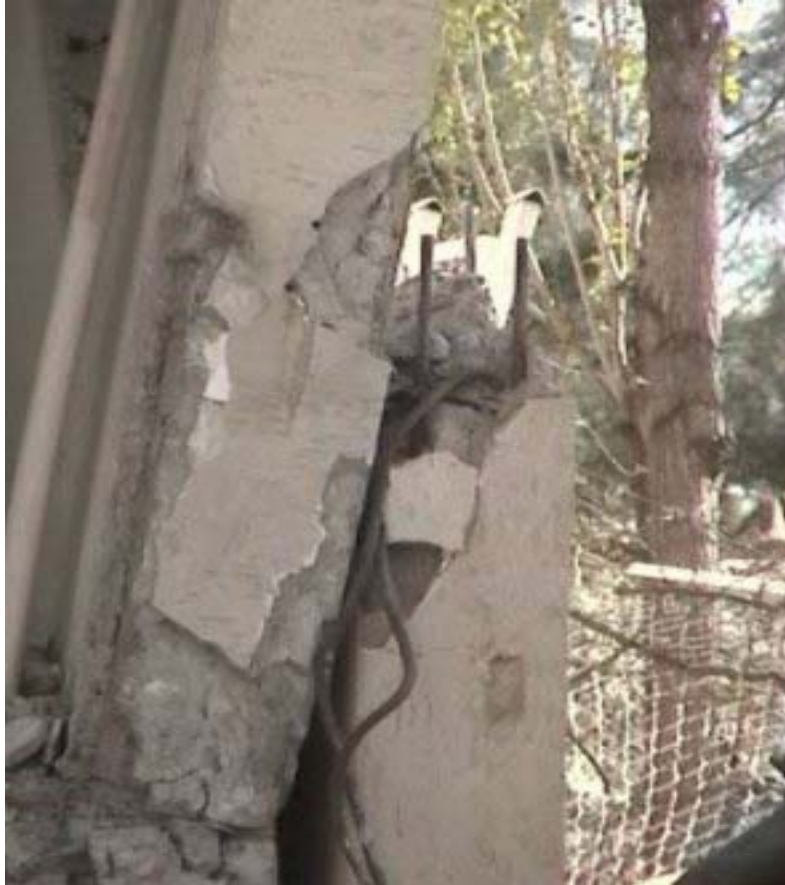
Figure 38. Insufficient development length at the top of column

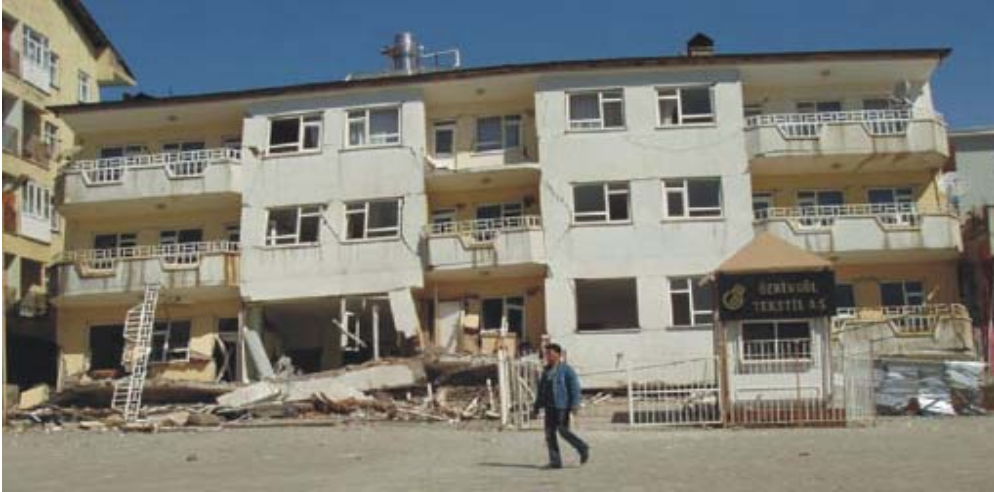
Figure 39. Typical First Story Collapses

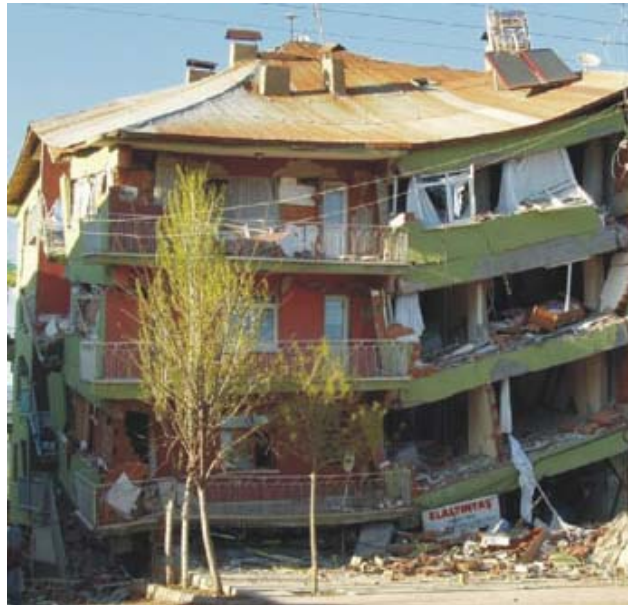
Figure 40. Typical First Story Collapses (After Emre et.al, 2003)

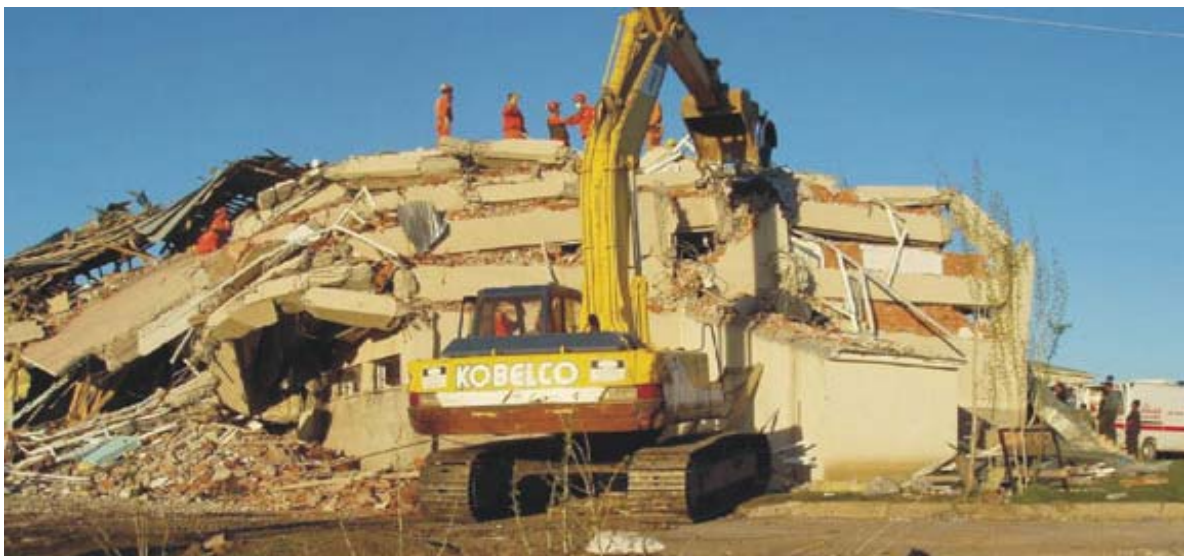
Figure 41. Pancaked Çeltiksuyu Primary School Dormitory (After Emre et.al, 2003)
