# The Dinar, Turkey, Earthquake of October 1, 1995

The following report is a combination of information compiled from three separate teams which investigated this earthquake and submitted reports summarizing their reconnaissance efforts. These teams were made up of the following people: Pan. G. Carydis, Professor of Earthquake Engineering, NTUA, and Efth. L. Lekkas, Geologist, Assistant Professor, Athens University; U. Ersoy, S. M. Uzumeri, G. Ozcebe,

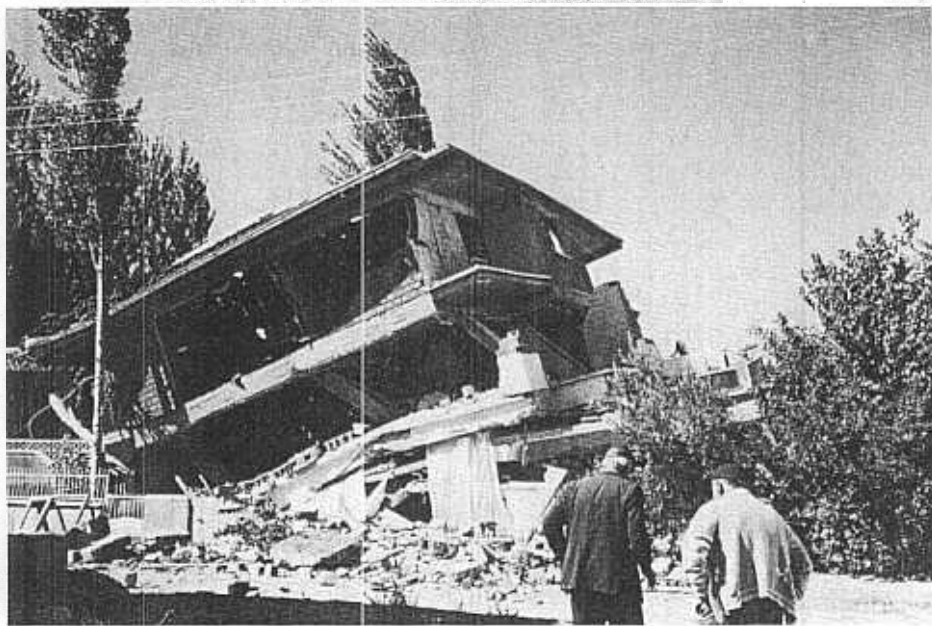
**Figure 2 - Typical case of the total collapse of a four-story R/C building.**

Most of the four- and five-story reinforced concrete apartment buildings were either heavily damaged or totally collapsed. Some three-story buildings suffered similar damage. One- or two-story building collapses were rare.

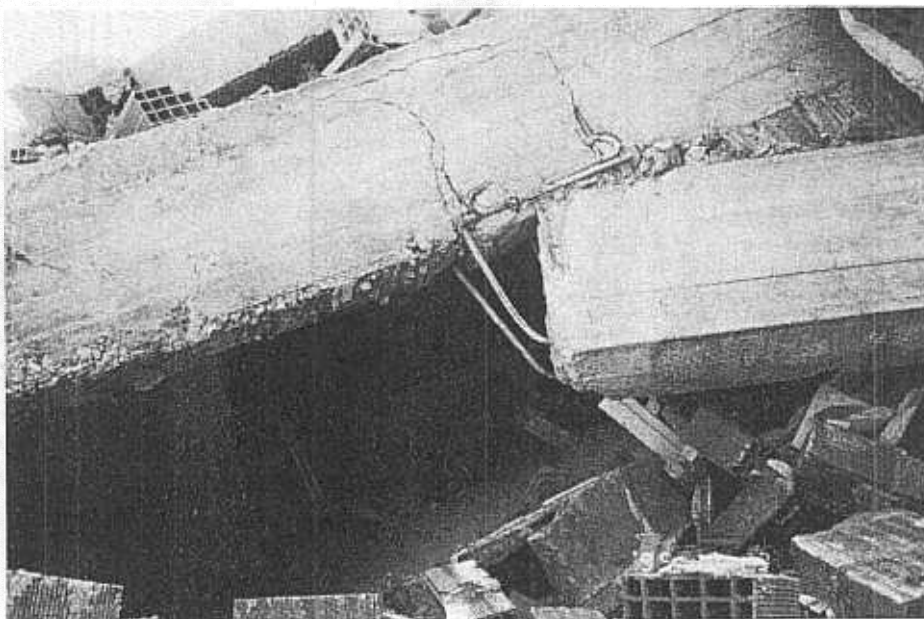
**Figure 3 - Typical detail of a beam-to-column joint.**

The code provisions and good detailing practice were not followed. Ends of columns were not properly confined. Ends of ties were not anchored into the core. The frames in Dinar could not be classified as ductile frames.

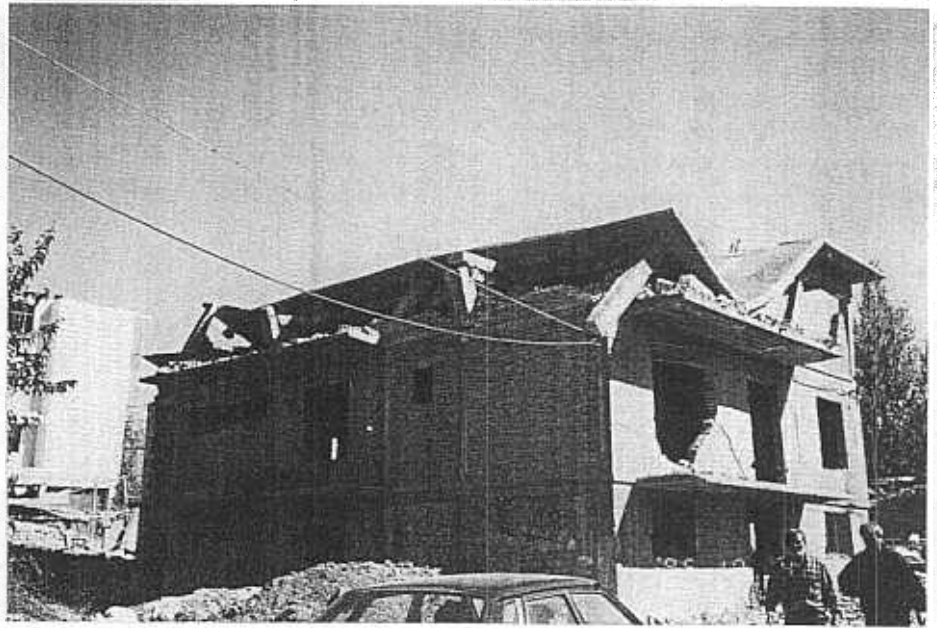
*Figure 4 - Collapse of a weak upper story.*

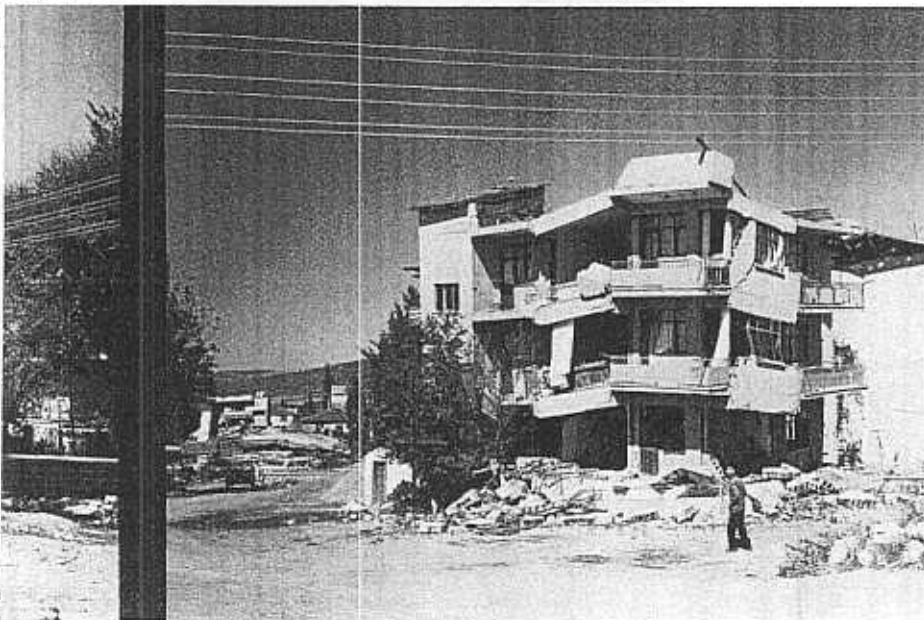
*Figure 5 - Most R/C buildings in the downtown area collapsed or were severely damaged.*

Most of the buildings located in the downtown area (the sediments) suffered damage. Even the series of preshocks prior to the main event caused light structural and mostly non-structural damage in some buildings in the southwestern part of town.

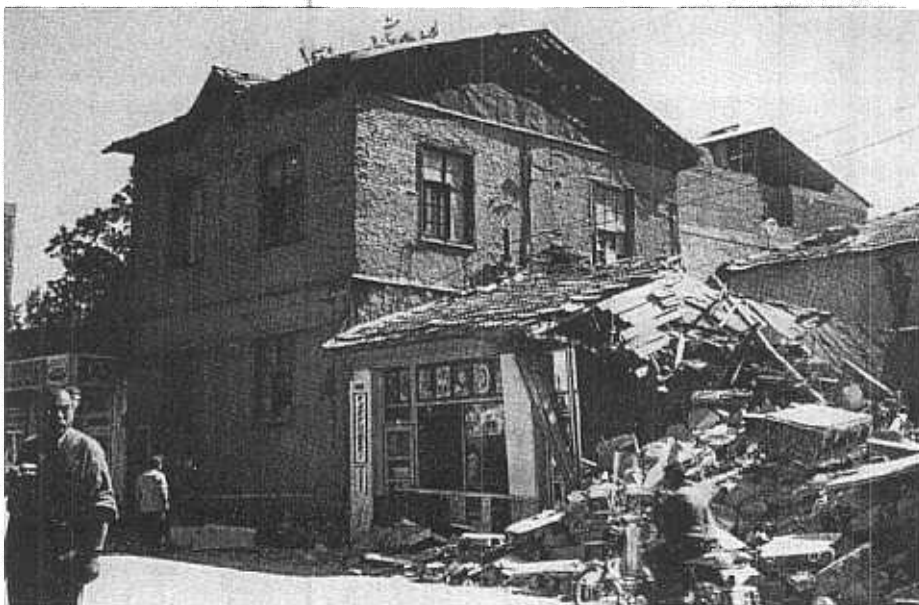
*Figure 6 - Damage to an adobe building.*

timber frames and some had no framing. Adobe buildings with timber frames suffered little or no damage. Plain adobe buildings suffered medium to heavy damage.

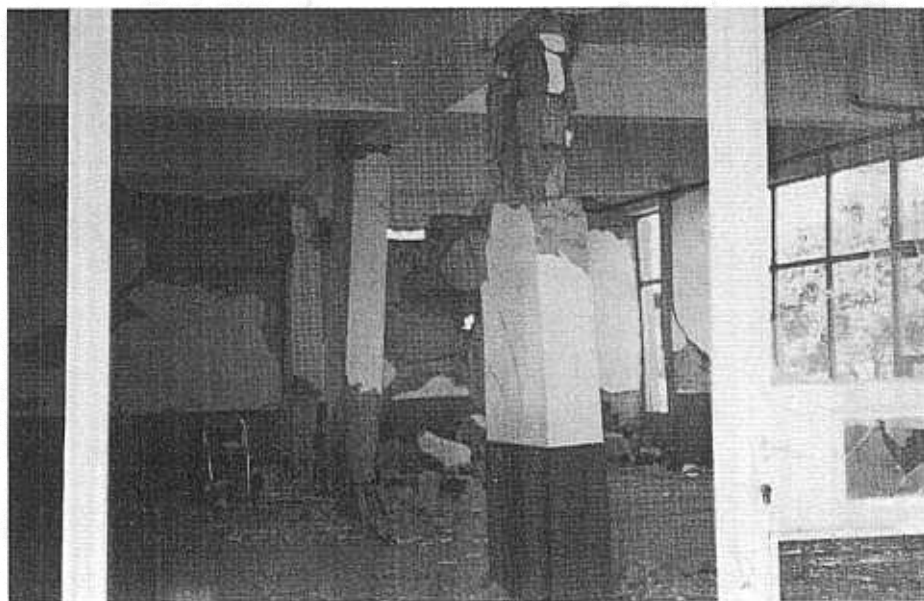
*Figure 7 - Damage to soft story columns.*

The main causes of damage to reinforced concrete buildings included soft story collapse,

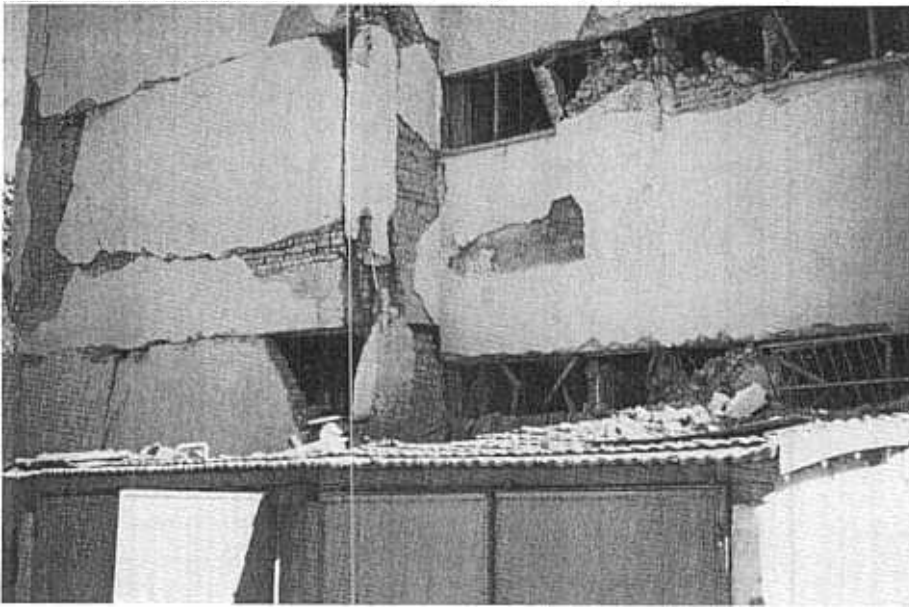
**Figure 8 - Short column failure.**

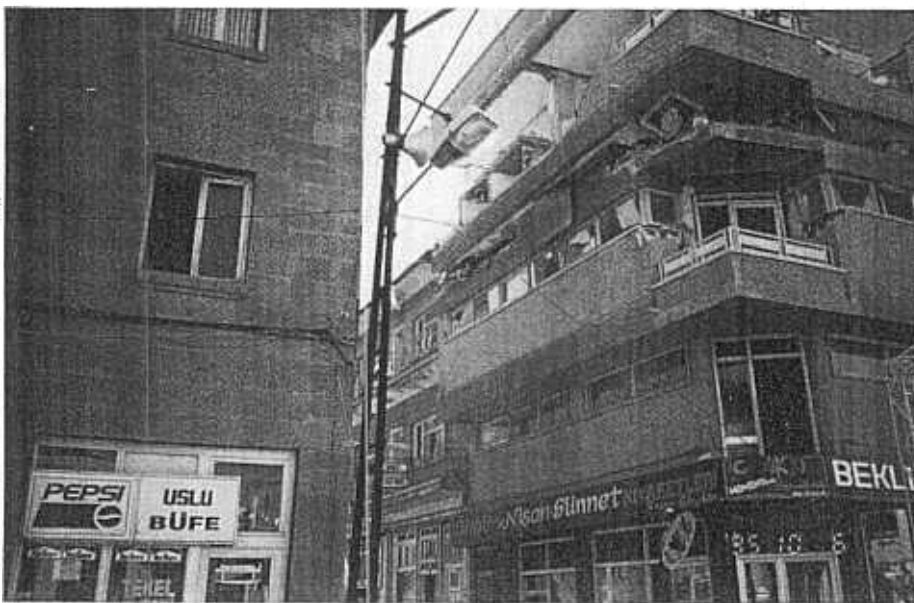
**Figure 9 - Failure of middle story due to pounding.**

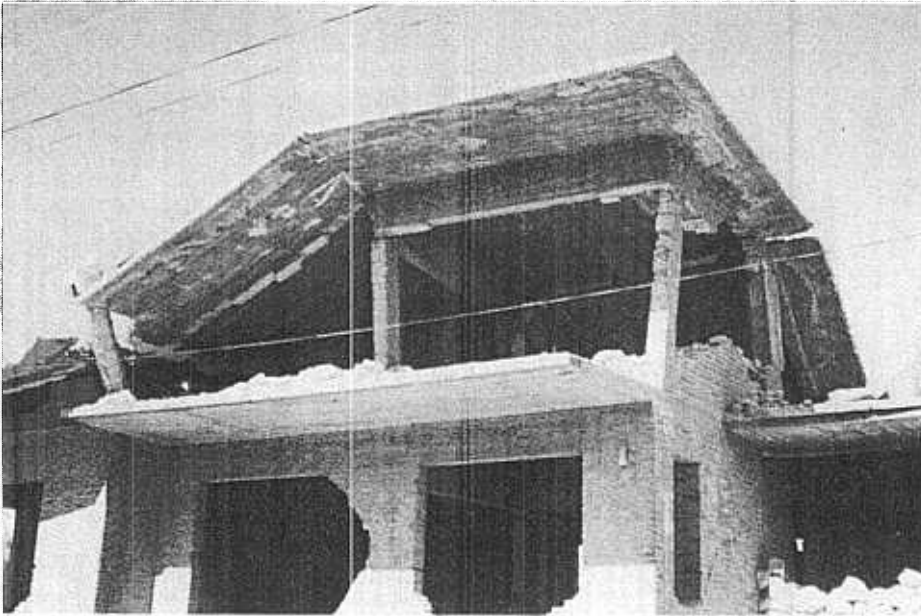
**Figure 10** - Inadequate lateral stiffness due to slender columns.

short columns, irregular framing, and a hammering effect from adjacent buildings. In general, no structural walls were used in Dinar buildings. The column sections were usually rectangular, being very slender in one direction. Therefore, a great number of buildings did not have adequate stiffness.

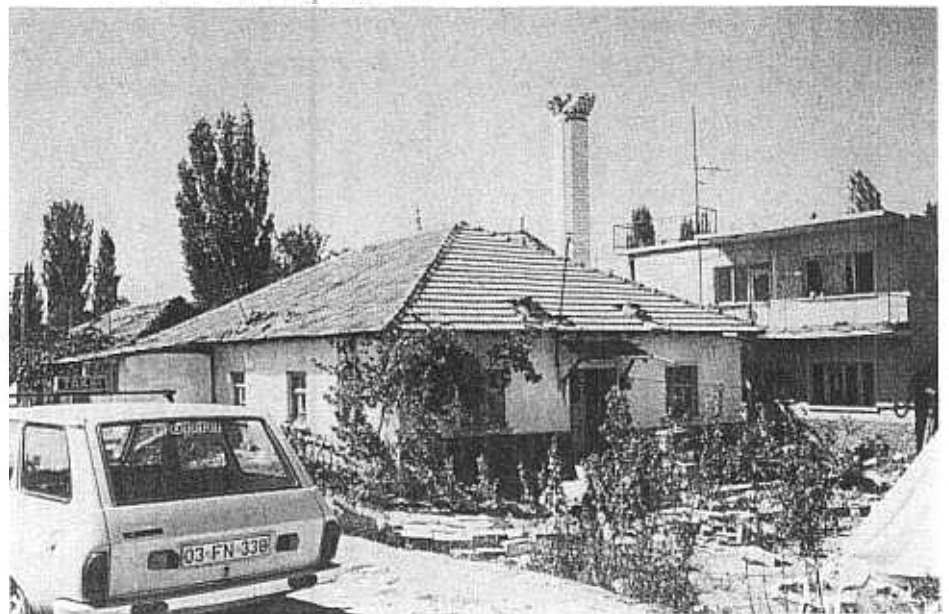
**Figure 11** - Chimneys were chopped off in the downtown area.

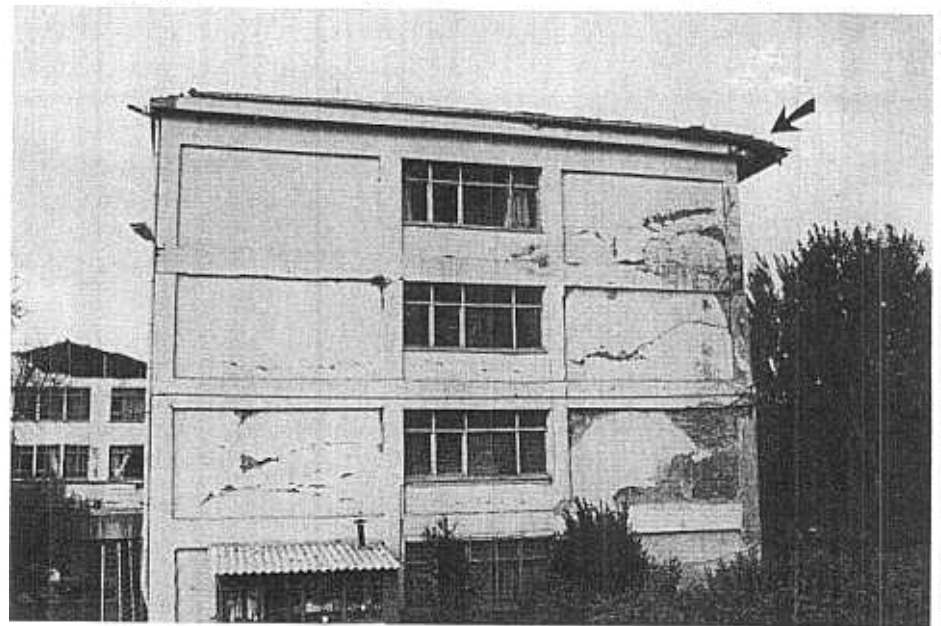
*Figure 12 - Many roofs were damaged - this one moved about 1 meter N-E.*

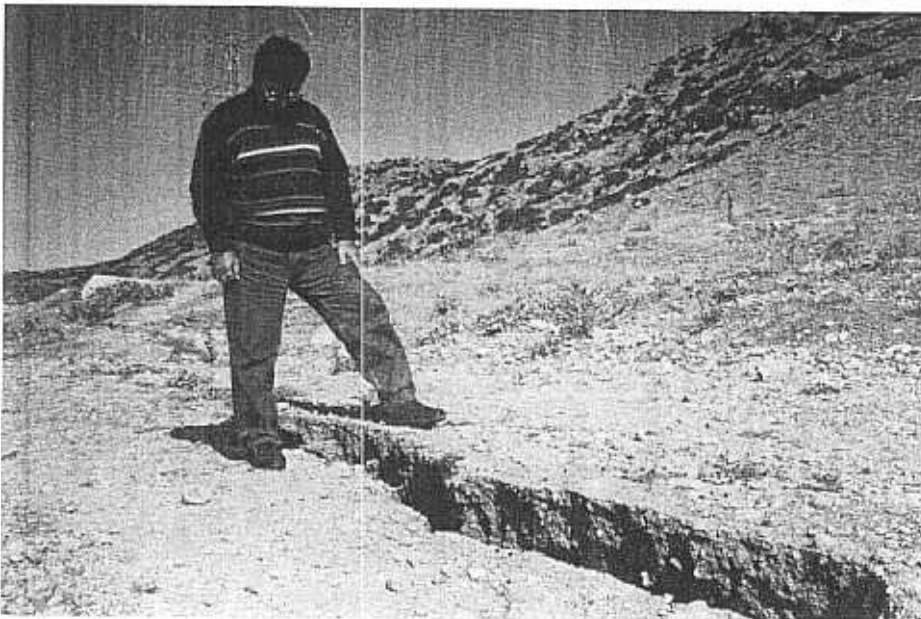
The surficial geology of the hills to the east of town consists of Eocene and Cretaceous limestones, marl, and schist. The plateau is covered with Quaternary alluvium containing sand, gravel, and clay. The transition areas at the foot of the hills are covered by continental deposits. Reports indicate that NW-SE trending fault ruptures have been observed at about 5 km north-east of Dinar following the earthquake.

*Figure 13 - Ground fracture near Dinar.*

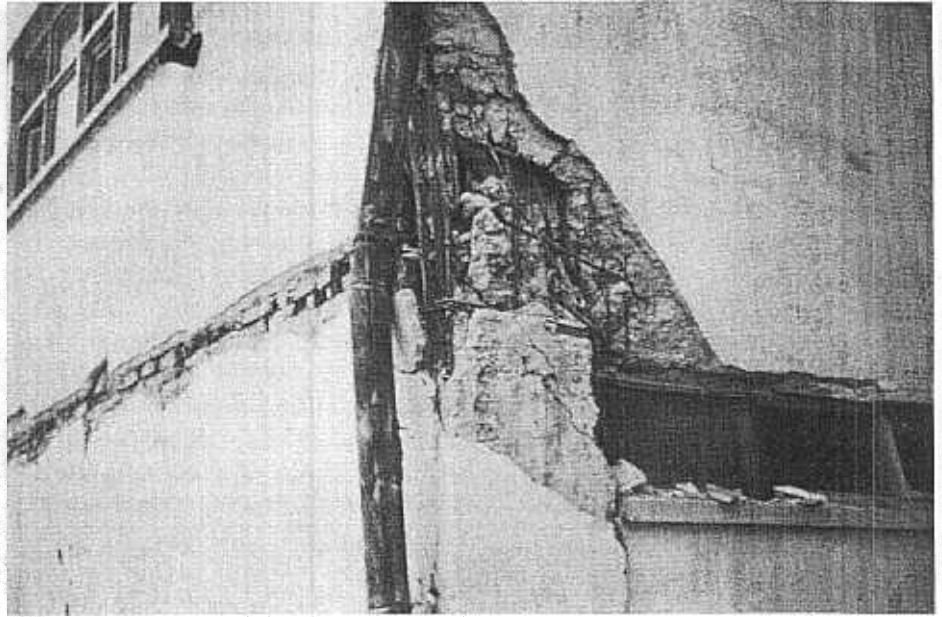
**Figure 14** - Inadequate confinement at the joints and at column ends.

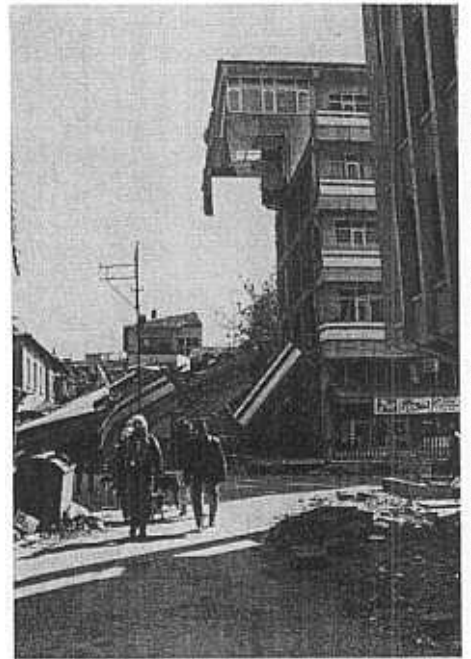
**Figure 15** - The unusual collapse of a five-story building.
