TECHNICAL COMMUNICATION:
THE LICE, TURKEY, EARTHQUAKE OF SEPTEMBER 6, 1975
(RECONNAISSANCE REPORT)

by
Peter I. Yanev

November 1975

URS/John A. Blum & Associates, Engineers

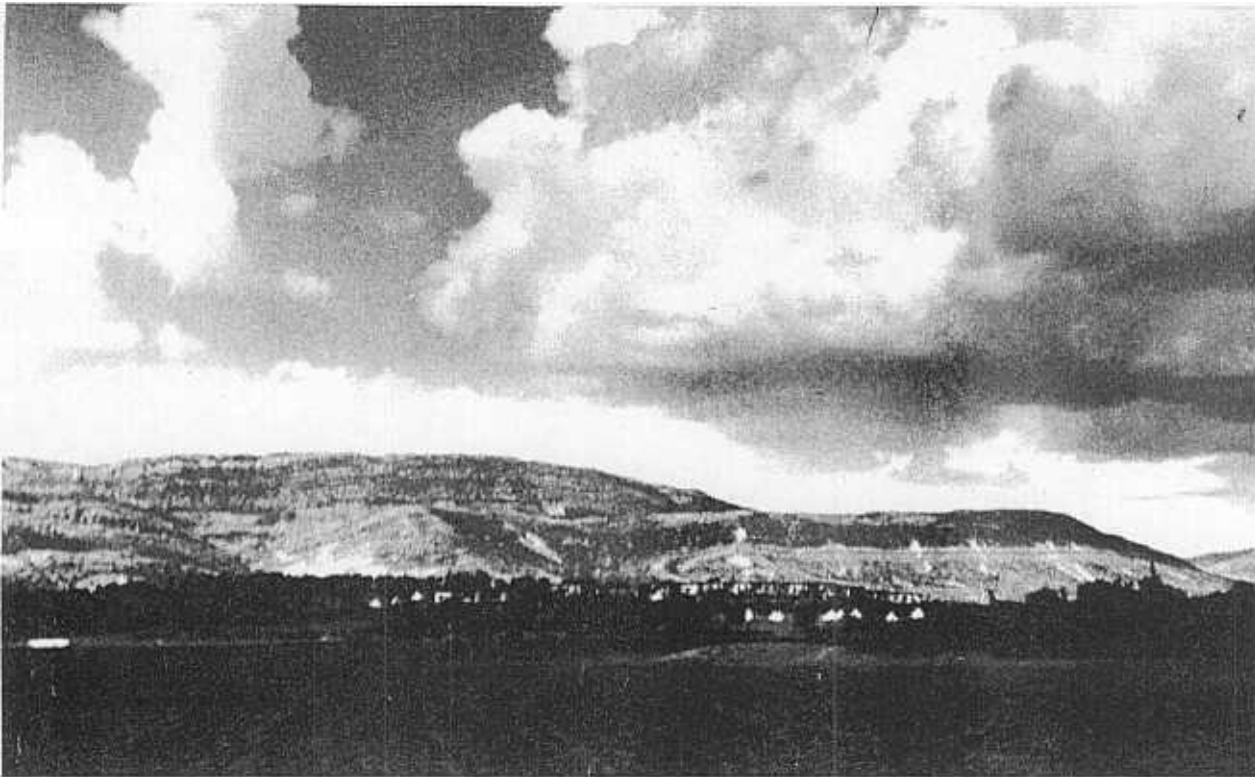
FIGURE 5 VIEW ALONG THE ROAD BETWEEN LICE AND HANI (WEST OF LICE)
SHOWING MANY LANDSLIDES AND A HEAVILY DAMAGED VILLAGE IN
THE FOREGROUND.

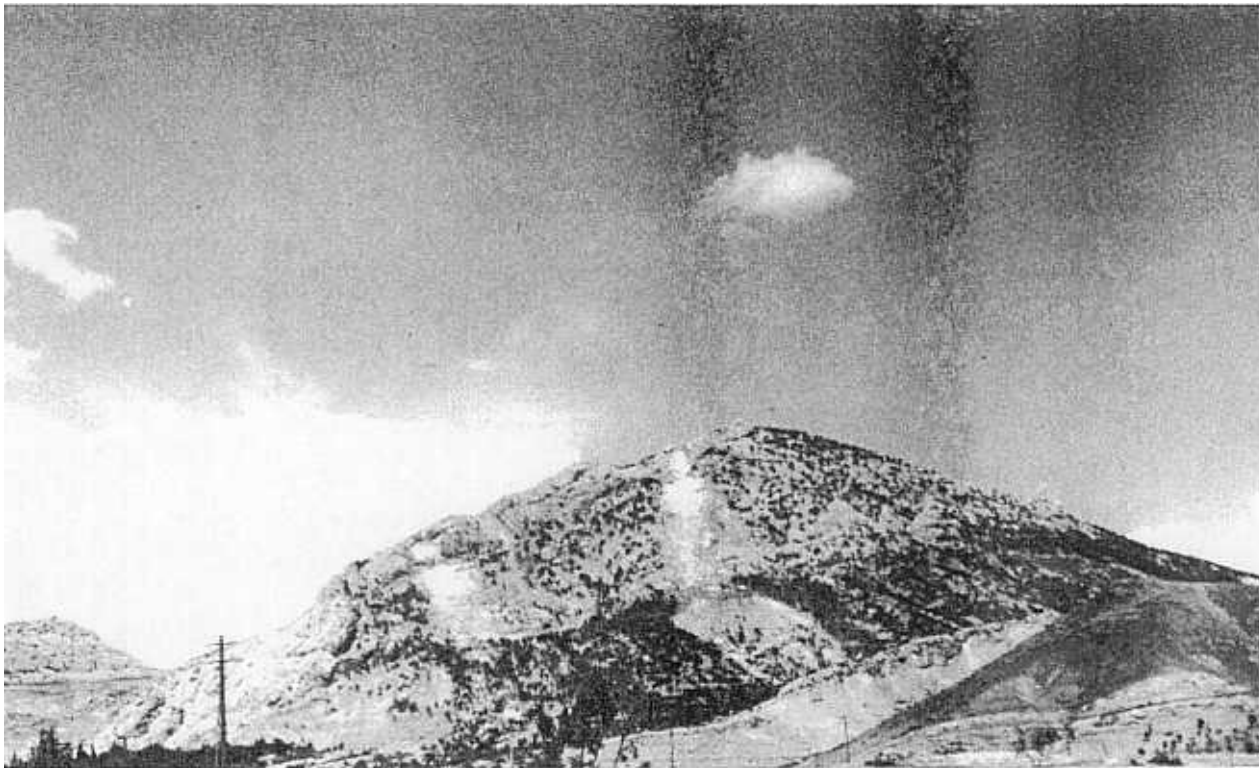
FIGURE 6 A MASSIVE SLIDE, TWO OR THREE KILOMETERS DIRECTLY WEST
OF LICE.

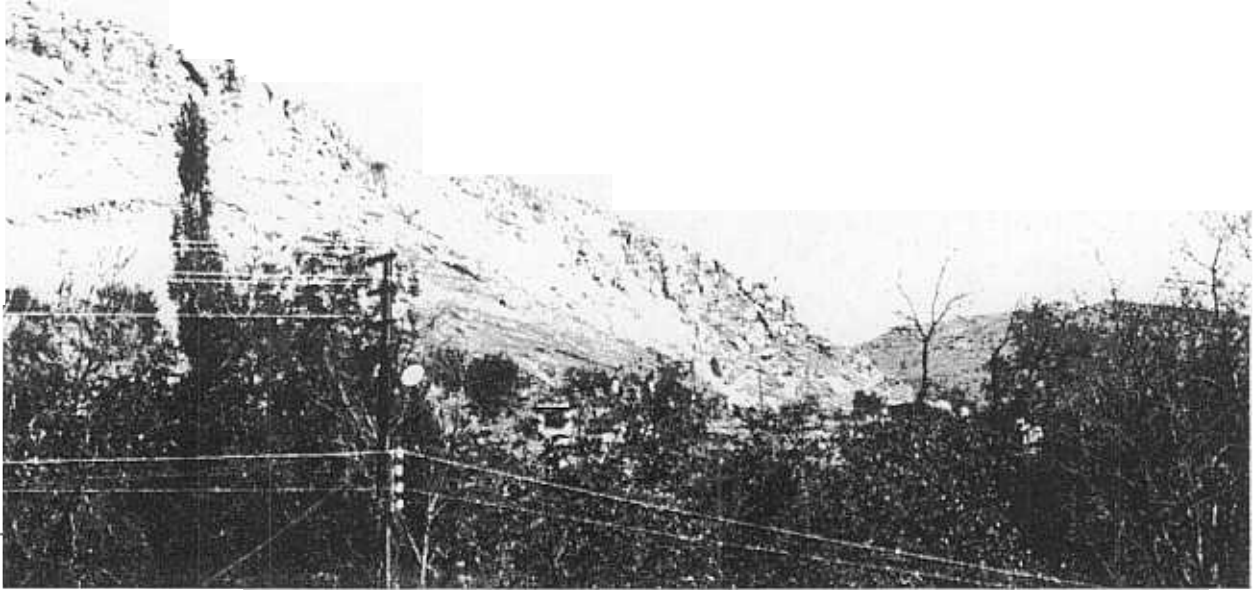
FIGURE 7 MASSIVE SLIDES ABOVE THE EAST END OF LICE. THE WHITER AREA IS RECENTLY EXPOSED LIMESTONE.

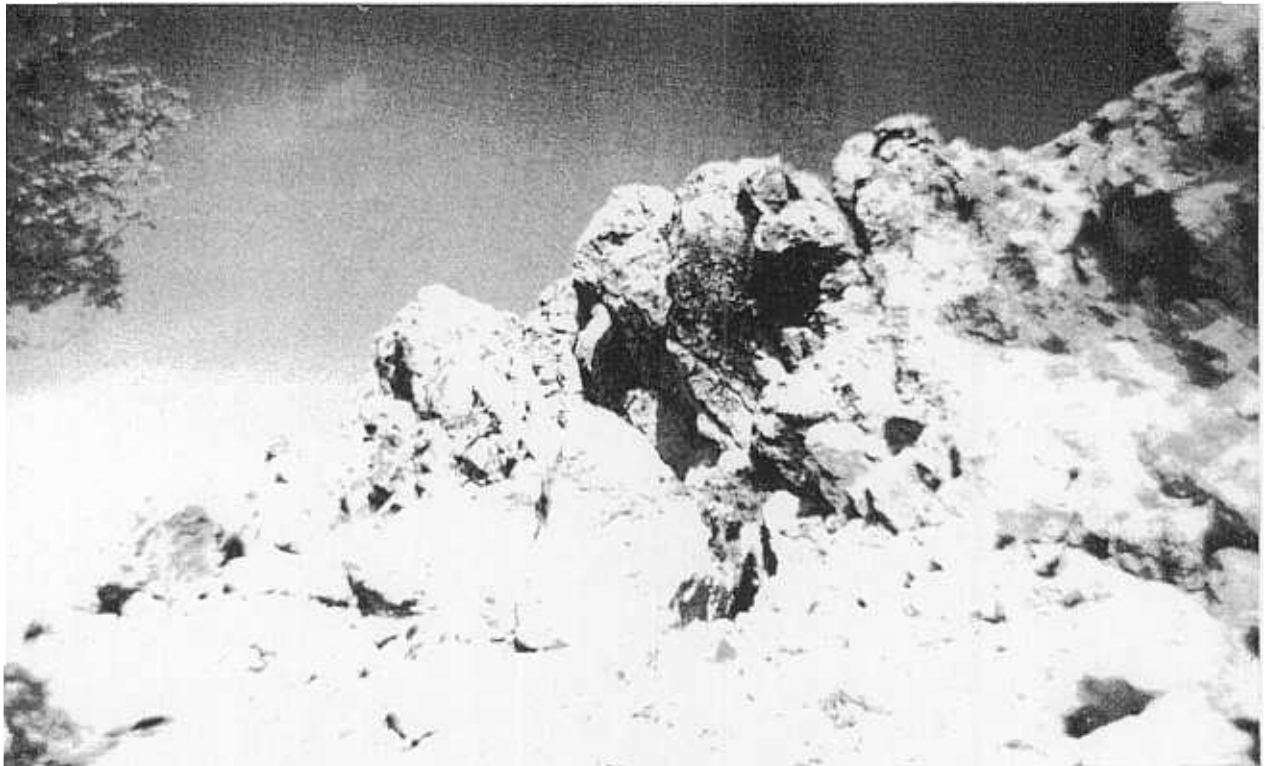
FIGURE 8 THE FACE OF RECENTLY EXPOSED LIMESTONE DIRECTLY ABOVE THE CENTRAL SECTION OF THE OLD PART OF LICE, NEAR THE OLD CEMETERY.

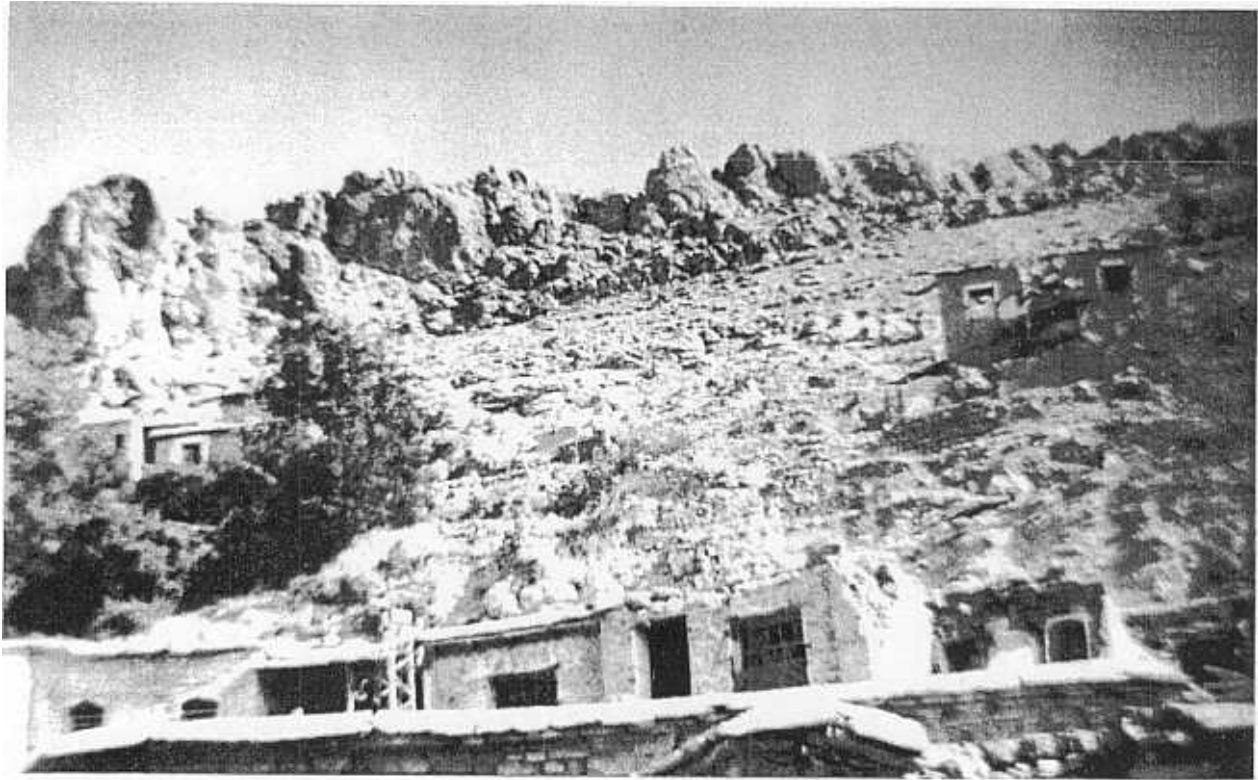
FIGURE 10 GENERAL VIEW OF ONE OF THE RIDGETOPS OVERLOOKING LICE.
FRESHLY EXPOSED LIMESTONE IS EVIDENT, ESPECIALLY AT THE
LEFT (WEST) END.

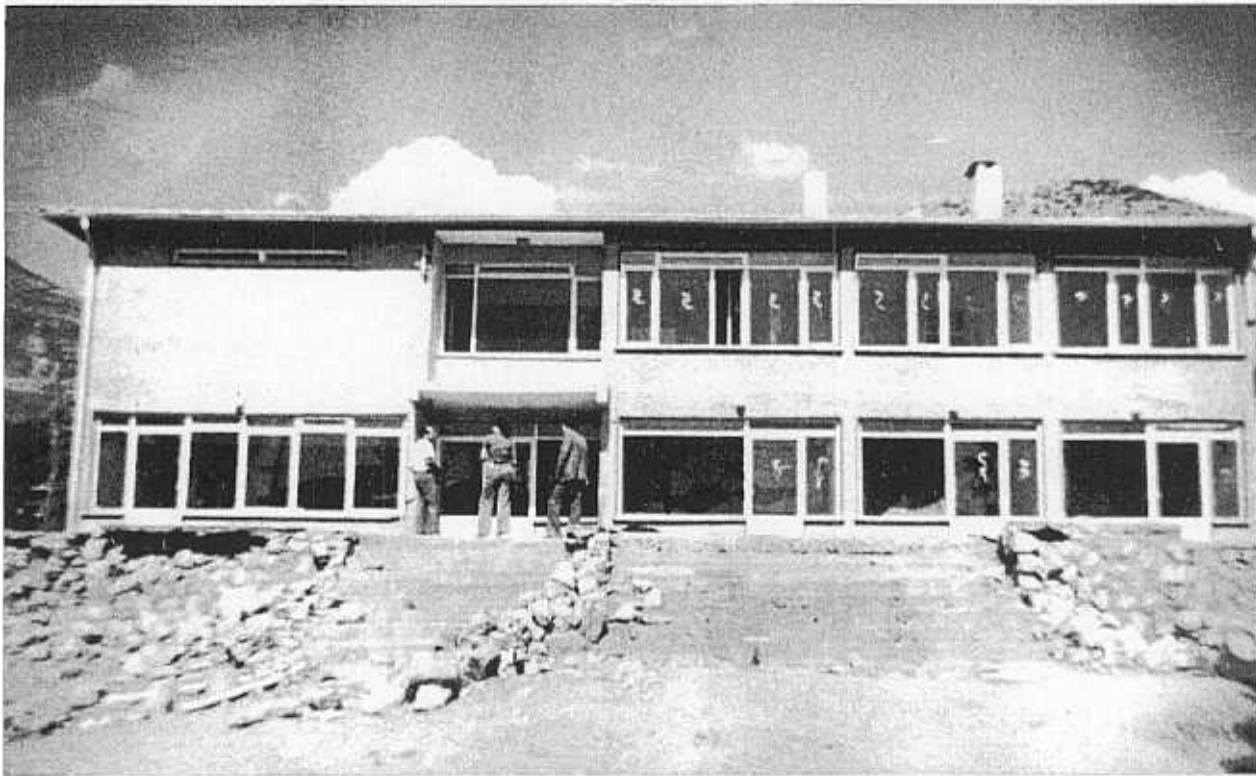
FIGURE 12 THE NEW REINFORCED CONCRETE MUNICIPAL BUILDING, ONE OF THE FEW ENGINEERED BUILDINGS IN THE AREA. IT SUFFERED MODERATE DAMAGE TO THE FRAME AND SIGNIFICANT DAMAGE TO ITS INFILL WALLS

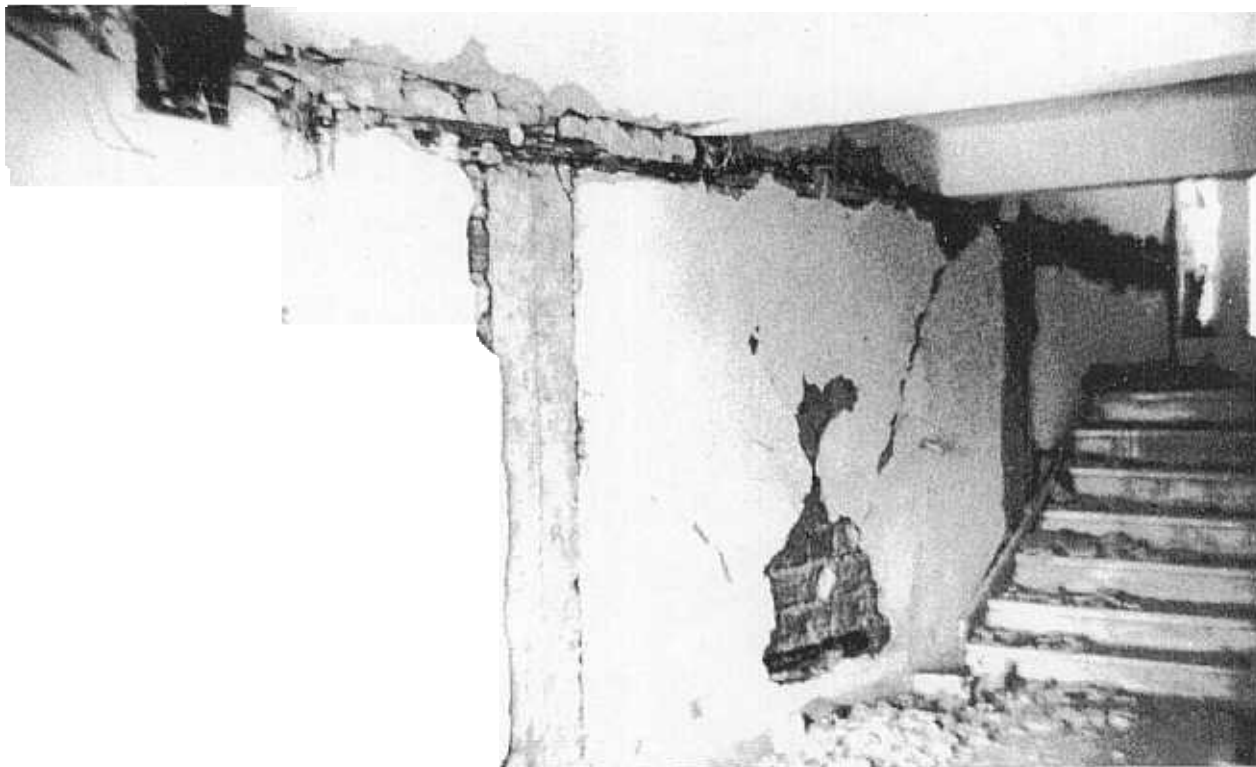
FIGURE 13 INTERIOR OF THE ENTRANCE HALL OF THE MUNICIPAL BUILDING SHOWING DAMAGE TO THE FRAME AND THE INFILL WALLS.

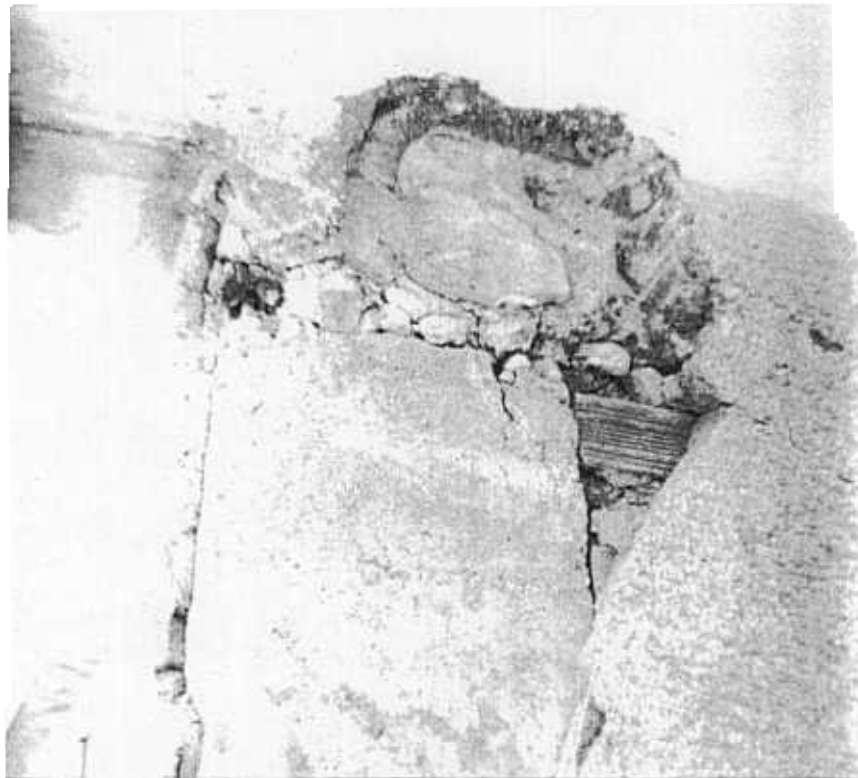
FIGURE 14 DETAIL OF A DAMAGED COLUMN IN THE MUNICIPAL BUILDING SHOWING DAMAGE IN AN AREA OF APPARENTLY POOR CONCRETE PLACEMENT.

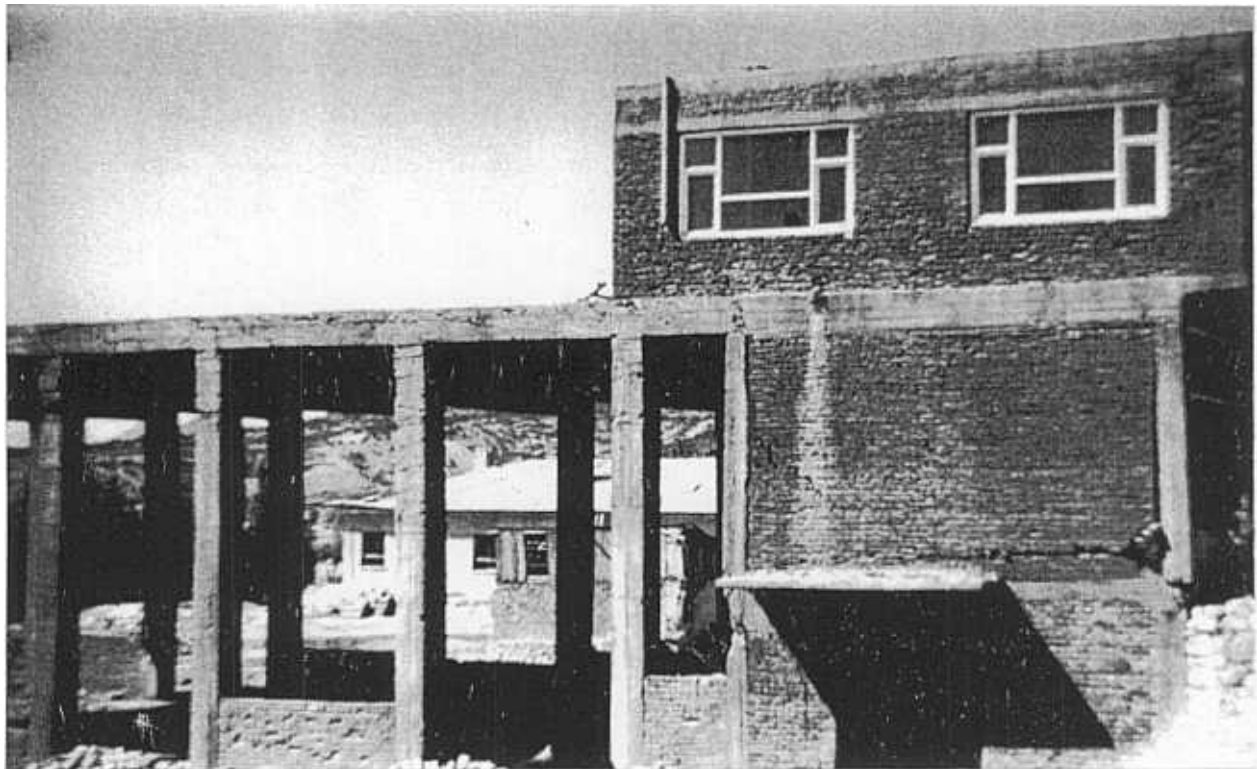
FIGURE 15 A REINFORCED CONCRETE BUILDING IN LICE THAT SUFFERED SOME COLUMN SHEAR FAILURES (LOWER RIGHT CORNER). A NUMBER OF THE BRICK INFILL WALLS HAD FALLEN OUT, MOSTLY ON THE OPPOSITE SIDE.

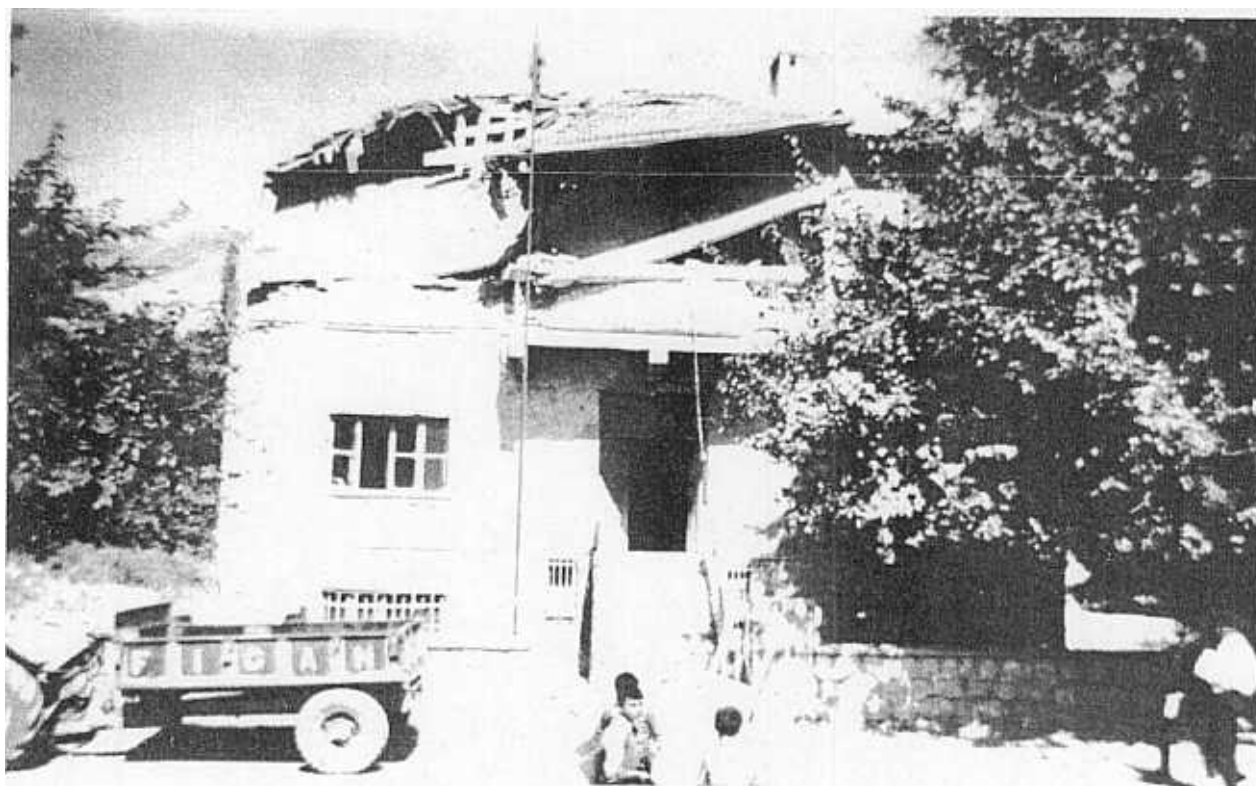
In Lice, almost all of these buildings suffered severe damage; several buildings partially collapsed. Figure 16 shows one such partial collapse of a government building built of cut stone and held together with weak cement/lime mortar. This failure was unusual because the most severe damage generally occurred in the lower floor. Figure 17 shows a collapsed masonry store. A number of these buildings had collapsed, leaving the concrete floor slabs intact.

FIGURE 16 A PARTIALLY COLLAPSED MASONRY GOVERNMENT BUILDING IN LICE

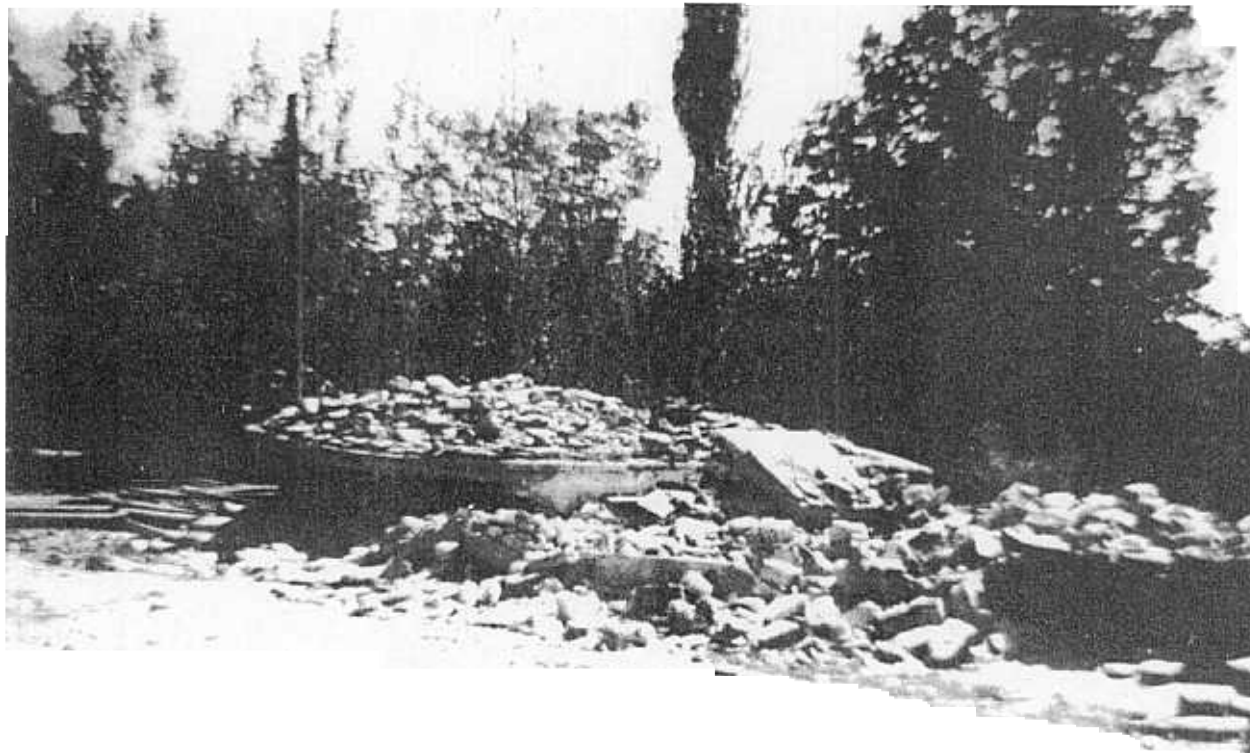
FIGURE 17 A COLLAPSED MASONRY STORE IN THE CENTER OF LICE.

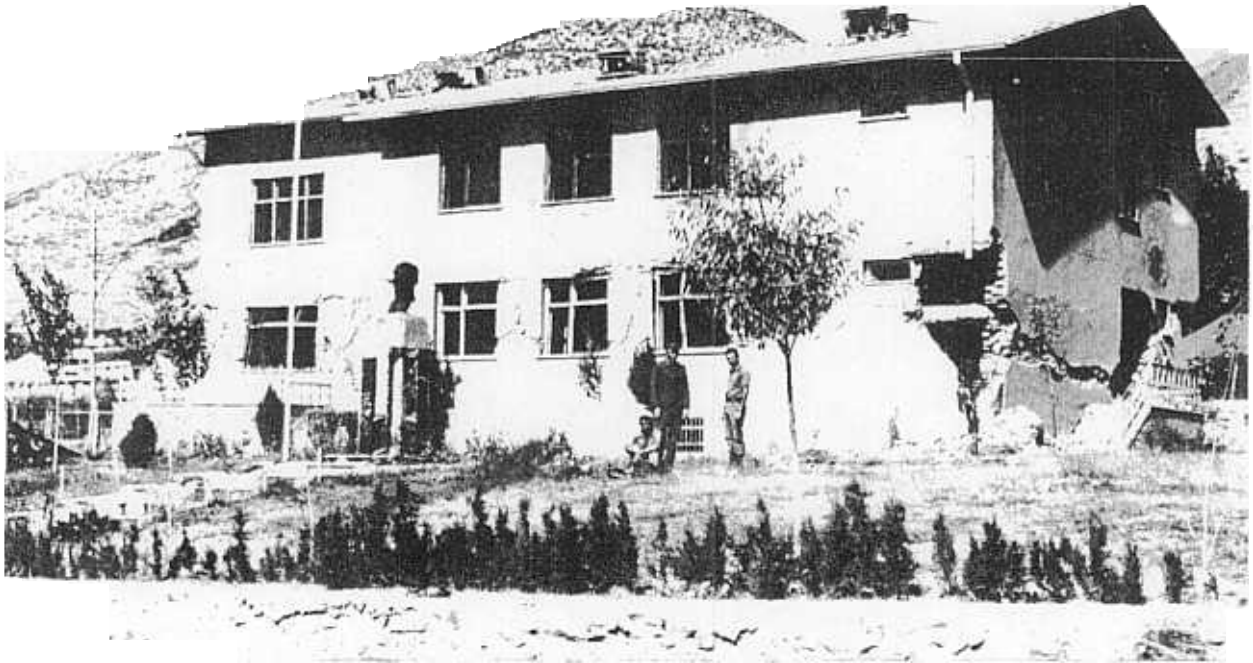
Three of the largest buildings in Lice, the police station (Figures 18 through 22) and two high school buildings (Figures 23 through 34), suffered the most spectacular damage. All three are of unreinforced brick, with weak mortar that has a high lime content. All three buildings were very severely damaged and were unsafe to enter, as aftershocks were continuing to occur. It can only be assumed that the buildings were held up by the interior walls because the outside bearing walls were generally totally damaged. The few interior walls that could be seen were also of unreinforced brick, were probably bearing walls, and had also suffered shear failures. Diagonal cracks were visible everywhere. Torsion had also caused some of the damage; in several cases, the concrete slabs had pushed out parts of the corner walls of the buildings. The entrances to all three of the buildings were littered with masonry debris and pieces of plaster. Most of the brick chimneys were broken off, and several had fallen through the wood and tile roofs. The buildings do not appear to be repairable.

FIGURE 18 THE POLICE BUILDING IN LICE. THE LOWER STORY IS VERY SEVERELY DAMAGED, WHILE THE SECOND STORY IS LESS DAMAGED.

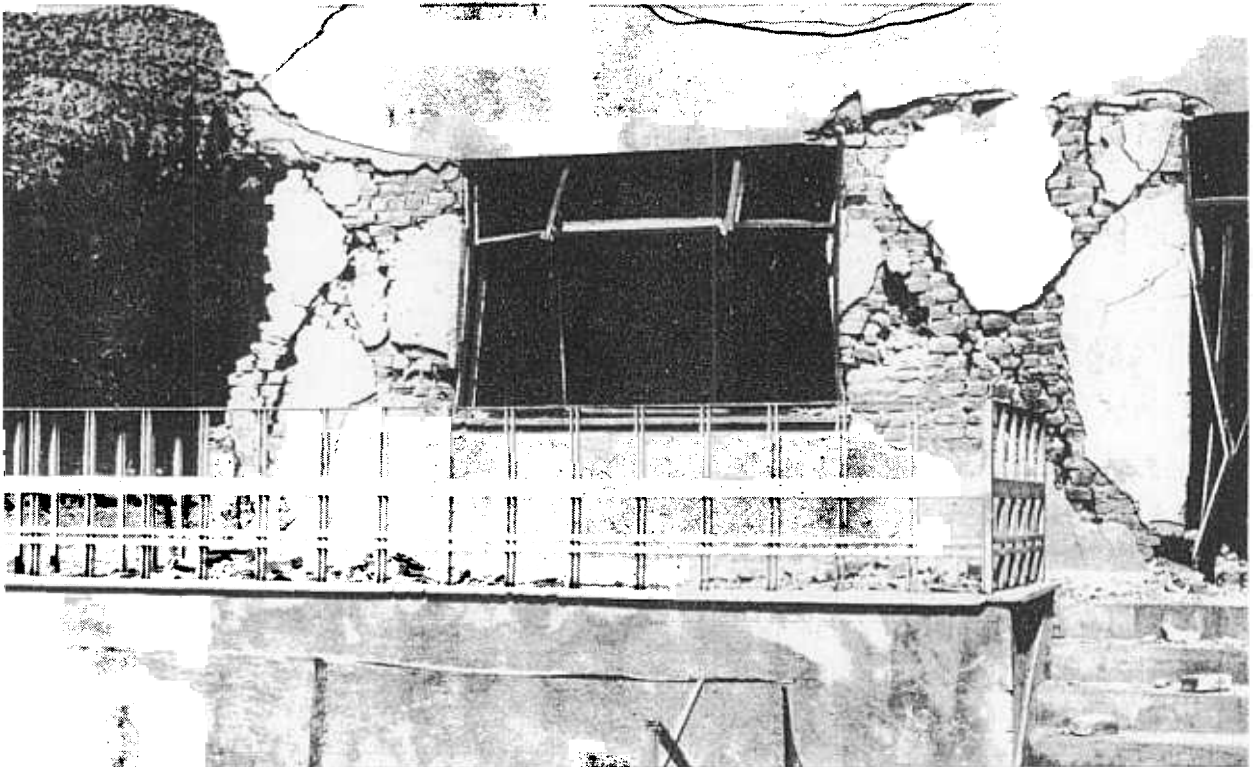
FIGURE 19 SHEAR FAILURE OF THE PIERS OF THE POLICE BUILDING. THE FIRST STORY HAS COMPRESSED A COUPLE OF INCHES, AS SHOWN BY THE BUCKLING OF THE WINDOW AND DOOR FRAMES.

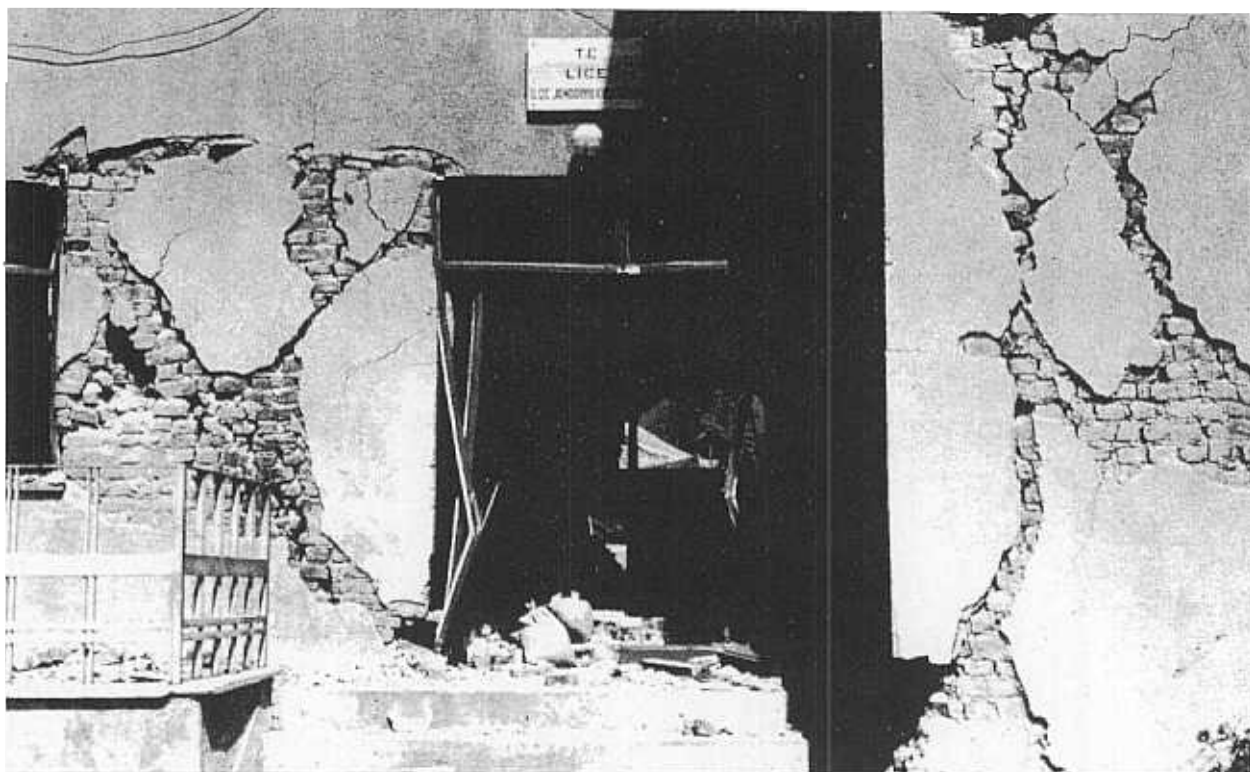
FIGURE 21 DETAIL OF DAMAGE AROUND THE ENTRANCE TO THE POLICE BUILDING.

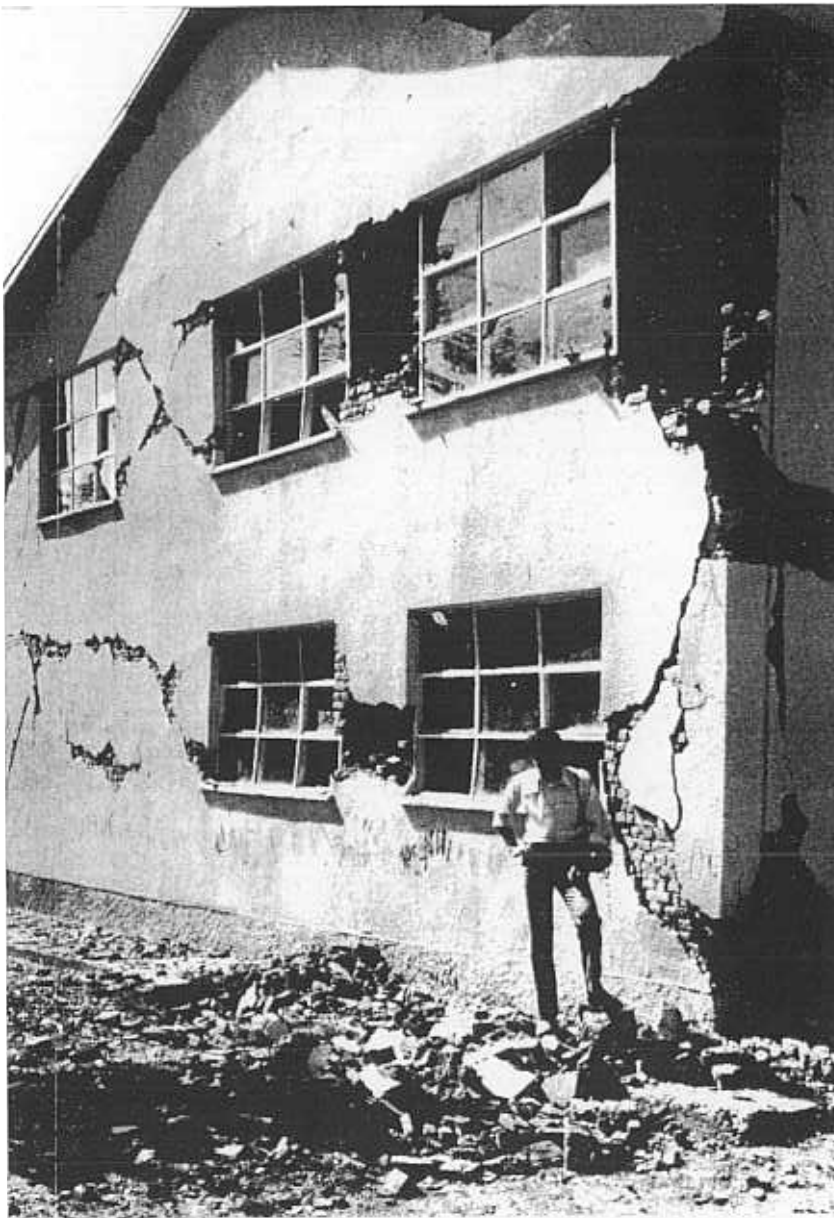
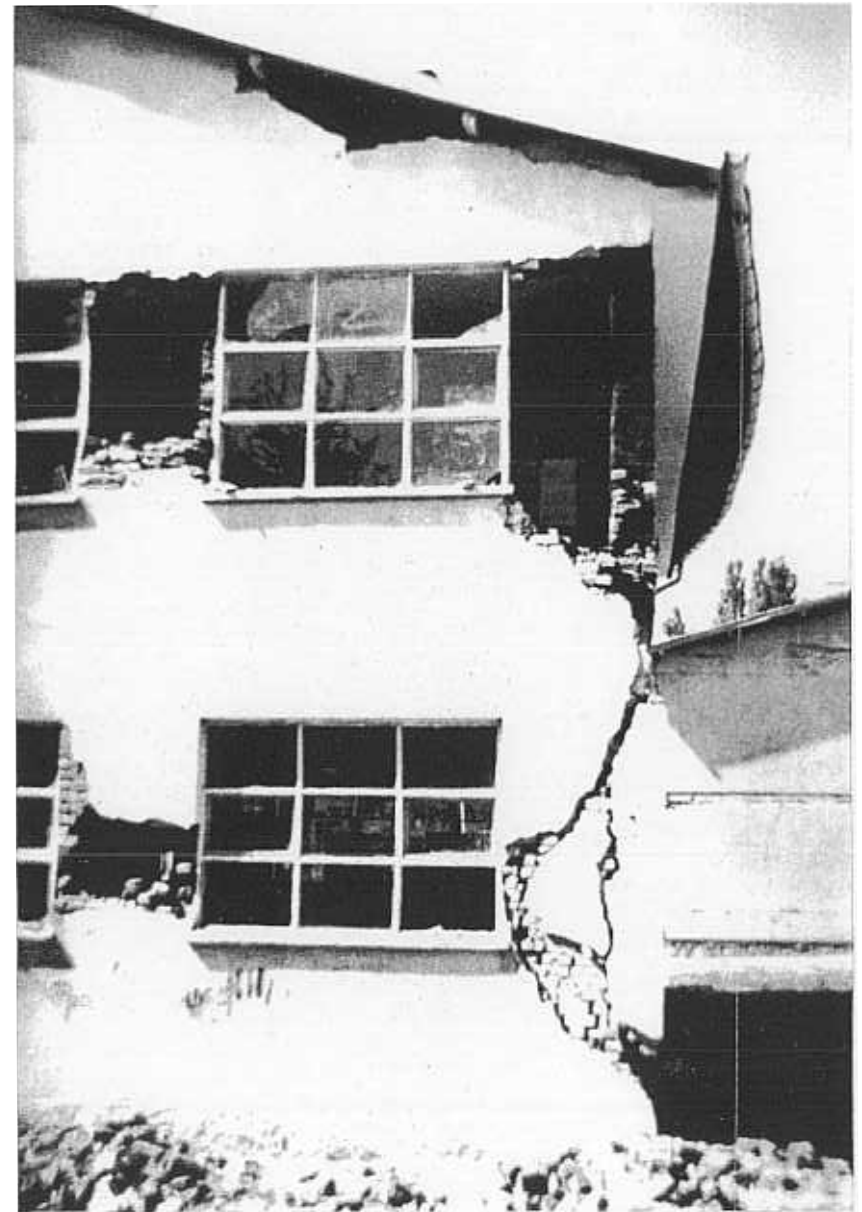
FIGURES 23 AND 24 THE EAST END WALL OF ONE OF THE HIGH SCHOOL BUILDINGS. ALL LATERAL RESISTING ELEMENTS OF THE WALL ON BOTH FLOORS WERE SHATTERED.
