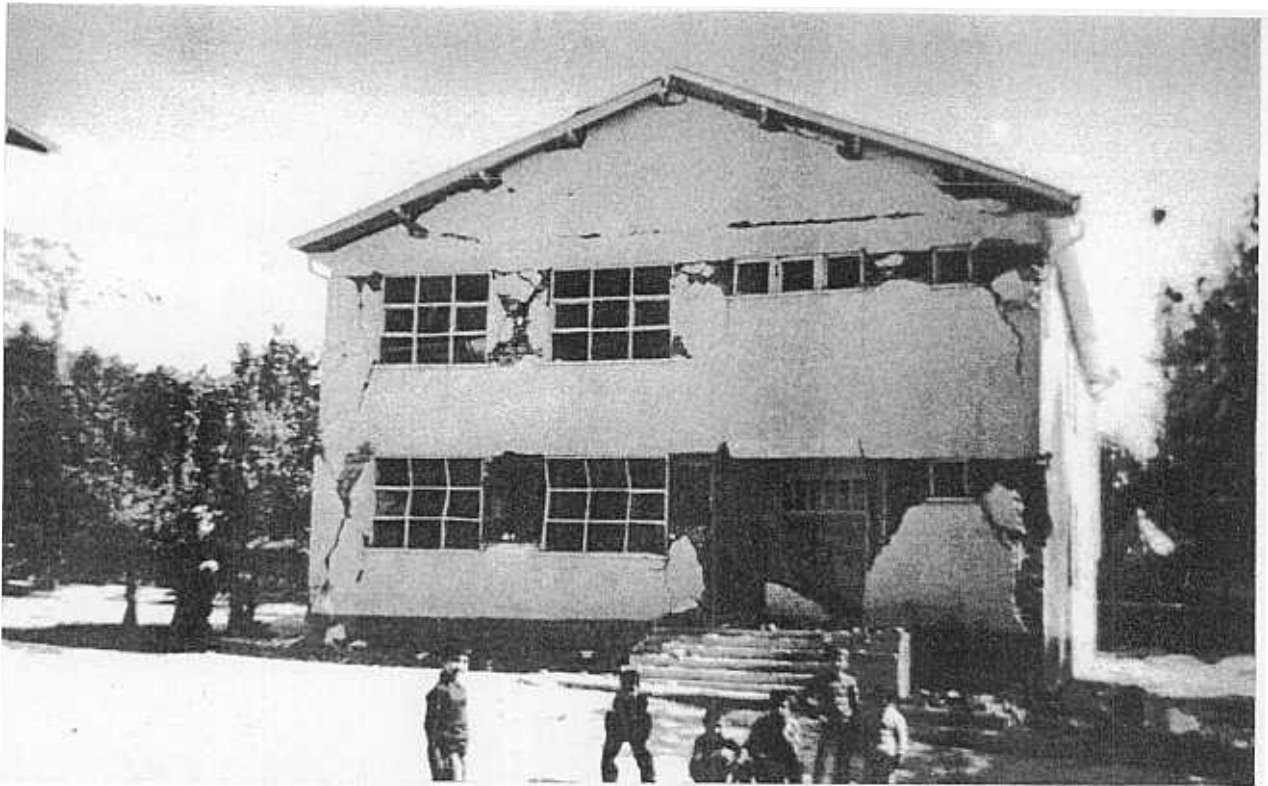
FIGURE 25 THE WEST WALL OF THE HIGH SCHOOL BUILDING SHOWN IN FIGURES 23 AND 24. AGAIN, ALL LATERAL RESISTING ELEMENTS ARE SHATTERED.

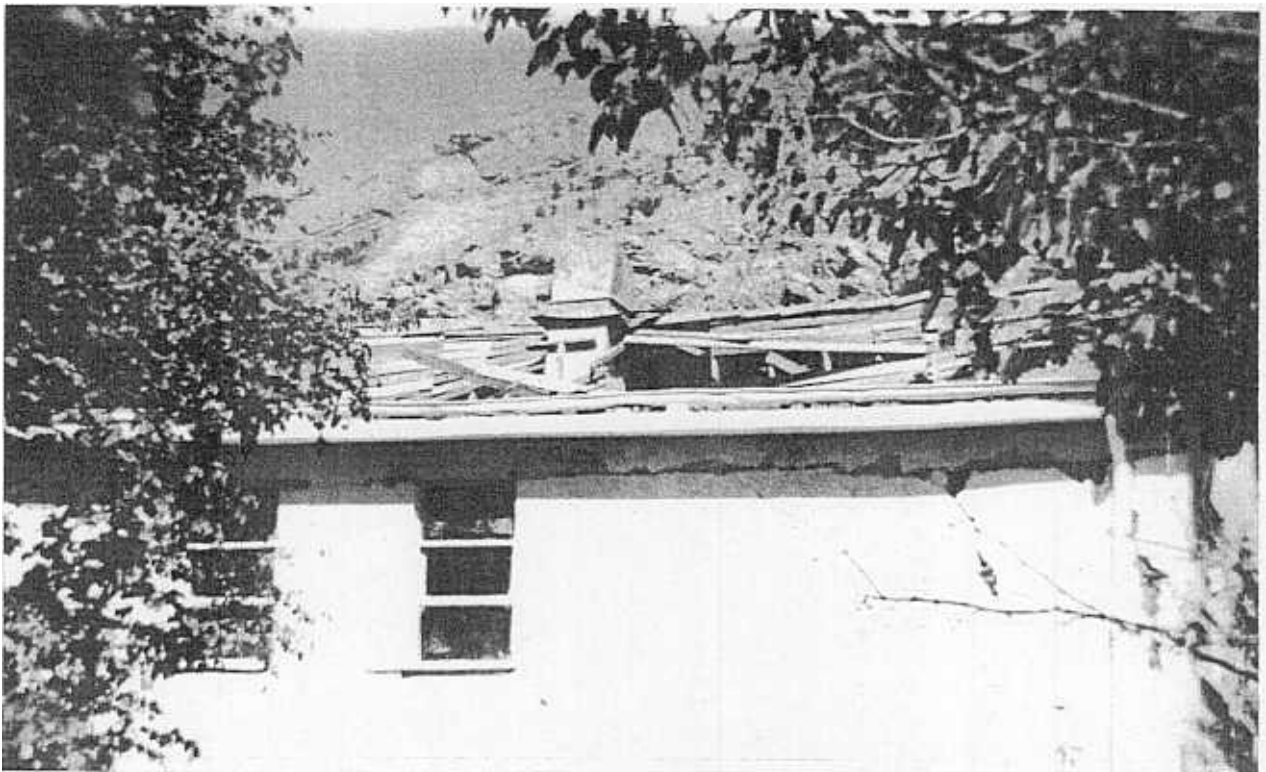
FIGURE 26 SEVERAL BRICK CHIMNEYS FELL THROUGH THE ROOFS OF THE HIGH SCHOOL BUILDINGS.

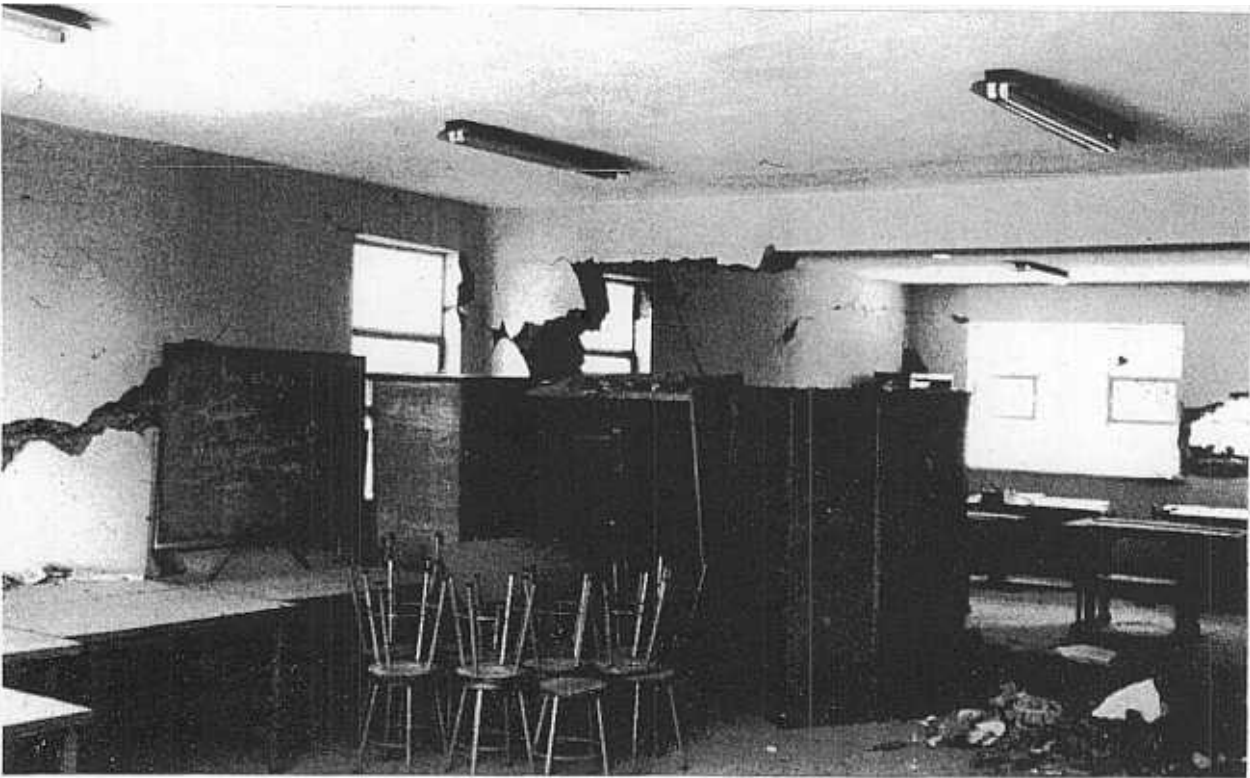
FIGURE 27 TYPICAL INTERIOR DAMAGE ALONG THE NORTH AND EAST WALLS OF THE HIGH SCHOOL BUILDING SHOWN IN FIGURES 23, 24, AND 25.

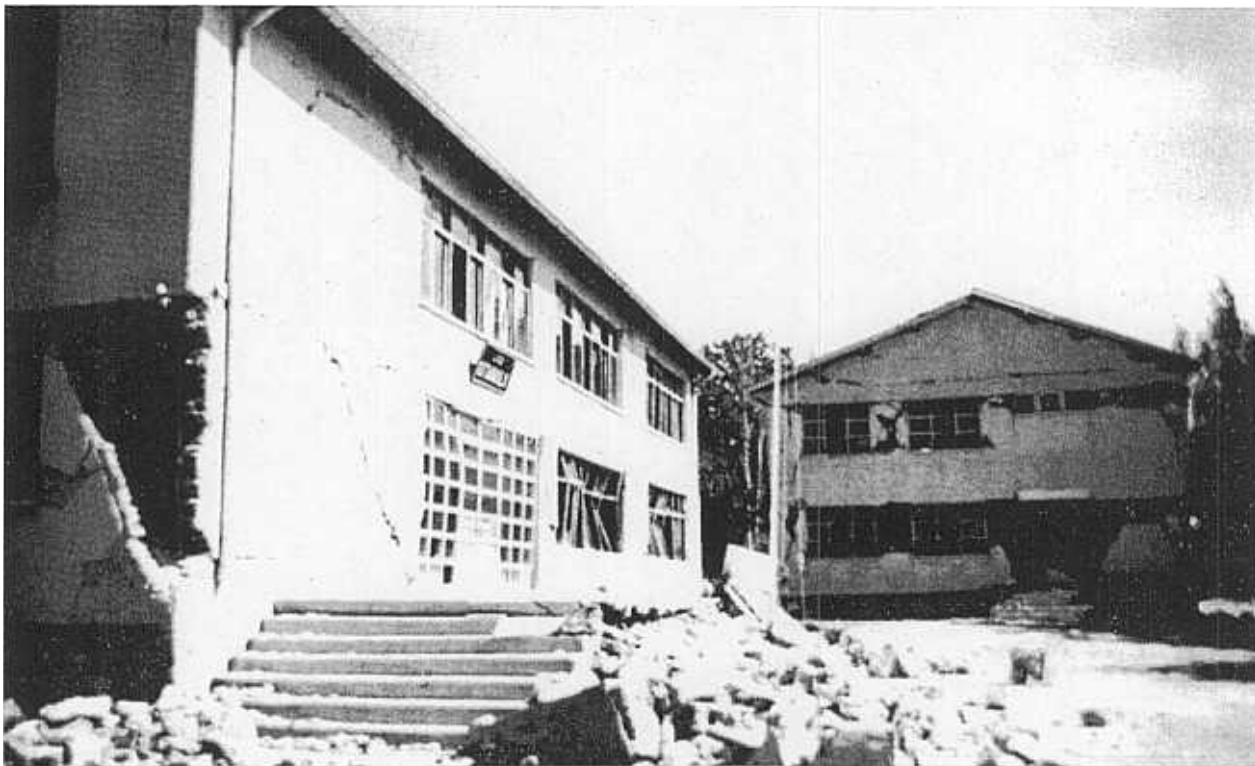
FIGURE 28 ANOTHER HIGH SCHOOL BUILDING THAT SUFFERED NEARLY TOTAL DAMAGE. NOTE THAT THE SECOND FLOOR WALLS ARE NOT AS SEVERELY DAMAGED.

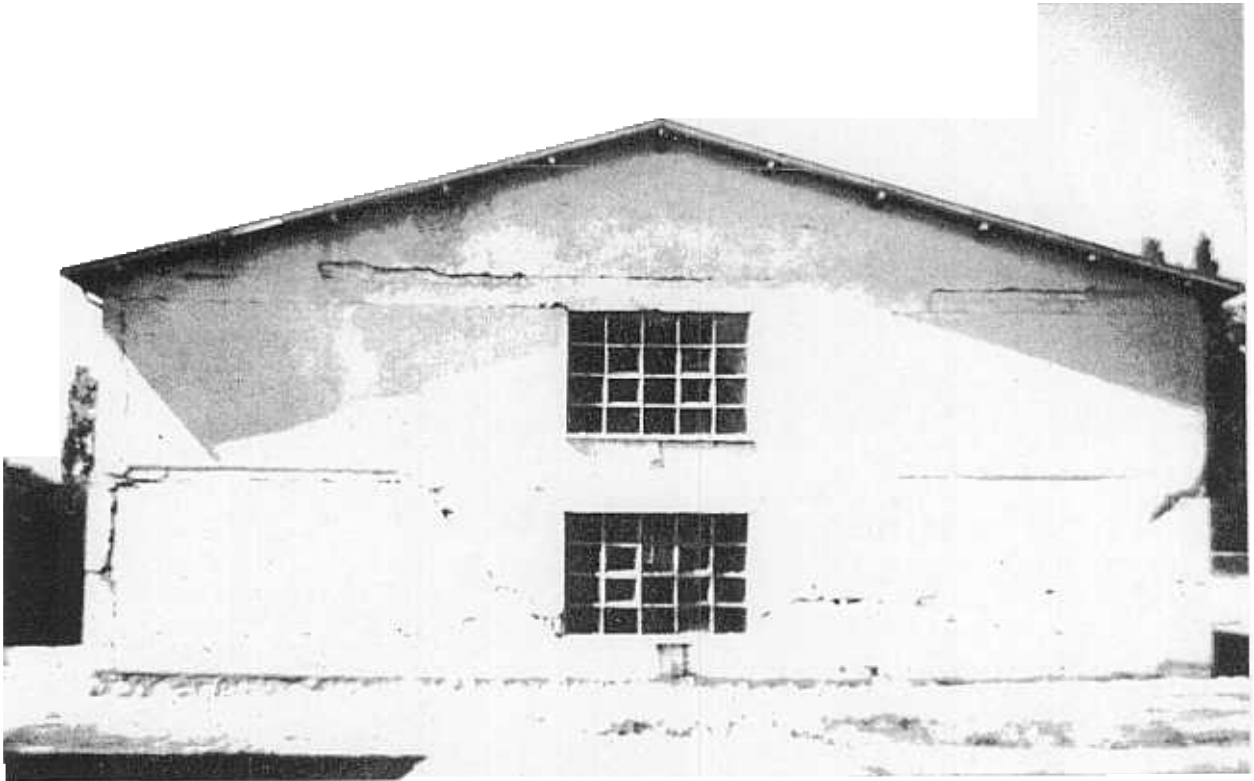
FIGURE 29 THE EAST END WALL OF THE HIGH SCHOOL BUILDING SHOWN IN FIGURE 28.

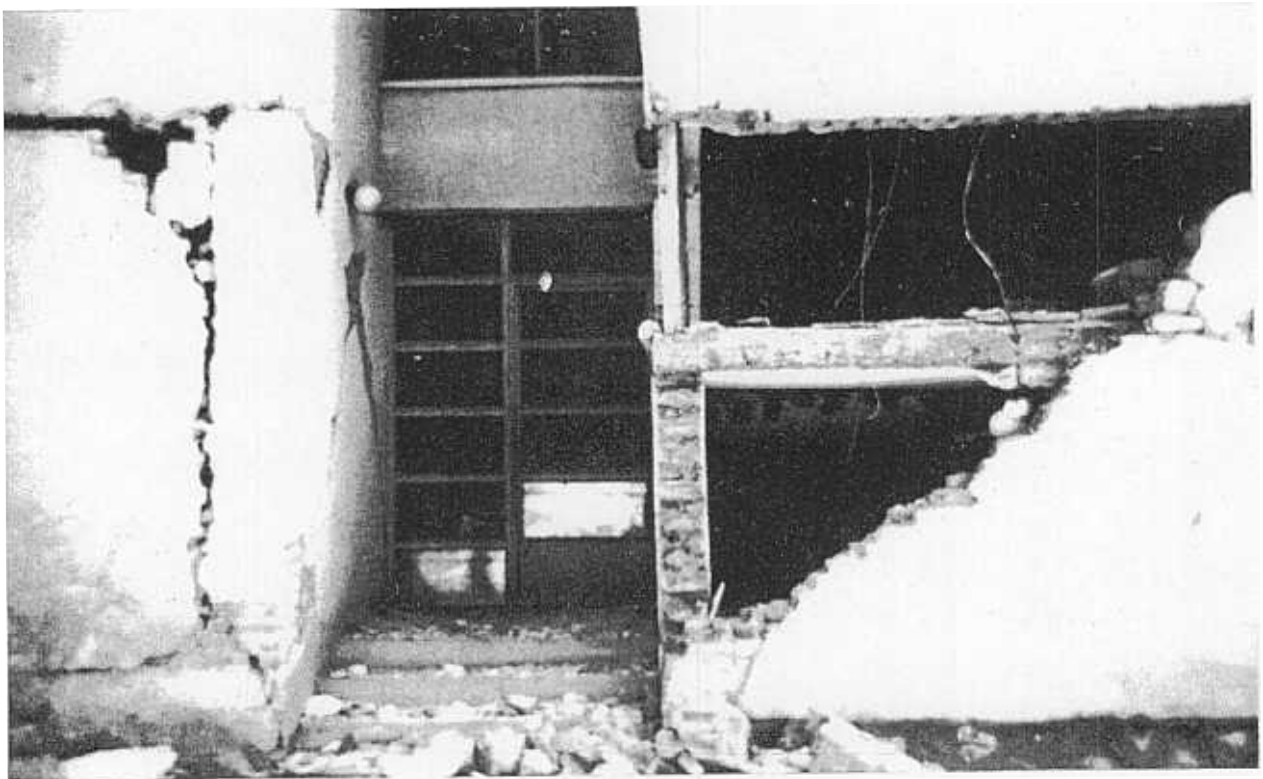
FIGURE 30 DAMAGE AND DEBRIS NEAR AN ENTRANCE TO THE HIGH SCHOOL BUILDING SHOWN IN FIGURES 28 AND 29.

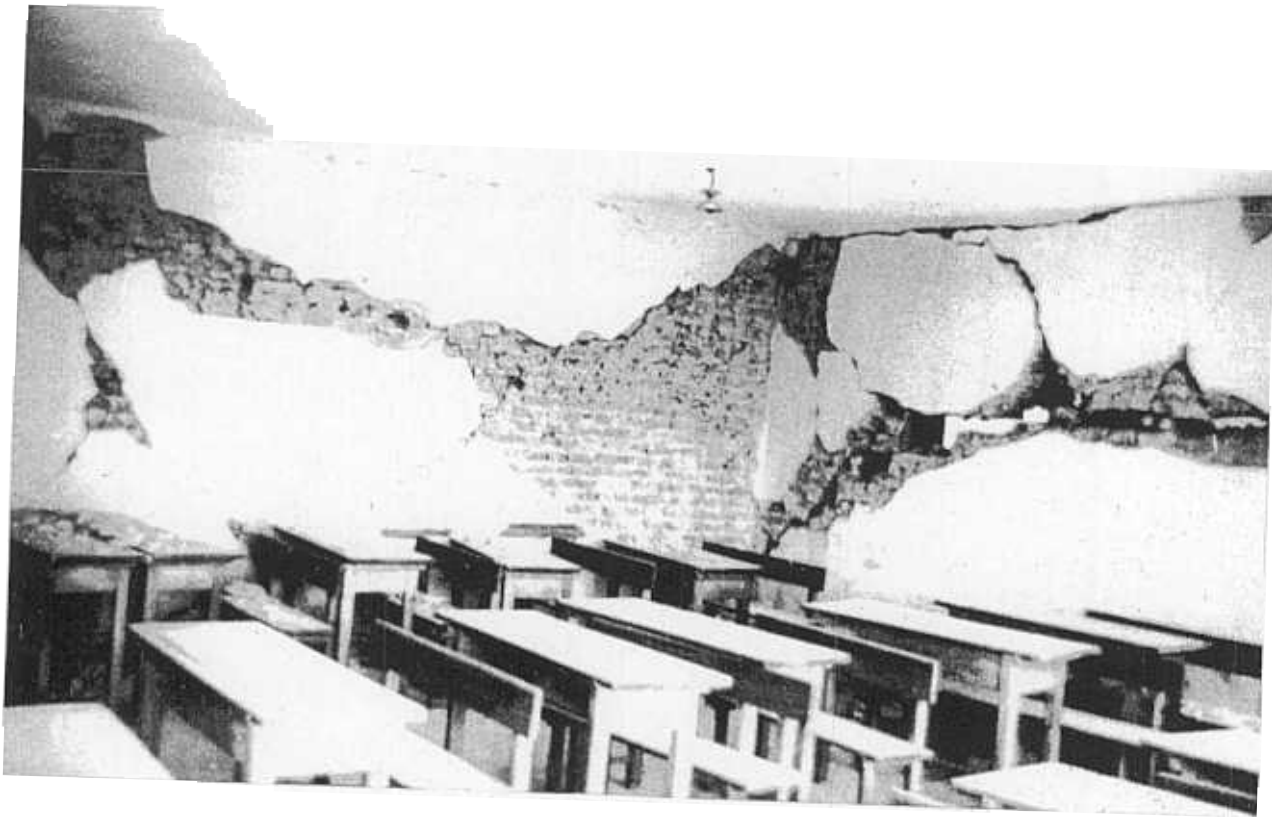
FIGURE 31 INTERIOR DAMAGE IN THE SECOND HIGH SCHOOL BUILDING

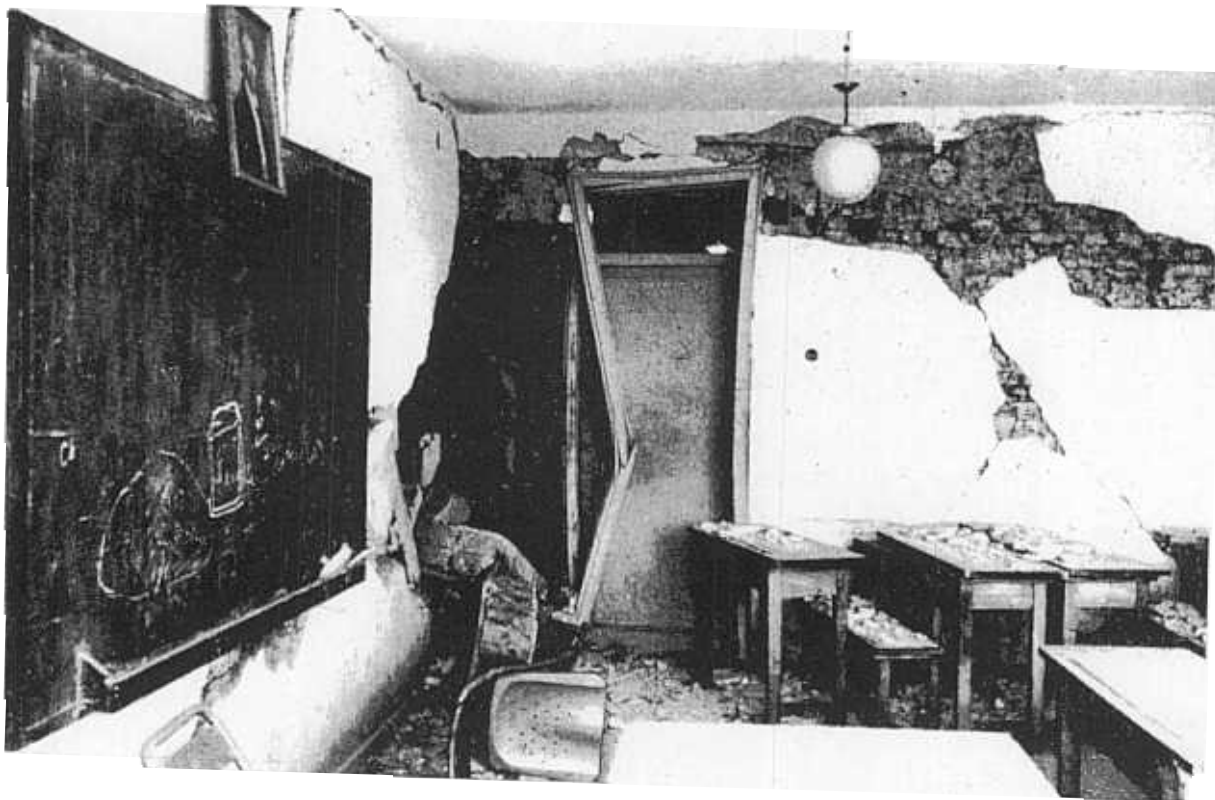
FIGURE 32 INTERIOR DAMAGE IN THE SECOND HIGH SCHOOL BUILDING

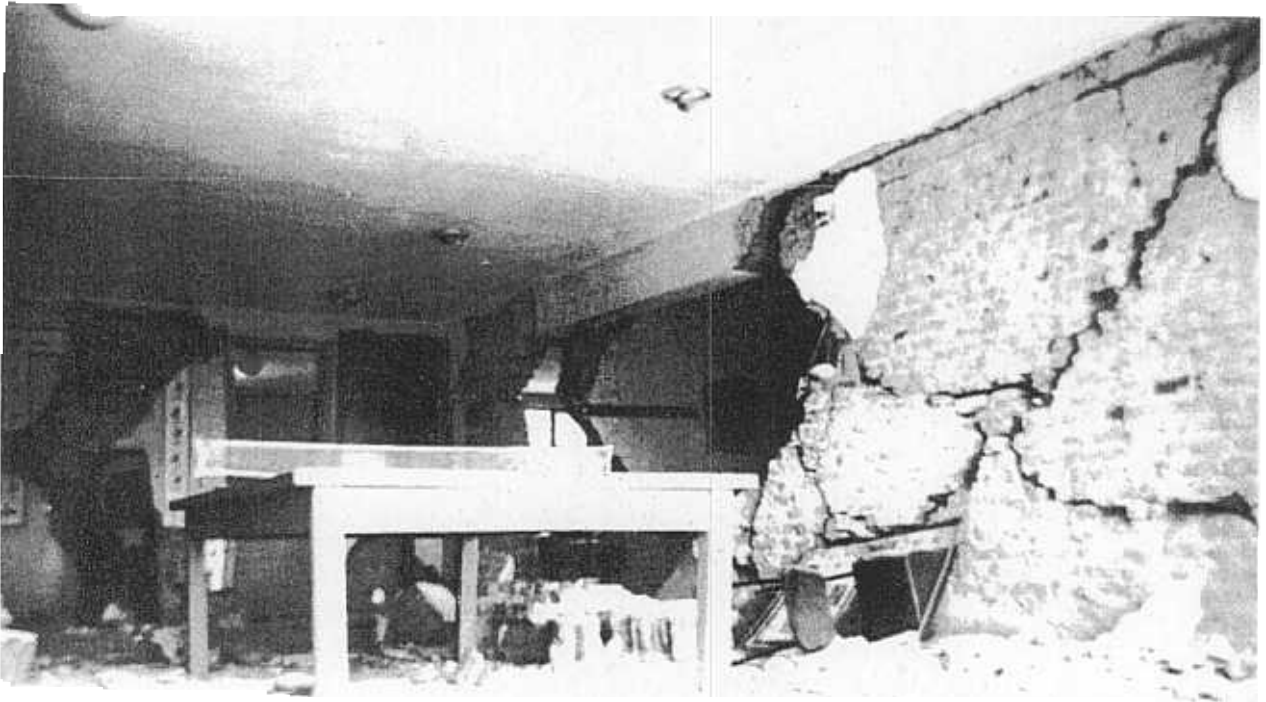
FIGURE 33 INTERIOR DAMAGE IN THE SECOND HIGH SCHOOL BUILDING.

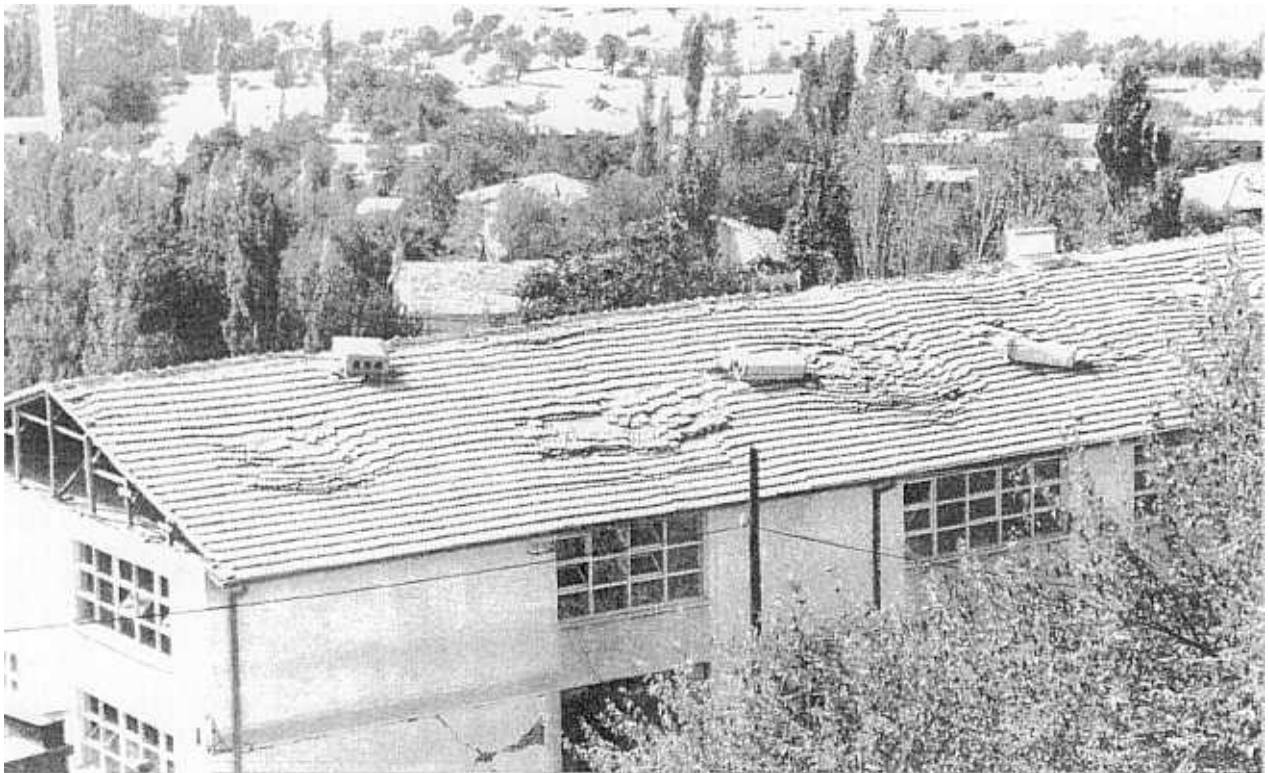
FIGURE 34 DAMAGE CAUSED TO THE ROOFING TILES, APPARENTLY BY AMPLIFIED VERTICAL VIBRATION IN THE CENTRAL AREAS OF THE HORIZONTAL ROOF SPANS BETWEEN THE VERTICAL TRUSSES.

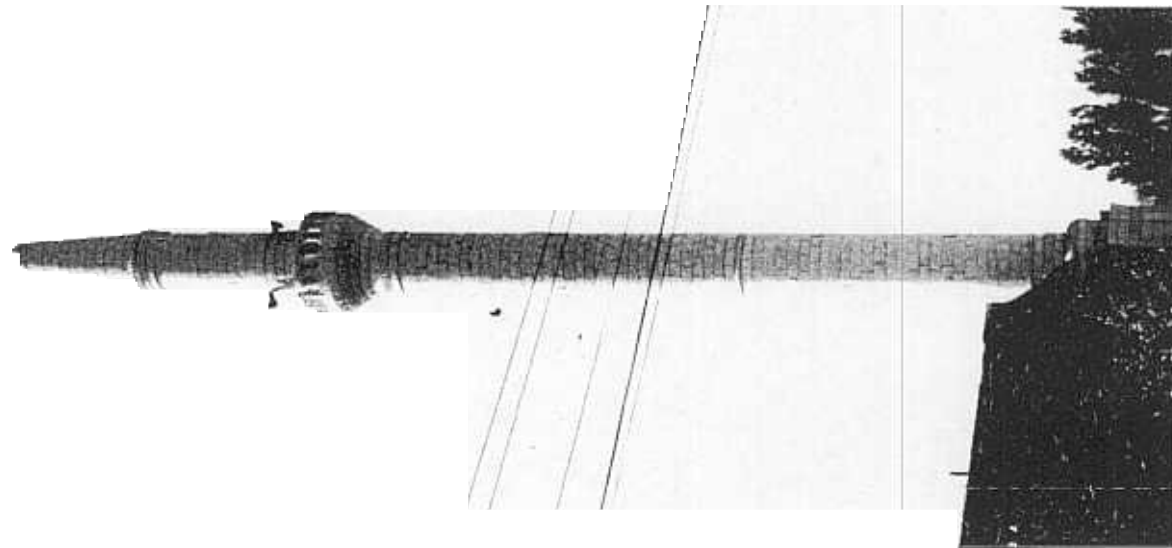
FIGURE 36 THE HIGHEST MINARET IN LICE LOST A FEW METERS FROM ITS TOP PORTION.

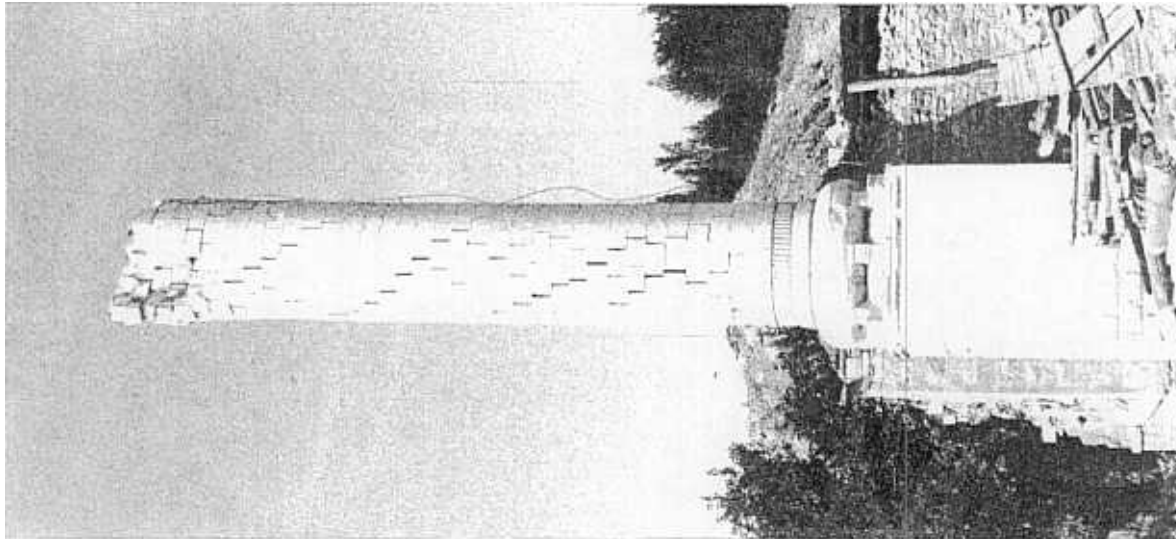
Several minarets in Lice failed, and at least one minaret in Hani survived, apparently undamaged. Two mosques, one in Lice and one in Hani, were completely destroyed, and there were no visible remains of their minarets. Two other minarets in Lice are shown in Figures 36 through 38. The first, located in the flat, newer area of the town, lost a few meters off the top, while the second and much shorter one, located in the hilly area near the hospital, was severely damaged. The unreinforced minaret (Figures 37 and 38), was built of grouted concrete blocks. The spiral separations between the blocks are particularly interesting.

FIGURE 37 THE REMAINING PORTION OF ANOTHER MINARET IN LICE. THE SEPARATIONS BETWEEN THE BLOCKS FORM AN INTERESTING SPIRAL PATTERN.

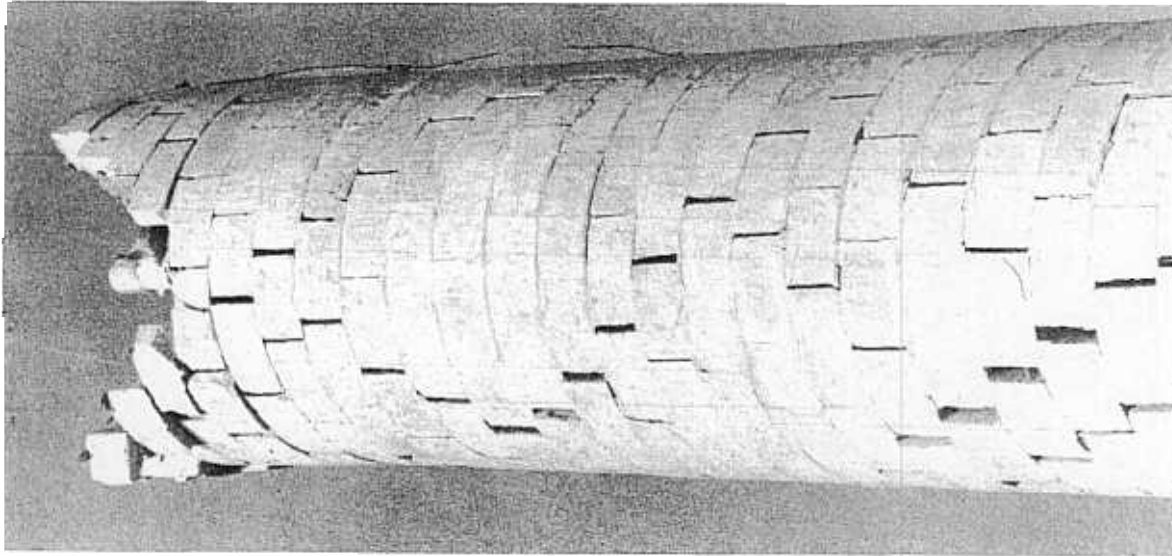
FIGURE 38 DETAIL OF THE DAMAGED MINARET SHOWN IN FIGURE 37.

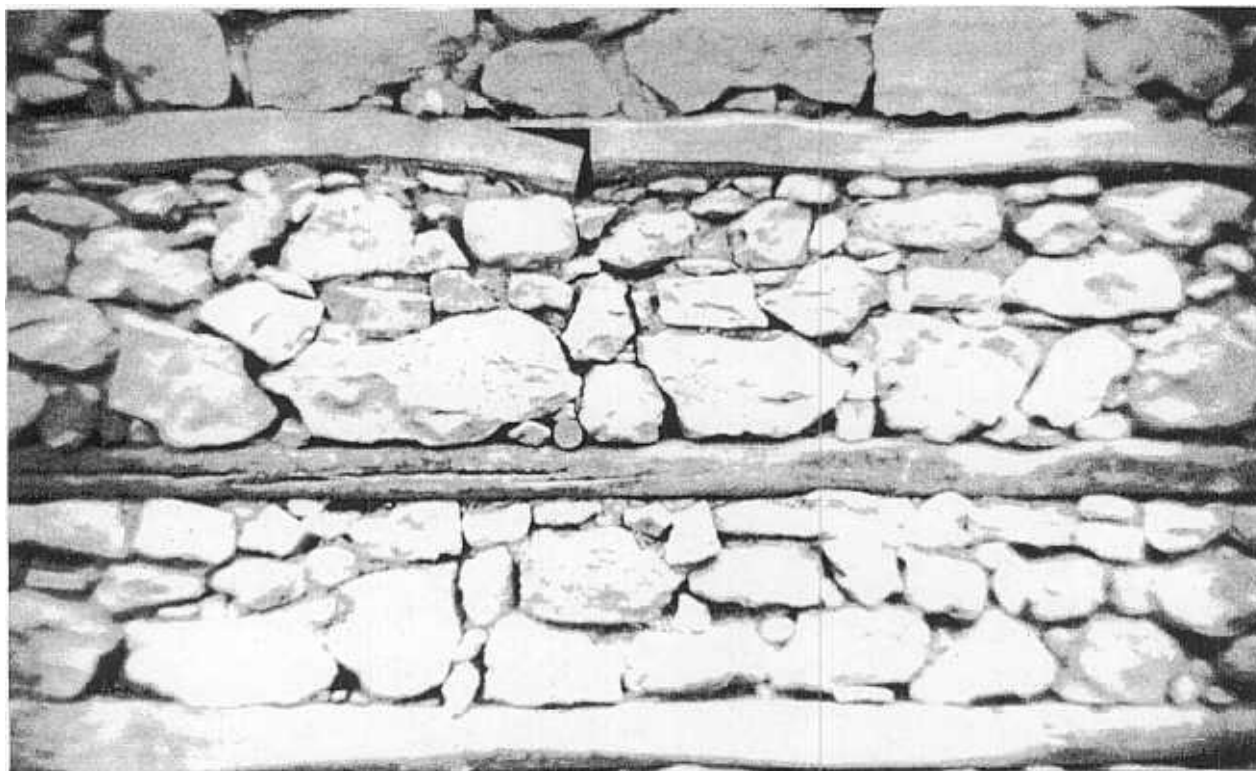
FIGURE 43 DETAIL OF THE EXTERIOR WALL OF A HOUSE IN HANI. THESE WOOD STRIPS WERE NOT AS ABUNDANT IN HOUSES IN LICE.

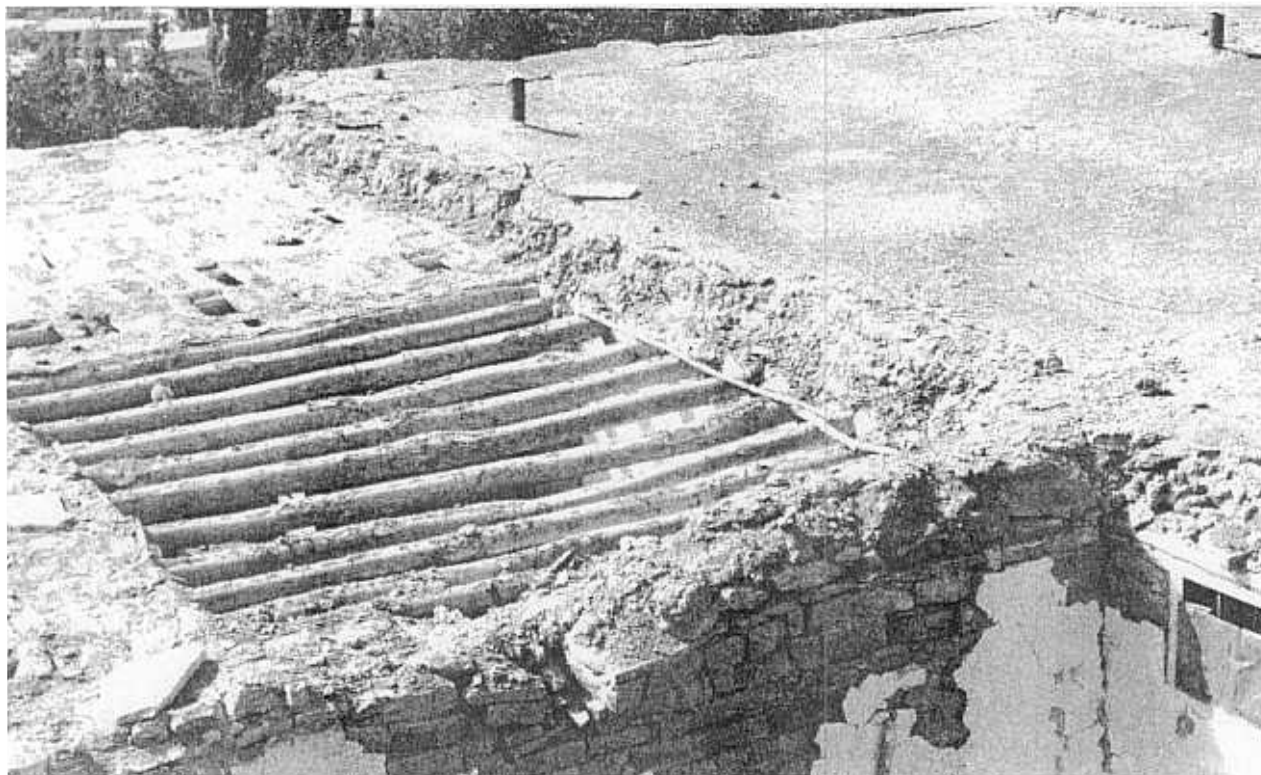
Figure 46 illustrates typical flat roof construction. The mud has been removed here, exposing the construction and showing the thickness of unremoved mud. Details of the roof-wall connections are shown in Figures 47 and 48. The usual failure mode of the roof was withdrawal of the timbers from the walls, which usually occurred at one end of the roof (Figure 49). In a few cases, the roofing timbers were encased in presumably reinforced concrete beams, as shown in Figures 50 and 51. In such cases the timbers generally remained in place. Other damage is shown in Figures 52 through 57.

FIGURE 46 TYPICAL FLAT ROOF CONSTRUCTION IN LICE. THE THICKNESS OF THE MUD ROOF IS BETWEEN 40 AND 60 CENTIMETERS; THE ROOF MAY WEIGH AS MUCH AS 1,000 KILOGRAMS/METER<sup>2</sup>.

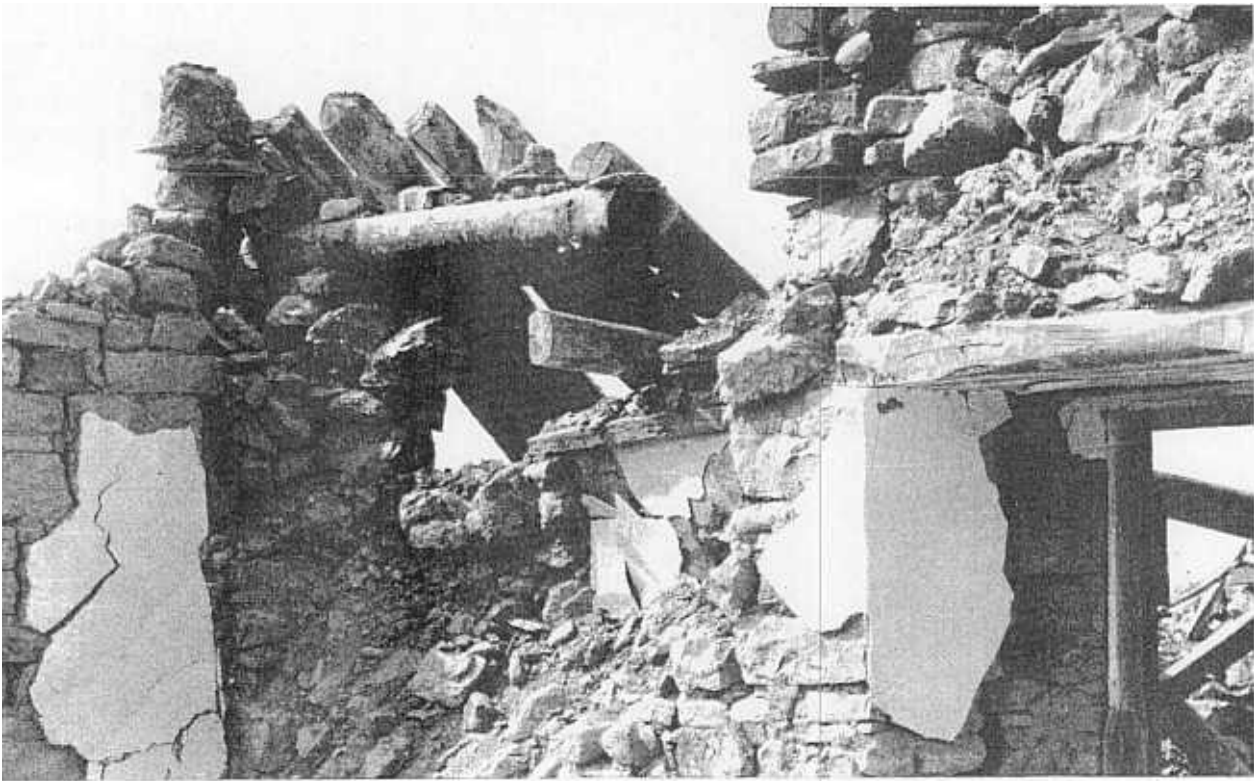
FIGURE 49 TYPICAL FAILURE OF A ROOF IN LICE.

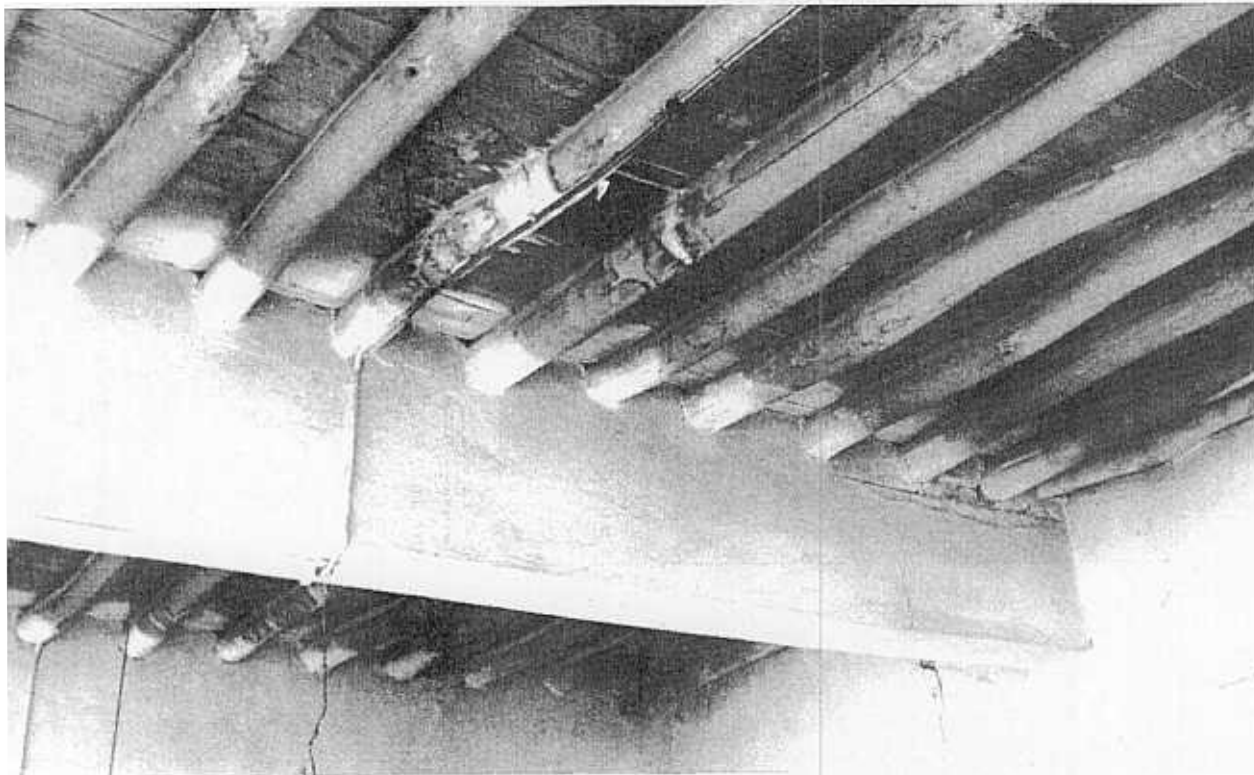
FIGURE 50 IN SOME STRUCTURES, THE ROOFS WERE SUPPORTED BY CONCRETE GIRDERS. IN SUCH CASES, THERE WAS SIGNIFICANTLY LESS DAMAGE TO THE ROOFS.

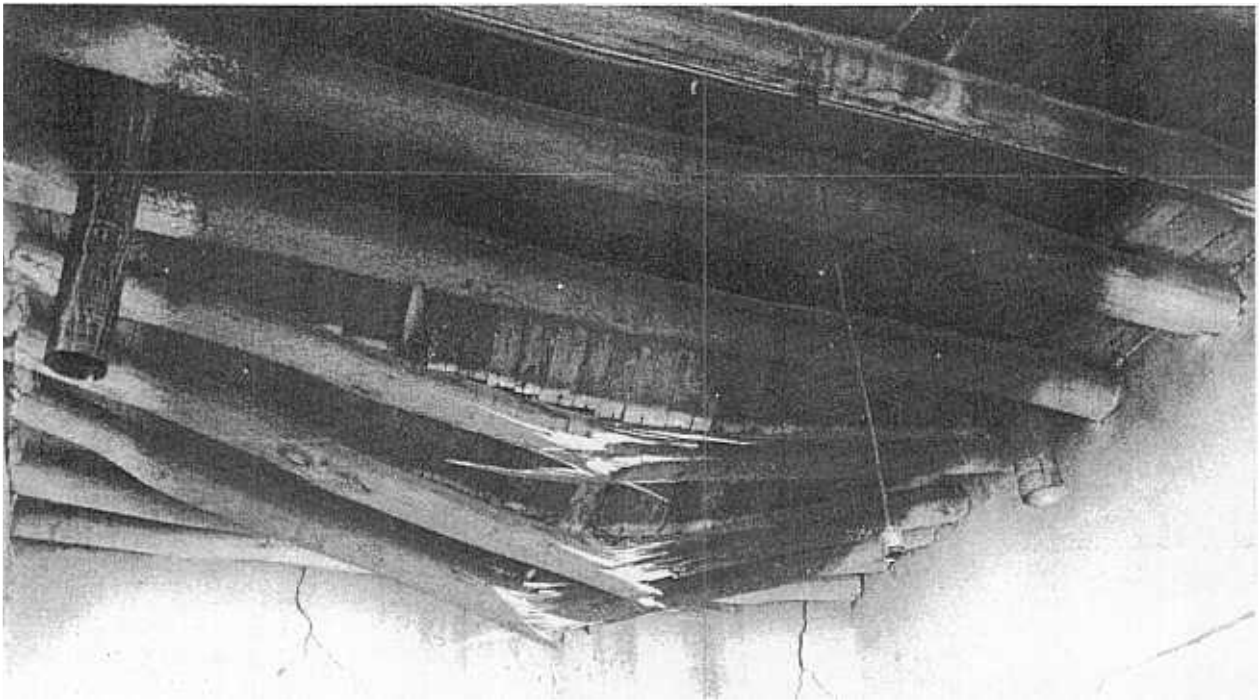
FIGURE 51 FAILURE OF THE ROOF TIMBERS IN A COMMERCIAL BUILDING WITH CEMENT MORTAR AND SOME CONCRETE FRAMING MEMBERS.

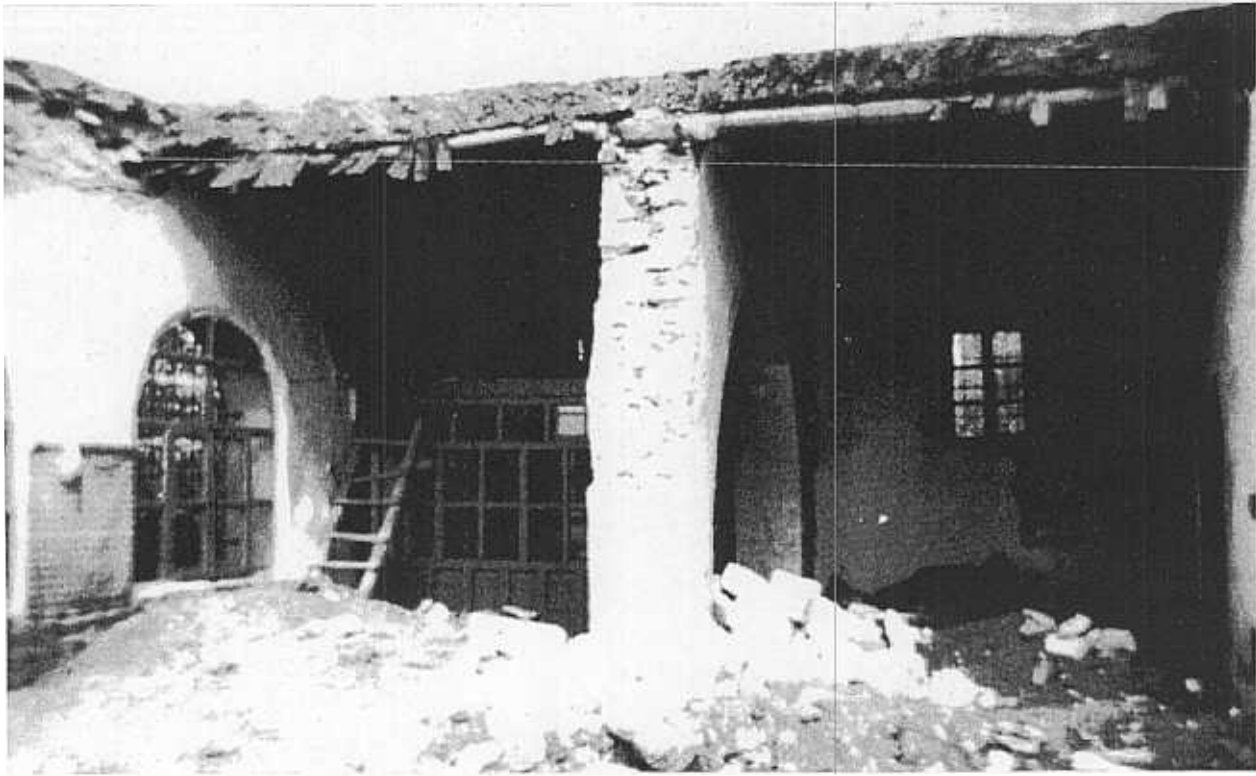
FIGURE 53 THE FAILURE OF INTERIOR LOAD-BEARING ARCHES IN THIS MOSQUE IN HANI LED TO THE COLLAPSE OF ITS HEAVY MUD ROOF.

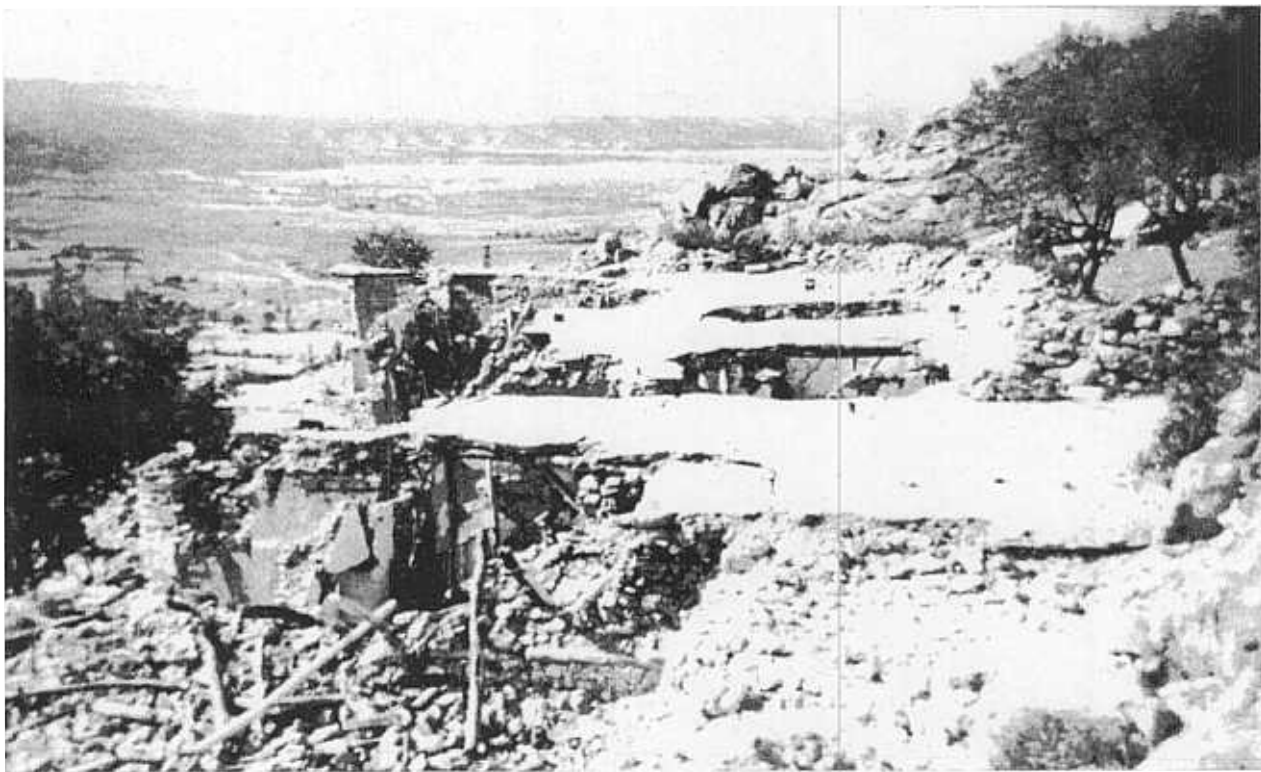
FIGURE 54 VIEW ACROSS SEVERAL PARTIALLY COLLAPSED ROOFS IN LICE.

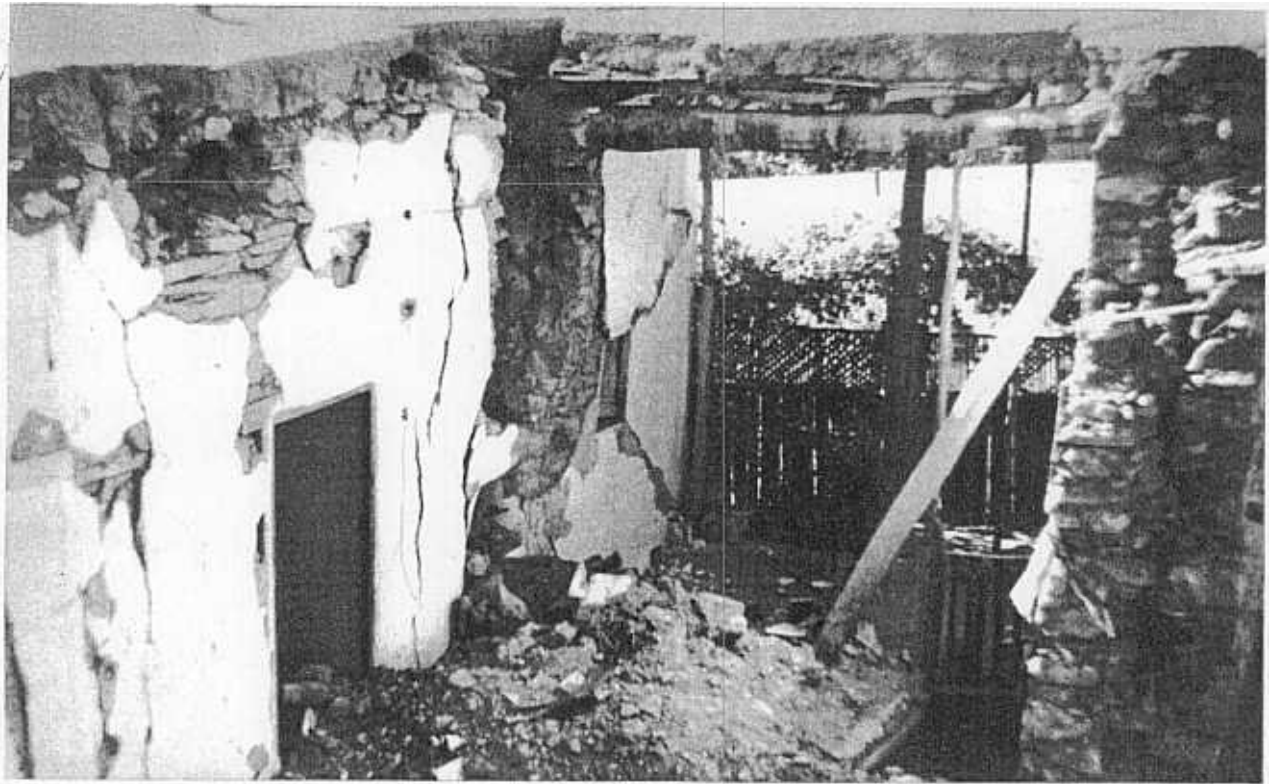
FIGURE 55 THE INTERIOR OF A HOUSE WITH A COLLAPSED ROOF IN LICE.

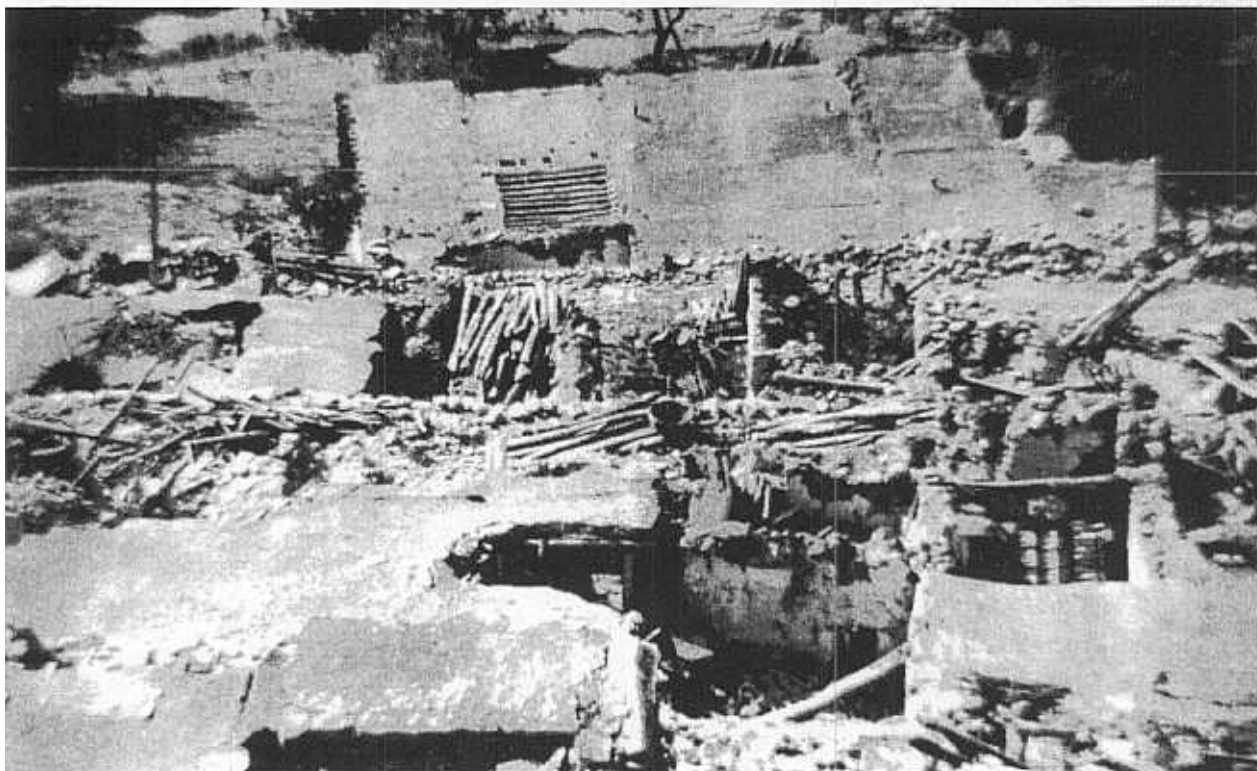
FIGURE 57 VIEW OF COLLAPSED ROOFS IN LICE. THE INTACT ROOFING TIMBERS HAVE BEEN PULLED OUT FROM THE RUINS, PRESUMABLY FOR RECONSTRUCTION.

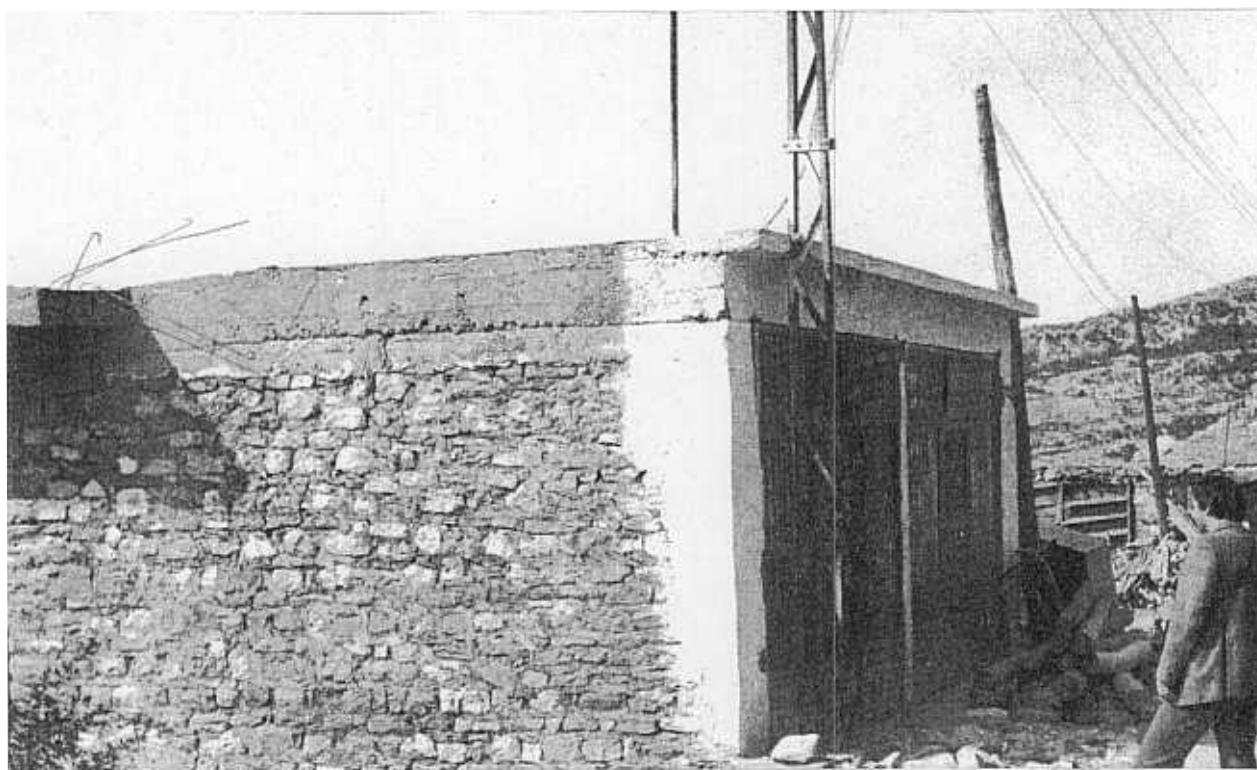
Many buildings, particularly smaller commercial buildings, had flat concrete slab roofs. As illustrated in Figures 58 and 59, these structures fared somewhat better; the load was carried into the walls, showing the importance of good diaphragm action. Often the wall damage consisted of substantial shear cracks and partial failure of the walls. There appeared to be fewer injuries from such failures.

FIGURE 58 A LIGHTLY DAMAGED MASONRY COMMERCIAL STRUCTURE IN LICE, WITH A CONCRETE FLAT SLAB ROOF. SOME OF THESE BUILDINGS HAD CEMENT MORTAR.

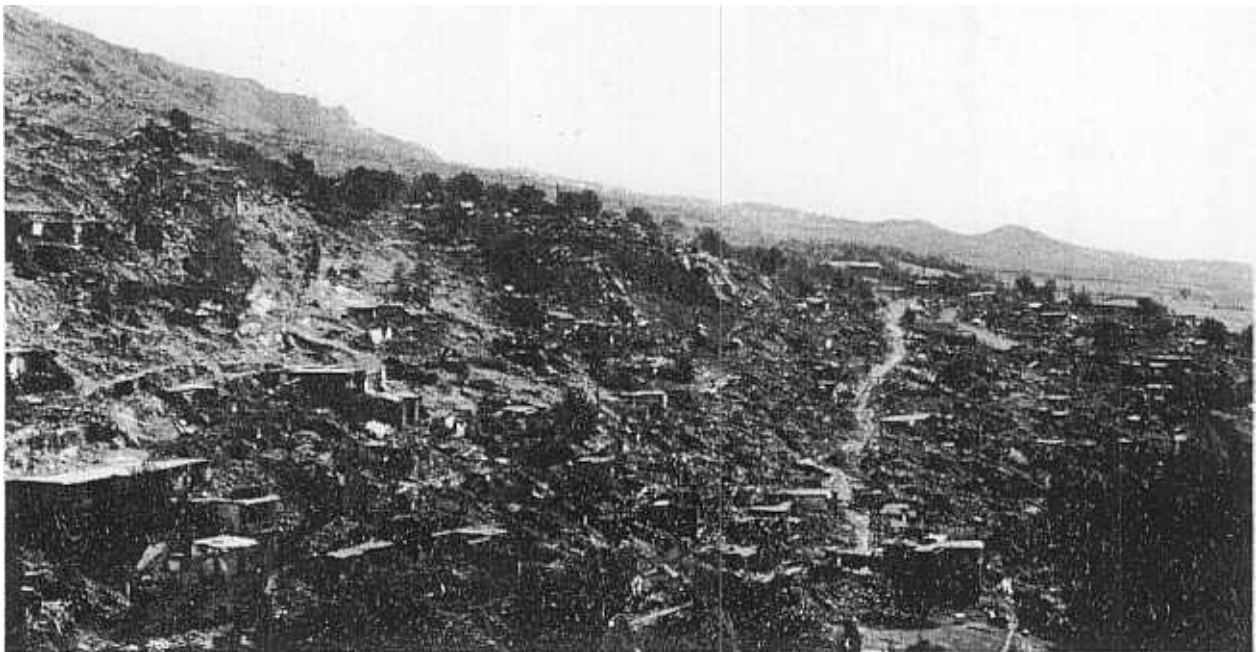
FIGURE 60 GENERAL VIEW ACROSS THE DEVASTATED EASTERN SECTION OF LICE.
