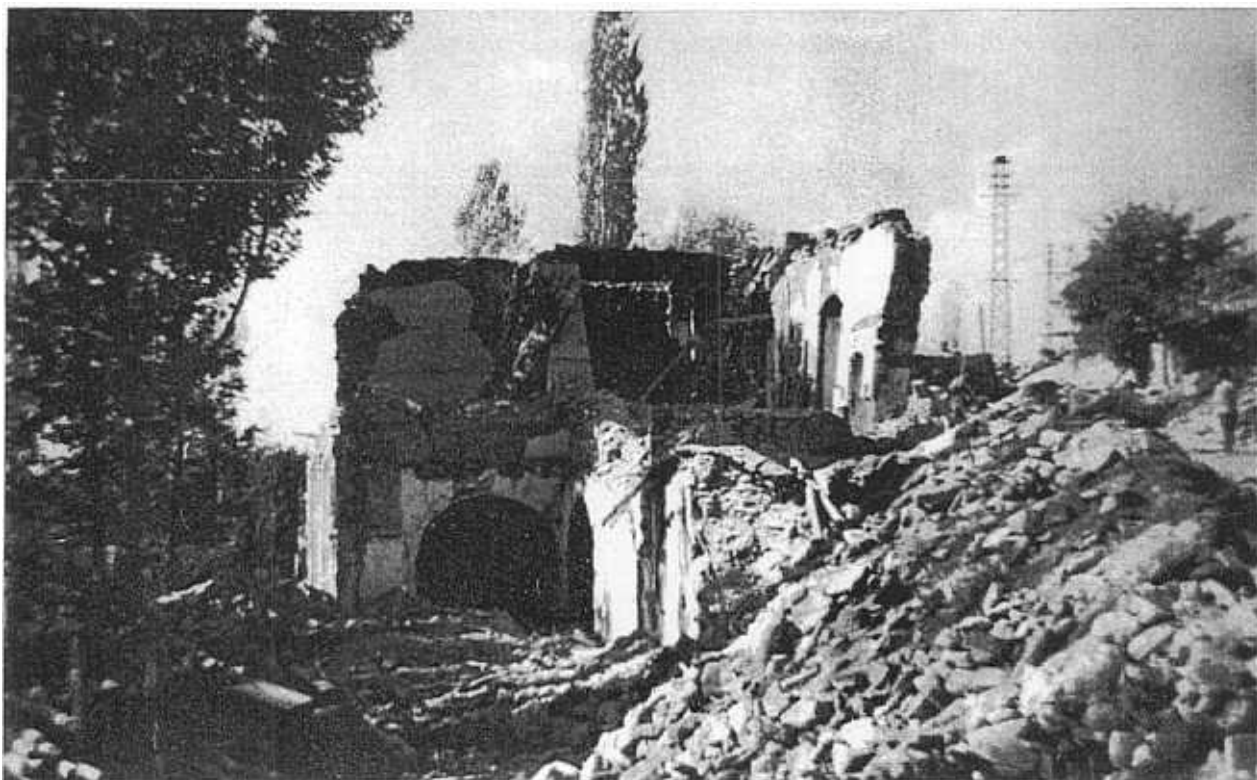
FIGURE 6 PARTIAL COLLAPSE OF AN ANCIENT BUILDING

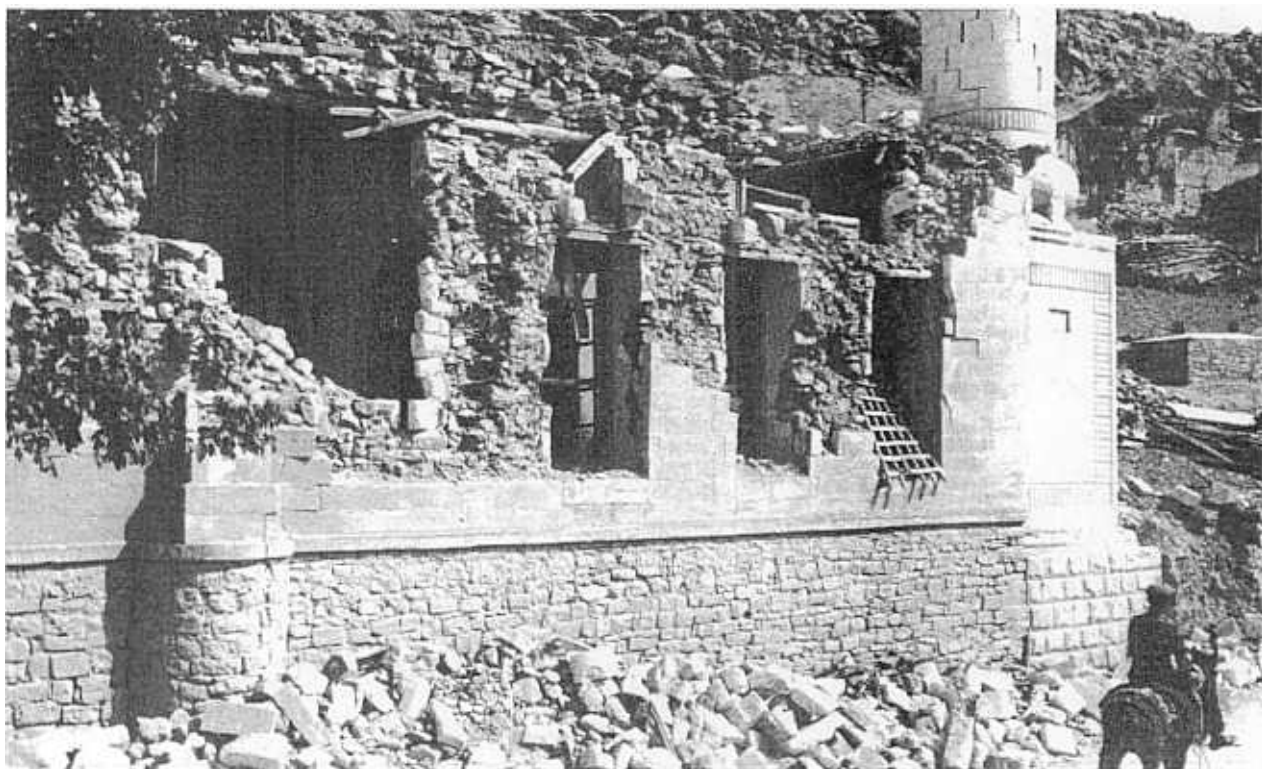
FIGURE 64 A PARTIAL COLLAPSE OF A MOSQUE

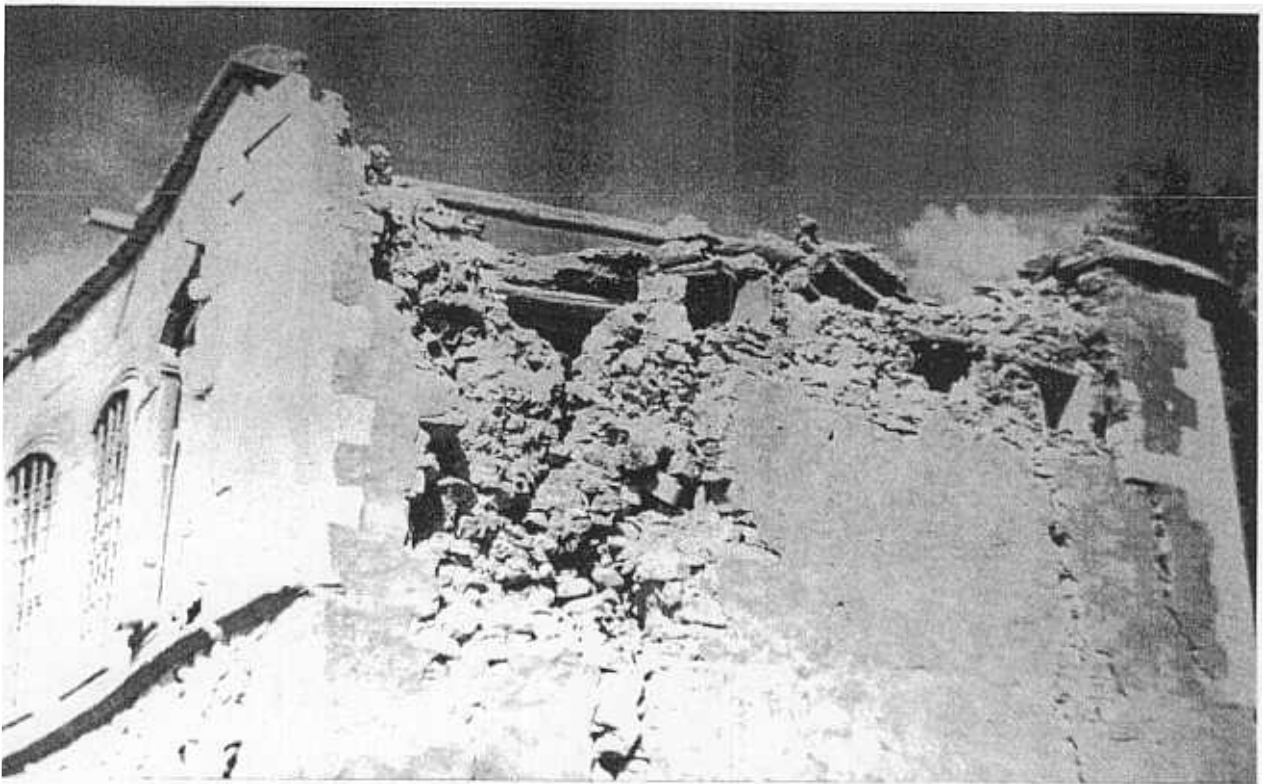
FIGURE 67 THE PARTIAL COLLAPSE OF A MUD MORTAR WALL FROM THE SAME BUILDING SHOWN IN FIGURE 66. IN GENERAL, BUILDINGS WITH CEMENT MORTAR FARED SIGNIFICANTLY BETTER.

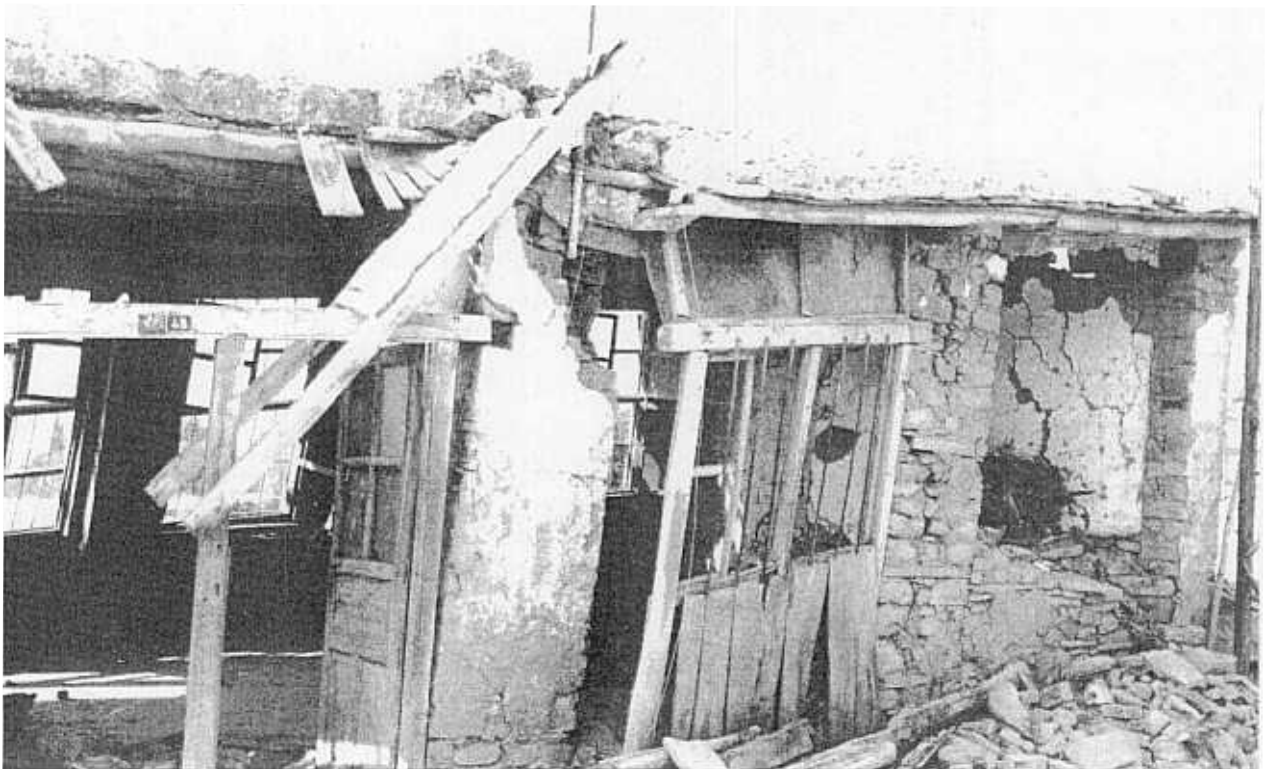
FIGURE 68 EXTERIOR OF A SEVERELY DAMAGED HOUSE IN LICE.

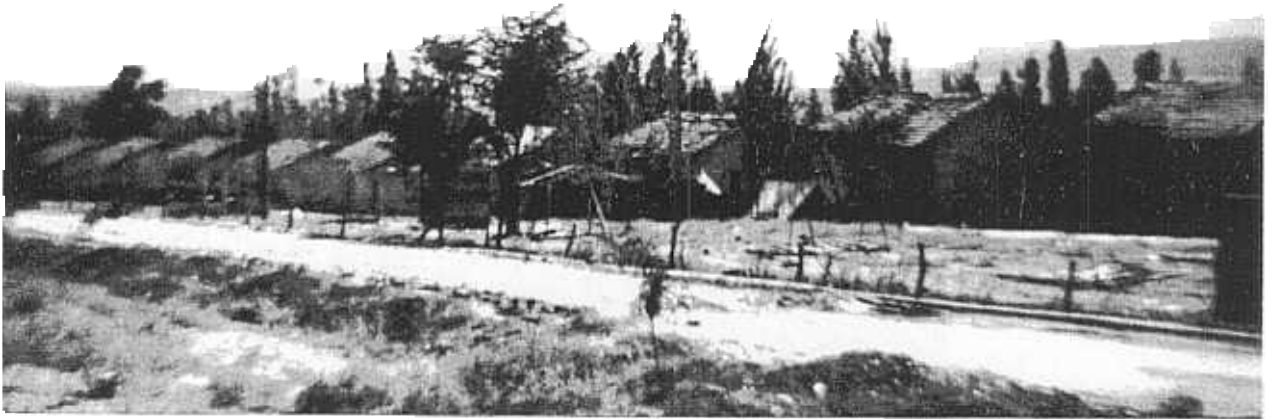
Figure 70 shows a row of these houses in the flat portion of Lice. None of the buildings seemed to be damaged severely although roofing tiles were shaken off and otherwise damaged. A number of similar homes were examined in the town of Hani (Figures 71 through 73). Here, the houses did not have tile roofs and experienced no noticeable damage. Our brief investigation indicated that these low-cost houses had survived a major shock without causing casualties. The MRR is now heavily committed to building about 3,000 similar houses in the stricken area. As of the beginning of October 1975, government plans called for the construction of 30 of these houses per day in Lice. Approximately 1,500 will be built in Lice, another 500 in Hani, and the rest throughout the area. All of these houses are prefabricated, as illustrated in Figures 74 through 77. About 440 of the homes are wood frame; they are purchased from Finland at approximately \$5,000 each, excluding utilities and construction but including shipping. The homes built by the MRR cost about \$3,300. Current plans call for the sale of these houses at approximately \$2,300 to those with higher incomes and at about \$1,200 to the poorer people. The loans are for 20 years, in-

FIGURE 70 A ROW OF LIGHTLY DAMAGED EARTHQUAKE-RESISTANT HOUSES BUILT BY THE MRR AND ERI FOLLOWING THE 1971 BINGÖL EARTHQUAKE.
