# Damage Assessment and Seismic Retrofit of Buildings Following the 2015 Nepal and 2016 Ecuador Earthquakes

*H. Kit Miyamoto, PhD SE and Amir SJ Gilani, PhD SE  
Miyamoto International  
Los Angeles, CA*

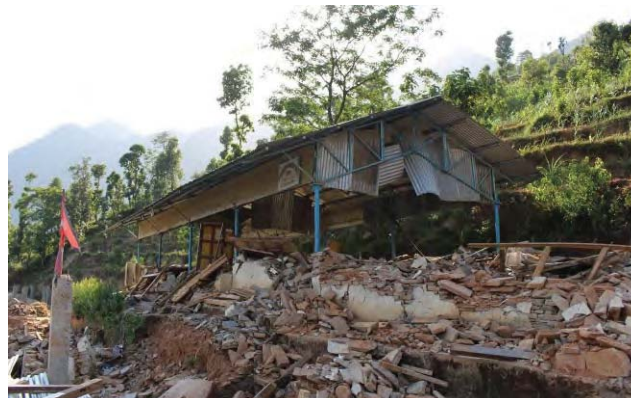
In the past earthquakes in developing countries, school buildings have been especially vulnerable to damage from earthquakes (Miyamoto et al 2011). The same was the case in Nepal; see Figure 3 and Figure 4. In the aftermath of the

**Figure 3. Collapsed school building**

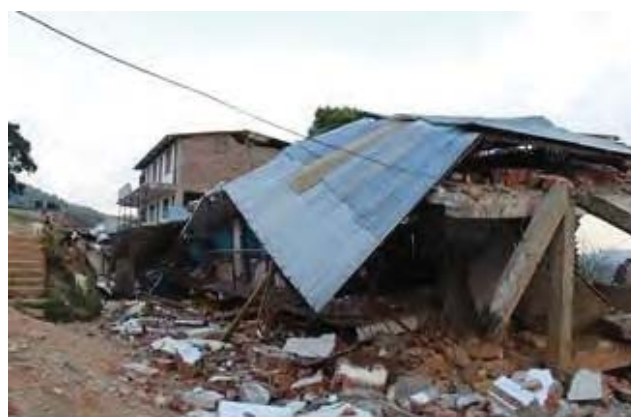
**Figure 4. Collapsed school building**

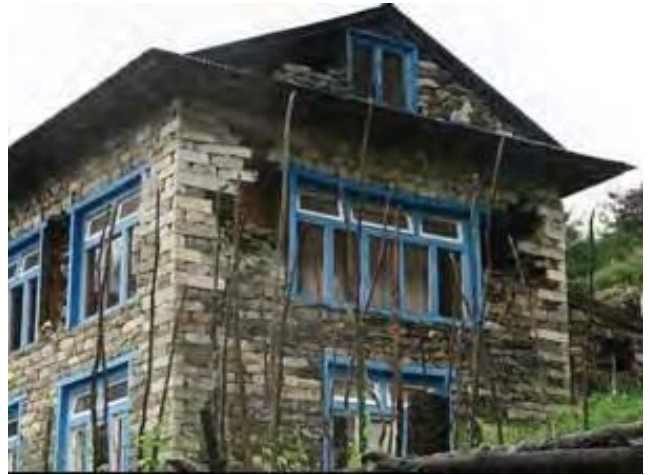
The level of damage in traditional construction was depended on the construction practice. The buildings with stone and mortar generally performed well. By contrast, in older buildings where either no mortar was used or when mud was used as mortar, there was significant damage. For these buildings, see Figure 5, the out-of-plane failure of walls was the most common mode of failure, where stonewalls fell over or stones fell out, generally at the top of the walls. Since these bearing walls carry both seismic and gravity loading, their out-of-plane failure can compromise the gravity load path and can result in collapse of roofs and floors. For the surveyed buildings, a secondary wood beam supporting the roof was observed in many of the buildings. This member supported the roof after the failure of walls and prevented collapse of the roof. Accommodation structure built with cut rock, cement and ring beams that performed well; see Figure 6. Wood structures were mostly undamaged. The structural assessment of the buildings was conducted in accordance with the internationally recognized ATC-20 (ATC 2005) and the national guidelines for post-earthquake damage assessment specified by the Department of Urban Development and Building Construction (DUDBC) of the Government of Nepal. Out of approximately 710 surveyed buildings, earthquake damage of structural concern was observed in 120 buildings (17%); 83 percent of buildings were given a green tag per ATC-20 and DUDBC guidelines. It was found that most of the damaged buildings were repairable

**Figure 5. Out-of-plane failure of wall building**

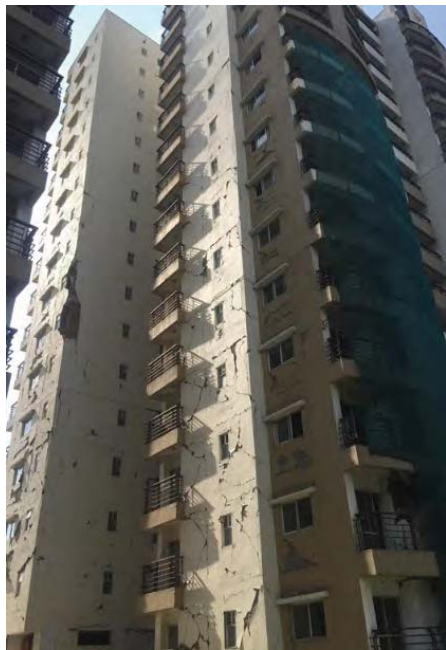
As mentioned previously, the soft soil underlying the Katmandu region produced large spectral accelerations in the 1-4 sec period range and excited mid-rise buildings. Many of these buildings are of newer construction vintage, had ductile detailing, and as such did not experience collapse. However, damage to these tower buildings was widespread; see Figure 7. Most of the mid-rise buildings used reinforced concrete moment framing as the lateral force resisting system. In addition, unreinforced infill walls were used for these buildings. The damage to the infill walls was extensive; see Figure 8, which caused the tenants to relocate temporarily from these units. It is noted that these are high-end condominium units.

**Figure 7. Exterior cracking, tower**

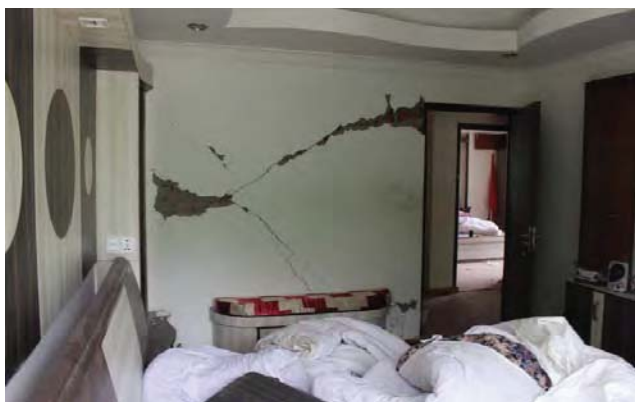
**Figure 8. Interior diagonal cracking of infill walls**

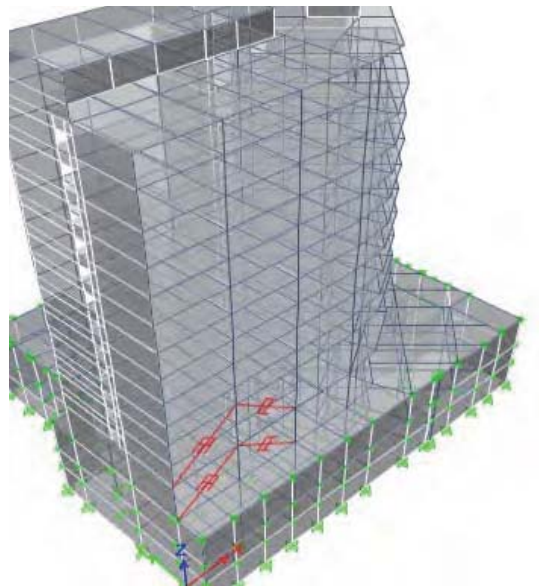
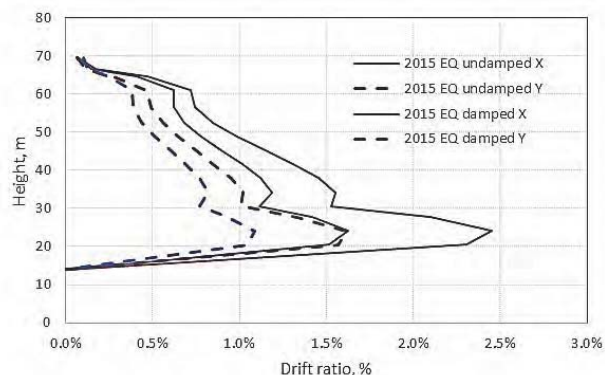
The new 70-m tall hotel building has 15 stories and 3 basement levels; see Figure 9, reinforced concrete moment frame exterior shear walls comprises the lateral load resisting system. The structure was designed per IS 2002. Following the 2015 Earthquake, it was decided to add the additional requirement of limiting the drift ratios to approximately 1.5% for a seismic event comparable to that earthquake. As shown in Figure 10, the building nearly met this criterion in the transverse direction. However, in the longitudinal direction, at the lower three levels, drift ratios exceeded this limit. To reduce the drift ratios, viscous dampers were added at these levels along the longitudinal direction. As shown in the

figure, in the new configuration, drift ratios were limited to approximately 1.5%.

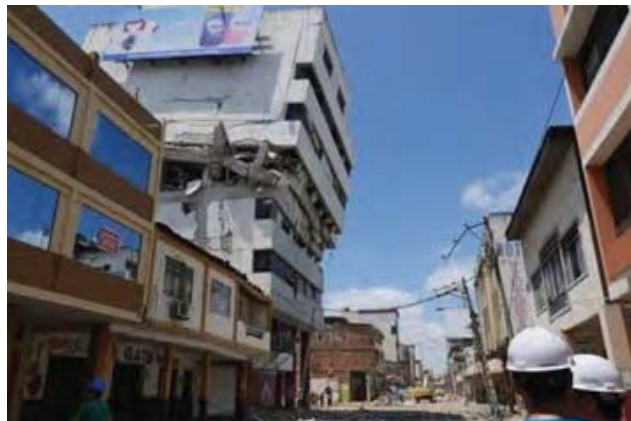
The team was divided into two teams and conducted damage assessment. Overall, 50%-60% of buildings appeared undamaged and 30% had slight to moderate damage. The remaining 10%-20% of buildings were severely damaged or collapsed. A multistory tower building; see Figure 12, was severely damaged and presented life safety hazard to nearby buildings and adjacent street.

**Figure 12. multi story damaged building**

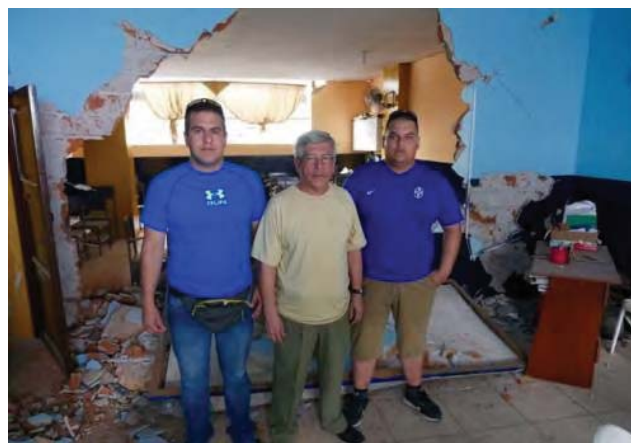
The municipal building, housing mayor's office, was damaged. However, the damage, although substantial, appears repairable and primarily is nonstructural. The building framing including reinforced concrete columns are undamaged. The damage to nonstructural components and contents, including furniture, and cabinets, was widespread. Nearby, a school building housing 400 students was inspected next. At the ground floor, structural damage is limited to superficial cracking of walls and concrete framing was intact. Upstairs, an interior brick wall dividing classrooms had collapsed and had fallen in one of the classrooms; see Figure 13. Fortunately, earthquake had occurred on a Sunday when the school was not open.

**Figure 13. Infill wall failure school building**

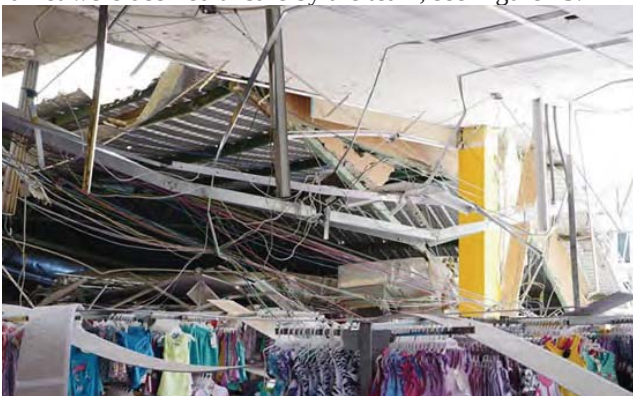
The Centro Municipal Commercial, taking up an entire city block, is a popular downtown market and includes a large department store on one floor, small, subterranean stalls of independent vendors below it and an eight-floor office building. A large section of the market was severely damaged. The damage had interrupted business for over 180 vendors on this site and had caused economic hardship. Damage assessment of the building was conducted. The older part of the building is the eight story portion, whereas, the department store is the new addition. The eight-story tower only sustained minor damage. However, sections of the market were deemed unsafe by the team, see Figure 15.

**Figure 15. Damaged market**

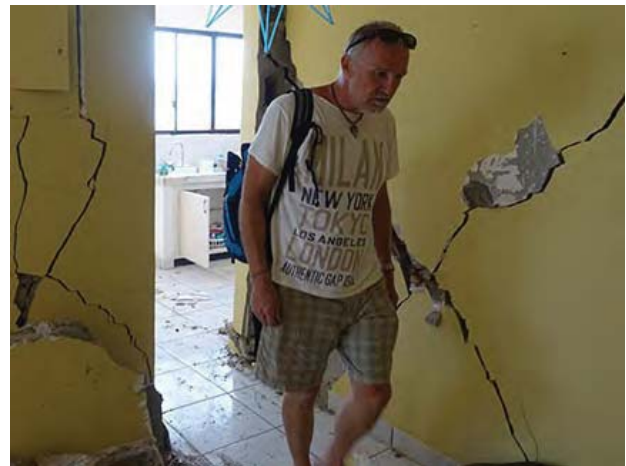
Bahía de Caráquez, located on a sandy peninsula at the mouth of the Chone River, suffered heavy earthquake destruction. A row of tents was setup to house displaced people from damaged buildings and others who were frightened to return home. The exterior wall of a five-story building was on the verge of out-of-plane failure. In downtown area, about one-third of the buildings were severely damaged or collapsed. Next, two eight-story twin towers that were constructed recently, were visited. One tower appeared undamaged, whereas, the second building had suffered complete collapse and caused 12 fatalities. Such occurrences, occurred in previous earthquakes, are attributable to variations in site condition, architectural detailing, material quality, and means of construction. In a neighborhood of oceanfront high-rise condominiums, nearly all towers have exterior cracks. They were no fatalities; however, the extent of damage was hampering recovery efforts. Visiting one of the towers, there was major cracking of infill walls; see Figure 16. However, the concrete columns appear to have suffered only limited damage.

**Figure 16. Damaged plaster and infills**

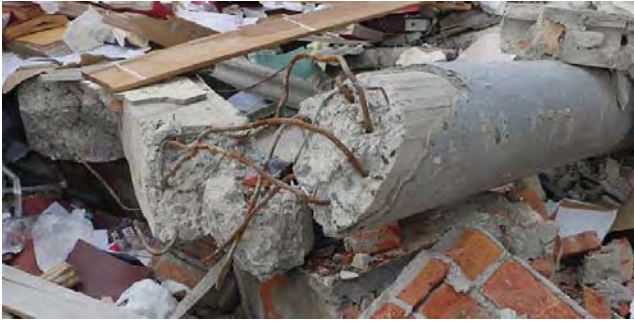
The coastal town of Pedernales, with 172 fatalities, is perhaps the worst hit by the earthquake. Many buildings collapsed here including a number of reinforced concrete structures with questionable material, inadequate strength, and detailing; see Figure 17.

**Figure 17. Poor detailing of reinforced concrete**

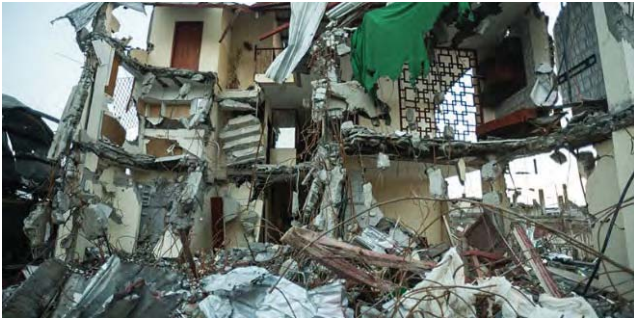
Chamanga is a humble fishing village tucked into a bay. Typical houses are rotted wood or concrete regularly flood and sit in a tsunami zone without a warning system. More than 50% of buildings had collapsed; see Figure 18 and 6000 people were living in temporary tents. One of the four schools constructed of bearing walls and tin roof, had collapsed walls.

**Figure 18. Collapsed building**

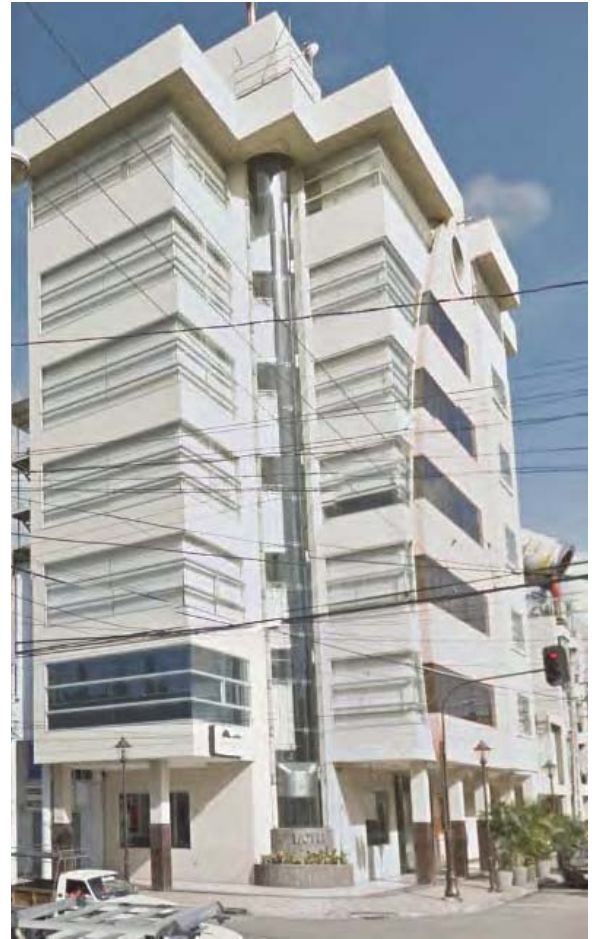
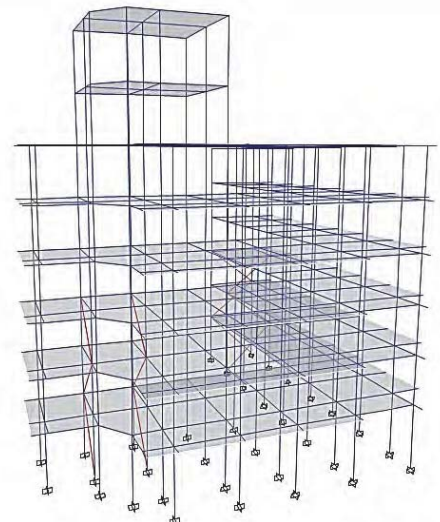
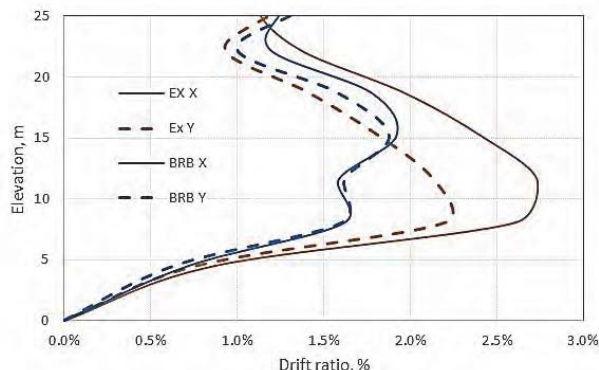
The 41-m tall building has 7 stories and 2 penthouse levels; see Figure 19. Reinforced concrete moment frame comprises the lateral load resisting system. Typical beams measure 350x450 mm and square columns vary in size from 450 to 700 mm. The structure was designed per Ecuador building code. Following the 2016 Earthquake, it was decided to add the additional requirement of limiting the drift ratios to approximately 1.5%-2% for the MCE event. And BRBs were added to the building model; see Figure 20. As shown in Figure 21 the drift ratios for moment frame alone exceeded this limit and were 2.8% at middle of the building. To reduce drift ratios, BRBs were added to the building and this reduced the maximum drift ratio to approximately 1.8%.
