Report to the Resilience Observatory: Chautara Municipality

prepared by the Housner Fellows Group

April 21, 2016

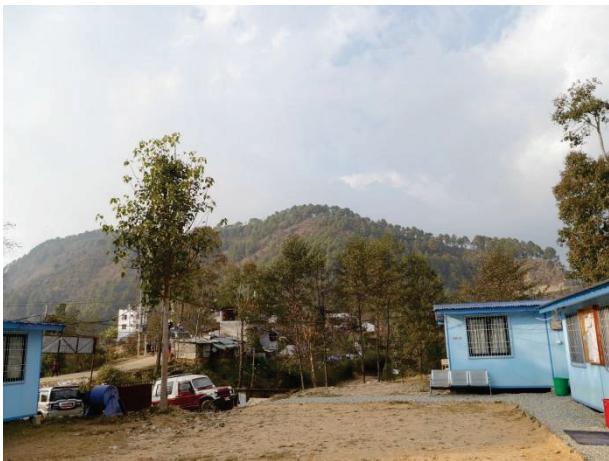
Figure 1 Pre-engineered buildings used for municipal service offices.

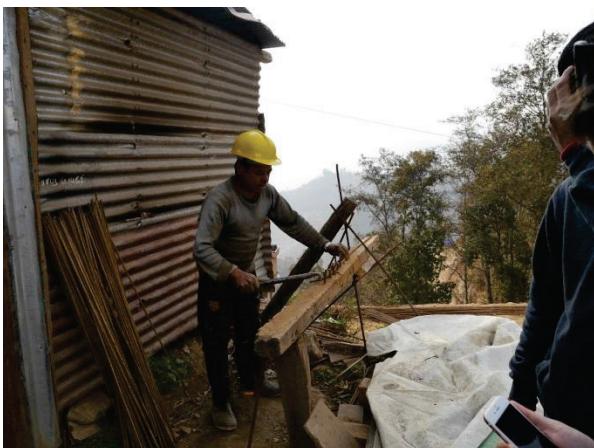
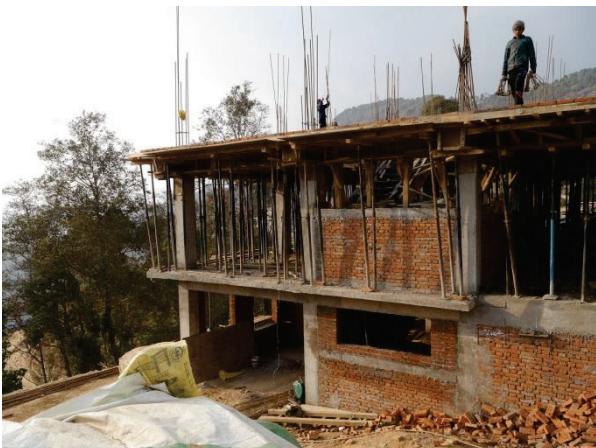
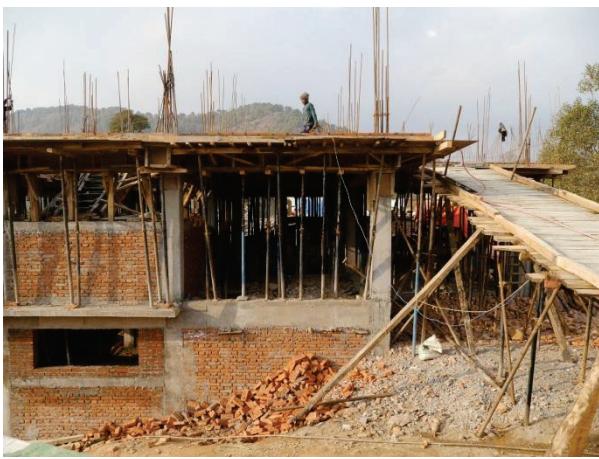
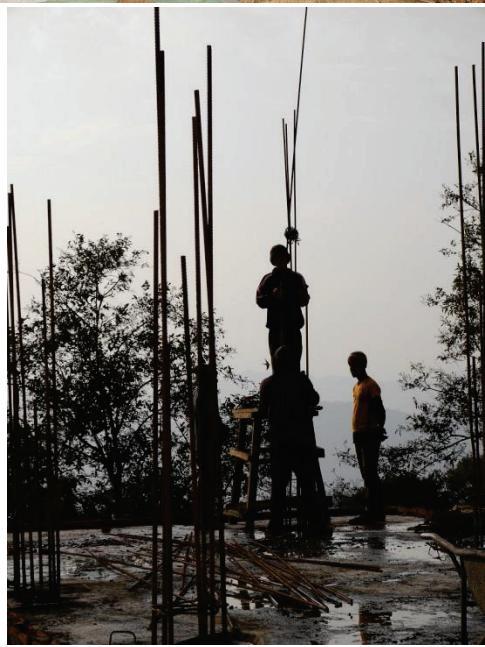
- The main municipal service offices were reconstructed with lightweight construction pre-engineered buildings (Figure 1).
- A new municipal government building consisting of 4-story reinforced concrete with brick infill walls, was under construction. The columns were observed to be 14" x 14" in size and well reinforced. The masons constructing this building reported that they had received training on constructing earthquake-resistant buildings (Figure 2).

Figure 2 Photos from construction site for new municipal office building.

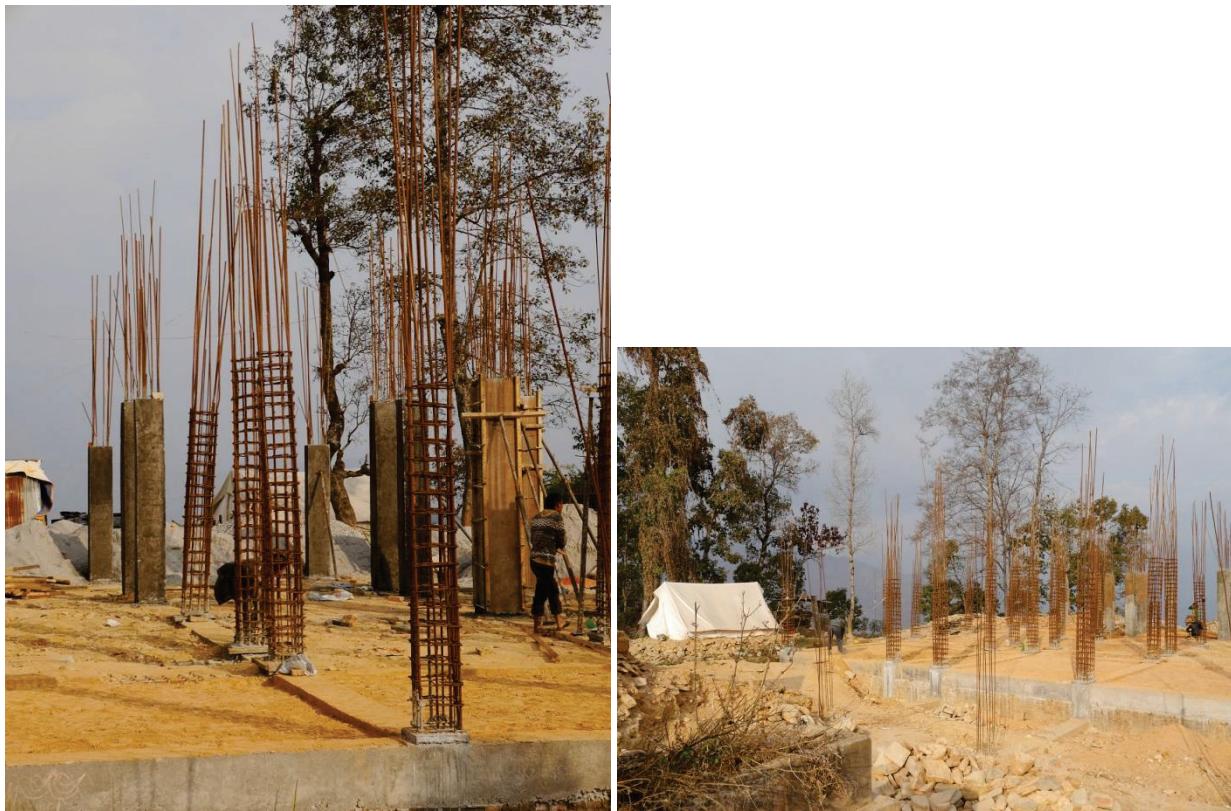
- A reinforced concrete with brick infill for UNDP was being constructed on top of foundations of previously demolished building (Figure 3).

Figure 3 Photos of UNDP building under construction.

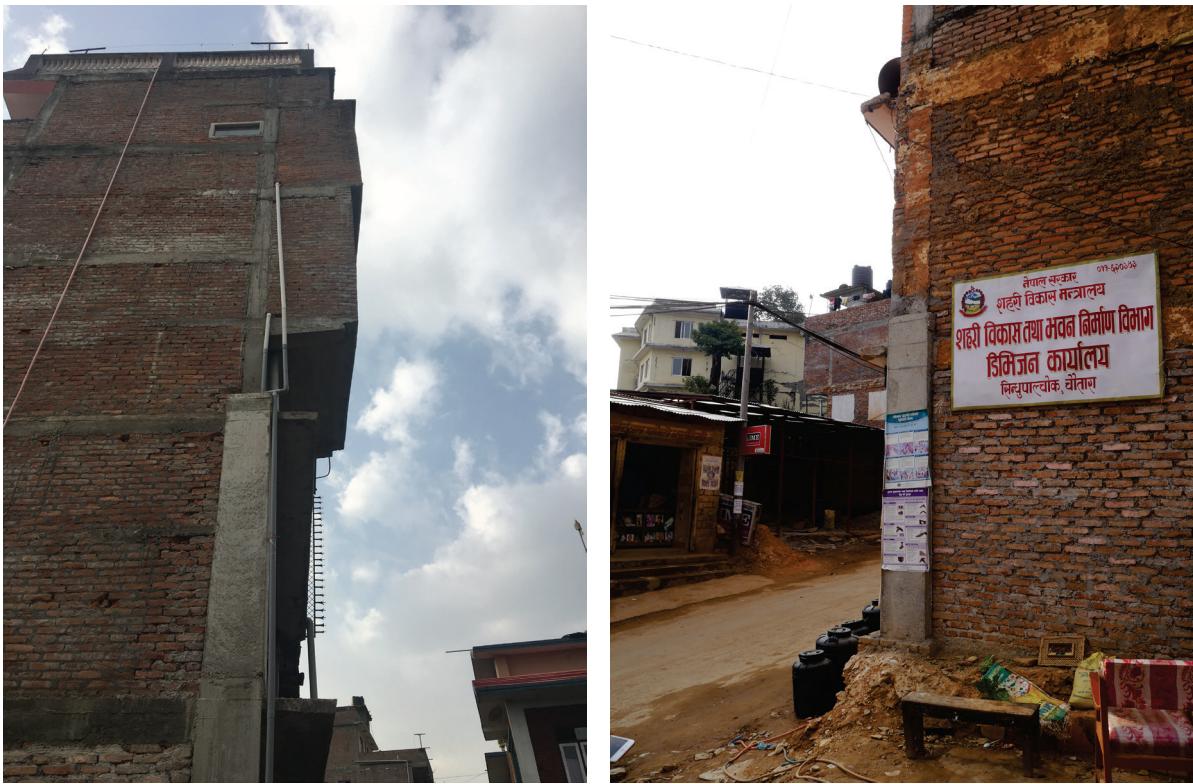
- One residential building was retrofitted by repairing and strengthening damaged exterior columns with fiberglass reinforced plastic (FRP), additional steel rebar, and concrete (Figure 4). The retrofit began in June 2015 and was recently completed. This retrofit was funded by the homeowner.

Figure 4 Photos of apartment building retrofitted with fiber-wrapped columns.

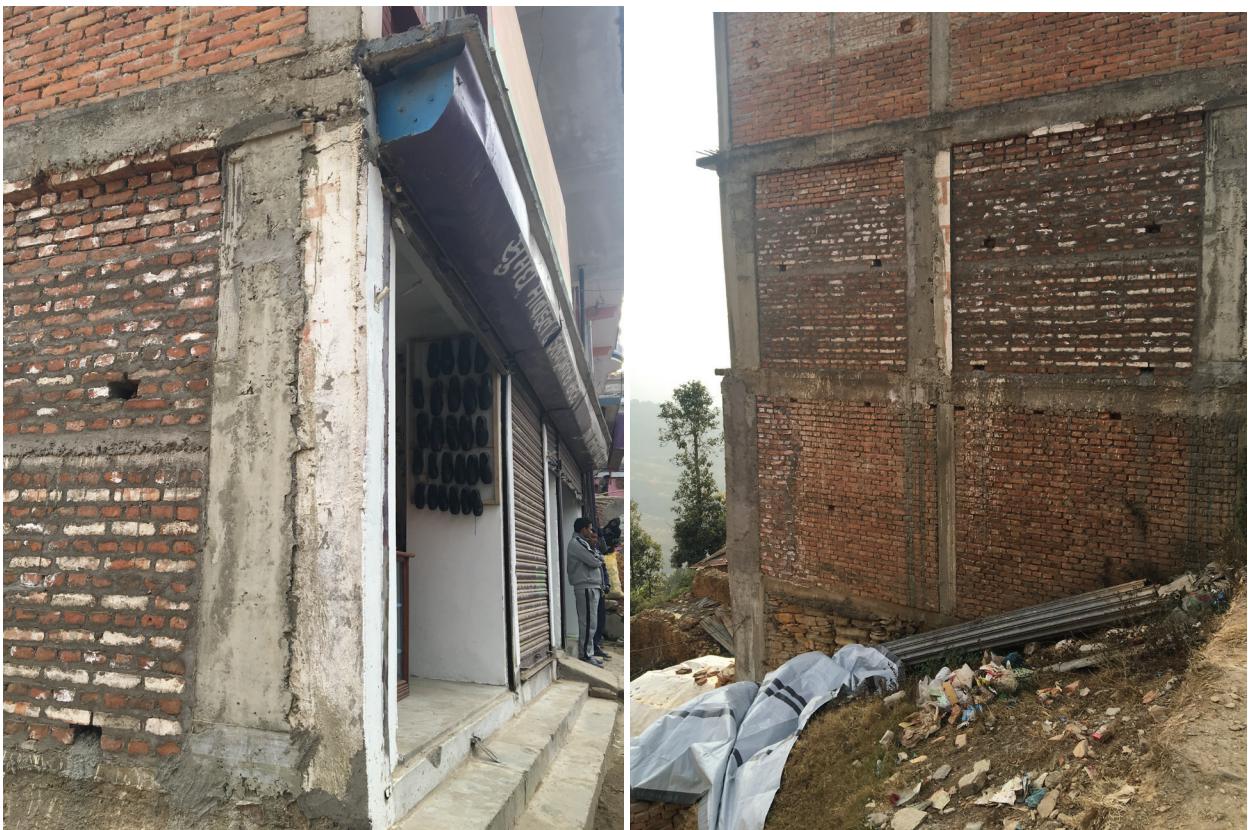
- A typical retrofit scheme observed at several multi-story apartment buildings was column jacketing (Figure 5). According to interviews with homeowners, the retrofit scheme was used because it was “the popular method in Kathmandu” as told to them by the contractor. The method involves removal of a vertical line of bricks in order to add more steel and concrete around the existing column. Note that only the first floor column is being strengthened in this method. One occupant (hotel owner) interviewed was a new tenant. He noted that he insisted on the retrofit before moving his business into the building.

Figure 5 Photos of apartment building retrofitted with column jacketing on lower floors.

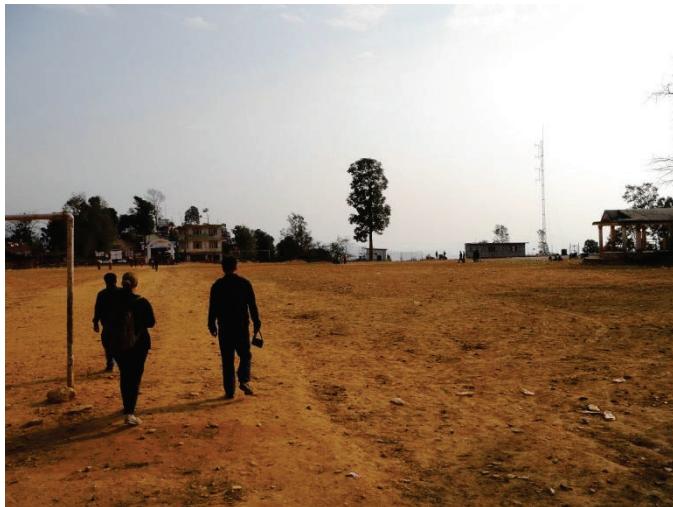
Figure 6 Empty open field where tents had been placed following the earthquake.

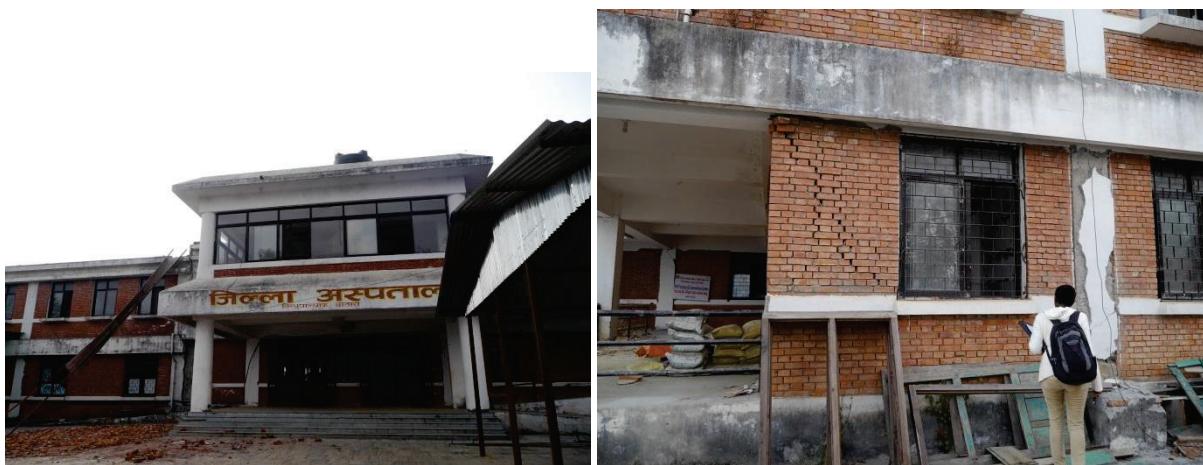
From a functional point of view, the hospital remains unoccupied because it was heavily damaged during the earthquake (Figure 7). The building requires detailed evaluation in order to determine if the building should be repaired and retrofitted or demolished and reconstructed.

Figure 7 Main hospital building with heavy earthquake damage.

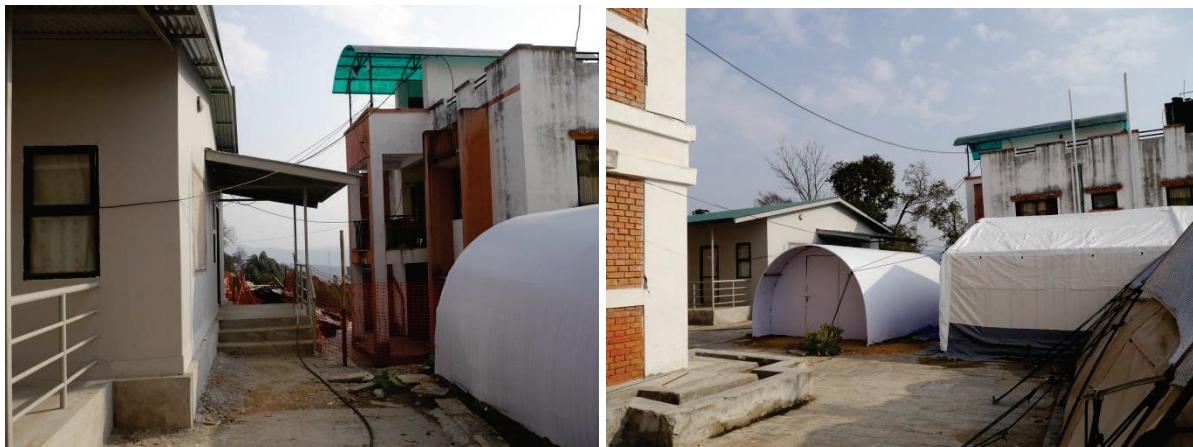
Figure 8 Location of temporary wards.

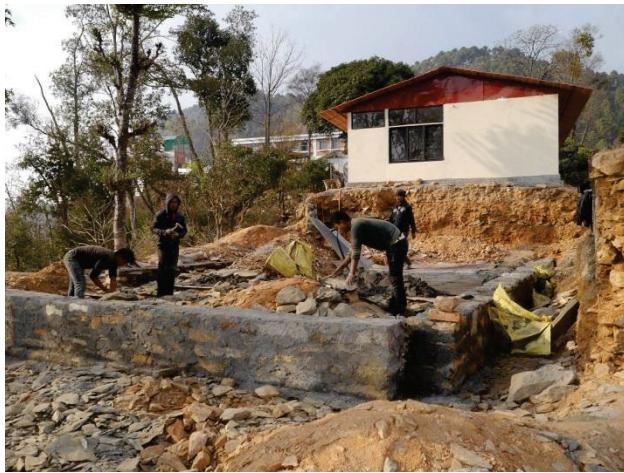
A new eye clinic building is currently being constructed down the street from the hospital building. The foundations were under construction at the time of the HFG visit. The masons had not yet received training from JICA, but will do before the construction of the superstructure (Figure 9).

Figure 9 New eye clinic under construction.

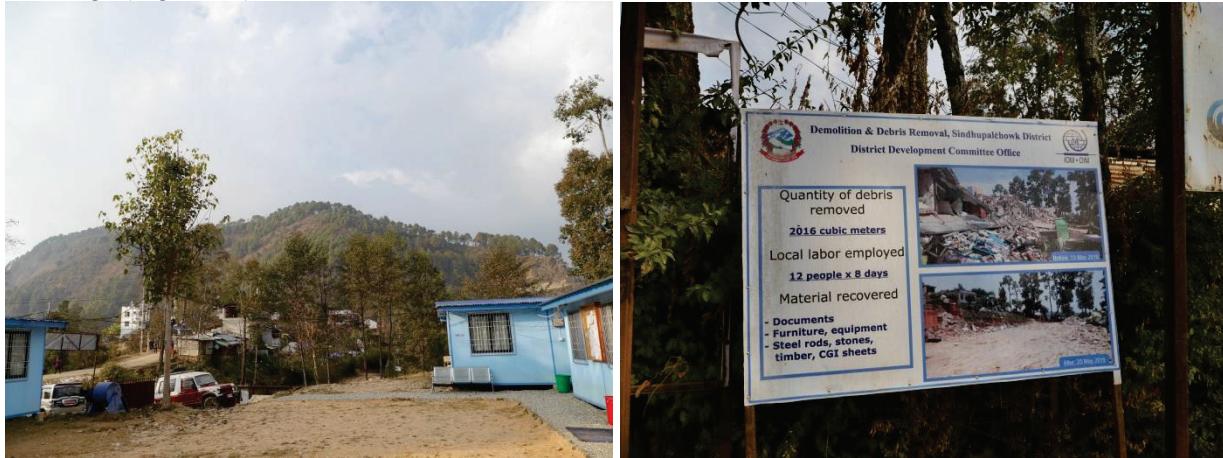
The damaged municipal services building was demolished and replaced with temporary pre-engineered buildings (Figure 10).

Figure 10 Temporary buildings erected for municipal services and information bulletin boards regarding debris removal services.

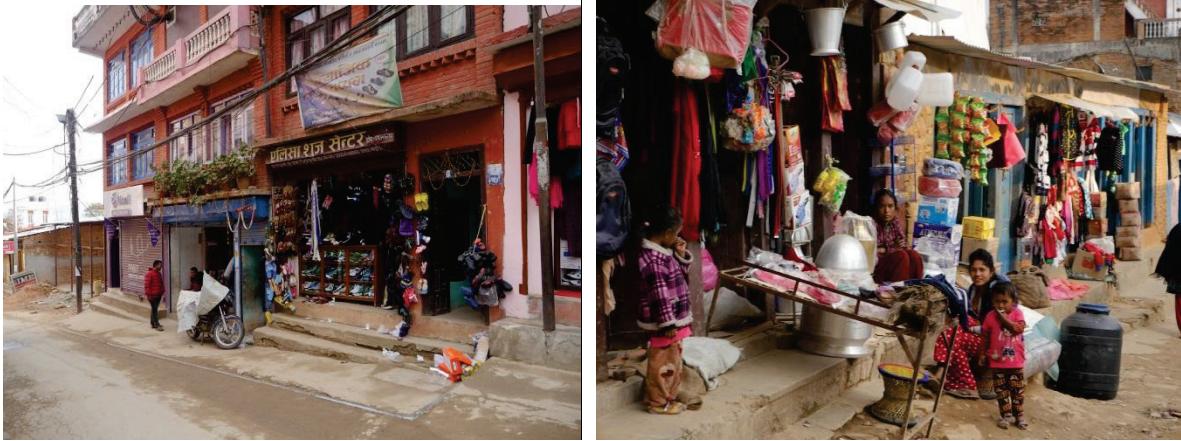
It was observed during the HFG visit that many of the shops were open and business was being conducted “as usual” (Figure 11). It was clear that shops were well stocked and the HFG did not hear of any shortages in any particular supplies. It was noted in several instances that business was being carried out of buildings that had been marked by red tags denoting the building was not safe for occupation.

Figure 11 Photos of open businesses on the streets of Chautara.
