Building damage patterns in Kathmandu Valley due to 25th April Earthquake

Kiran Acharya (acharyakiranraj@gmail.com, kacharya@baseengr.com)

This report presents the nature of the earthquake that struck Nepal on 25th April, 2015 and the damages observed in the buildings in Kathmandu valley.

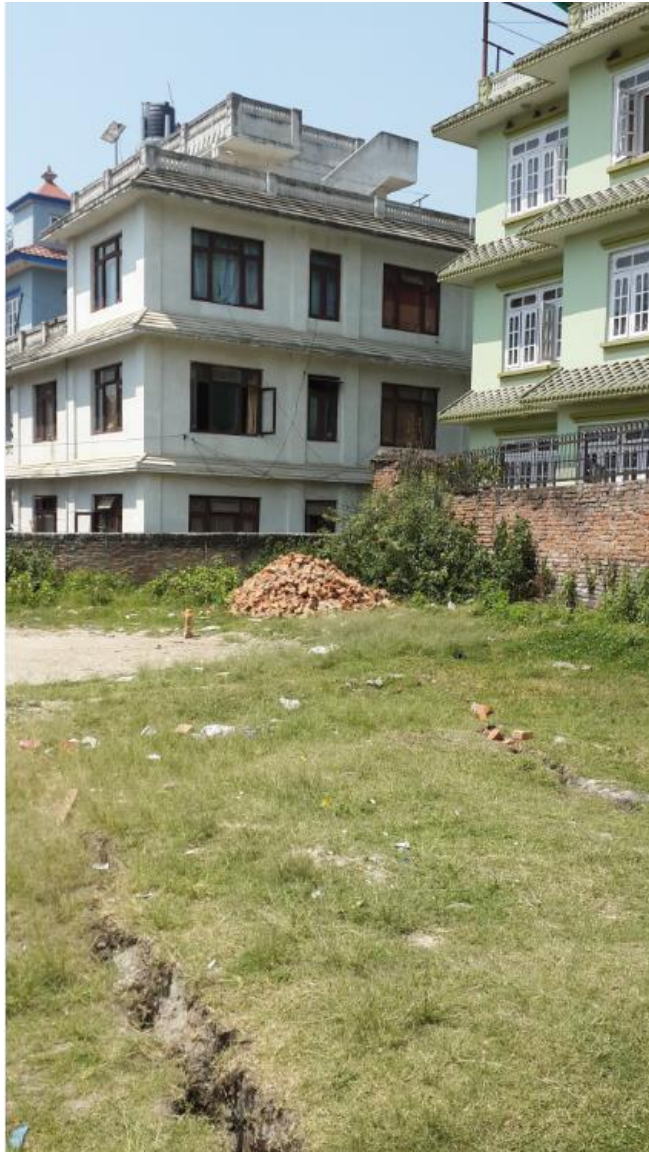
Figure- Ground fissures in Bhaktapur district. There is no damage in the nearby houses seen in the photo *(Photo by Kiran Acharya)*

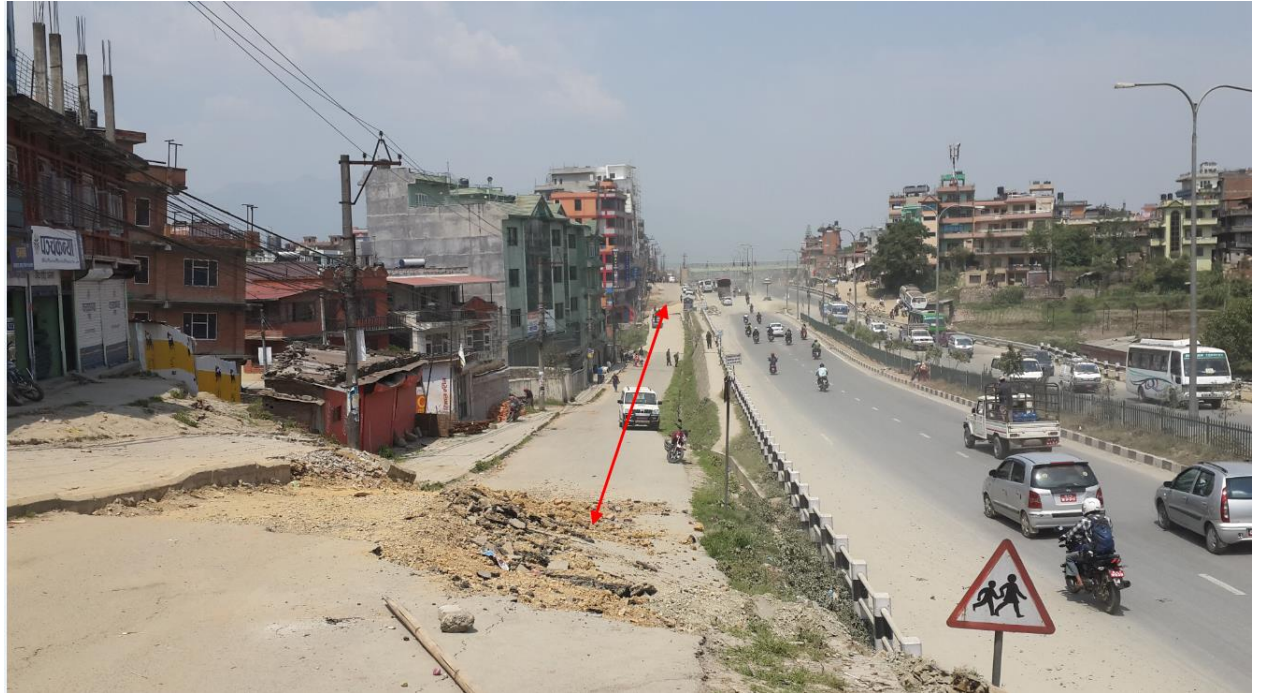
The land along the marked width has been settled by around 1.5 m. No major cracks in the surrounding houses except tilting and shifting of the affected house. *(Photo by Kiran Acharya)*

7. No major damage in the components of the building near to surface fissures. However they suffer excessive tilting and settlement
8. Collapse of the cultural heritages dated back up to 5th century.

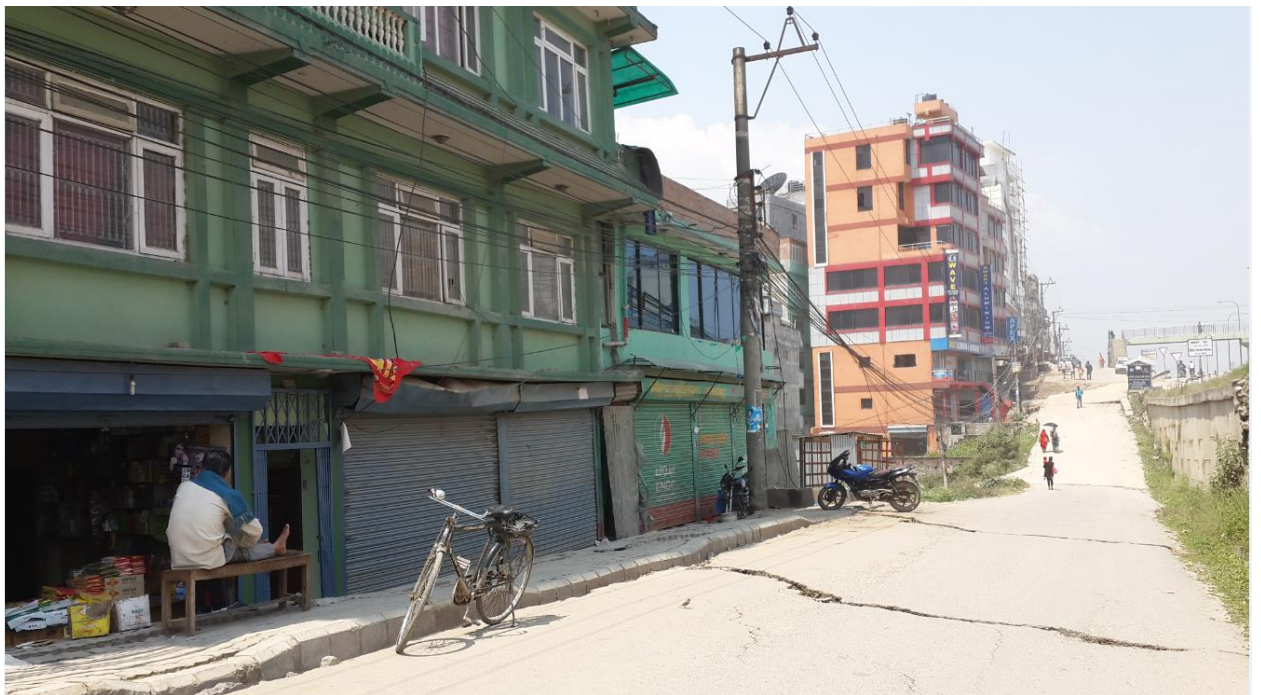
Surface ruptures in the settled part of the land *(Photo by Kiran Acharya)*

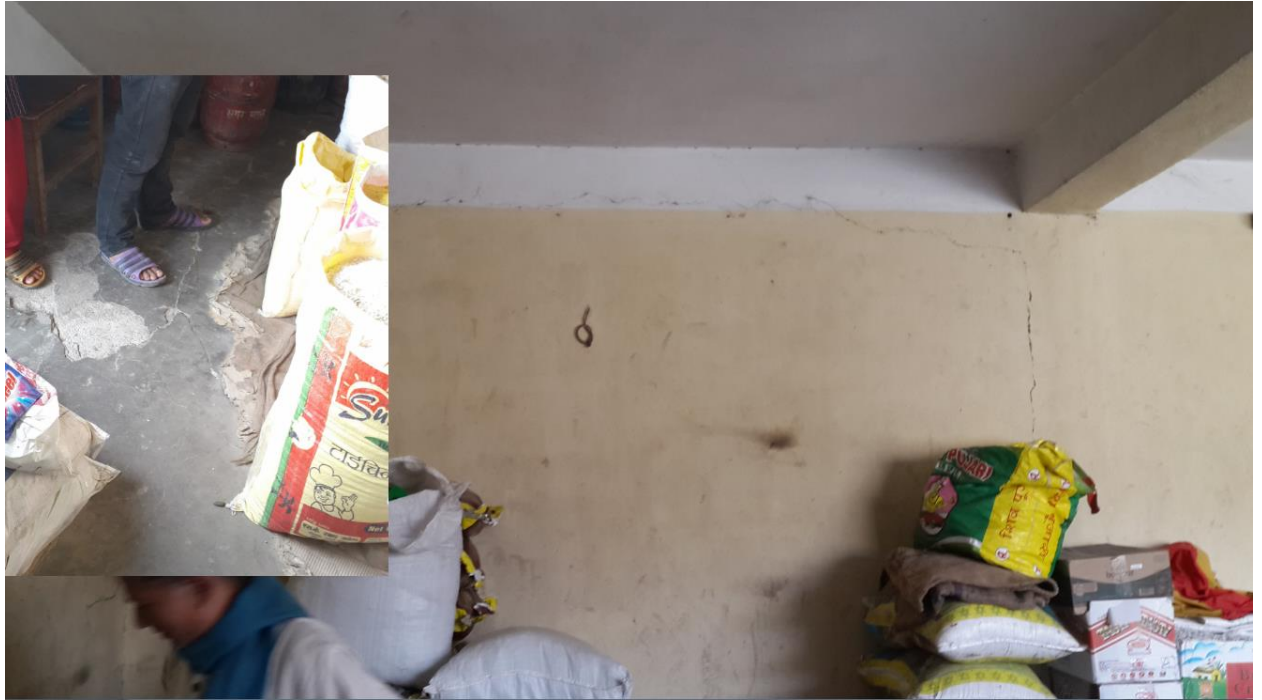
Maximum damages on the walls and floors of the green house seen in the previous figure.
(Photo by Kiran Acharya)

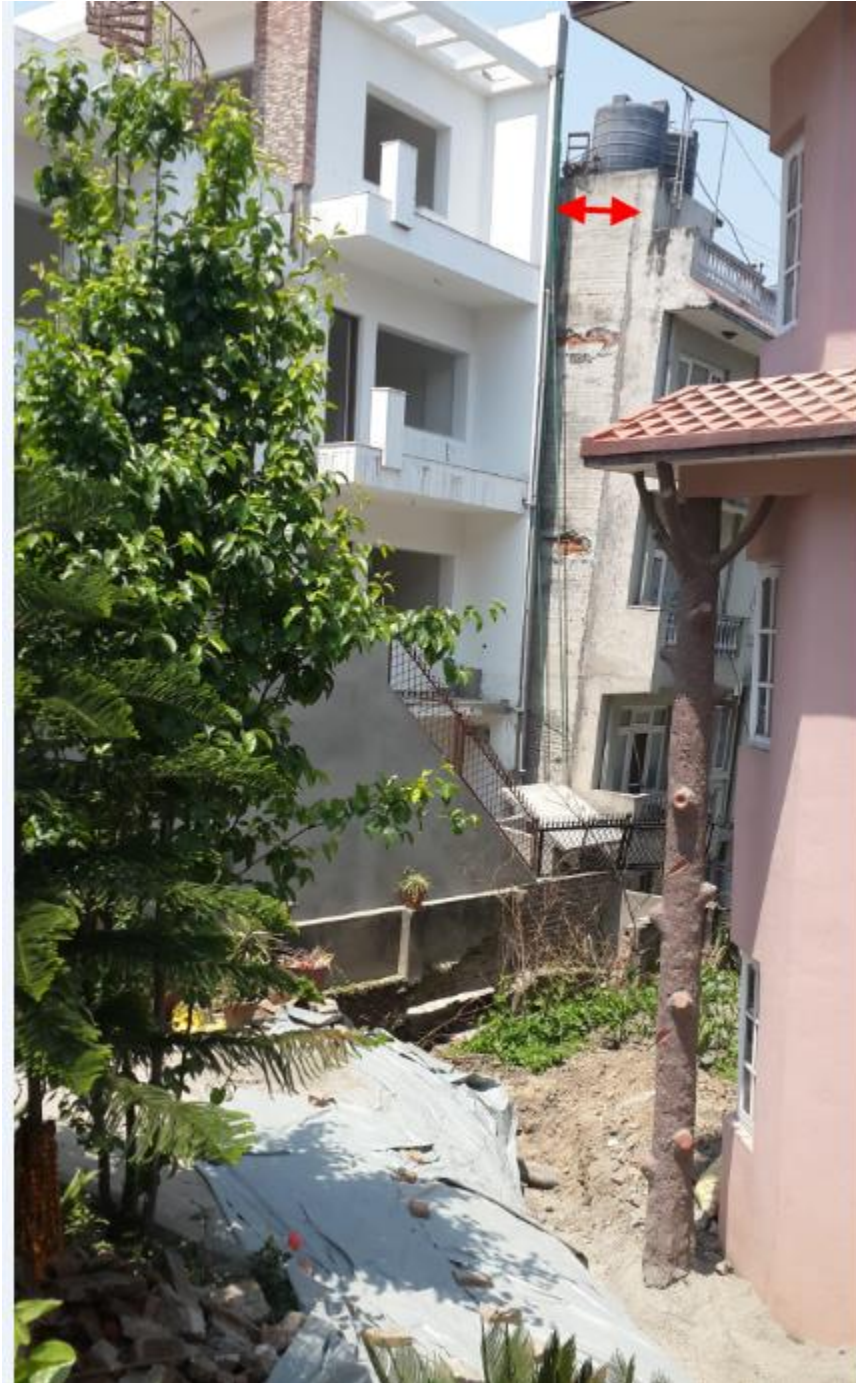
Tilting of the house by around 1 m near the surface cracks (Photo by Kiran Acharya)

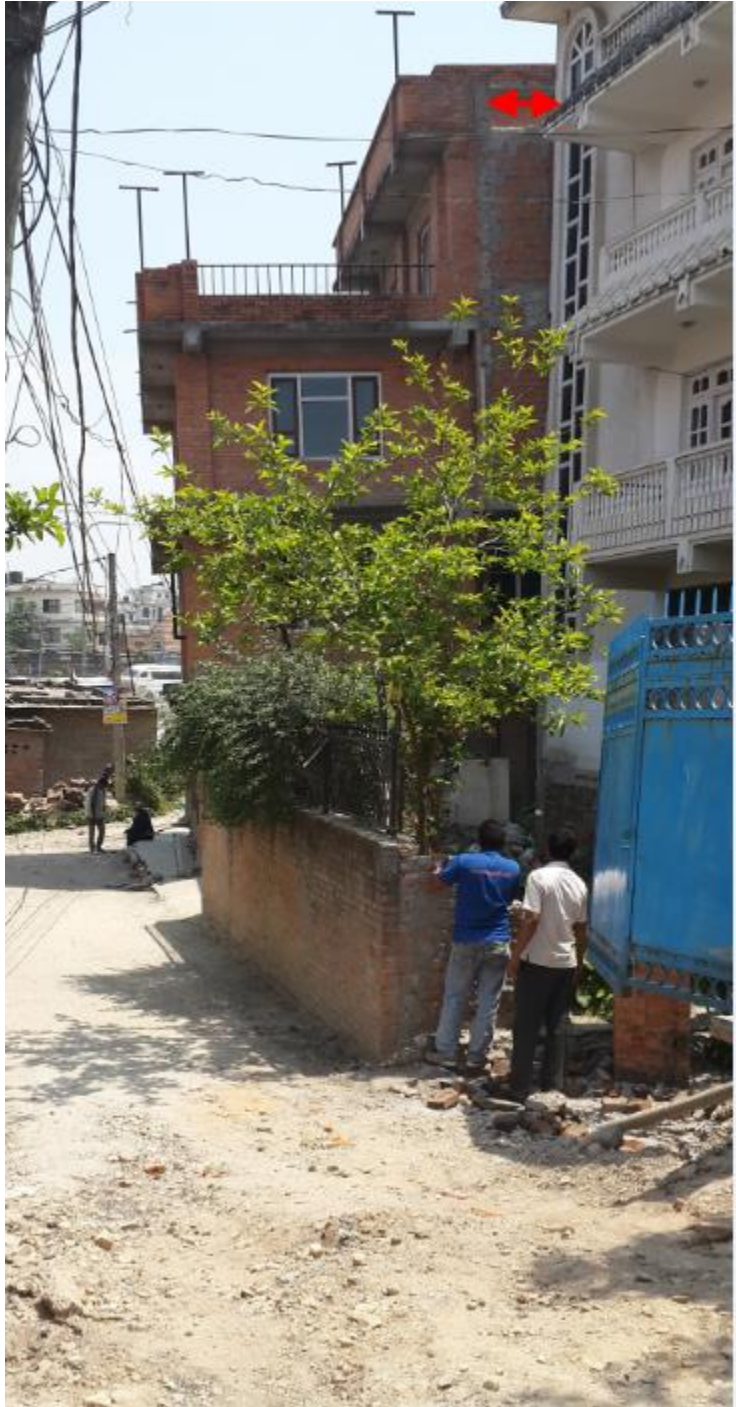
Tilting of the red house. No structural damage in the white house (Photo by Kiran)

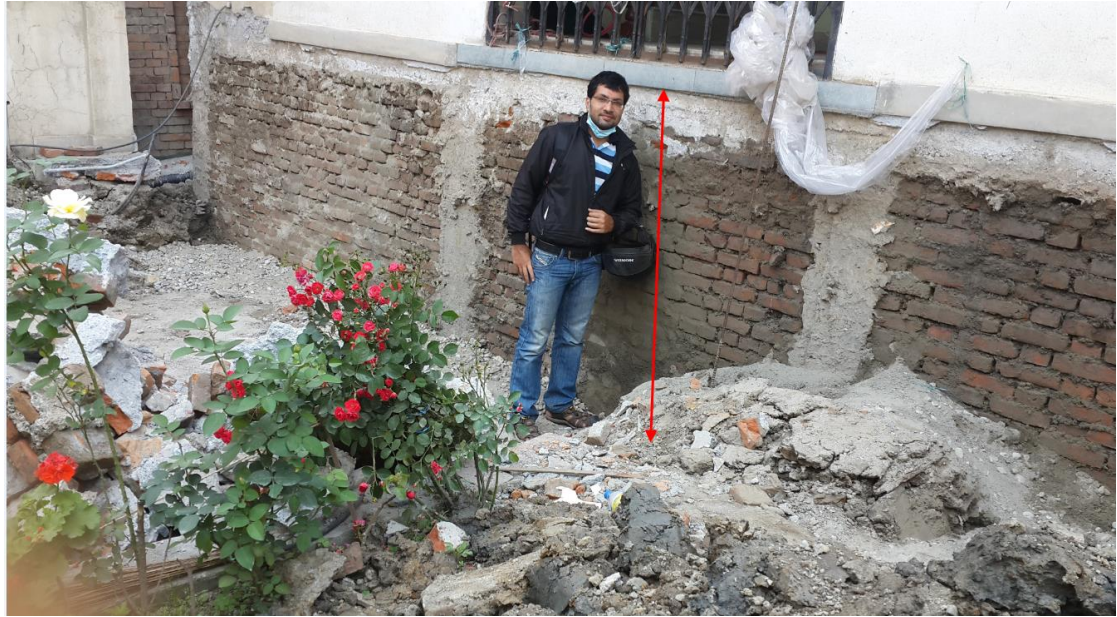
Settlement of the front garden of the white house seen in the previous figure by around 1.5 m (Photo by Kiran)

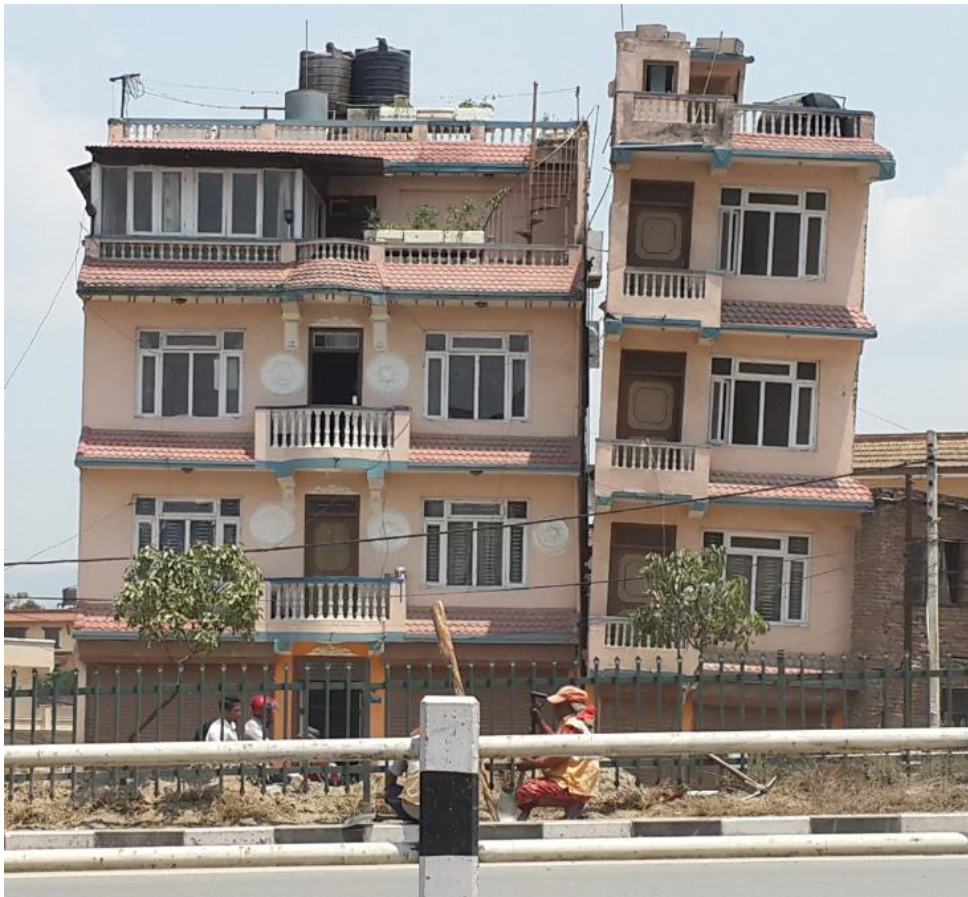
Houses near the surface rupture. These are two different houses (Photo by Kiran)

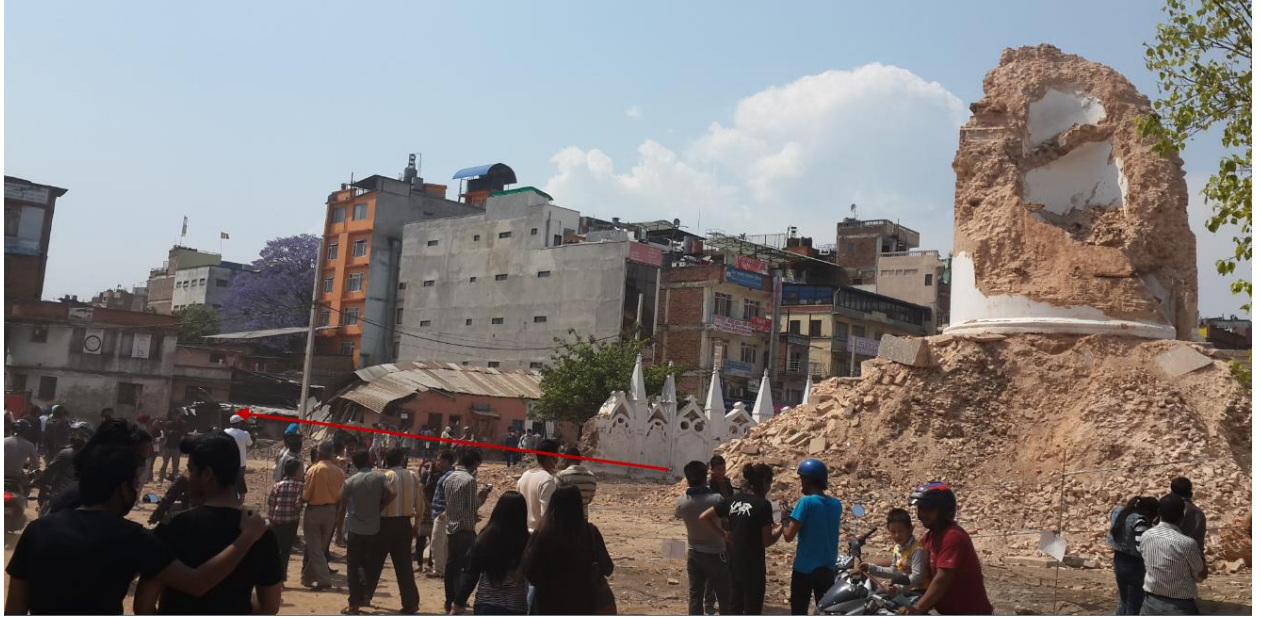
Stump of the 9 storey tall Dharahara tower. It felled down towards the marked direction
(Photo by Kiran)

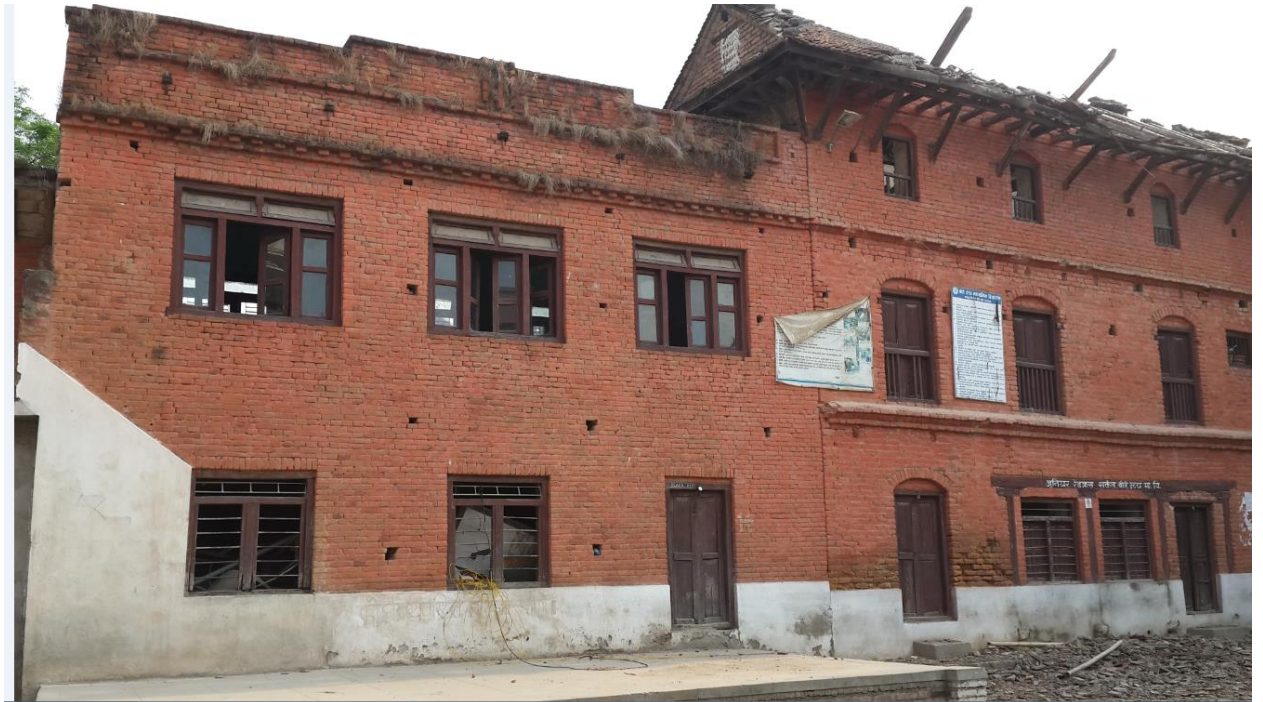
Damage in the roofs of a school in Bhaktapur. There are not even minor cracks at other locations (Photo by Kiran)

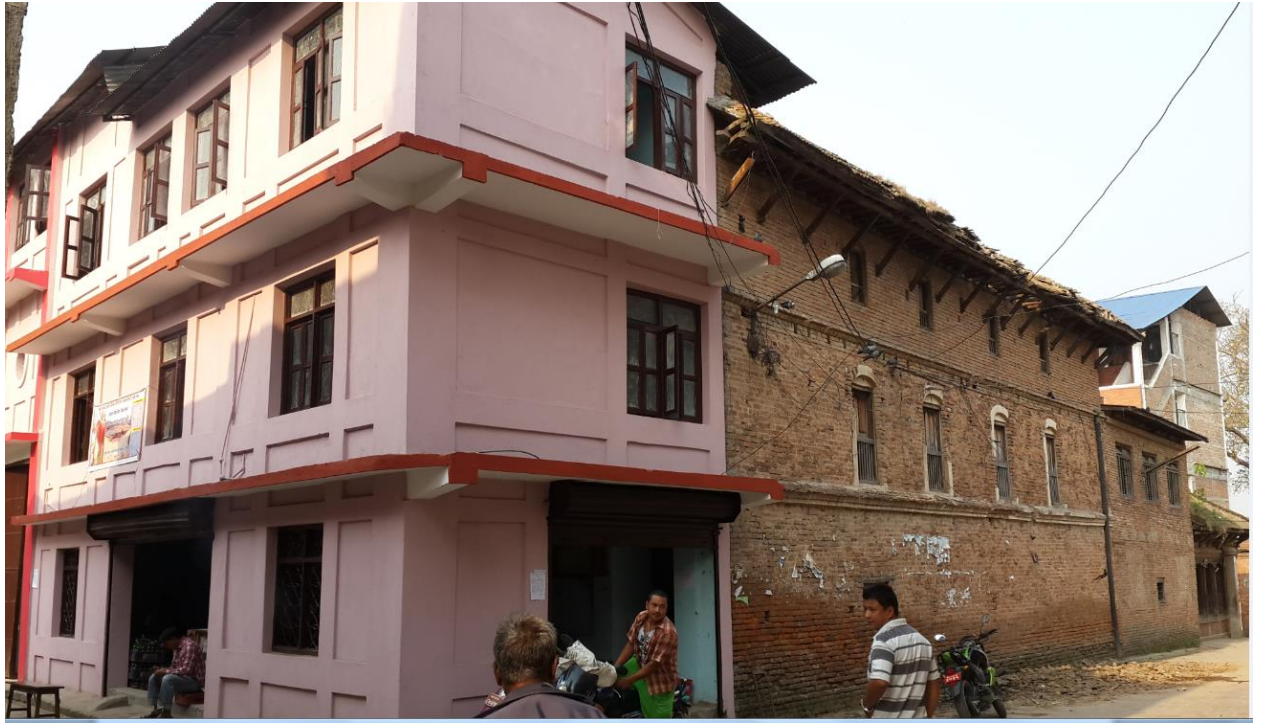
Pink colored is the retrofitted part of the school while the other had not been retrofitted.
(Photo by Kiran)

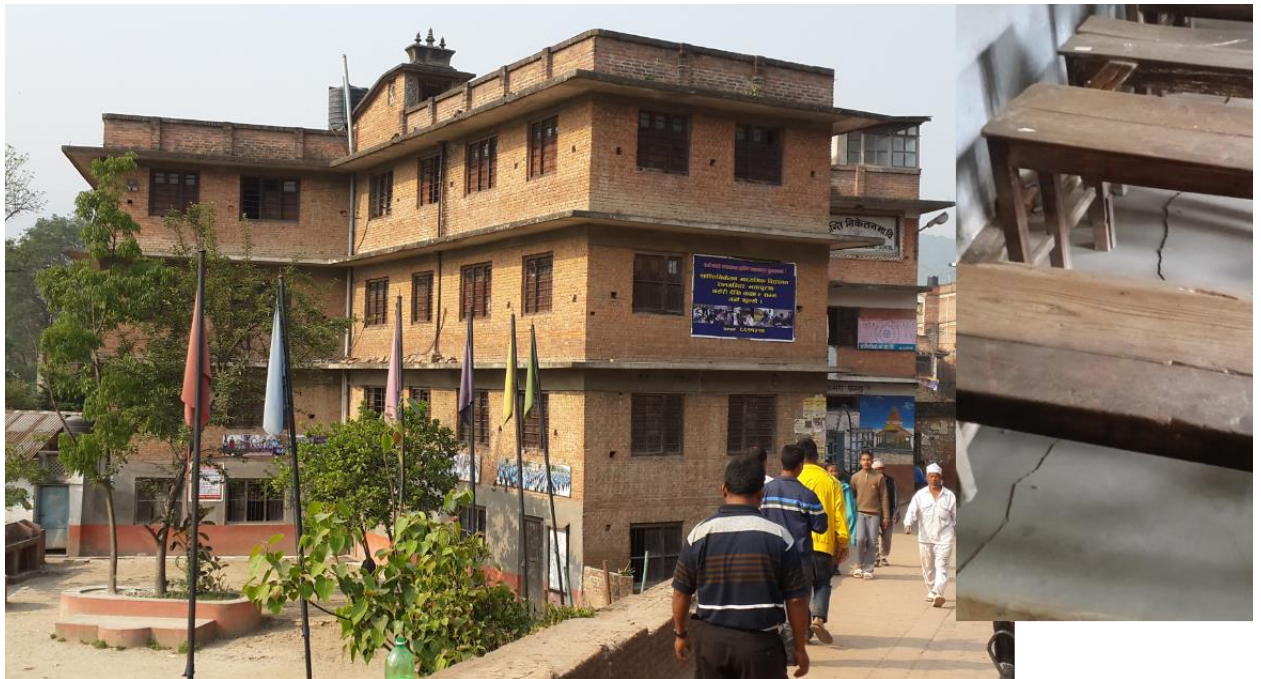
This "Y" Shaped 4 story school building has no cracks on the walls except on the floor of one room on ground floor, shown aside. (Photo by Kiran)

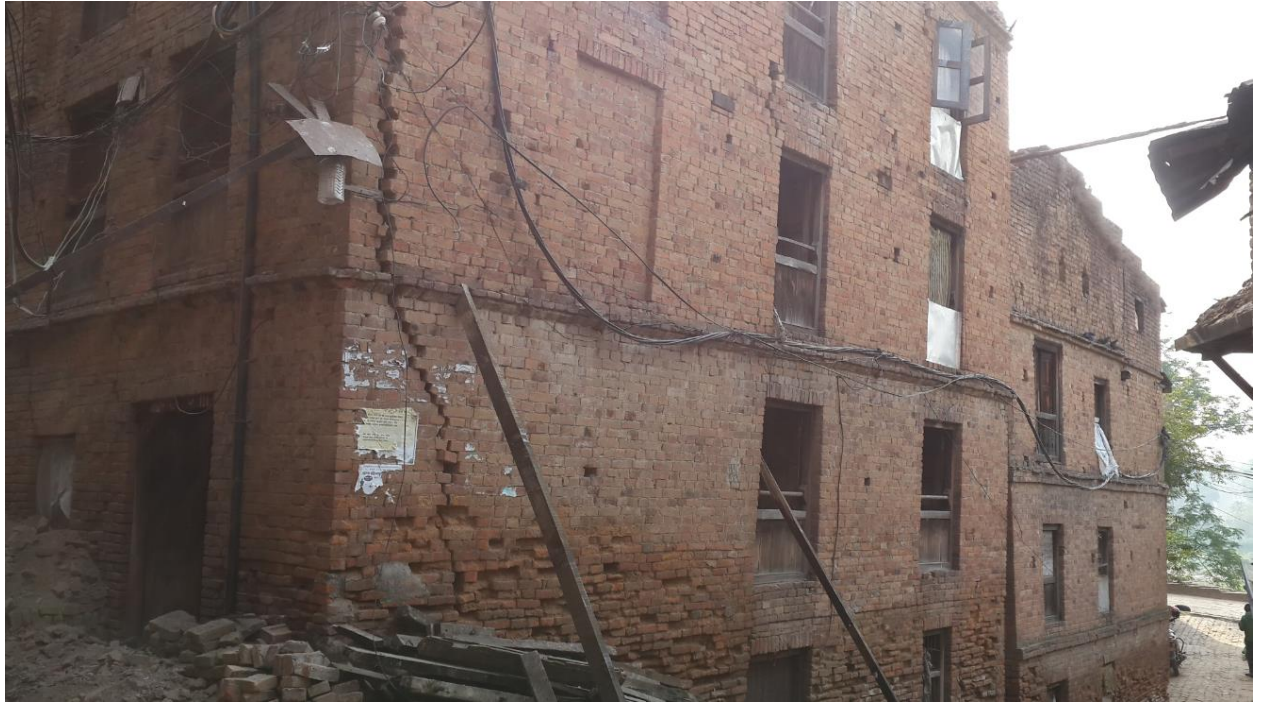
Damaged house near to the “Y” shaped school building. (Photo by Kiran)

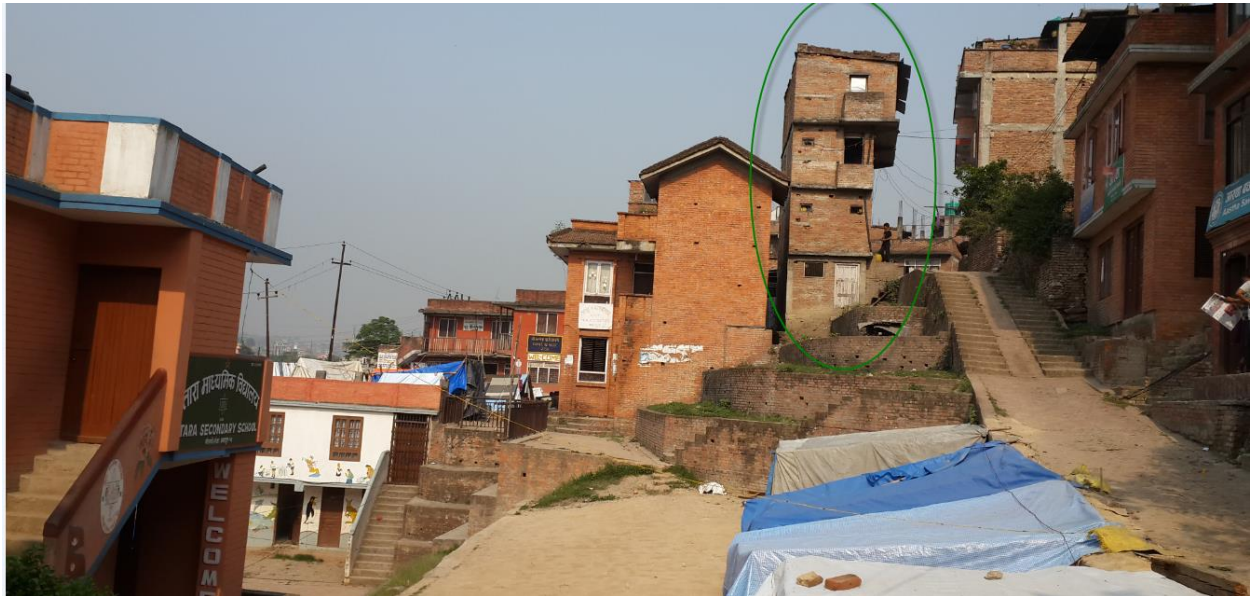
Surprisingly no damage in the marked house, near to the above cracked house. The building on the left corner of the photograph is the retrofitted school building which has no damage at all. (Photo by Kiran)

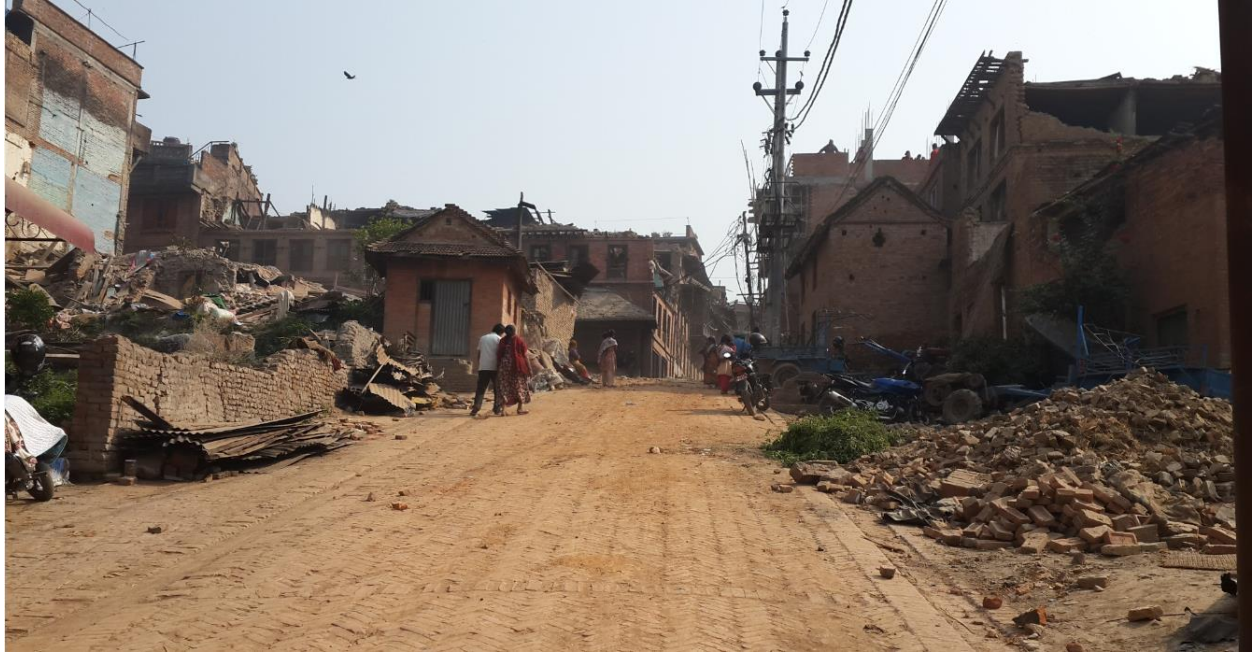
Damaged old houses in the village of Bhaktapur district (Photo by Kiran)

9. Complete collapse of the over aged masonry buildings.
10. Partial collapse of the wooden roofs of relatively new load bearing masonry buildings. Other part of the building remain intact with no critical damage

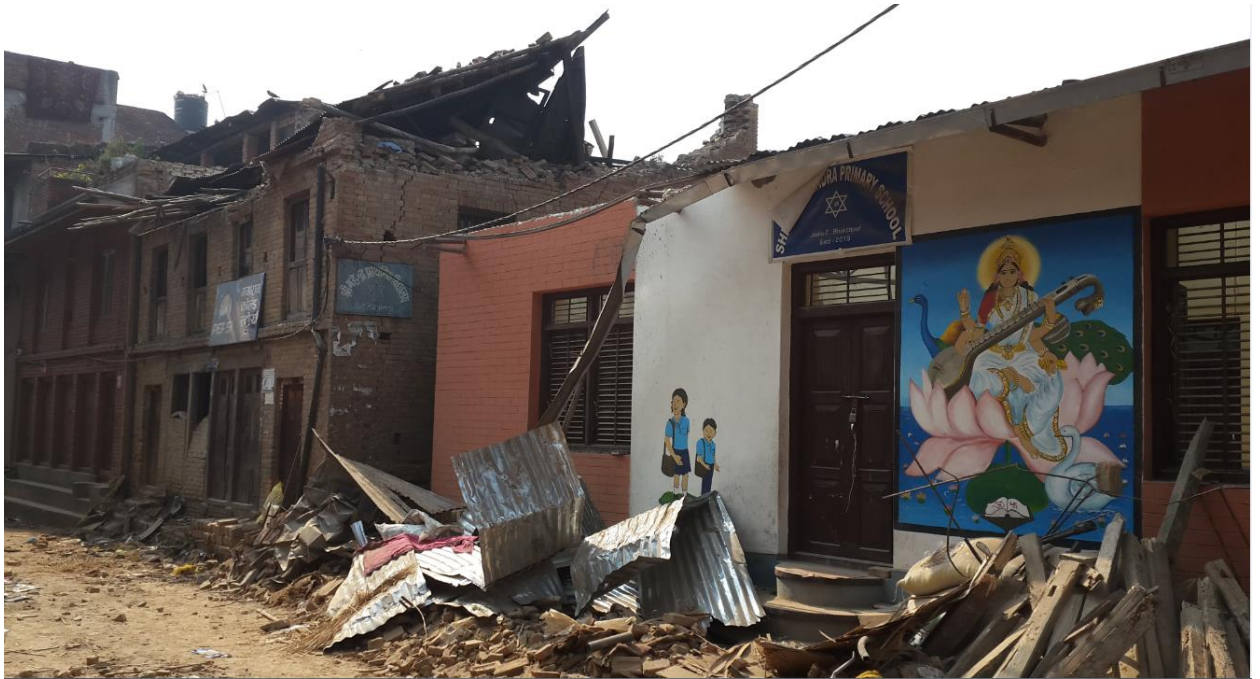
Roof of the retrofitted school building is damaged by the adjacent house (Photo by Kiran)

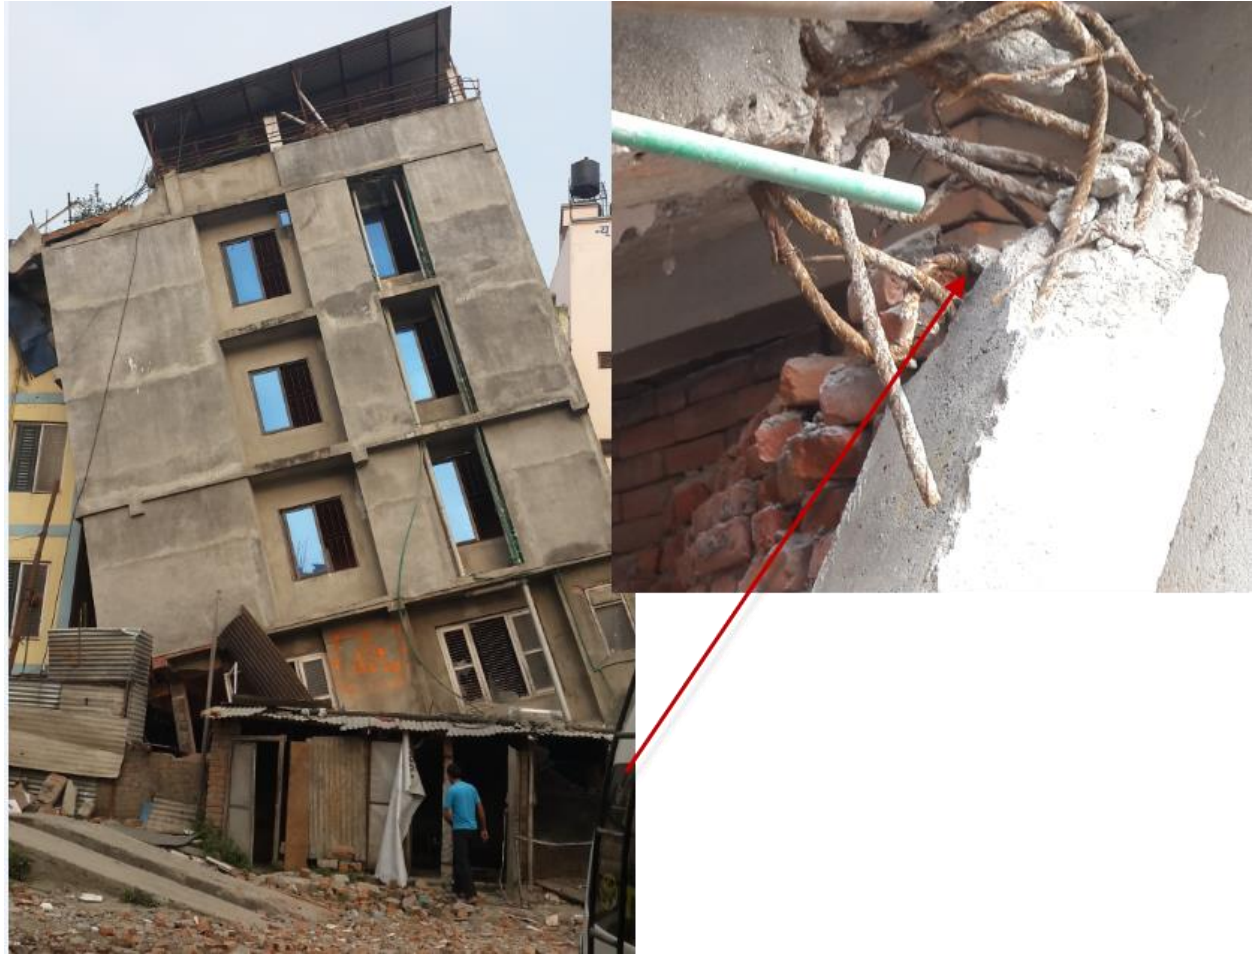
Column shear failure on the ground floor of the house Balaju, Kathmandu (*Photo by Kiran*)

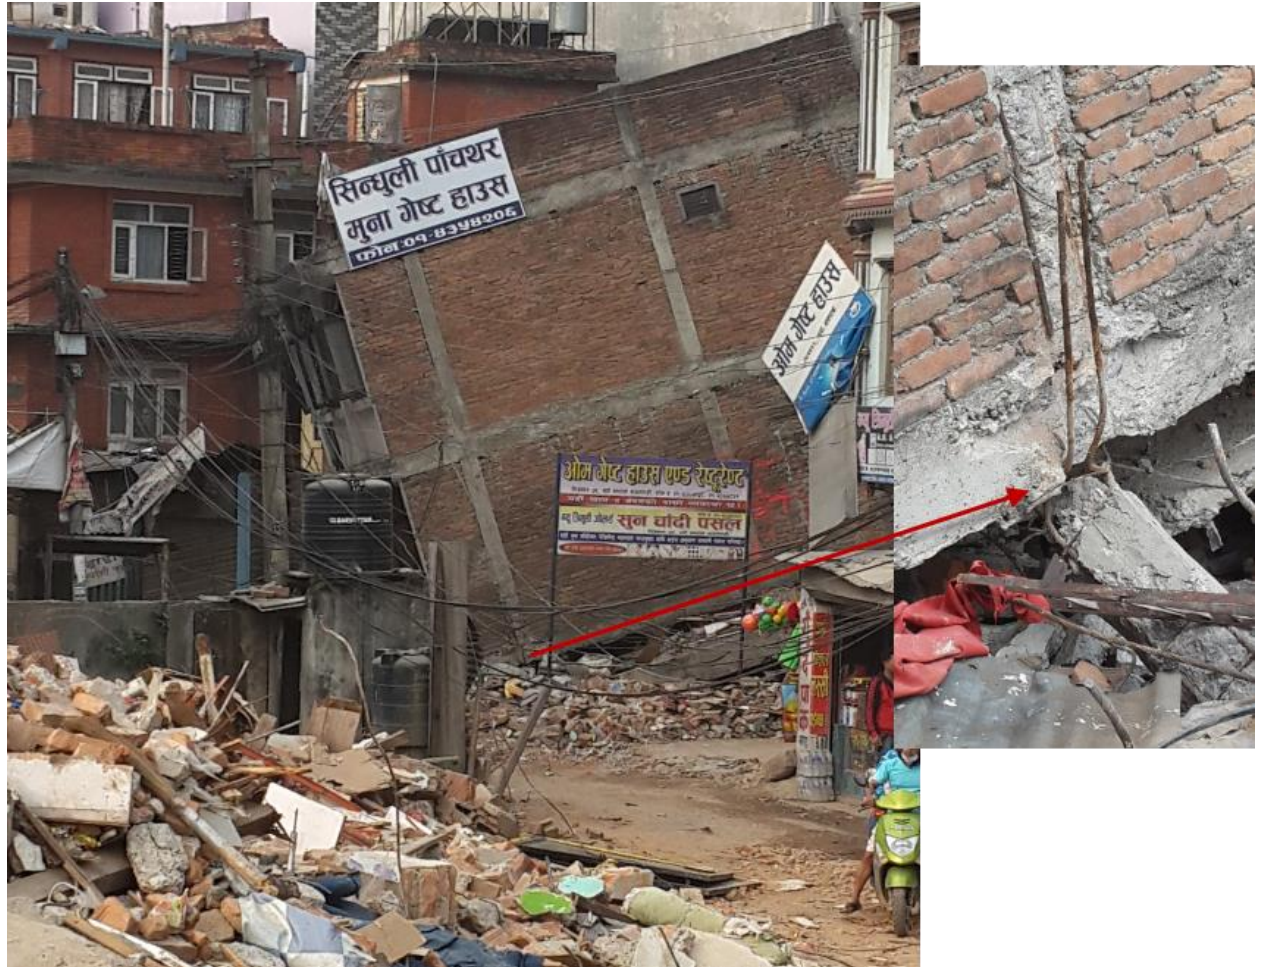
Damaged column of the house in Balaju, Kathmandu area (Photo by Kiran)

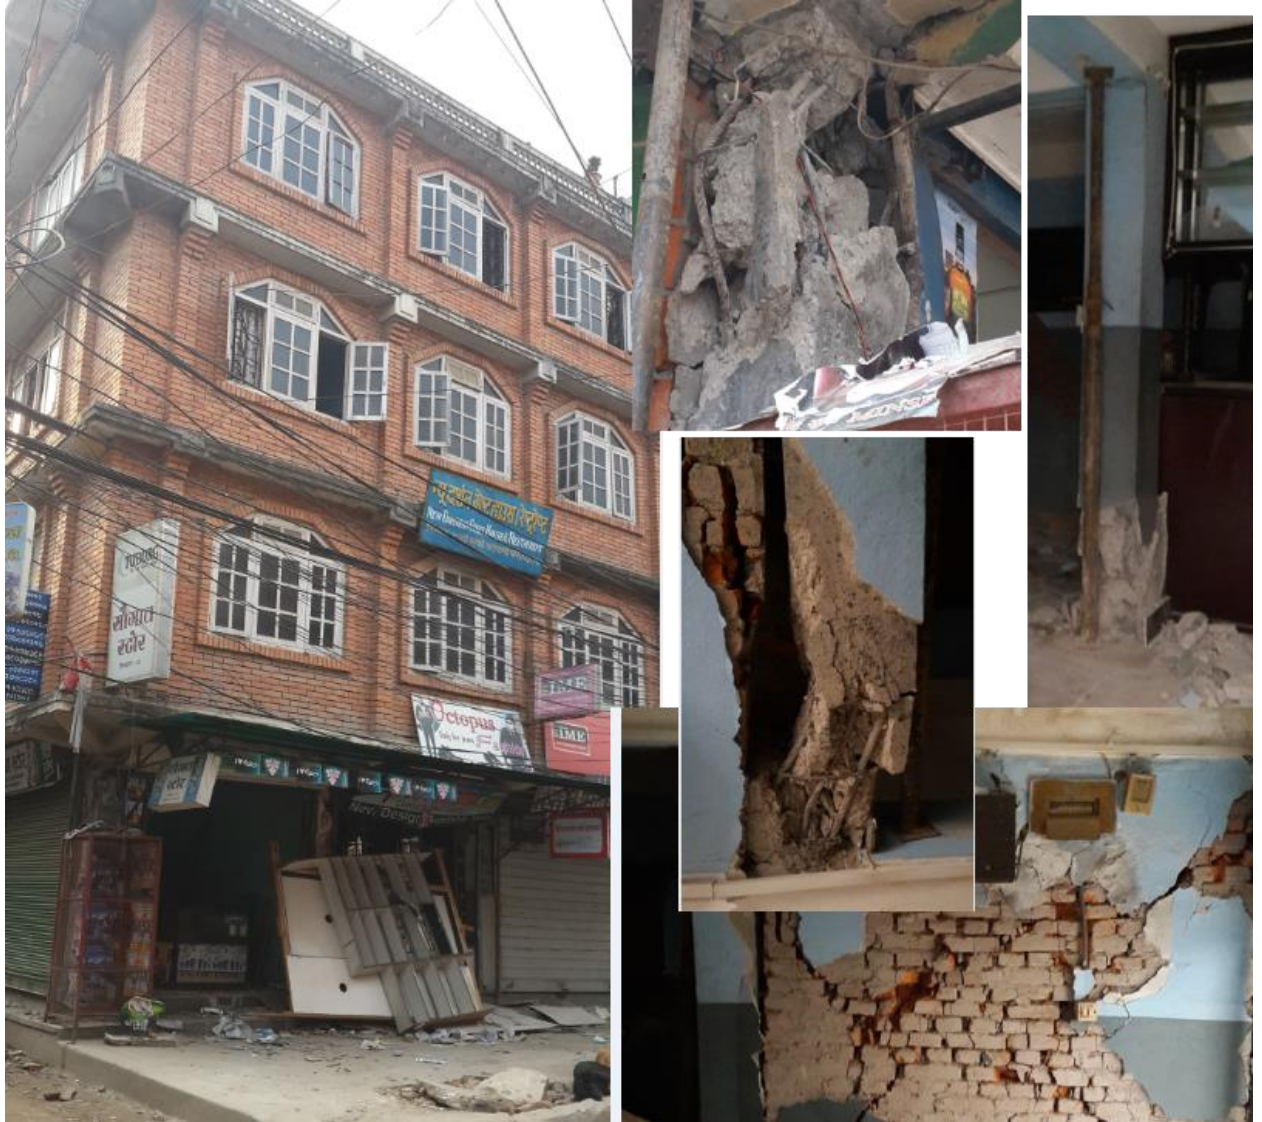
Damages in the interior walls and columns of the house in Balaju, Kathmandu. Longitudinal rebar are buckled after concrete crushing at the soffit of the beam and at column base (Photo by Kiran)

4. Most of the columns are failed by crushing of the concrete at the soffit of the beam or at column base leading to the subsequent buckling of the longitudinal bars.

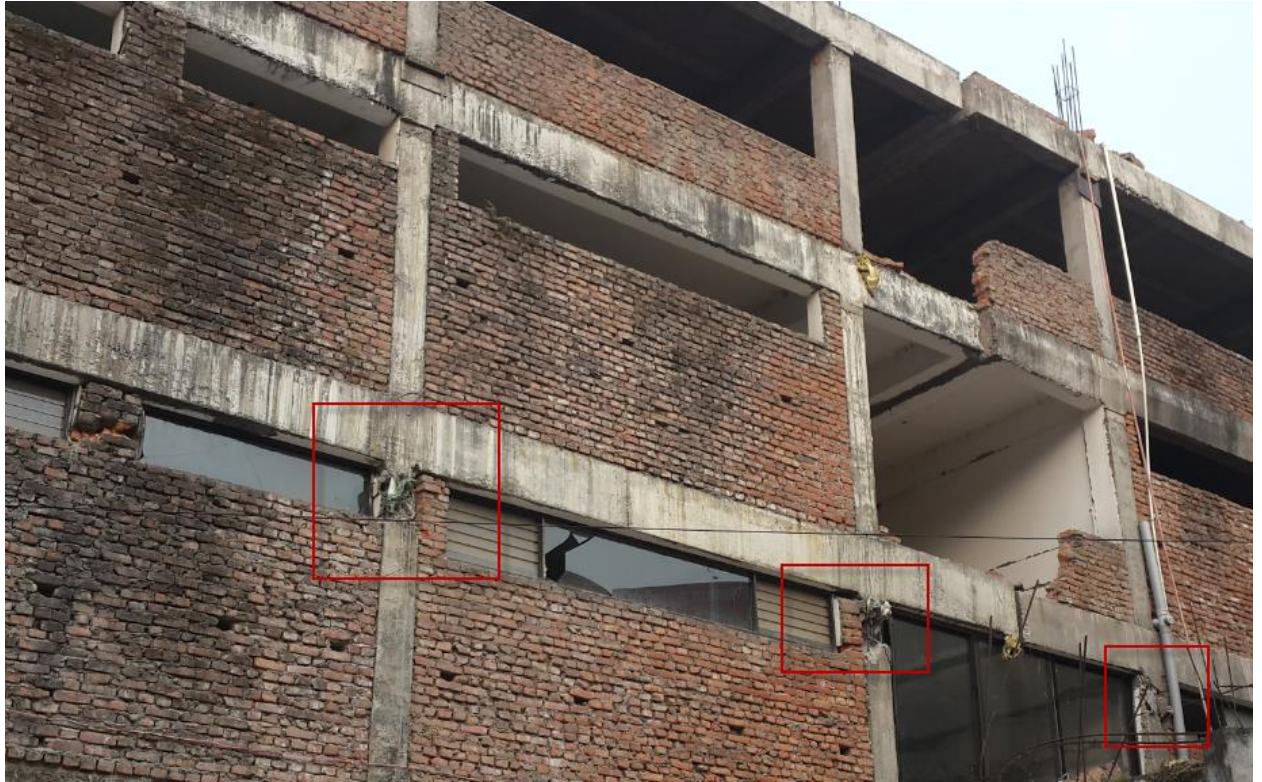
Shear failure of the columns on ground story at the soffit of the beam due to short column effect induced by the infill wall in Balaju, Kathmandu (*Photo by Kiran*)

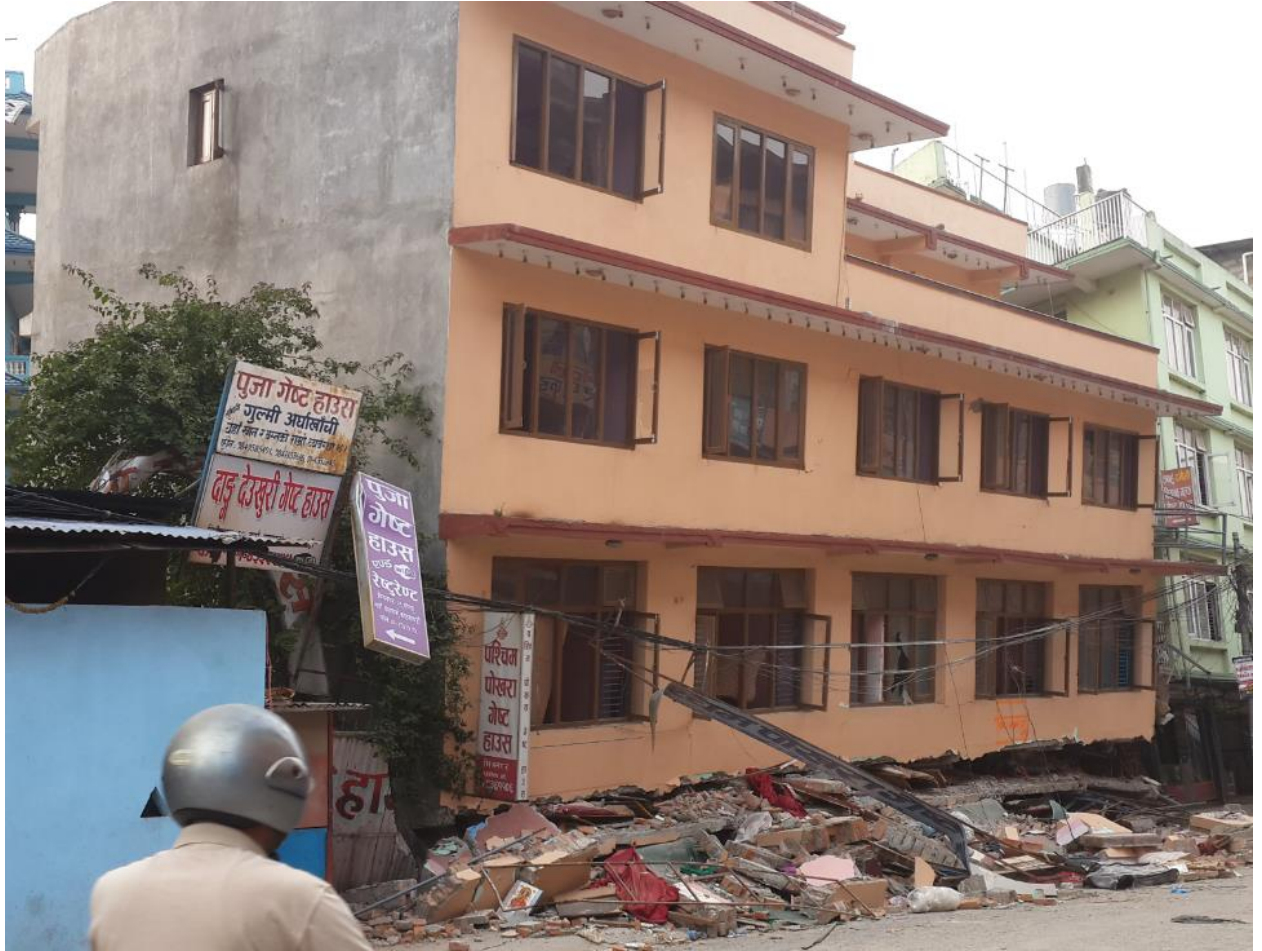
Complete collapse of first two story of a five story house Balaju, Kathmandu, due to soft story effect. There were no infill walls at the periphery of the ground floor. (Photo by Kiran)

6. Complete collapse of the ground floor and in some cases up to 2nd floor of mid-rise buildings (4 to 6 story tall) due to soft story mechanism. This kind of buildings did not have infill walls on the periphery grid on ground floor for commercial purpose and the column sizes were 9"x9".

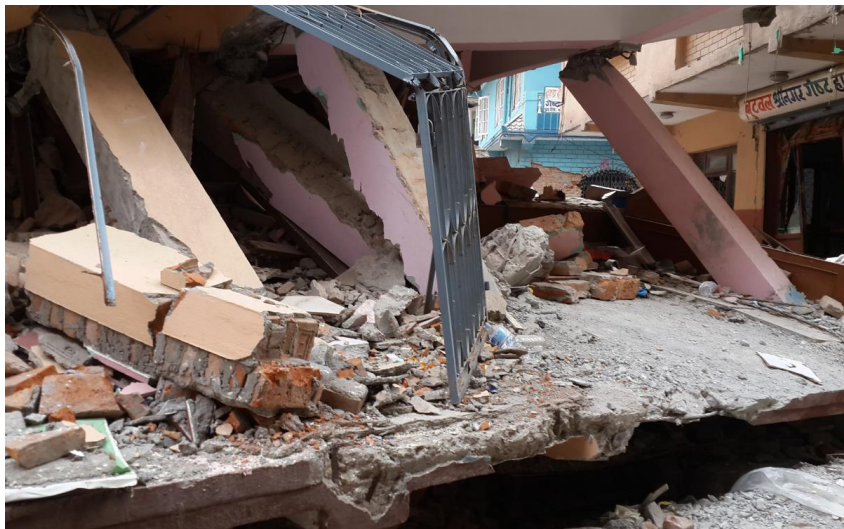
Close up view of the damaged columns of the previous building. (Photo by Kiran)

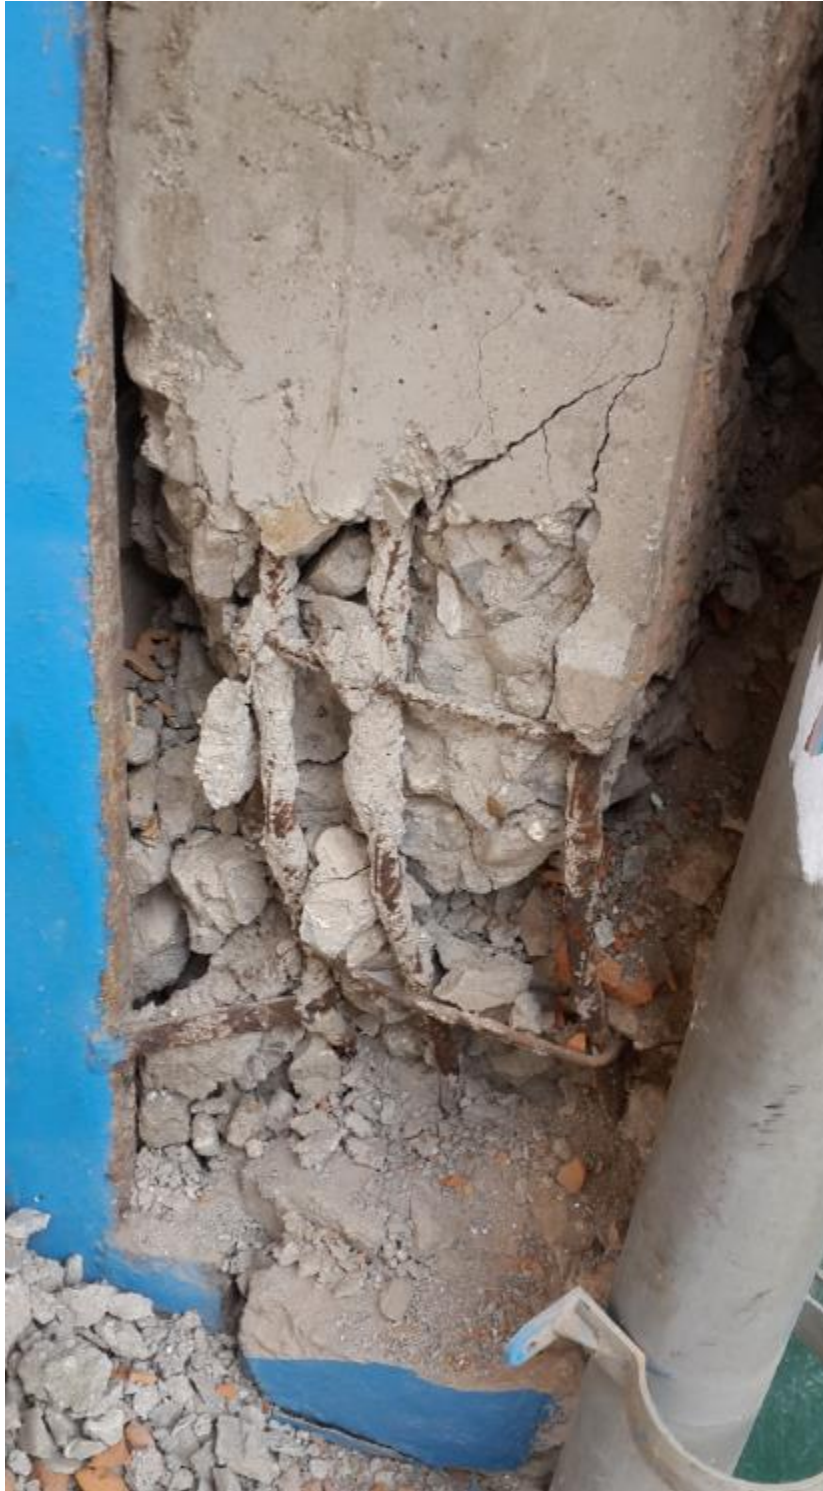
Shear failure of the column at base of other building in Balaju, Kathmandu. *(Photo by Kiran)*
