Building damage patterns in Kathmandu Valley due to 25th April Earthquake

Kiran Acharya (acharyakiranraj@gmail.com, kacharya@baseengr.com)

This report presents the nature of the earthquake that struck Nepal on 25th April, 2015 and the damages observed in the buildings in Kathmandu valley.

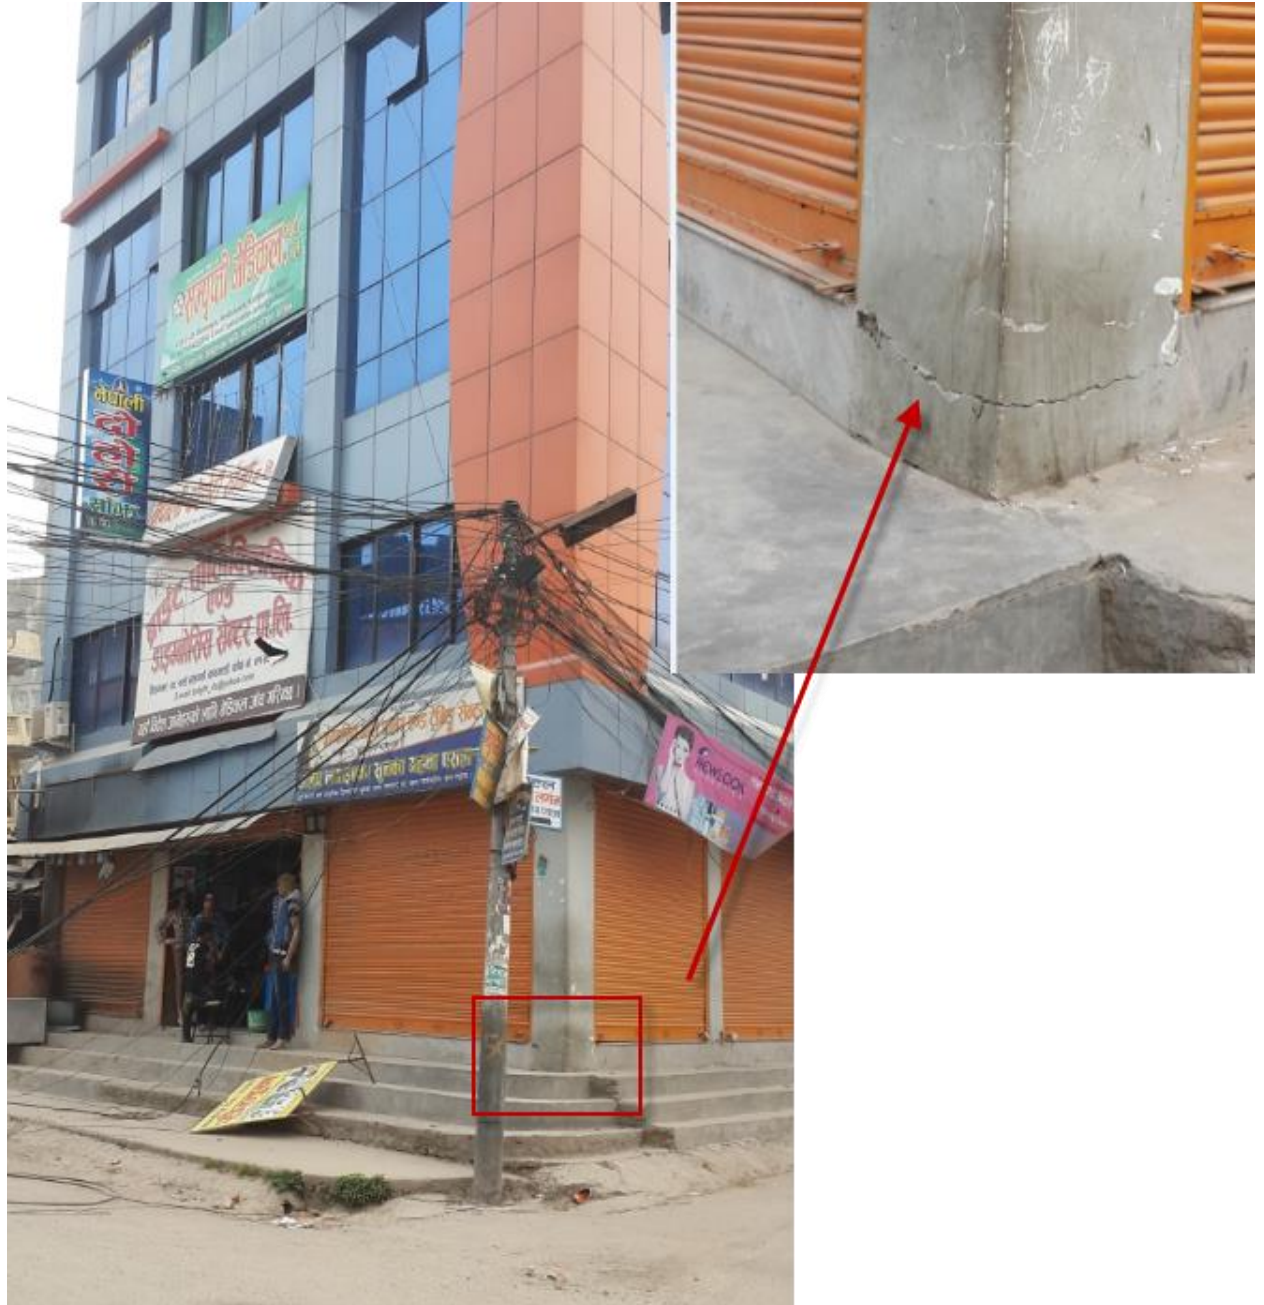
Critical flexural crack at the column base in the building in Balaju, Kathmandu (Photo by Kiran)

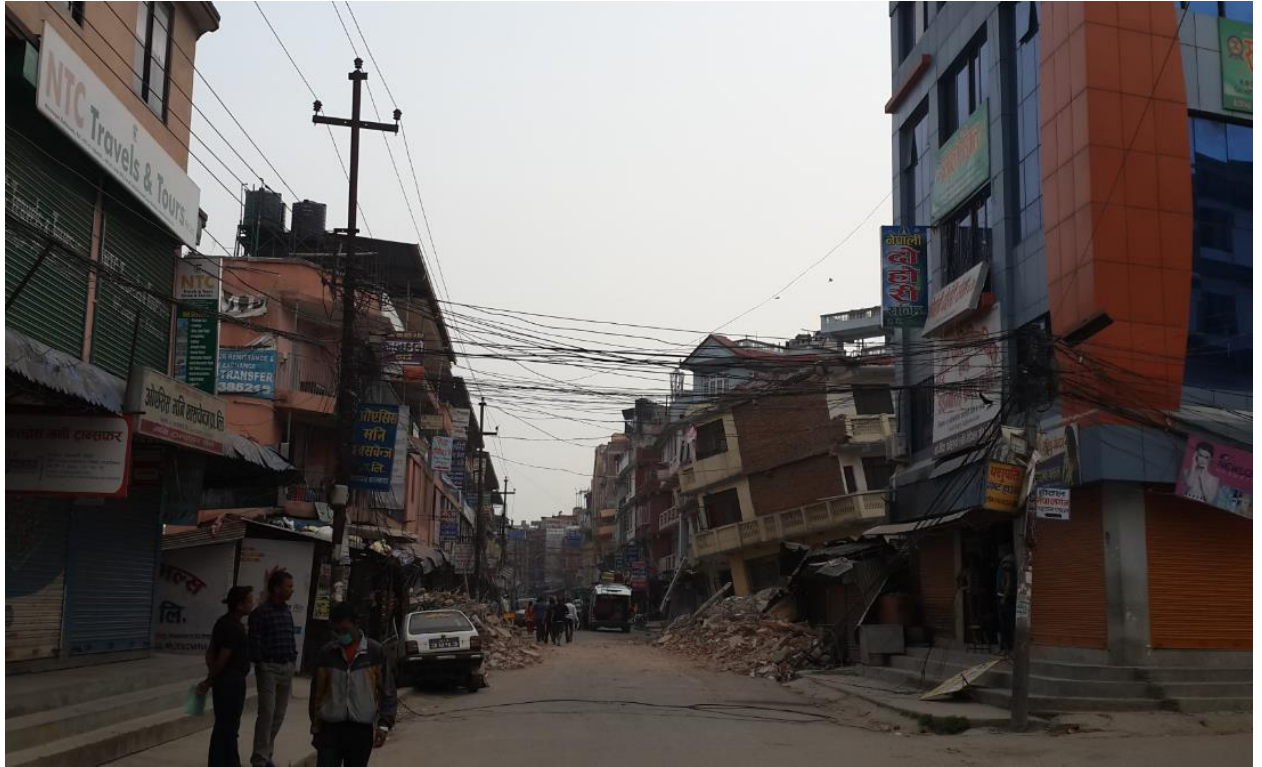
More damage in the buildings on right side than on the left side of the road in Balaju, Kathmandu (Photo by Kiran)

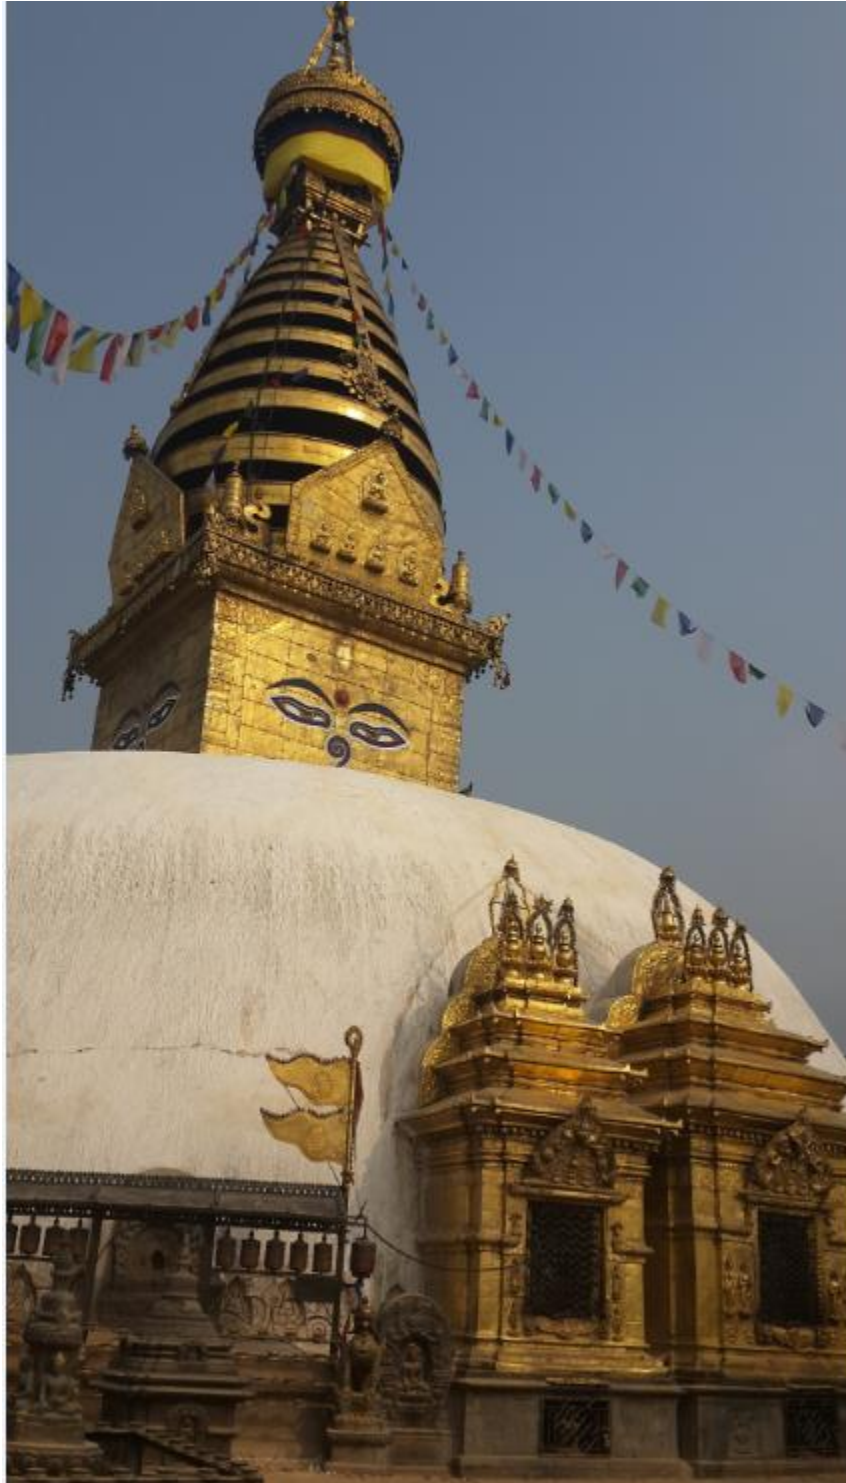
Horizontal cracks in Swyambhu stupa, Kathmandu (Photo by Kiran)

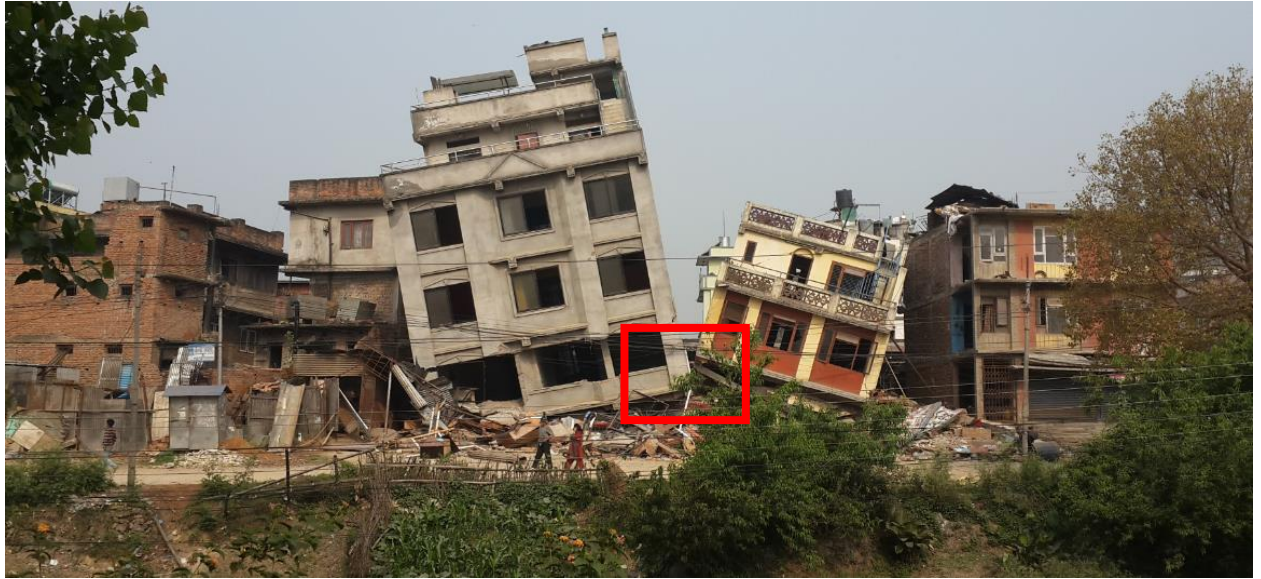
Collapsed buildings due to soft story effect, Sitapaila, Kathmandu (*Photo by Kiran*)

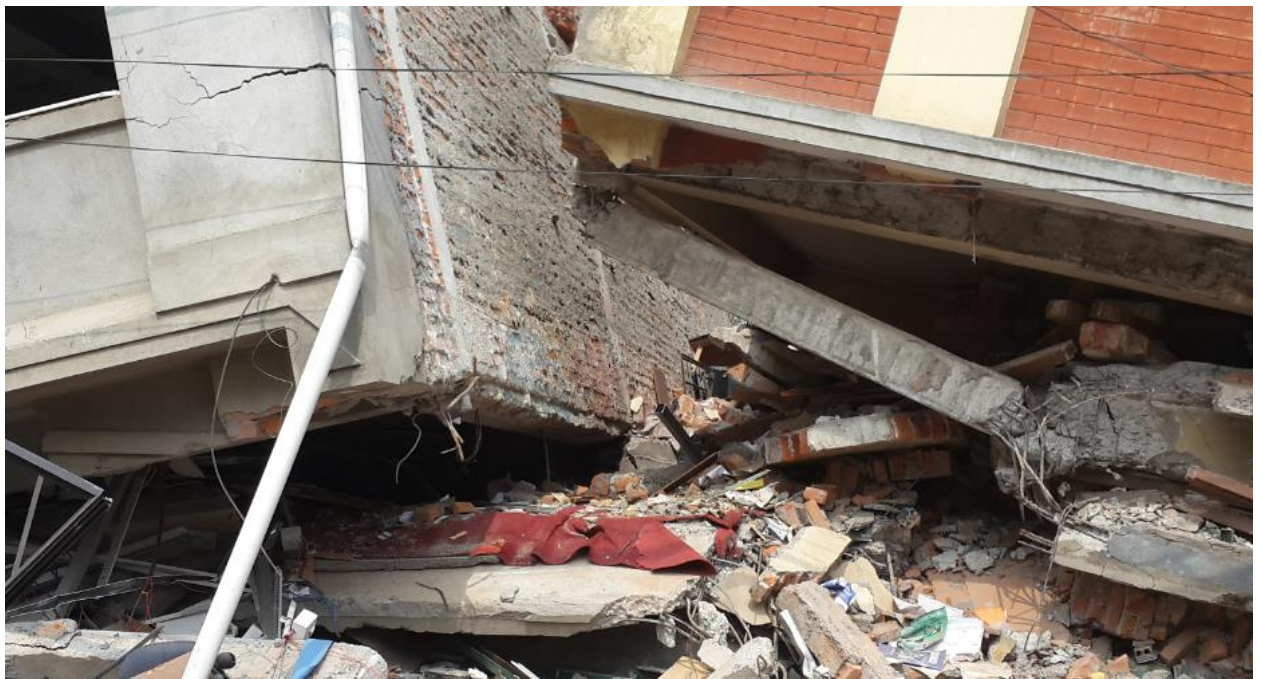
Damaged columns at the marked location of the previous photos (*Photo by Kiran*)

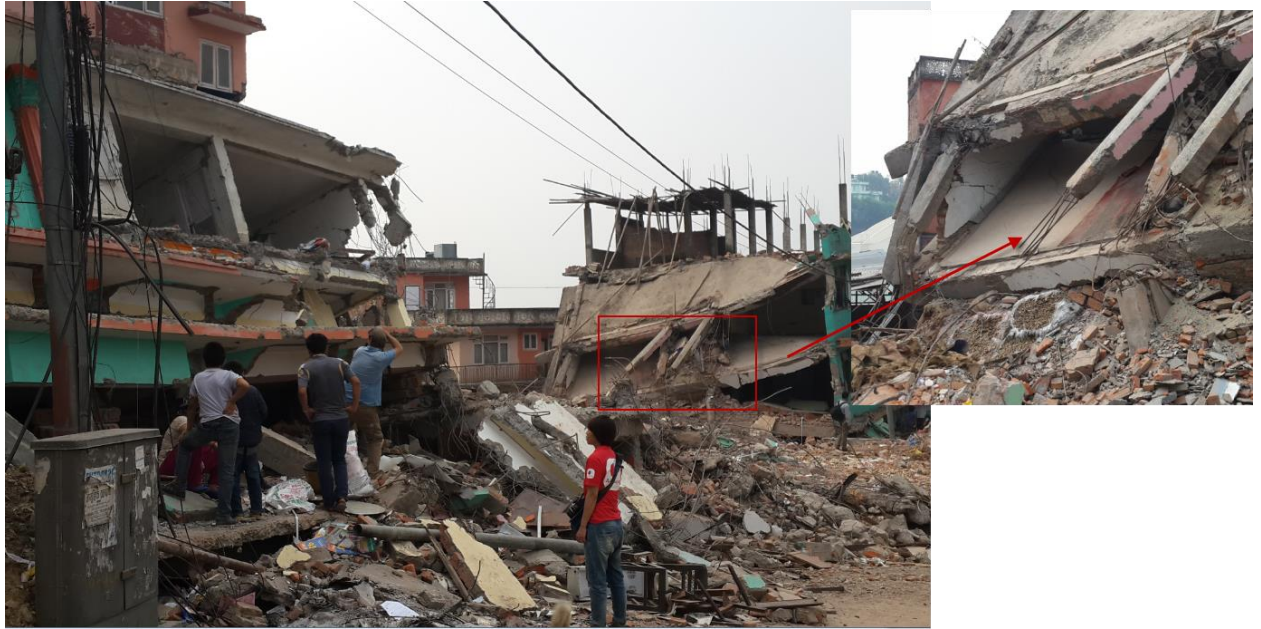
Collapsed building in Sitapaila, Kathmandu. All the rebar were spliced at the same location in the column as marked in the diagram. *(Photo by Kiran)*

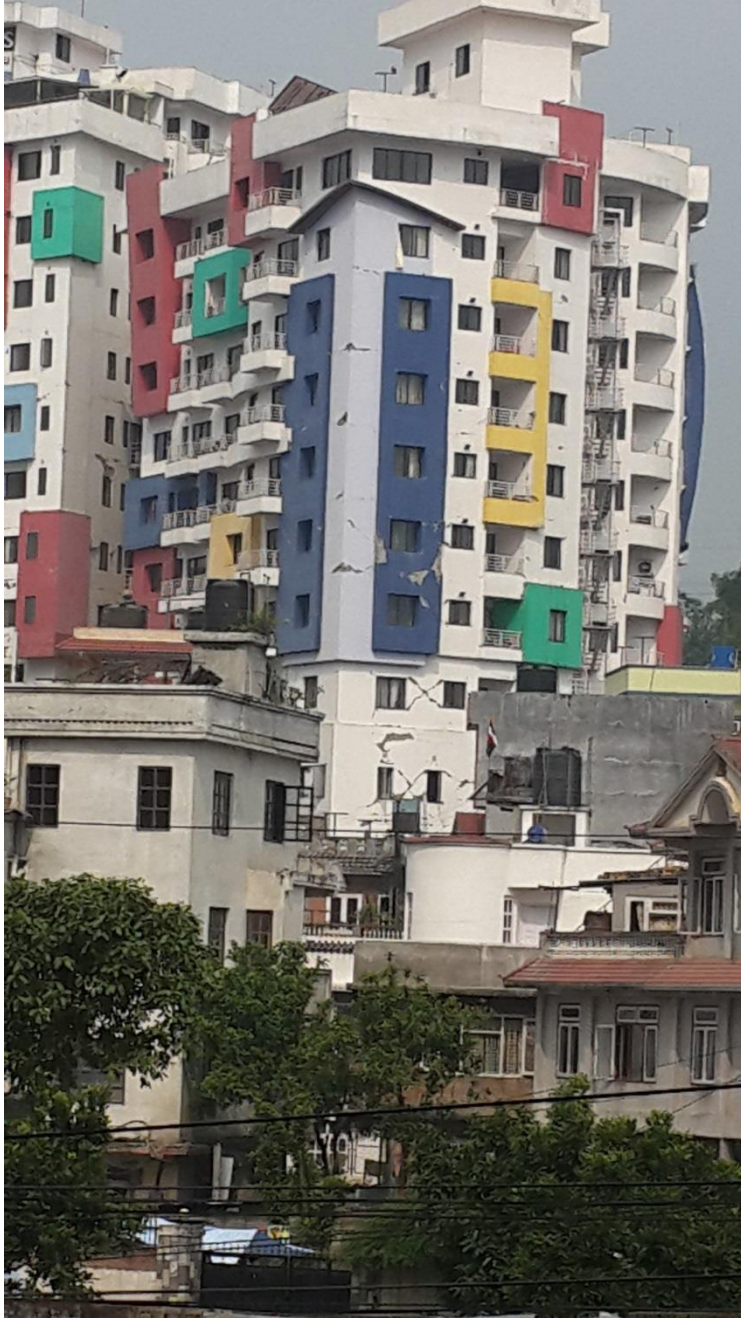
Damages in the infill walls and at the corners of the high-rise apartment buildings Kathmandu
(Photo by Kiran)

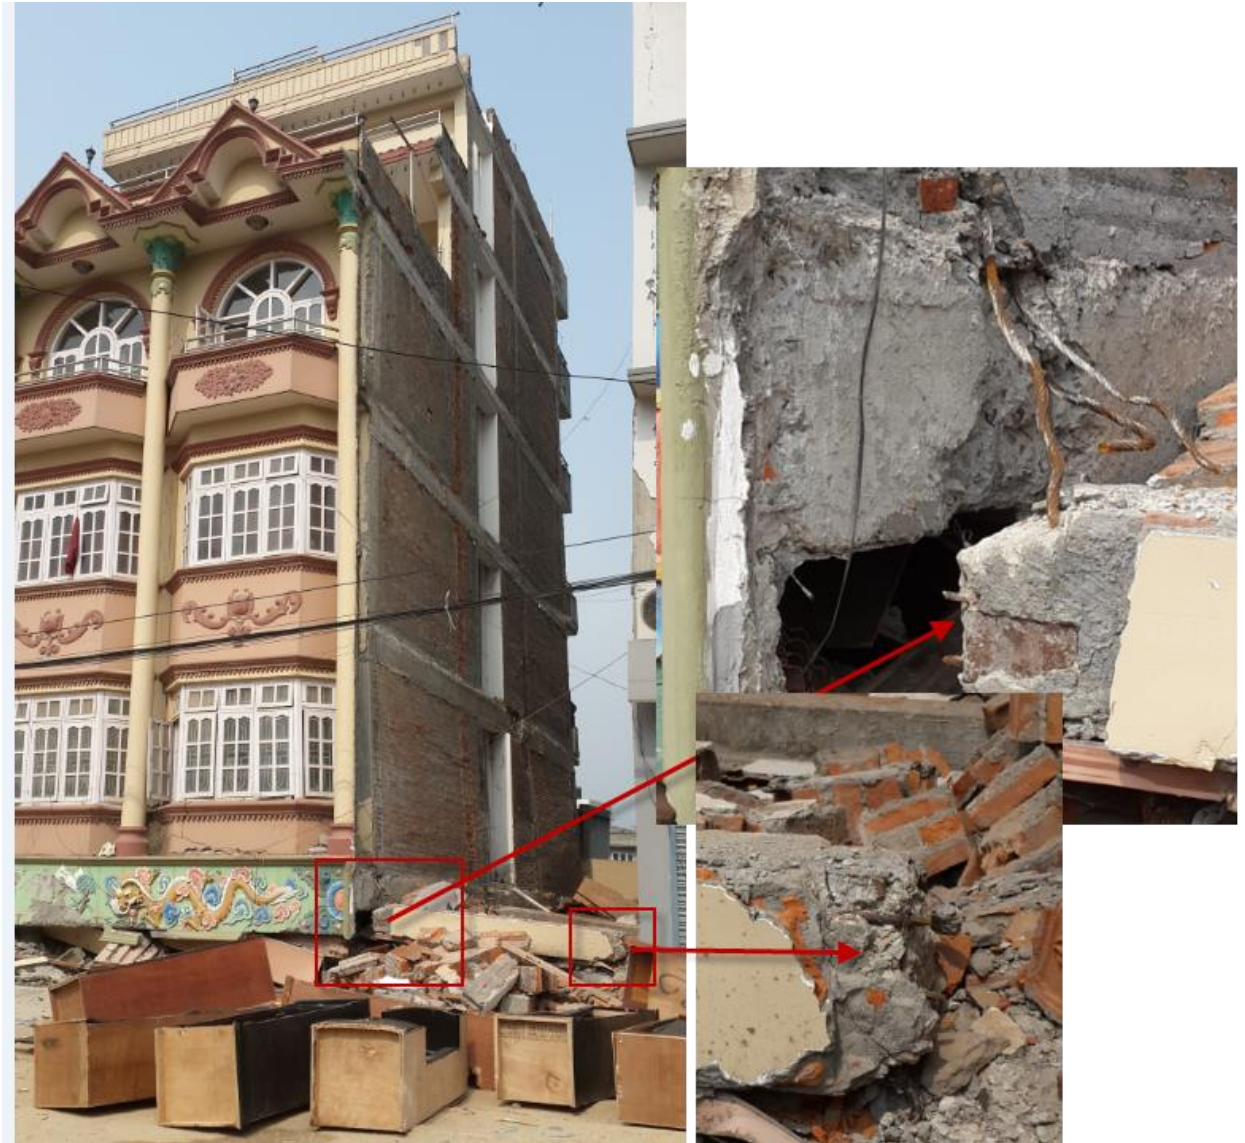
Soft story collapse of another building in Sitapaila, Kathmandu. No stirrups were provided at the beam column joint location. (Photo by Kiran)

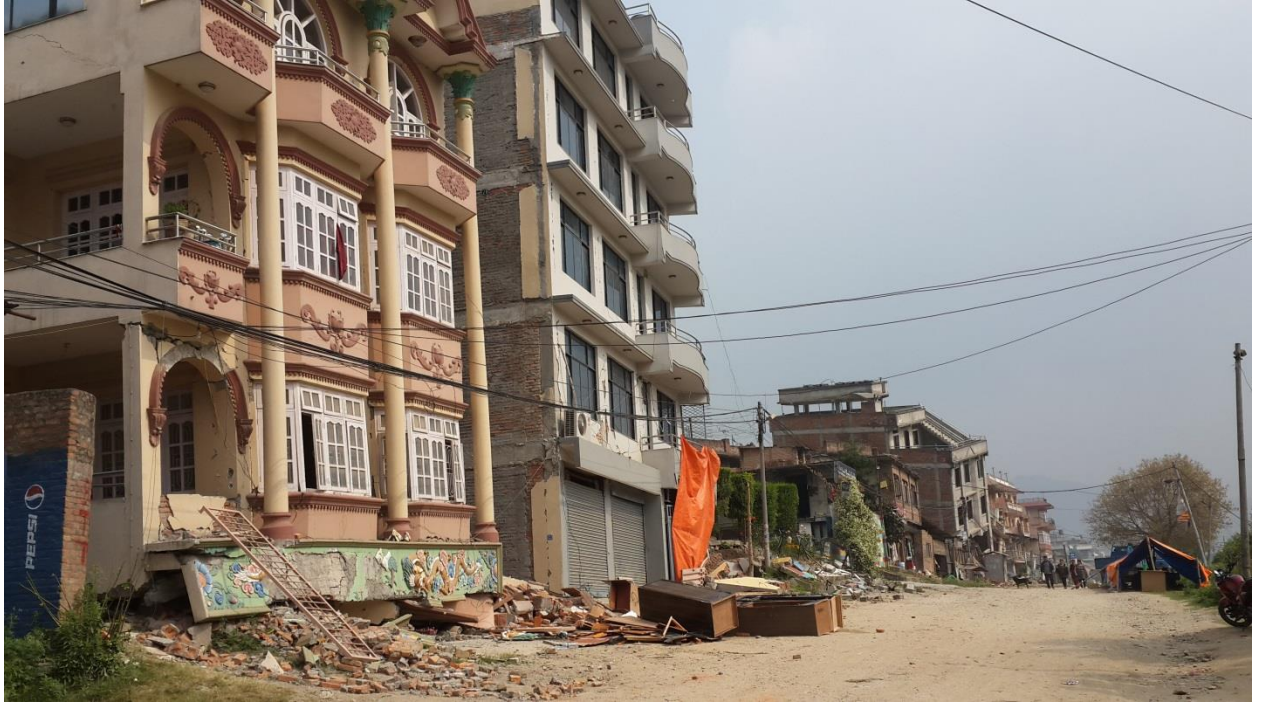
Collapsed houses in Sitapaila, Kathmandu (*Photo by Kiran*)

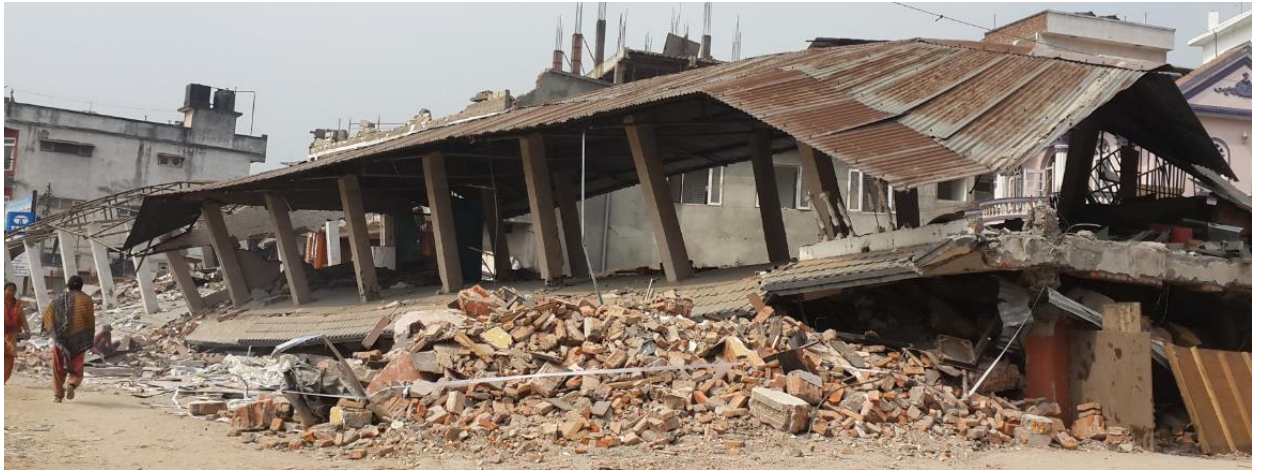
Collapse of a two story frame structure in Sitapaila, Kathmandu. Column bases on the upper story are also damaged. (*Photo by Kiran*)

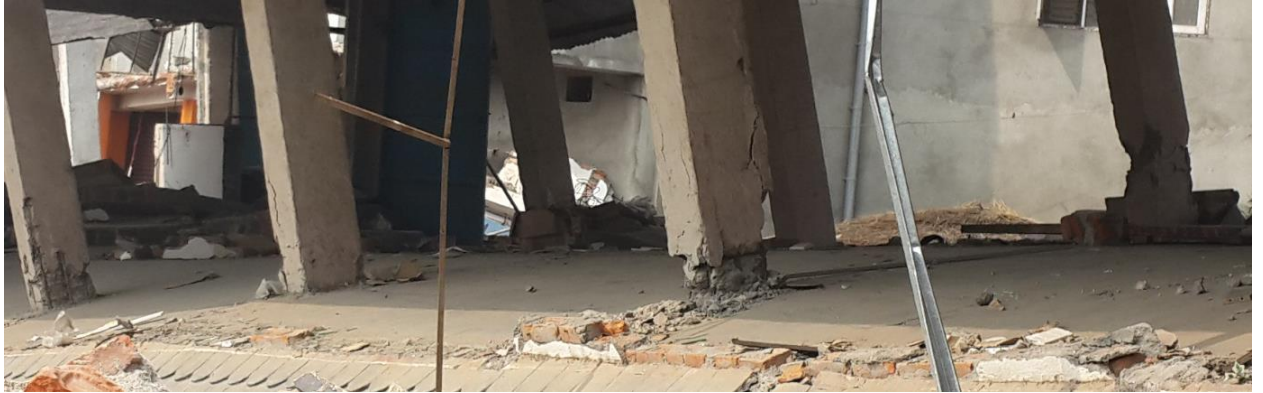
Damaged column bases on upper story of the previous building (*Photo by Kiran*)

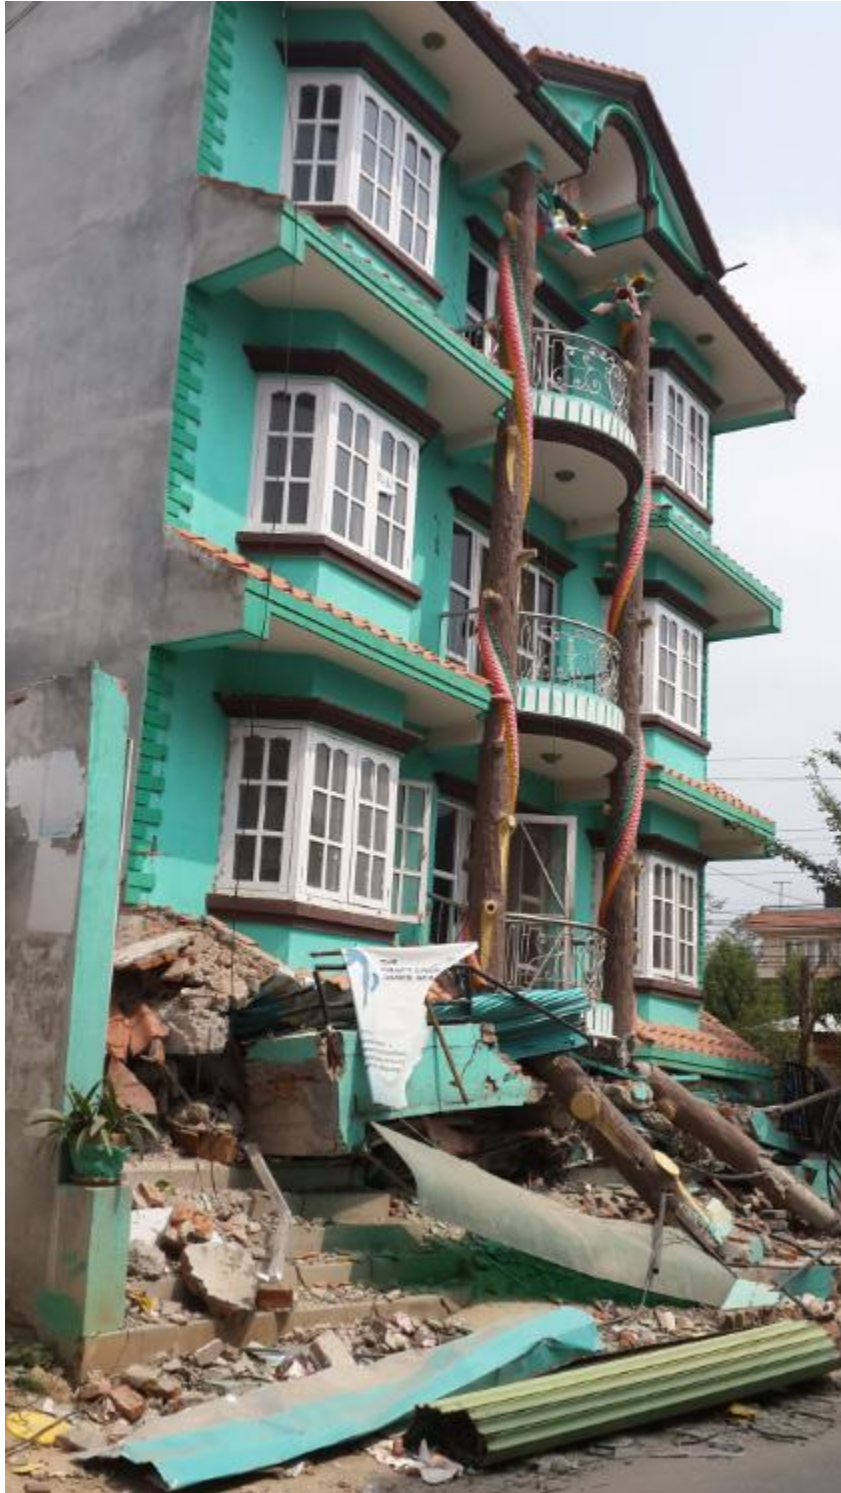
Soft story collapse of a 5 story house in Dhapasi, Kathmandu

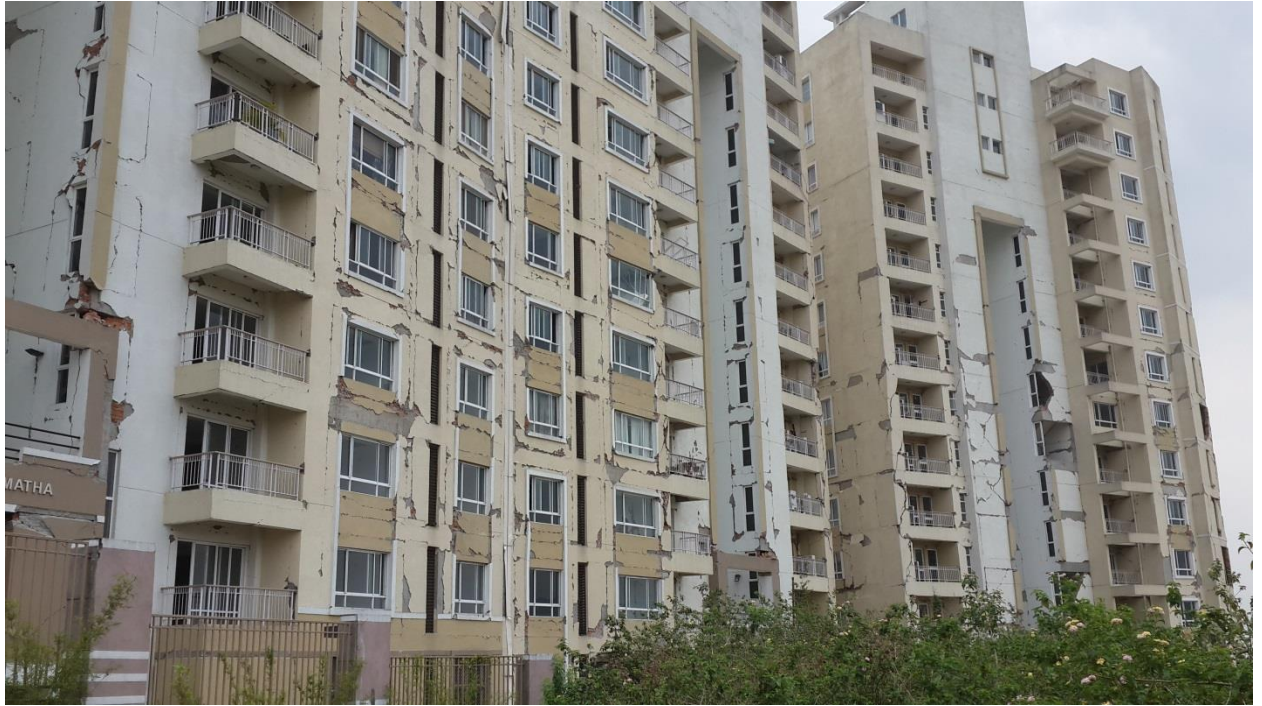
Infill wall damage of a 17 storey tall apartment building in Kathmandu (Right face of the building) (Photo by Kiran)

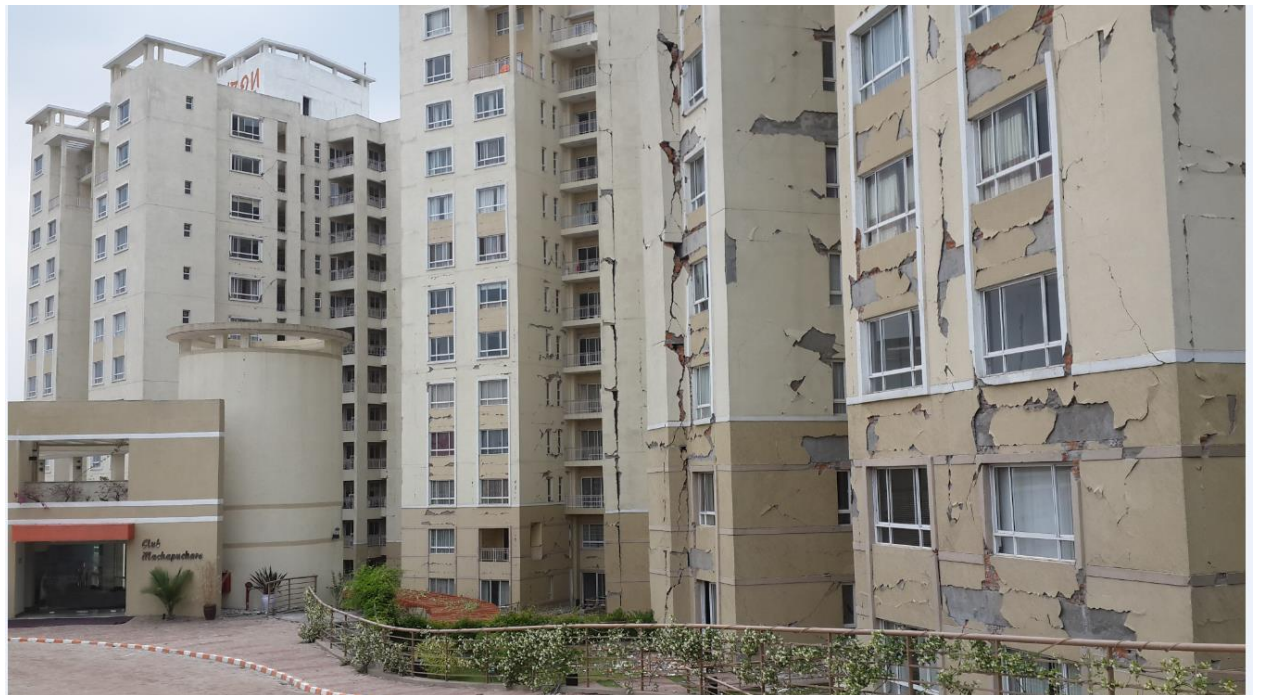
Left face of the building. Damage to the middle part of the structure may be attributed to the higher mode participation. (Photo by Kiran)

11. High rise buildings and mid-rise flexible buildings are at more risk than the low to mid-rise stiff buildings in Kathmandu valley.
12. Damage pattern of the High-rise building like Park View Horizon apartment may be attributed to the excitement of higher modes of vibration.

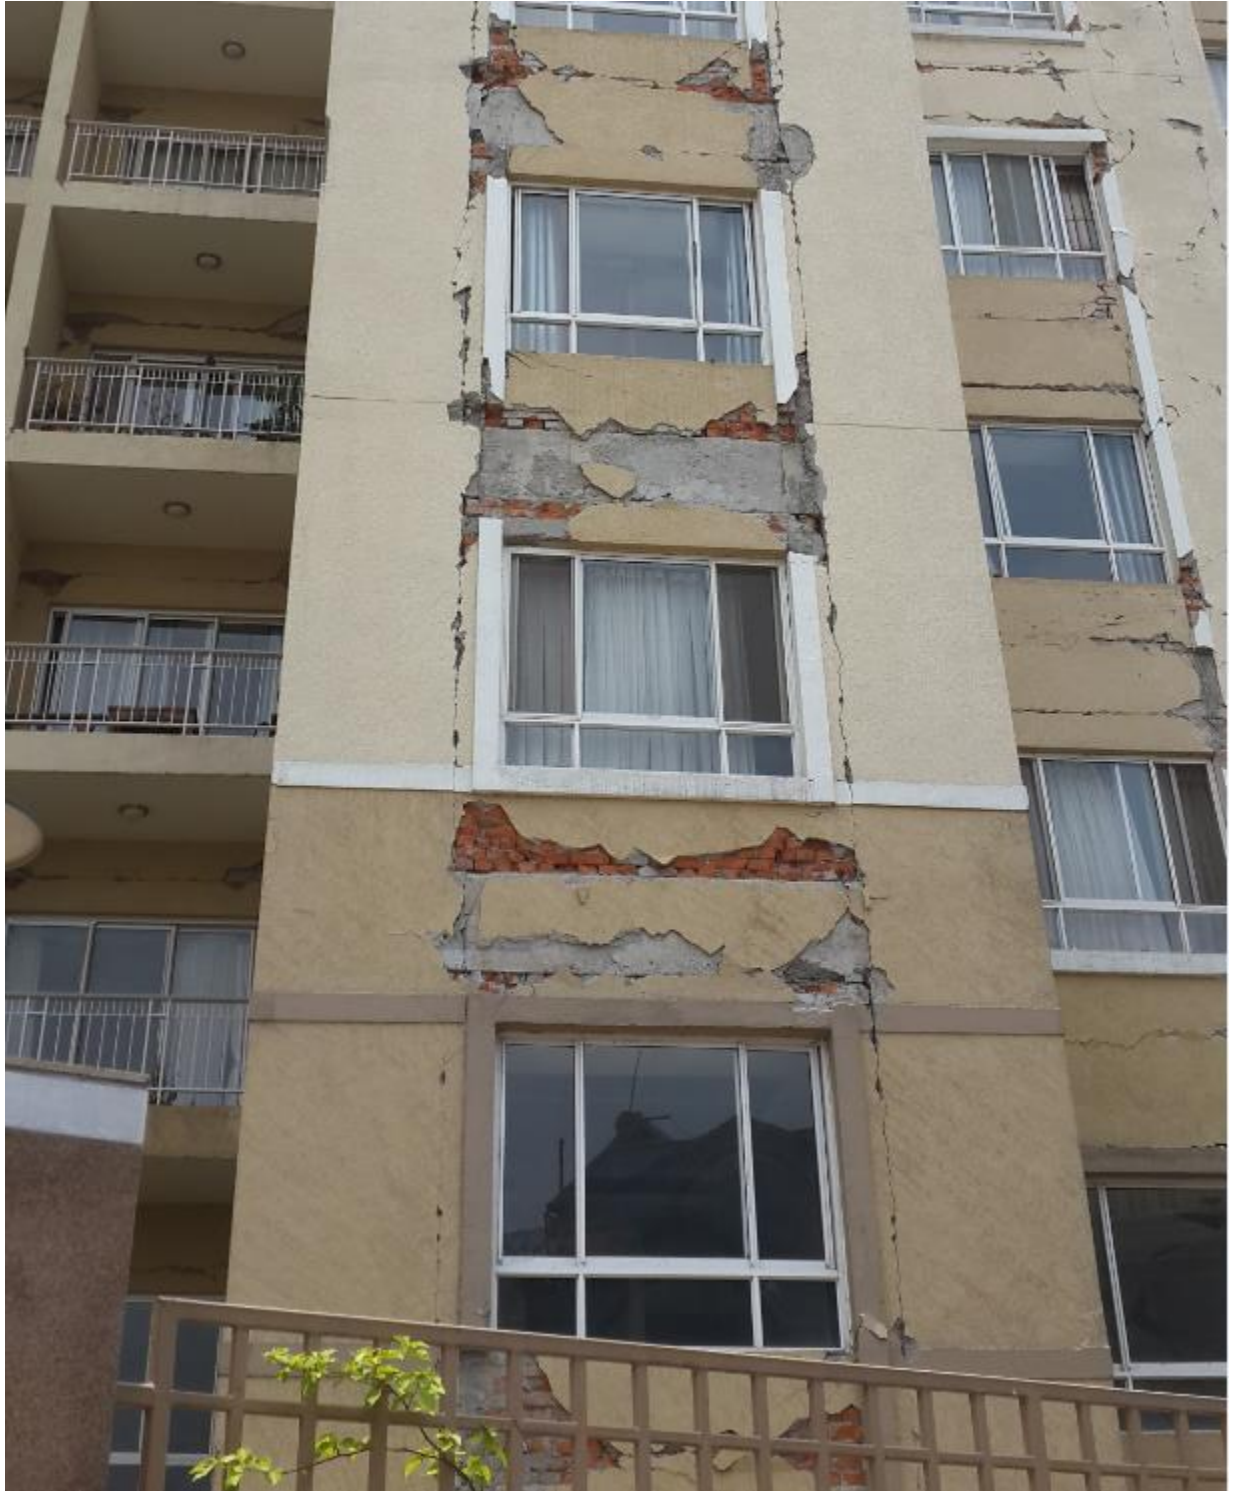
Damage in Spandrel on left face of the (Photo by Kiran)

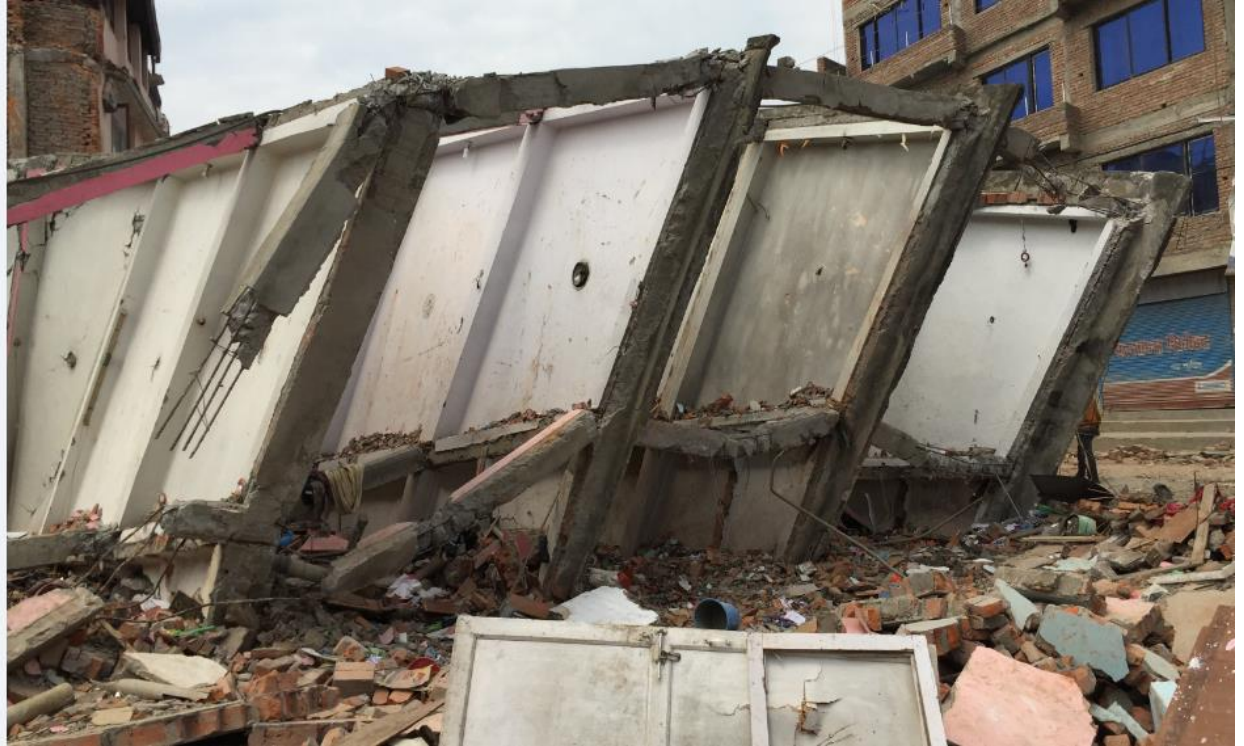
Overturning of a 7 storey tall building in Kapan area, Kathmandu (Photo by Surya Raj Acharya)

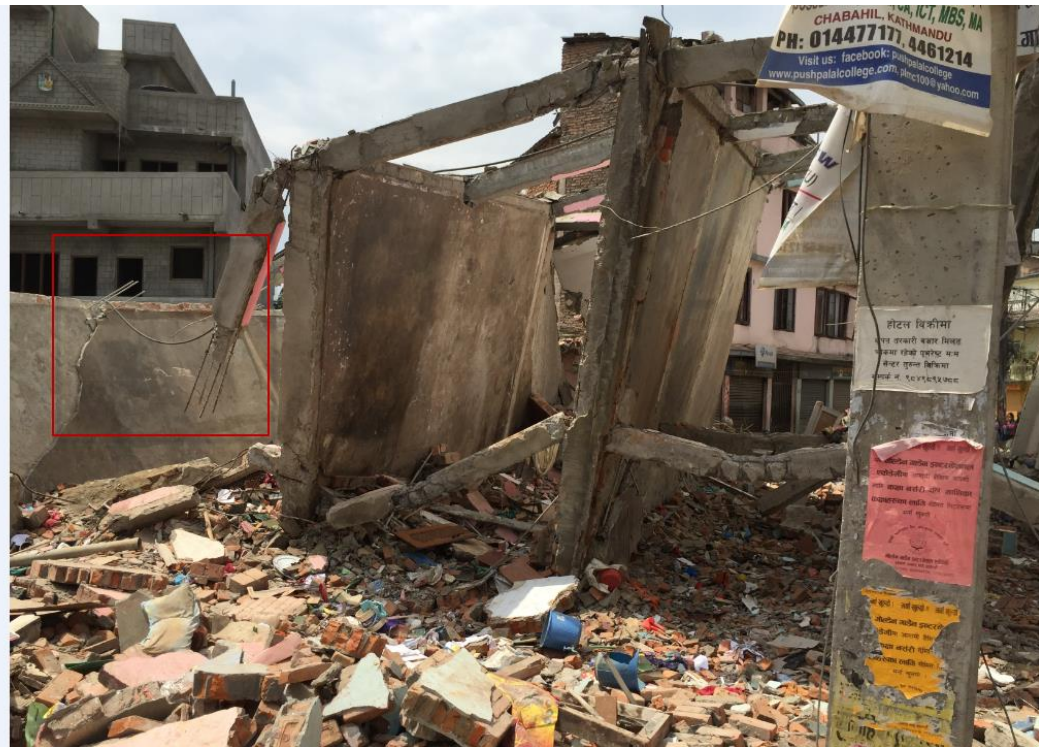
Longitudinal reinforcements were spliced at same location in the column and building overturned by lap splice failure at tension location (Photo by Surya Raj Acharya)

5. In some buildings it is observed that the building could not resist the overturning moment due to lap splice failure on the tension side. It was observed that all the longitudinal rebar were spliced at same location in such buildings.

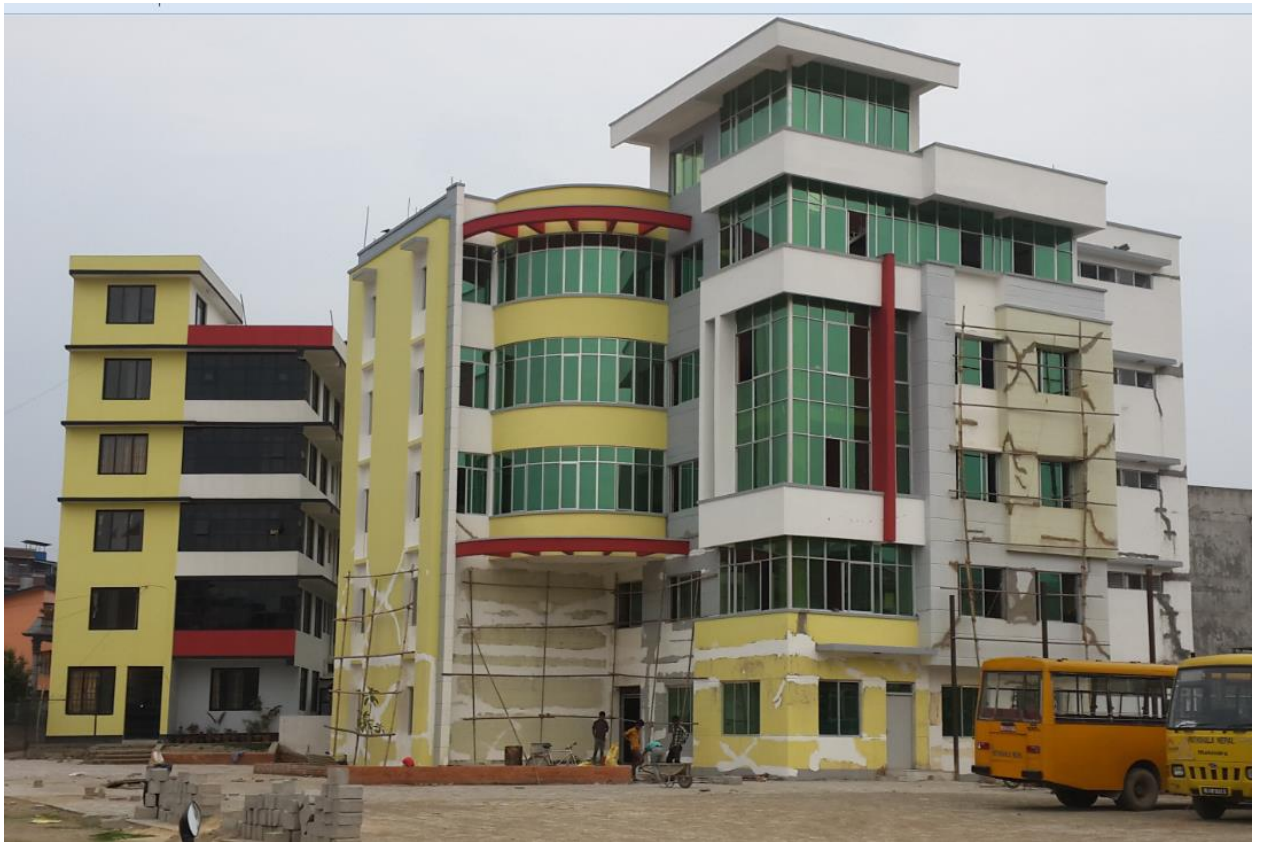
Repaired diagonal shear cracks in a school building in Imadol area, Lalitpur (Photo by Kiran)

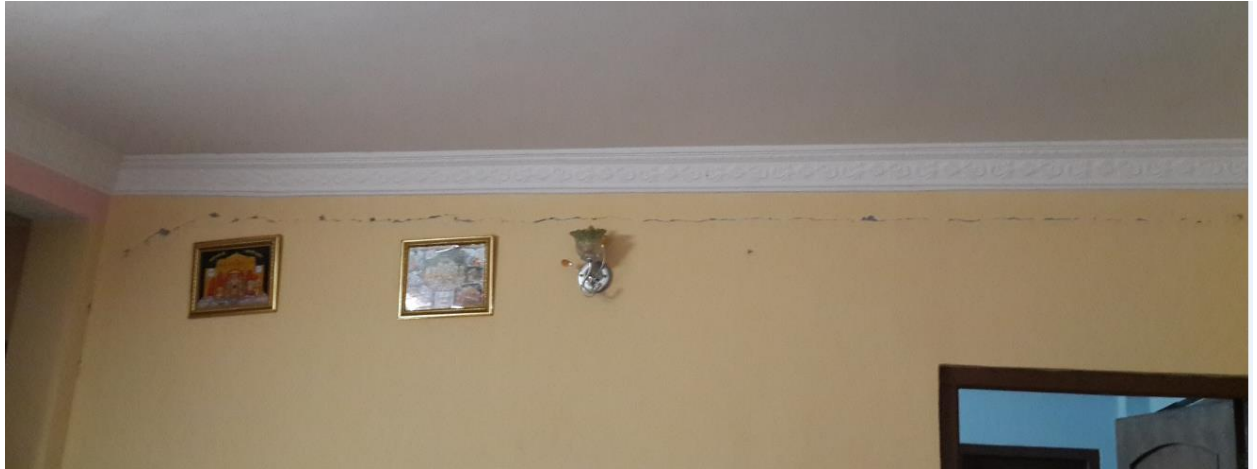
Horizontal crack at the beam interface in a wall that was constructed after constructing the frame in Lalitpur. No other cracks are seen in this 4 story RC frame building except similar vertical cracks at column interface. *(Photo by Kiran)*

2. Buildings where infill walls were constructed after constructing the frames suffered more cracks at beam and column interface, while, the buildings where infill walls and frames were constructed together suffered no such damages.
