## Reconnaissance of the effects of the M7.8 Gorkha (Nepal) earthquake of April 25, 2015

# Reconnaissance of the effects of the M7.8 Gorkha (Nepal) earthquake of April 25, 2015

Department of Civil Engineering, Indian Institute of Technology Kanpur, Kanpur, India

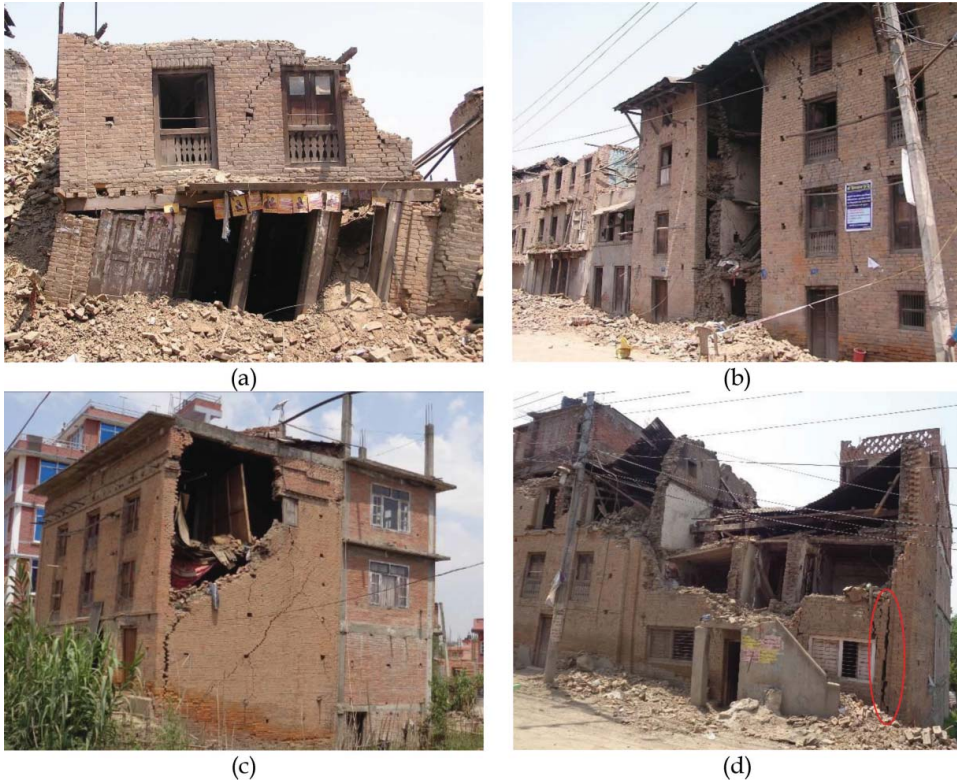
Figure 4. Performance of 50–60-year-old URM buildings at Nikosera in Bhaktapur: (a) collapse of three-storey unreinforced masonry building, (b) out-of-plane failure of the masonry wall, (c) combined in-plane and out-of-plane failure of the wall, and (d) collapse of a building due to poor connection of wall with the floor and cross walls. To view this figure in colour, please see the online version of the journal.

horizontal bands, which was further aggravated due to the poor connection between the walls and floors (Figure 4(a)–(d)). The absence of confining members at the corners of the building plan added to the poor performance of the buildings, as vertical cracks were initiated along the corner of masonry walls leading to loss of structural integrity, making the walls highly vulnerable to out-of-plane collapse (Figure 4(a) and 4(c)). The timber floors and roofs used created a flexible diaphragm and the poor connection between diaphragm and walls was ineffective in resisting the lateral forces. Also, the poor bonding of the cross walls with the main wall along with the associated heavy mass resulted in the collapse of the walls in out-of-plane direction as shown in Figure 4(d). The in-plane damage caused step-type diagonal cracks in the masonry wall which were extended to the full storey height. It also resulted in the decrease of the out-of-plane capacity of the wall, which caused the combined in-plane and out-of-plane failure of the wall in some buildings as shown in Figure 4(c).

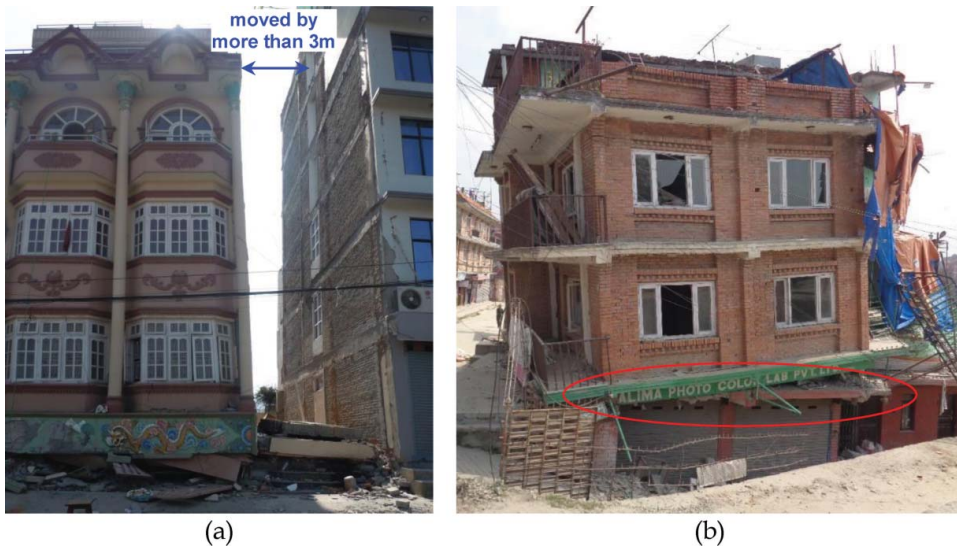
Figure 5. (a) Open ground storey failure of four-storey building in Sitapaila, Kathmandu, and (b) intermediate storey failure of four-storey building in Kalopul, Kathmandu. To view this figure in colour, please see the online version of the journal.

construction features significantly added to the seismic vulnerability of these structures. Buildings with open ground storey have performed very poorly in the past earthquakes and similar performance was observed during this earthquake. As shown in Figure 5(a), a residential building with open ground storey in Sitapaila, Kathmandu, which stood immediately adjacent to another building, collapsed due to plastic hinge formation in the ground storey columns and moved away laterally about 3 m from the adjacent building. Another residential building in Kalopul, Kathmandu collapsed due to the presence of weak storey at the second floor (Figure 5(b)). There were many examples of pancake collapse of various commercial and residential buildings (Figure 6). The collapse of these buildings was caused by the formation of

weak storey mechanism due to the inadequate wall area, small sizes of RC frame members and poor reinforcement detailing at critical locations.

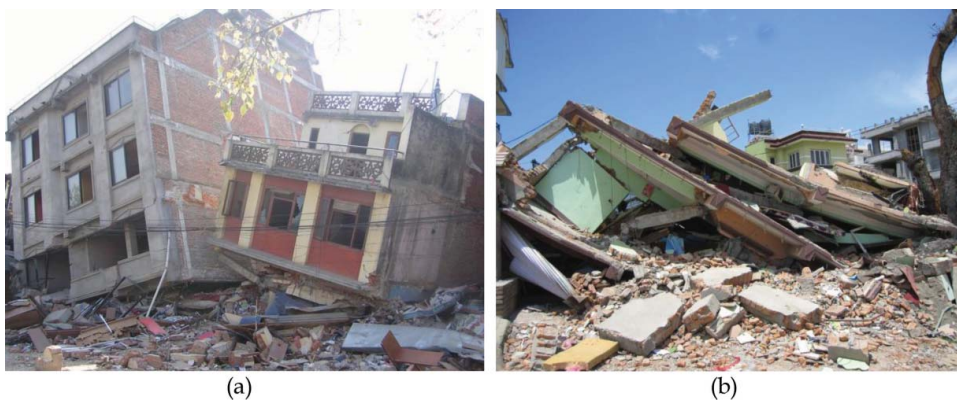
Figure 6. (a) Open ground storey failure of two adjacent buildings in Sitapaila, Kathmandu, and (b) complete collapse of residential building in Khadka Gaon, Kathmandu. To view this figure in colour, please see the online version of the journal.

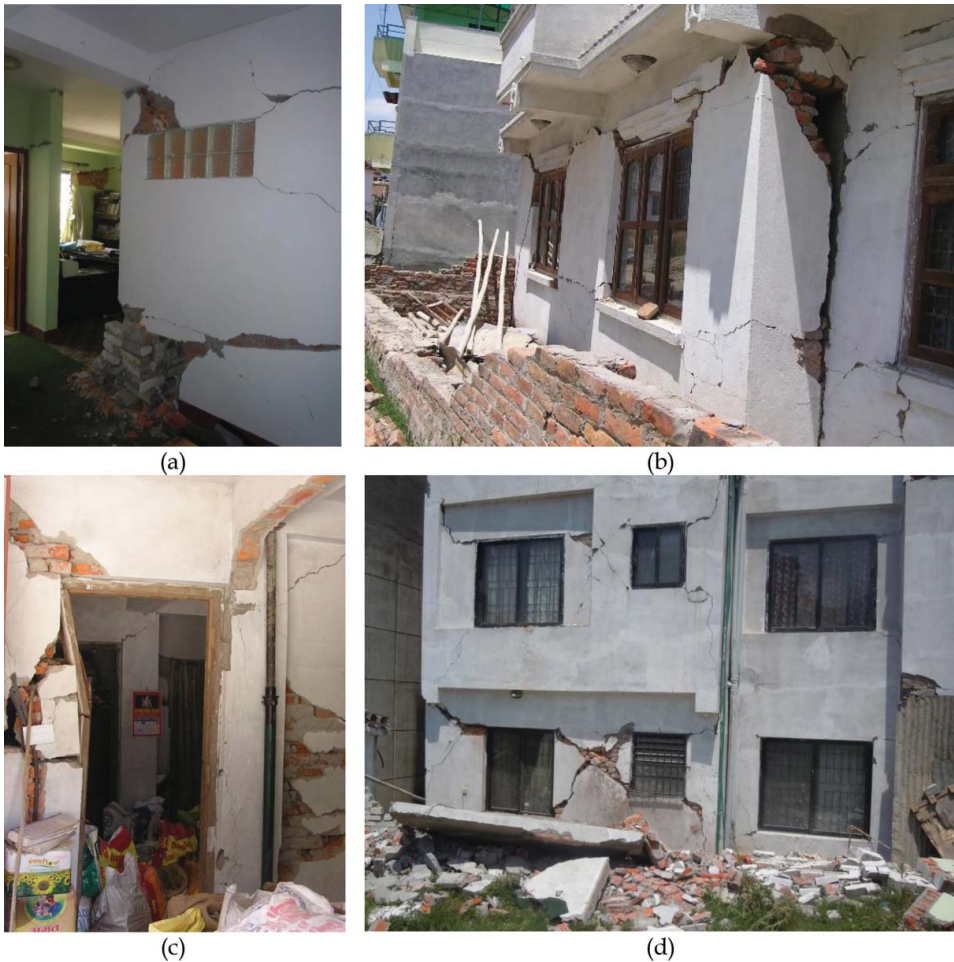
Figure 7. Various structural defects in newly constructed residential buildings: (a) absence of column at the intersection of two walls, (b) projection of masonry wall beyond the column grid line, (c) and (d) damage to the wall panel due to absence of confinement all around the openings. To view this figure in colour, please see the online version of the journal.

Severe damage was observed in many non-engineered buildings which had been constructed recently. Use of half-brick thick partition walls (about 120 mm thick) and construction of buildings on sloping ground without proper assessment of the site condition increased the level of damage in the buildings. The absence of confining members/columns at the critical locations such as at the intersection of two walls, areas adjacent to door openings and at the outer periphery of the building resulted in extensive damage in many houses (Figure 7). The lack of adequate columns at the corners of the building resulted in lower stiffness of the walls projecting beyond the column line, leading to separation cracks at the regions of projection and severe damage to masonry walls (Figure 7(a) and 7(b)). The absence of continuous horizontal concrete bands around openings, as in the case of URM buildings of Bhaktapur, also caused severe damage in the masonry infill RC frame buildings (Figure 7(c) and 7(d)).

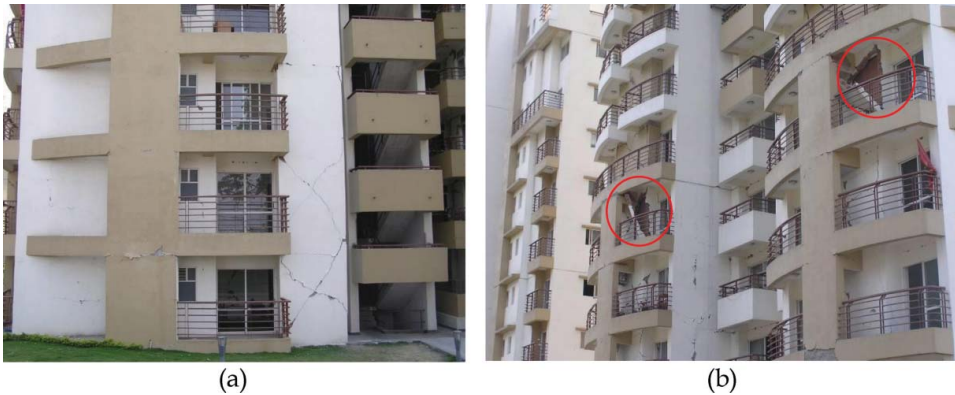
Figure 8. Seventeen-storey apartment building in Patan: (a) shear cracks in the lower storeys of infill wall; (b) combined in-plane and out-of-plane failure of the extended infill wall in upper storeys. To view this figure in colour, please see the online version of the journal.

It was rather surprising that many tall RC apartment buildings which were supposed to be engineered construction had suffered significant damage. These high-rise RC structures suffered from similar structural defects as observed in the non-engineered construction. Large diagonal cracks in masonry panels and cracks at the interface between boundary frame and the wall was very common in multistorey-infilled RC frames. A 17-storey tall RC apartment building in Patan suffered damage in the form of diagonal cracks and combined in-plane and out-of-plane failure of infill panels (Figure 8), which can be attributed to the use of weak and slender walls, partial open-ground storey and box-type extension of walls beyond column line. Non-compliance with the building codes and poor monitoring of the development in the valley have led to conversion of many three-storey buildings to multi-storey high-rise structures which have contributed in further increasing the seismic vulnerability of the valley.

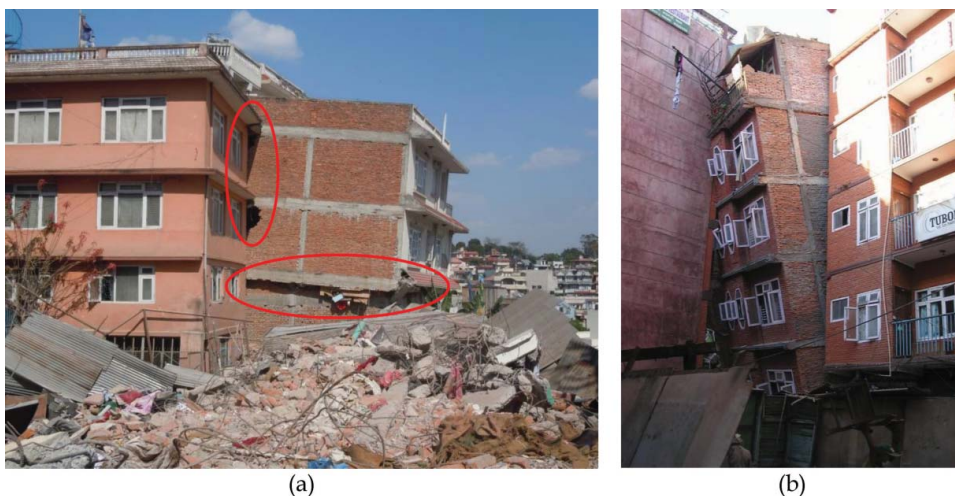
Buildings in the worst affected regions were built very close to each other, in many places with almost no gap between them. Pounding of such buildings led to chain of collapses in the densely built environment and some leaned out of plumb (Figure 9 (a) and 9(b)). Buildings were also collapsed due to the vertical irregularity caused by the extension of the upper storey plan beyond the column grid lines (Figure 9(b)). An overview of the seismic performance of RC buildings suggests that some of the key features that contributed to the poor performance of the structures include inadequate size and poor reinforcement detailing of the RC frame members, poor beam–column connection details, weak and slender brick masonry partition walls, extended floor plans in upper stories supported on cantilevered beams and slabs, open ground and soft storey, large vertical and horizontal plan irregularity, discontinuity in load transfer system, and lack of soil investigation. Such poor construction features also resulted in widespread damage to RC buildings in Sikkim during the M6.9 India–Nepal border earthquake of September 2011 (Rai et al. 2012).

Figure 9. (a) Collapse of intermediate storey due to pounding of adjacent building, and (b) collapse due to extension of the upper storey plan beyond the column grid lines which created vertical irregularity. To view this figure in colour, please see the online version of the journal.

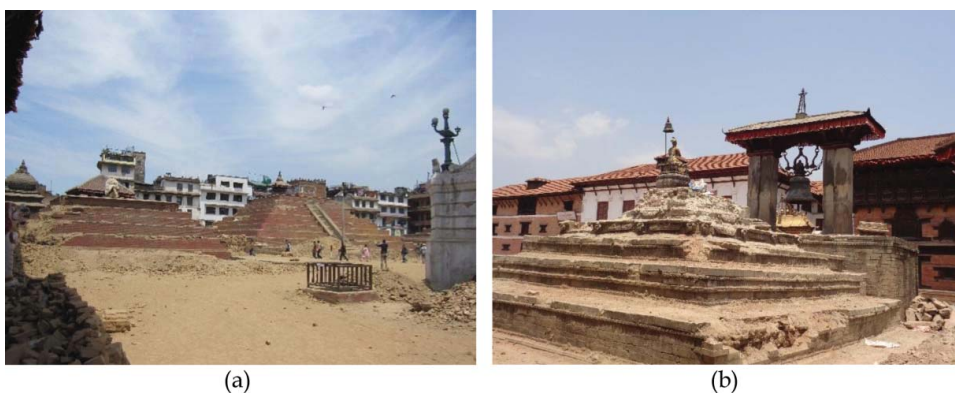
Bhaktapur and Patan suffered severe damage. The *dega* temples of Nepal are built with timber structural frame and brick masonry walls. The thick masonry walls are made of two leaves, with the inner leaf of simple rendered finish, the outer leaf well dressed and the cavity filled with rammed earth (Bonapace & Sestini 2003). Such *dega* temples have collapsed completely and some were moderately damaged in Kathmandu, Bhaktapur, and Patan Durbar squares (Figures 10 and 11). These temples have been found to be short-period structures (fundamental natural period less than 0.6 s), and masonry piers near the base were the most critical components susceptible to large compressive and tensile stresses (Jaishi et al. 2003). Unreinforced masonry buildings in the Palace complex of Kathmandu Durbar Square also suffered severe damage (Figure 11(b)). The flexibility of the wooden flooring system and lack of rigid connection between the walls and the diaphragm led to the poor lateral

Figure 10. (a) Complete collapse of dega temples in Hanuman Dhoka, Kathmandu, and (b) collapse of Vatsala Durga temple made of sandstone in Bhaktapur Durbar square. To view this figure in colour, please see the online version of the journal.

strength of the structure, and the heavy mass of the buildings due to the presence of thick walls increased the seismic vulnerability of these *dega* temples.

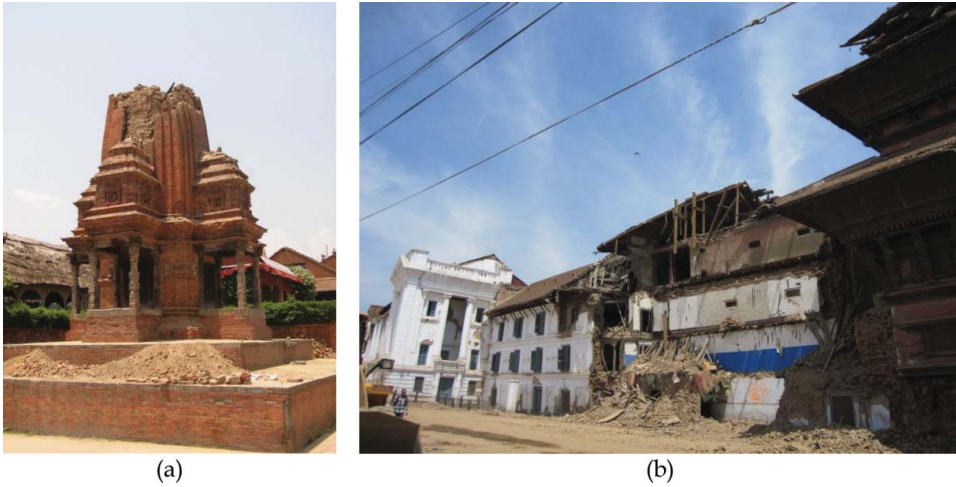
Figure 11. (a) Partial to complete collapse of temples in Bhaktapur Durbar square, and (b) severe damage to unreinforced masonry buildings in the Palace complex of Kathmandu Durbar square. To view this figure in colour, please see the online version of the journal.

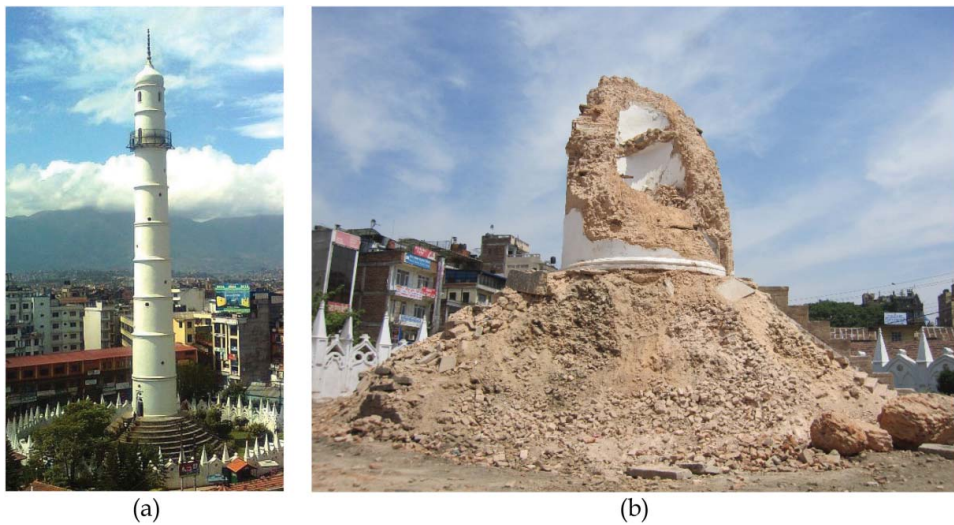
Figure 12. Dharhara tower in Sundhara, Kathmandu: (a) before earthquake (“Creative Commons Dharhara November 10, 2011” by Sugat Shrestha is licensed under CC BY-SA 3.0, link: [creativecommons.org/licenses/by-sa/3.0/](https://creativecommons.org/licenses/by-sa/3.0/)), and (b) after earthquake. To view this figure in colour, please see the online version of the journal.

earthquake was completely collapsed as shown in [Figure 12](#). Almost all the brick masonry temples suffered severe damage during the earthquake.
