Weiguan Building

Summary Information about Building Performance during M6.4 Southern Taiwan Earthquake in February 2016

Date: February 15, 2016

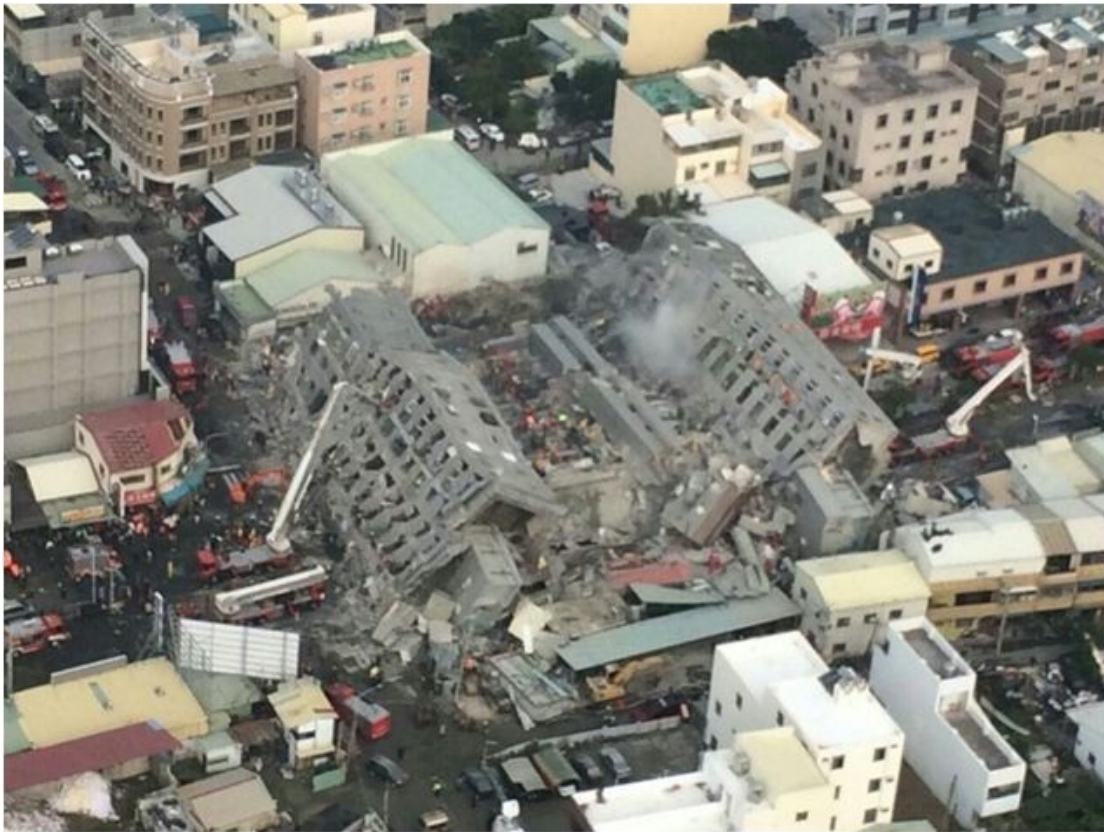
Figure 5: Post-collapsed photo (Source: www.udn.com.tw)

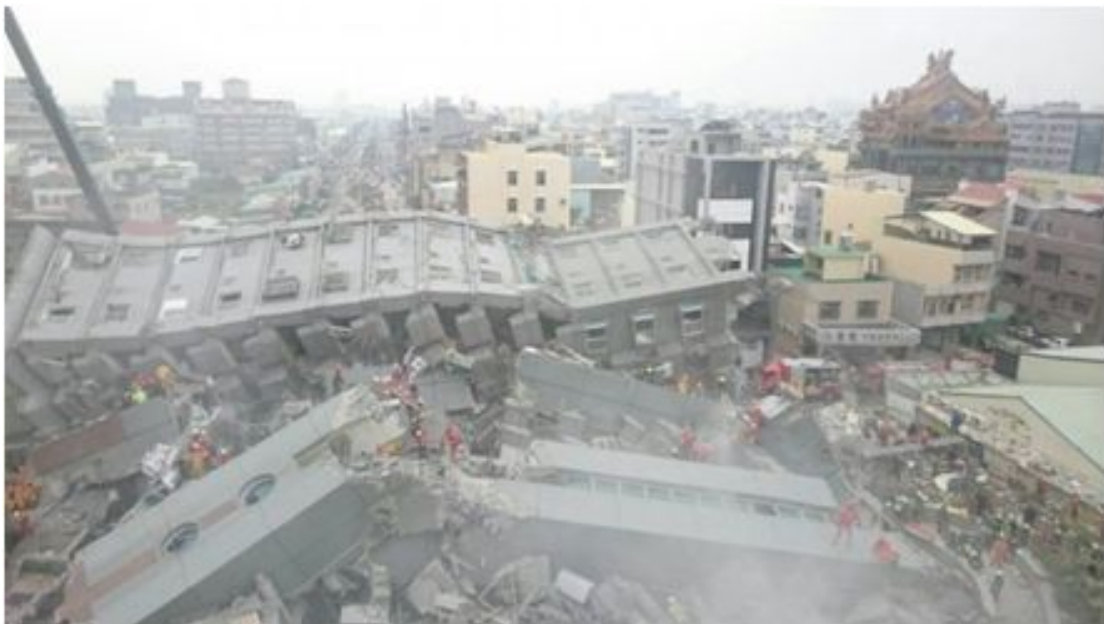
Figure 6: Post-collapsed photo (Source: www.udn.com.tw)

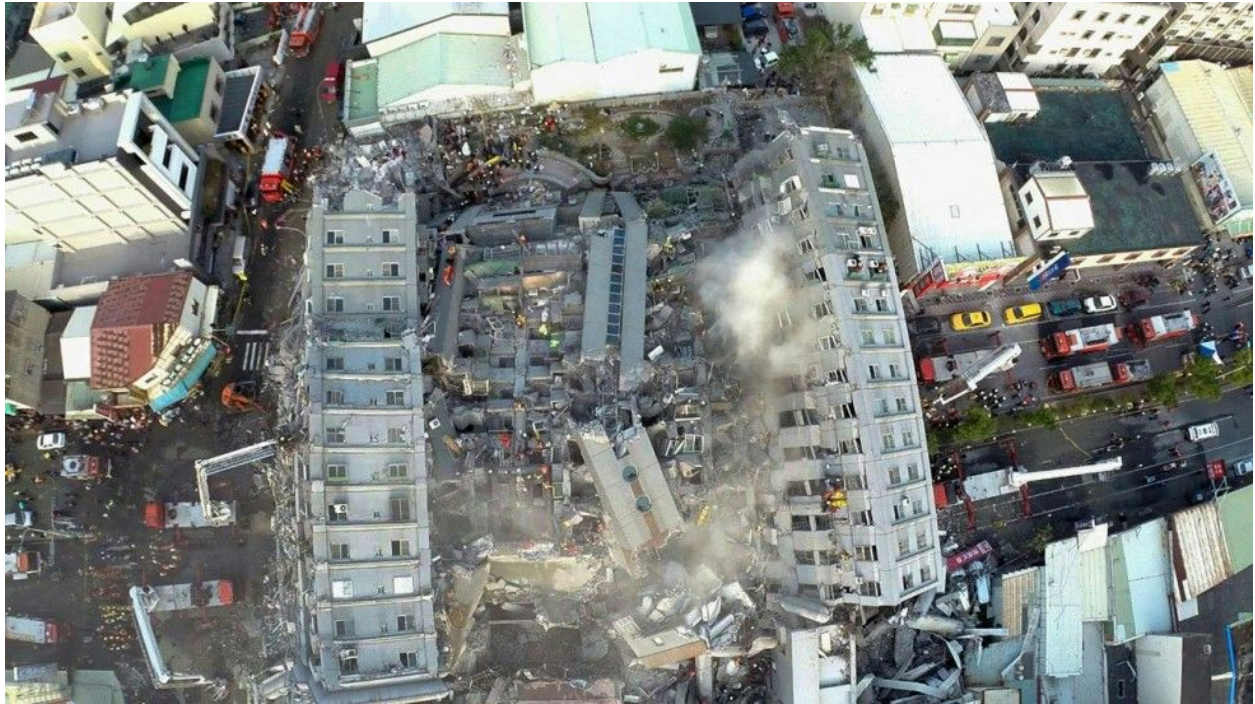
Figure 7: Aerial post-collapsed photo

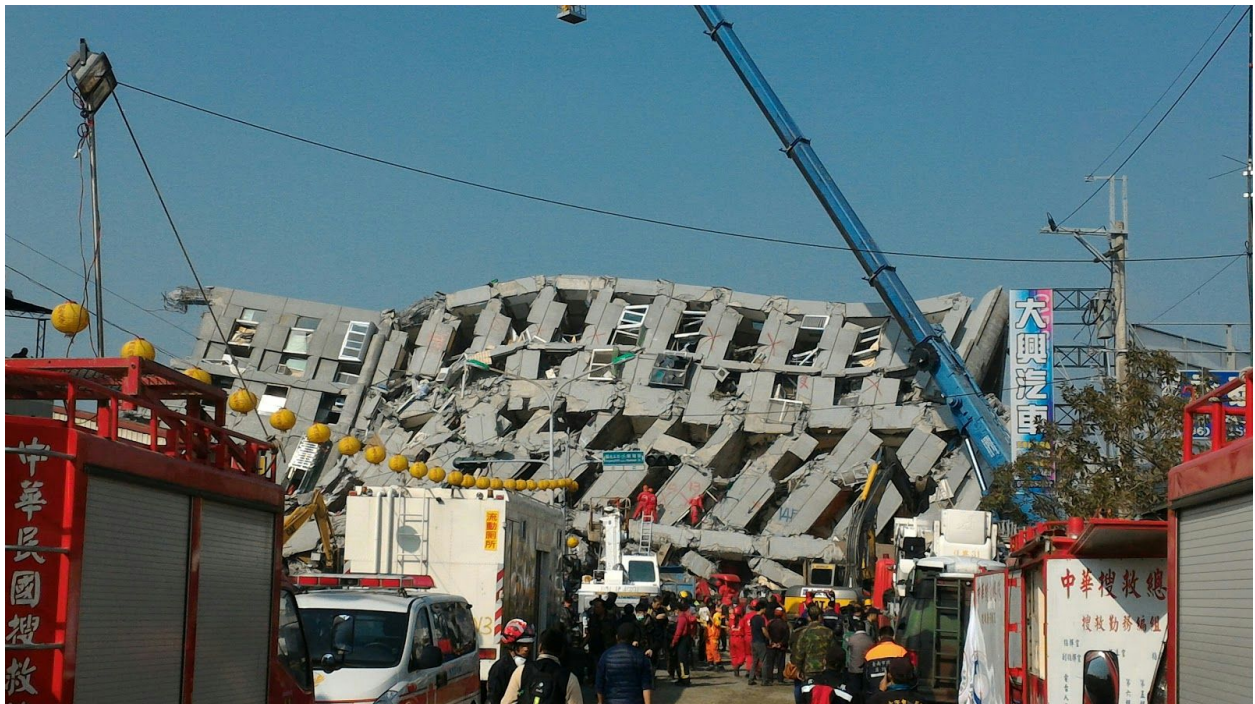
Figure 8: A more general view of one of the towers laying in the ground

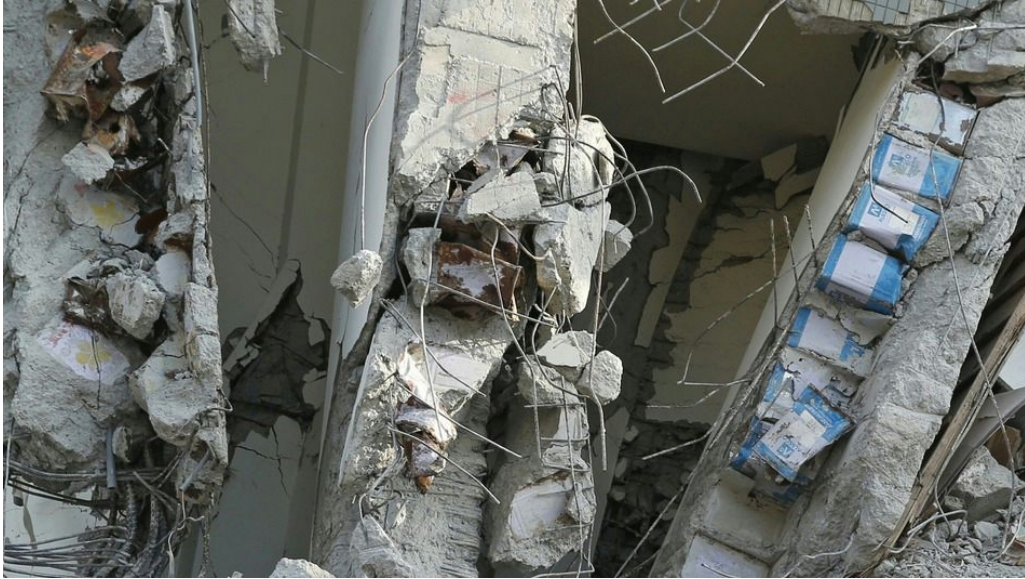
Figure 9: Oil cans observed in parts of the structure which created a lot of controversy

CNN mentions that oil tins have been found in beams, other sources state that these were placed in walls, being an incognita if those were resisting walls or just separation walls for floor distribution. They were reportedly used as lightening of the members. Not due to the fact that this practice doesn't seem very safe (Building code in Taiwan changed in 1994, after this building was designed and built) it is also the fact that the own execution of the project doesn't seem very right. The accumulation of the tins in one side of the member while pouring the concrete or some indices of cold joints in different photos can allow you to think about this idea.

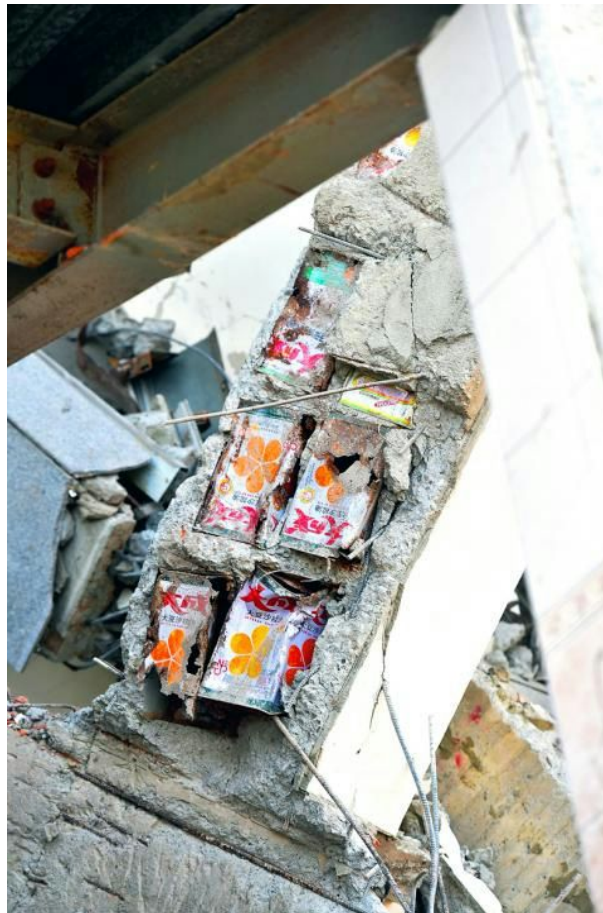
Figure 10: Cans in pillars

In http://shanghaiist.com/2016/02/08/taiwan_earthquake_building_collapse.php mention that tin were found in the pillars: "In the wake of a 6.4 magnitude earthquake that struck southern Taiwan early Saturday morning, killing at least 37 and injuring hundreds more, controversy has risen from the discovery of cooking **oil and paint cans built into the pillars** of a 17-story building in Tainan that toppled in the quake, resulting in the majority of the casualties. However, at this point, experts claim that they were not responsible for the building's collapse." Still not clear where these were actually placed, if not all over the building.

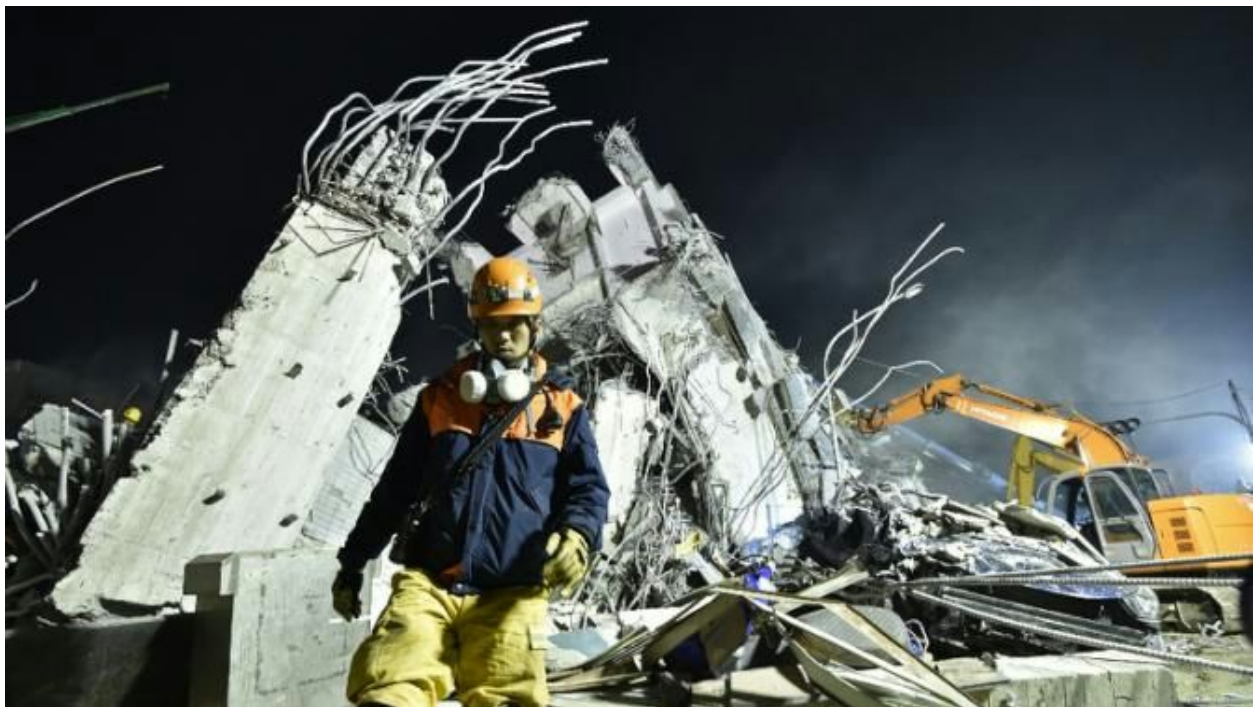
Figure 11. We can see what might be the base floor columns totally teared off (maybe a case of soft story building?)

The building collapsed and overturned to the street side. As clearly observed from the photos, there were no walls on the ground floor. Hence, there is a high likelihood that the basement acted as a soft storey and caused the building to collapse. (Generally, when shear walls are discontinued at a particular floor, the increased lateral demand is resisted by designing the columns for additional shear force. Hence, it would be worth observing if the ground floor columns were designed to handle the additional shear demand)

Also, the fact that the base columns completely teared off and the building overturned indicates that the connection between the building and foundation may not have been properly detailed.

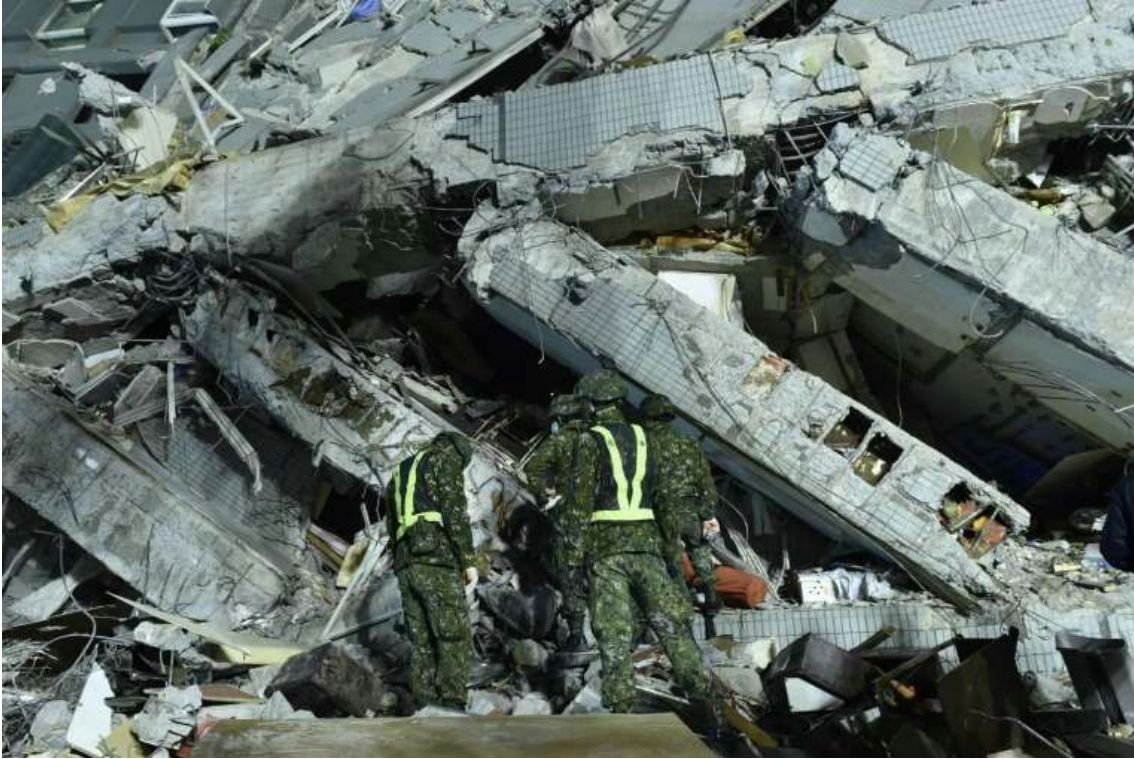
Figure 12: Another image showing the collapse of the beams or slabs between the resisting walls.

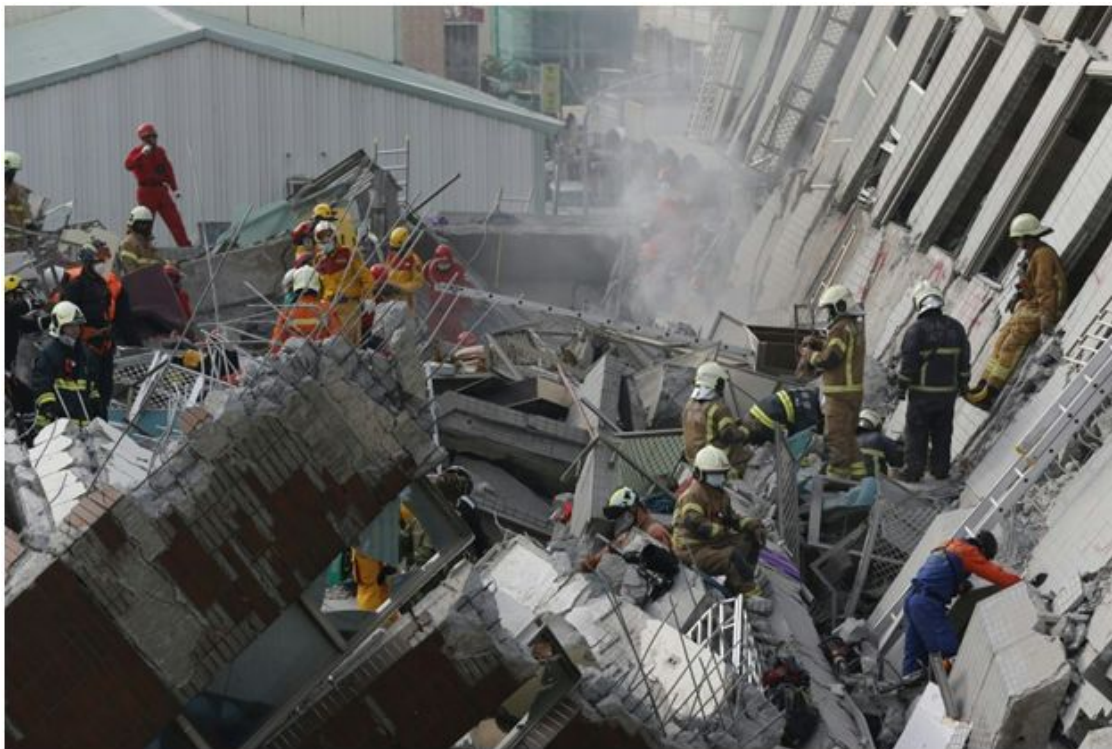
Figure 13: Complete debonding of reinforcement at connection is visible (Source <http://www.adn.com/article/20160206/over-100-missing-14-dead-strong-quake-rattles-taiwan>)

In photographs, the reinforcement seems to have either buckled, or decoupling of transverse and longitudinal reinforcement seems to have occurred. This indicates possibility of improper reinforcement detailing.

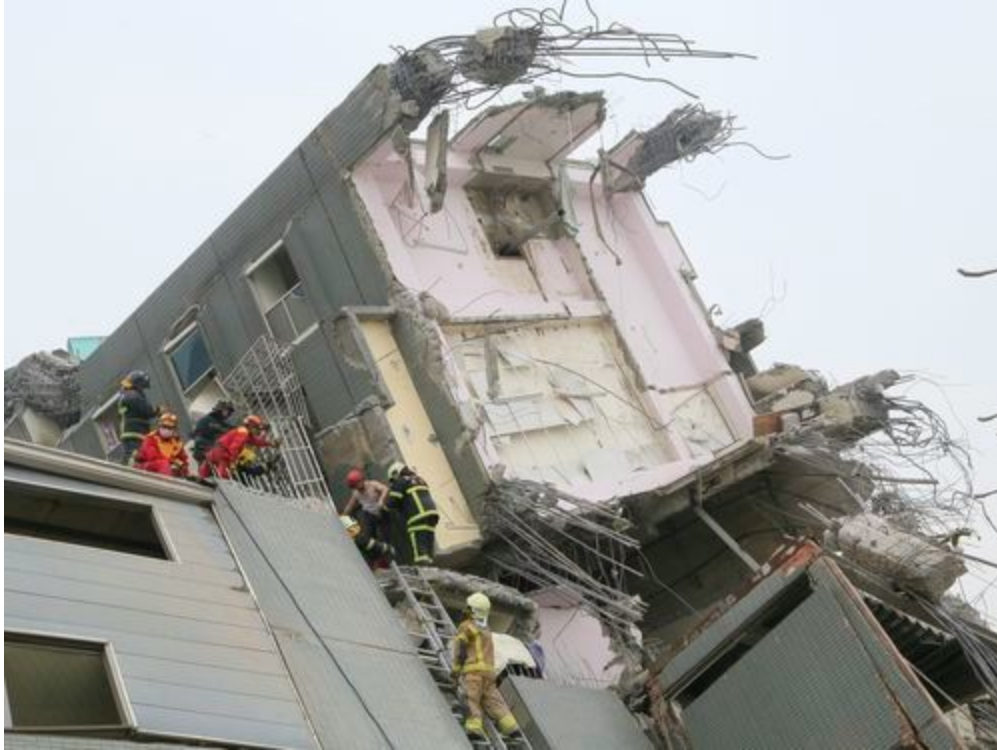
Figure 15:: Complete Overturning of base is observed
(Source: <http://focustaiwan.tw/news/asoc/201602070017.aspx>)

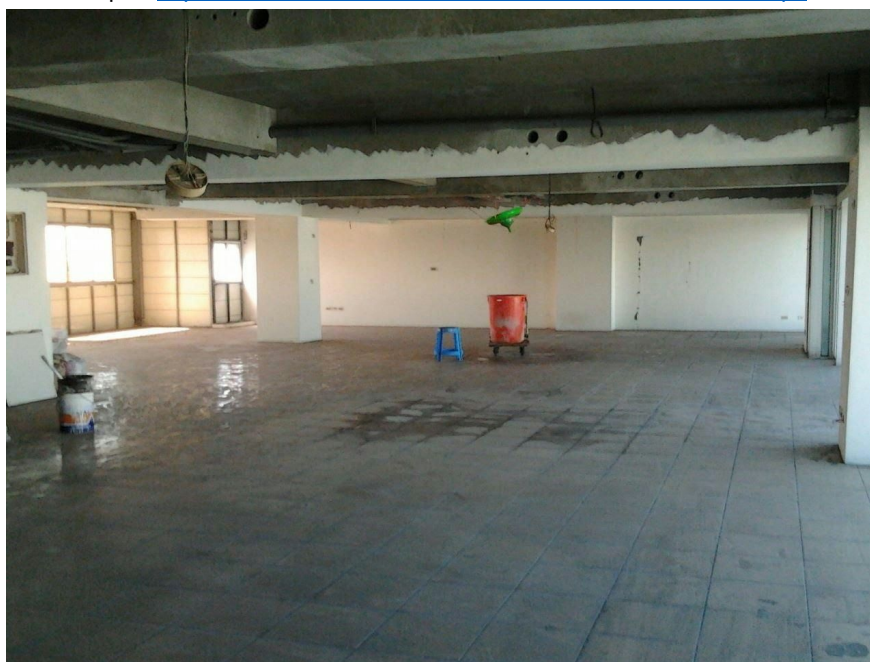
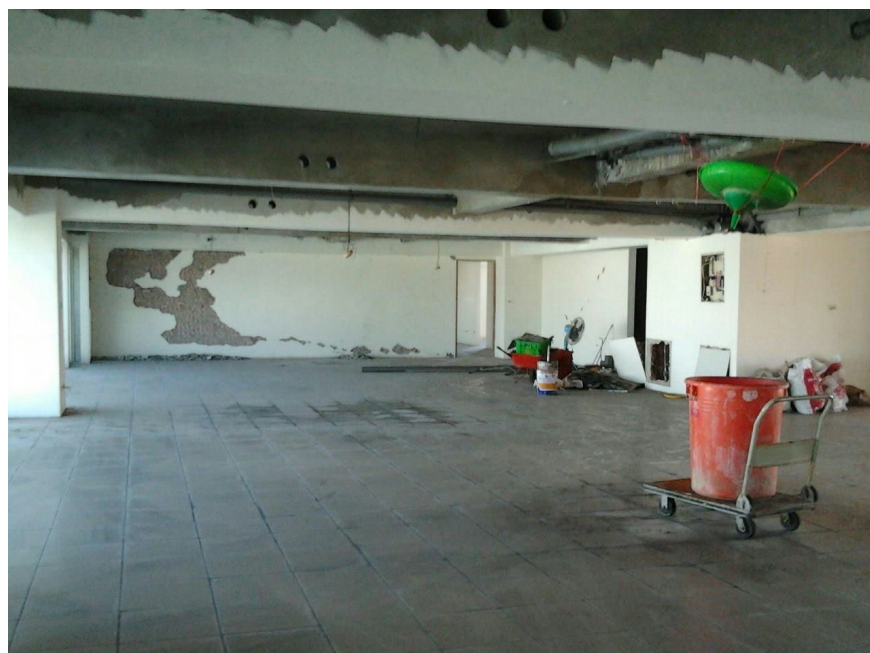
Report from Central News Agency, CNA, says that according to a victim of the earthquake, one of the reasons why the building collapsed may be that some resident in the building broke and cleared many infills and columns of a storey so that more rooms could be arranged for rent.

Pictures from the victim's Facebook.
