April 24, 2016

Preliminary Reconnaissance Report on Building Damage  
(2016 Kumamoto Earthquake)

Objective: Preliminary reconnaissance of reinforced concrete (RC) buildings damaged by the 2016 Kumamoto Earthquake

Site: Kumamoto city, Mashiki town, and Uto city in Kumamoto prefecture

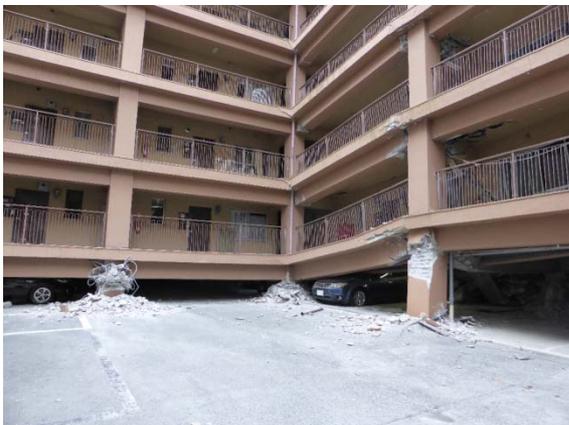
- Built on a plateau.
- L-shape floor plan with stilt first floor.
- 5 bays in the longitudinal direction and 4 bays in the transverse direction.
- 1<sup>st</sup> story collapsed due to formation of plastic hinges at the top of the columns in the main shock.
- Shear cracks in non-structural panels on 2<sup>nd</sup> story and above.
- Tombstones overturned in north and south direction at a surrounding cemetery. The maximum aspect ratio (Depth/Height) of the overturned tombstone is 0.40, and the minimum aspect ratio of survived tombstone is 0.39. This indicates that the maximum acceleration in this area is about 0.4g.

Soft 1<sup>st</sup> story collapse in north east frame

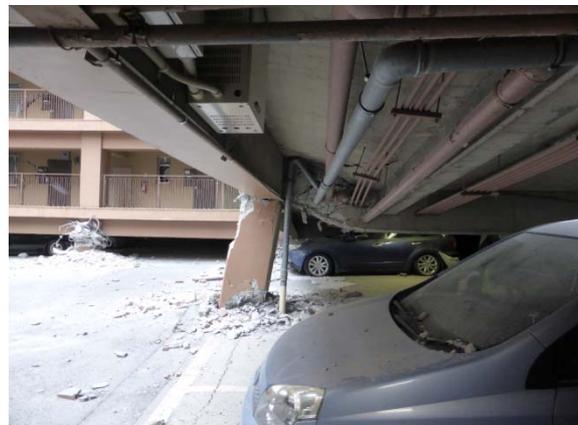
Bending of the transverse beam in north frame

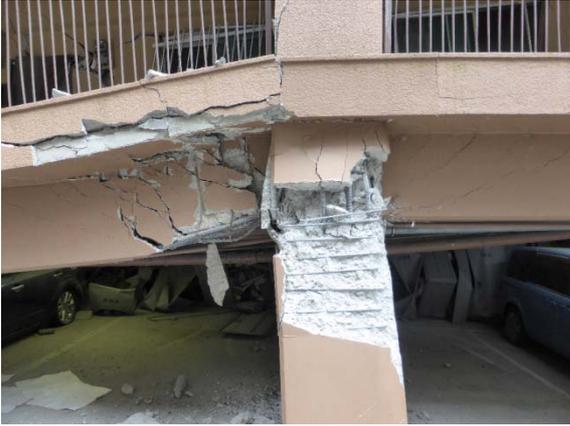
Column damage in the north frame

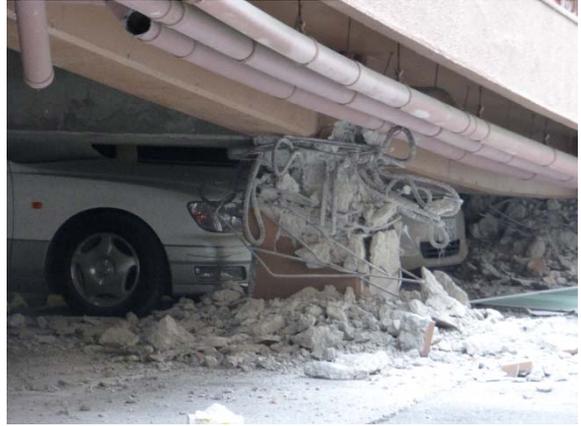
Crushed column in the south frame

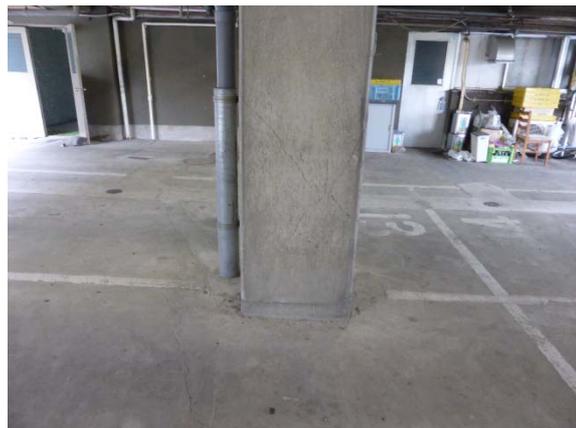
- Located diagonally opposite to the previously reported collapsed apartment.
- L-shape floor plan with stilt first floor.
- 6 bays in longitudinal direction and 4 bays in transverse direction.
- Shear cracks in first story columns in the transverse direction with maximum residual crack width of 1.6 mm.
- Flexural cracks on the first story beams in the longitudinal direction.
- Vertical cracks at the middle span of the beams in first story
- Surrounding reinforced brick walls overturned by the earthquake.

Shear cracks in a first story column

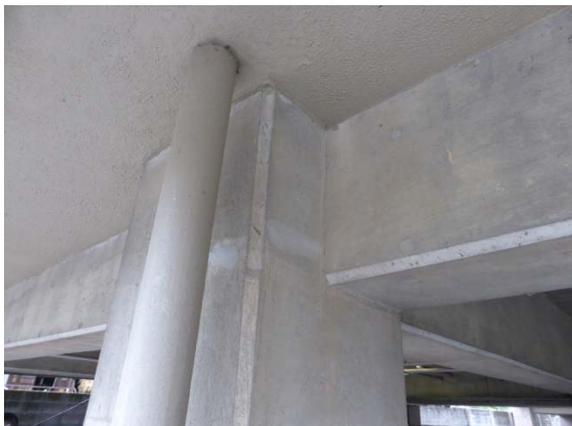
Flexural cracks in a first story beam

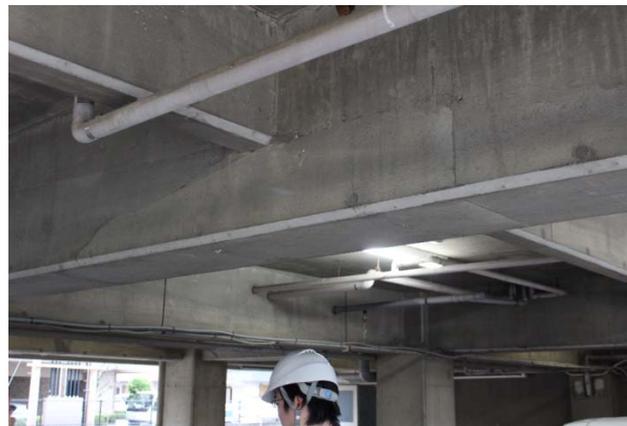
Vertical cracks at the middle span of a beam

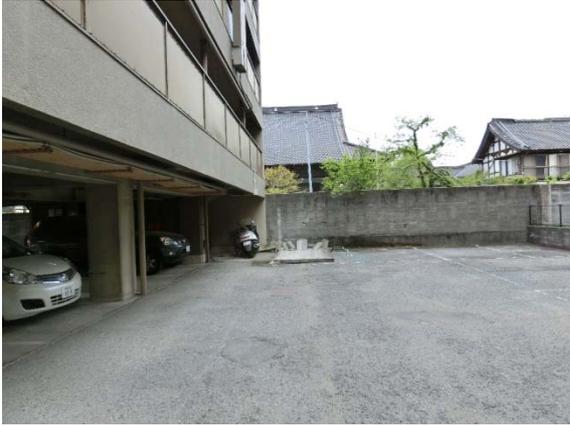
Overturned reinforced concrete brick wall

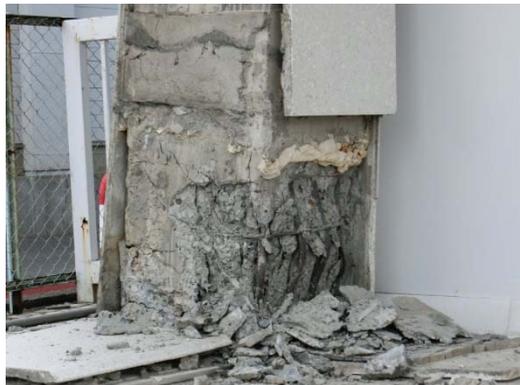
Damage to corner column

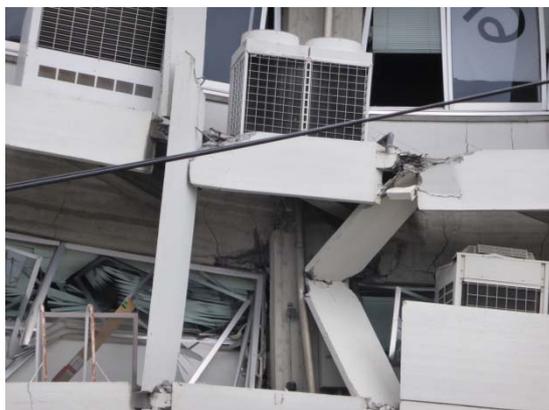
Failure of an interior beam-column joint at the fifth floor on west side of the building

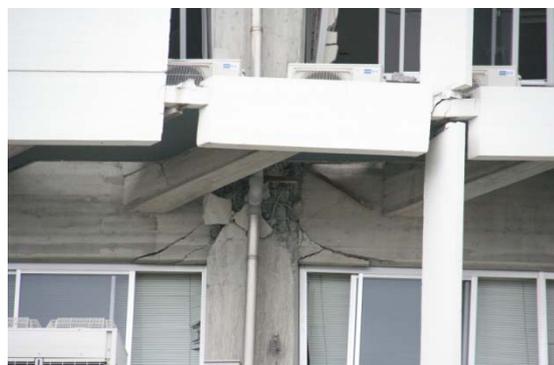
Failure of an interior beam-column joint at fifth floor on south side of the building

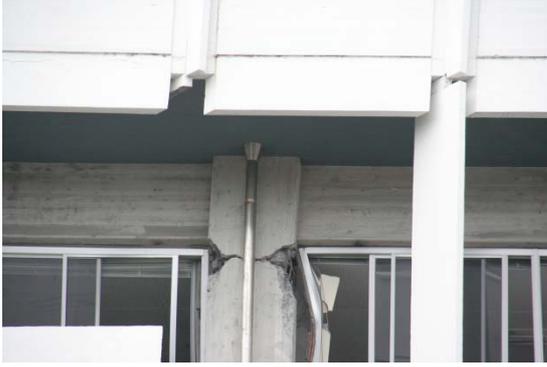
Flexural failure at the top of an interior column  
in fifth story

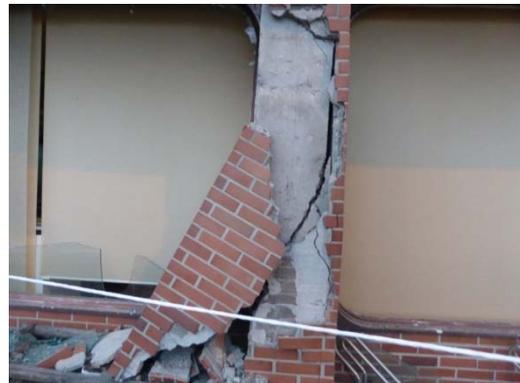
- Building frame consists of three bays in the longitudinal direction and one bay in the transverse direction. Exterior frames on the south and west are infilled with concrete shear walls with small windows.
- Shear failure was observed in a first story column on the side facing the road.
- No other damage was observed in the structural system otherwise.

Shear failure in a column

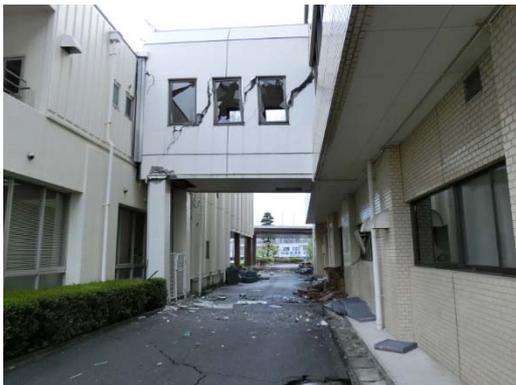
Damaged connecting corridor

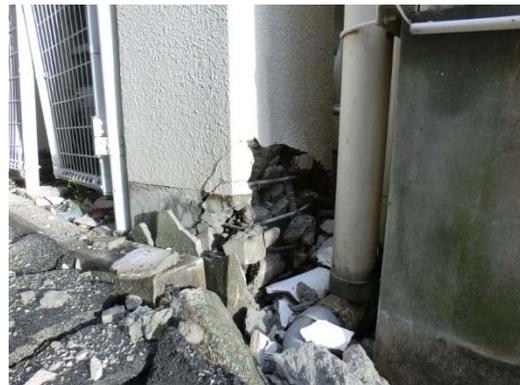
Damage to the column of the connecting corridor

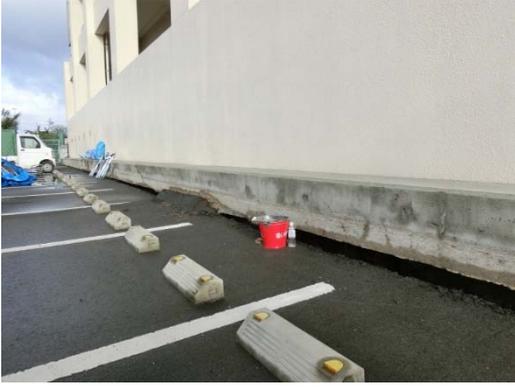
Settlement around the outer frame

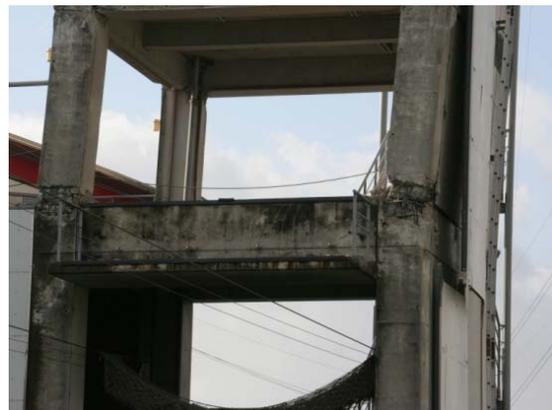
- Structural system above the third floor consists of a single bay moment resisting frame in both directions.
- Building is inclined to the west due to large residual inter story drift at the third and fourth stories.
- Flexural failure at the column base in third story and failure of the beam-column joints at fourth and fifth floors are prominent.
- According to the hearing from a staff, only cracking and spalling of concrete at the bases of the third story columns were observed after foreshock (on April 14th) while severe crushing of concrete at the column base and significant inclination appeared after the mainshock on April 16th.

Flexural failure at the base of third story columns

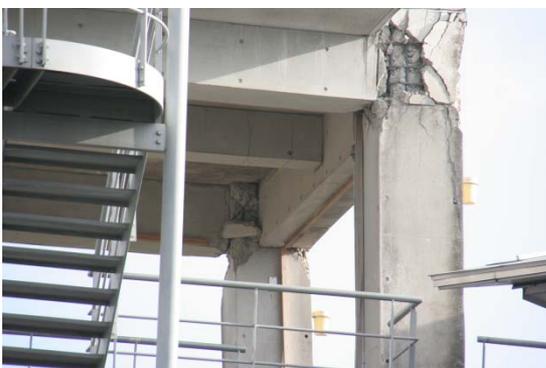
Failure in the beam-column joint at fourth floor

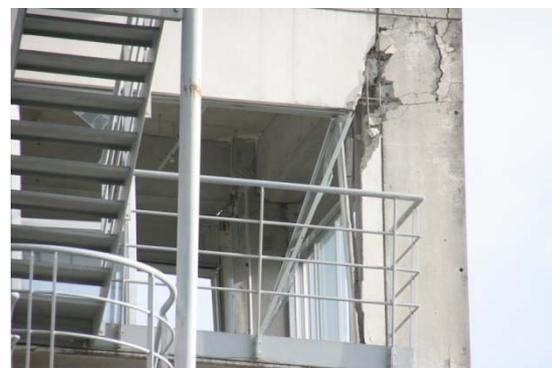
Failure in the beam-column joint at fifth floor

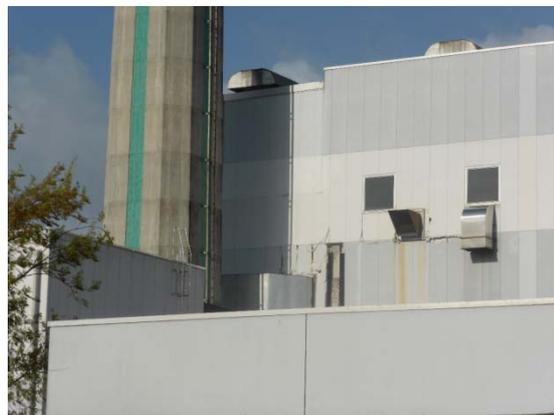
Damage to exterior wall panels

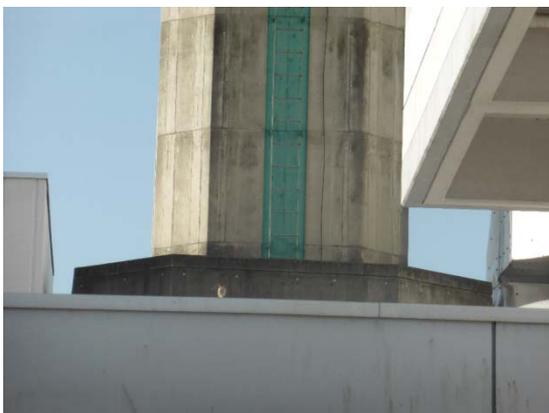
No damage at the bottom of the chimney

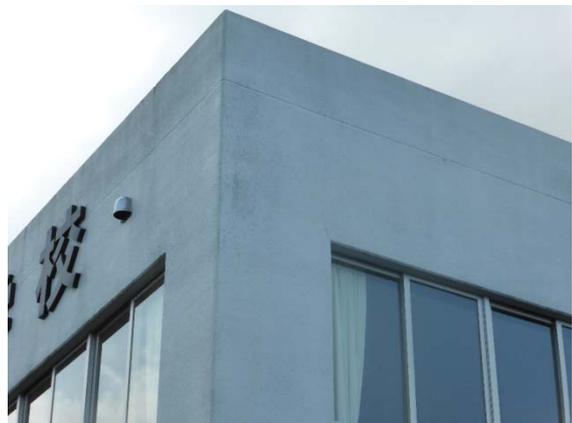
Cracks at the top of second story columns

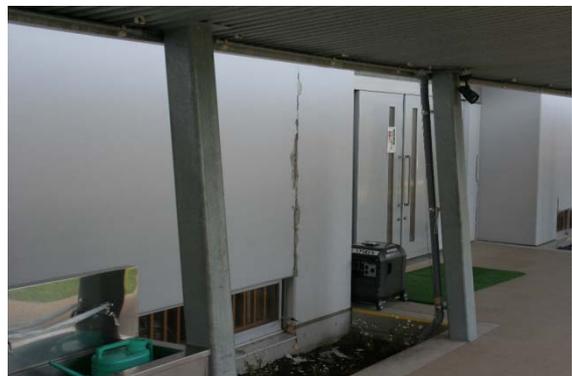
Damage to the exterior walls

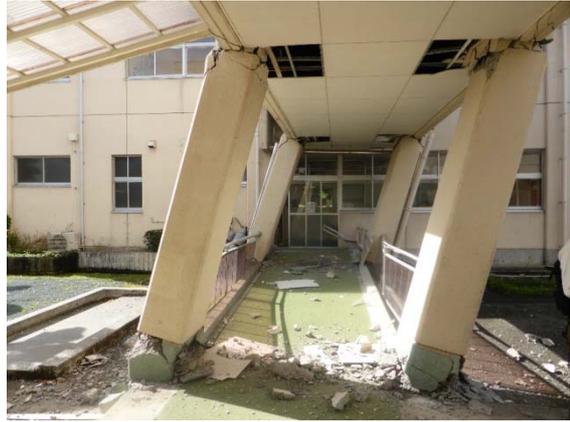
- Two parallel school building are joined by two connecting corridors. This connecting structure exhibits flexural failure at the top and bottom of columns, and is inclined largely in transverse direction. Residual drift ratio is 6 % in the west corridor, and 20% in the east corridor.
- South building consists of 8 bays in longitudinal direction and 2 bays in transverse direction. No obvious damage was observed.
- North building consists of 9 bays in longitudinal direction and 2 bays in transverse direction. Two central spans are braced on the first and second story. Cracks observed in the concrete mortar connecting the brace to the RC frame.
- Shear cracks in a mullion wall (residual crack width 2.5 mm) and flexural cracks in columns and spandrels also observed in the south part of the north building.
- All the steel braces in the second story of the gymnasium show buckling.

Story drift of the east corridor

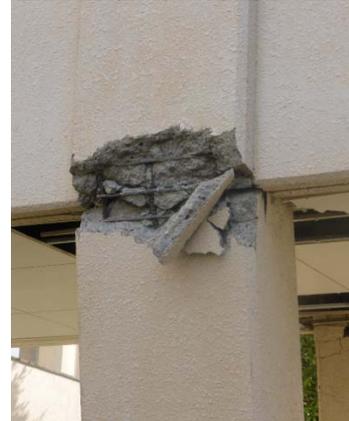
Top of the damaged column  
(connecting corridor)

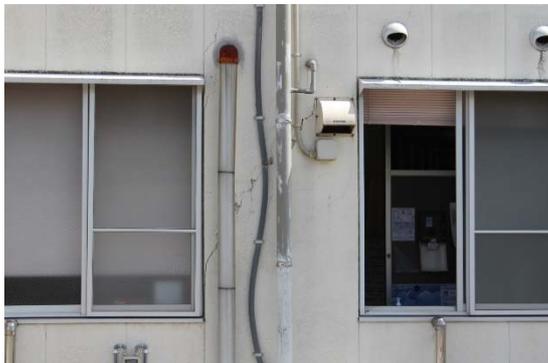
Crack in non-structural wall

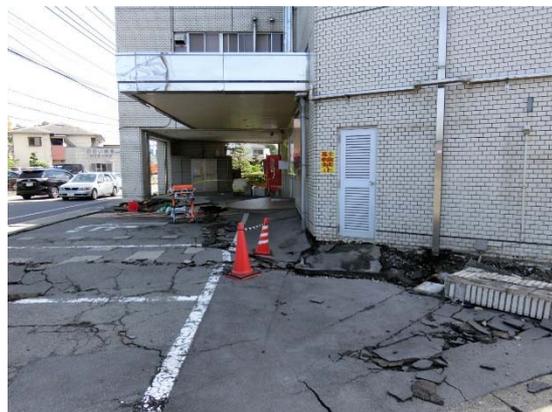
Broken asphalt around the building

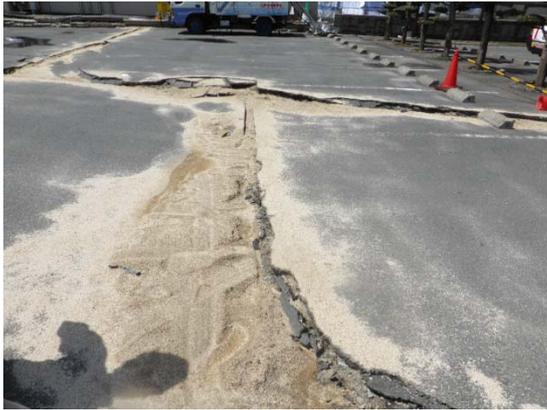
Ground opening in the parking

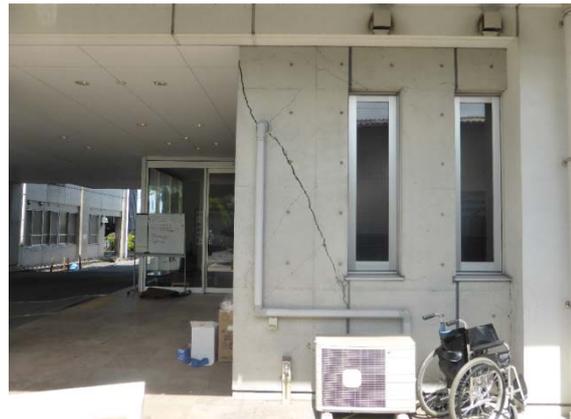
Shear cracks in the nonstructural panel  
(due to subsidence of the supporting ground)

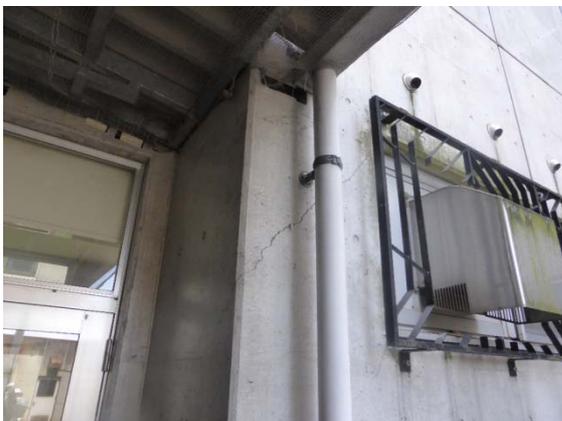
- Amount of wall section is considerably larger compared to the building area
- Two short columns in each story show shear cracks. Maximum width of the observed cracks is 1.7mm.

Shear cracks on a short column

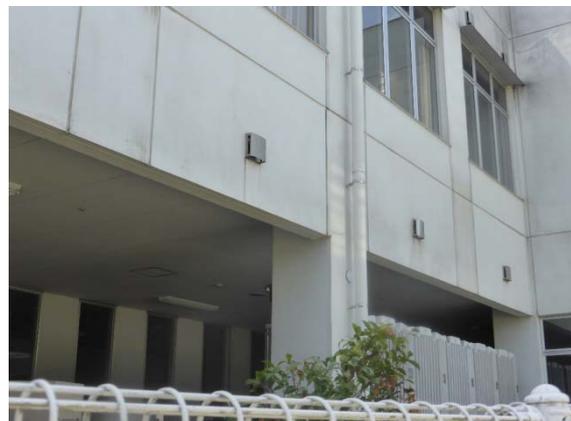
- Flexural cracks observed in the columns of stilt first story. Beams connected to these damaged columns was a wall girder.
- Shear cracks on non-structural panels and damage at the expansion joint due to the subsidence of supporting ground were observed.

Flexural cracks on a stilt story column

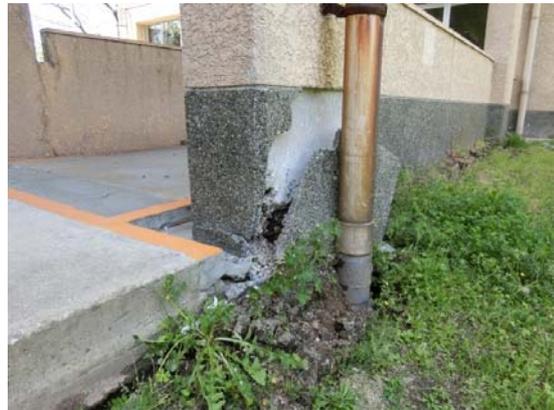
Damaged column of the corridor

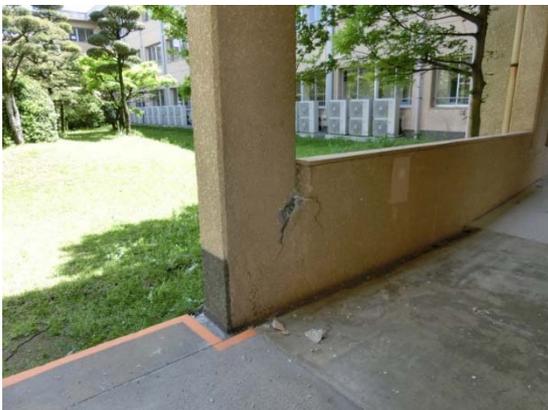
Cracks at the end of spandrel wall in the corridor

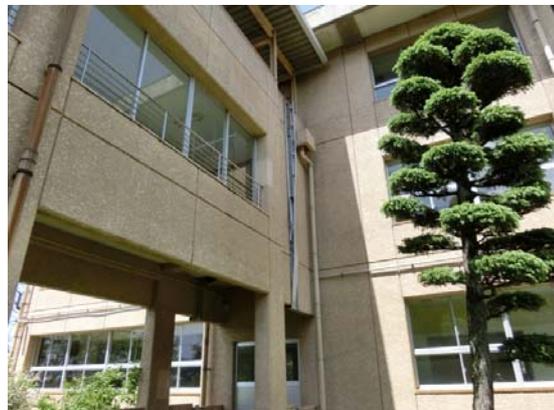
Displacement at the expansion joint between the corridor and the school building

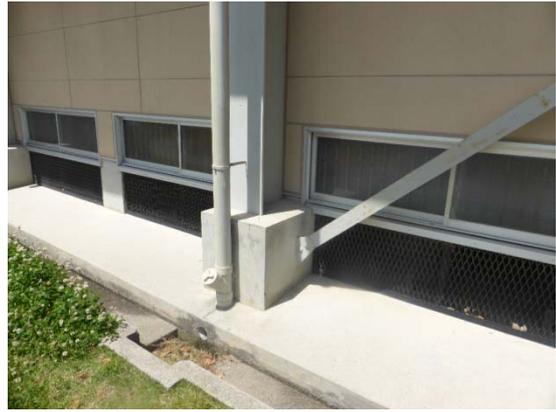
Cracking in a concrete foundation of the brace

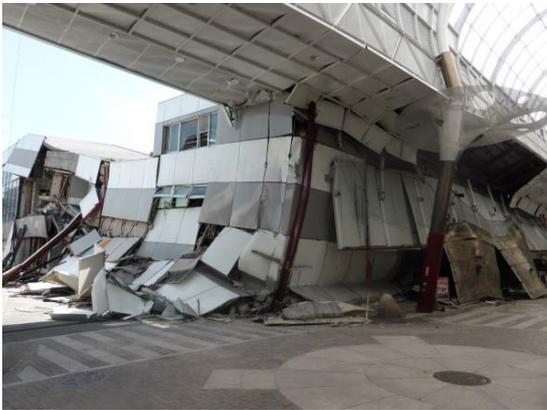
Building leaning against the columns of the arcade

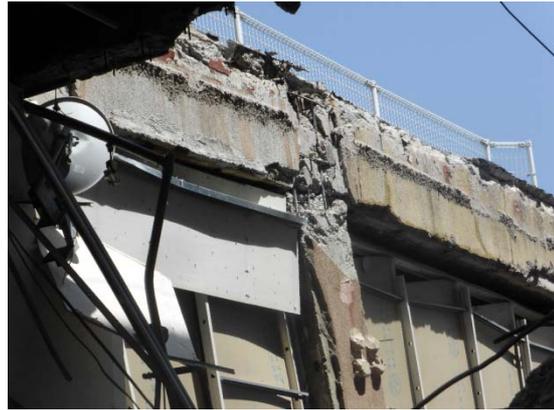
Failure of a beam-column joint at the top of  
a second story column

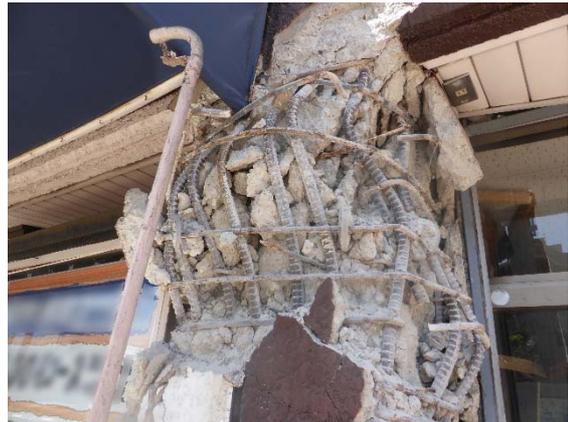
Shear failure at the lapping of reinforcement

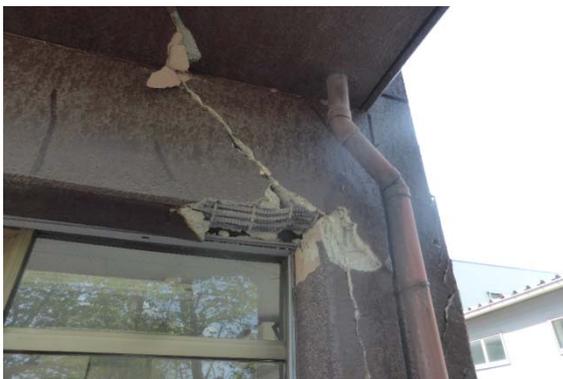
Shear failure of a beam

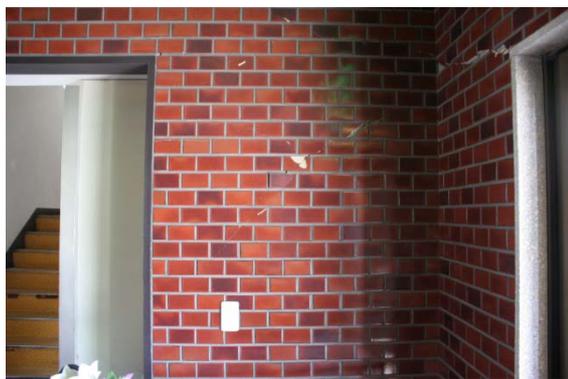
Shear cracks on a wall

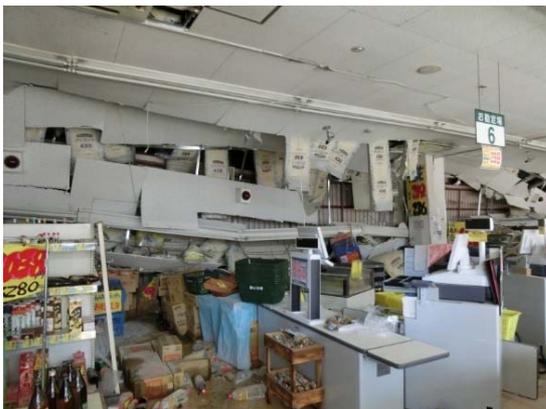
View of the damage from inside the building in the first floor. (The upper floor collapsed down)

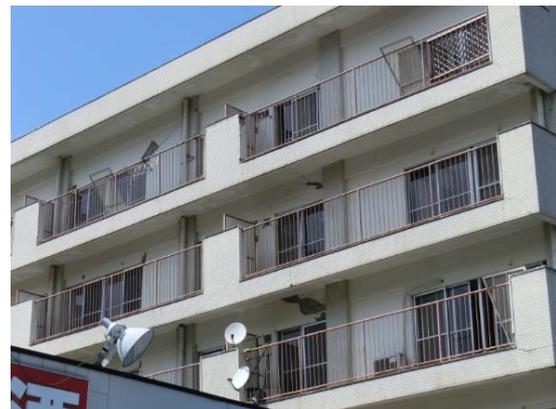
Shear failure in a beam

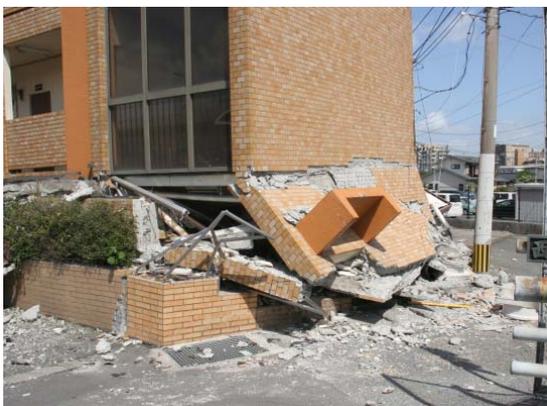
Failure of the gable wall at the south side

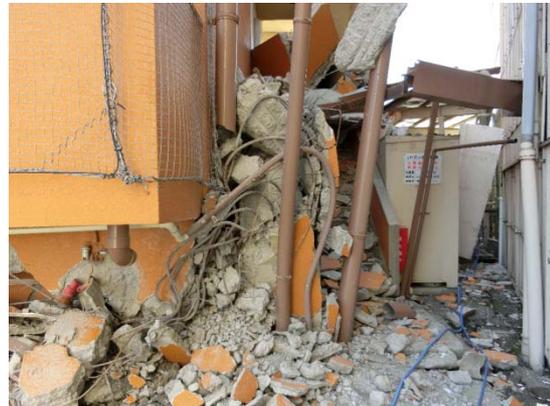
Collapsed column at the northeast corner

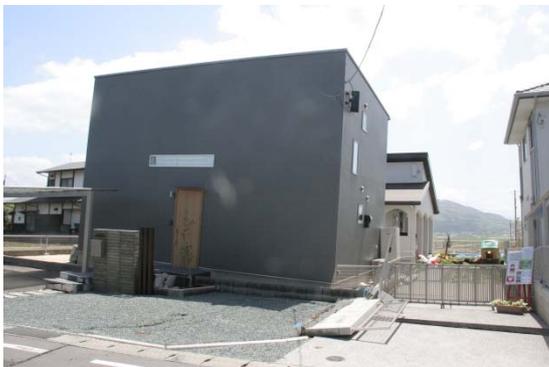
Mashiki town

(4) Inclination of wooden house due to ground displacement

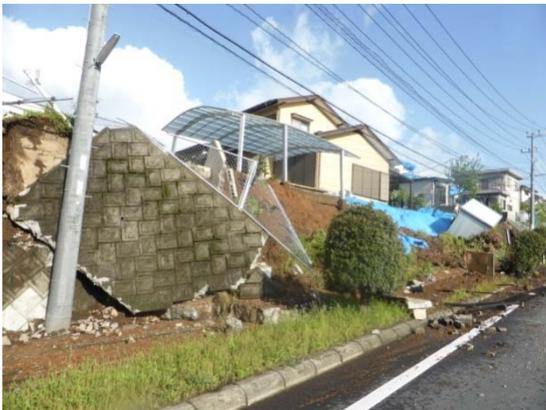
Mashiki town

(6) Failure of retaining wall
