# **Preliminary update - Mw7.8 Kaikoura Earthquake (15 November 2015)**

## **Upper Part of South Island**

**By Dmytro Dizhur and Marta Giaretton**

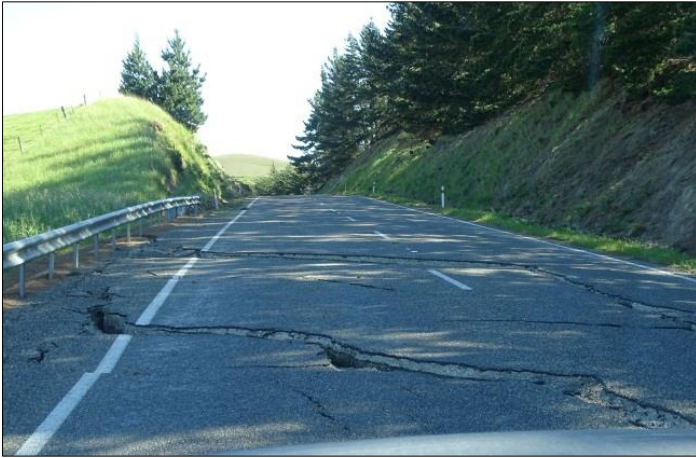
Typical road conditions on approach to Clarence

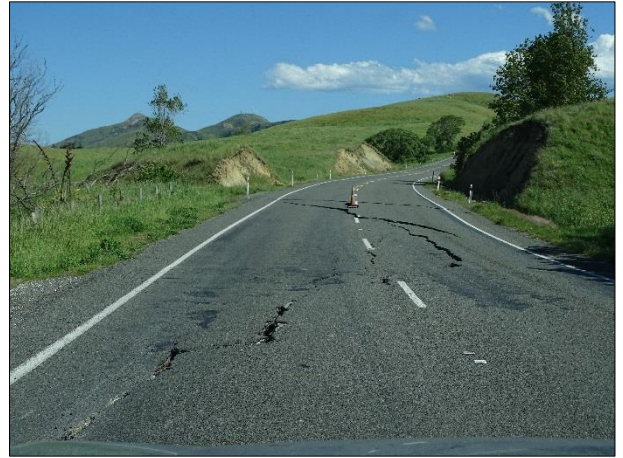
Typical road conditions on approach to Clarence

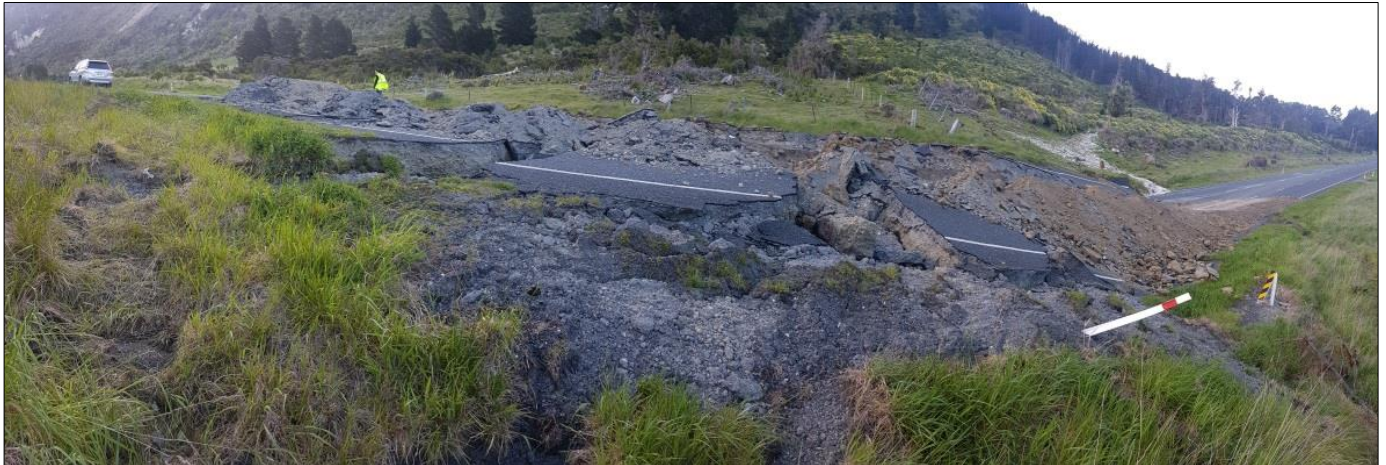
Meteres of vertical uplift, road completely destroyed – 4WD access across

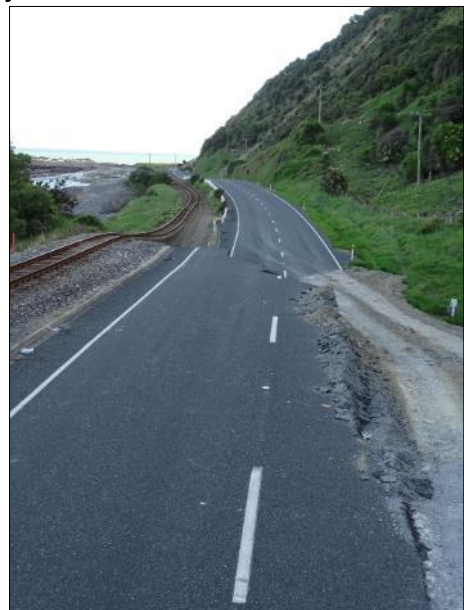
Upto 3 meters of vertical drop in (looking south)

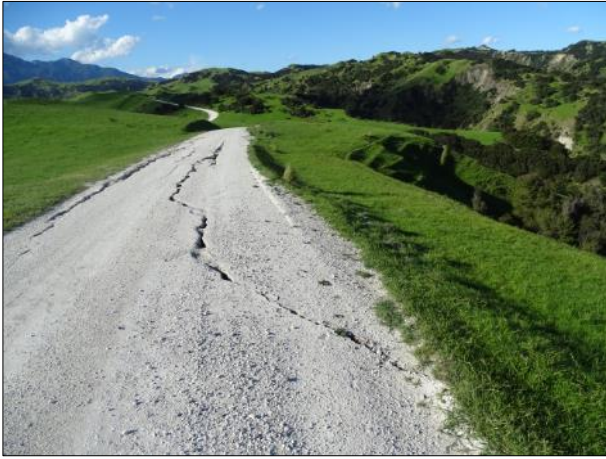
Typical condition of nearby rural roads - 100s land slips

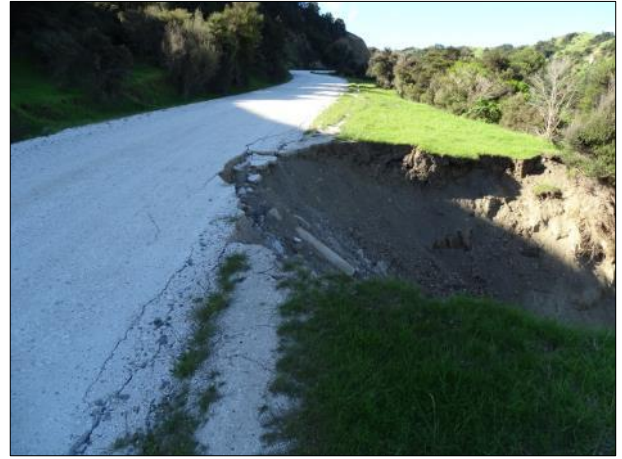
Typical condition of nearby rural roads - 100s land slips

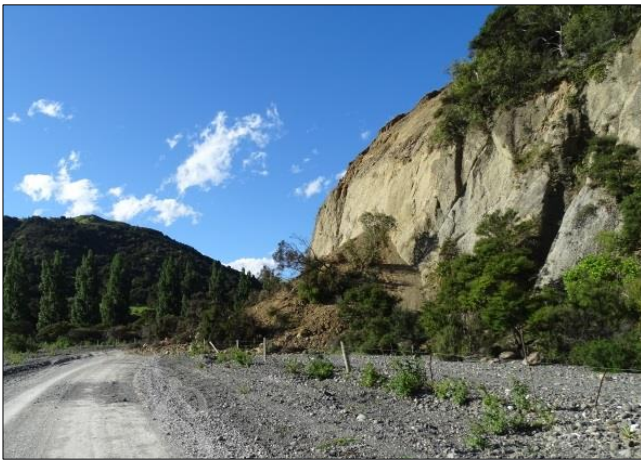
Typical condition of nearby rural roads - 100s land slips

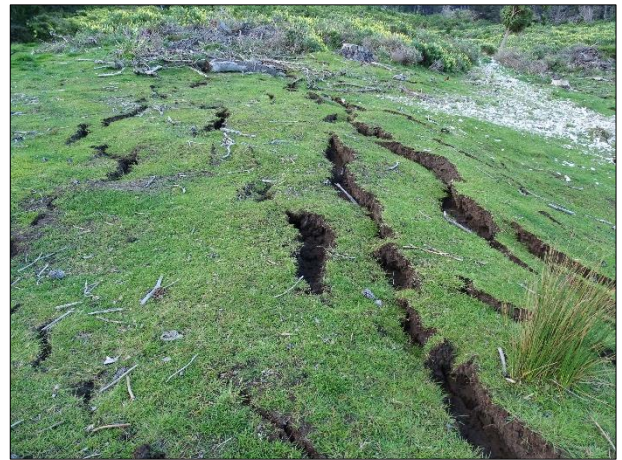
Significant soil deformation near SH1 – vertical and horizontal translation

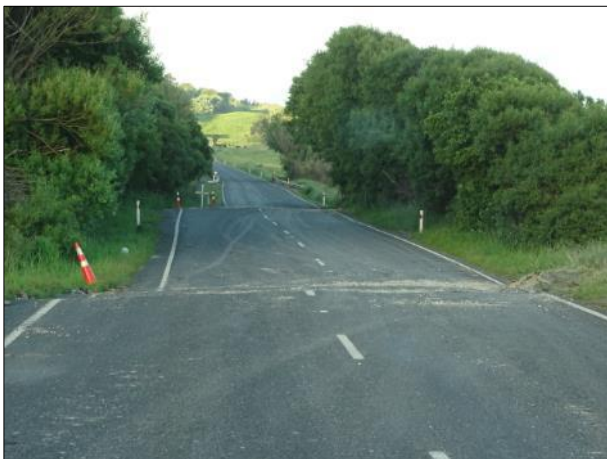
Significant vertical and **horizontal** shifts in road alignment

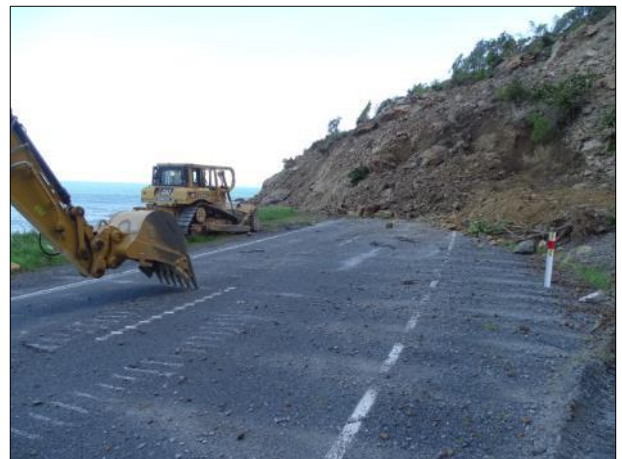
End of the road – Okiwi Bay. Attempts are being made to start removing the mammoth slip

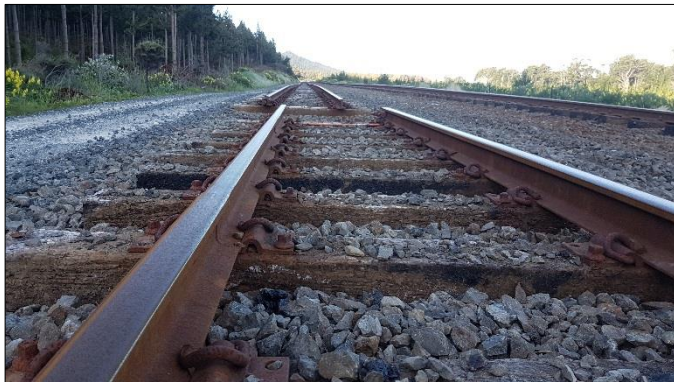
Rupture of railway lines at bolted joints – horizontal translation

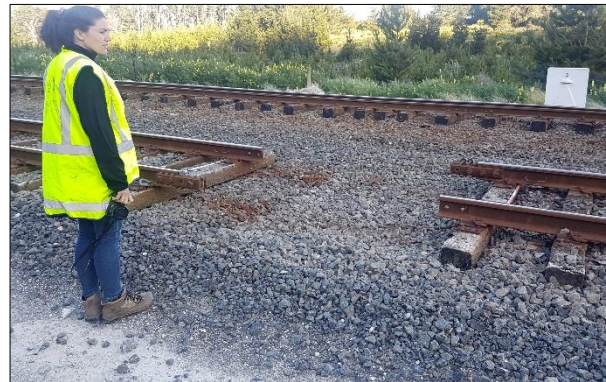
Shear failure and spread of railway lines

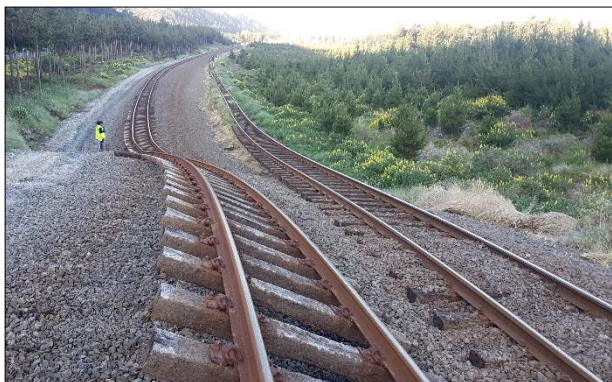
Major lateral displacement of railway lines

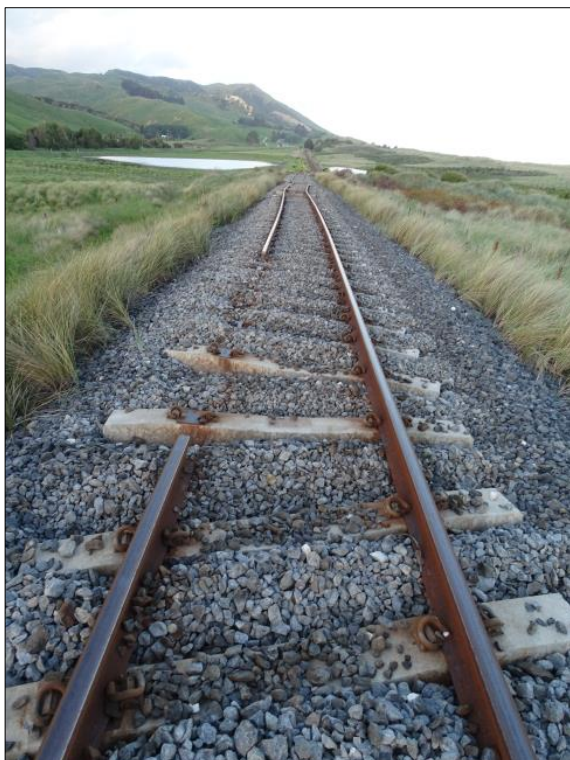
Stretch and major dragging of lines

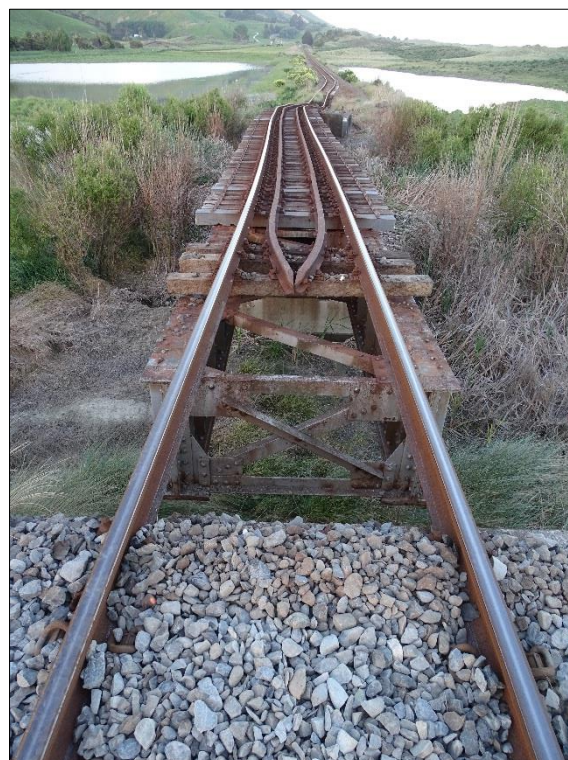
Major horizontal and vertical movement of land near bridge

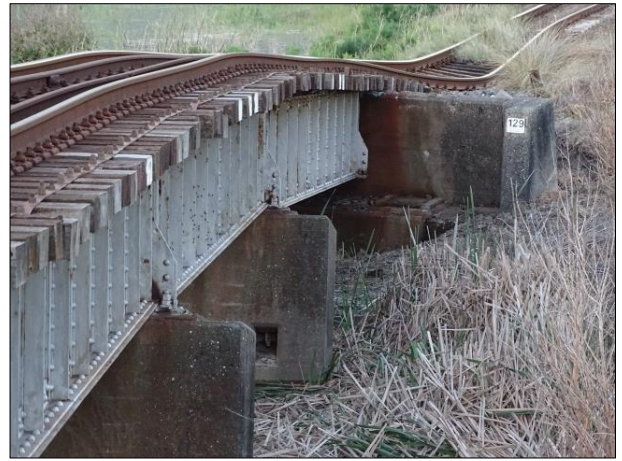
Major vertical and horizontal movement – appears to be swampy land

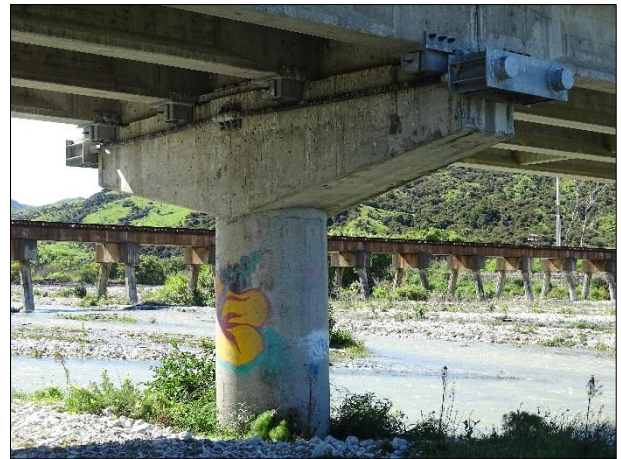
Evidence of pier inclination towards west

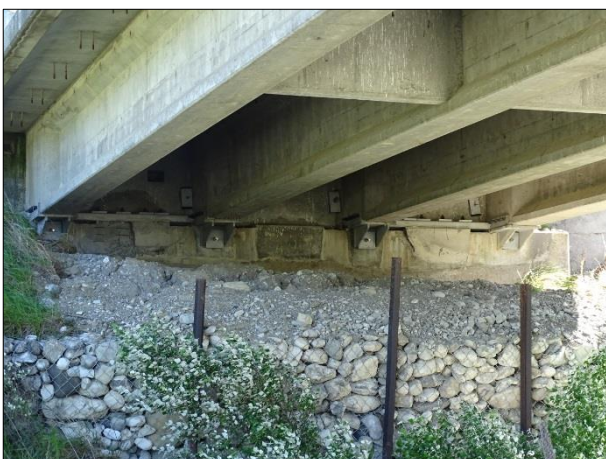
Minor concrete spalling at south abutment

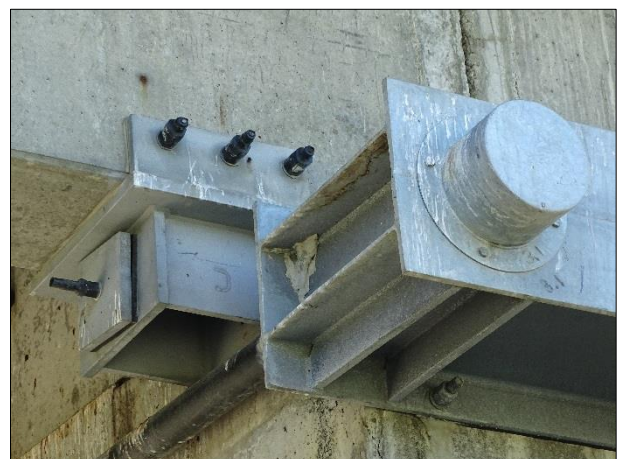
Evidence of distress

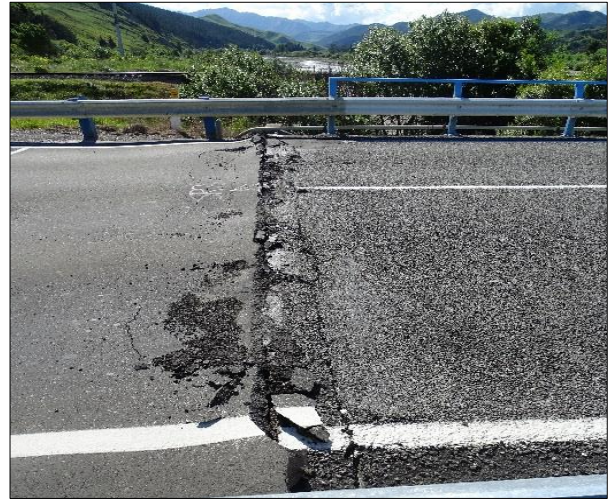
Damage to south approach

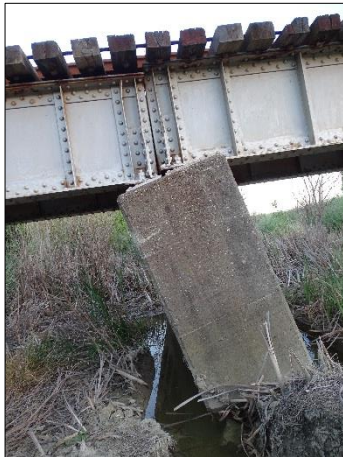
Major railway bridge pier rotation

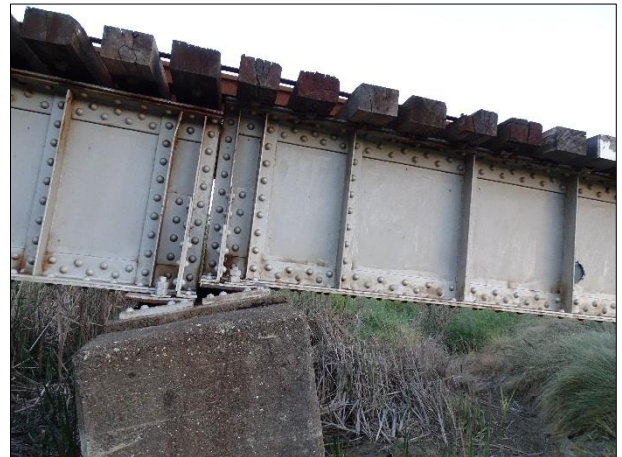
Close up of pier rotation

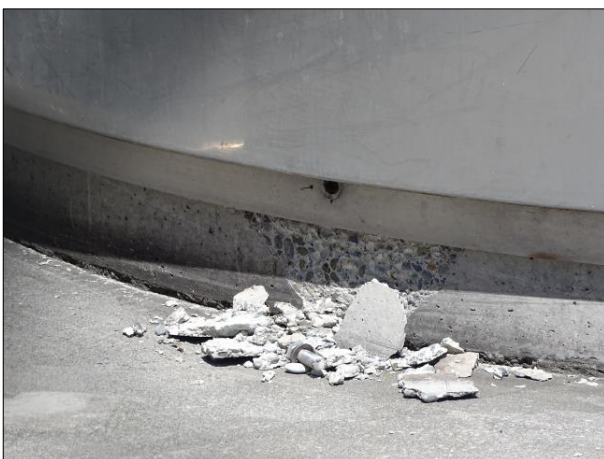
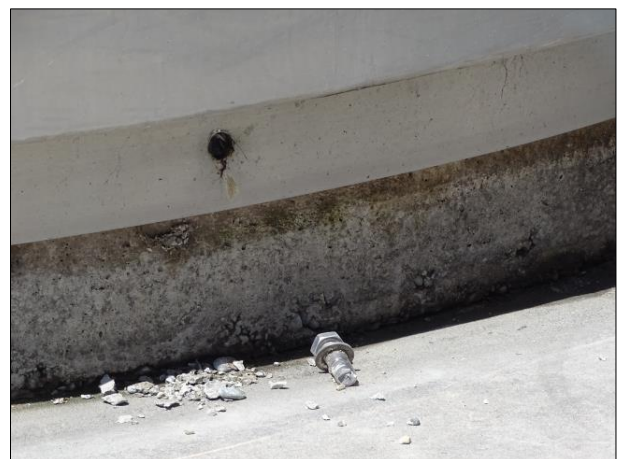
Shear failure of tank connections

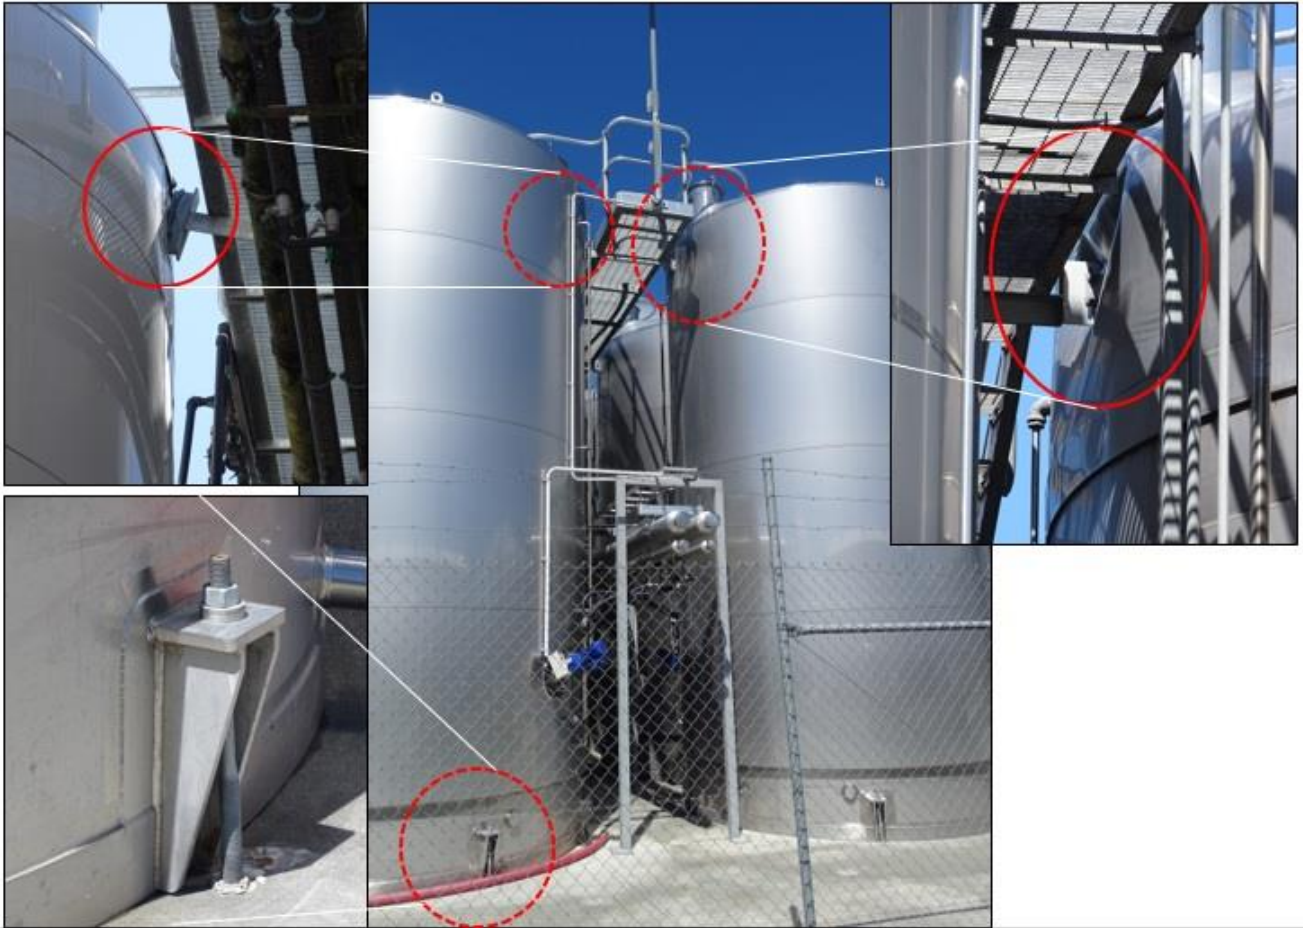
Damage to the walking platforms atop of tanks and anchoring connections due to tank movement

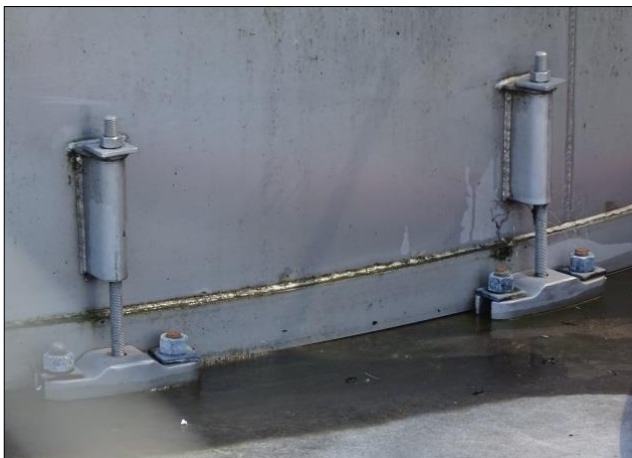
Evidence of movement and losing of connections

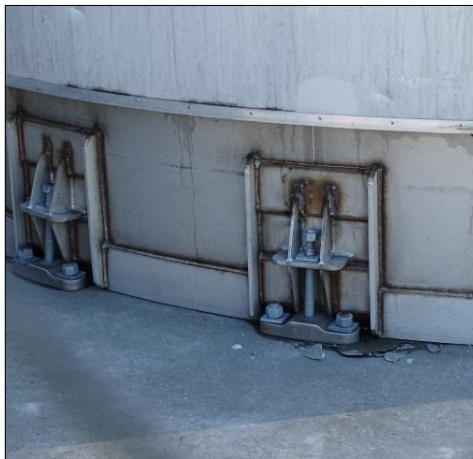
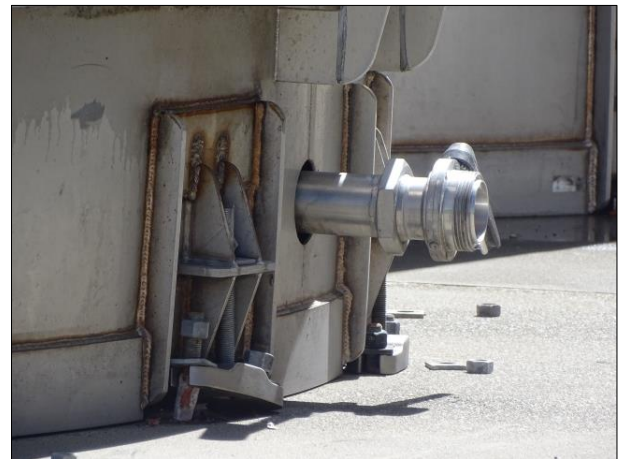
Pull-out of some adhesive anchoring connection

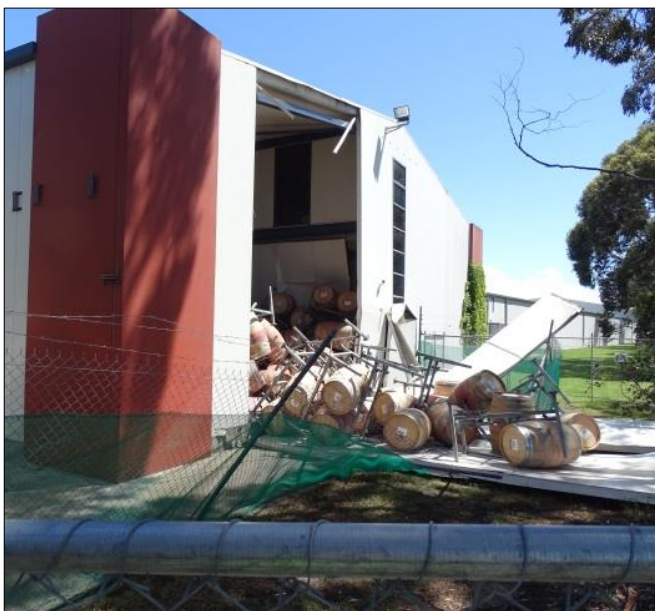
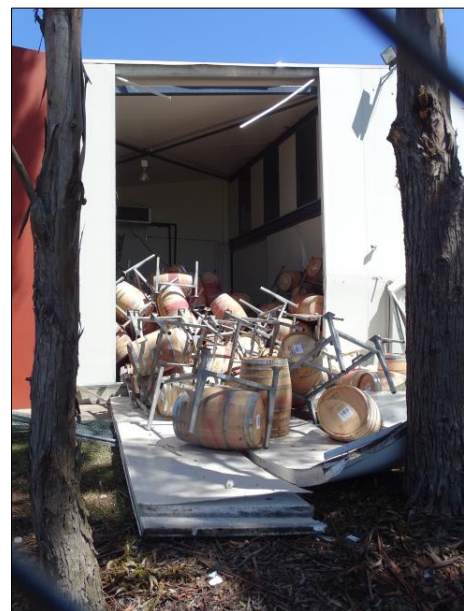
Collapse of stacking systems - wooded barrels' storage

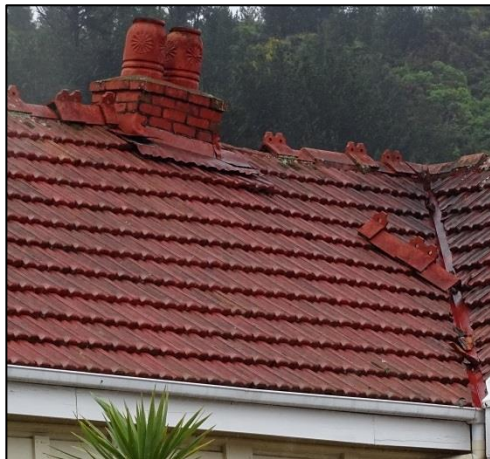
Chimney damage and consequent ceiling damage

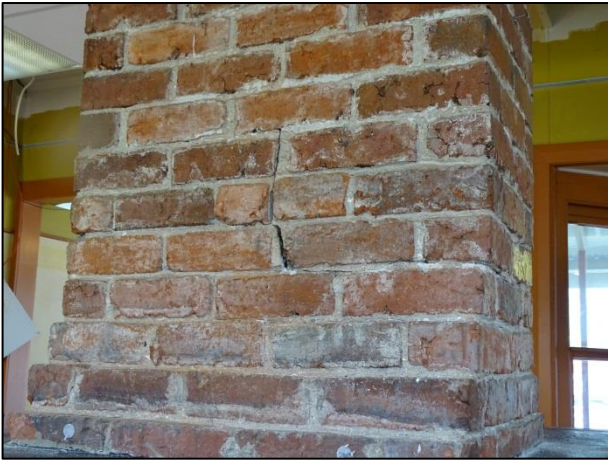
Chimney internal stack, torsional damage

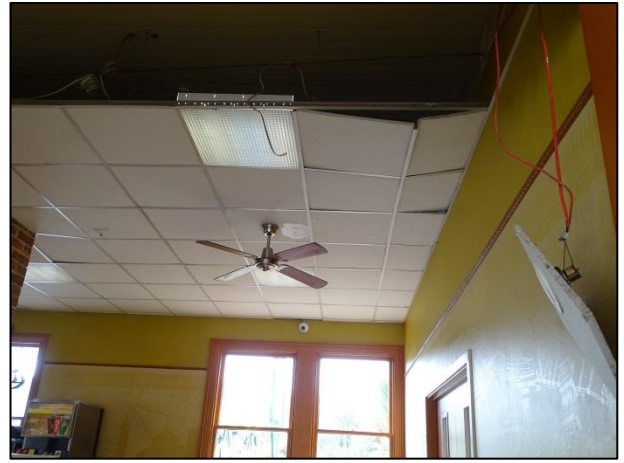
Ceiling damage due to chimney

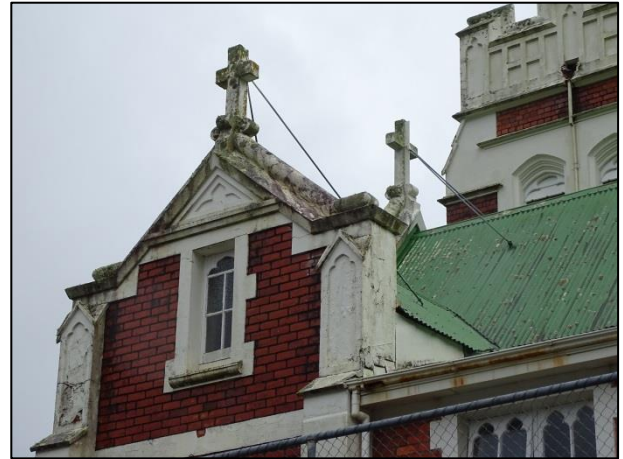
Presence of existing damage (cracks and deteriorated bricks)

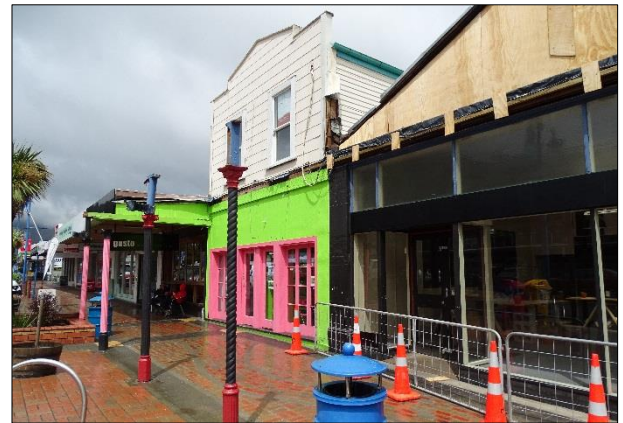
Collapse of front façade and canopy – all cleared and removed

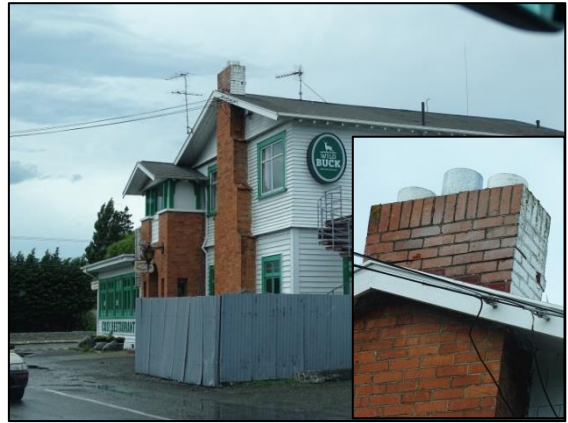
Junction Hotel – movement of chimney

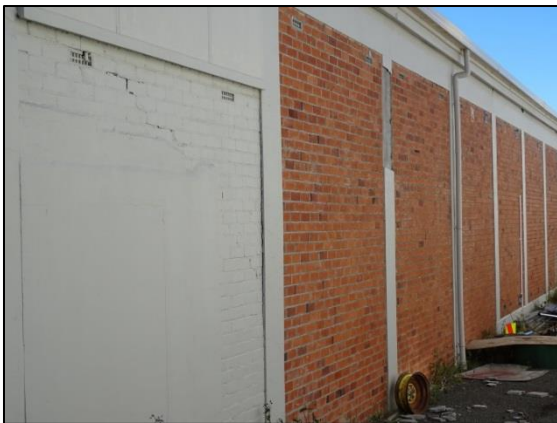
- Damage to non-structural elements, ceilings
- In-plane damage to RC with in-fill masonry buildings

RC with masonry in-fill buildings

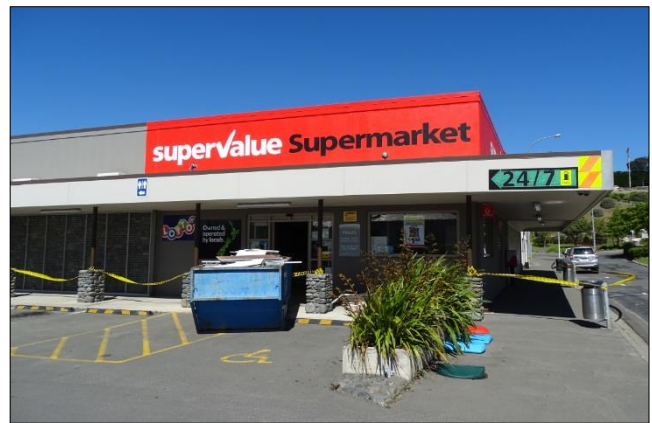
Major non-structural damage to local supermarket, shops and cafes

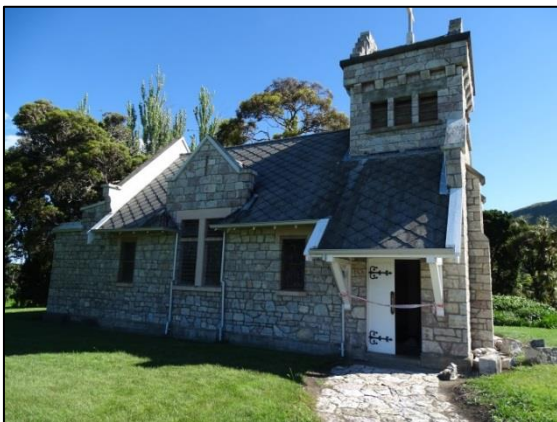
St Oswald's Church, stone and concrete, collapse of parts of front parapet

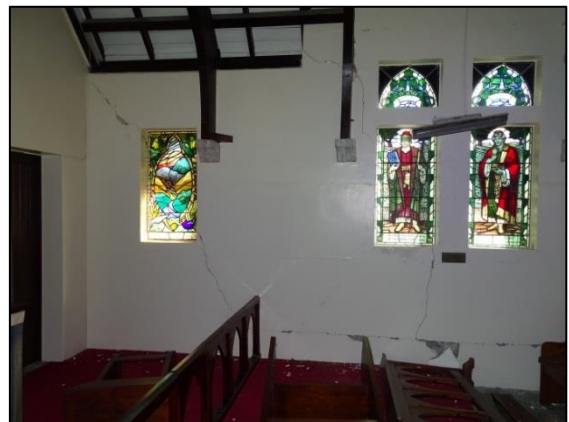
Internal view with diagonal shear and shear sliding cracks

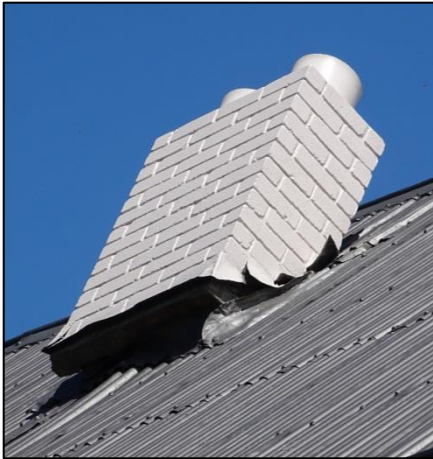
Inward collapse, Blenheim

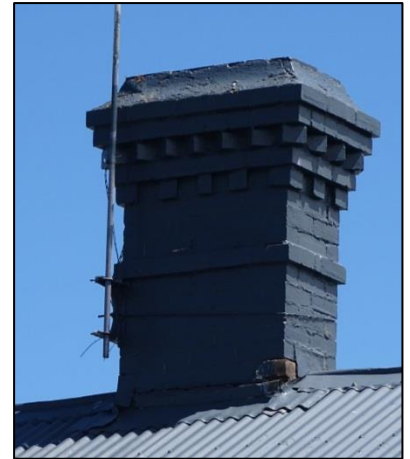
Horizontal crack at the roofline, Blenheim

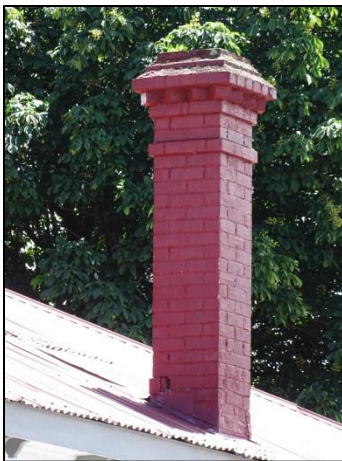
Horizontal crack at the chimney base and torsion, Blenheim

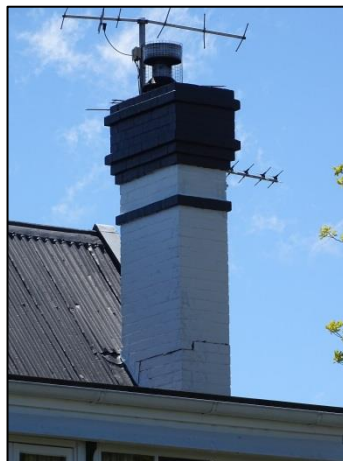
Horizontal crack at the base, Blenheim

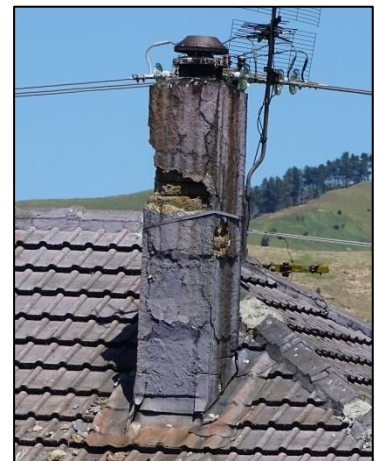
Extensive damage of the plaster, Blenheim

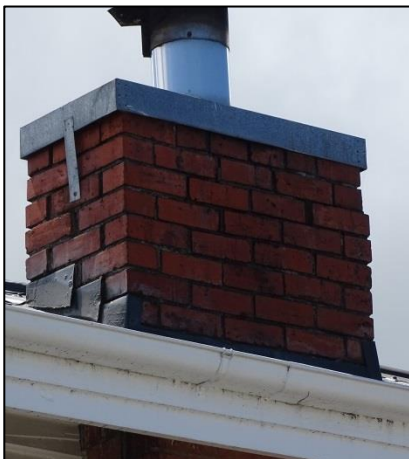
Dislodgement of the bricks, Blenheim
