# **Preliminary update - Mw7.8 Kaikoura Earthquake (15 November 2015)**

## **Upper Part of South Island**

**By Dmytro Dizhur and Marta Giaretton**

This is a preliminary set of notes from observations made on 15 November 2016, route taken is shown below.

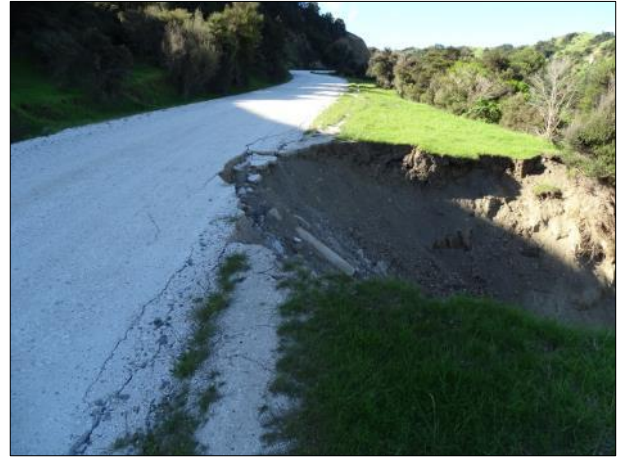
Typical condition of nearby rural roads - 100s land slips

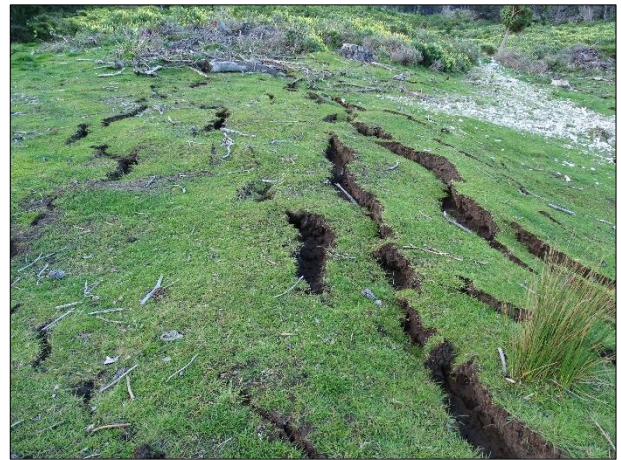
Significant soil deformation near SH1 – vertical and horizontal translation

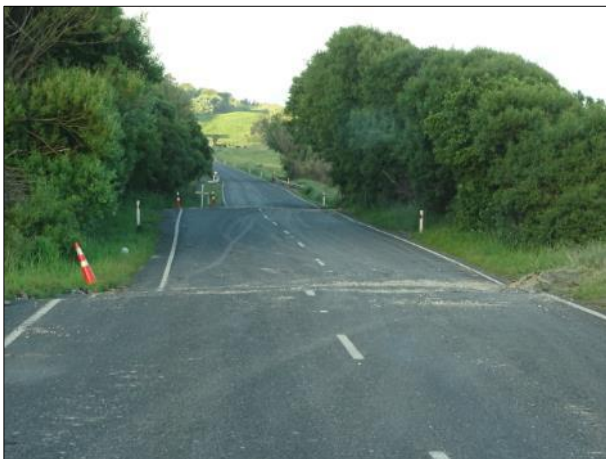
Significant vertical and **horizontal** shifts in road alignment

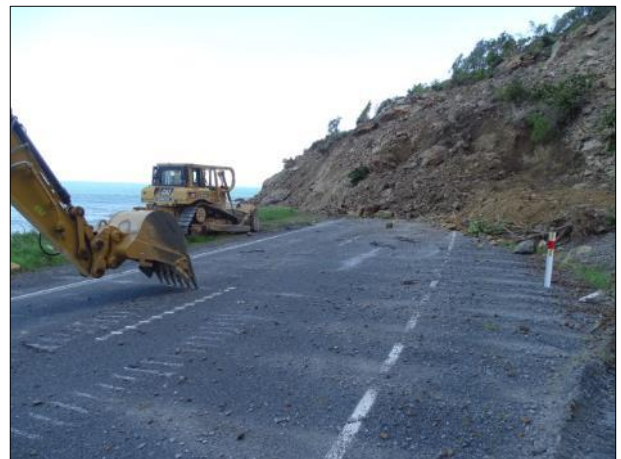
End of the road – Okiwi Bay. Attempts are being made to start removing the mammoth slip

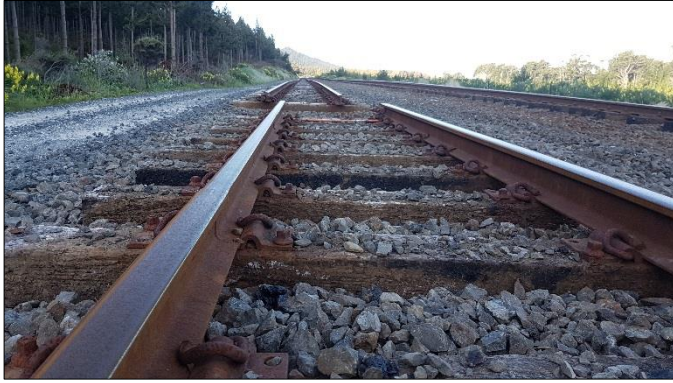
Rupture of railway lines at bolted joints – horizontal translation

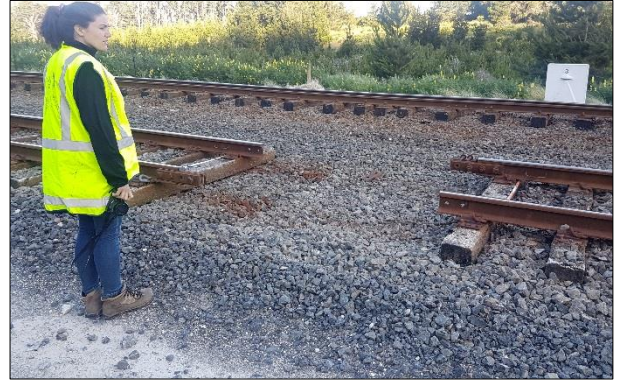
Shear failure and spread of railway lines

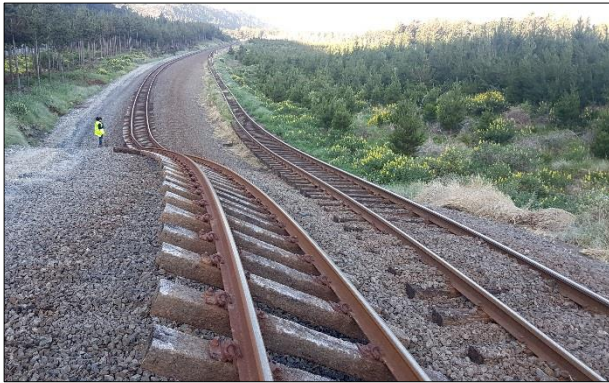
Major lateral displacement of railway lines

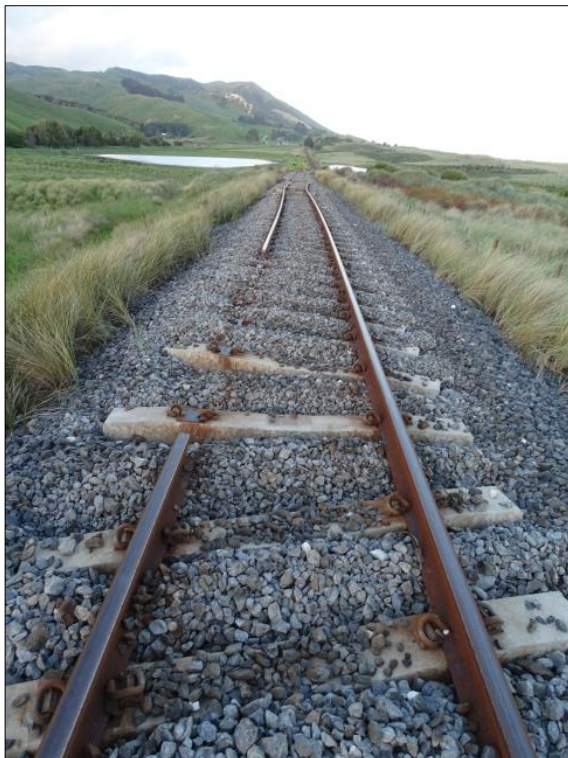
Stretch and major dragging of lines

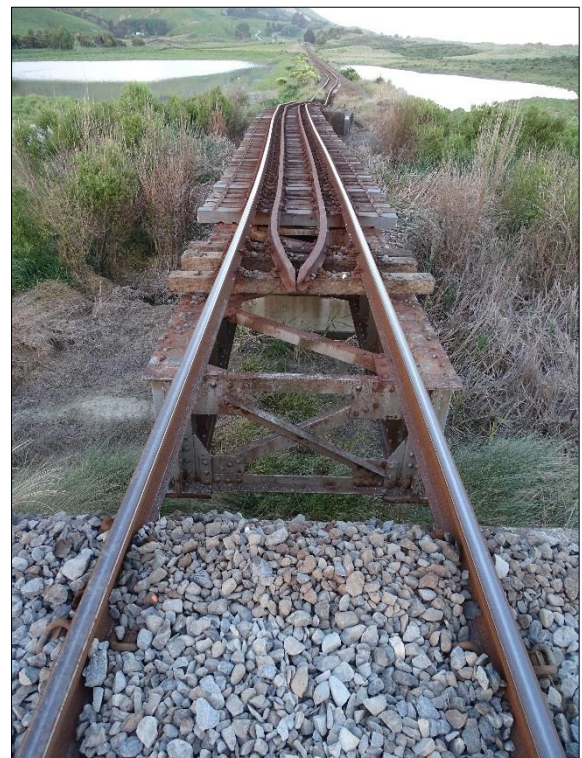
Major horizontal and vertical movement of land near bridge

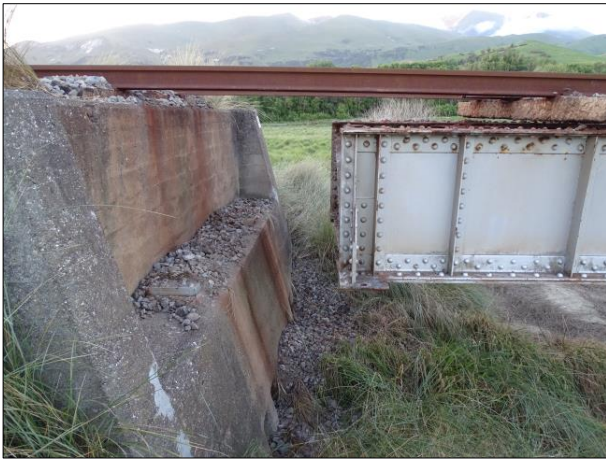
Bridge movement over one meter away from abutment

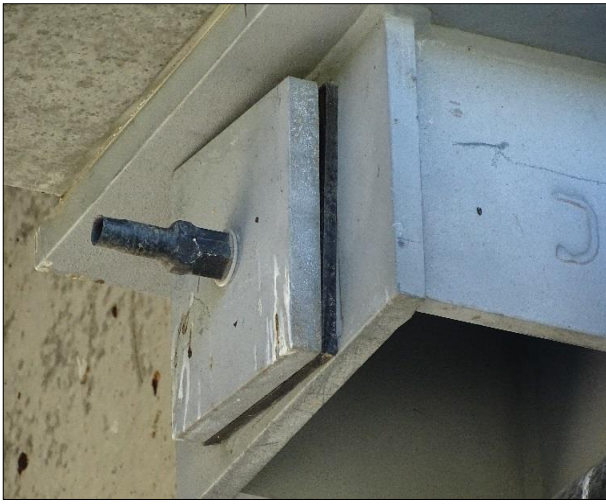
Evidence of plate movement and losing of connections

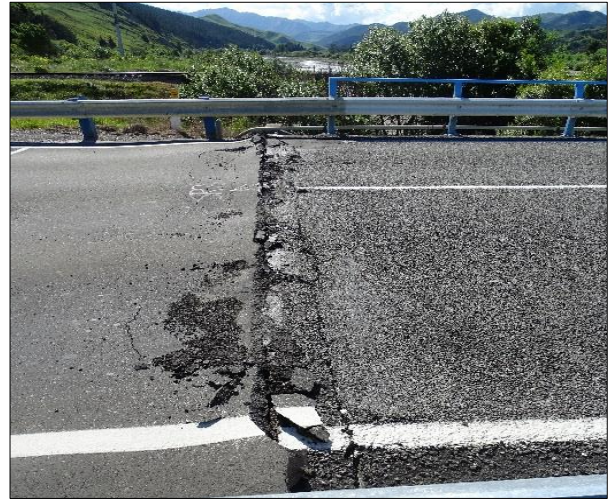
Damage to south approach

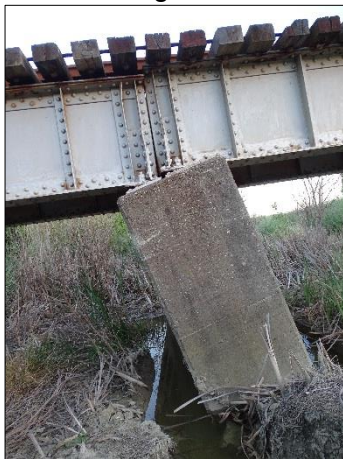
Major railway bridge pier rotation

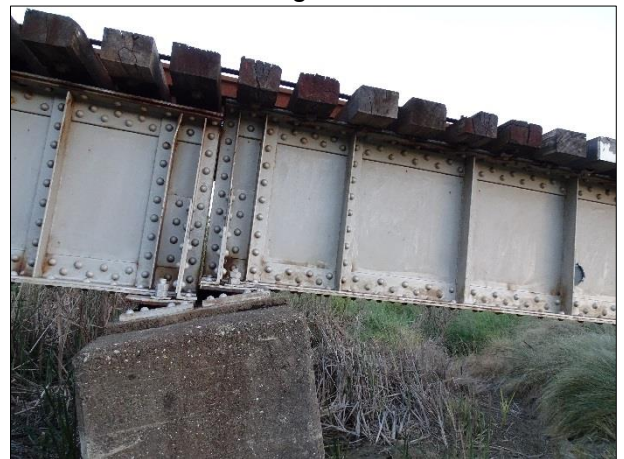
Close up of pier rotation

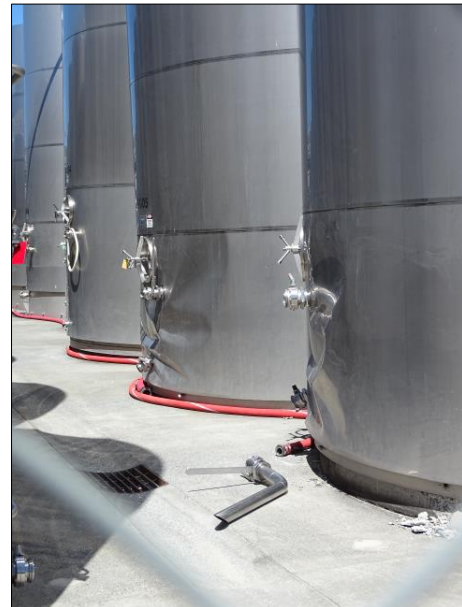
Tank buckling observed

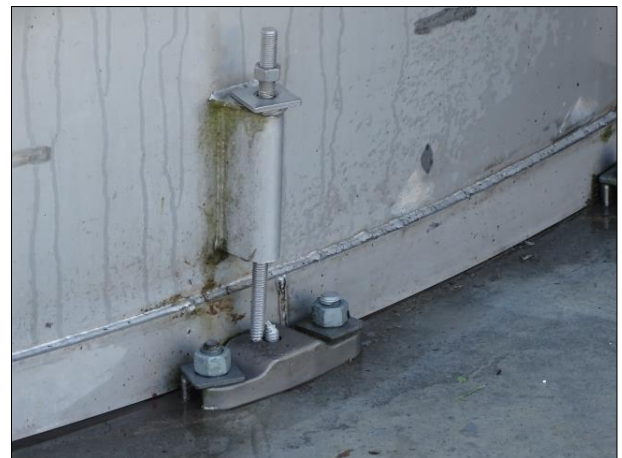
Shear failure of connection rods

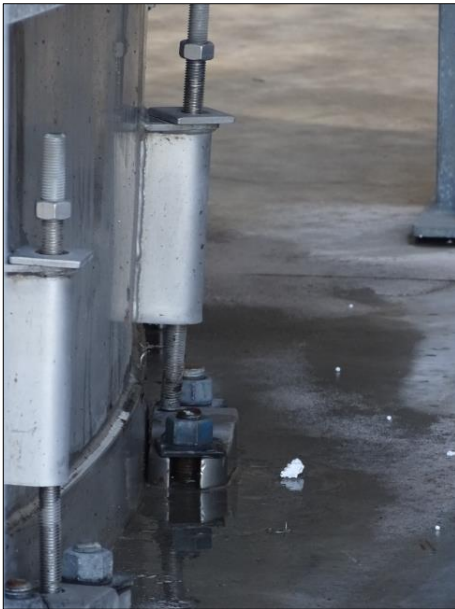
Shear failure of connection rods

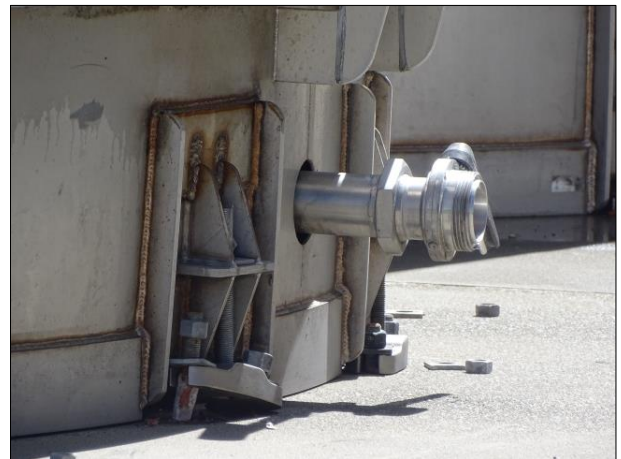
Pull-out of some adhesive anchoring connection

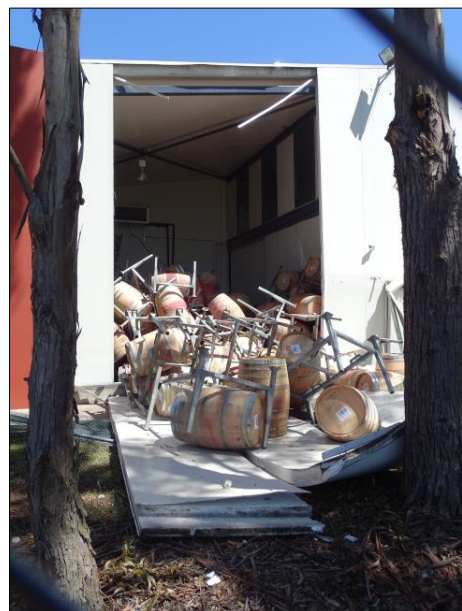
Collapse of stacking systems - wooded barrels' storage

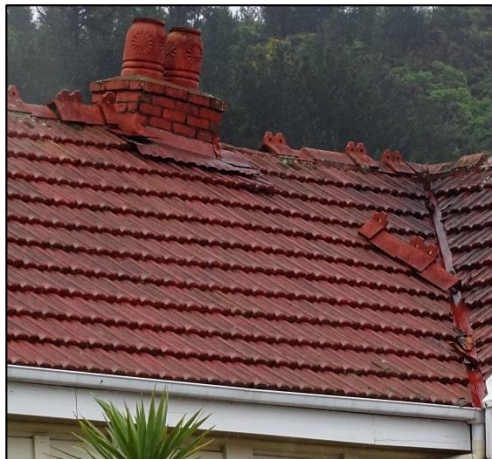
Chimney damage and consequent ceiling damage

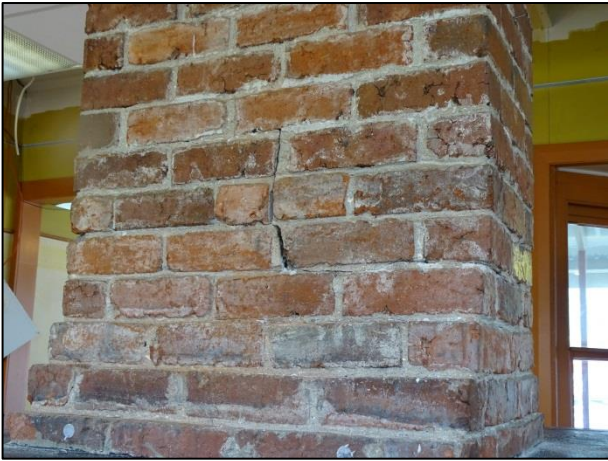
Chimney internal stack, torsional damage

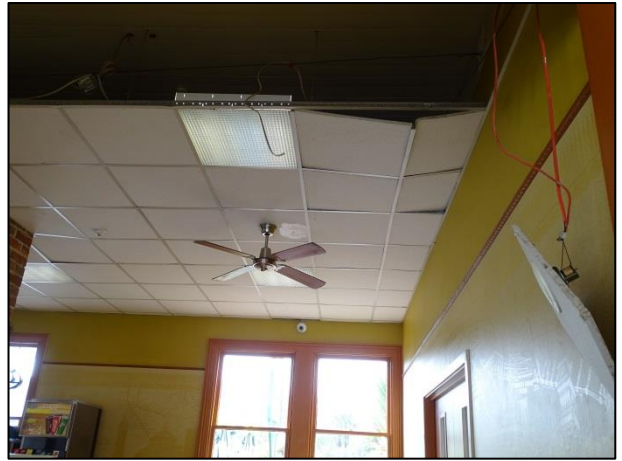
Ceiling damage due to chimney

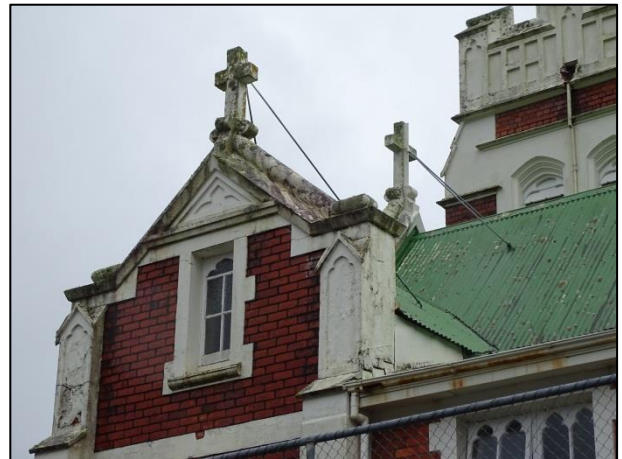
Presence of existing damage (cracks and deteriorated bricks)

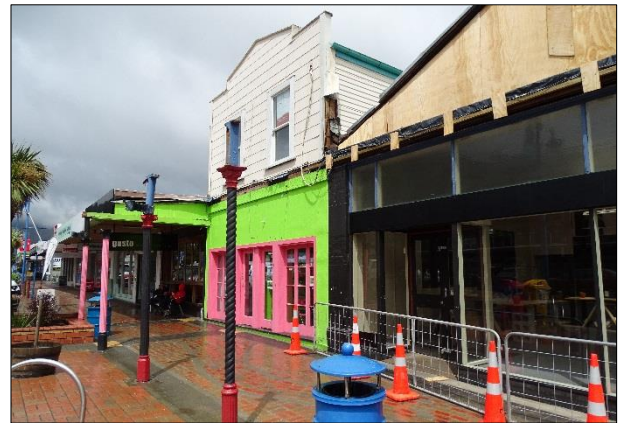
Collapse of front façade and canopy – all cleared and removed

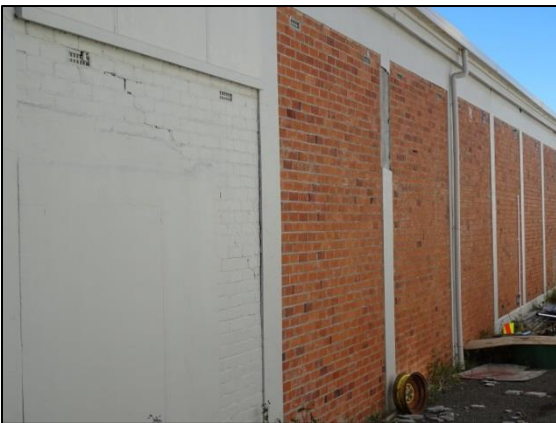
- Damage to non-structural elements, ceilings
- In-plane damage to RC with in-fill masonry buildings

RC with masonry in-fill buildings

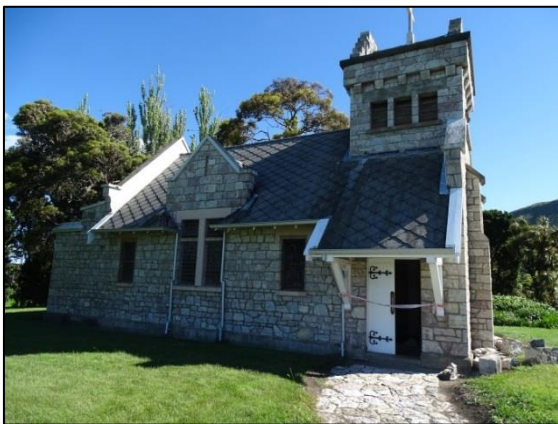
St Oswald's Church, stone and concrete, collapse of parts of front parapet

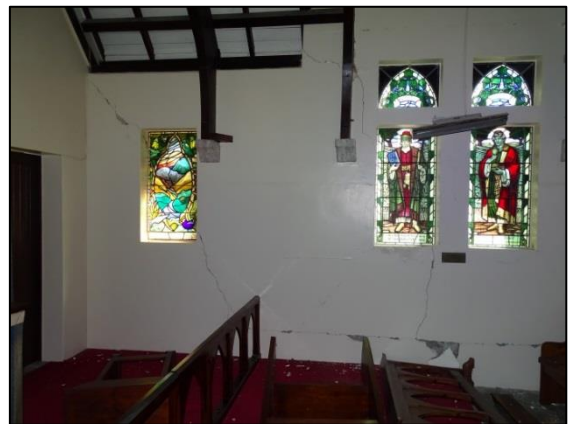
Internal view with diagonal shear and shear sliding cracks

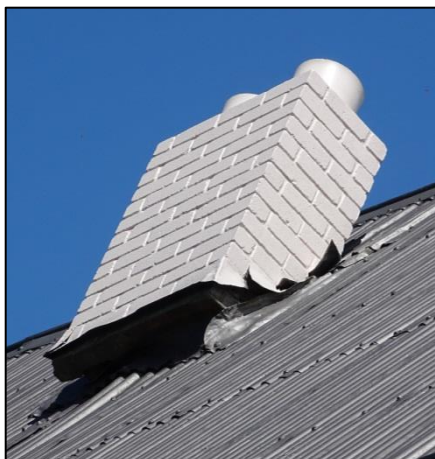
Inward collapse, Blenheim

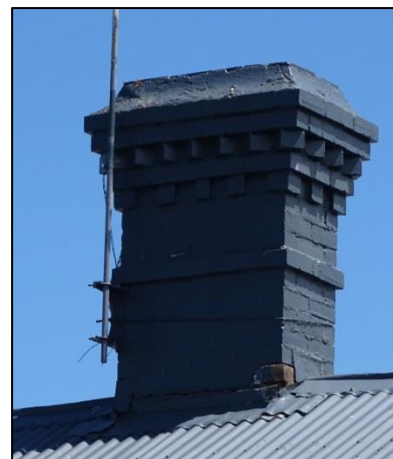
Horizontal crack at the roofline, Blenheim

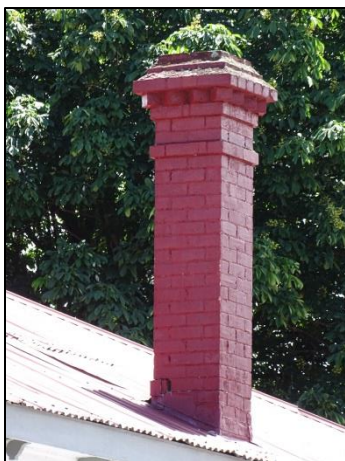
Horizontal crack at the chimney base and torsion, Blenheim

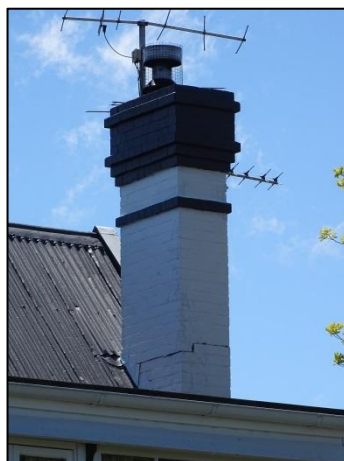
Horizontal crack at the base, Blenheim

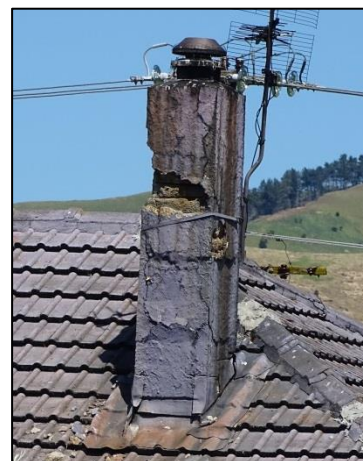
Extensive damage of the plaster, Blenheim

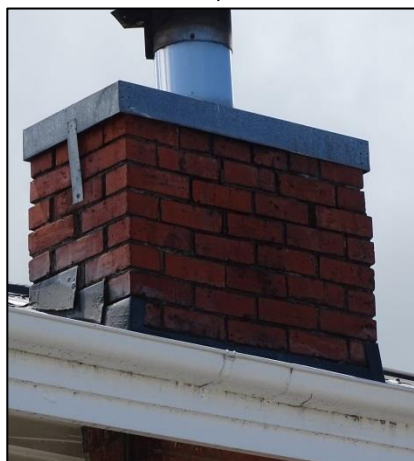
Dislodgement of the bricks, Blenheim
