## Preliminary update - Mw7.8 Kaikoura Earthquake

**(16-17 November 2015, supplement to 15 November update)**

### Upper Part of South Island

# Preliminary update - Mw7.8 Kaikoura Earthquake (16-17 November 2015)

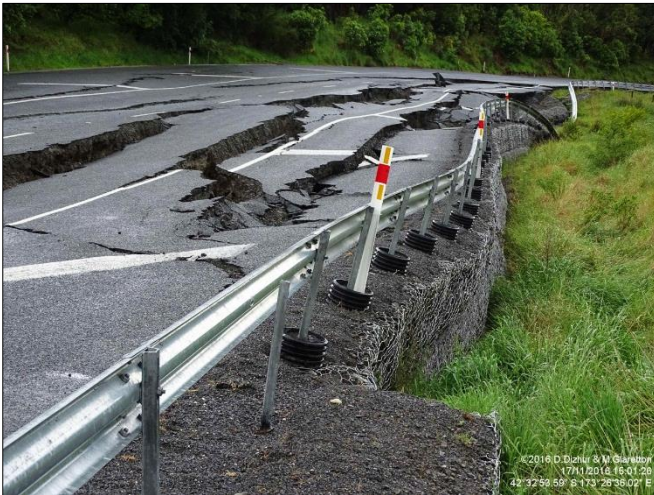
Significant damage to the road pavement and movement of retaining structure

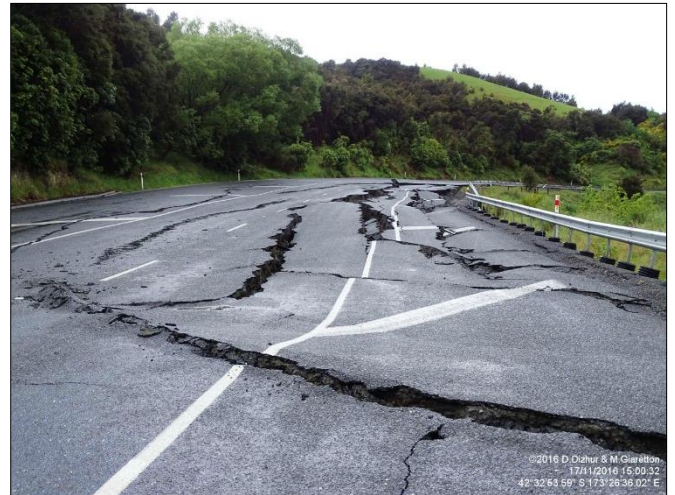
Significant damage to the road pavement

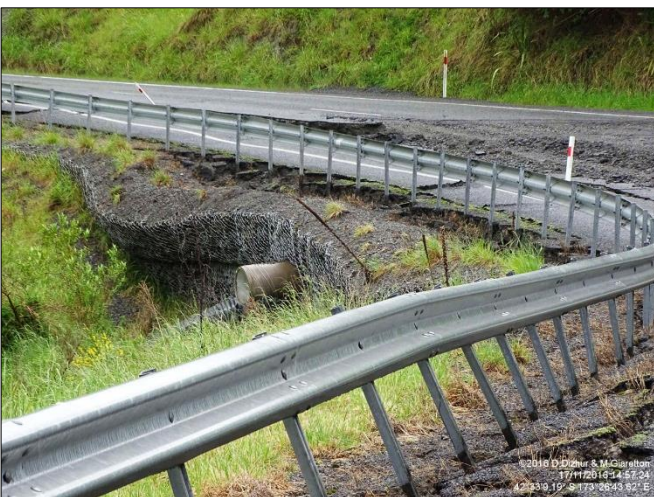
Major movement of a retaining wall

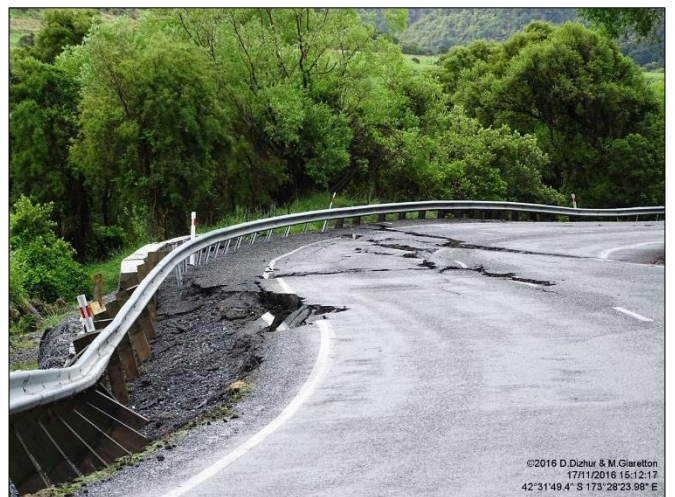
Significant damage to the road pavement and railing

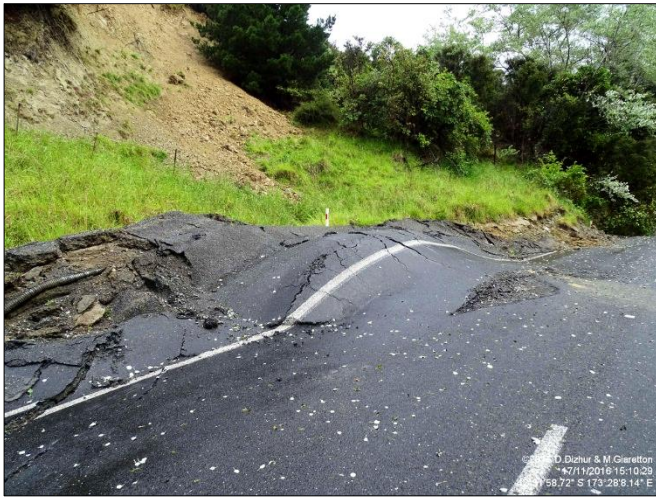
Major bulging of the road pavement due to land slip above

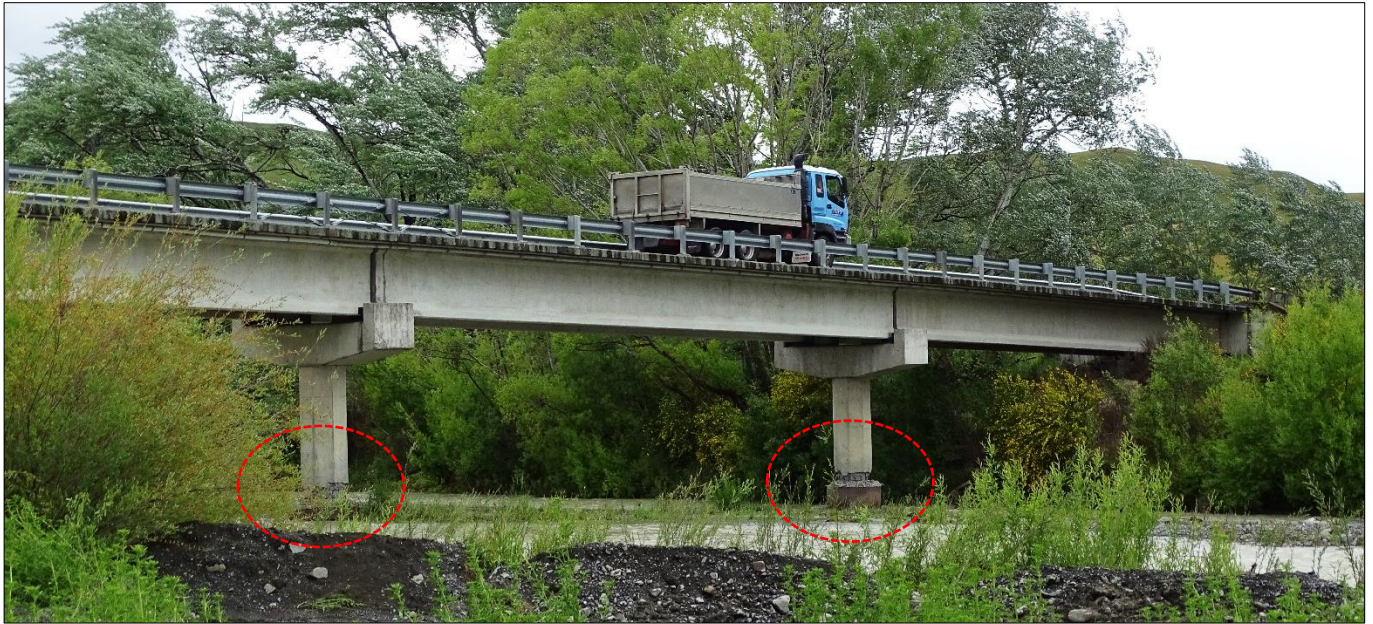
Bridge along Inland Road, open for emergency heavy vehicles. Major damage to the bridge structure, all columns showing signs of plastic hinges (-42.634382, 173.066299)

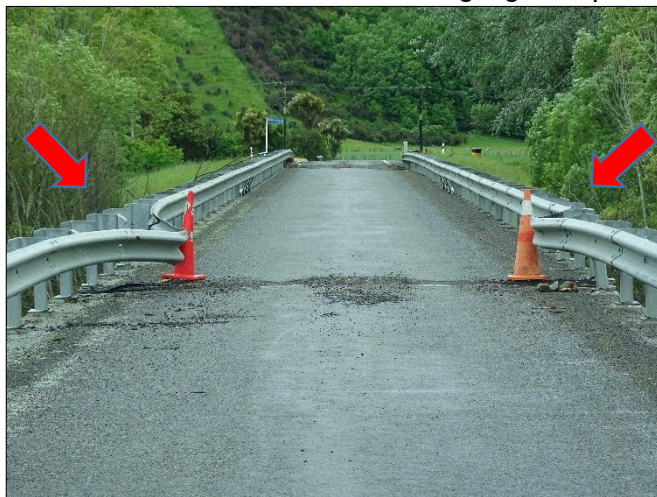
Buckling of the bridge side railing due to deck movements

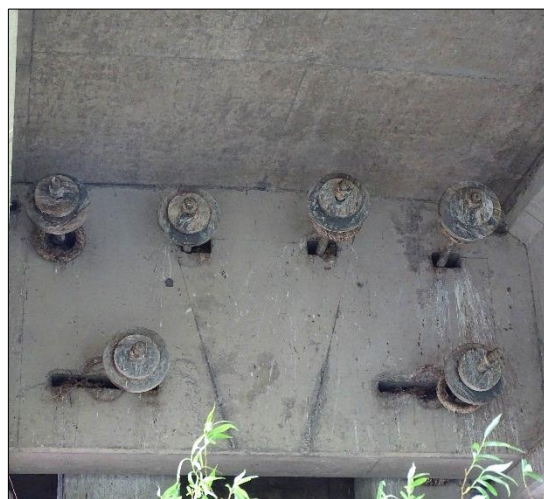
Loosening of connections

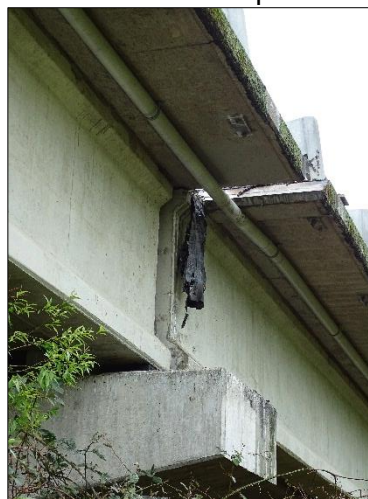
Significant differential movement of bridge girders

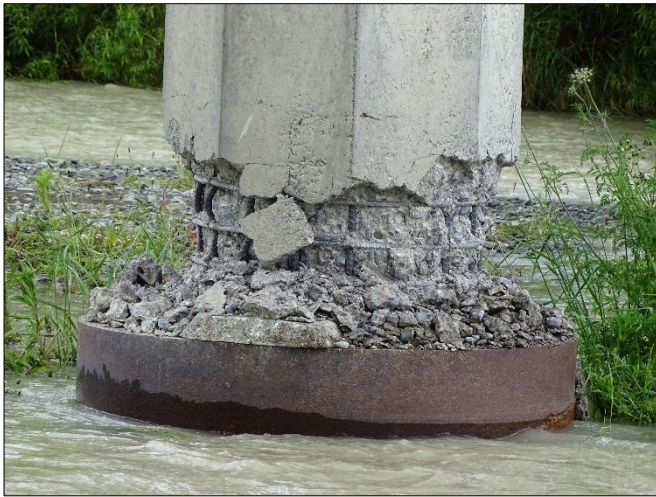
Significant spalling at the base of column.  
Longitudinal reinforcing bar buckling

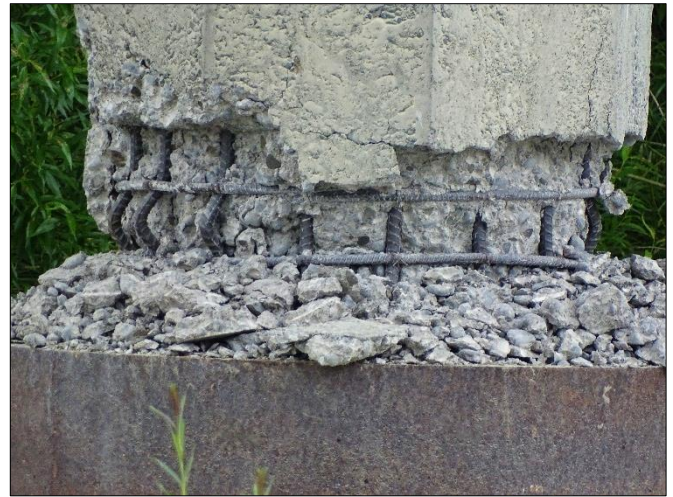
Significant spalling at the base of column (southern column). Longitudinal reinforcing bar buckling

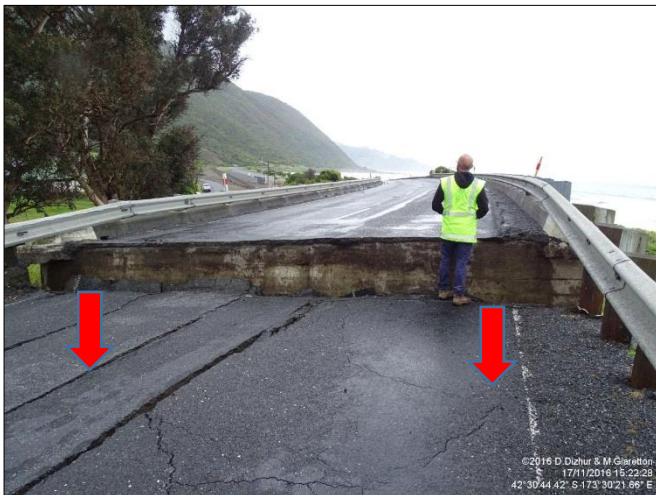
Major settlement of abutments, Oaro overbridge  
#1790 (-42.512124, 173.506385)

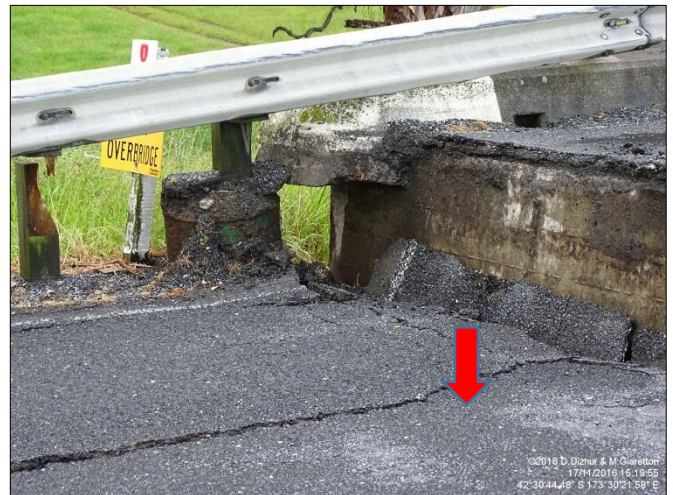
Upto 1.0 meter of differential movement observed

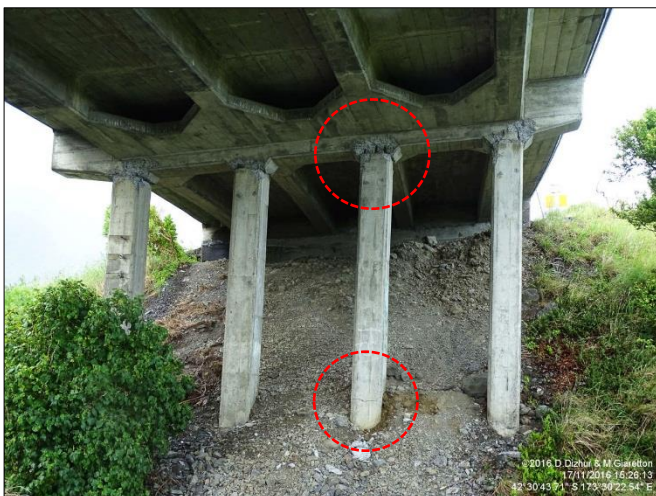
Under bridge deck, visible hinging of the columns

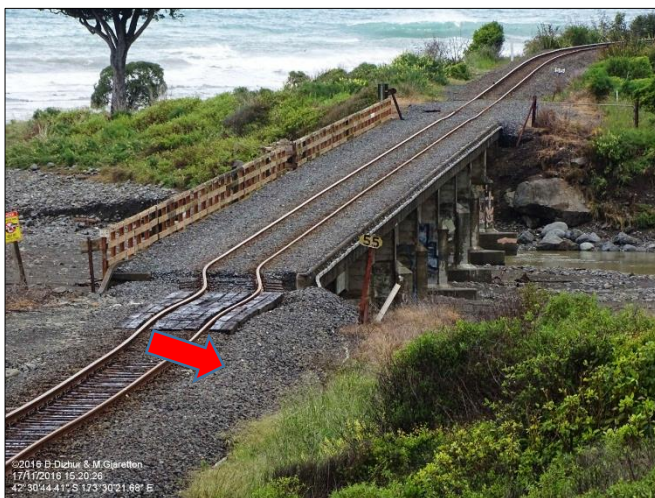
Lateral movement of the bridge abutment, not observed damage of the bridge structure  
(-42.513496, 173.506657)

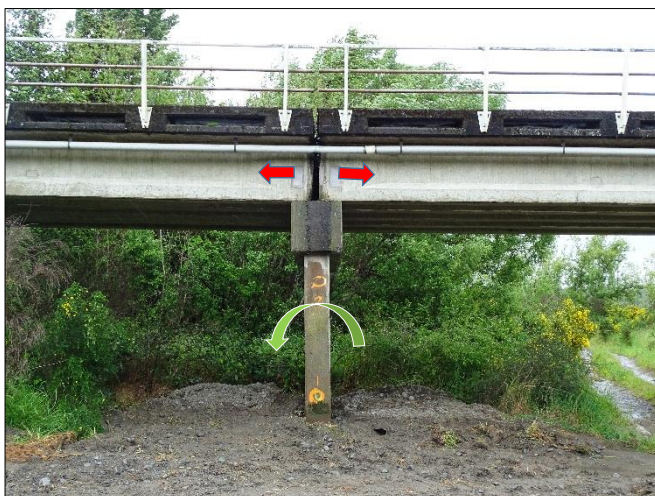
Movement of the Waiau River bridge #1842 deck and potential rotation of the pier (-42.655400, 173.033227)

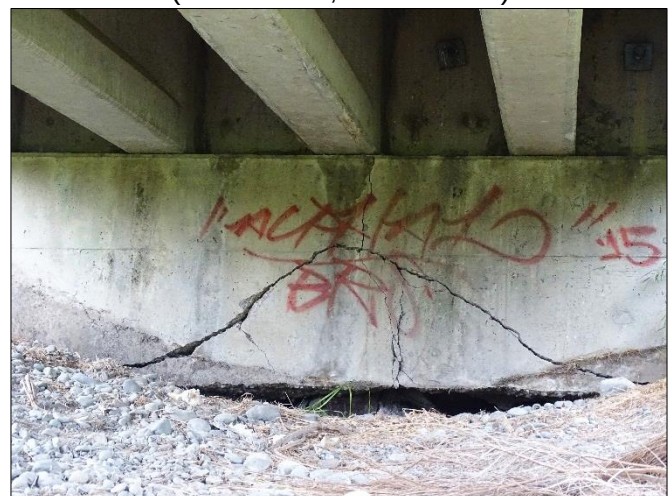
Damage to the Waiau River bridge #1842 abutment (evidence of ground movement in the vicinity) (-42.655495, 173.031173)

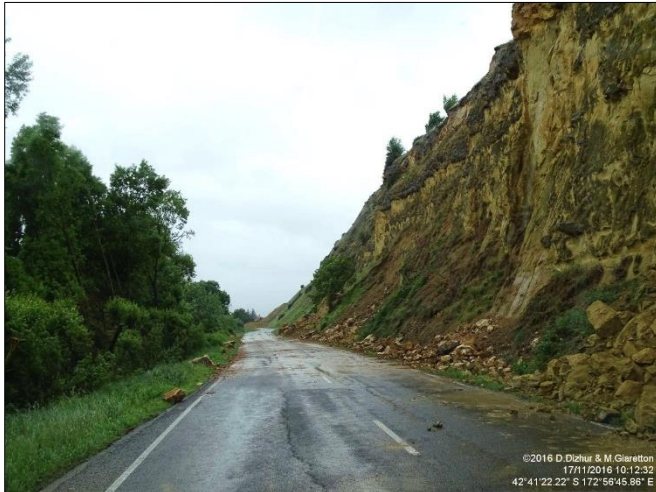
Cleared rock fall on SH70 towards Waiau

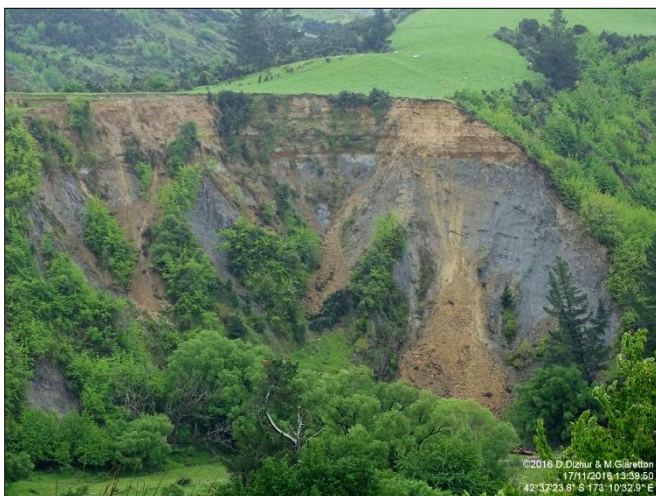
Example of commonly observed landslides (photo taken along Leads Road)

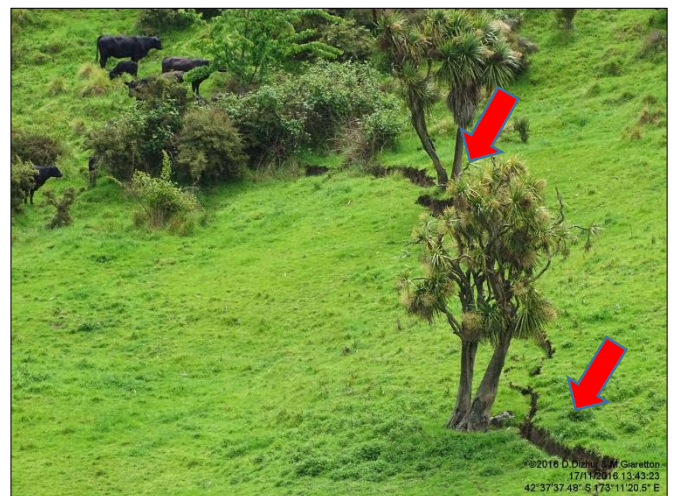
Example of commonly observed initiation of ground spreading (photo taken along Leads Road)

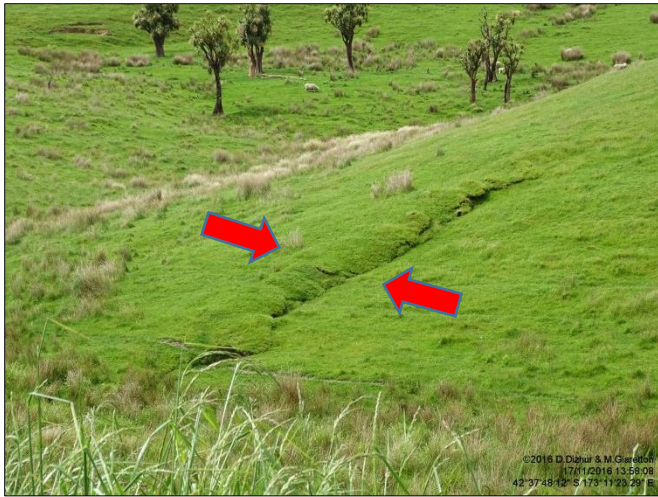
Example of commonly observed along Leads Road

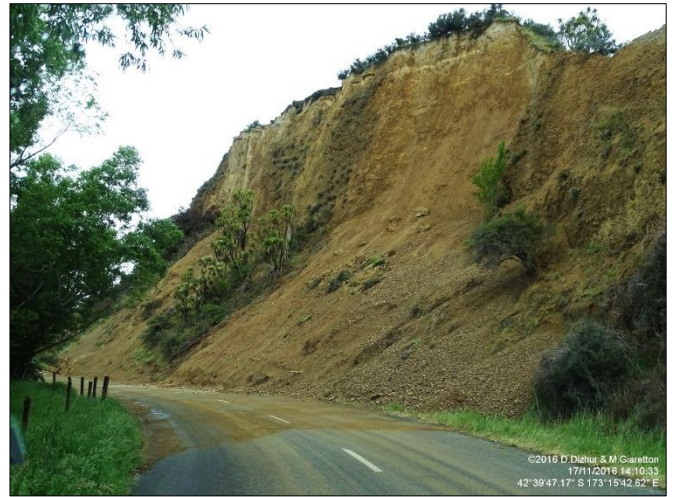
Major rock fall on Leads Road

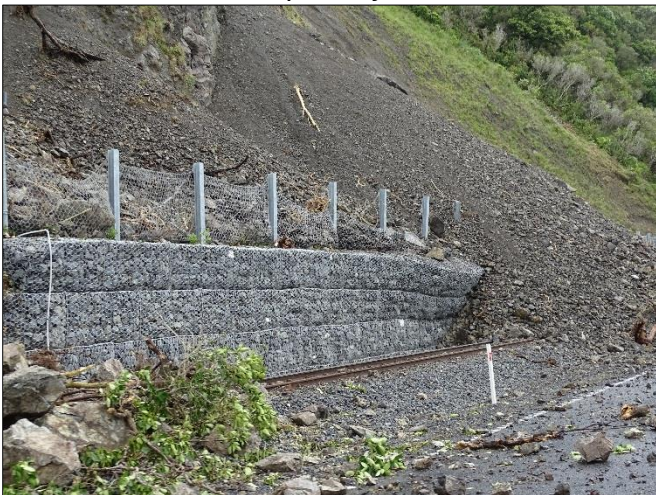
(c) Damage to retaining structure and rock fall protection system

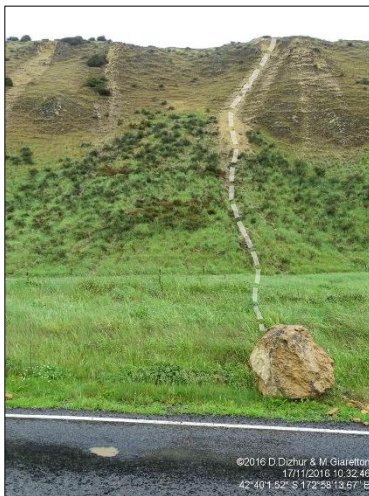
Commonly observed rock rolling path. Multiple examples along SH 70 towards Waiau

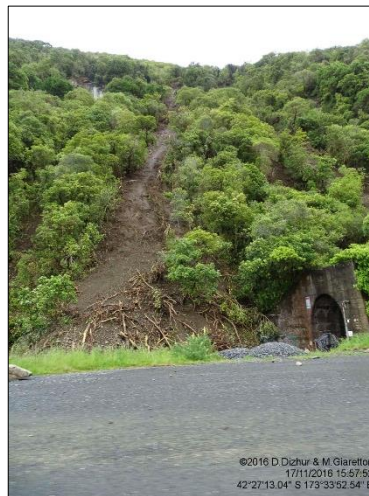
Typical example of soil sliding – blocking railway lines and tunnel entry

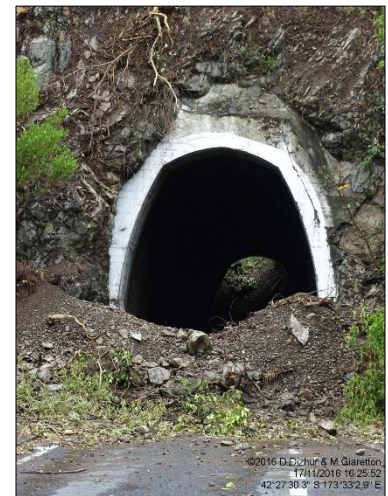
(e) Entry tunnel blocked due to rock fall, looking south

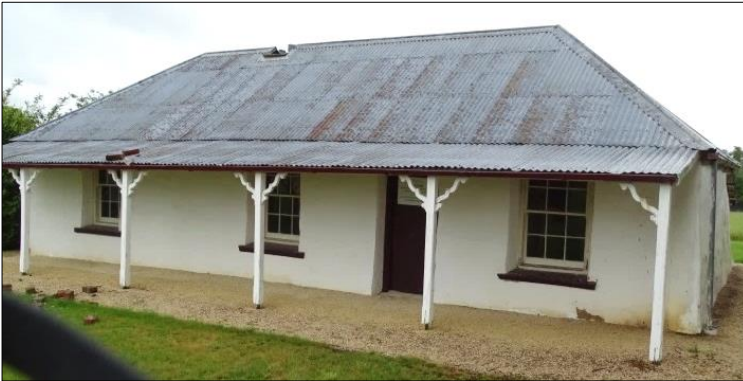
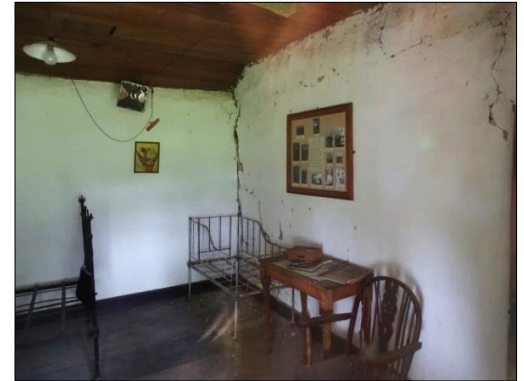
Watters Cob Cottage – minor damage and collapse of chimney

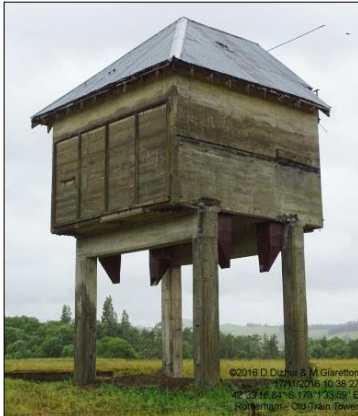
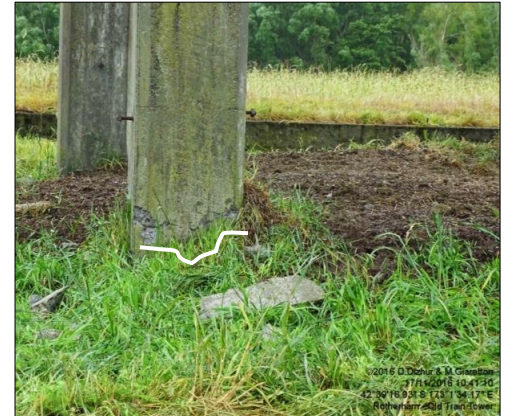
Old Train Tower

Hinging of the column-to-beam joints

Column base detail

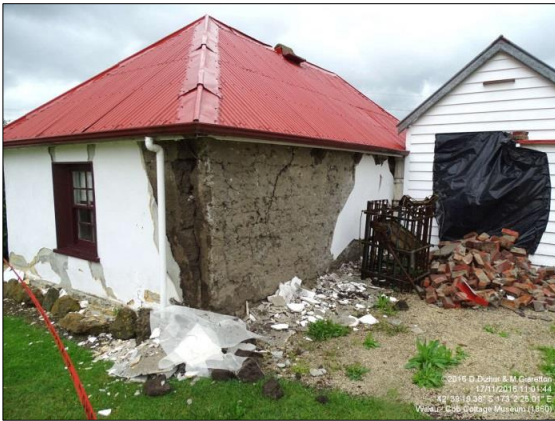
Damage to the Cob Cottage museum

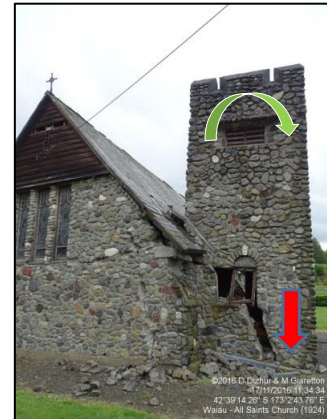
Tilting of the bell tower (note significant settlement of tower foundation)

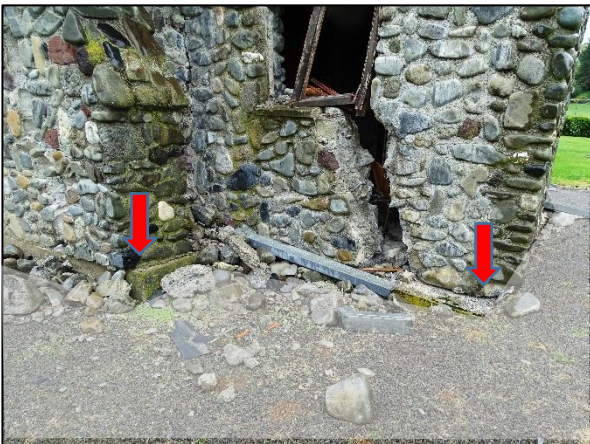
Close-up of the significant bearing failure of tower foundation

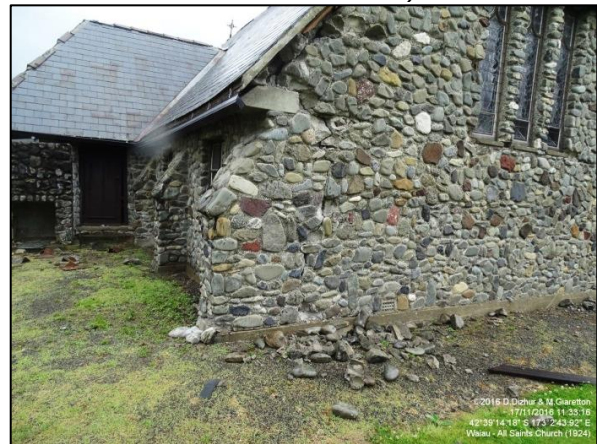
Significant cracking of corners and gable wall

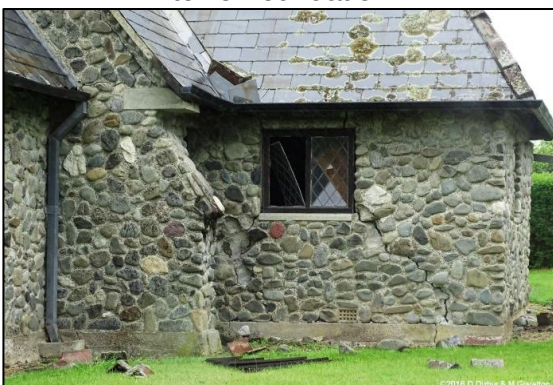
In-plane damage

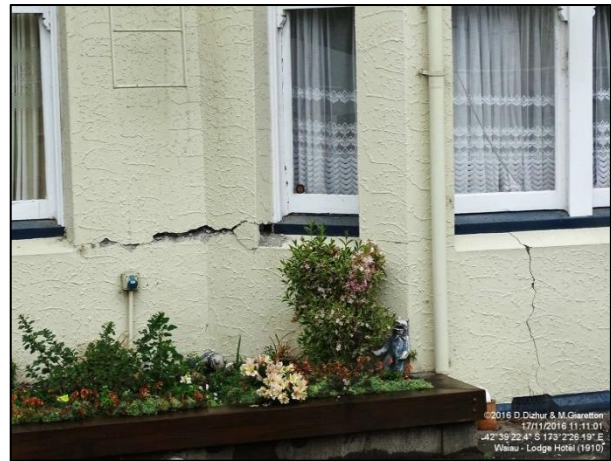
Horizontal cracking showing evidence of pier rocking

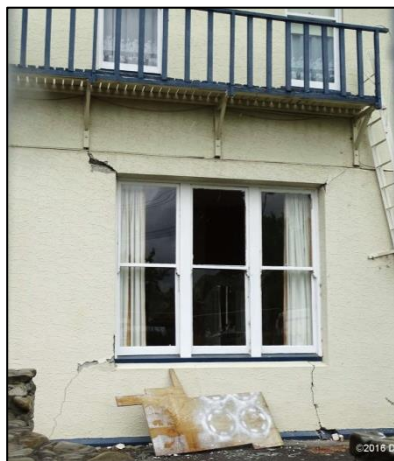
Cracking around widow openings

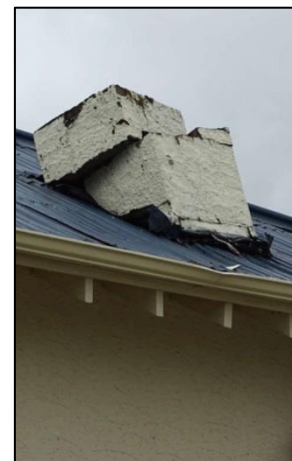
Partial collapse of chimney

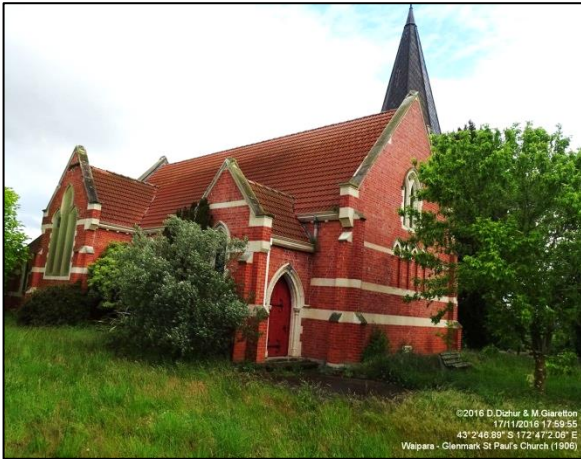
Glenmark St Paul's Church – damaged also following the 2010/2011 Canterbury earthquakes

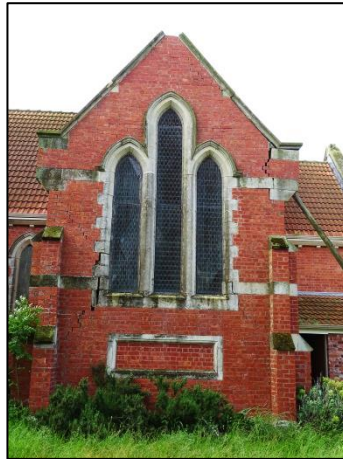
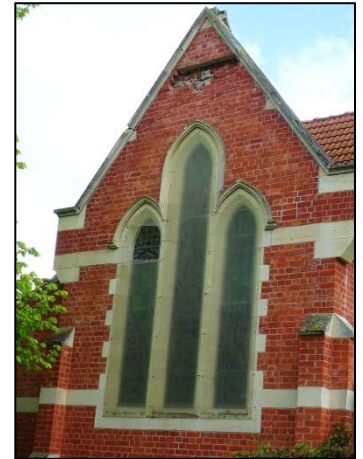
In-plane damage and gable end walls

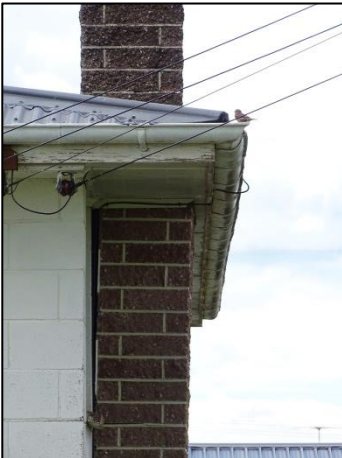
Out-of-plane detachment of the chimney stack, Seddon

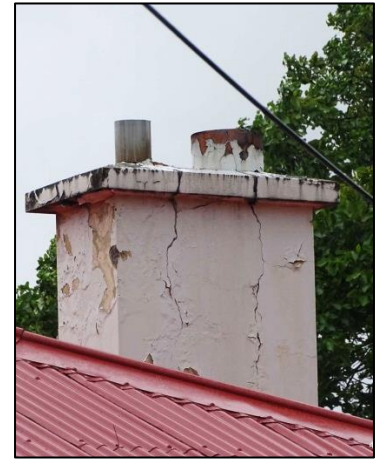
Vertical crack-pattern, Waiau

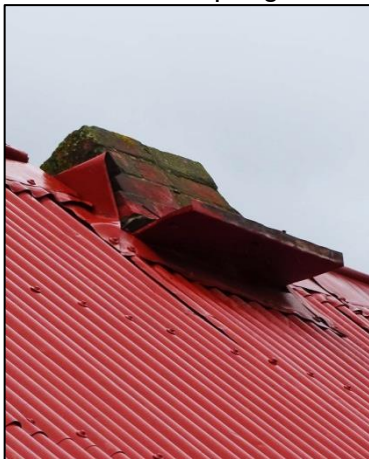
Inward collapse, Waiau

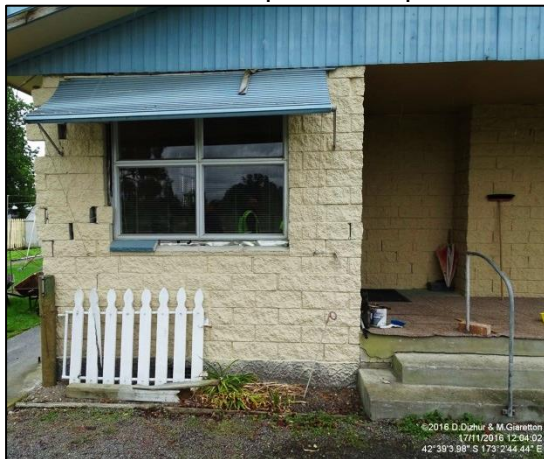
Significant damage to veneer dwellings, Waiau

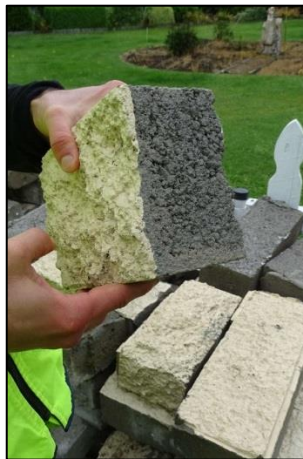
Heavy solid veneer cladding blocks

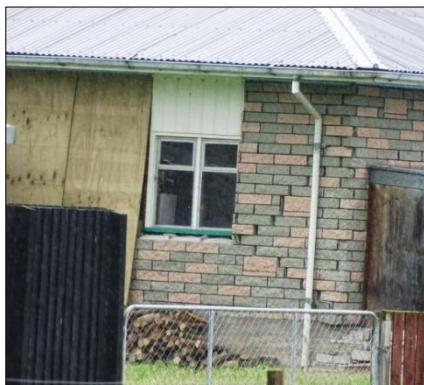
Corner damage and collapse of large veneer panels, Waiau

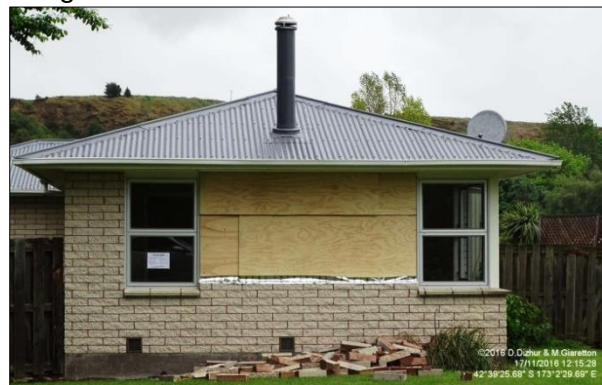
Collapse of large veneer panels, Waiau

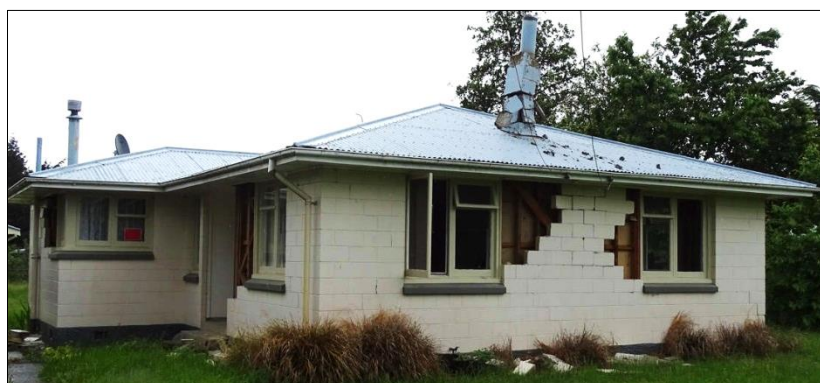
In-plane and out-of-plane damage to veneer, Waiau

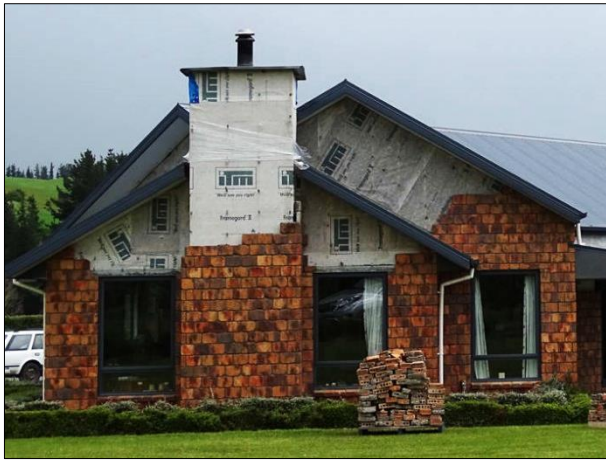
Collapse of moder brick veneer system, Waiau

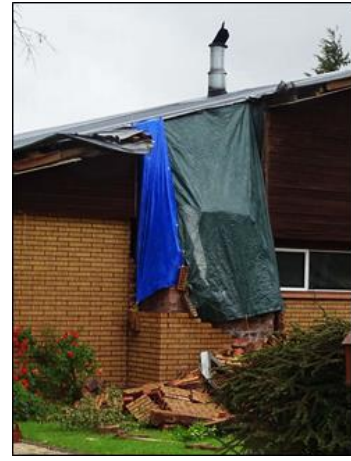
Collapse of moder brick veneer and chimney, Waiau

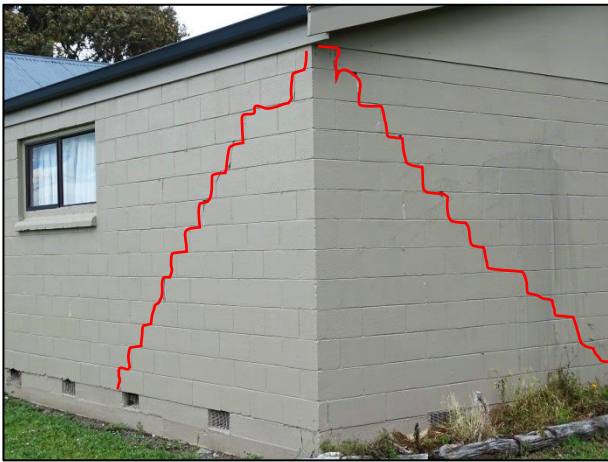
Concrete blocks building, corner damage, Seddon

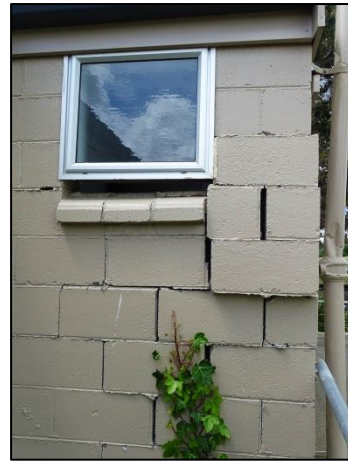
Dislodgement of the concrete blocks and close-up, Seddon

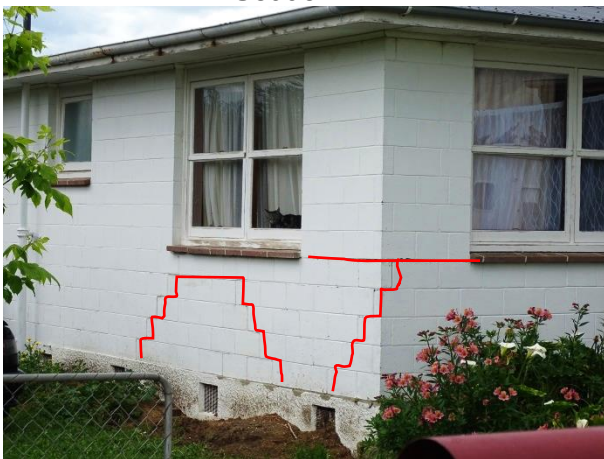
Concrete blocks building, corner damage, Seddon

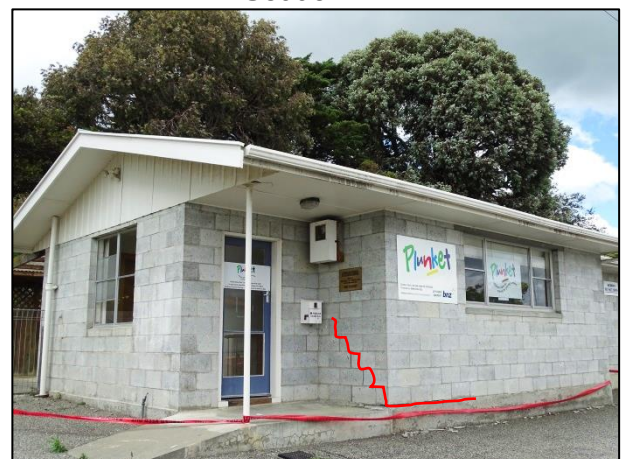
Concrete blocks building, corner damage, Seddon

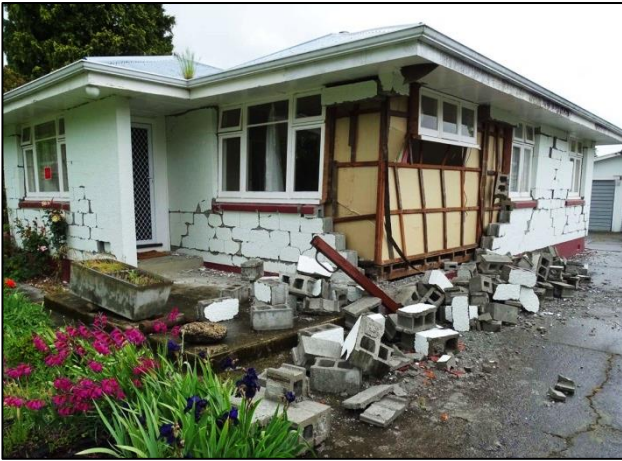
Concrete blocks building, out-of-plane collapse, Waiau

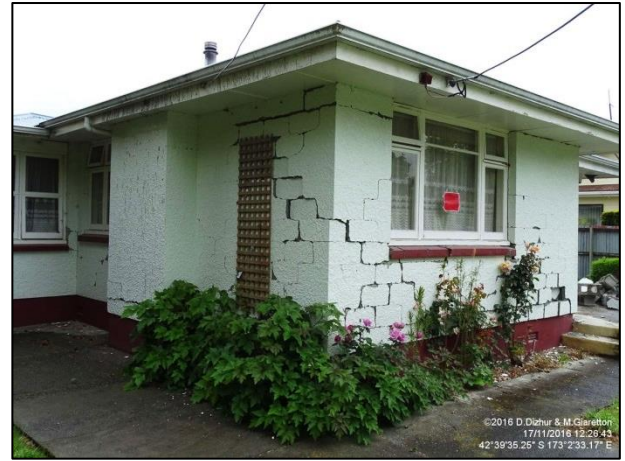
Concrete blocks building, extensive cracking and dislodgment of the blocks, Waiau
