# **Wellington City Council Targeted Assessment Programme**

## **Briefing on Targeted Damage Evaluation Additional Guidance:**

### ***Precast Concrete Floor Systems and Cladding Panels***

17 January 2017

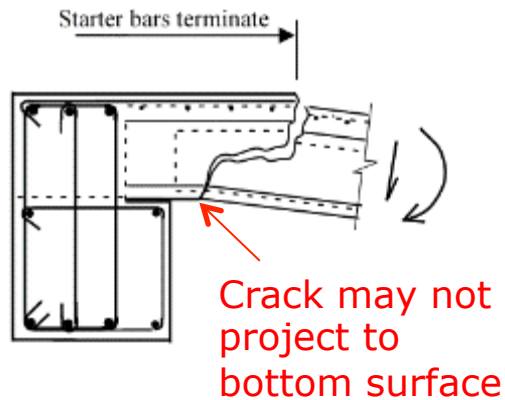
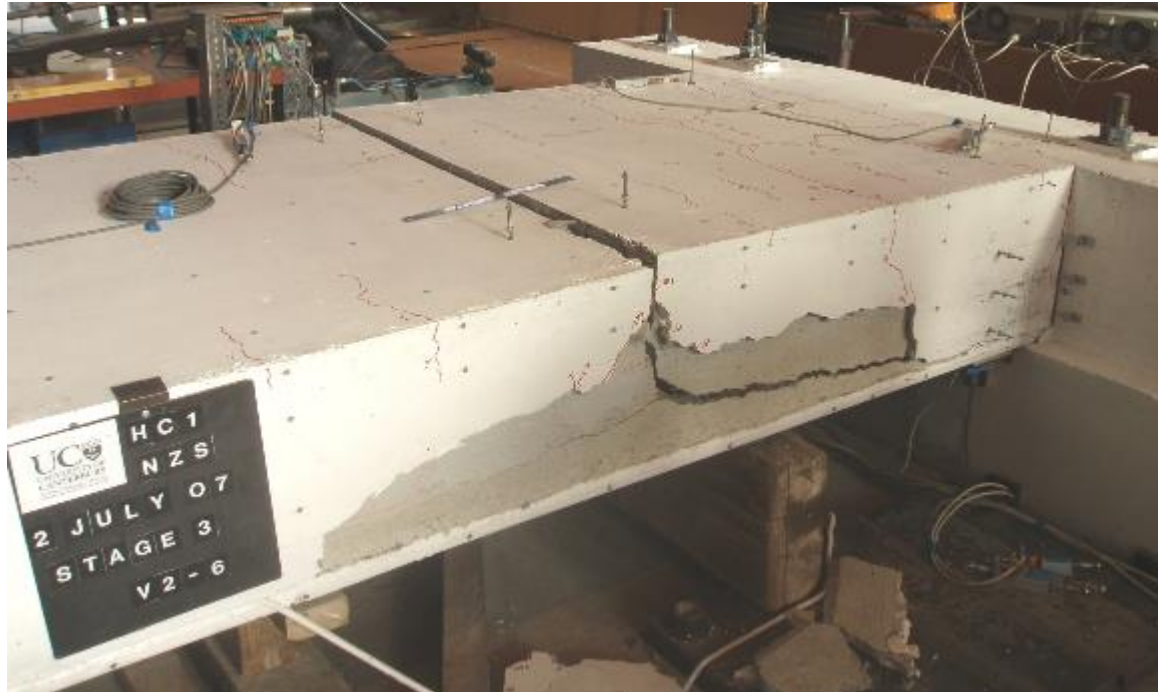
# Transverse crack at end of hollow core

Lift the carpet at end of starter bars.  
Start in the corners.  
Use level to check for vertical offset.

***With vertical offset OR diagonal crack in web***  
**→ CDS A**

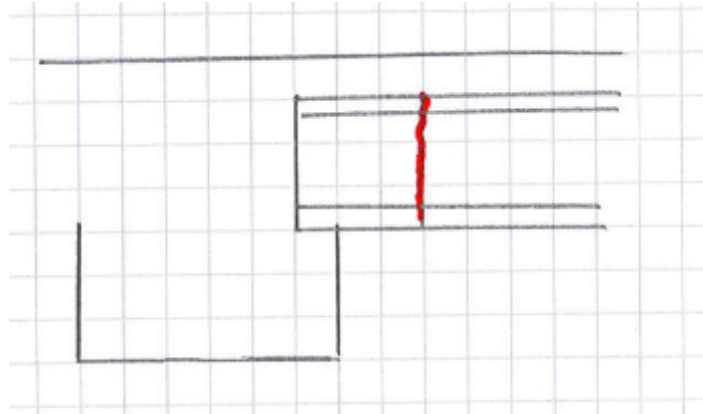
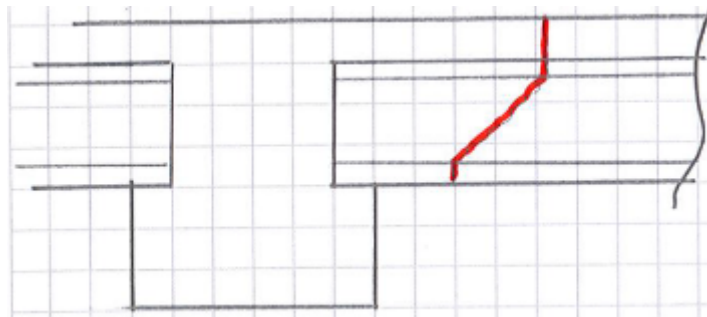
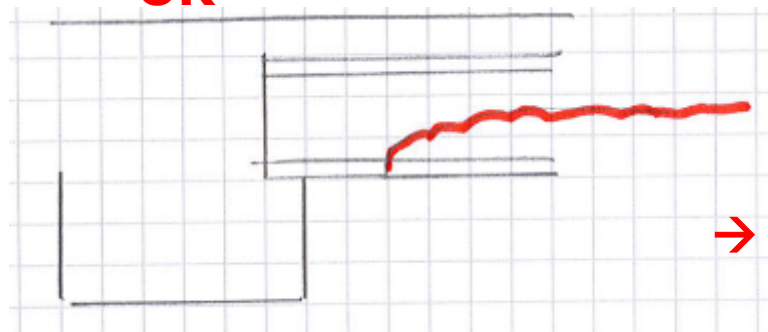
# Transverse crack at end of hollow core

→ CDS B

But if

→ CDS A

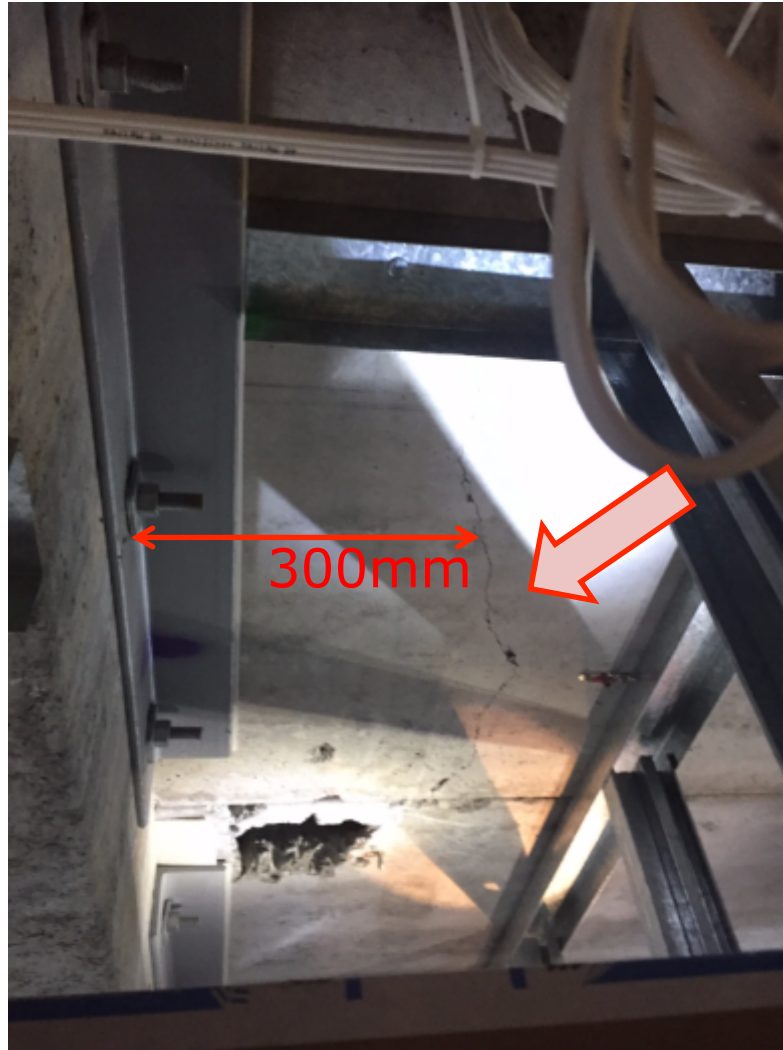
# Transverse crack at end of hollow core

Example damage from the field:

→ At least CDS B

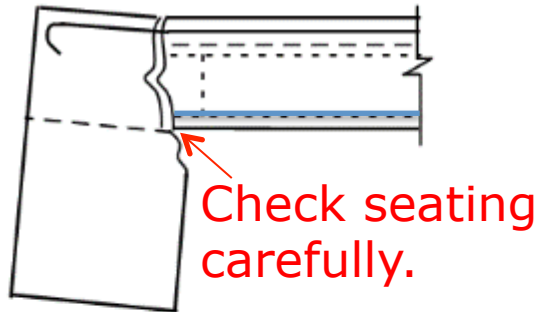
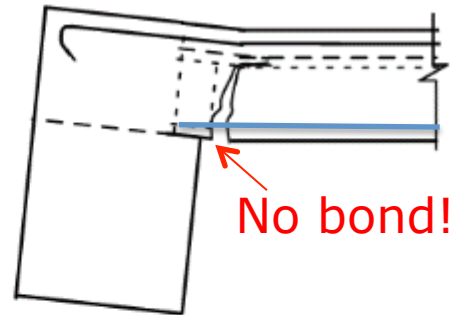
**Figure A-4: Loss of support and positive moment flexural failure**

(a) Loss of support with critical section at back face of precast unit

(b) Positive moment flexural failure with critical section near front face of support (see Section A4)

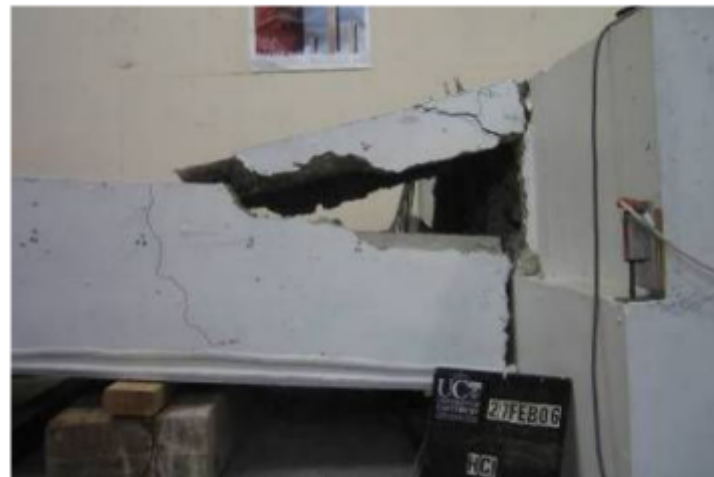
**Figure 5-9: Positive moment failure of hollow-core unit** (Photo from reference 7)

***With vertical offset → CDS A***

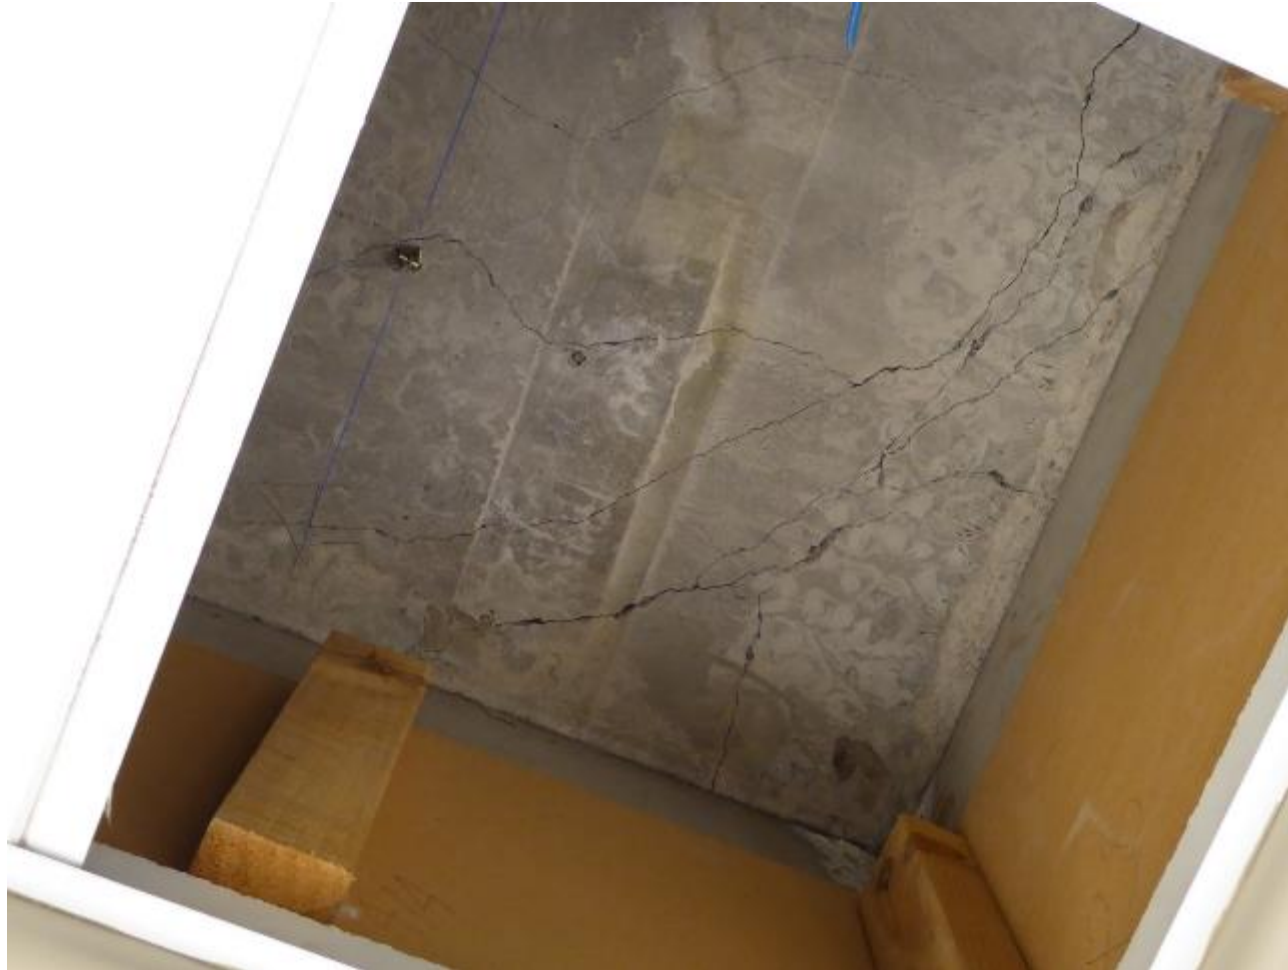
# Transverse crack at end of hollow core

Example damage from the field (corner of hollow core):

→ At least CDS B

Need to inspect  
webs of hollow core  
for diagonal cracks.

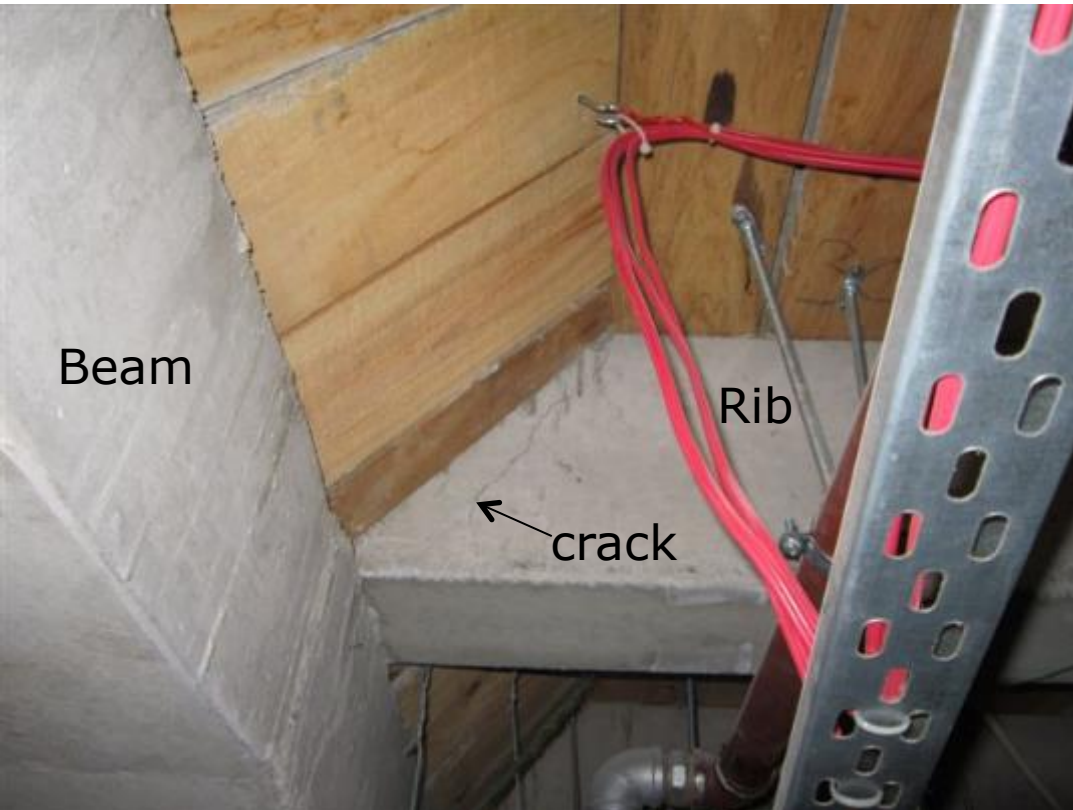
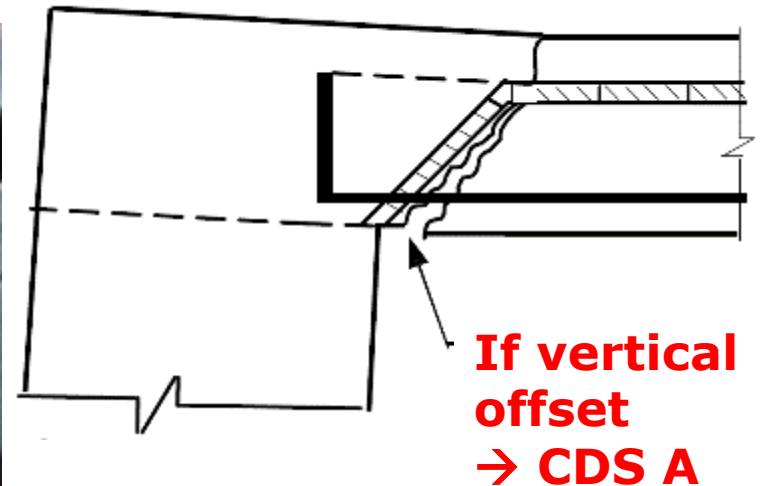
# Transverse crack at end of ribs

Example damage from the field (Ribs):

- If crack width at level of lowest strand  $< 0.4$  mm  
→ not CDS B (or A)

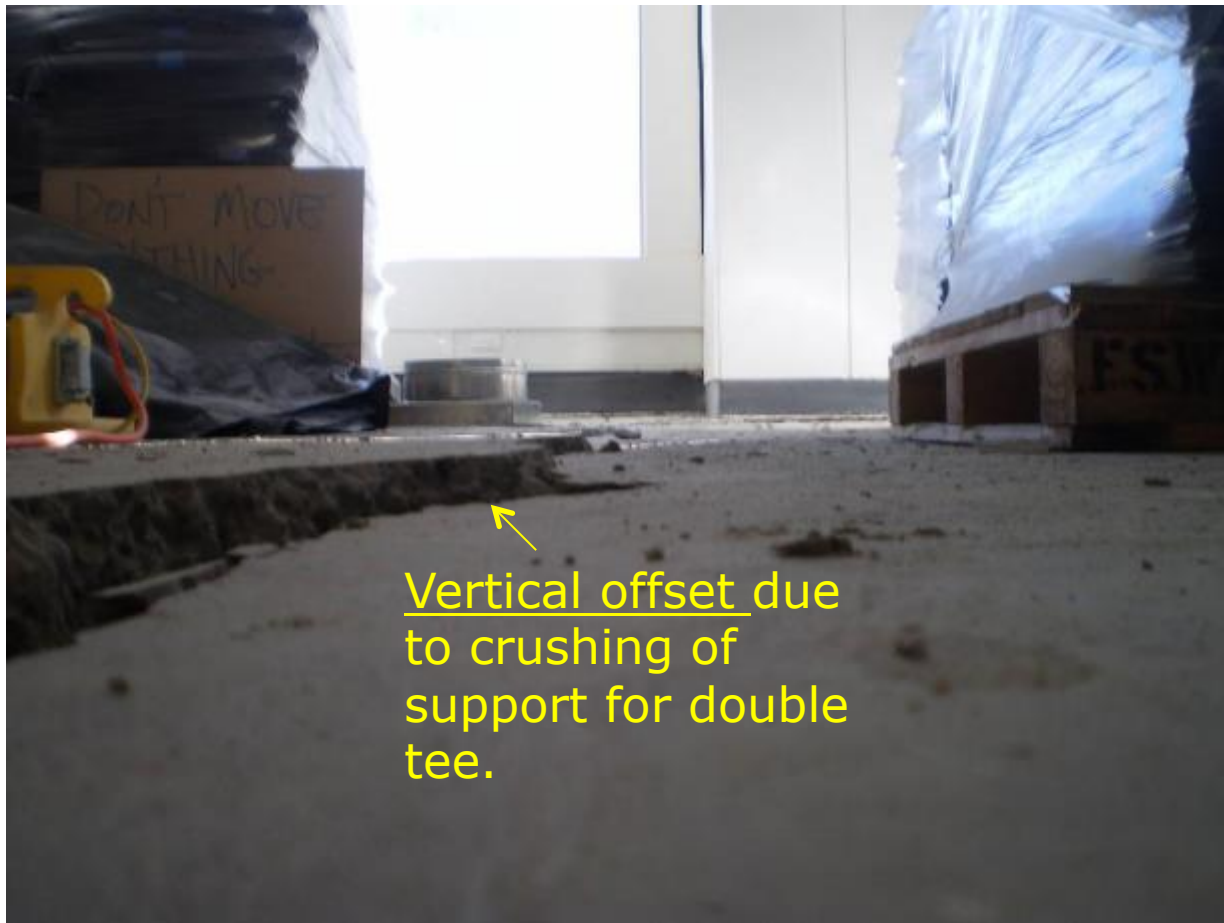
# Damage to support for flange hung double tee

Example damage from the field:

Vertical offset due to crushing of support for double tee.

→ CDS A

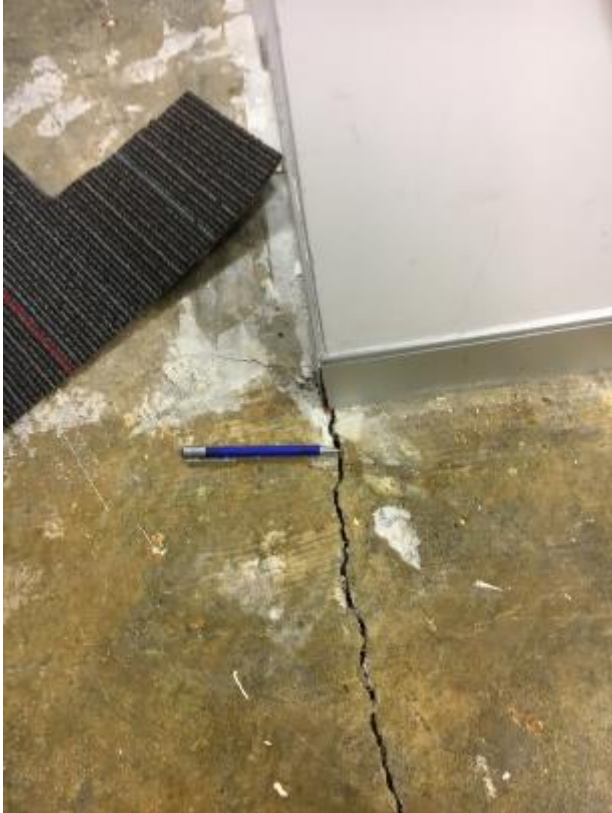
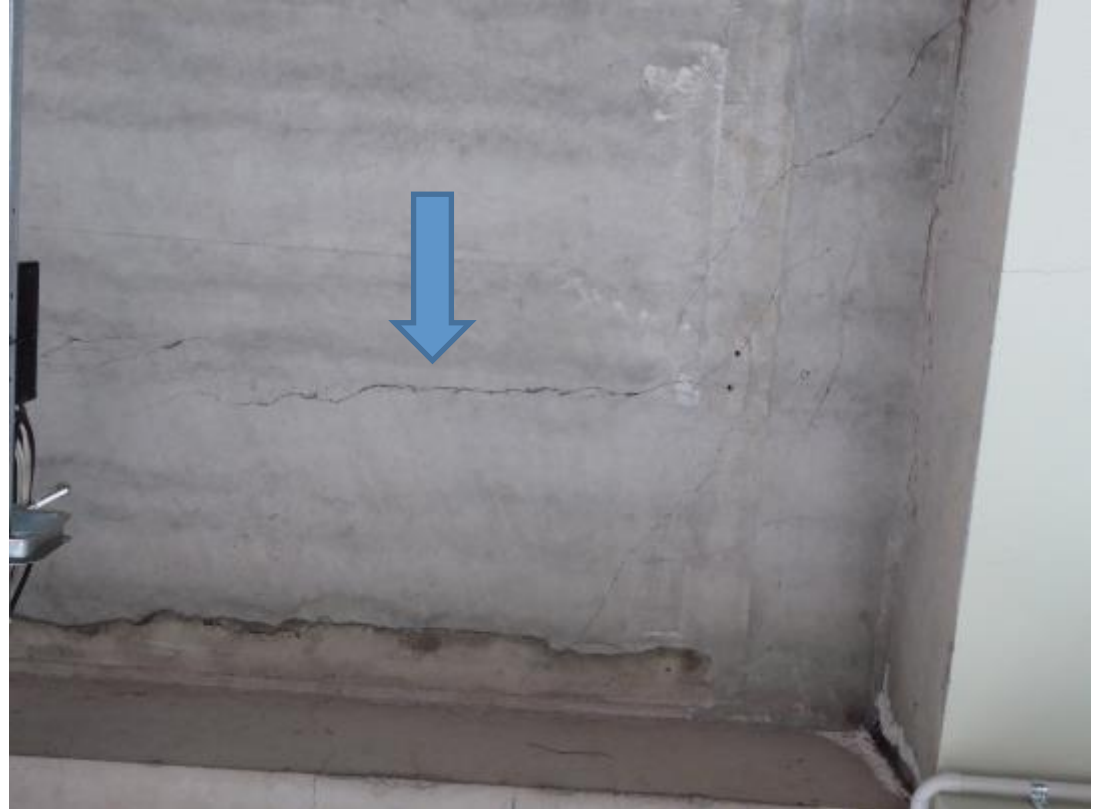
# Longitudinal cracking of hollow core

Example damage from the field:

**Not a collapse concern, but impacts diaphragm performance  
→ CDS C**

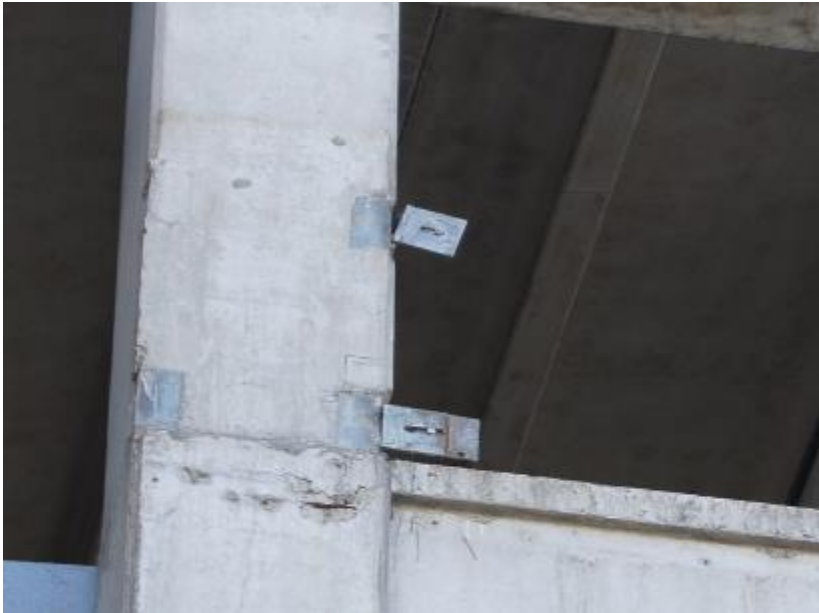
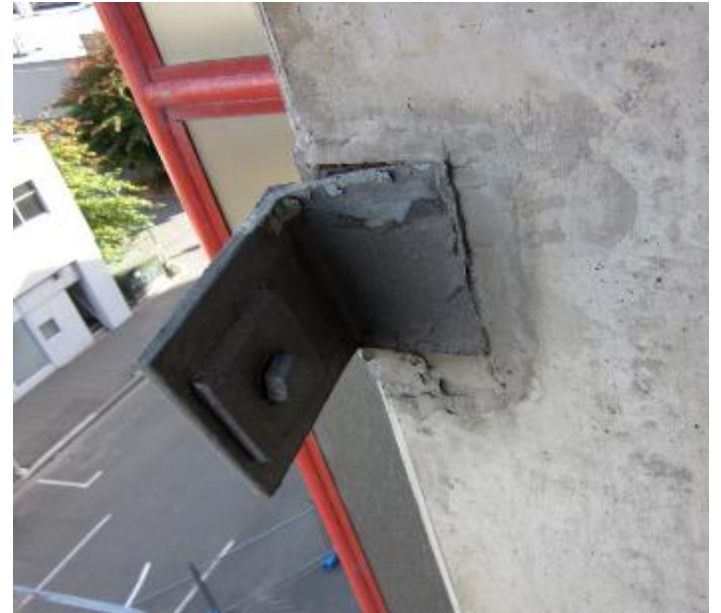
Deformed connections

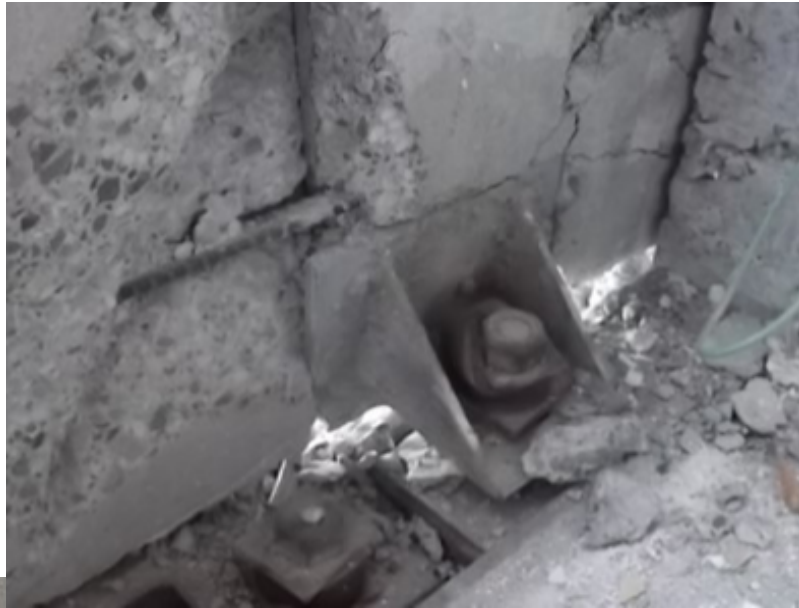
Cracked and  
spalled  
concrete

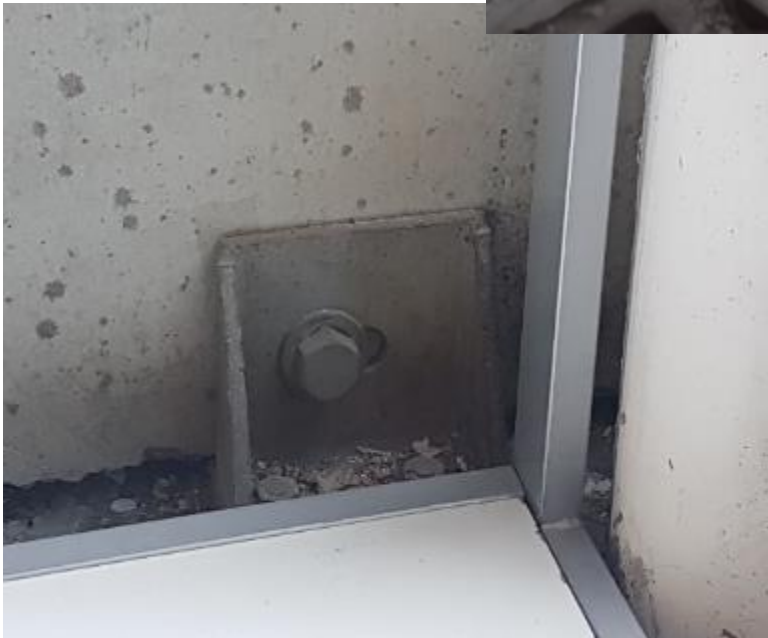
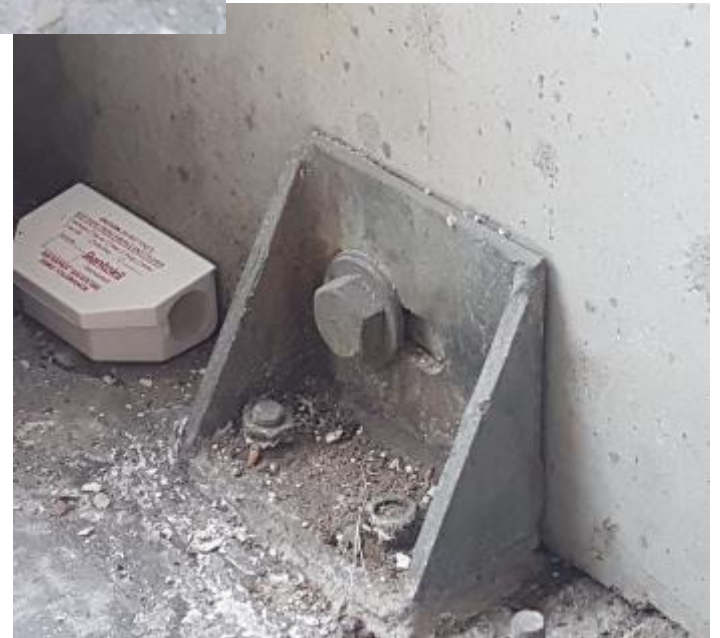
All the movement tolerances taken up
