USGS post-event overflight to assess impacts of the 1 December 2018 M 7.0 Anchorage Earthquake

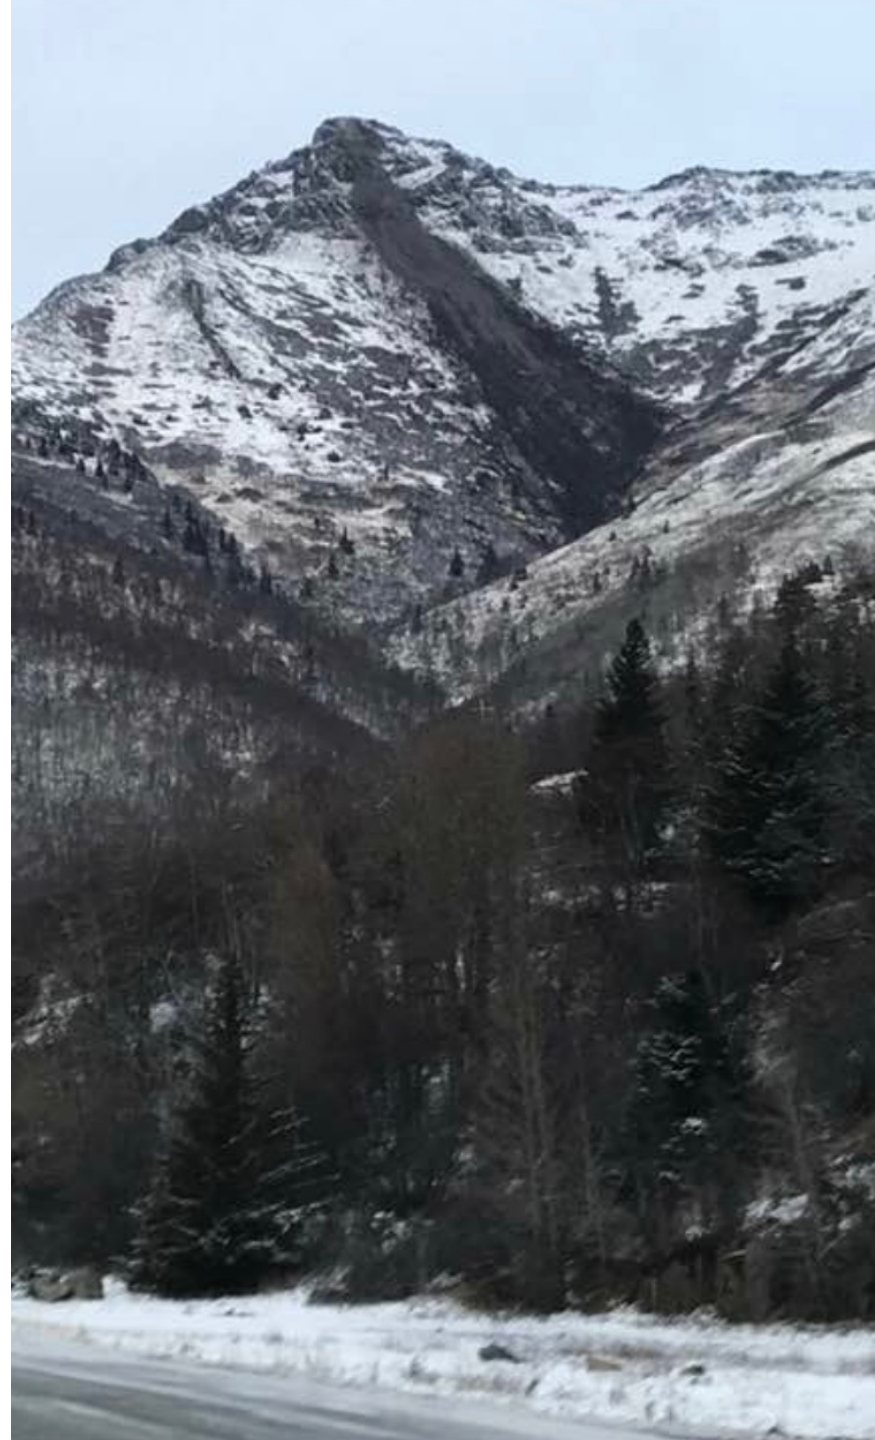
Rock avalanche, Rainbow Peak

Large rockfall on east-facing slope of Rainbow Peak, about 8 miles east of Potter Marsh along the Seward Highway. This rockslide has fallen into a valley and may have impounded a stream. Secondary hazards include landslide dams that may break and cause flooding.

2. The large Rainbow Peak rockfall between Anchorage and Girdwood presents possible additional hazards if it impounded a stream.
 - Additional overflight recommended.

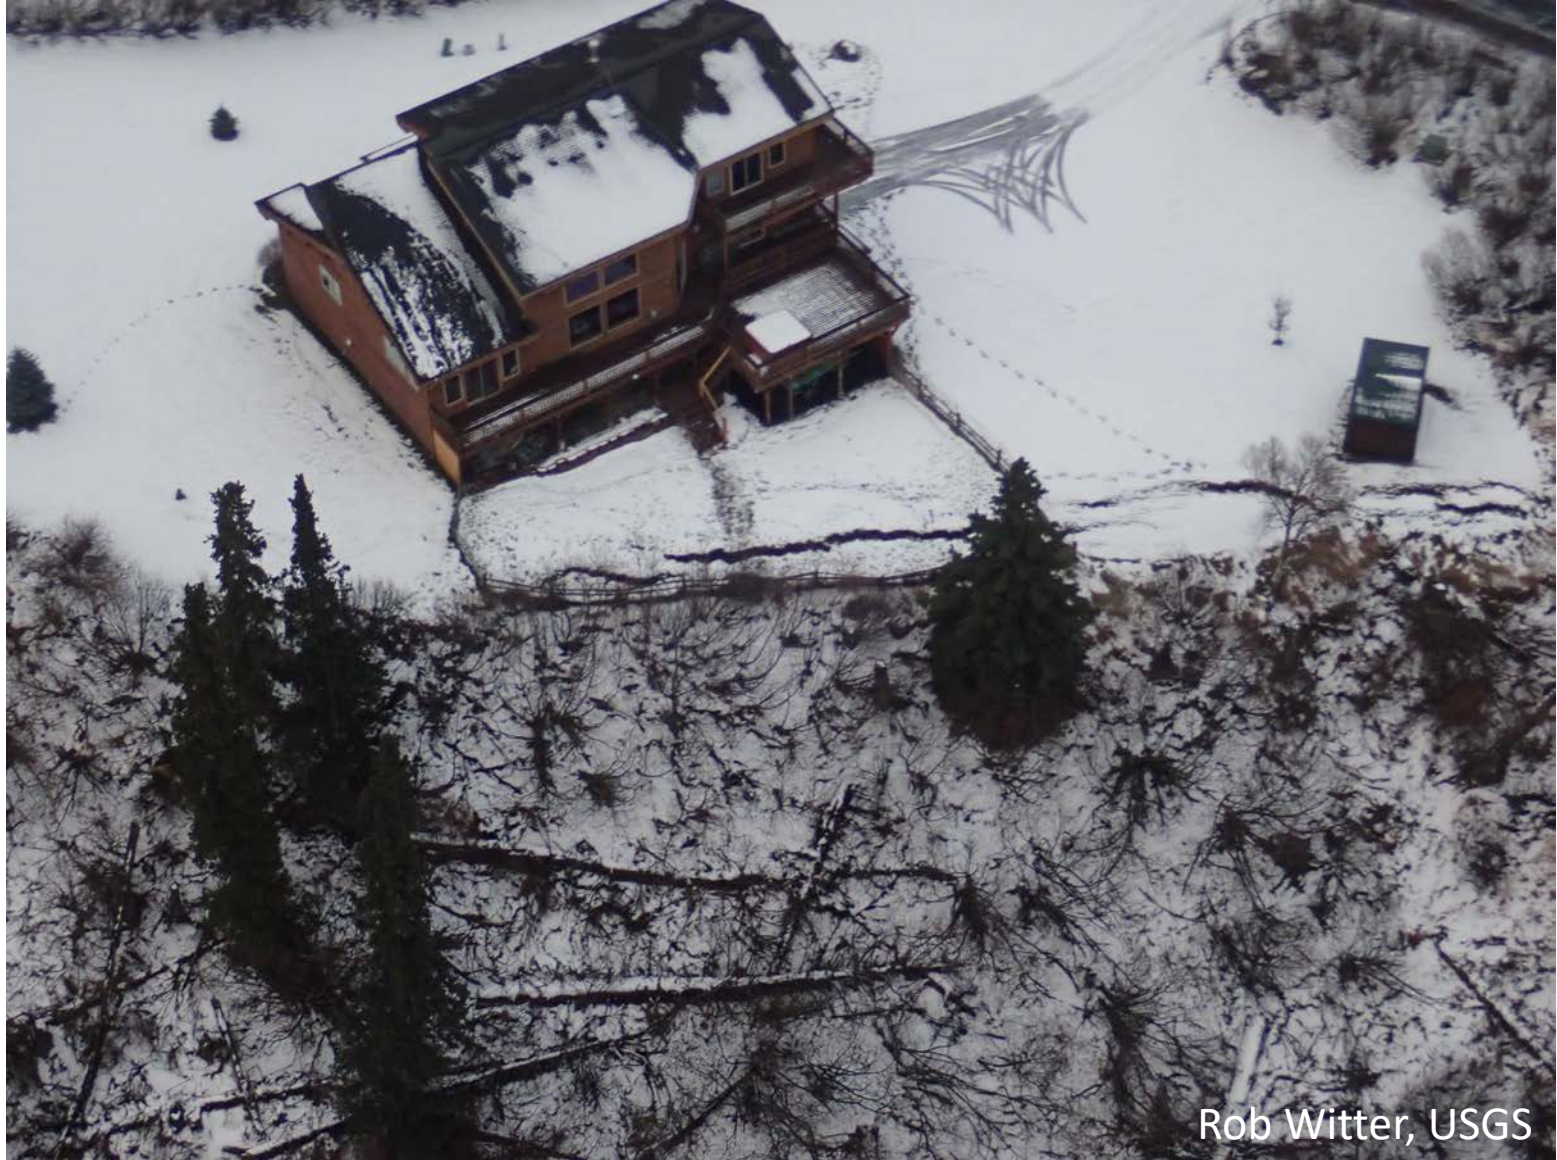
Ground cracks present the potential for future slope failure during aftershocks or heavy rainfall. These cracks occur at the top of a steep valley wall on the south side of Potter Creek in south Anchorage.

- These cracks present secondary landslide hazards that could be triggered by aftershocks or heavy rainfall and should be monitored to assess continued movement.

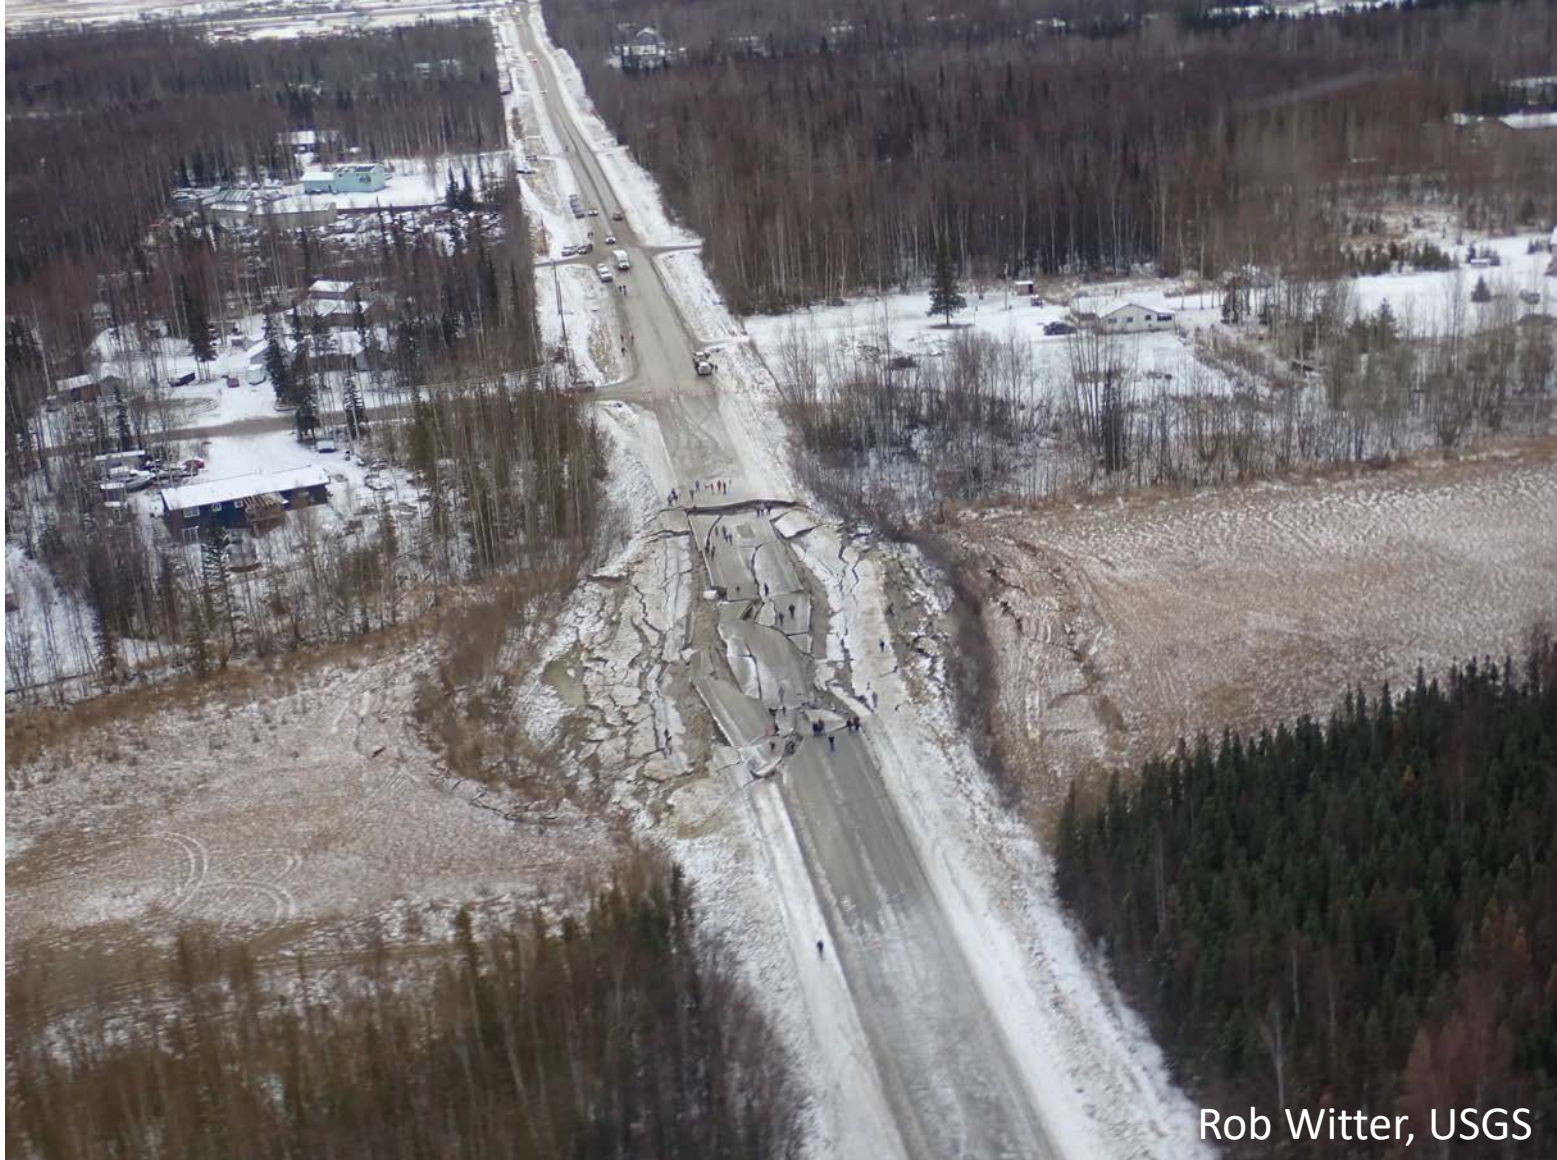
Lateral spreading disrupted Vine Road near Wasilla. Many failures of engineered materials occurred on or adjacent to saturated lowlands filled with organic sediment, silt, or sand.

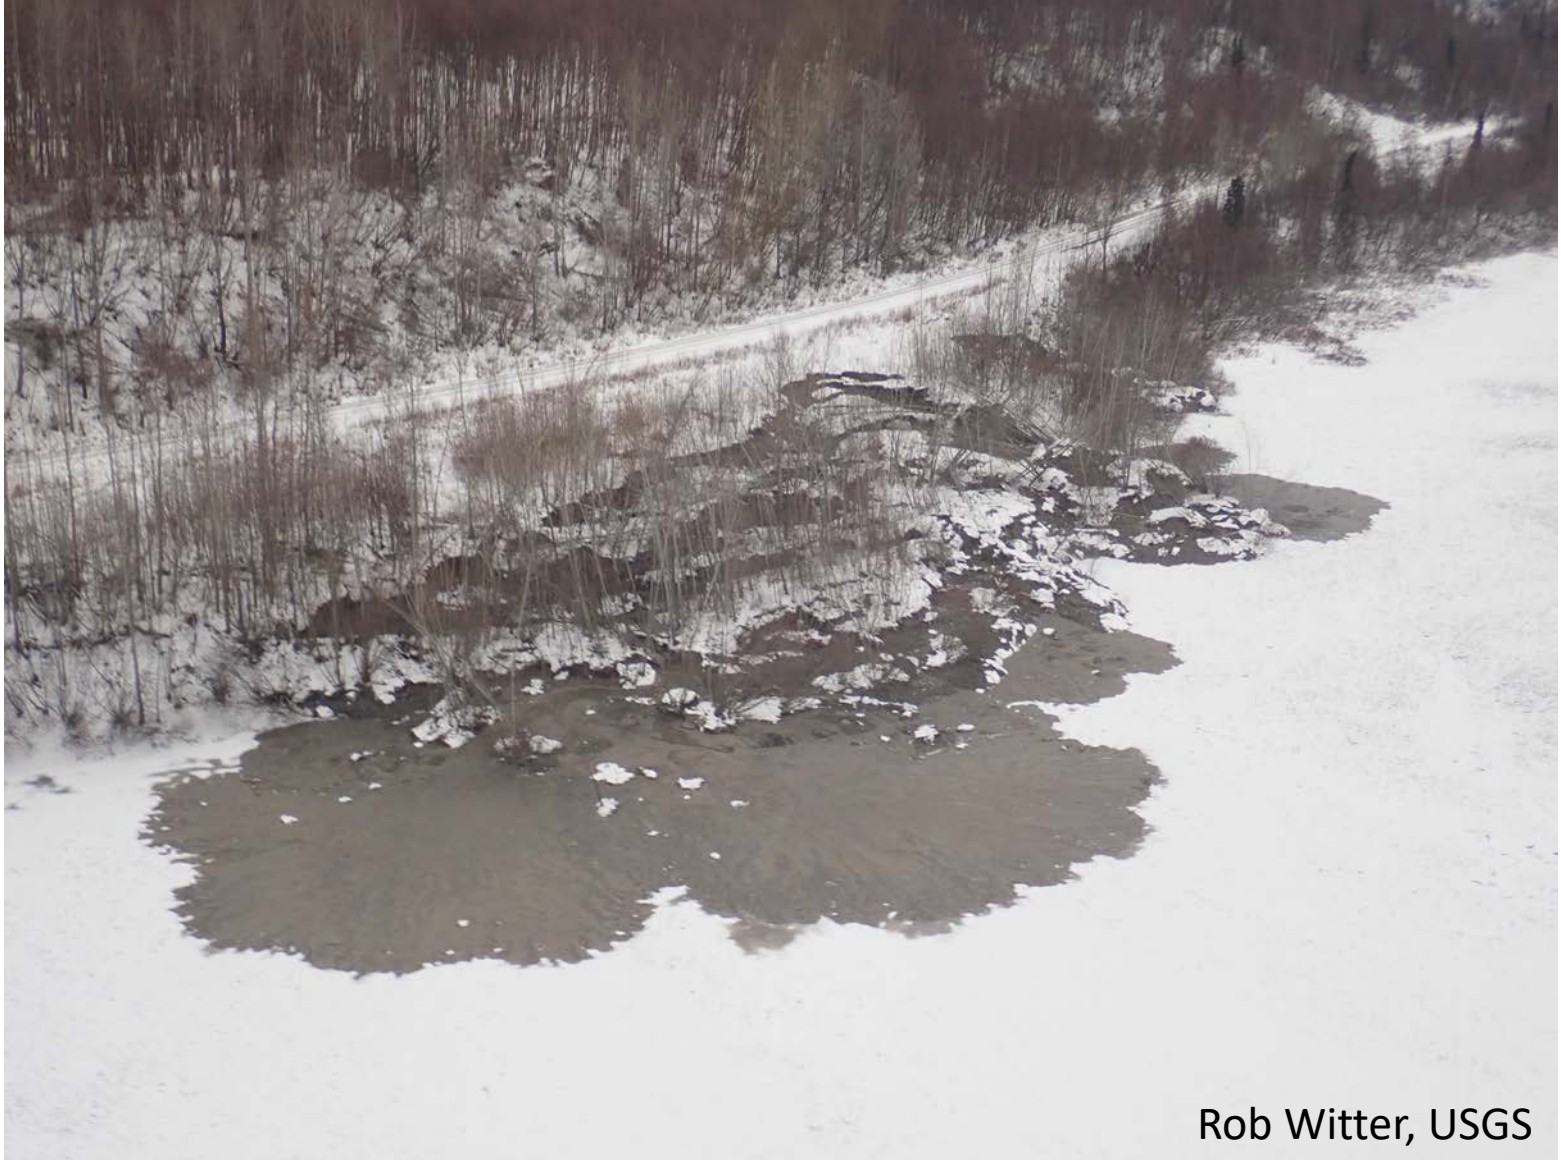
Complex earthflow slumping along Alaska Railroad overlooking tidal flats along Knik Arm near Mirror Lake. Failure of these low bluffs may have involved liquefaction.

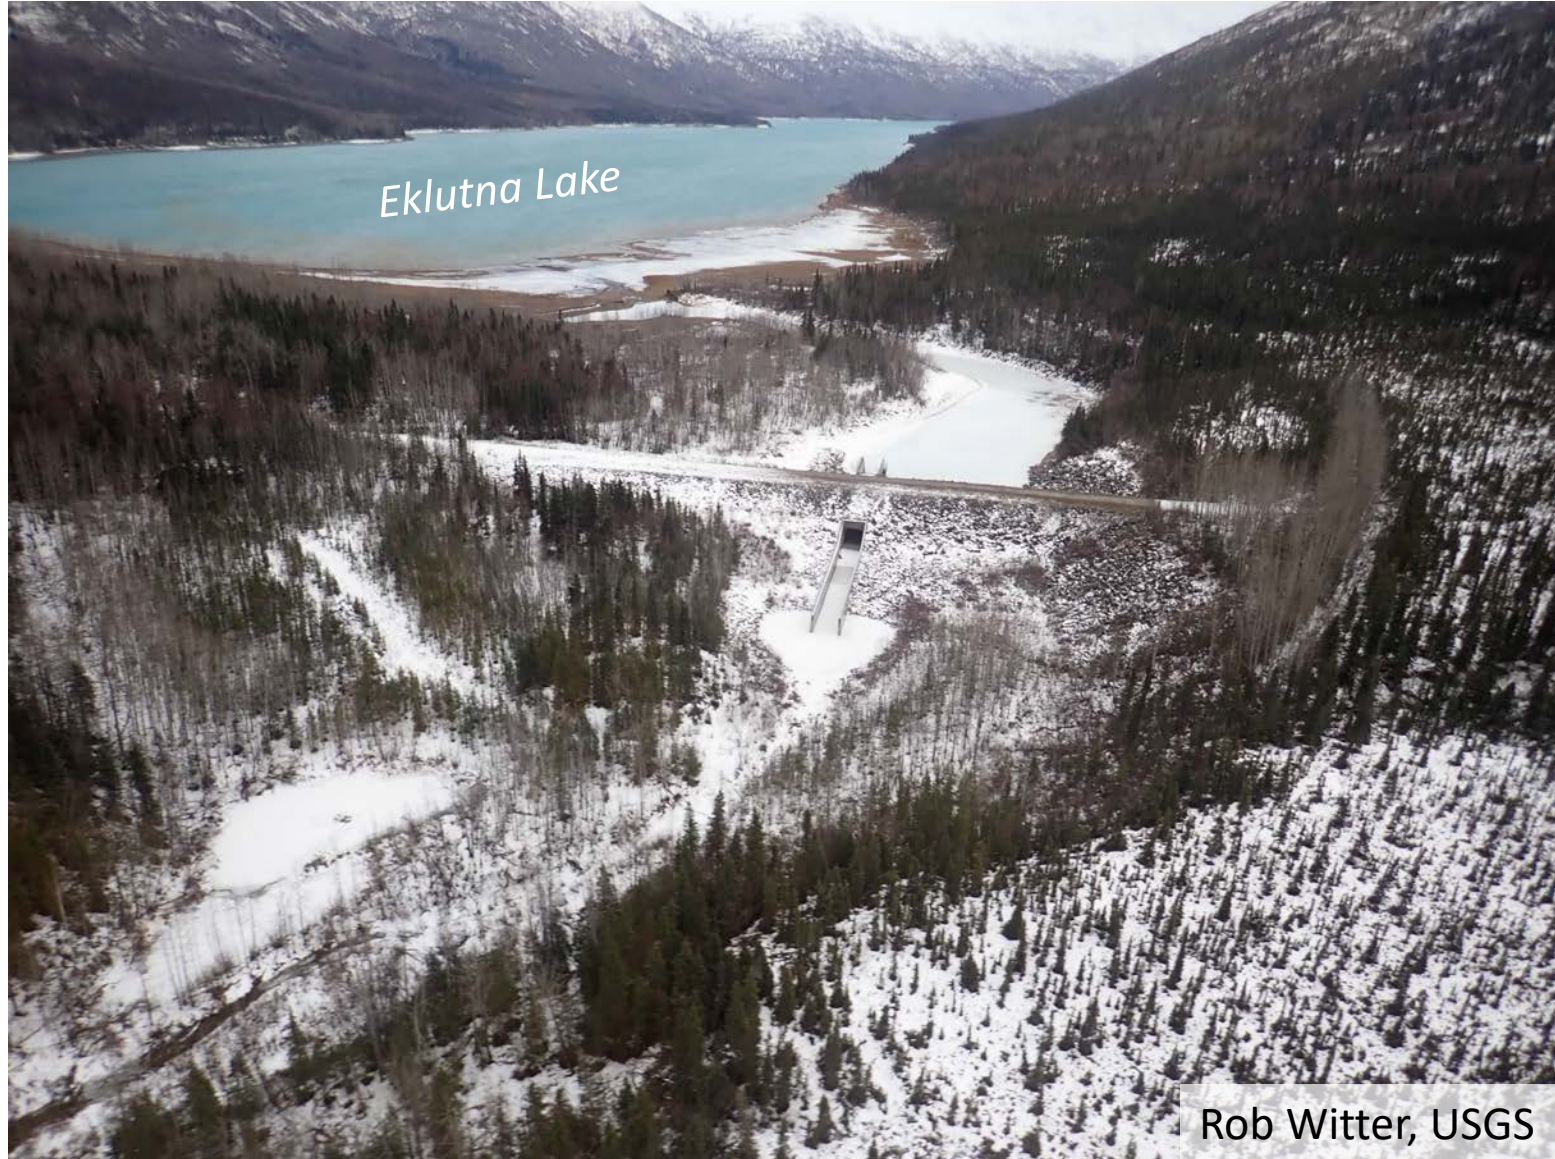
Eklutna Dam where we observed no evidence for ground deformation from aerial reconnaissance. Municipal utilities appeared to perform well during the earthquake.

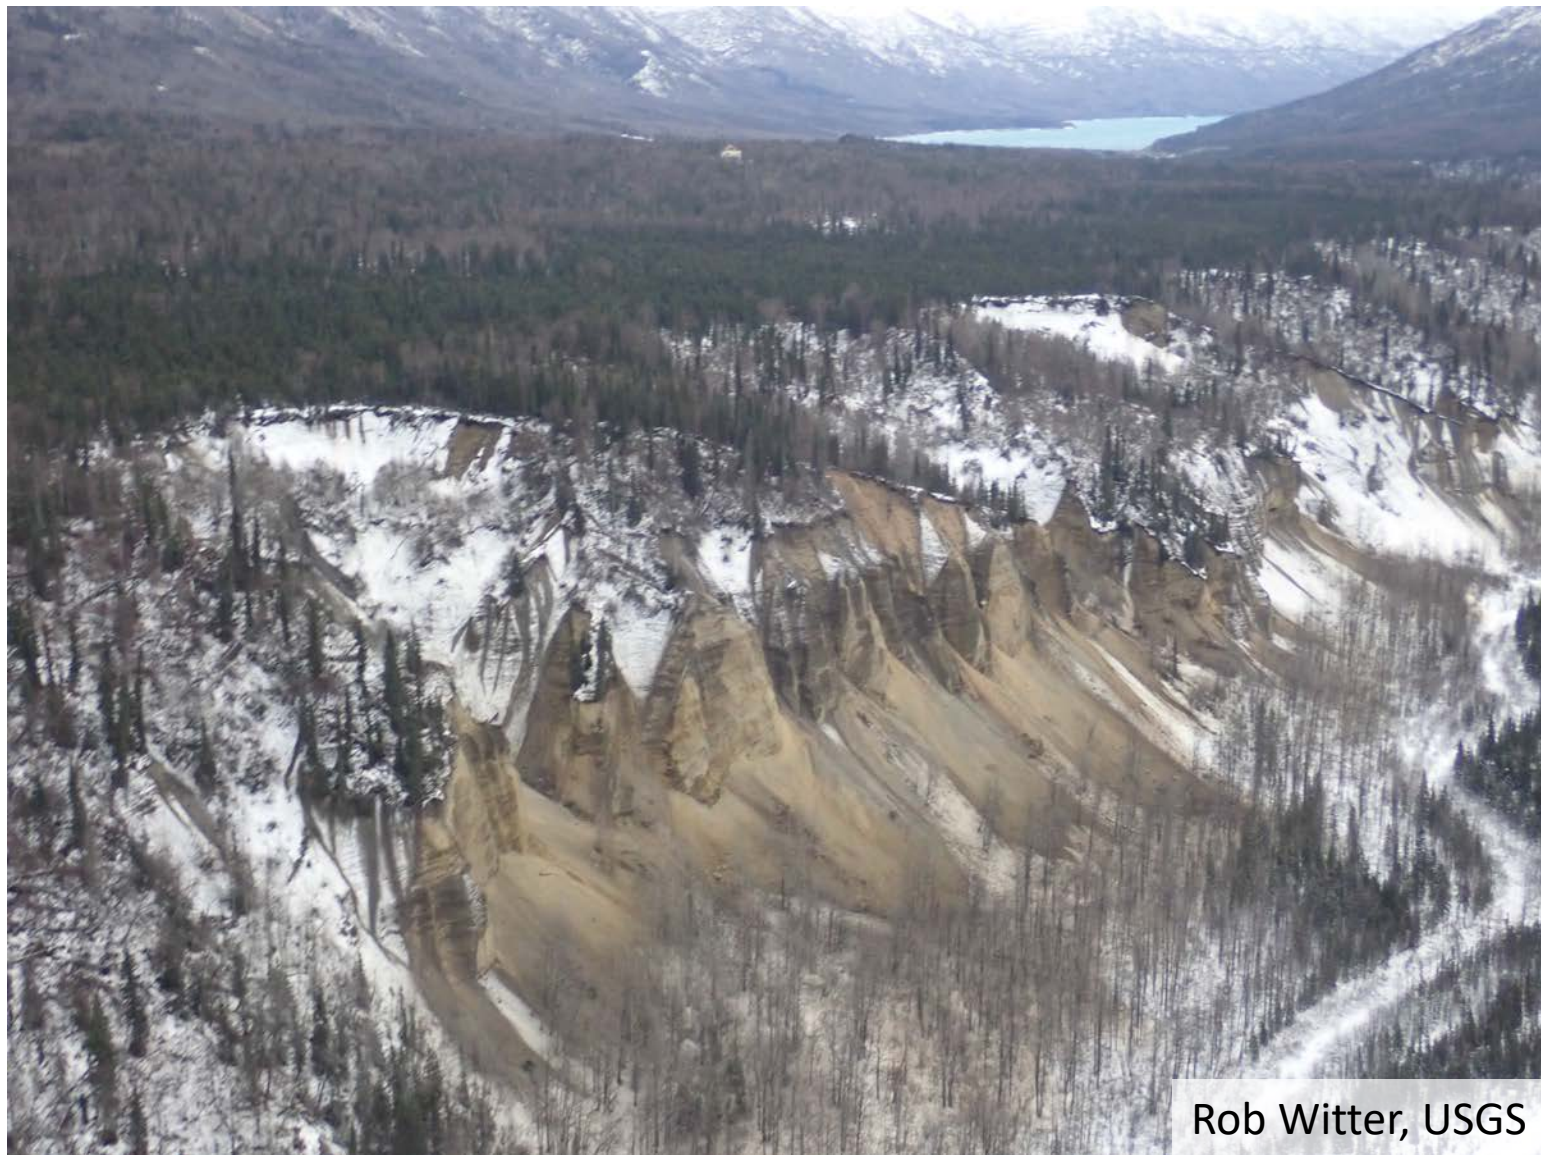
Debris avalanches on bluffs composed of glacial outwash sediment along the Eklutna River.

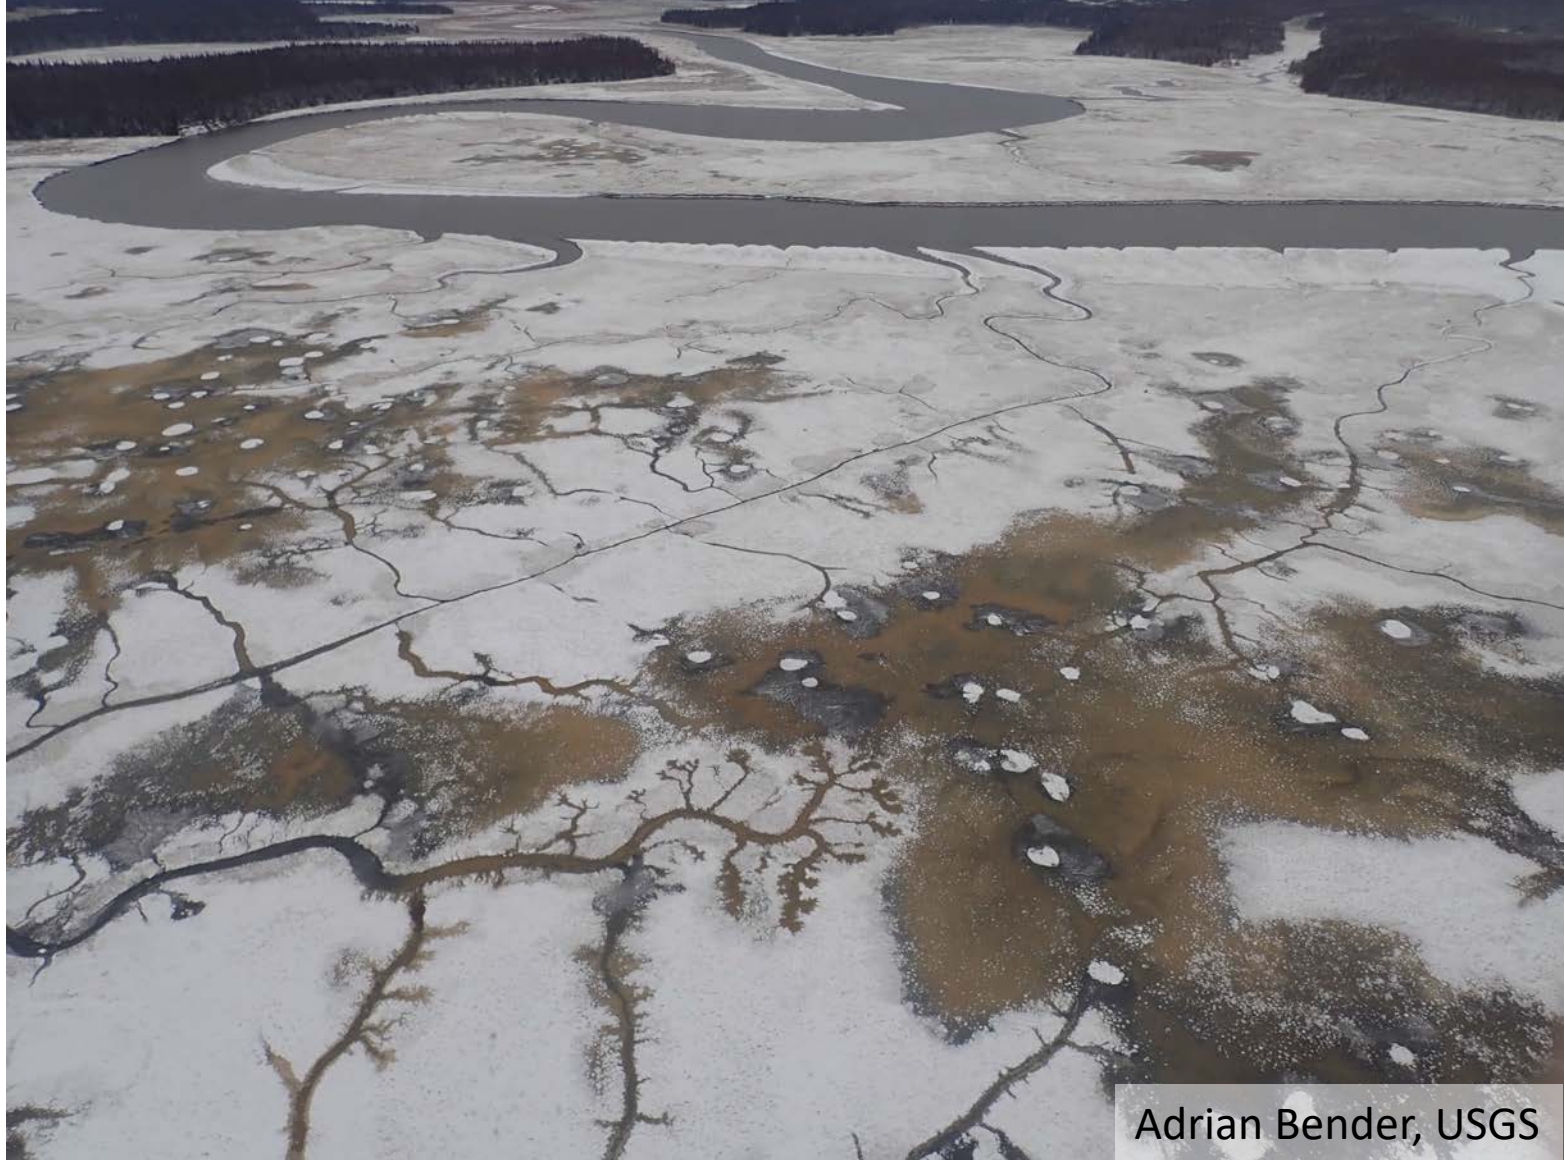
Sediment vented by earthquake-triggered liquefaction at the mouth of the Little Susitna River.
