## **USGS Post Event Investigation—1 December 2018 M 7.0 Anchorage Earthquake**

3 December 2018

### **SUMMARY OF OVERFLIGHT**

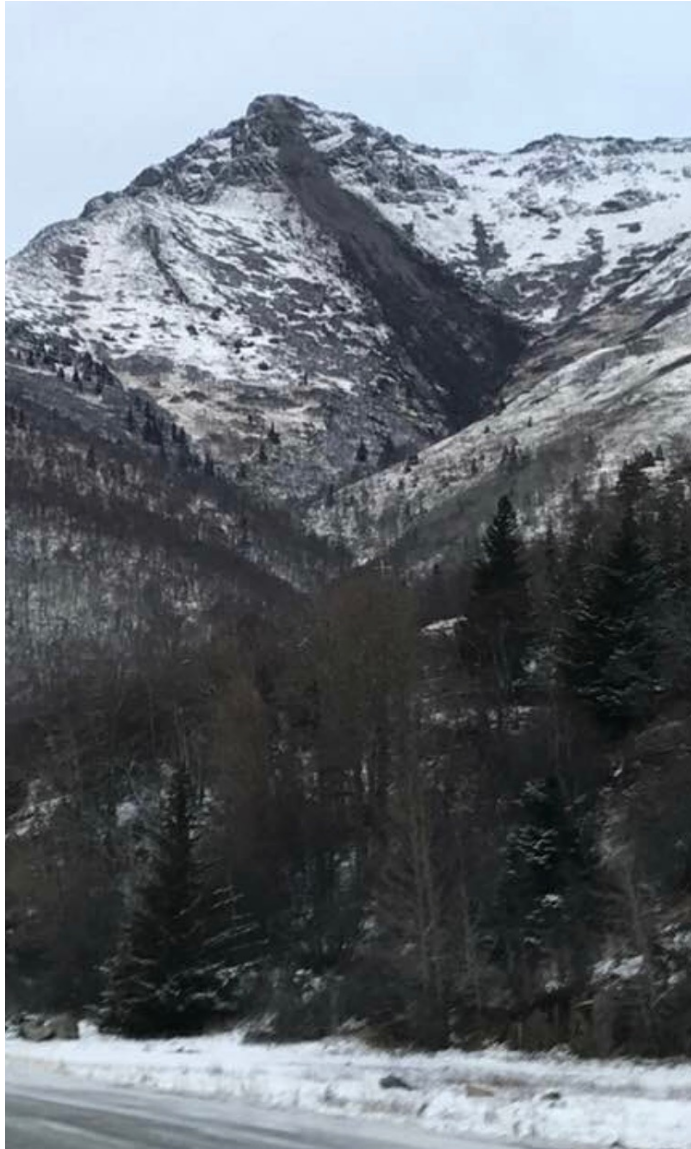
Secondary hazards caused by earthquake-triggered ground failures include landslide dams blocking rivers and incipient cracks that may promote further slope instability after initial movement. We did not observe landslides that dammed streams along three drainages over which we flew, including Eagle River, Peters Creek, and Eklutna River. However, we cannot rule out the possibility that landslides have blocked these water courses upstream of our survey. Also, we recommend additional reconnaissance of a large rockfall on the east slope of Rainbow Peak along Turnagain Arm to assess the possibility of stream obstruction (Photo 3).

*Photo 3. Large rockfall on east-facing slope of Rainbow Peak, about 8 miles east of Potter Marsh along the Seward Highway. This rockslide has fallen into a valley and may have impounded a stream. Secondary hazards include landslide dams that may break and cause flooding. (Credit: Vin Robinson)*

The 2018 Anchorage earthquake released rockfalls and avalanches in the Chugach Mountains. The largest rockfall, reported by local eyewitnesses, may be the rock avalanche on the east face of Rainbow Peak, located ~8 miles east of Potter Marsh. This rockfall and avalanches in the higher terrain near Girdwood are documented by the Chugach National Forest Avalanche Information Center (<http://www.cnfaic.org/site/observations/rainbow-peak/>). During our overflight, we observed two large rockfalls along Seward Highway between Potter Marsh and McHugh Creek. Small rockfalls also occurred in the higher terrain above Eklutna Valley and in the peaks overlooking the Glenn Highway near the Knik Arm bridge.

2. We know of one large rockfall on the east slope of Rainbow Peak between Anchorage and Girdwood. Additional observations (National Guard overflight?) are needed to determine whether the rockfall has obstructed the stream and impounded water, which might present additional flooding hazards.

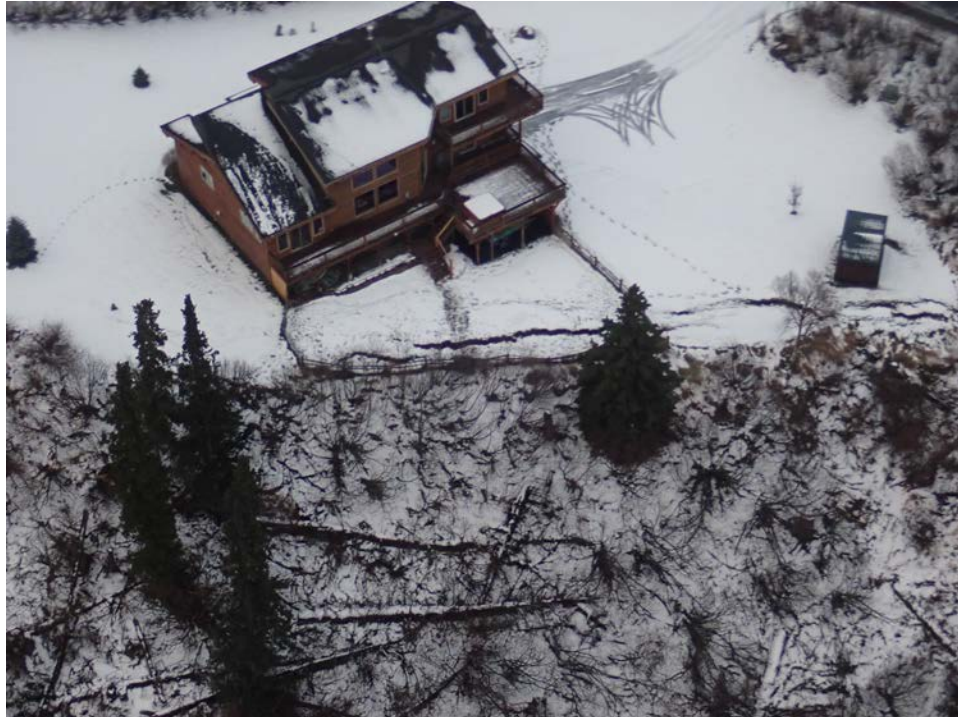
Another type of failure we observed at the top edges of steep valley slopes were deep cracks. These incipient failures may be important secondary hazards to consider as days pass after the earthquake. Some residents have reported that cracks above steep slopes have widened in the days since the earthquake. These cracks should be monitored for further movement in the coming weeks (Photo 4).

*Photo 4. Ground cracks present the potential for future slope failure during aftershocks or heavy rainfall. These cracks occur at the top of a steep valley wall on the south side of Potter Creek in south Anchorage. GPS position: 61.437615872°, -149.449646563° (Credit: Rob Witter, USGS)*

3. Numerous ground cracks occur at the crests of steep slopes along Potter Creek, Eagle River, Peters Creek, and possibly other deep valleys in the area impacted by ground shaking. These cracks present secondary landslide hazards that could be triggered by aftershocks or heavy rainfall and should be monitored to assess continued movement.

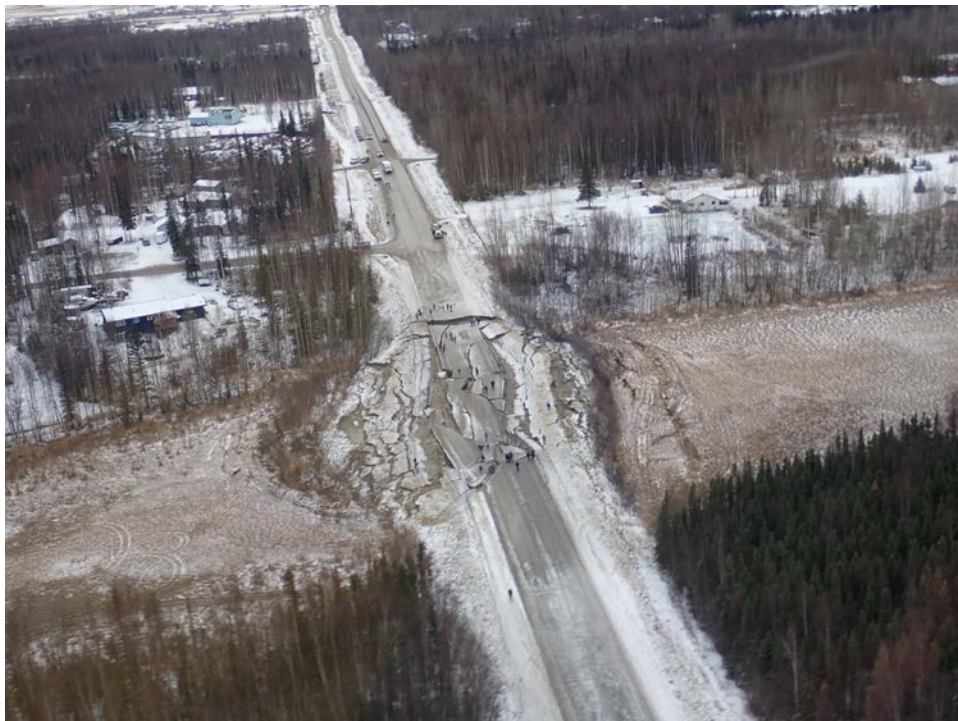
Ground failure in engineered materials occurred along roadways and railroad grades throughout the area we surveyed. Many of these failures were identified in the hours after the earthquake and reported in the news and social media. The Alaska Daily News published striking photos of slumped and lateral spreading of road embankment, including the north bound offramp of Minnesota Road and International Airport Way in Anchorage and the collapse of Vine Road near Wasilla (Photo 5). Some road failures occurred in engineered fills placed on or adjacent to low-lying ground, possibly saturated and filled with organic sediment, silt, or sand.

*Photo 5. Lateral spreading disrupted Vine Road near Wasilla. Many failures of engineered materials occurred on or adjacent to saturated lowlands filled with organic sediment, silt, or sand. GPS position: 61.437615904°, -149.449646520° (Credit: Rob Witter, USGS)*

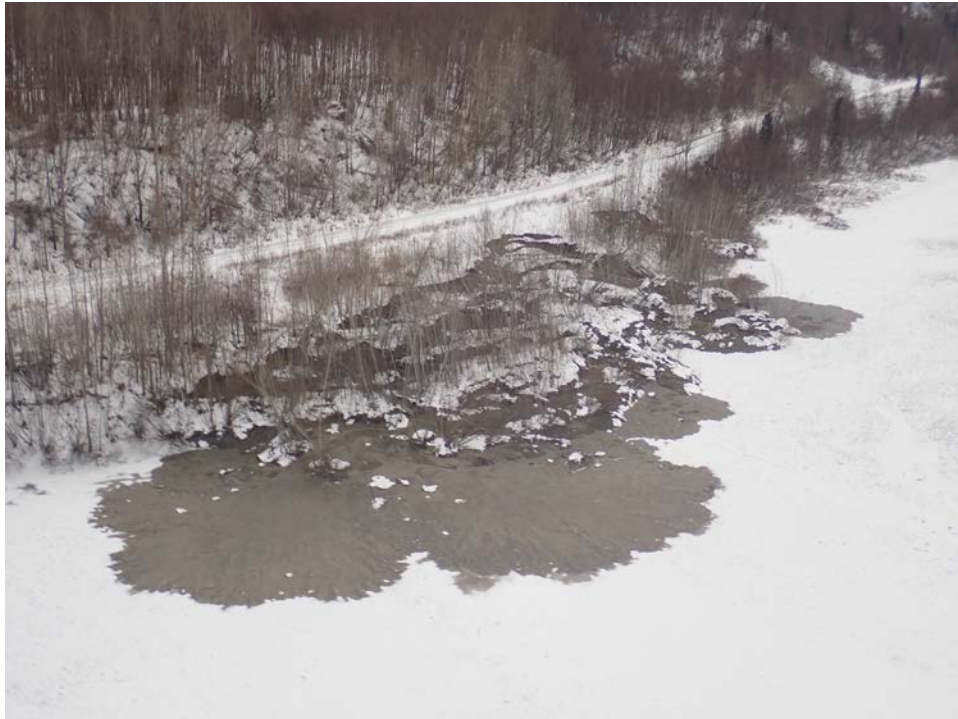
We also identified damage to the Alaska Railroad due to slumping and lateral spreading along bluffs near Oceanside and Chugiak. Failures in the railroad grade occurred along low bluffs of Cook Inlet and Knik Arm shorelines that slumped toward the coastal flats where significant liquefaction was evident (Photo 6). We suspect that these landslides initiated in natural materials underlying coastal bluffs and propagated upslope to impact the railroad. Most of the ground failures appeared to be slumps, earthflows, and lateral spreads possibly induced by liquefaction.

*Photo 6. Complex earthflow slumping along Alaska Railroad overlooking tidal flats along Knik Arm near Mirror Lake. Failure of these low bluffs may have involved liquefaction. GPS position 61.437615866°, -149.449646677° (Credit: Rob Witter, USGS)*

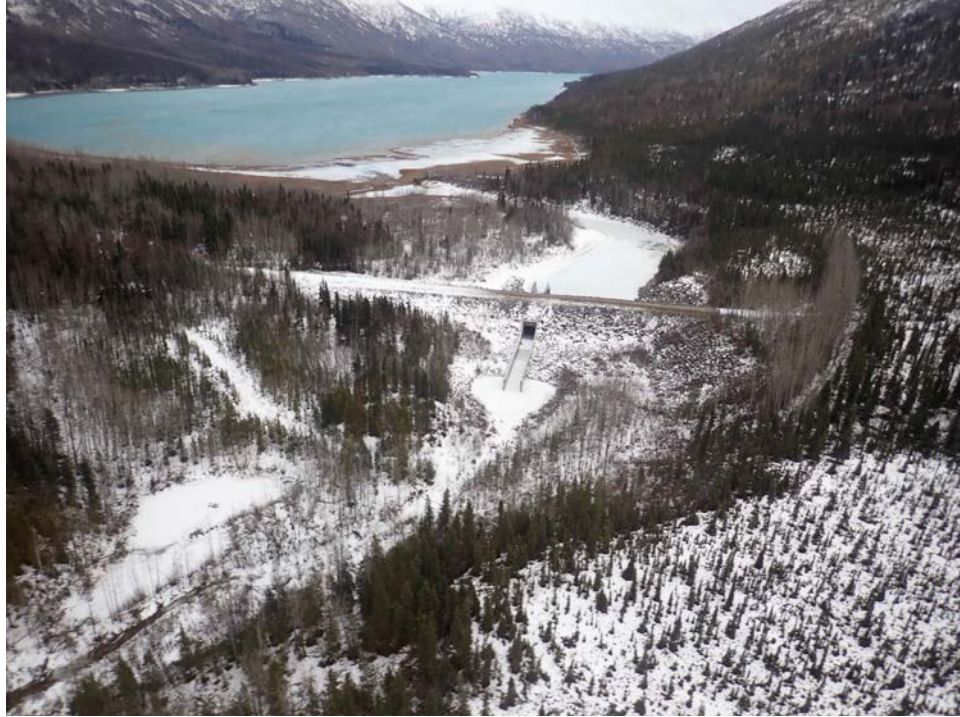
Some municipal facilities appeared to perform well during the earthquake suffering little or no ground deformations that could be resolved from our overflight. We flew over the Municipal Light & Power facility, which showed no evidence for large ground failures from the air. We also inspected the Eklutna Dam at the west end of Eklutna Lake, which appeared intact and undamaged (Photo 7). We will share oblique aerial photos of these sites. However, comprehensive assessments of the earthquake impacts to these facilities require detailed field surveys that are beyond the scope of our reconnaissance overflight.

*Photo 7. Eklutna Dam where we observed no evidence for ground deformation from aerial reconnaissance. Municipal utilities appeared to perform well during the earthquake. GPS position: 61.420135314°, -149.220729256° (Credit: Rob Witter, USGS)*

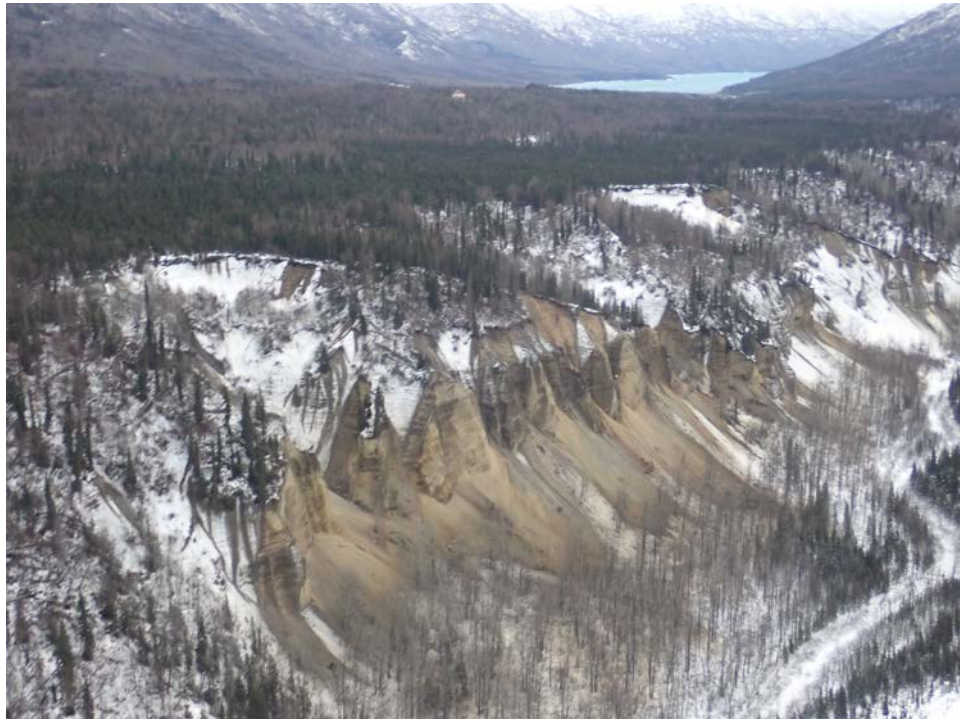
We identified debris avalanches on steep slopes underlain by glacial deposits at Point Woronzoff, and along the Eagle River and Eklutna River valleys (Photo 8). These slope failures appeared to be superficial sloughs of sand and gravel deposits that spread downhill into broad debris aprons at the base of hillslopes. Freshly exposed glacial deposits in steep slopes elsewhere mantled by snow made these ground failures easy to recognize.

*Photo 8. Debris avalanches on bluffs composed of glacial outwash sediment along the Eklutna River. GPS position: 61.420186150°, -149.220729332° (Credit: Rob Witter, USGS)*

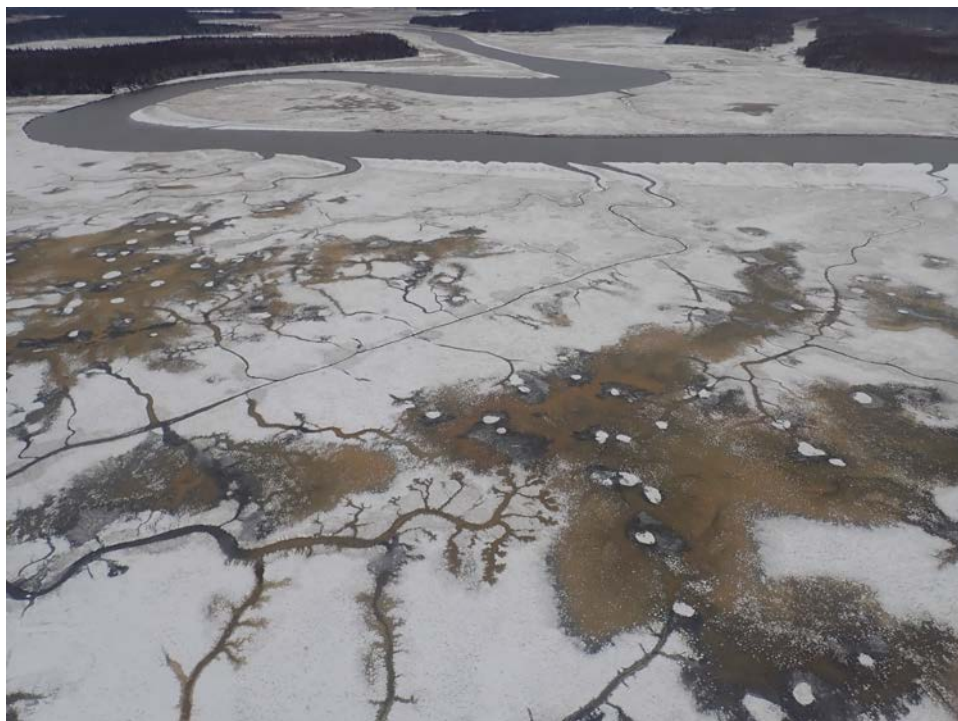
Liquefaction-related deformation and venting of saturated sediment occurred on tidal flats along Turnagain Arm, Cook Inlet, Knik Arm, and the Little Susitna River delta. We did not fly over the Sand Lake neighborhood where localized liquefaction impacted residential buildings. The most voluminous liquefaction occurred at the Little Susitna River delta where vented liquefied sediment blotted the coastal plain like large ink stains (Photo 9). Often the source of the sediment appeared to be a white dot that marked the

source vent. Further geotechnical study is needed to evaluate the role of liquefaction in failure of coastal bluffs adjacent to sand blows observed in tidal flats.

*Photo 9. Sediment vented by earthquake-triggered liquefaction at the mouth of the Little Susitna River. GPS position: 61.420135331°, -149.220729268° (Credit: Adrian Bender, USGS)*
