# **Chimney Performance 2019**

## **Searles Valley Earthquakes**

Bruce Maison, S.E.

August 2019

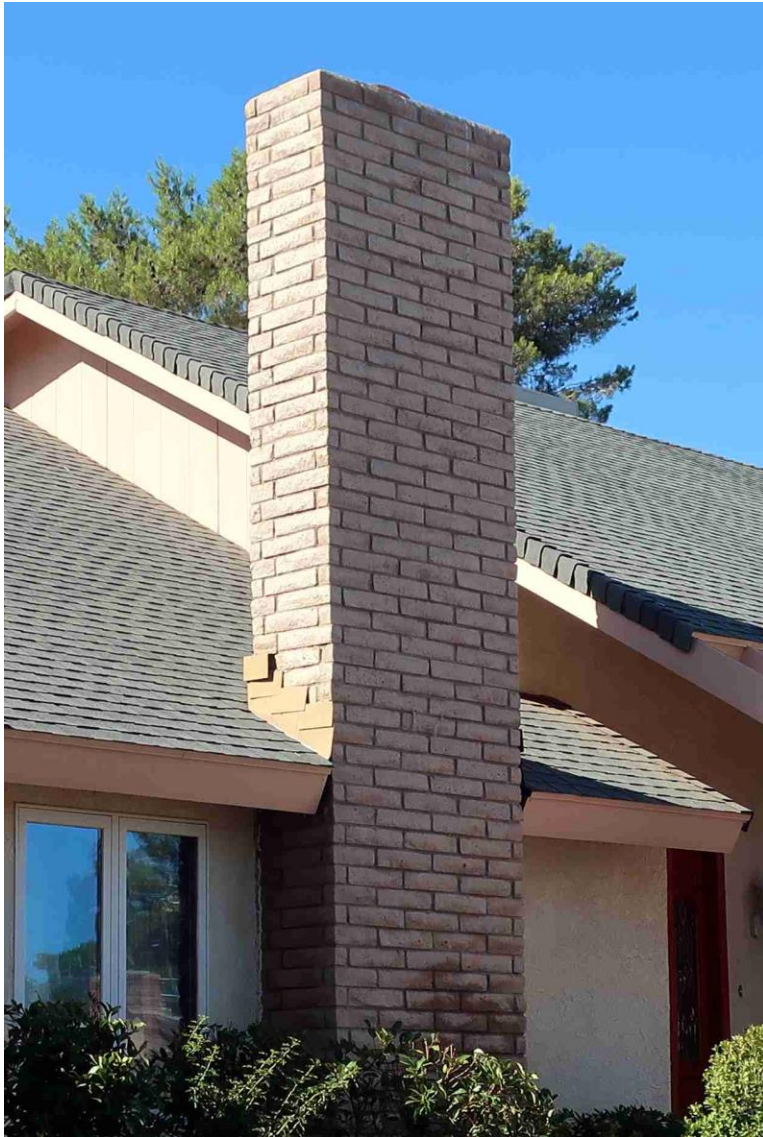
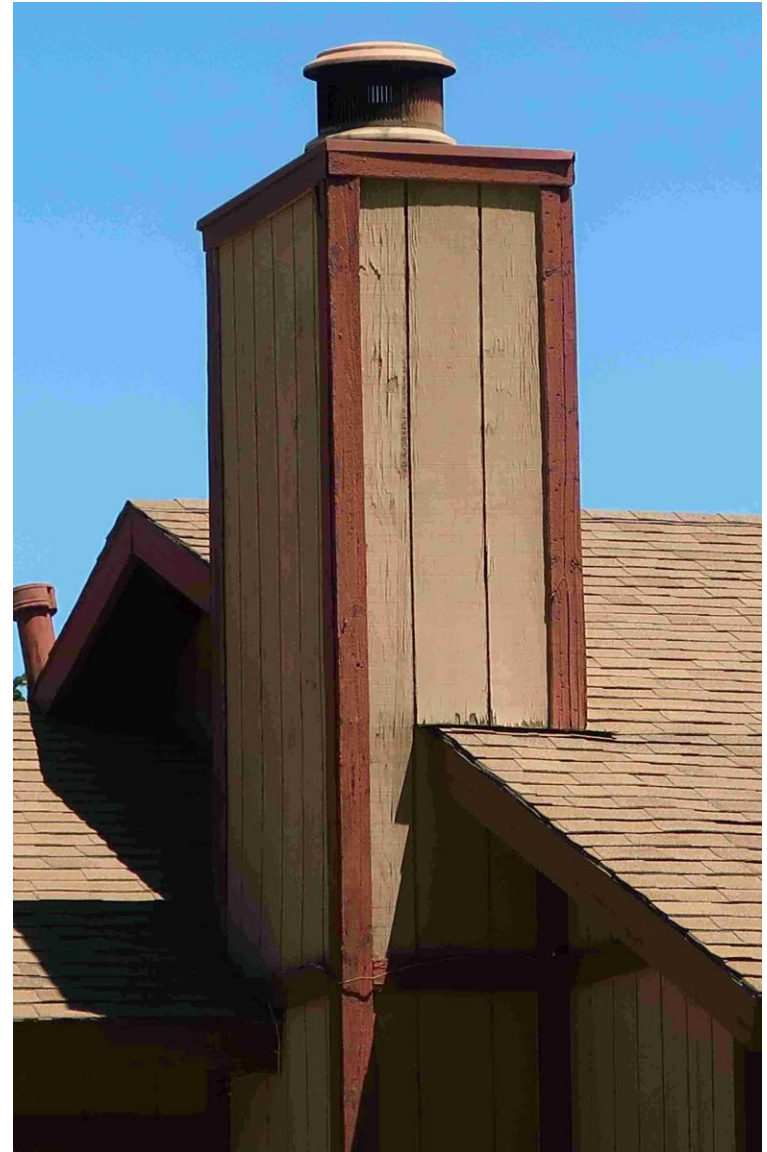
# Ridgecrest Chimneys

- Housing stock = 13,000 units
  - 75% built after 1970
  - Metal and masonry chimneys popular
- Metal-in-wood-chase
  - Very rugged...no damage
- Masonry
  - Code required reinforcement & strapping
- Some masonry chimneys damaged
  - Due to low quality construction

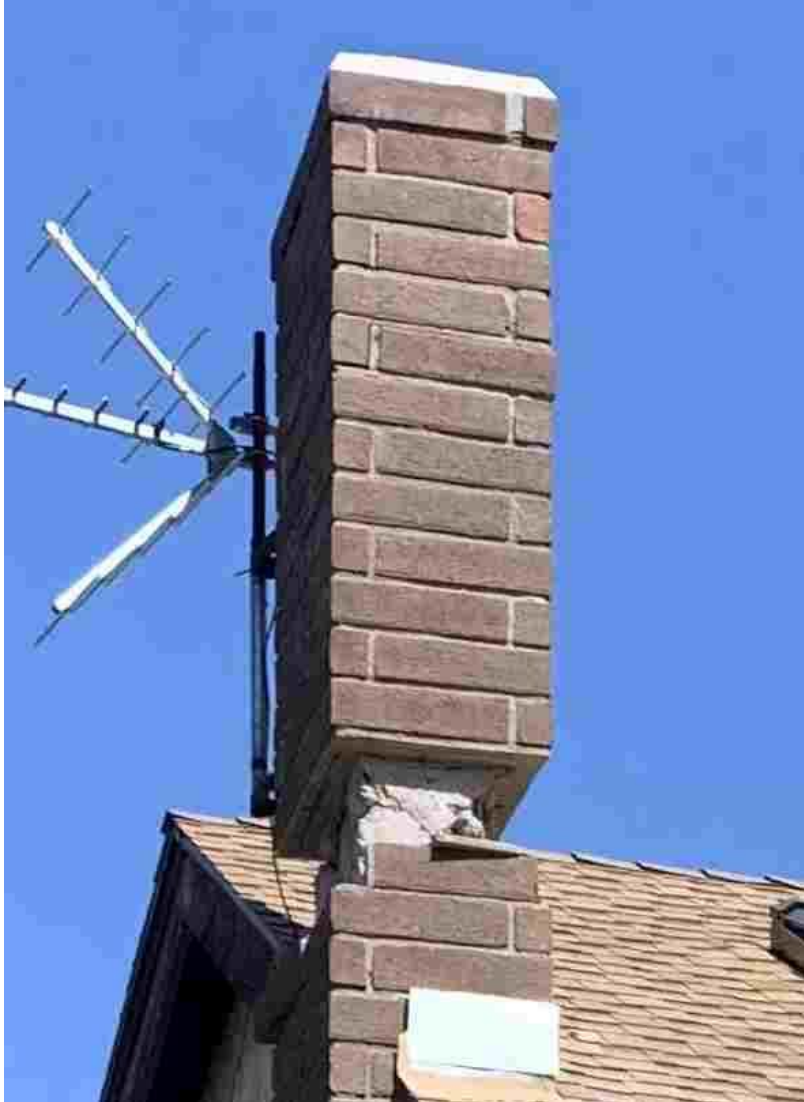
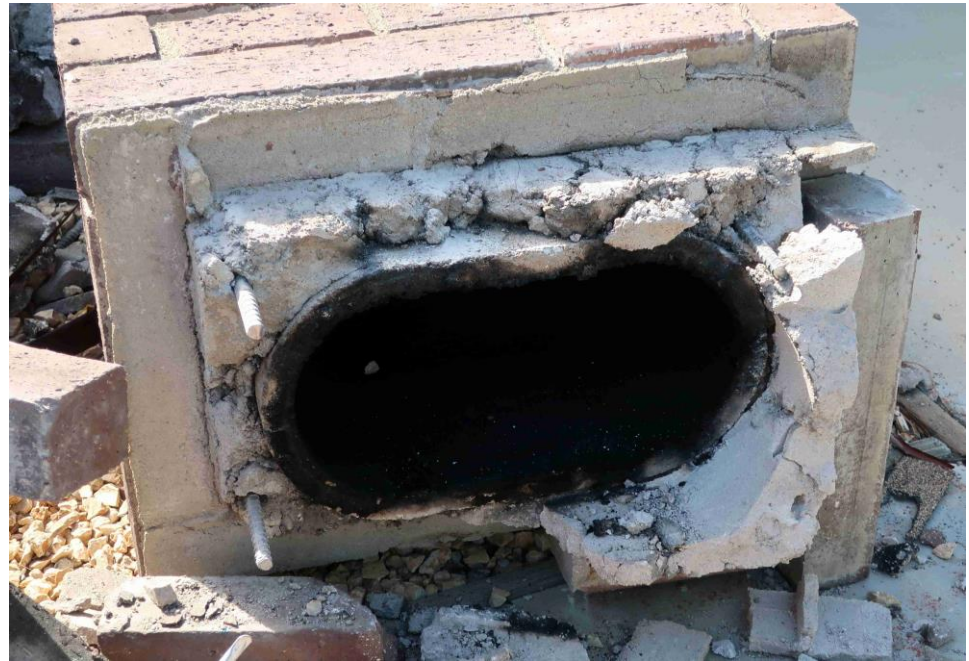
# Poor Grouting

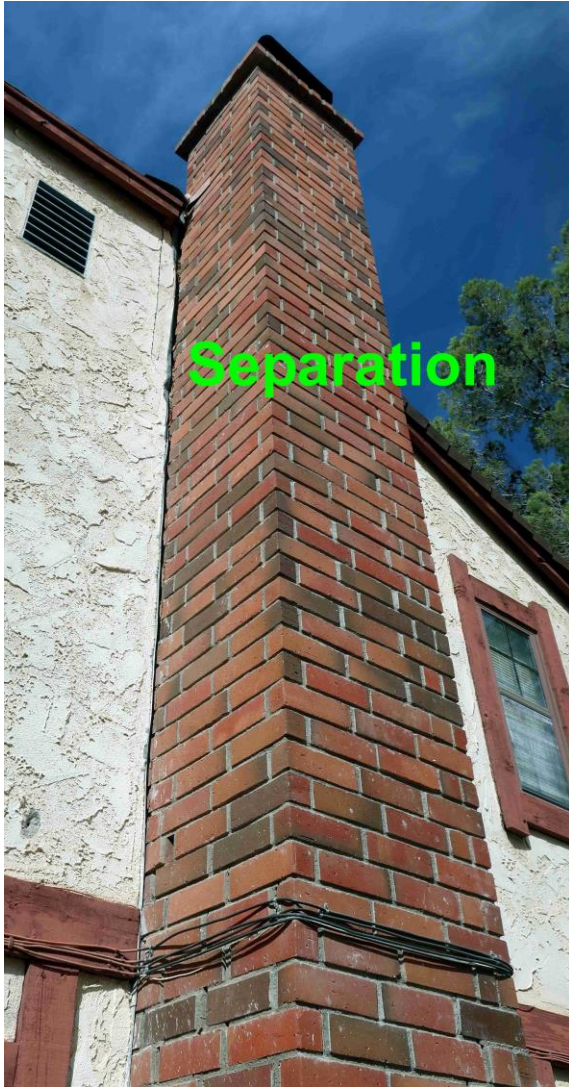
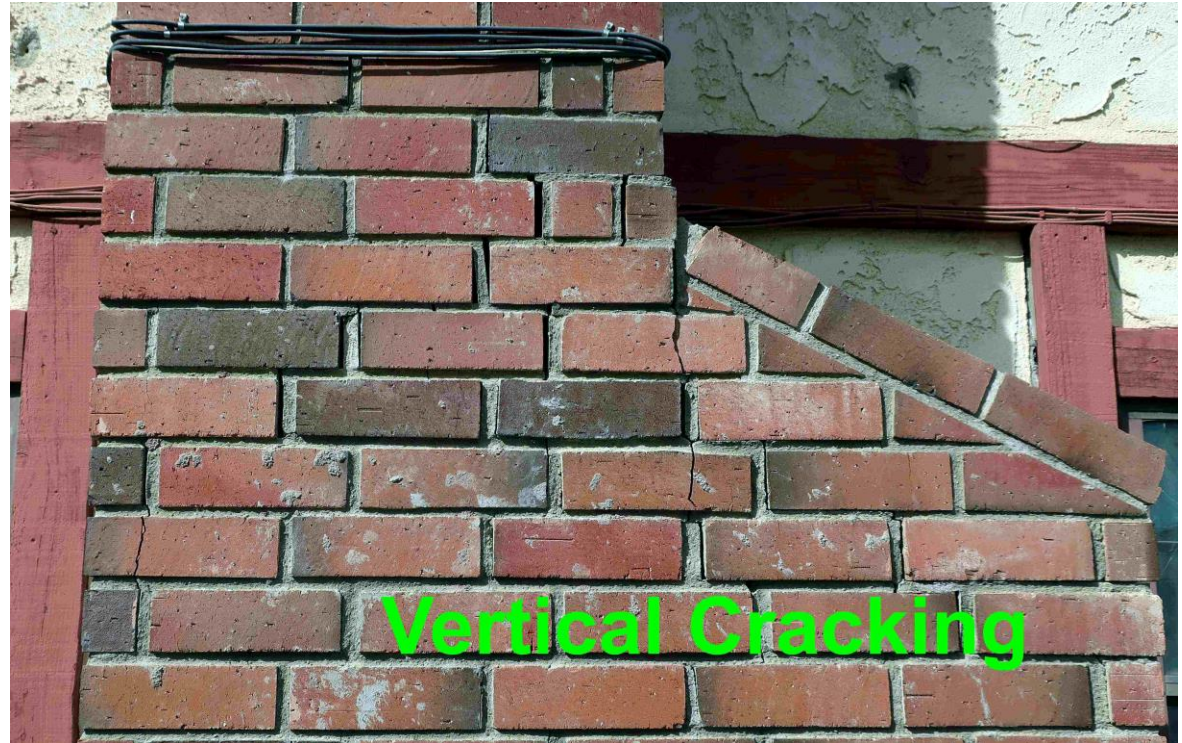
# Chimney Pull-Away (Inadequate Strapping Likely)

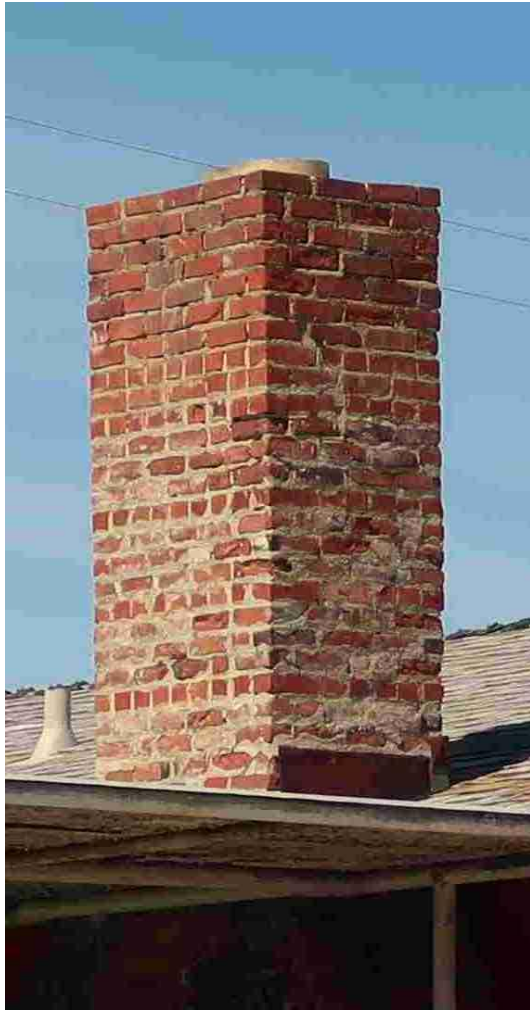
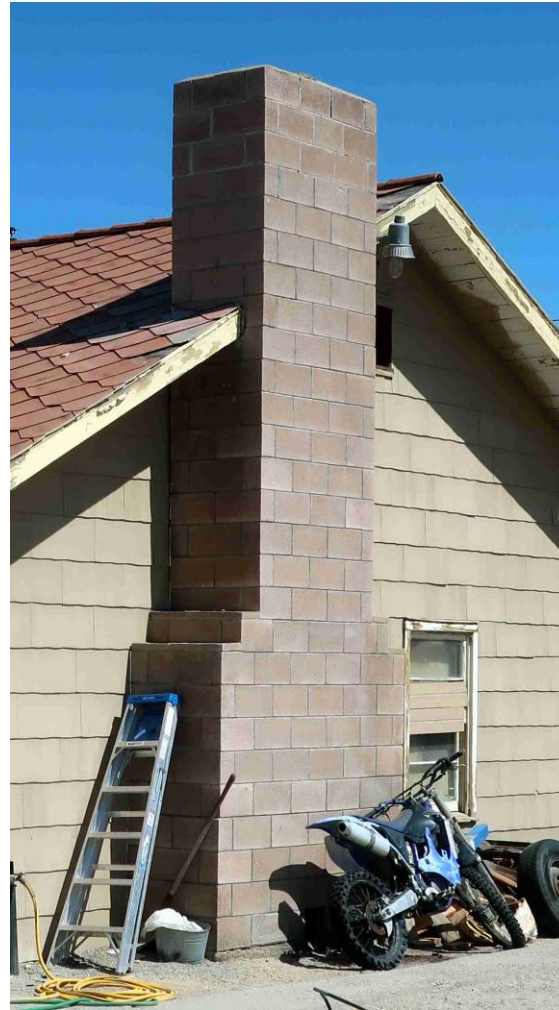
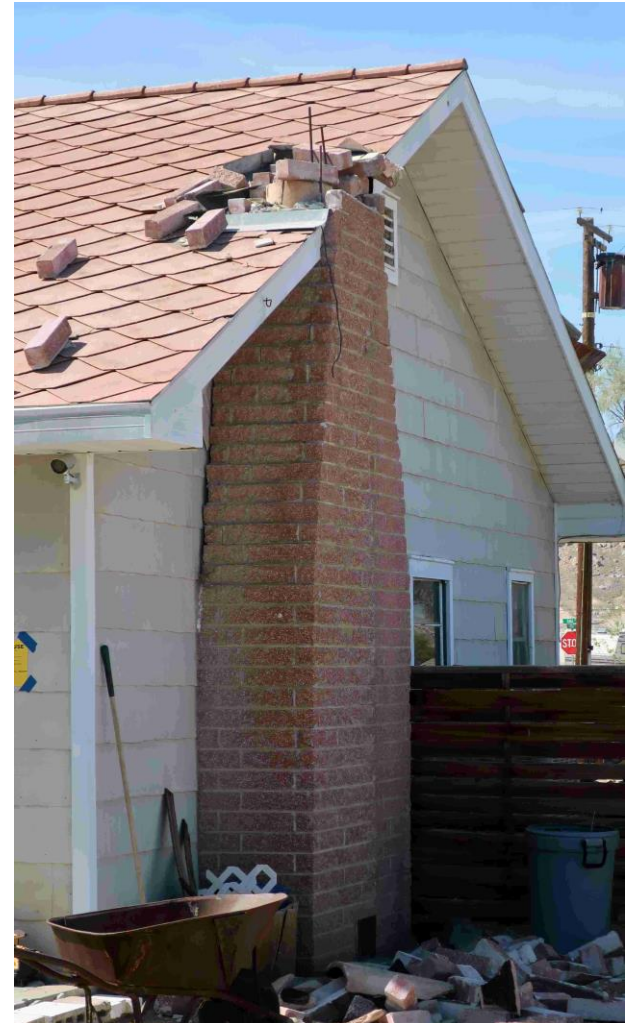
# Trona Chimneys

- Housing stock about 500 units
  - Many built in 1940s
  - Clay brick and concrete block chimneys
- Some chimneys collapsed
  - Rebar sticking out
  - Inadequate (or no) grouting
- Construction quality issue
  - Reinforced chimney should be unscathed
