SOUTHERN ITALY EARTHQUAKE, NOVEMBER 23, 1980

Reconnaissance Summary

E. Berger and J. Studer, EERI Members

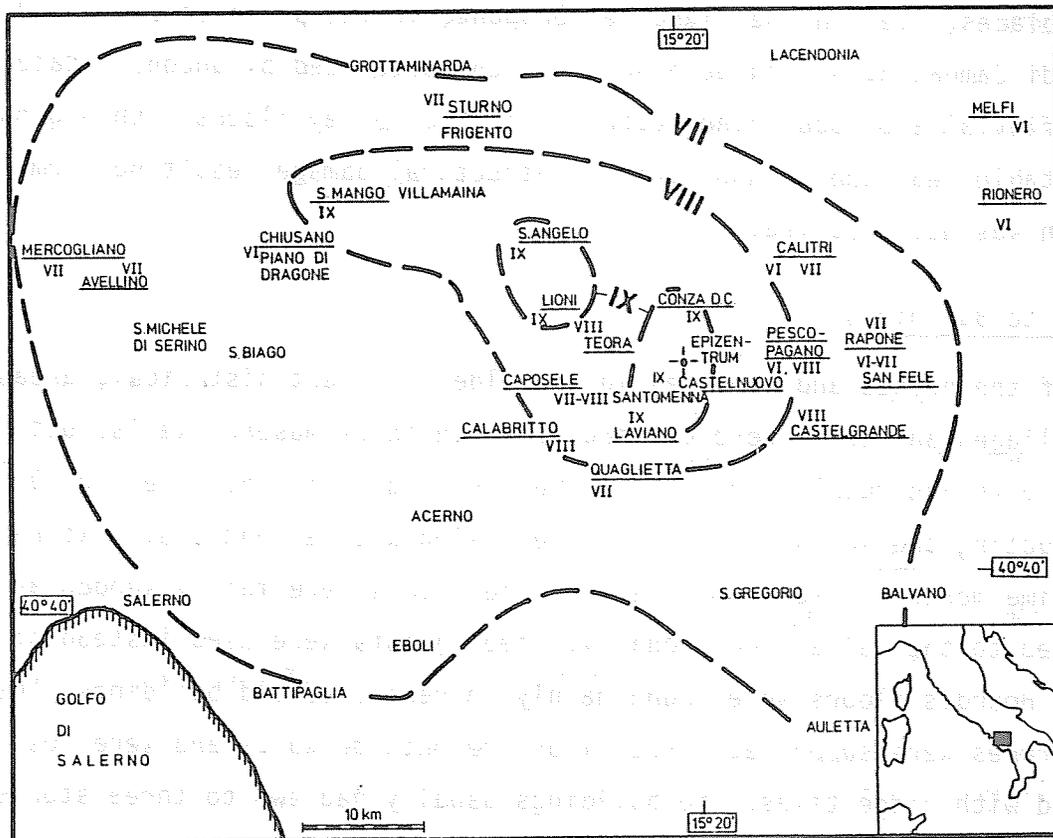
Fig. 1 shows a first assessment of the distribution of seismic MSK-intensities, based on our own observations and supplemented by information from the Osservatorio Vesuviano in Naples. Shown are in Roman numerals MSK-intensities for selected locations and general isoseismal lines. For the purpose of determining MSK-intensities at specific locations the team used a new damage survey sheet issued by the Swiss Federal Earthquake Service. With this survey sheets it was possible to correlate different kinds of damage with typical building structures, evaluate the results with respect to the MSK scale, and establish average intensity values.

Figure 1 - MSK-Intensities for Selected Locations and General Isoseismal Lines in Epicentral Region Based on Data from Different Sources.

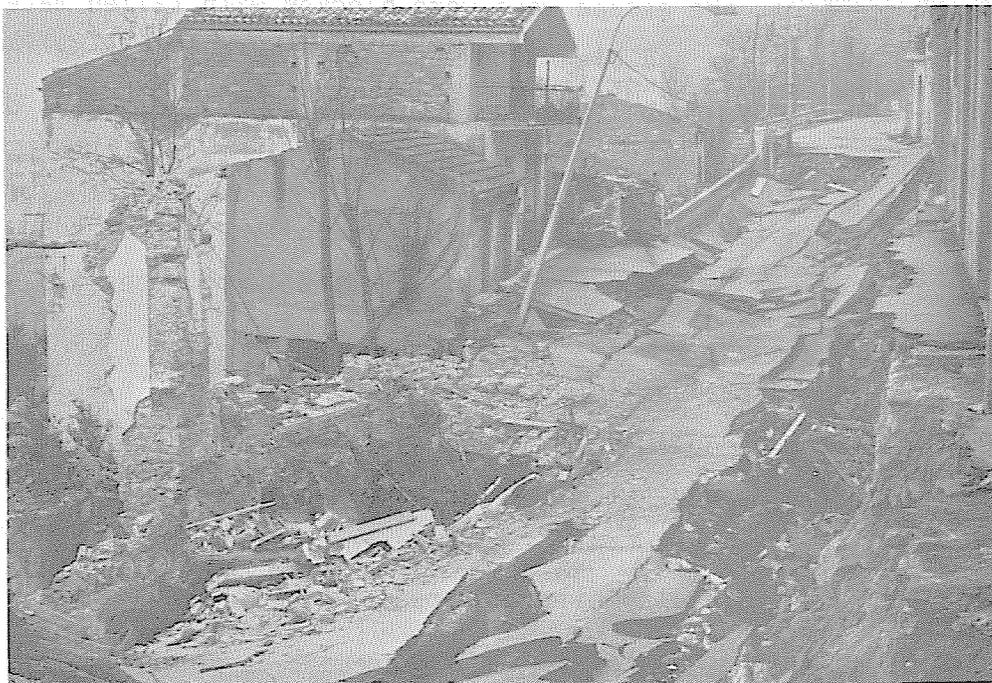
Especially spectacular were two slides near San Fele and one near Calitri. All three were more than 500 m wide and up to 1.3 km long. The largest slide movement of nearly 150 m was observed at one of the slides near San Fele. The buildings in the slide area were completely destroyed. The greatest damage to both old and new buildings was caused by the slide which affected large parts of the town Calitri (see Fig. 2). However, the damage caused directly by ground shaking in this town was of minor importance. The breaks in the ground along the different sliding zones in the upper part of the town exhibited both vertical and horizontal displacements from 50 cm to several meters.

Figure 2 - Slide in Calitri with Damage to Road

Fig. 6) as well as along the side of the road. This damage was most likely brought about by instable conditions in the underlying embankment. In slide areas the roads were frequently heavily damaged and sometimes no longer passable (see Fig. 2).
