EARTHQUAKE IN SOUTHERN ITALY NOVEMBER 23, 1980

Reconnaissance Tour December 2-5, 1980

Dr. A. Smolka, Geologist* and J. Eber, Civil Engineer

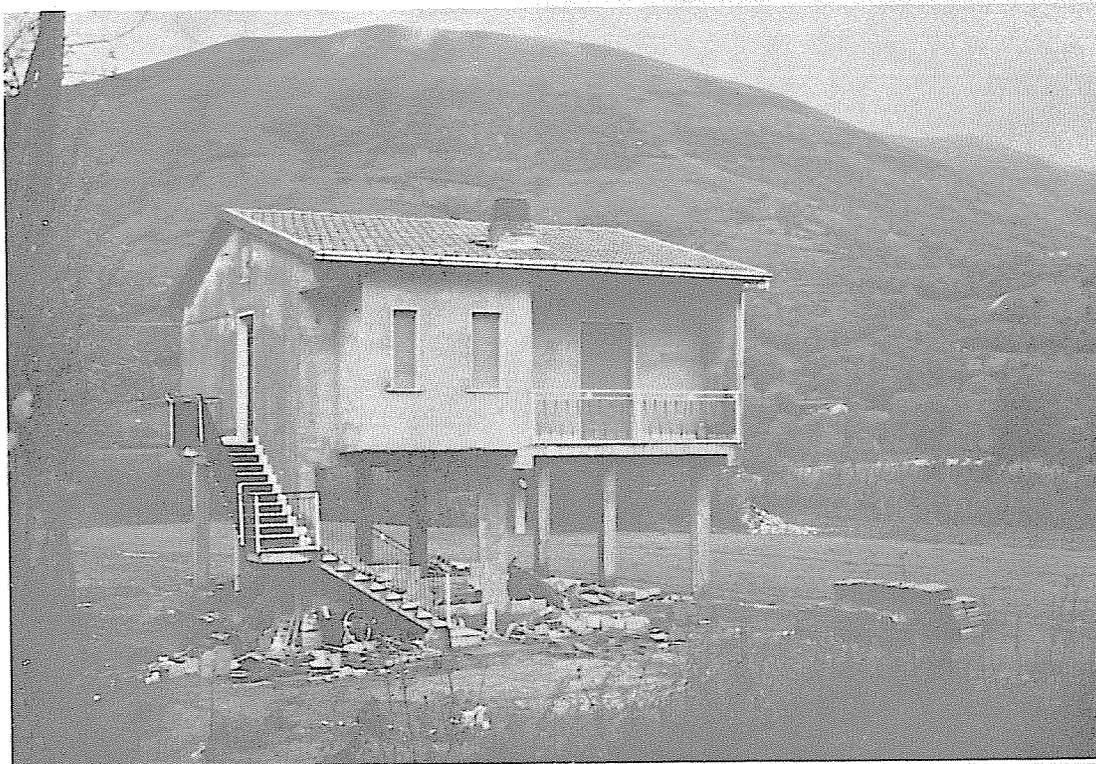
One-family dwelling in valley floor near Muro Lucano:
Undamaged inspite of "soft" ground floor.

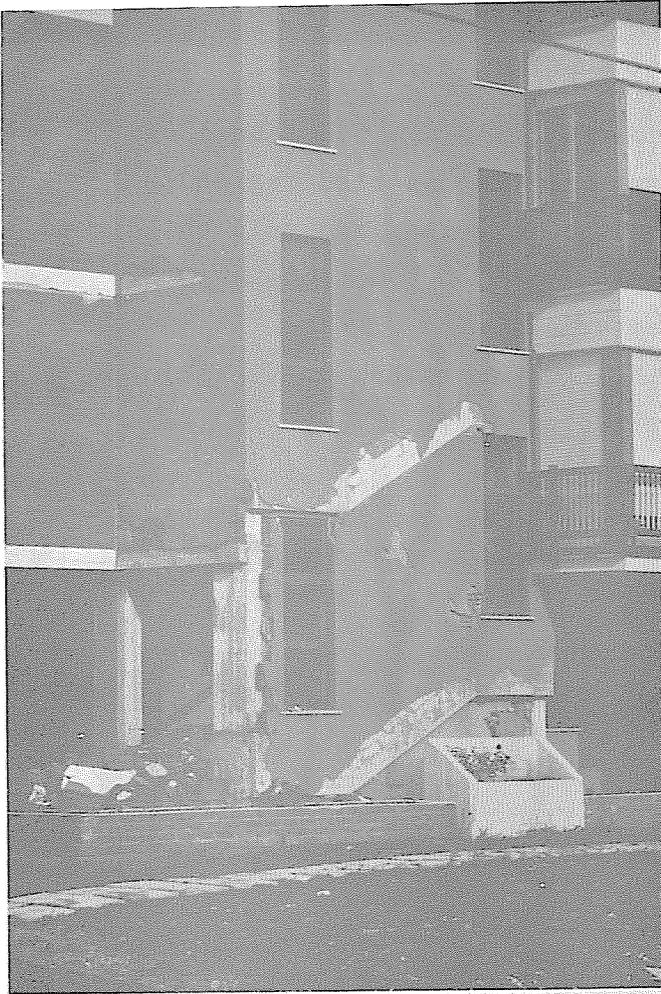
Nonstructural damage to ground and first floors of apartment house at Monteforte Irpino (near Avellino). Construction was just finished.

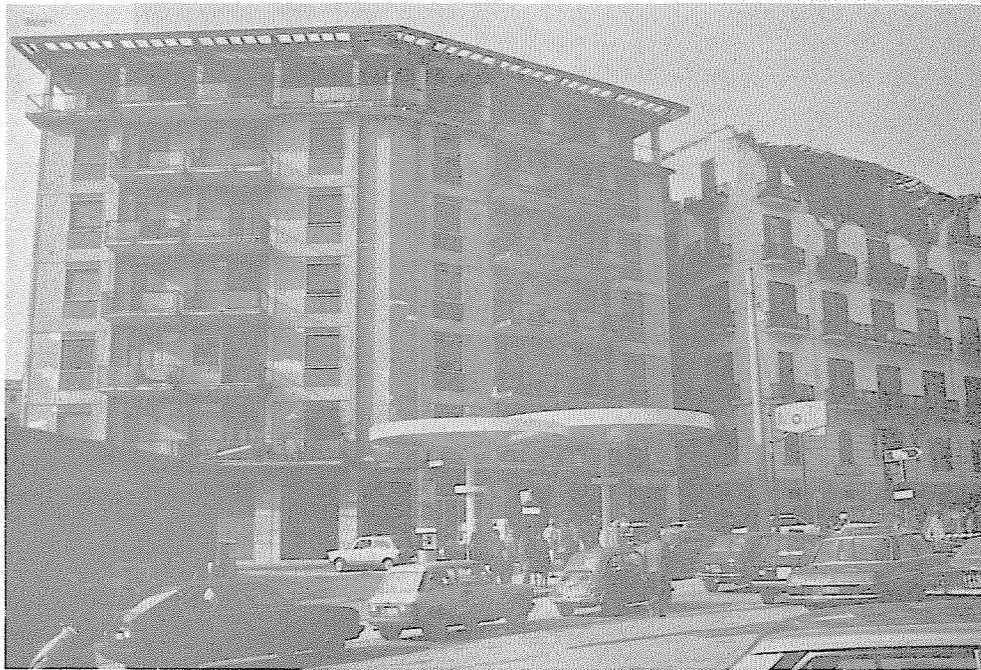
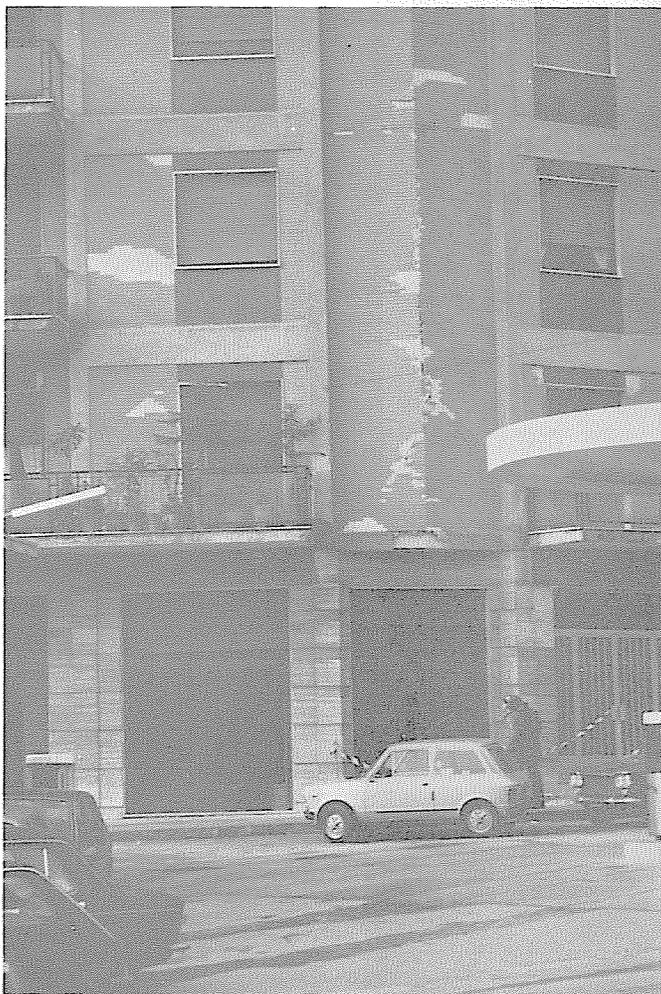
Roof collapse and severe damage to brick building in Avellino (right). Minor damage to reinforced concrete structure (left).

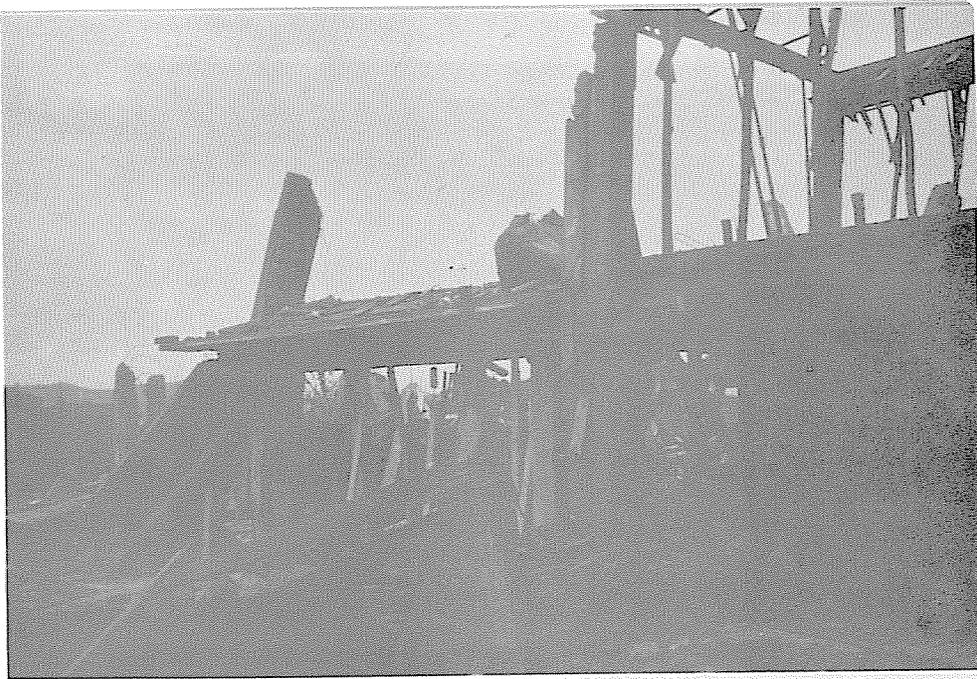
Severe damage to building under construction (Lioni).

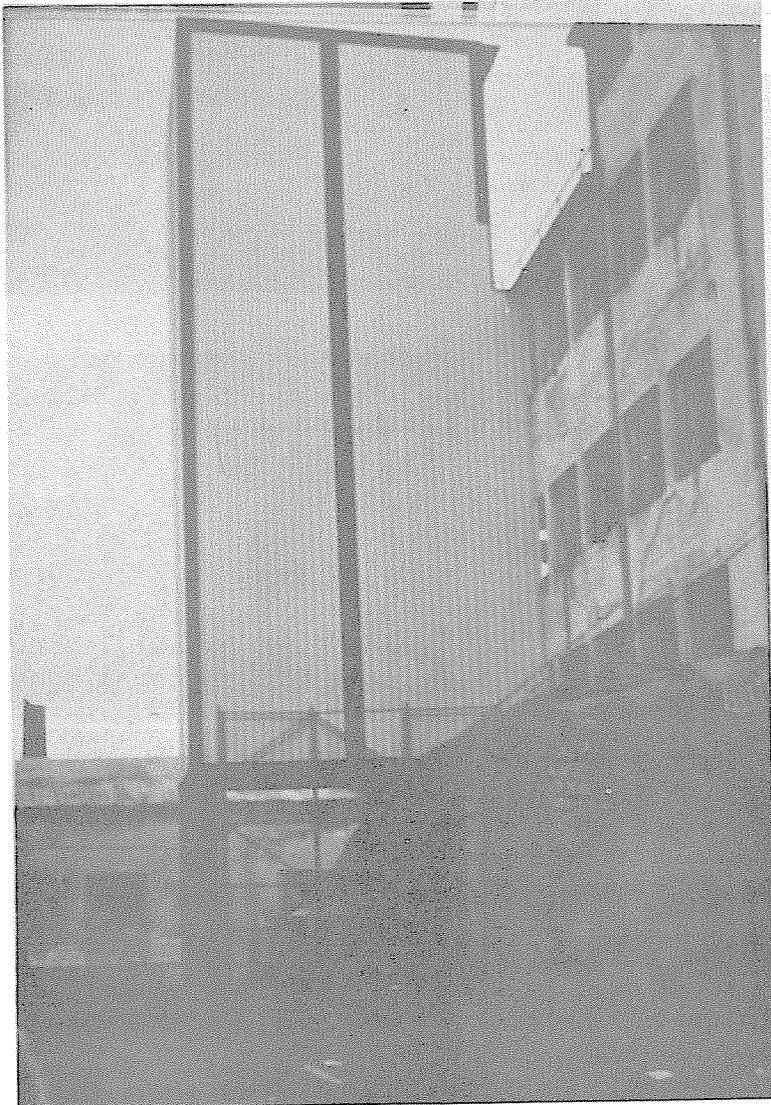
Steel tower in paper mill at Lioni: undamaged.

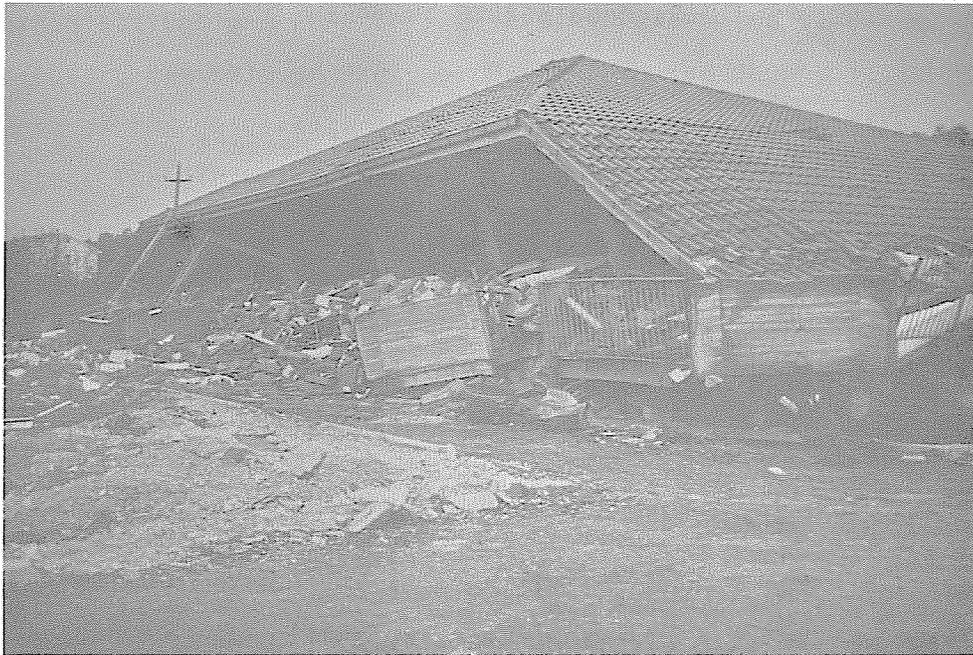
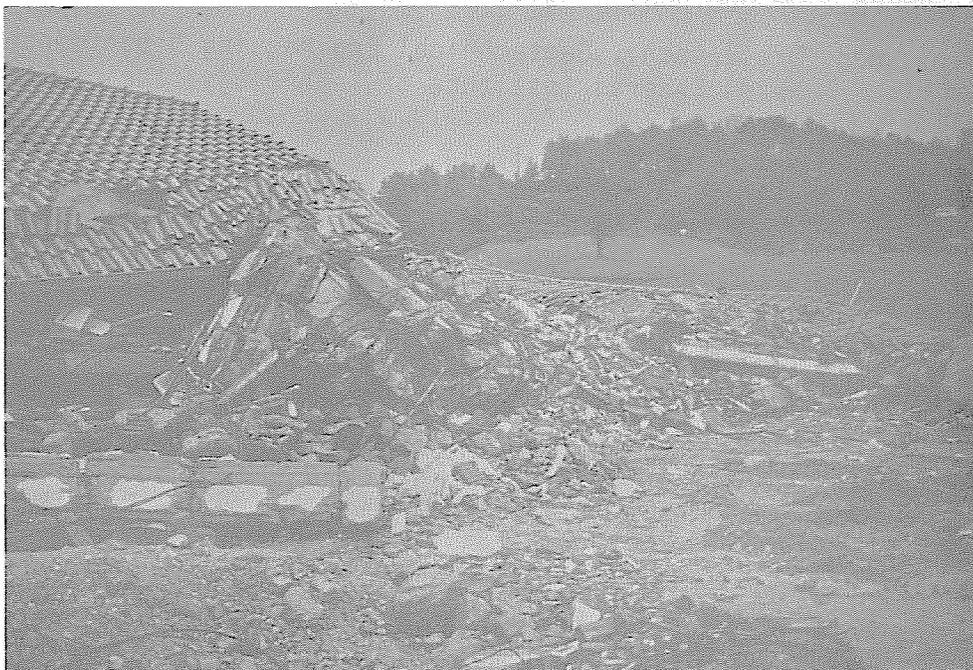
Collapse of 4-storey apartment building near Lioni.
