Fast Report on The Nagano-ken Seibu Earthquake of September 14, 1984 in Central Japan

- Prepared for the EERI Newsletter Earthquake Insert by Yasushi Sasaki, Head, Ground Vibration Division, Earthquake Disaster Prevention Dept. PWRI, MOC.

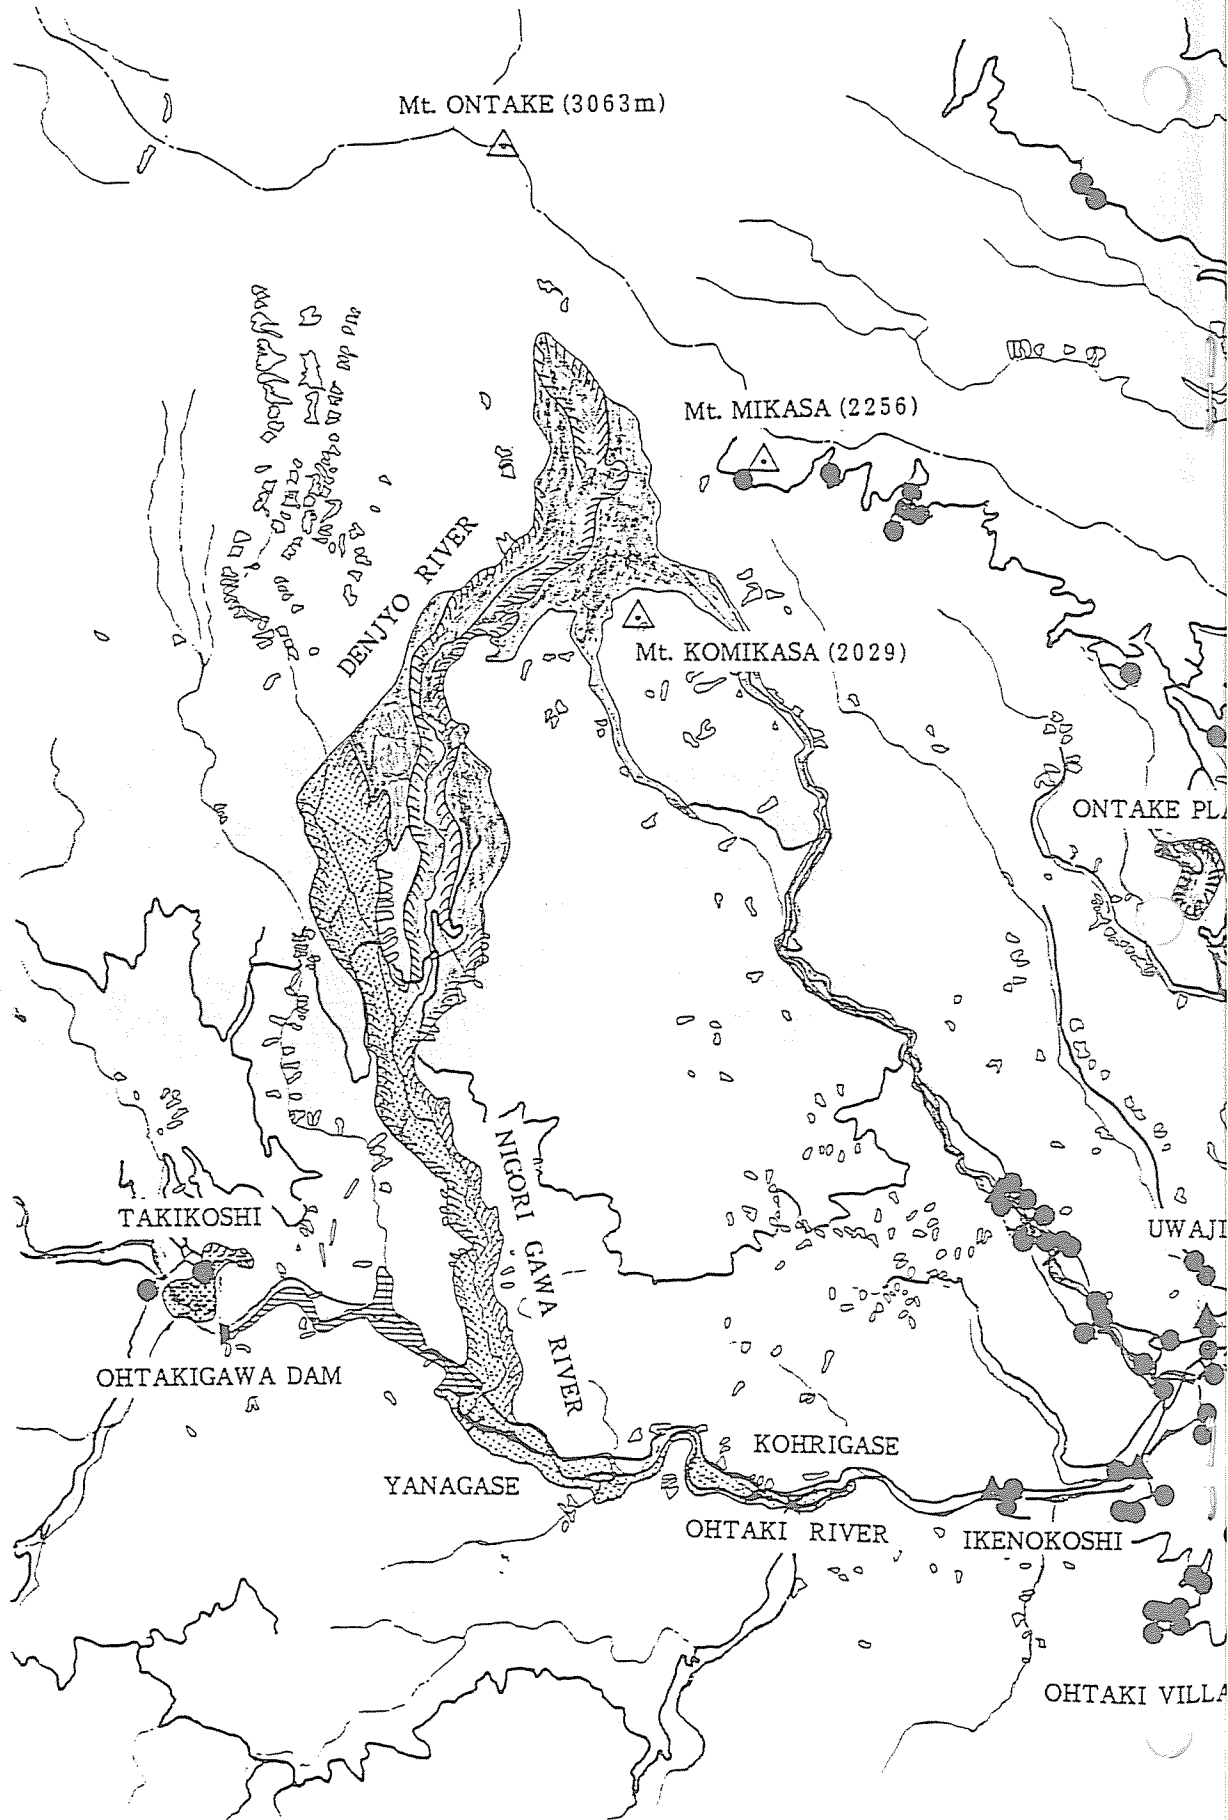
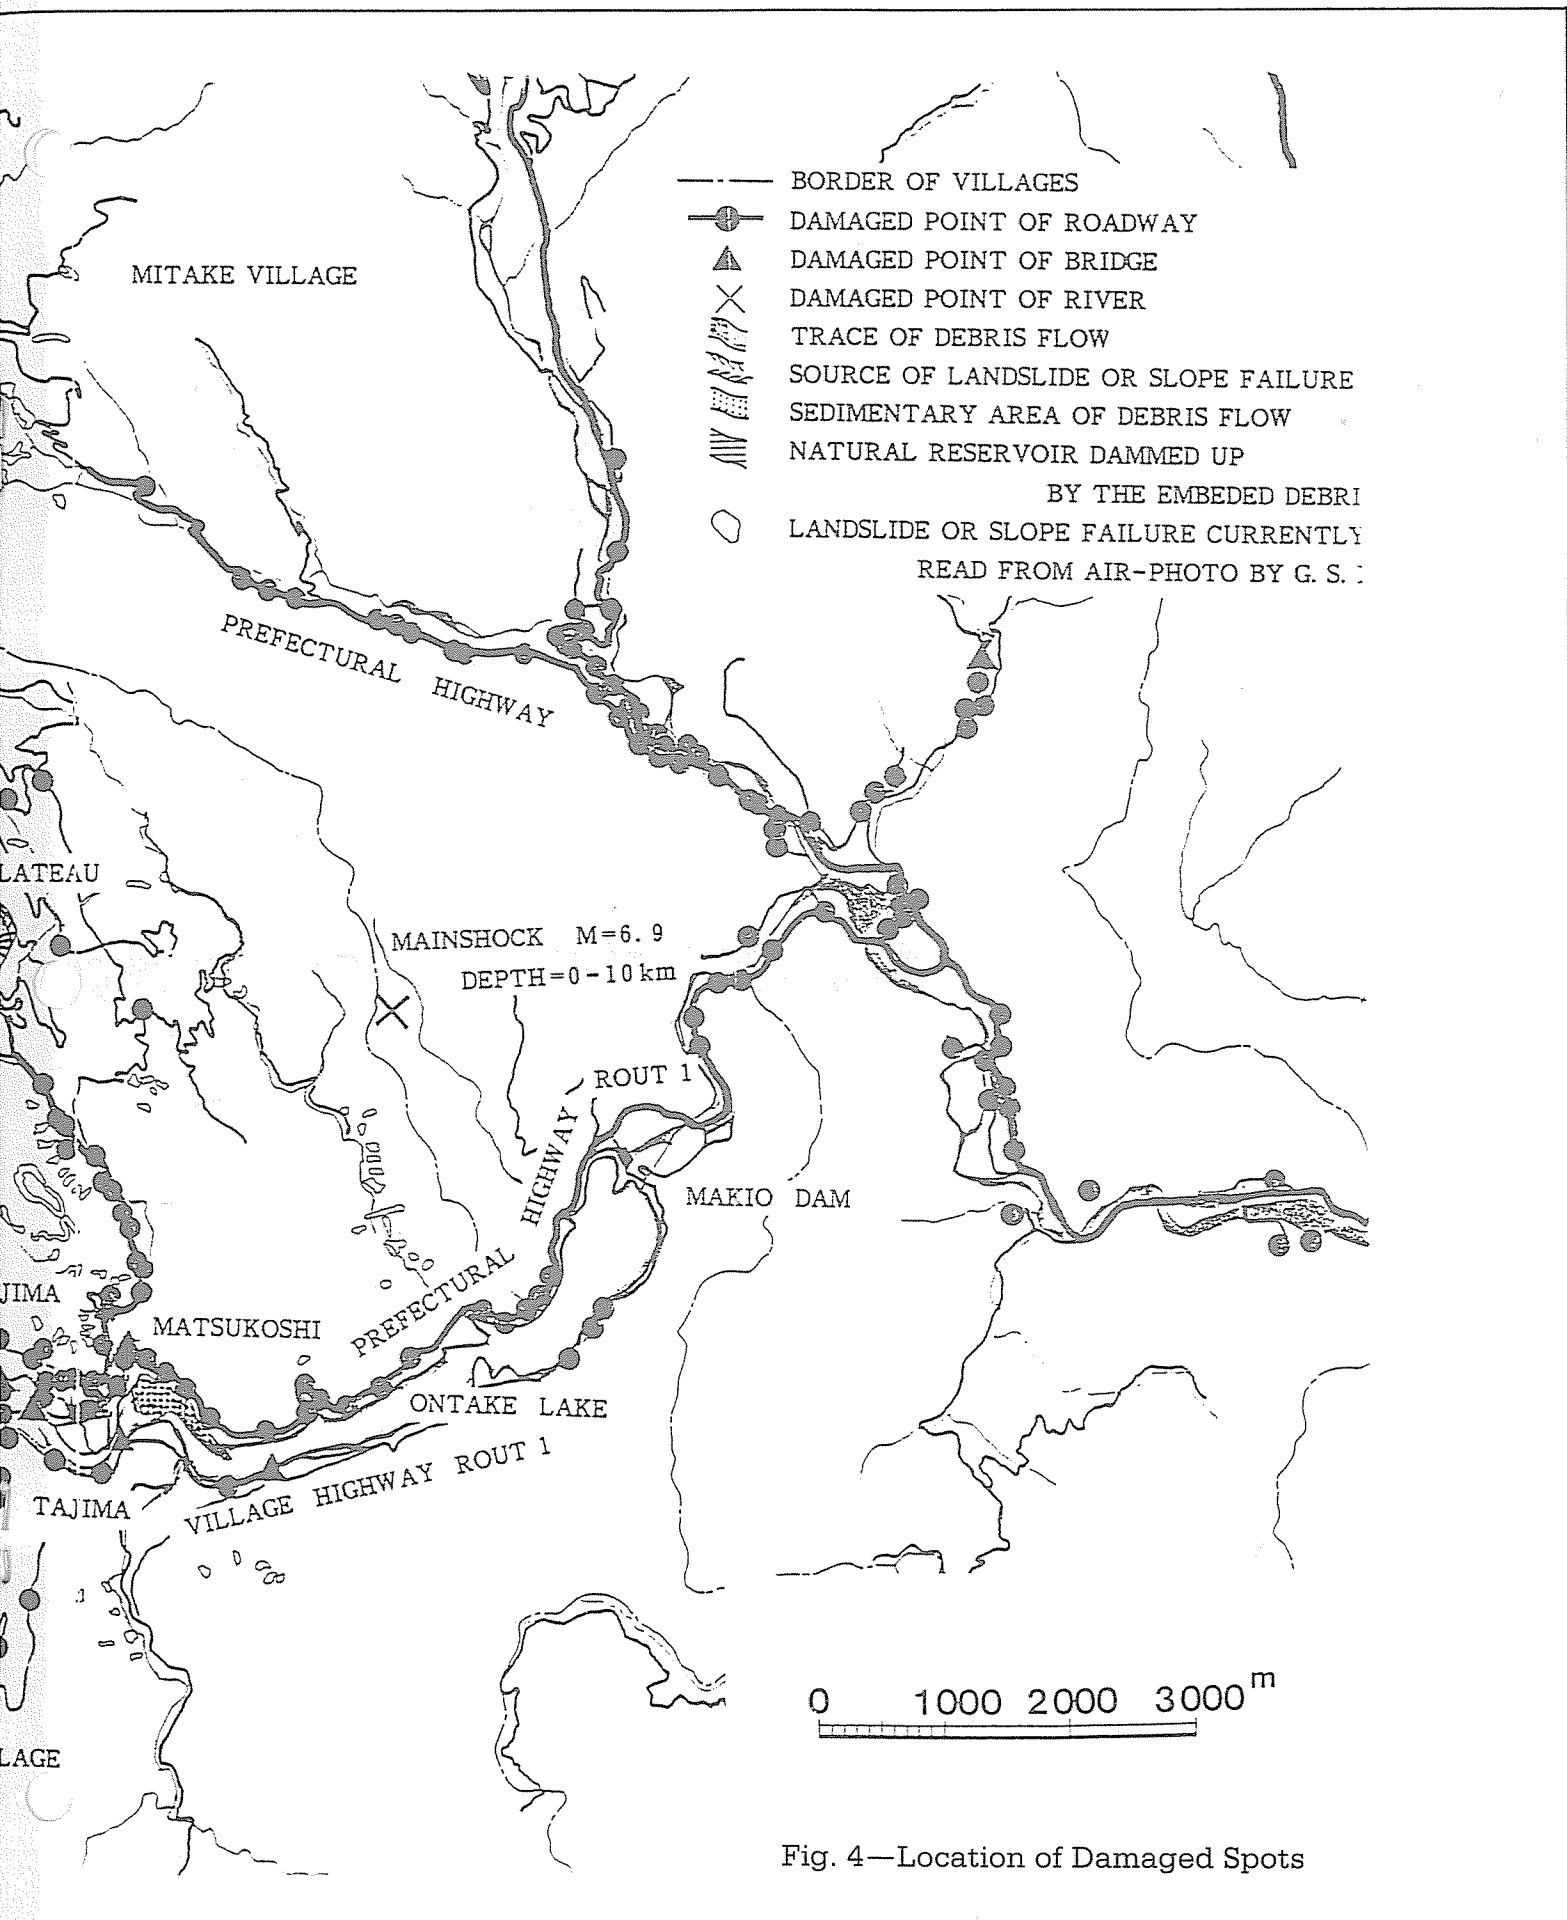
Fig. 4—Location of Damaged Spots

The damaged spots are concentrated near the epicentral area as shown in Fig. 4, and the general aspects of the damage are as follows. Although the earthquake occurred in a rural area, the loss of human lives and properties were fairly extensive because of the large landslides and debris flow.

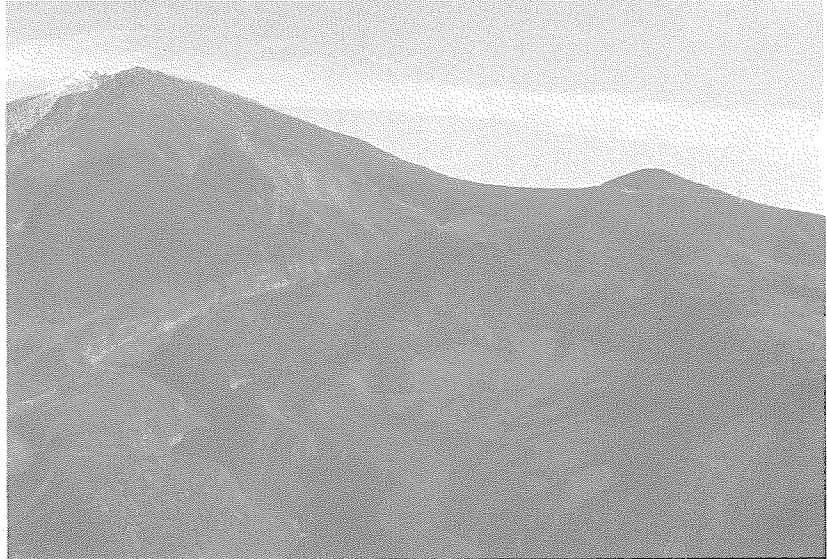
Photo - 1

A large landslide at Mt. Ontake slope
 (Failed volume is about 36 million m³)

The failure at Denjoh River was the largest caused by this earthquake and is thought to be one of the largest earthquake-induced landslide ever experienced in Japan. The volume of the failure at the source area, which was a small ridge about 600 m below along the slope from the top of the Mt. Ontake, is currently estimated 36 million cubic meters, and the source material is composed of volcanic exploded materials.

Most of this failed masses caused a very rapid debris flow along the Denjoh river and the Nigorikawa river reaching to the Ohtake river which flows 8 km down from the source area. The length of the imbedded debris material at Ohtaki river is about 3.5 km and dammed up the stream of the river and creates a natural reservoir.

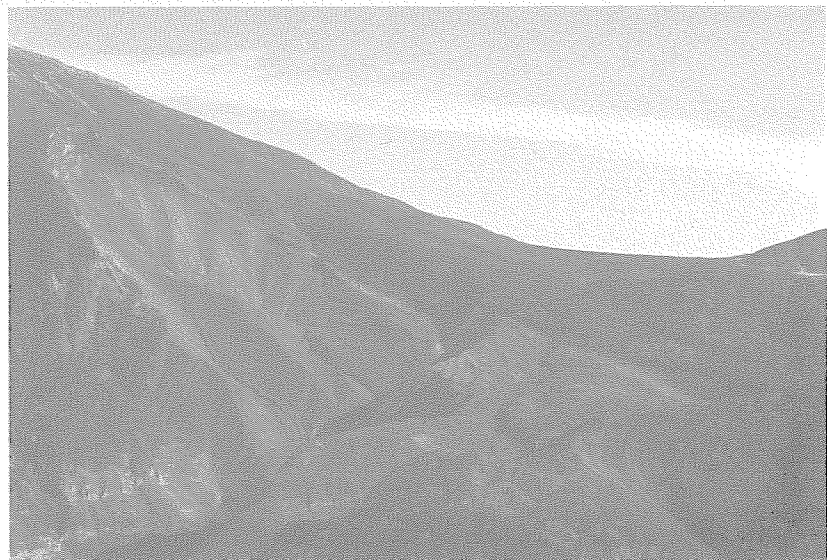
Photo - 2

Source area of Mt. Ontake slope landslide

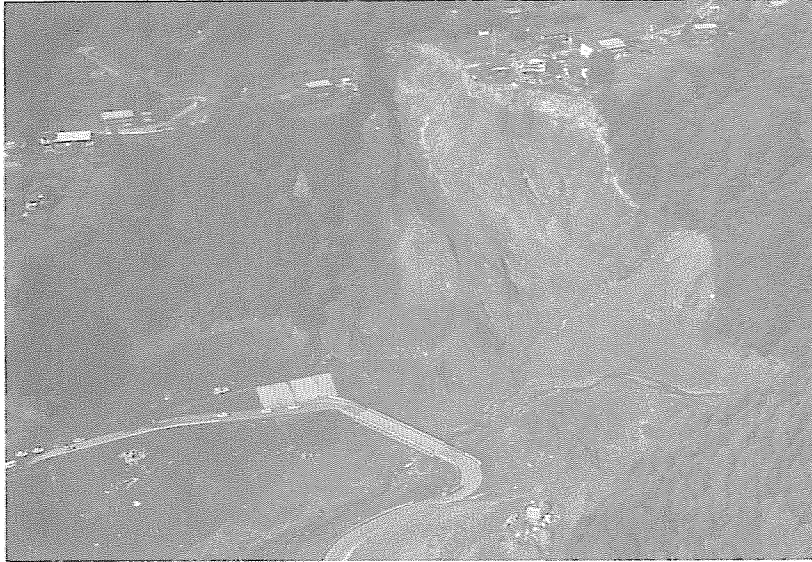
Photo - 3

A large landslide at Matsukoshi

(The bridge seen below is a transportable
 built-up bridge erected after the damage)

The road in the epicentral area were damaged at many spots. The severest damage to the road was the loss of the Shin-Ohmatagawa Bridge due to the landslide at Matsukoshi. Large rock falls, collapse of retaining walls or fissures on the shoulder of the embankment are principal damages to the road.

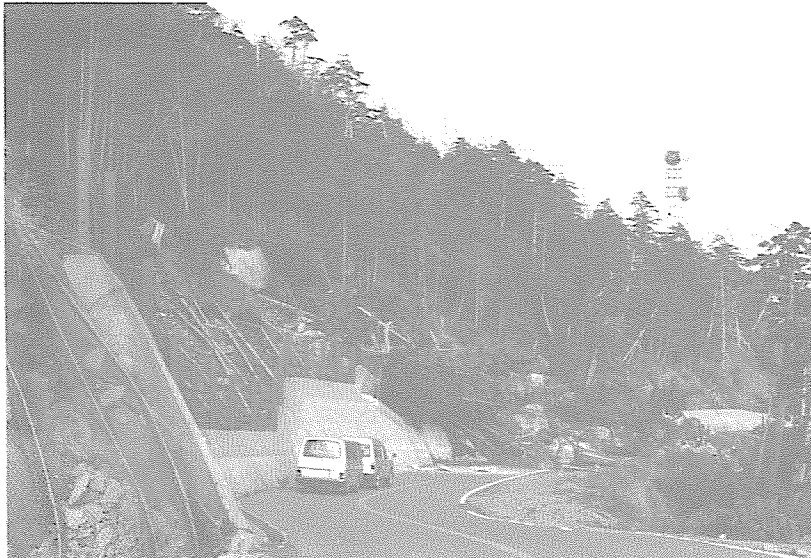
Photo - 4

Slope failure along roadside slope and
 collapse of rock-fence

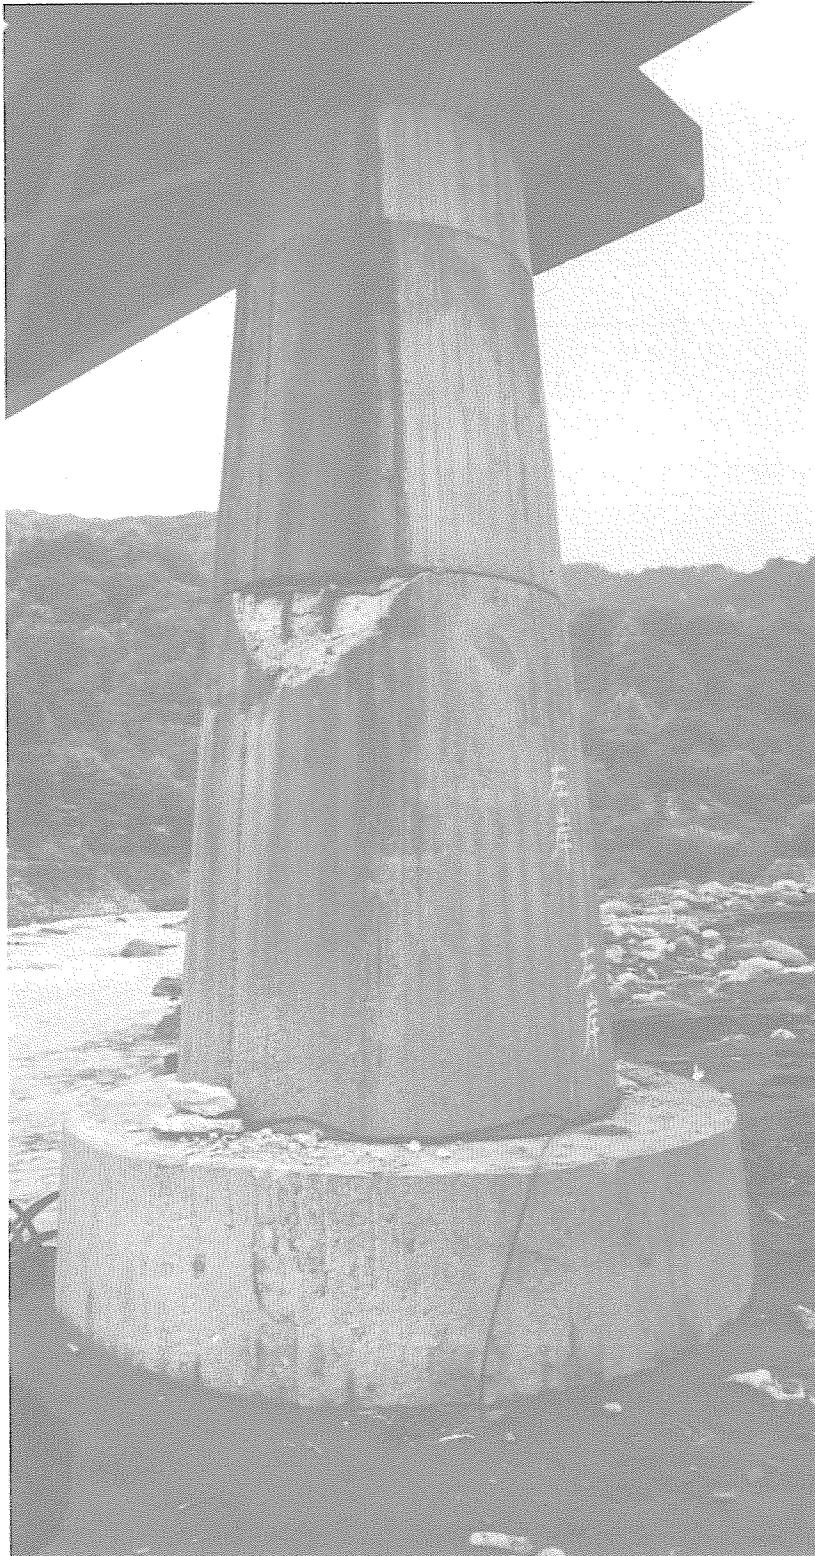
Photo - 5

Damage to the pier of the Matsubara Bridge

Photo 5 shows a crack of a pier-column of Matsubara Bridge.
