March 08, 2010 BASYURT-KARAKOCAN (ELAZIG) EARTHQUAKE Kandilli Observatory and Earthquake Research Institute-Bogazici University-Istanbul, Turkey

1. Introduction

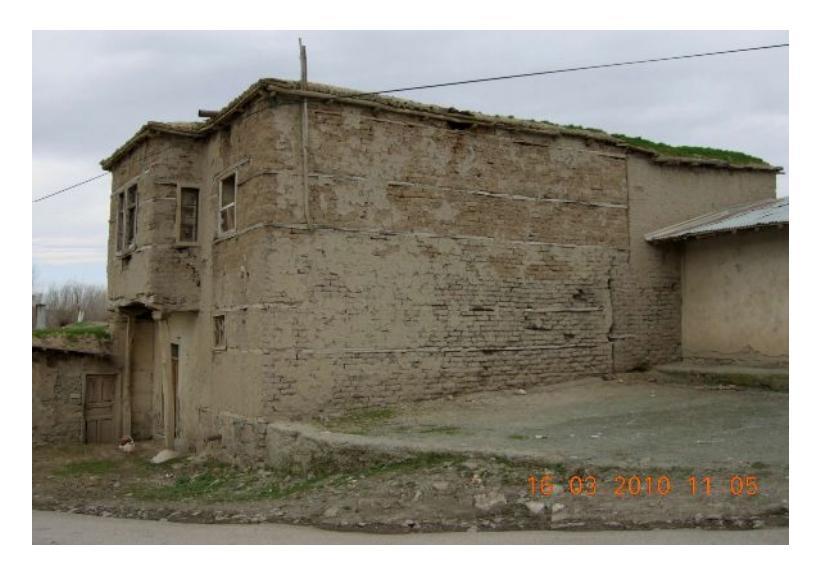
Figure 6 : Outside view of two storey soil brick house in Kökan-Bayramyazı (Almost no damage)

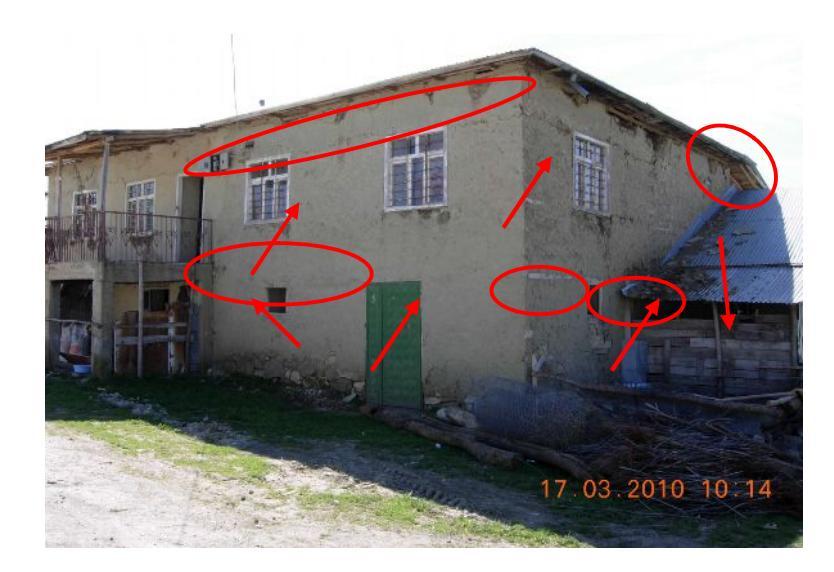
Figure 7. Two storey soil brick house in Incedal village-front view (Light Damage)

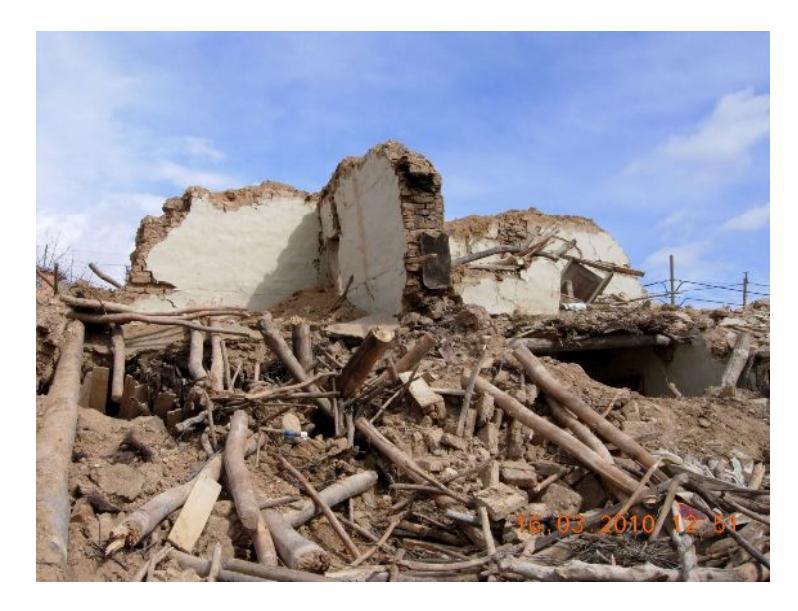
Figure 8. Two storey adobe house, front view, Okcular (Total damage)

The most common damage type is partial collapse of load bearing walls due to "out of plane" behavior. Even if load bearing walls could stand after earthquake without total or partial collapse, wide cracks prevents usability of the buildings.

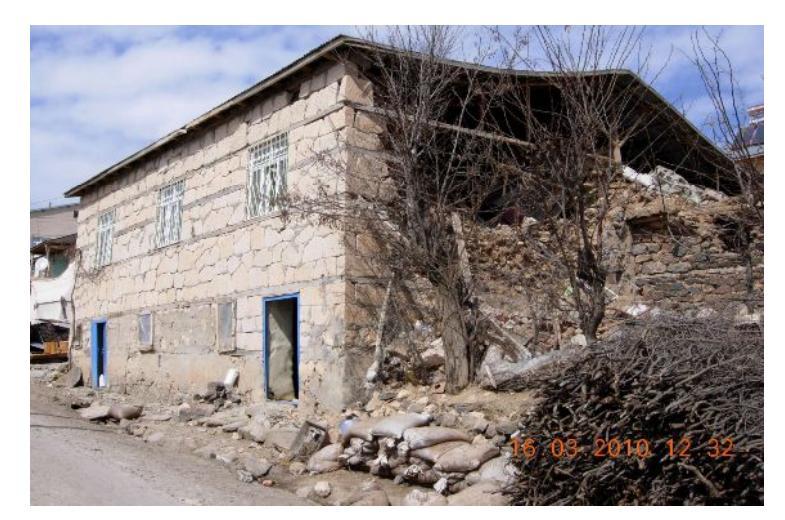
Figure 10. Two storey light stone house, with a stall as ground floor, Okcular (Partial Collapse)

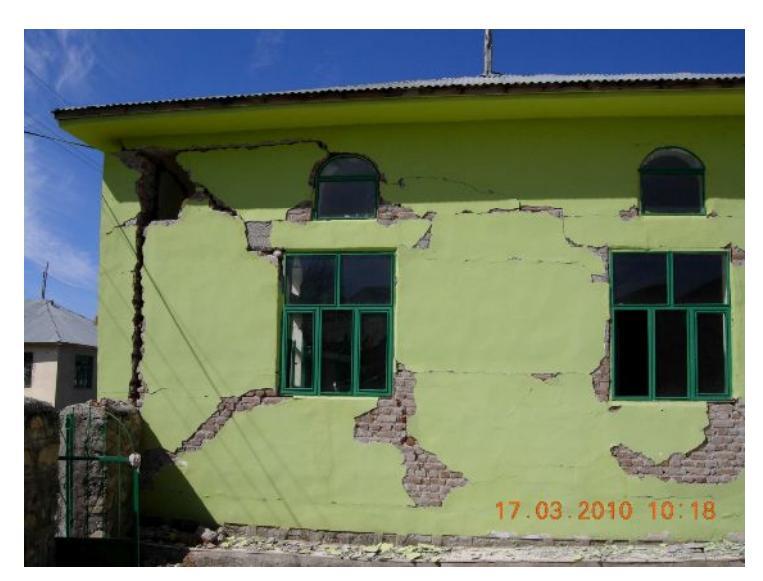
Figure 1: Damage to Brick URM Building, Incedal village

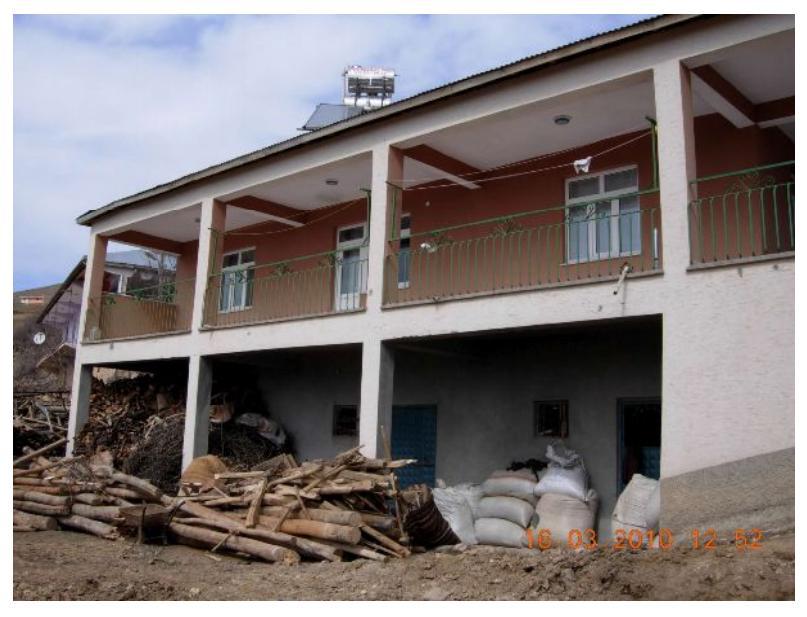
Figure 14: RC house, without any damage in beam-column joints, Okcular village
