# THE OCTOBER 23, 2011 VAN, TURKEY EARTHQUAKE (MW=7.2)

## EARTHQUAKE DAMAGE

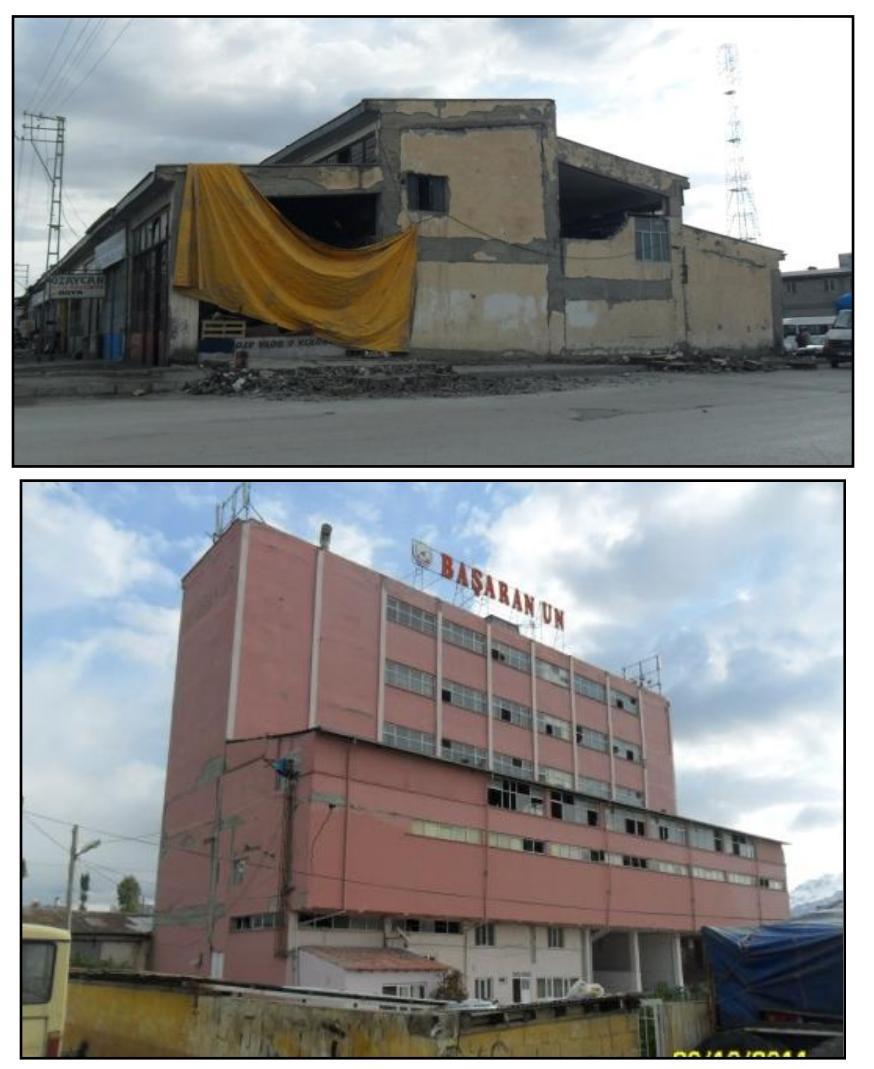
Most of the building damage in zone 1 was limited to damage of the partition walls (Figure 6). No significant damage was observed in the new section (zone 2). Most of the damage concentrated in the main industrial zone (3) where most of the critical facilities and storage units are located. The main cause of damage was ground shaking. No damage was observed due to geotechnical effects such as liquefaction or soil failure. Most of the small size facilities were not insured.

Figure 6. Damaged walls of a mechanic shops in zone 1 (top). Similar damage to a facility in zone 3 (bottom).

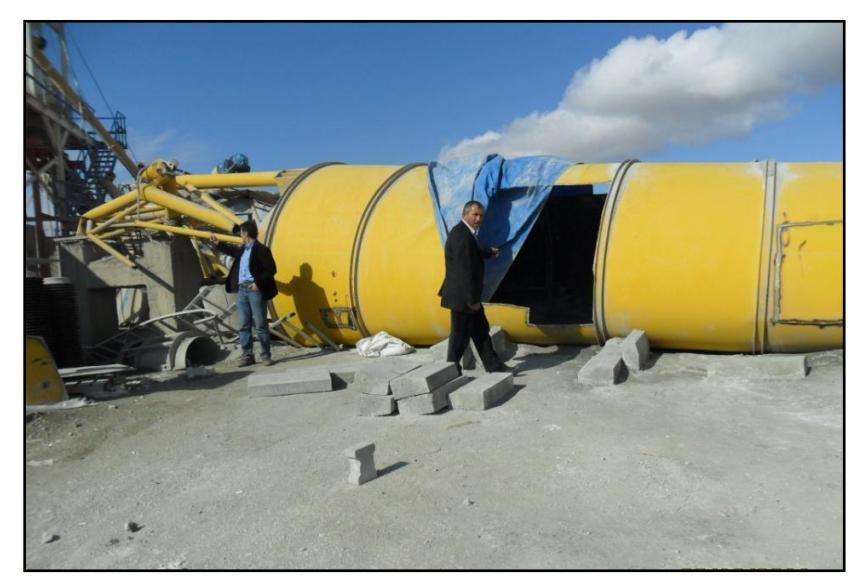
The heavy and slender, elevated steel cement silos collapsed due to improper detailing/dimensioning or suffered from inadequate seating width of the supporting concrete (Figures 7-9.)

Figure 7. Collapsed cement silo in the Van Industrial Zone

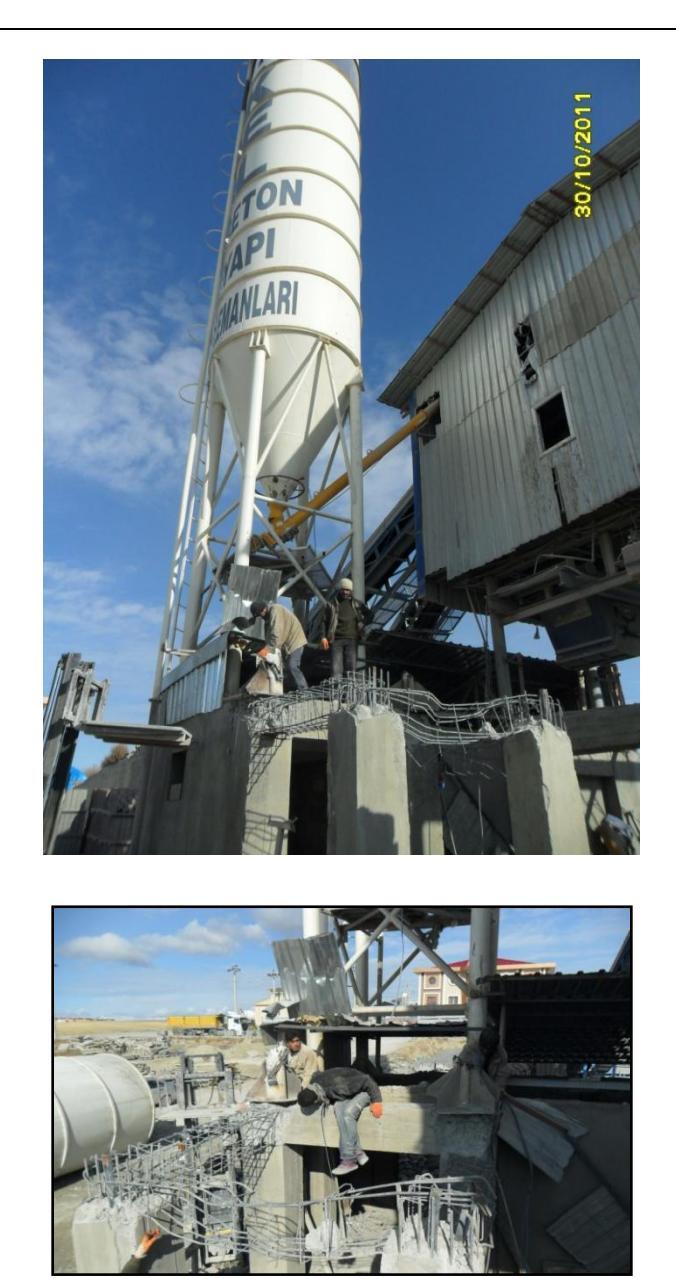
Figure 8. Damaged cement silo in Van Industrial Zone due to concrete crashing

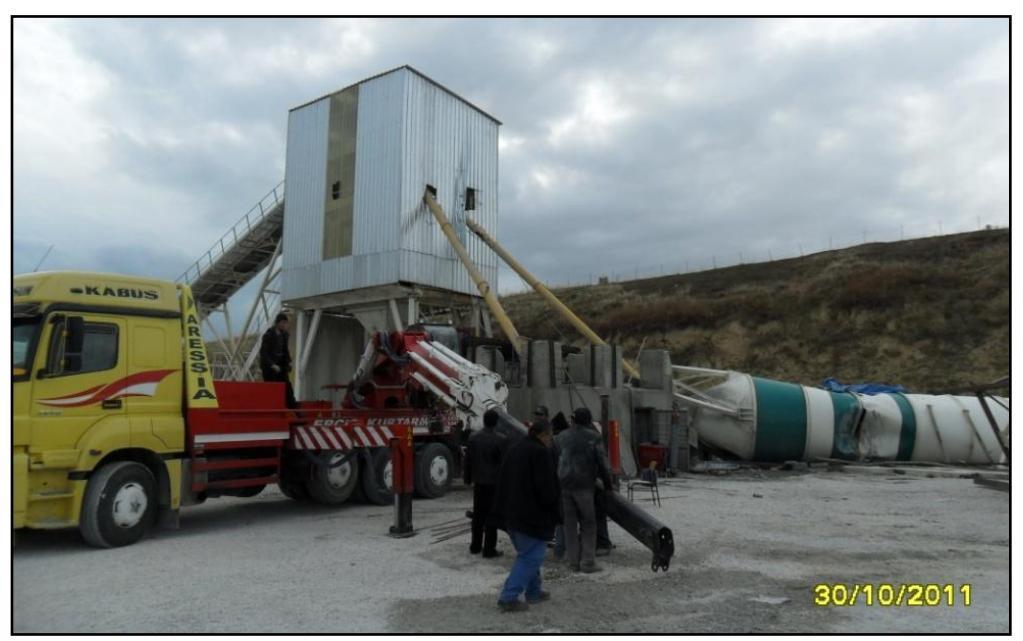
Figure 9. Collapsed silo on the Ercis-Patnos highway due to failure of the supporting concrete

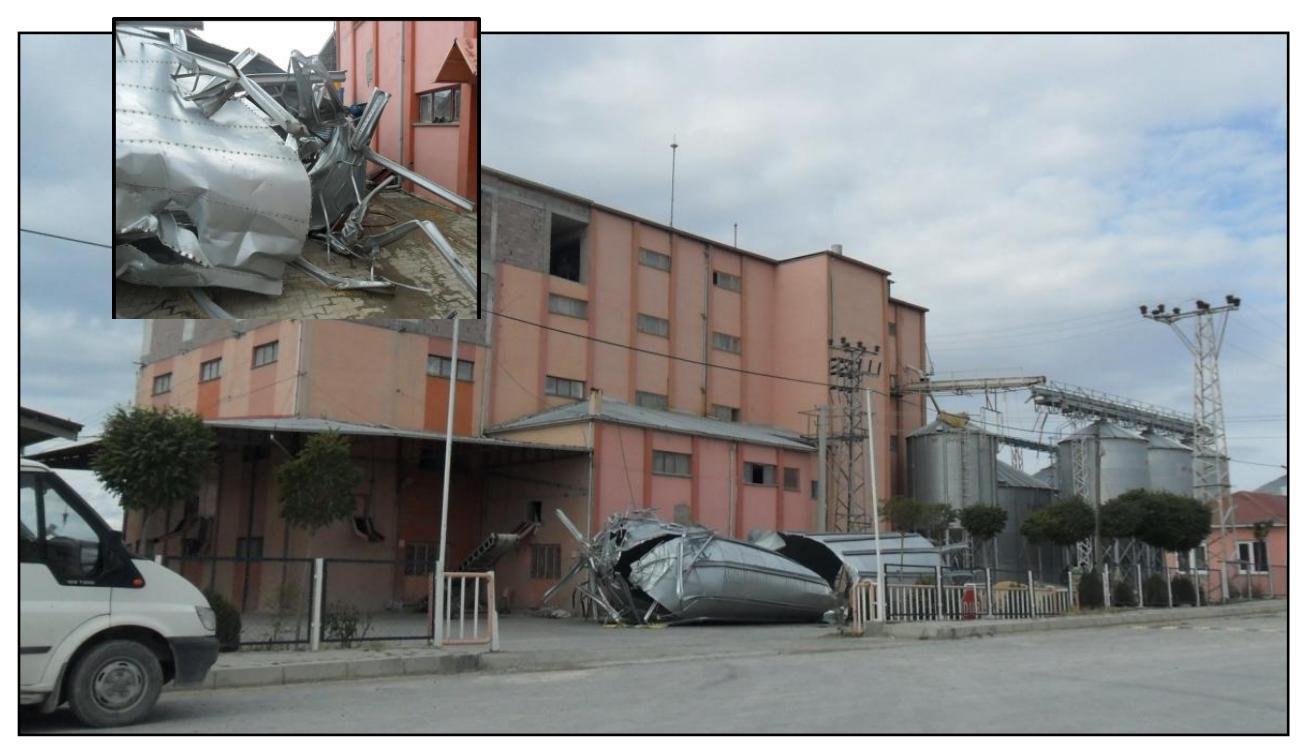
A number of wheat silos in Van Industrail Zone, collapsed due to inadequate dimensioning (Figures 10 and 11).

Figure 10. Collapse of the elevated wheat silos (Facility 1) due to inadequate dimensioning, Van

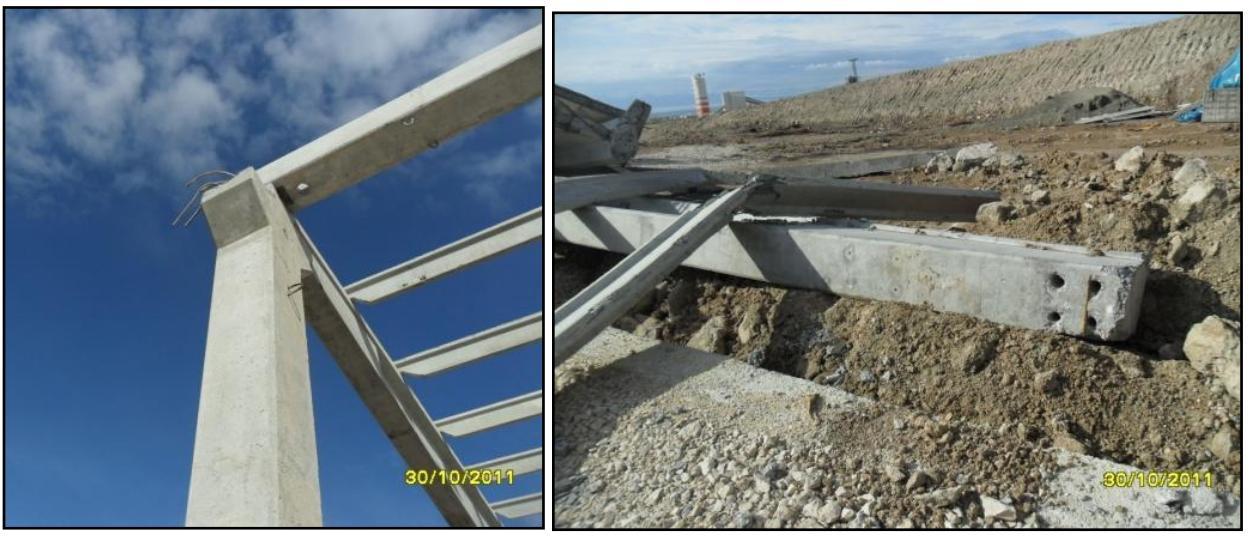
The heavy precast-concrete frames with precast roof beams suffered from connection problems. Noticable movements were observed at the beam- column connections (Figure 14) of the structures located around the Van-Ercis highway. More severe cases were observed at the Industrial zone of Van. The beams slipped-off from their seats because of inadequate steel-concrete bondage (Figures 15-17). Precast-concrete beams collapsed because of inadequate anchorage at the column –beam connections (Figure 17), at the top. Also column bending cracks occured at the bottom of columns (Figure 18).

Figure 16. Failure of precast beams due to weak connection and lack of steel bondage

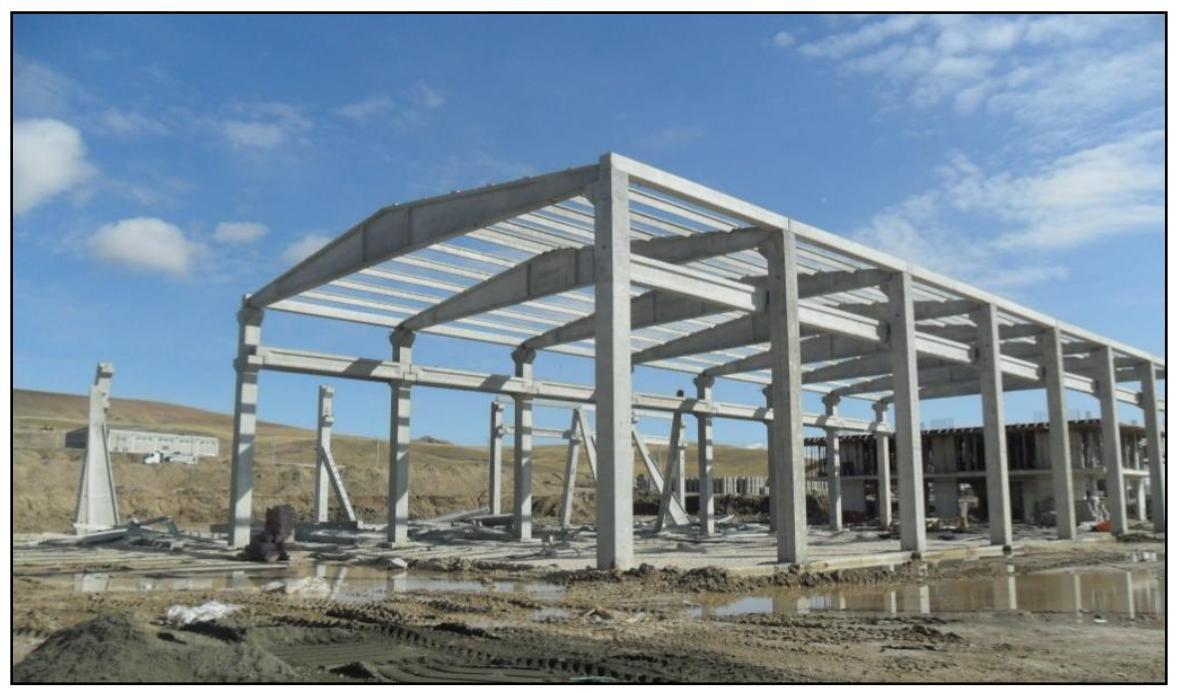
Figure 17. Collapsed prefabricated structure in new construction in Van

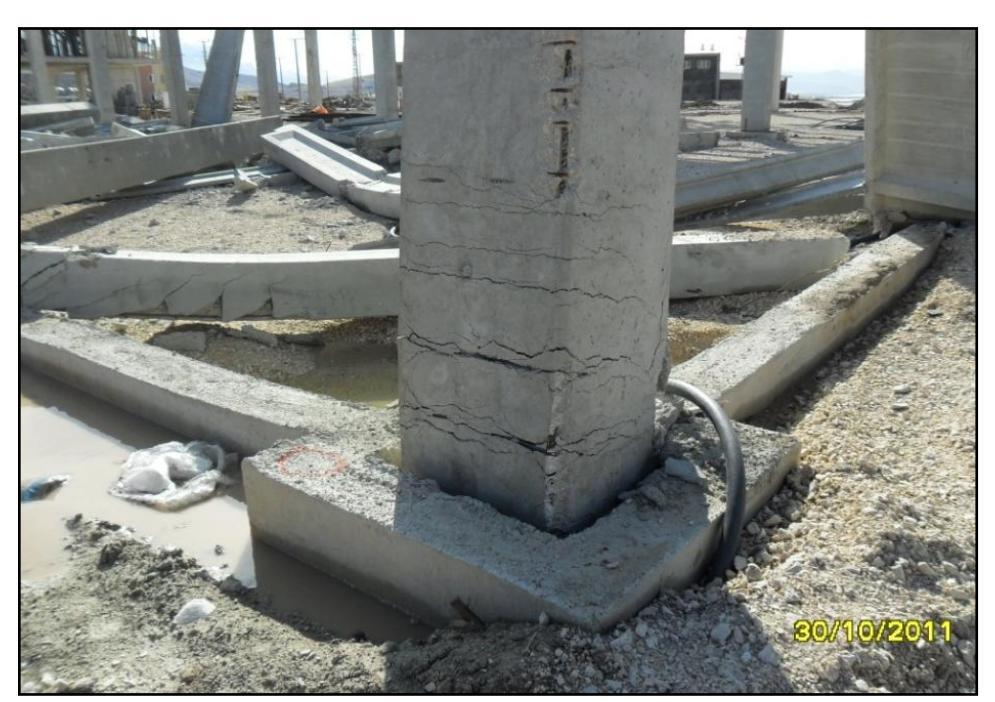
Figure 18. Cantilever column bending cracks at the base

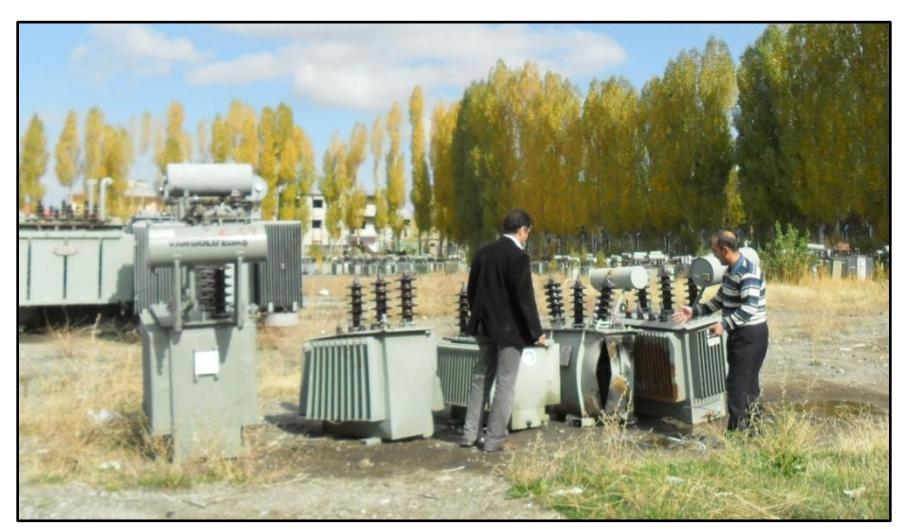
Figure 19. Burned/damaged 400 kW and 600 kW transformers due to fall from elevated locations

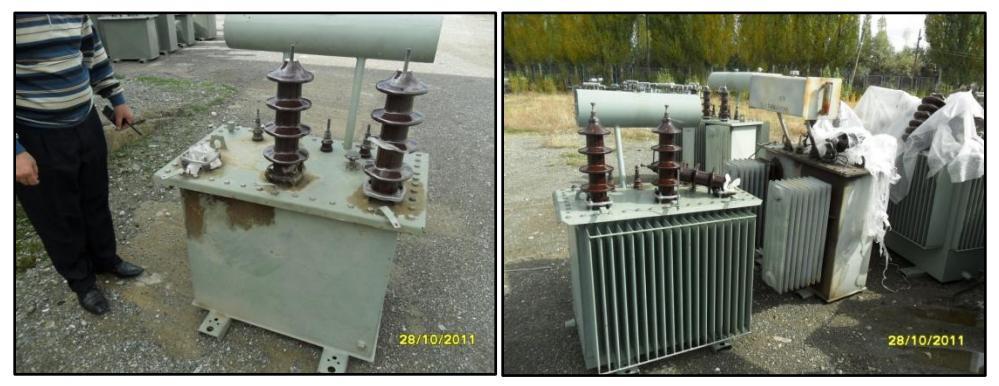
Figure 20. Damage to brittle bushings due to fall of building elements onto the interconnecting cables

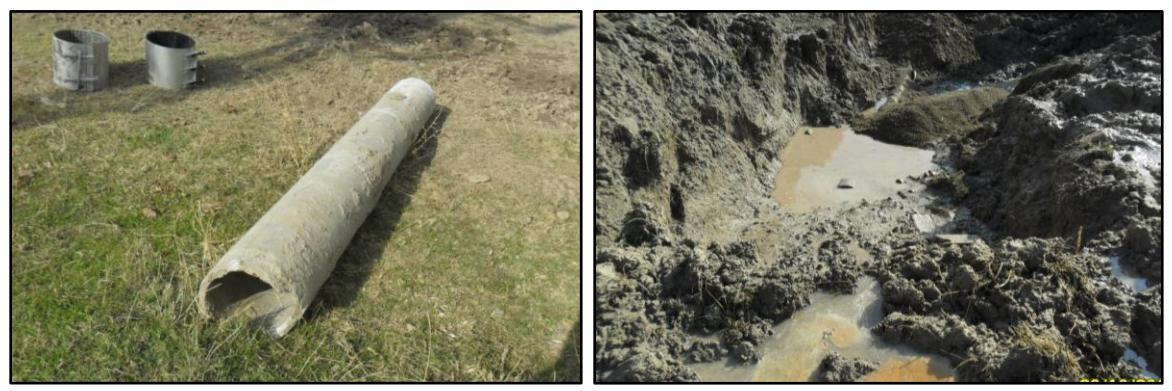
No damage to water supply and sewege systems was reported in Van. The water supply was uninterrupted. However, pipe breaks occured outside the city. The water transmission line of 100. Yıl University had pipe breaks at many locations due to soil liquefaction and settlement/land slide (Figure 21). There was a number of pipe breaks in the transmission line from the source to the city. Many pipes had to be repaired in order to provide water to the surrounding villages and to temporary accommodations.

Figure 21. Pipe breaks and repaired sections in Topakca village due to liquefaction induced lateral spreading

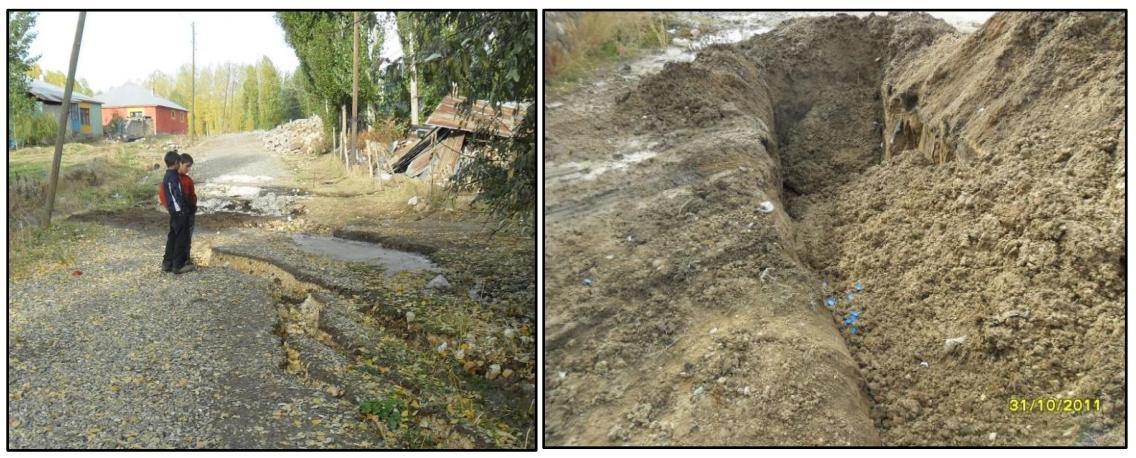
localized damages in Celebibağ region (Figure 22). However after minor repairs and reconfigurations all services were fully functional.

Figure 22. Pipe crash and pullouts and repaired pipes in Celebibag, Ercis

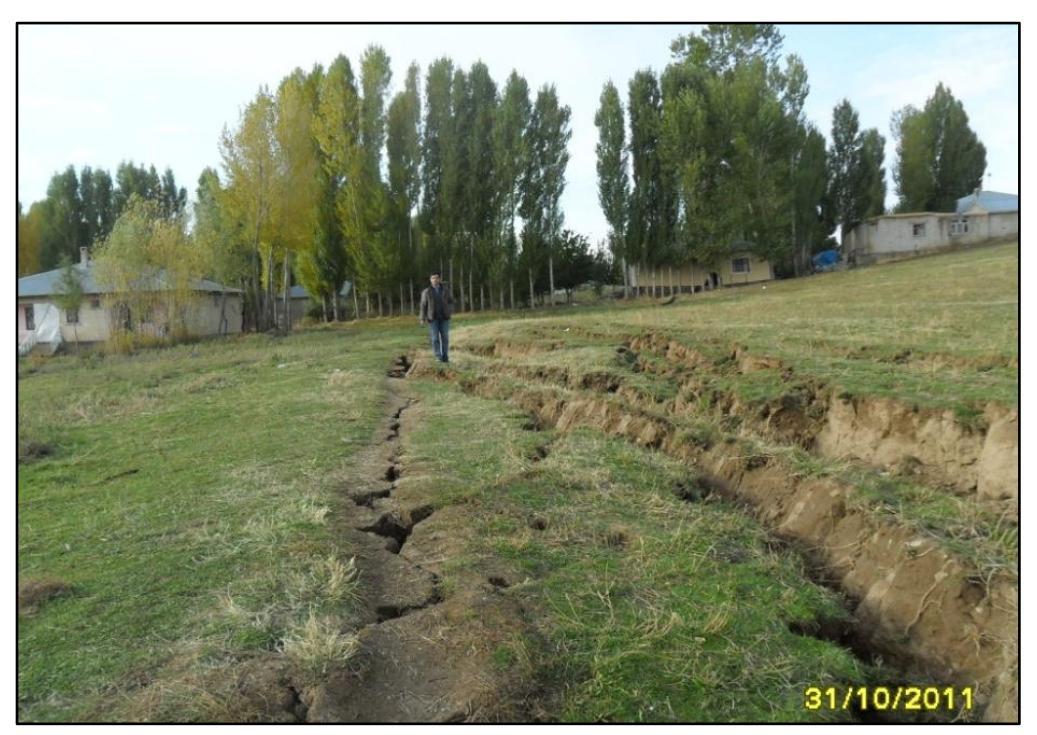
In Çelebibağ (Western Ercis near the Erciş-Patnos highway), land slide induced lateral spreading and settlement was observed in weak soils. Permemant ground deformations reached 50 cm in the horizontal and vertical directions. Water transmission/distribution in the vicinity of tension zones were damaged. The damage was repaired immediately after the earthquake (Figure 23).

Figure 23. Soil cracks due to land slide in Celebibag, Ercis

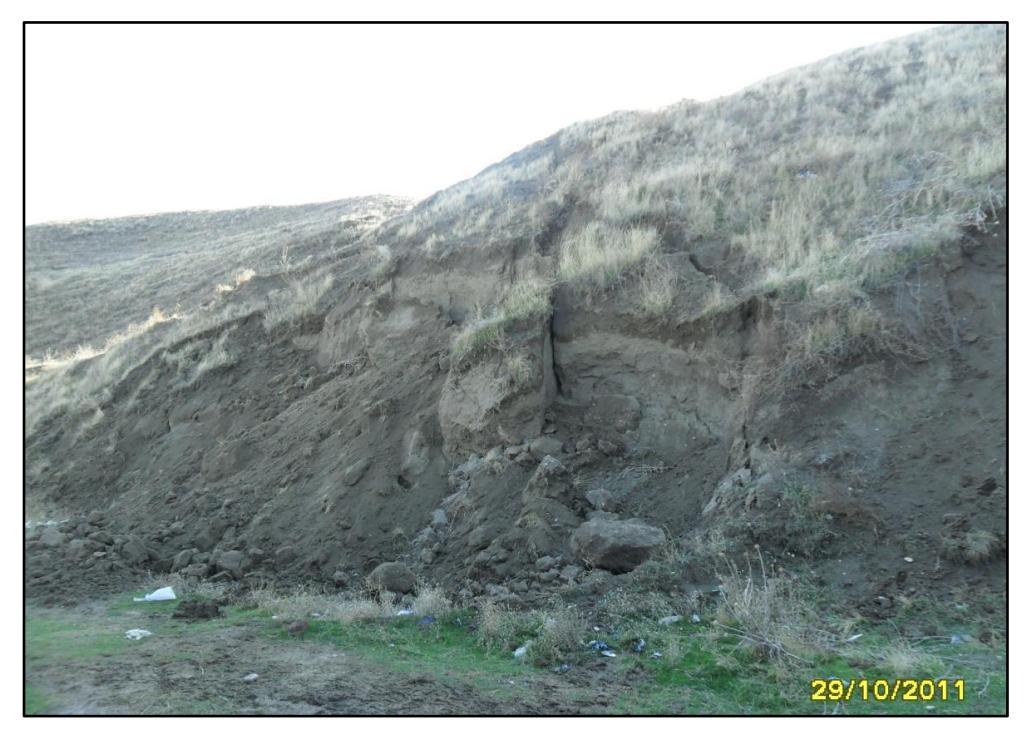
In Van, extensive liquefaction induced lateral spreading, settlement and rock falls took place near the village Topakca, next to the river in Northern Van, 6 km's to the nortwest of the 100. Yıl University (Figures 24- 28).

Figure 28. Rockfall in Topaktas (Mermit) village behind the damaged house
