The September 29, 1993, M6.4 Killari, Maharashtra, Earthquake in Central India

Sudhir K. Jain (EERI 1987), C.V.R. Murty, Navin Chandak (all three of the Indian Institute of Technology in Kanpur; sponsored by EERI), Leonardo Seeber (of the Lamont-Doherty Geological Observatory; sponsored by NCEER), and N.K. Jain (of the Joint Assistance Center in Delhi) joined in a team to investigate the effects of the Killari earthquake. This report is the result of their cooperative effort. The publication and distribution of this report is supported by National Science Foundation grant #BCS-9215158 as part of the EERI Learning From Earthquakes project.

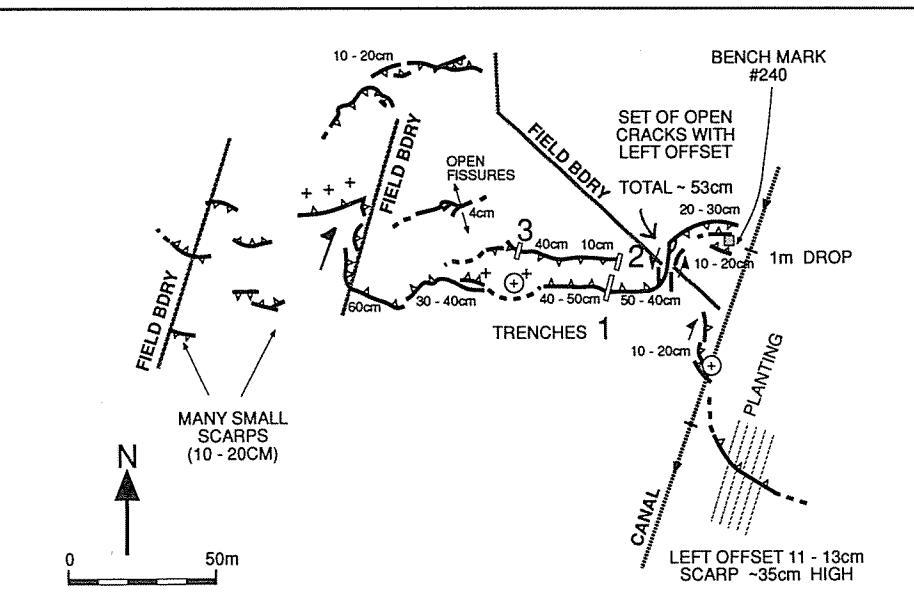
Figure 2 - Portion of the surface rupture associated with the 1993 Killari earthquake. This rupture was mapped discontinously in an east-west zone over a distance of about 1 km. Barbs indicate the uplifted side of the scarps; the approximate height of the scarps is also indicated. Plus signs indicate uplifted area, circled when localized. Note that a "transform" fault connects a southfacing scarp in the center of the map with a north-facing scarp on the right. This "transform" offsets a field boundary by 53 cm left laterally, which is a minimum measure of the shortening. The strike of this and other "transforms" in this map is north-northeast, the inferred direction of shortening.

The 1993 Killari earthquake ruptured the surface. Three weeks after the main shock, at the time of our field investigation, discontinuous scarps were discernible along a west-northwest zone about 1 km long and starting 1.5 km west of the village of Killari. Where best expressed, the surface trace of the rupture is very complex; it is multibranched, double vergent, and discontinuous (Figure 2). Most scarps trend approximately east-west; a few northnortheast trending scarps show evidence of predominant horizontal components of motion. The sense of movement is in each case consistent with their interpretation as "transform" faults connecting different branches of the system.

Faults associated with two northverging scarps and a south-verging scarp were exposed in three 1-1/2 m deep hand-dug trenches. Two distinct modes of faulting could be identified in the weathered basalt exposed in the trenches. In regions where the fault could not develop along pre-existing fractures, shear was accomplished in a zone, typically 10-20 cm wide, where pre-existing and newly splintered fragments were rotated. These zones had lost cohesion (and probably density as well) and were easily identifiable on the trench walls. The evidence for motion was much more subtle where the fault followed preexisting fractures. In these cases the movement was often confined to a very small thickness, possibly a single fracture.

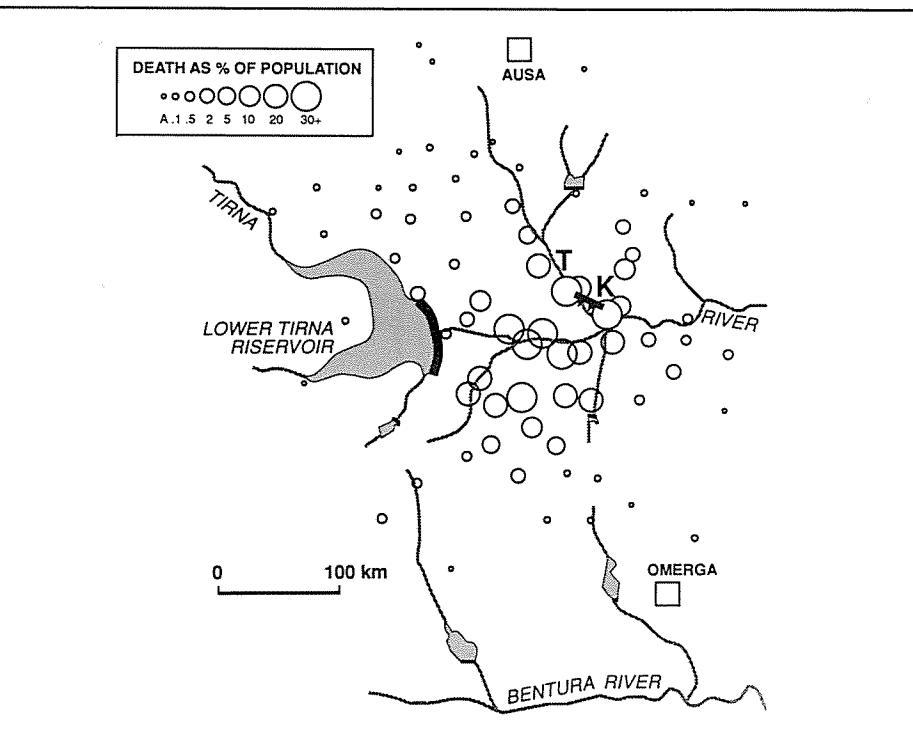
Figure 3 shows fatalities relative to the total population in each village. These gruesome statistics are quite effective in delineating the mesoseismal area. In an area about 10×10 km centered on the Tirna River, 20-30 percent of the people were killed. Outside this area relative casualties decrease rapidly. This mesoseismal area orobably corresponds spatially to the main shock rupture; the surface trace of the rupture is along the northern limit of this area.

Figure 3 - Number of officially recorded fatalities as percentage of population in villages in the epicentral area. A surface rupture was mapped near the village of Killari (K) and inferred to extend at least to the village of Talni (T). Surface deformation features reflect a reverse fault dipping to the southwest. Note that the zone of highest relative fatalities (20-30 percent) is centered southwest of the trace of the thrust, above the inferred rupture. Note also that this rupture is centered about 10 km from the Lower Tirna Dam.

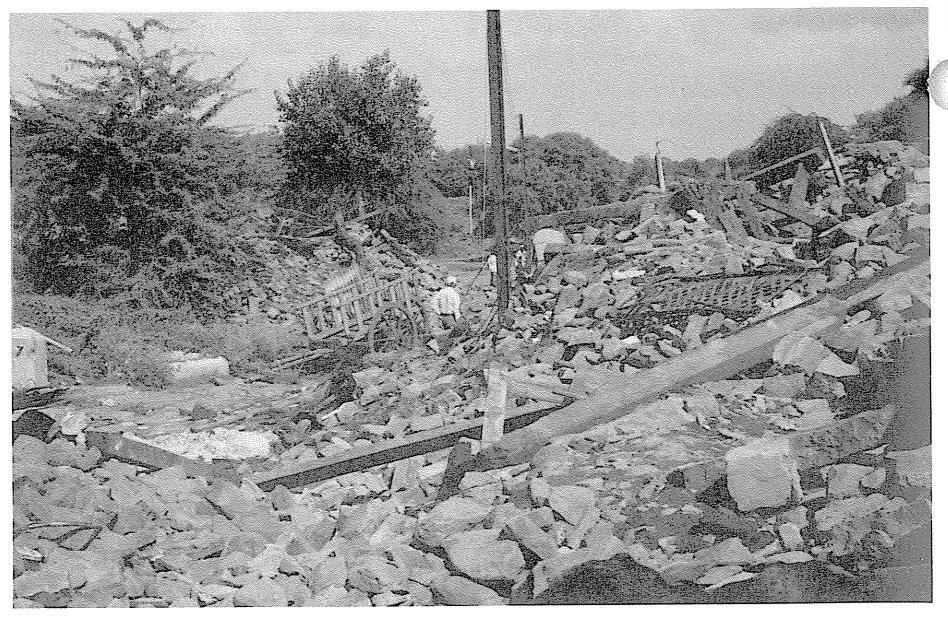
The collapse of traditional stoneand-mud buildings in the mesoseismal area was nearly total. The wood-plank roofs of these singlestory dwellings typically are topped with a 30-60 cm thick layer of clay to provide protection from rain and heat. All such constructions behaved very poorly due to the heavy mass at the roof and the poor strength of the supporting rubble masonry walls; such houses were the main cause for the high number of casualties.

Figure 4 - Destruction of traditional stone-and-mud construction was almost total in the hardest-hit villages. The thick layer of clay (30-60 cm) that topped most roofs to provide thermal insulation contributed heavily to destruction and casualties. [Photo provided by Haresh Shah.]

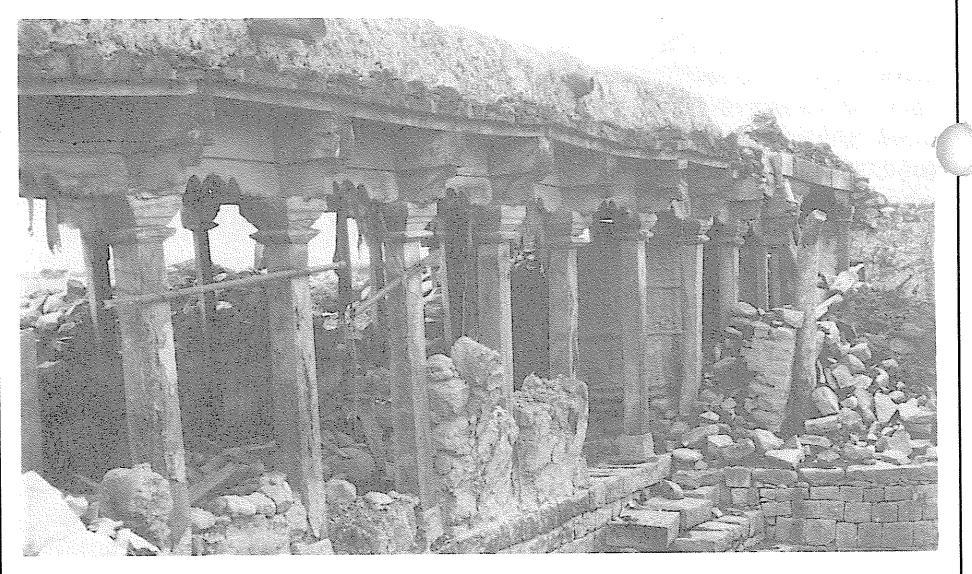
A number of dwellings in the affected villages had timber columns connected together with transverse and longitudinal beams. The roof planks in these houses were supported by the timber beams and columns rather than the rubble masonry walls. When securely anchored to the floor and to the roof beams, the posts tended to hold up the roof and prevent the inward collapse of the walls, thereby saving the inhabitants.

Figure 5 - In some buildings, the traditional heavy clay roof was supported on a frame of wood posts and beams. In most cases, the timber columns continued to hold the roof together while the walls collapsed, generally outwards from the timber frame, saving the lives of many occupants.

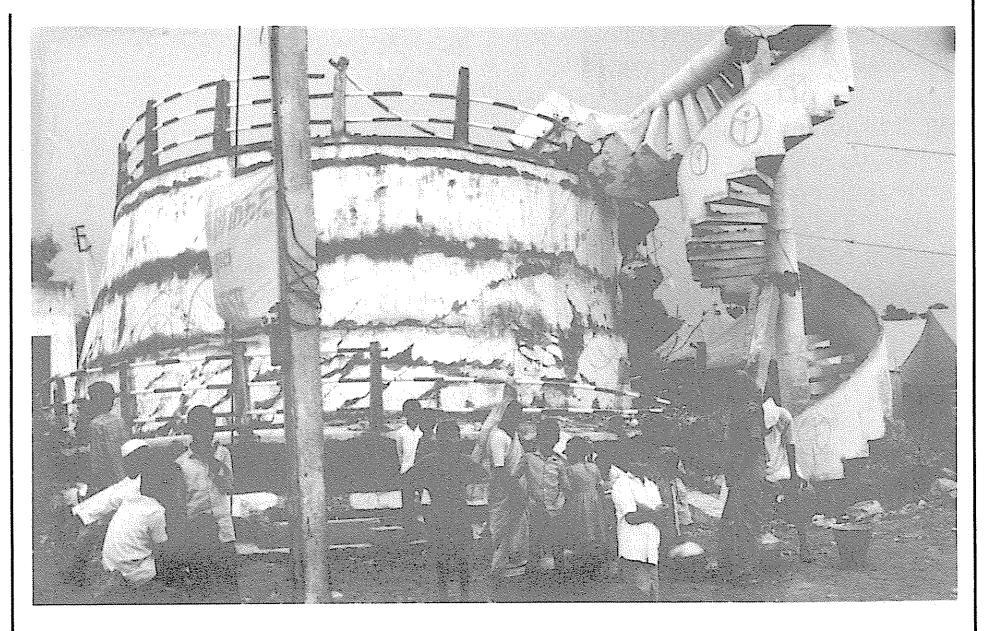
Figure 7 - While most elevated water tanks performed quite well, this tank at Kautha collapsed straight down onto its crumpled supports. Circumferential displacement of about 0.5 m suggests that rotational vibration led to its collapse.

For water supply, most of the villages had an elevated water tank consisting of a reinforced concrete container supported on a concrete moment-resisting frame about 10 m high, a standard design of the Public Health Engineering Department. Tank capacities ranged from 40 kl to 200 kl. Most of these tanks survived the earthquake with little or no damage. The one tank that suffered a complete collapse came straight down, burying the remains of the six supporting columns directly under the bottom dome of the tank. That, and evidence of a circumferential displacement of about 0.5 m, suggest torsional vibrations were the primary cause of the damage.

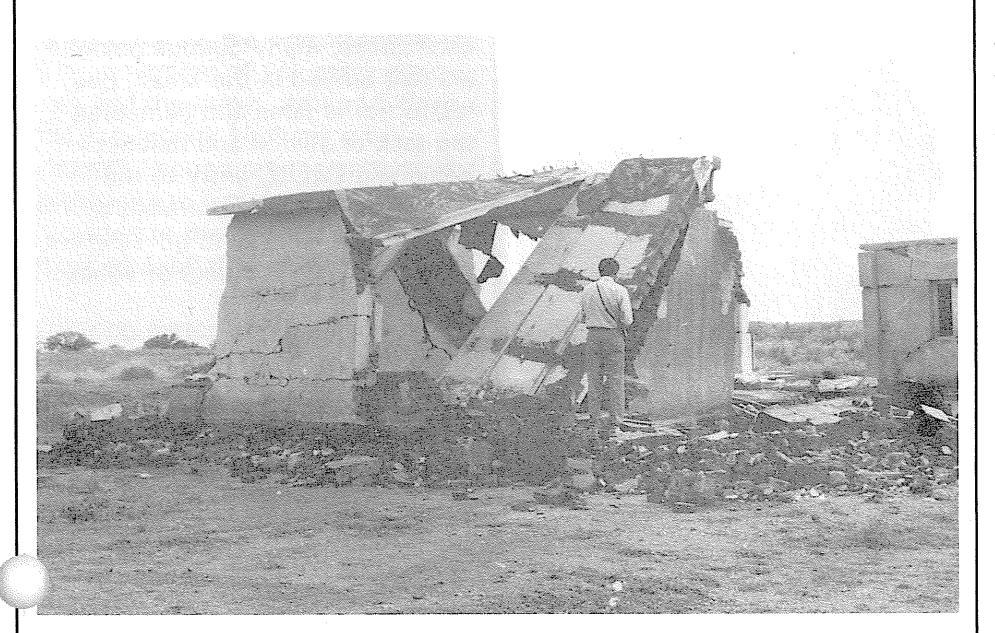
A one-room 8x8 m school building in the village of Rajegaon had exterior load-bearing walls of brick masonry with cement mortar. The roof consisted of lightweight pre-

ast planks 4 m long and 12 cm thick spanning from a light steel truss at the center of the building to the masonry walls. The planks were held together at the line of the truss by steel strips tacked with an epoxy material. No diaphragm action was possible due to the lack of proper connections between the walls and the panels, between the panels and the truss, and between the panels themselves. The roof panels collapsed, demonstrating, yet again, the seismic vulnerability of precast panels without adequate connections.

Figure 6 - A brick masonry school building in Rajegaon collpased. The roof of precast panels lacked adequate connections.
