2010 HAITI EARTHQUAKE

Final Report

POST- DISASTER BUILDING DAMAGE
ASSESSMENT USING SATELLITE AND
AERIAL IMAGERY INTERPRETATION,
FIELD VERIFICATION AND MODELING
TECHNIQUES

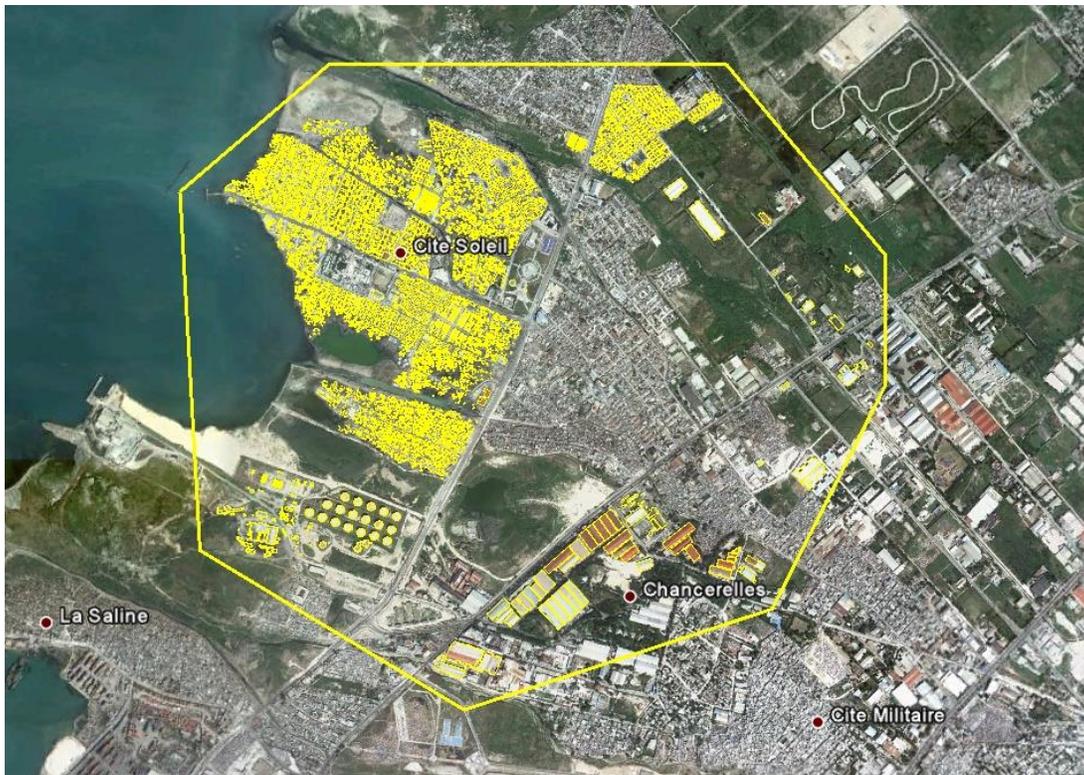
Figure 3.1 Purdue’s Analysis of Building Footprints using Imagery from the January 21st and 22nd World Bank–ImageCat–RIT LIDAR data mission. Footprints are displayed in yellow.

- **Purdue University**, <http://www.purdue.edu/>-Researchers from Purdue University conducted a land-use classification analysis for the central/downtown portion of Port-au-Prince based on the January 13, 2010 GeoEye-1 satellite imagery. The classification scheme assigned all space within the area-of-interest to one of the following categories: roads, buildings, water, vegetation, shadow, open land, and miscellaneous. Additionally, utilizing the World Bank-ImageCat-RIT LIDAR elevation data acquired on January 21st and 22nd, researchers at Purdue extracted building footprints and heights for central Port-au-Prince. See Figure 3.1 below.

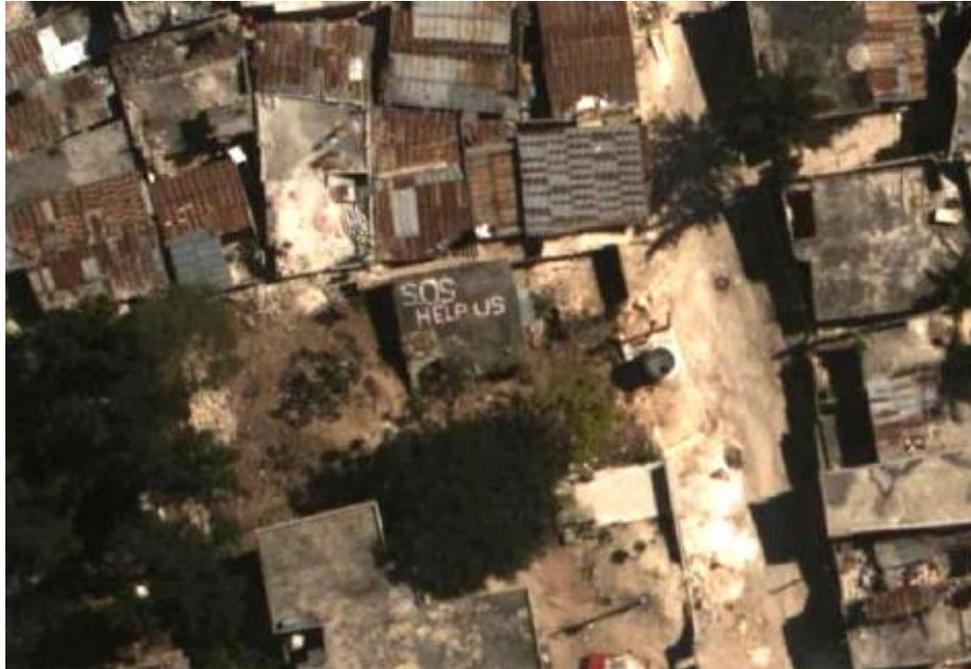
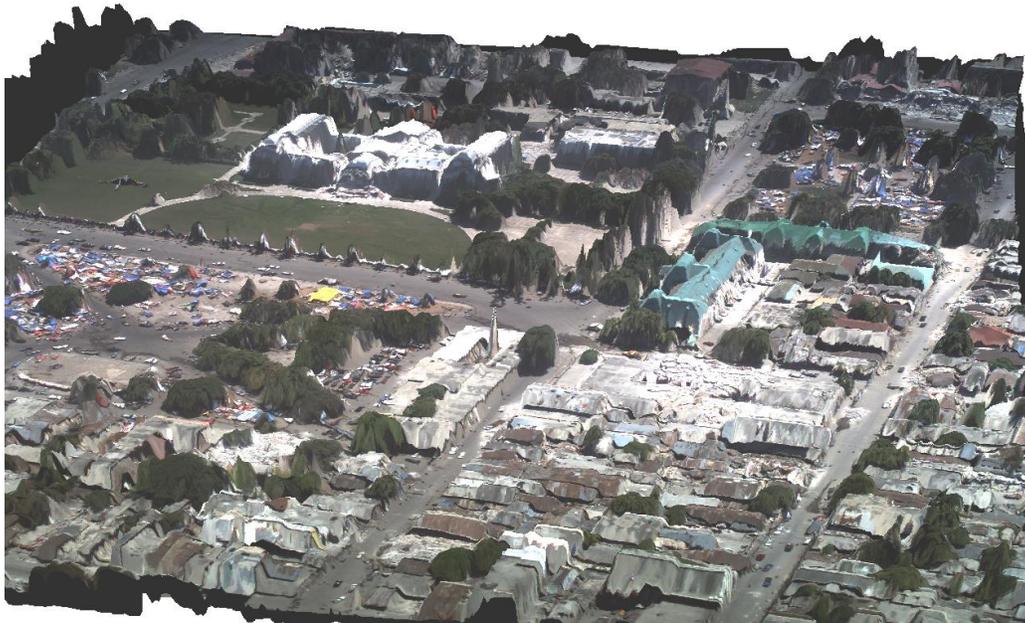
Figure 4.1 (a) Example of Color High-Resolution Aerial Imagery Collected over Haiti. (b) Combined LiDAR and High-Resolution Aerial Imagery for the Presidential Palace Area in Port-au-Prince. .

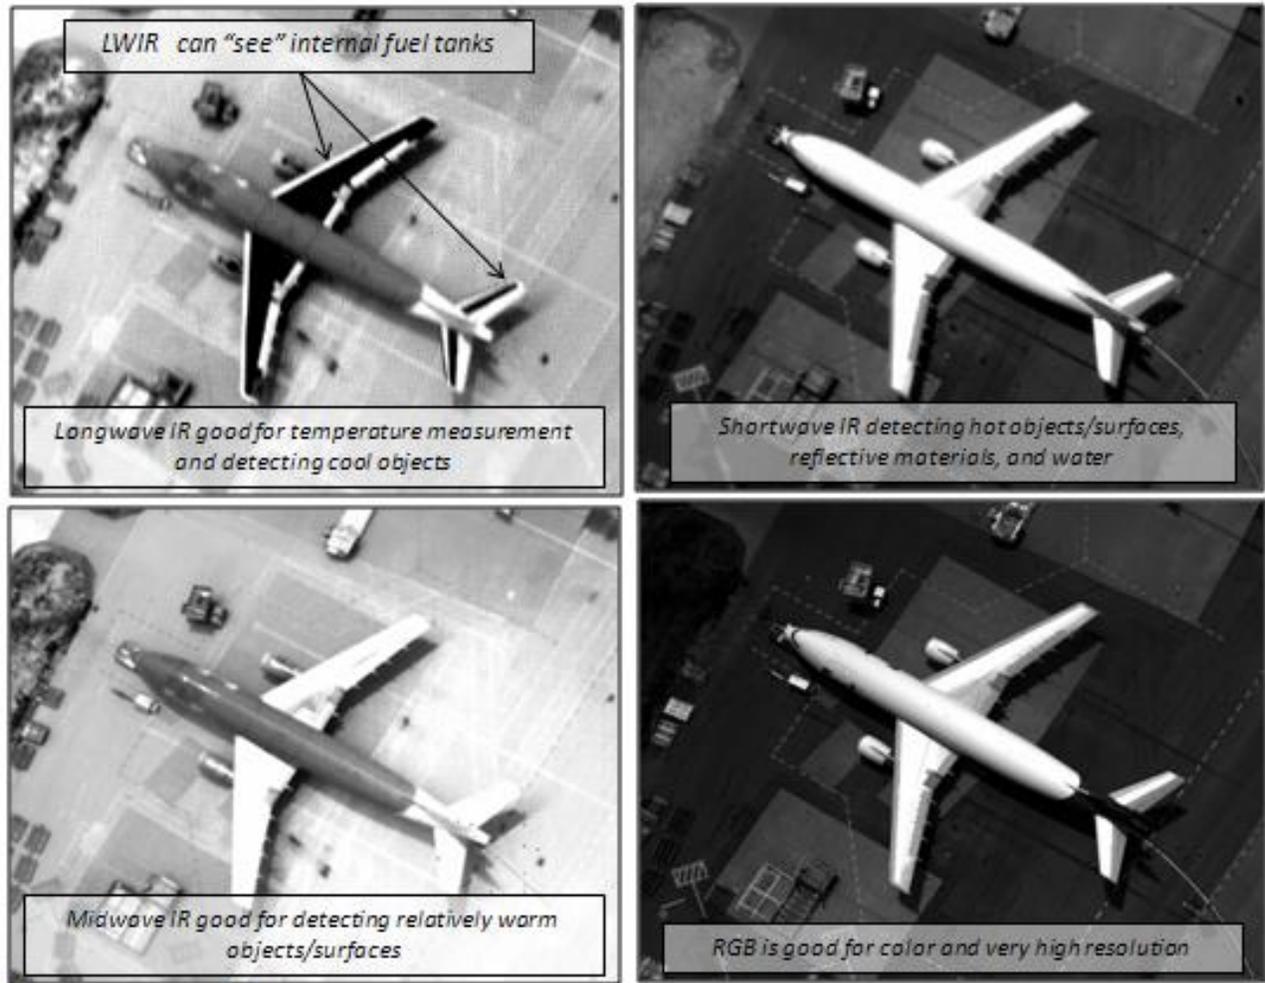
Figure 4.2 Four Cameras for Color and Infrared Imaging

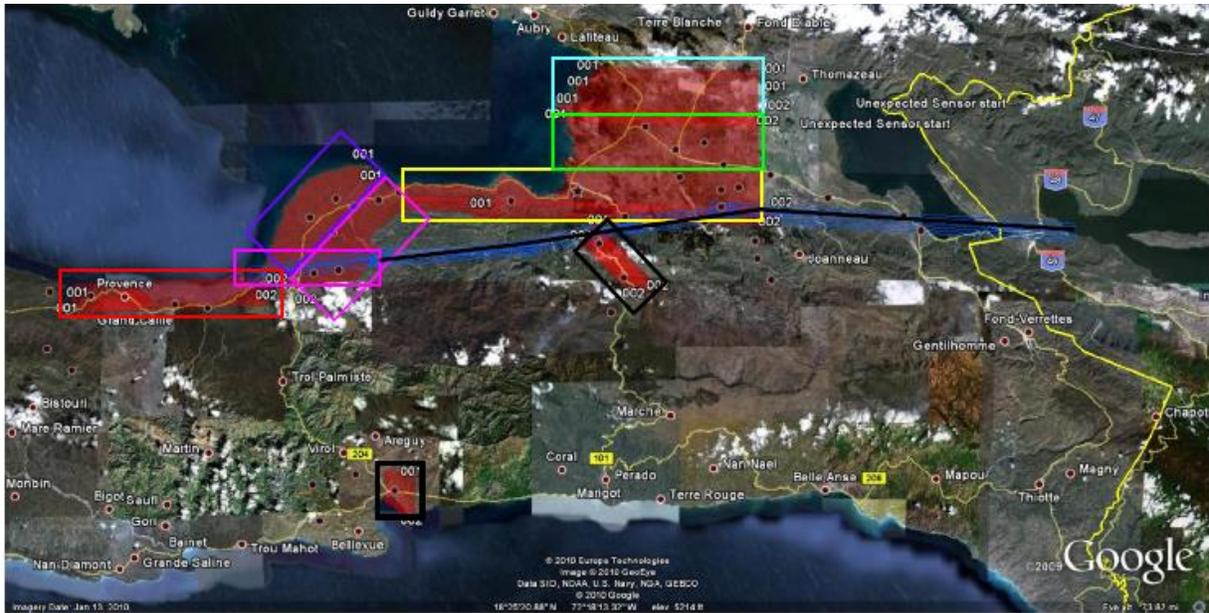
- Day 1 – 1/21/2010: Southern Port-au-Prince and coast
- Day 2 – 1/22/2010: Central Port-au-Prince
- Day 3 – 1/23/2010: Northern Port-au-Prince
- Day 4 – 1/24/2010: Western Léogâne
- Day 5 – 1/25/2010: Eastern Léogâne & western fault line section
- Day 6 – 1/26/2010: Petit Goâve & Grand Goâve
- Day 7 – 1/27/2010: Fermate & Jacmel & central fault line (east of Léogâne)

Figure 4.3 shows a summary of the areas covered by RIT in 7 days of flying over Haiti. RIT covered 250 sq. miles (650 sq. km) in 148 flight lines that added up to a total of 1,933 line-miles (3,115 km). All Haiti campaign imagery has been reprocessed, based on the LiDAR-derived 1m digital elevation model, and has been released to the general research community and various response organizations, including the ImageCat/GEO-CAN team. RIT has also provided *.tar compressed files for all imagery for quicker and easier downloading. LiDAR data are available as 1m and 10m bare earth (DEMs) and surface elevation models (SEMs; 1st return surface) in ERDAS *.img and in TIFF formats. LiDAR data are also available as point clouds in *.las format: classified point clouds.

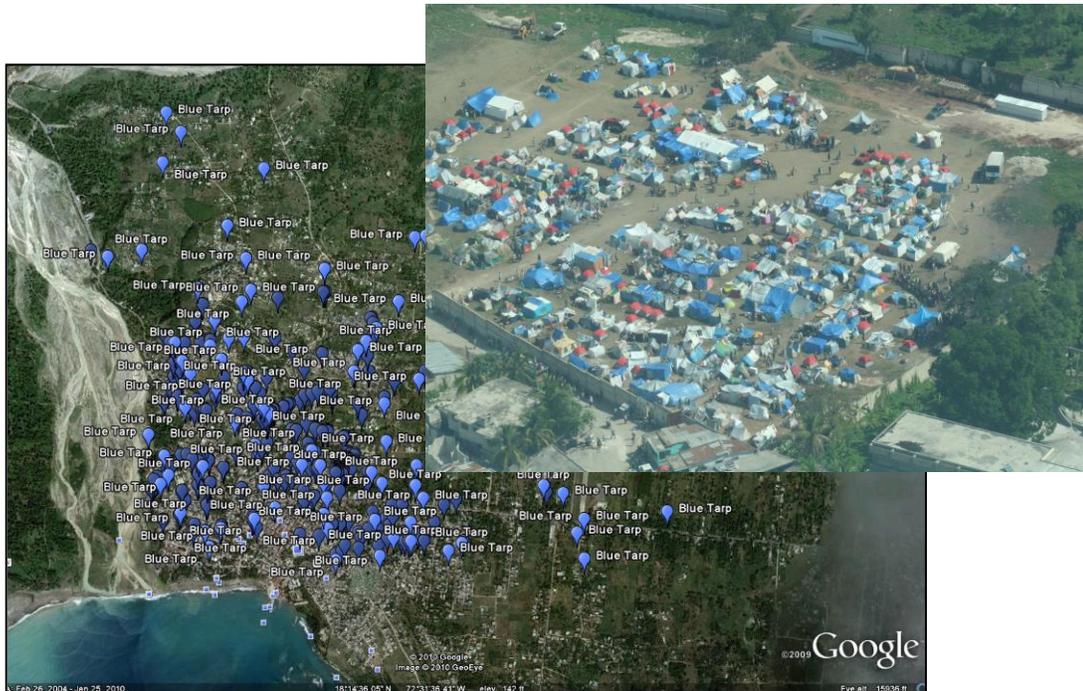
Figure 4.4 Prototype Example of Automated Target Detection Map Product

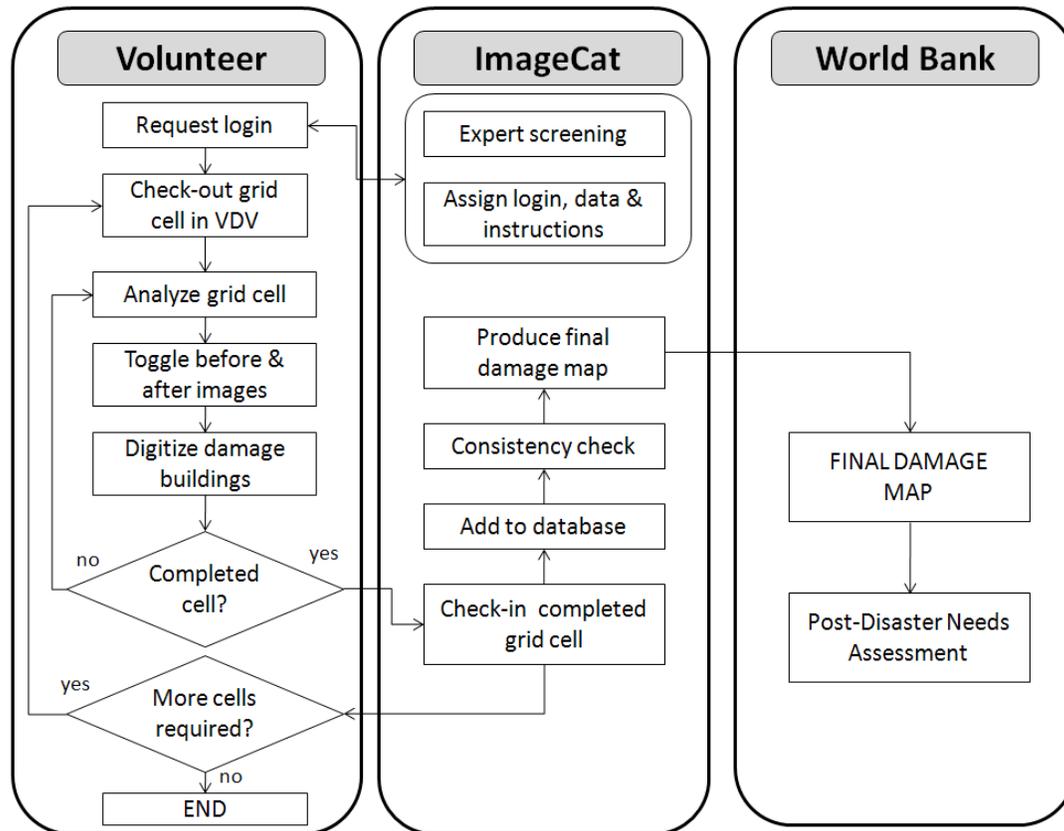
Figure 5.3 GEO-CAN Operational Workflow

Once the analysis of each cell was complete, the user checked the grid cell back into VDV and registered the tile as complete. The analyst then had the opportunity to continue his or her analysis on a new cell. The data was then uploaded to a central repository, where a thorough QA and consistency check was performed by ImageCat scientists. Once all cells were collated and checked, the data was sent to the World Bank client.

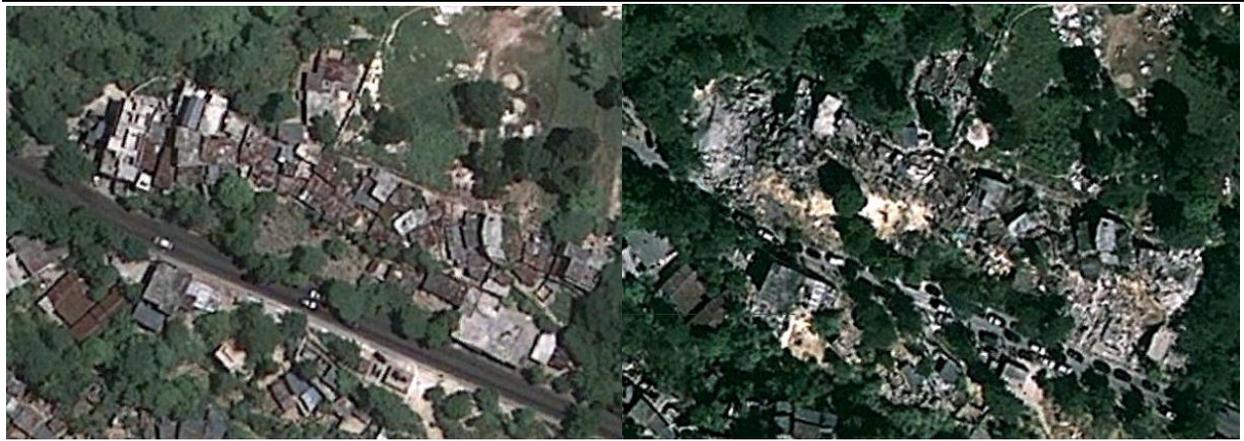
Figure 6.3 Pre- (left) and Post-event (right) Imagery of Dense Development

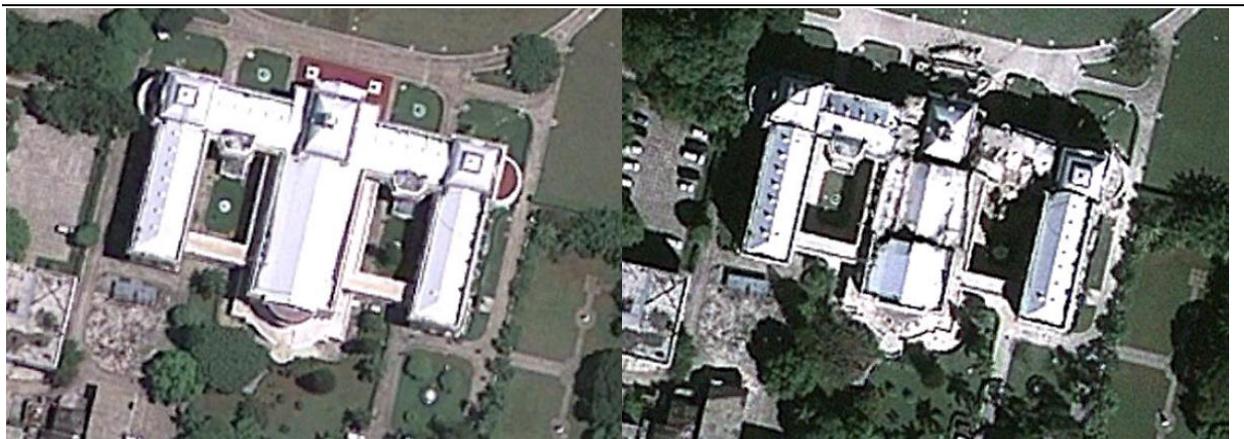
Figure 6.4 Pre- (left) and Post-event (right) Imagery of the National Palace

Well-known and significant structures were identified and double-checked in all the images. Figure 6.4 shows the National Palace before and after the earthquake.

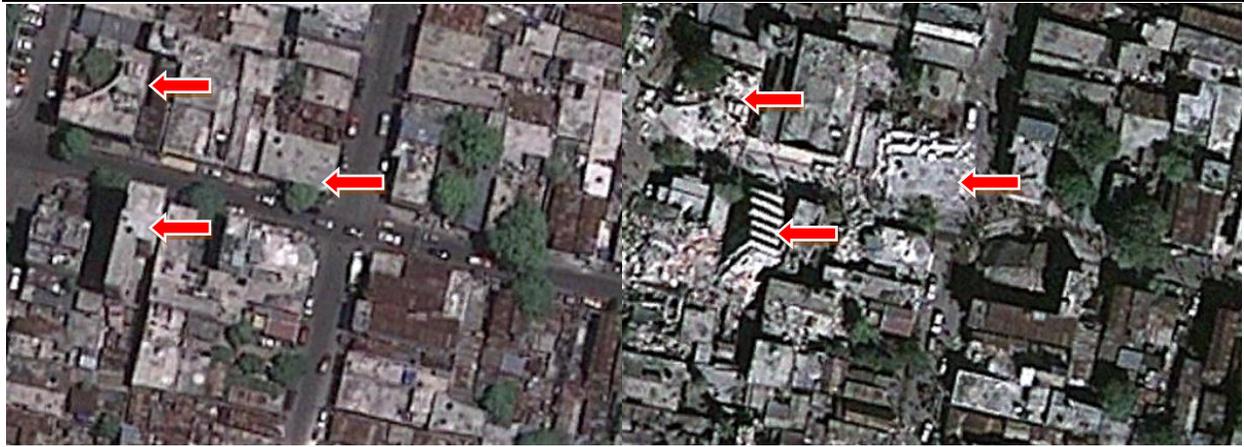
Figure 6.5 Pre- (left) and Post-event (right) Imagery of “Pancaked” and “Stair-step” Damage Patterns

Analysts were also careful to review all tall structures, specifically looking for “stair step” effects which could indicate the presence of a “pancaked” structure (see Figure 6.5)

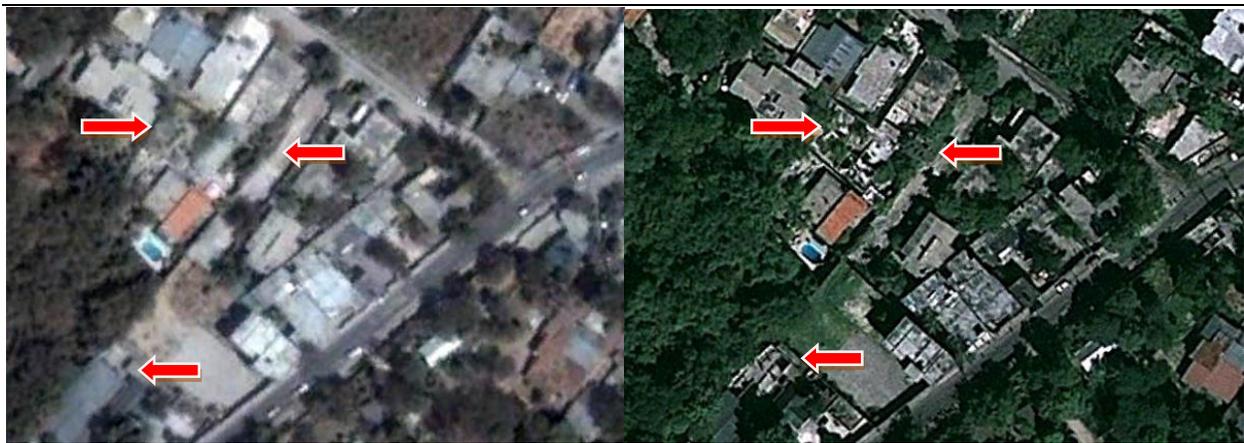
Figure 6.6 Pre- (left) and Post-event (right) Imagery displaying examples of Recent Construction and Structures without Roofs

Many structures elicited signatures that are typically associated with building collapse; however, upon more careful examination revealed either structures without roofs or construction in progress (Figure 6.6). Analysts were careful to crosscheck these sources.

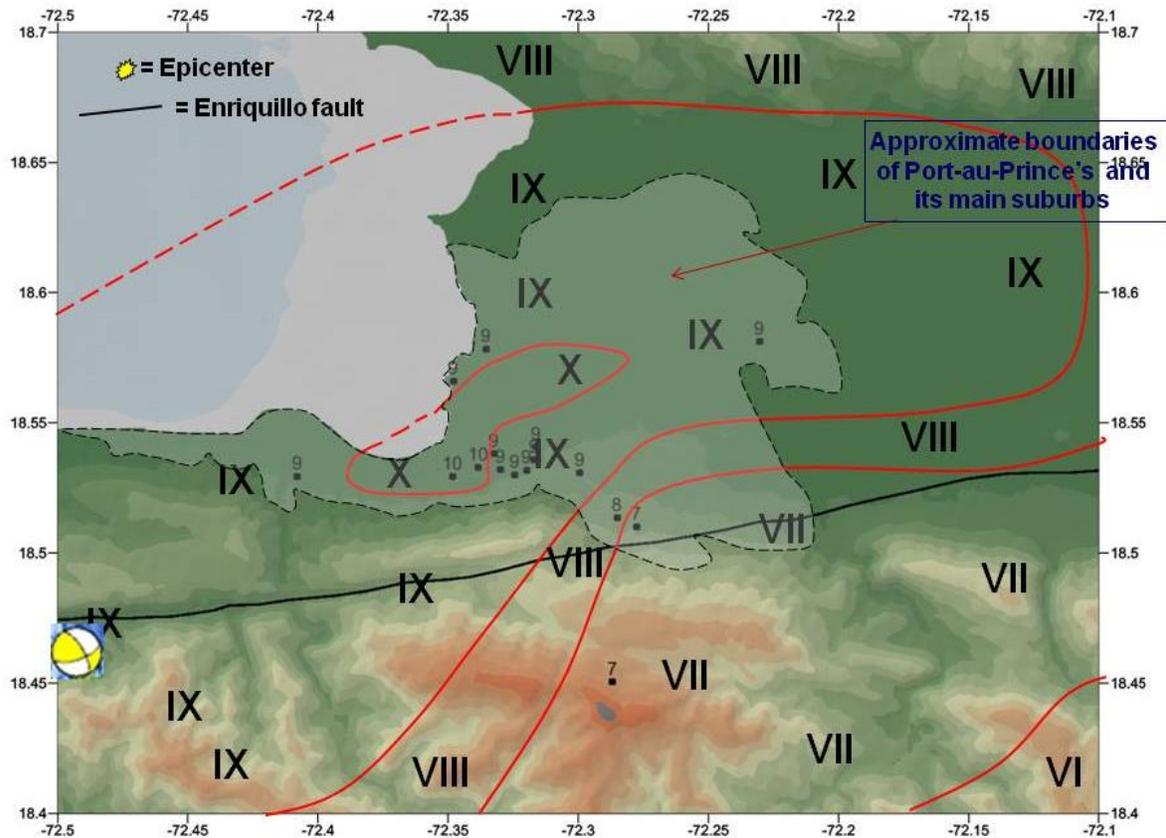
Figure 6.10 Haiti Main Shock January 12, 2010 Modified Mercalli Intensities around PaP (McCann and Mora, 2010)

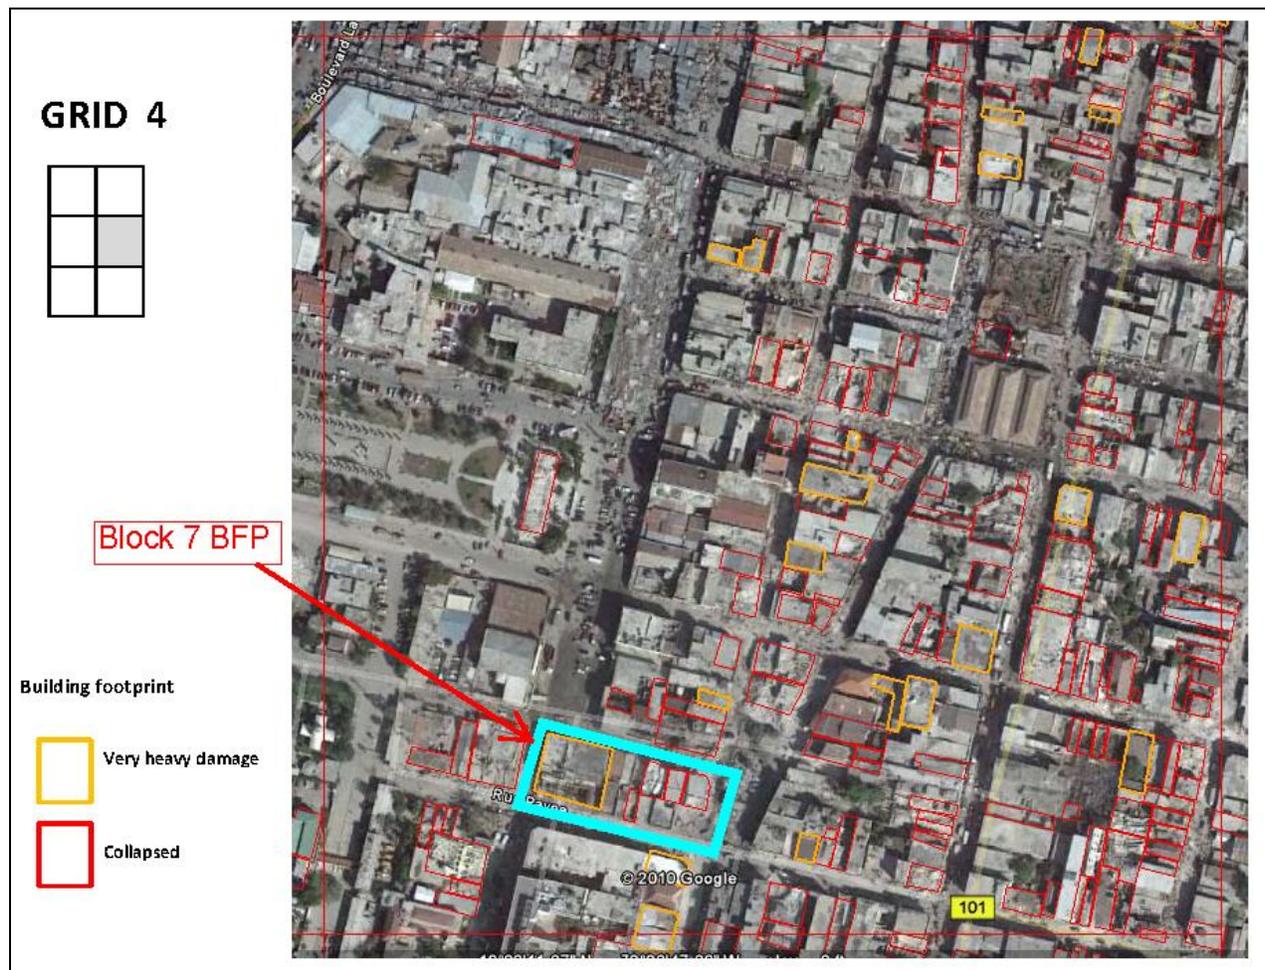
Figure 6.11 Plan View of Damage Assignments Completed by BFP for Central PaP (Fierro, 2010)

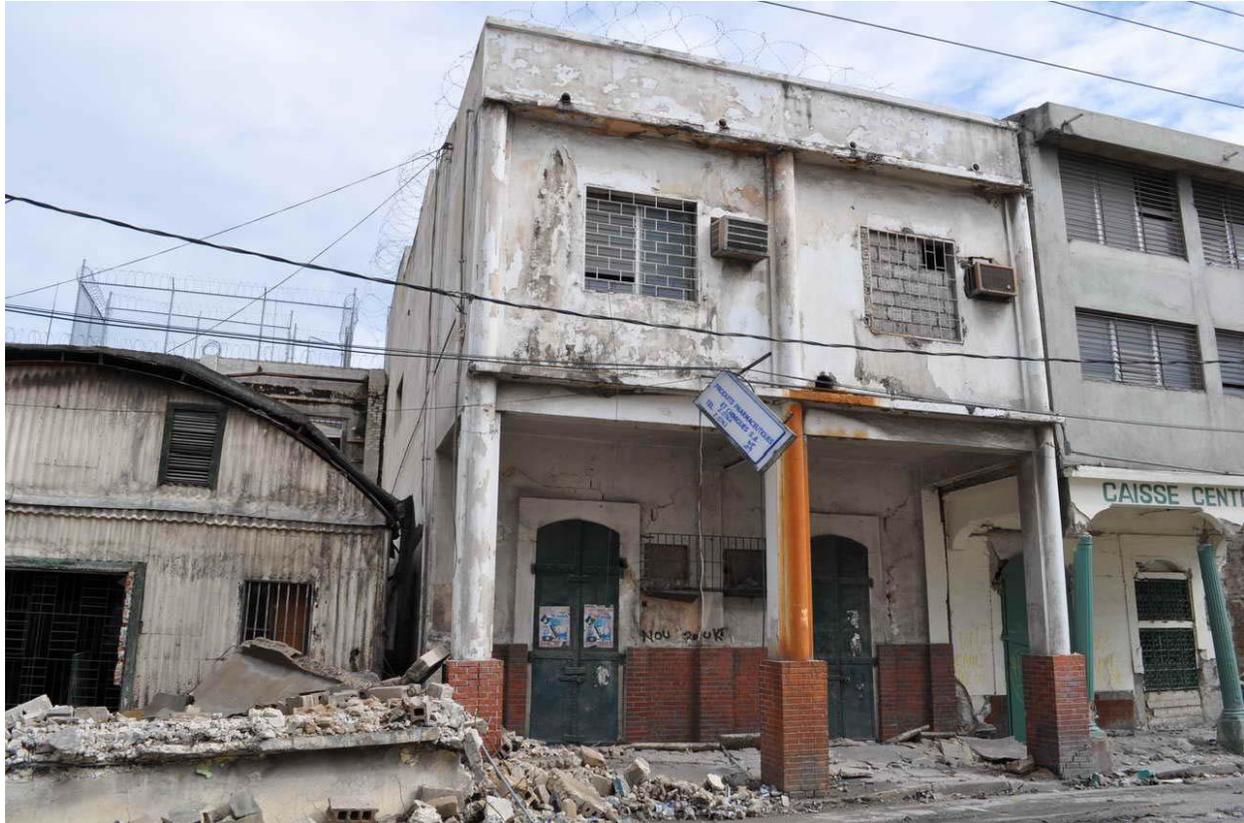
Figure 6.12 Typical Photo used by BFP in assigning specific Damage Grades to Buildings in Central PaP (Fierro, 2010)

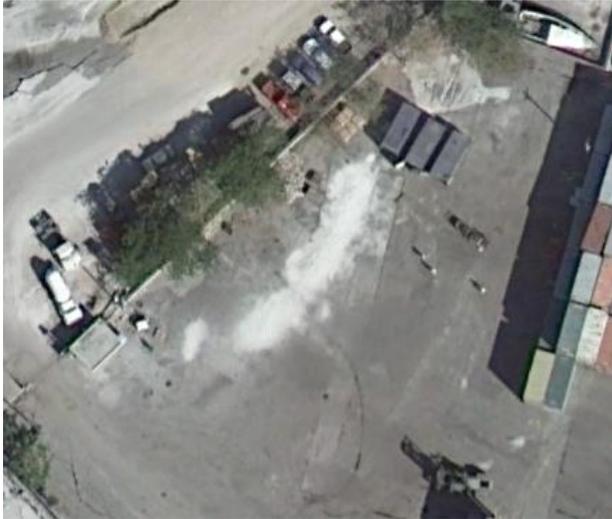
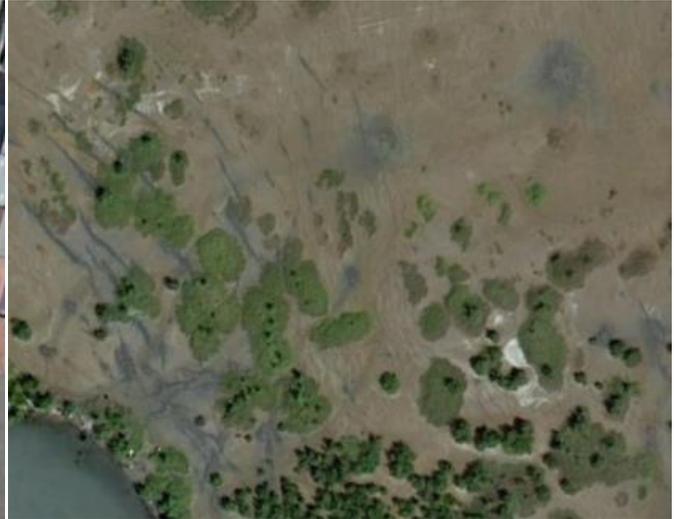
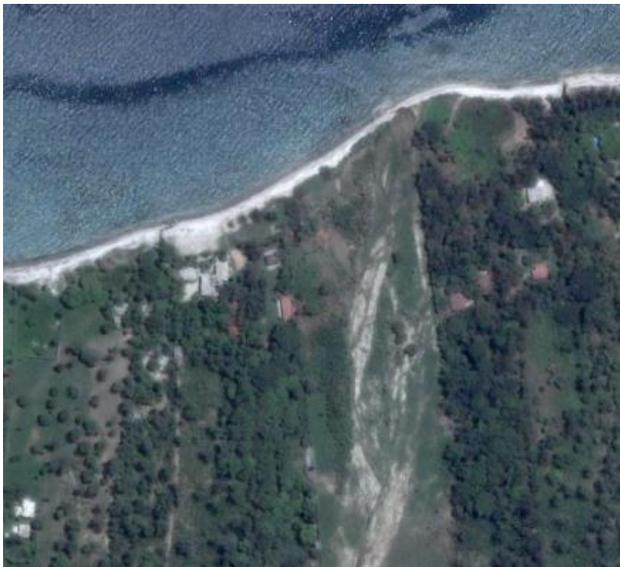
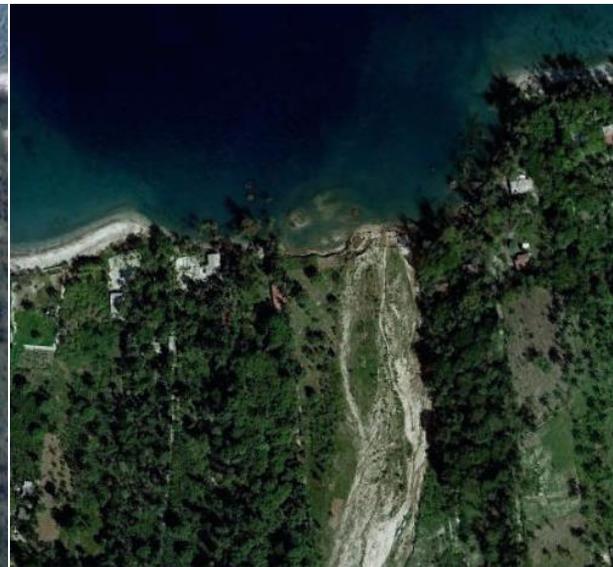
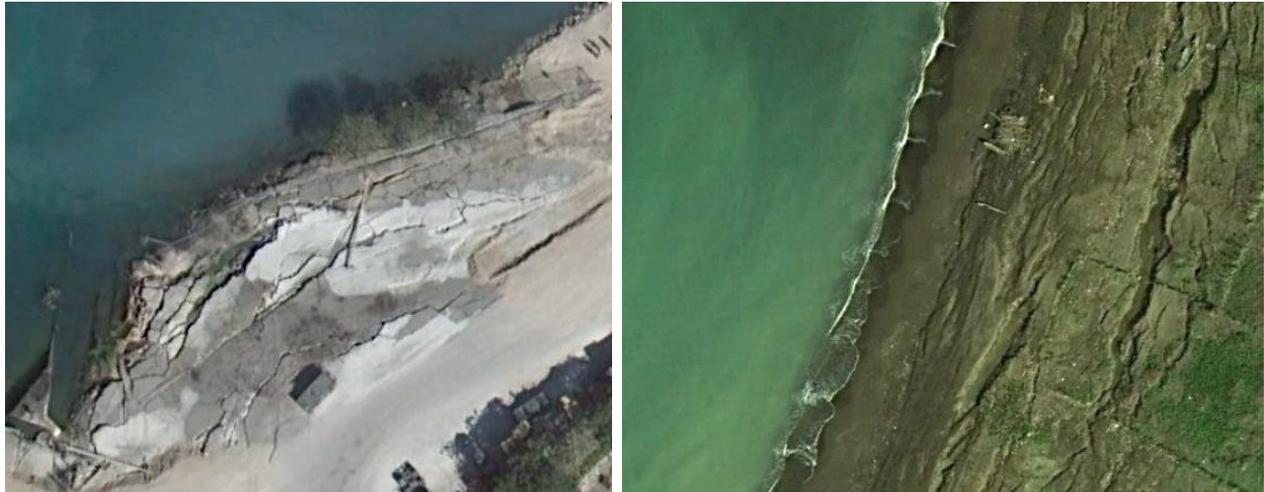
(a) Sand ejecta overlies the ground surface, and may be a lighter color than the adjacent areas. If the ejecta has vented through a crack, the feature will be linear

(b) In some instances, sand ejecta will be darker than the natural ground surface due to its large water content. Sand blows will be circular in shape.

(c) For coastal slumping, it is most useful to compare pre- (left image) and post-event (right image) shorelines. Coastal slumping will show significant coastal retreat and loss of beach zone.

(d) Ground cracking is readily apparent parallel to the coastline (both left and right images show ground cracking)

Figure 6-15 shows some examples that were provided as part of the liquefaction damage assessment protocol. The complete protocol is contained in Appendix A4.

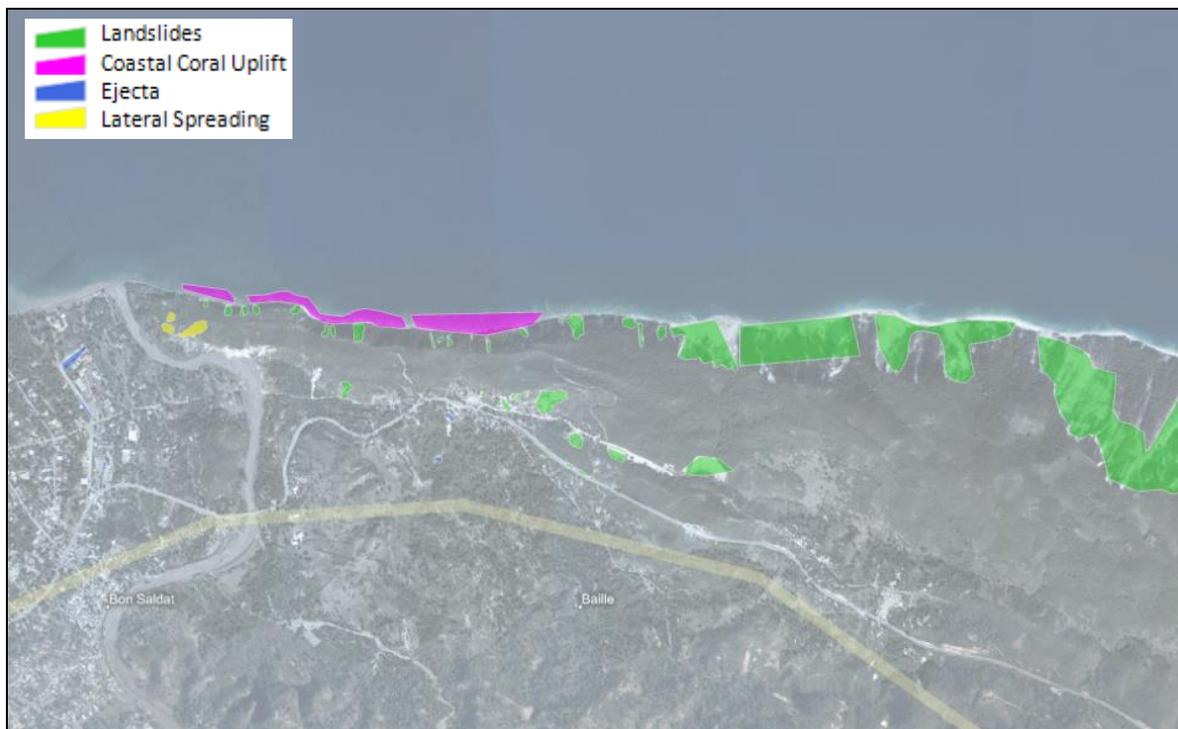
Figure 6.16 Liquefaction Assessment Data Layer - available for download via the VDV site

The same check-in and check-out process used in the building damage assessment was used here for liquefaction. A preliminary map showing the results of Phase 3 is available on the Virtual Disaster Viewer (<http://virtualdisasterviewer.com/haitiGrids/liquefaction>). Figure 6.16 shows the most recent data layer (as of 24 May, 2010). The data can also be downloaded from the VDV site.

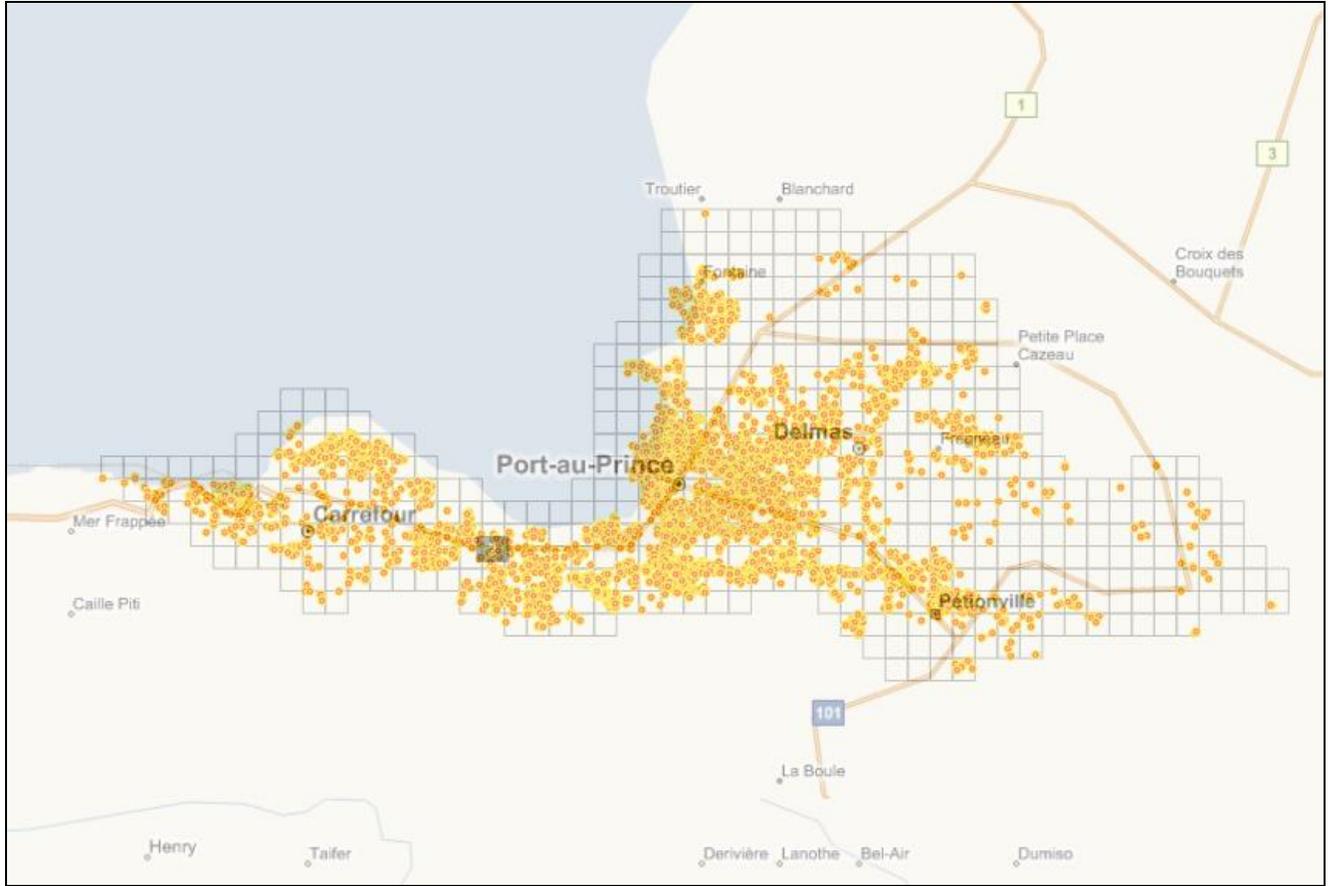
Figure 8.1 Point Locations of Collapsed Structures

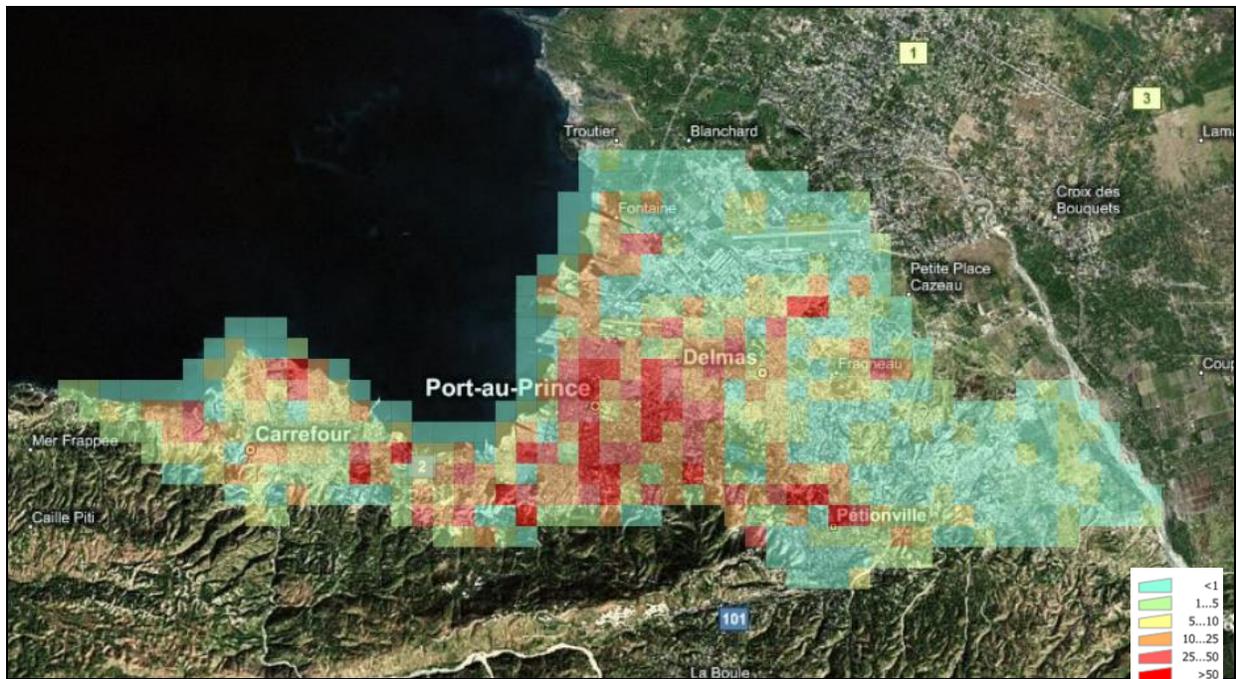
Figure 8.2(a) Number of Collapsed Buildings pejur 500 m Grid Cell

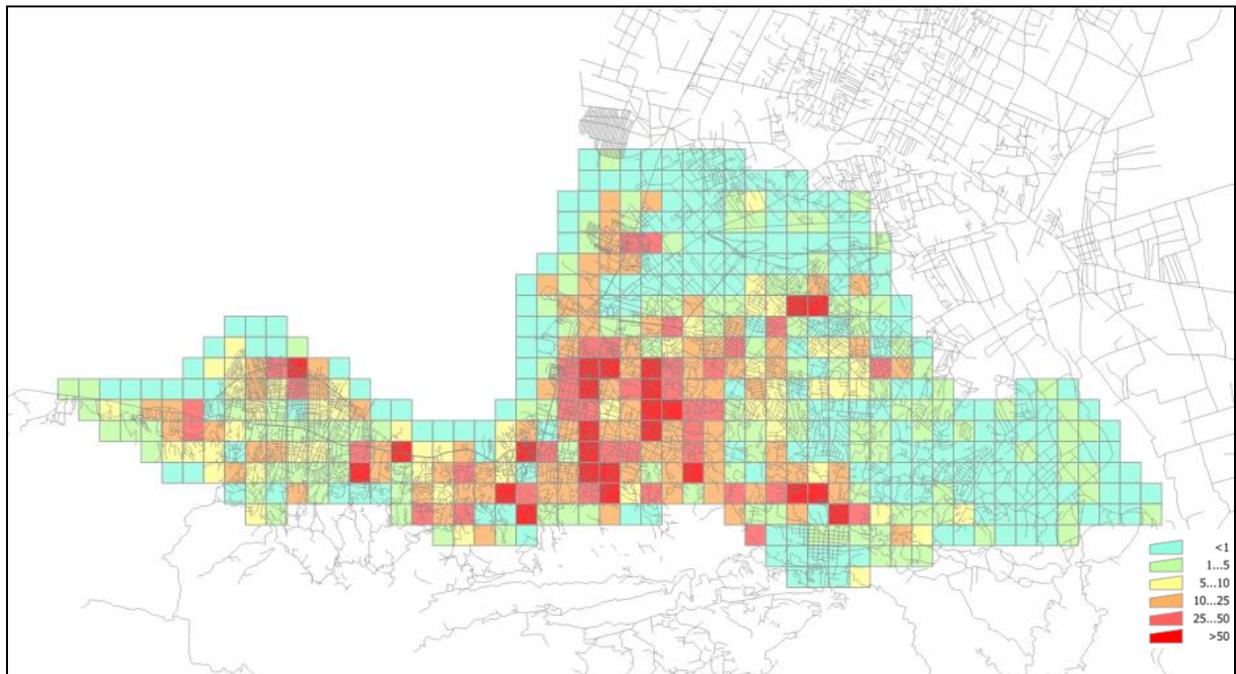
Figure 8.2(b) Number or Collapsed Buildings per 500 m Grid Cell, without Imagery Underlay

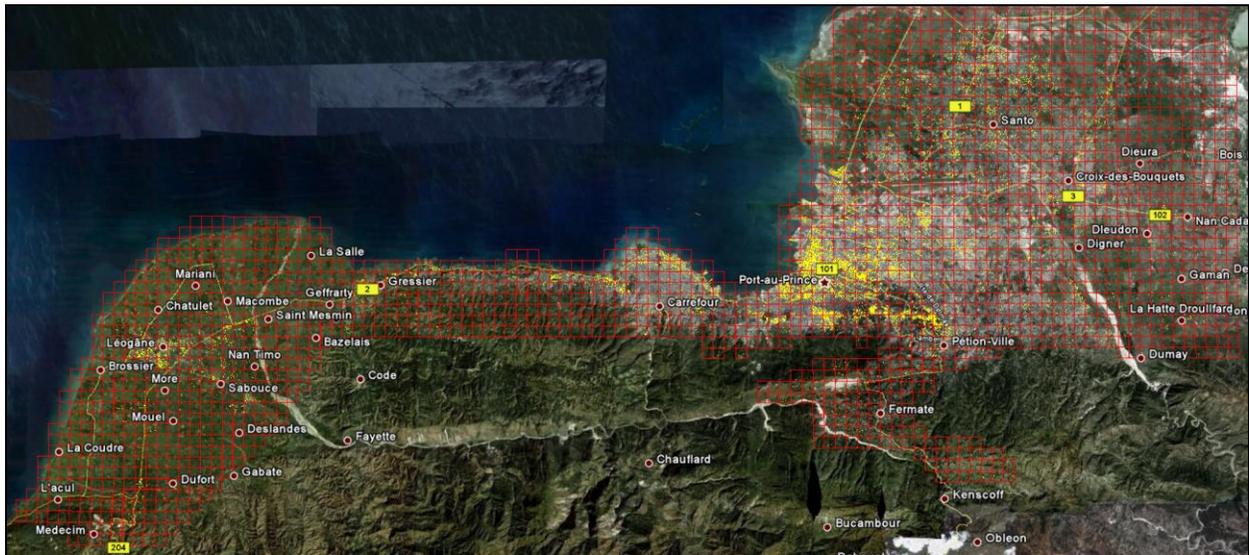
Figure 8.5 Locations of Collapsed and Heavily-Damaged Buildings in PaP, Carrefour, and Leogane (Damage Points in Yellow)

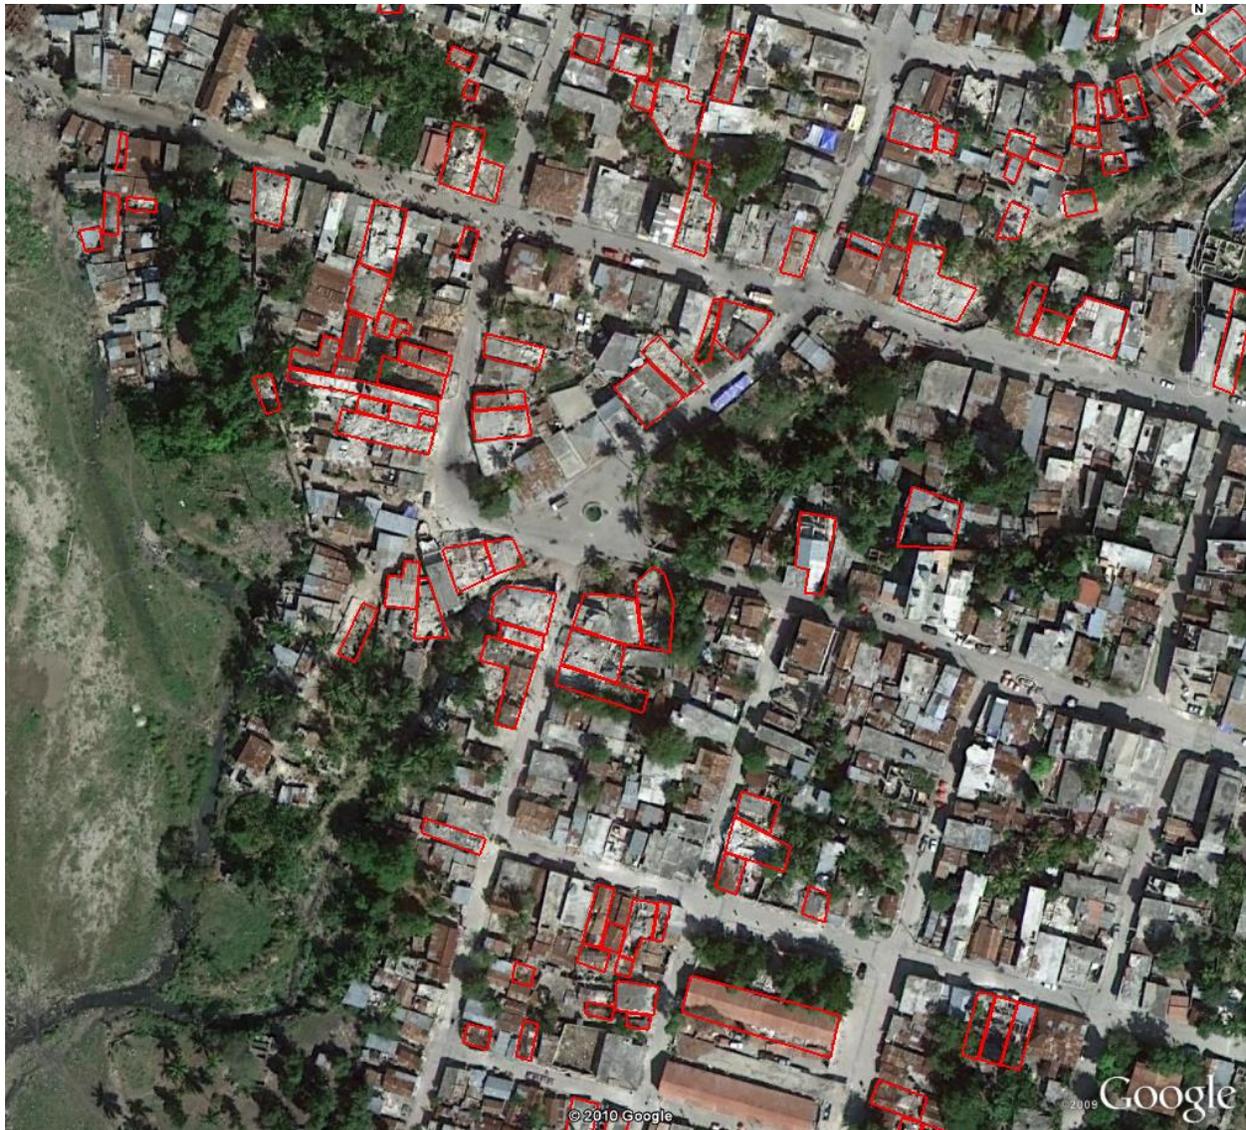
Figure 8.7 Locations of Collapsed and Heavily-Damaged Buildings in Jacmel (Footprints in Red)

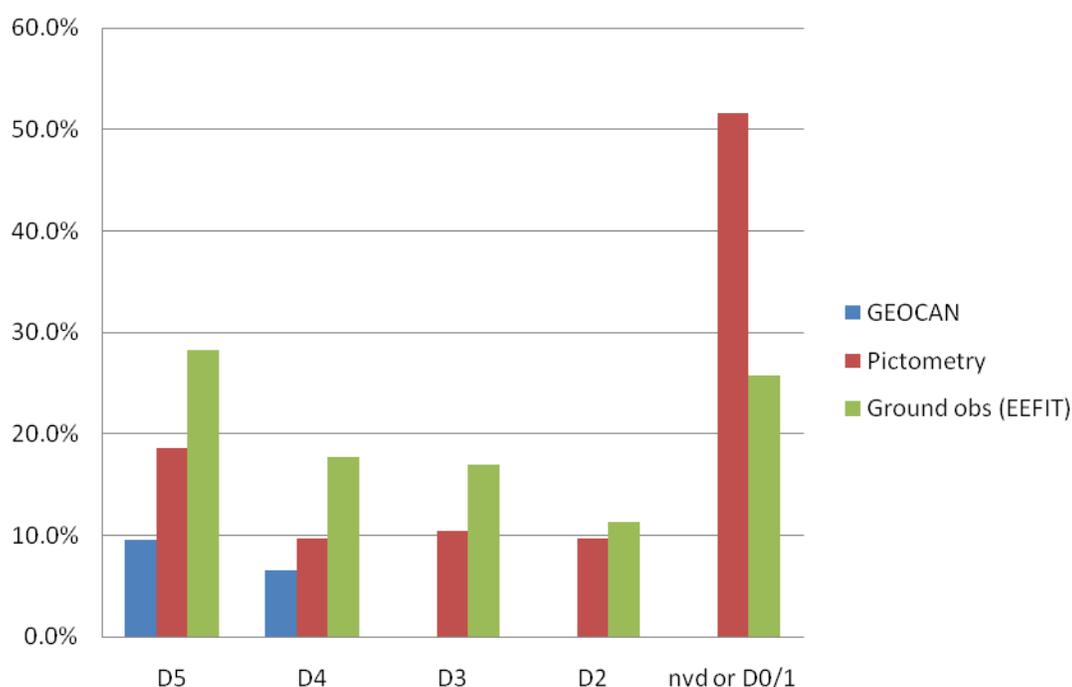
Figure 8.12 Comparison of GEO-CAN, Pictometry and EEFIT Damage Results. Sample size = 124

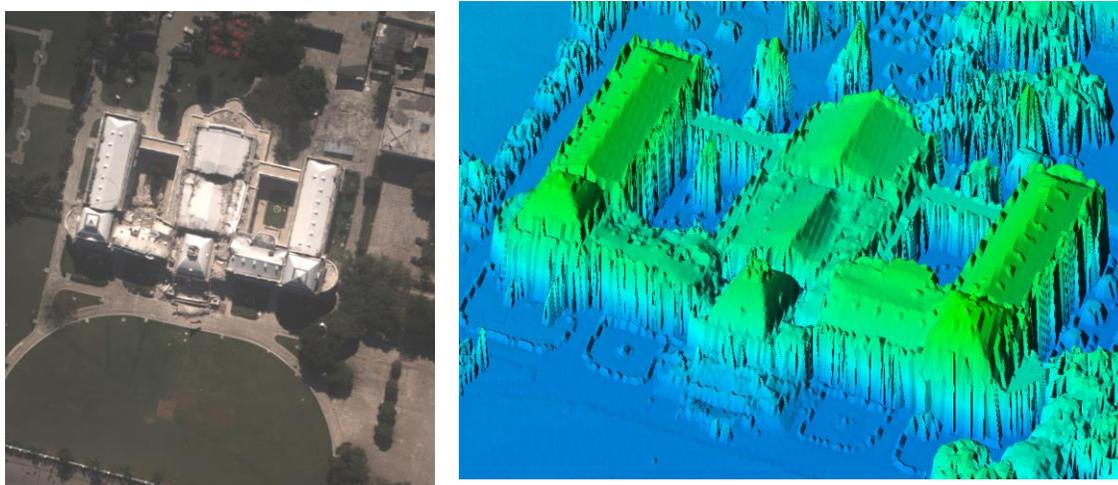
Figure 10.1 The National Palace as viewed in Optical Imagery (left) and LiDAR

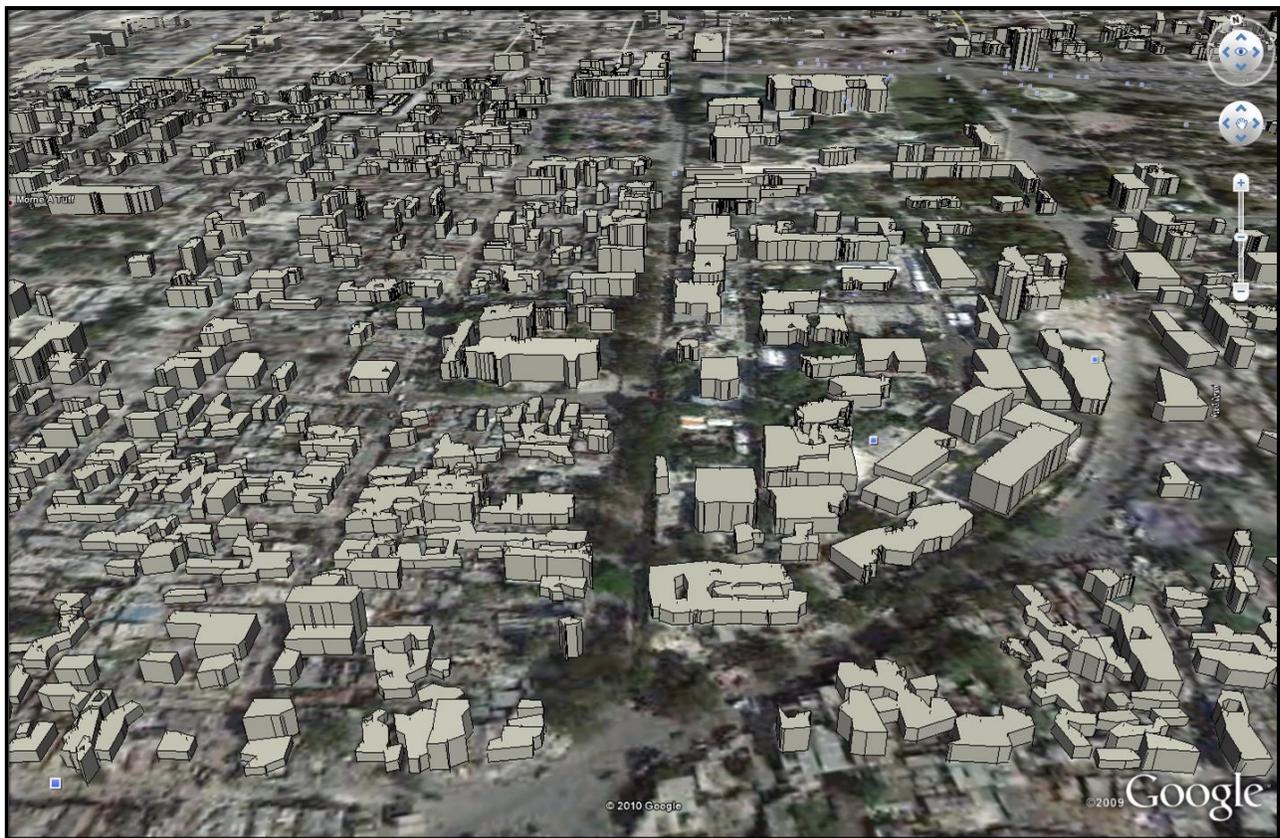
Figure 10.2 Purdue University's 3-D building Models as viewed in Google Earth
