2010 HAITI EARTHQUAKE

Final Report

POST- DISASTER BUILDING DAMAGE
ASSESSMENT USING SATELLITE AND
AERIAL IMAGERY INTERPRETATION,
FIELD VERIFICATION AND MODELING
TECHNIQUES

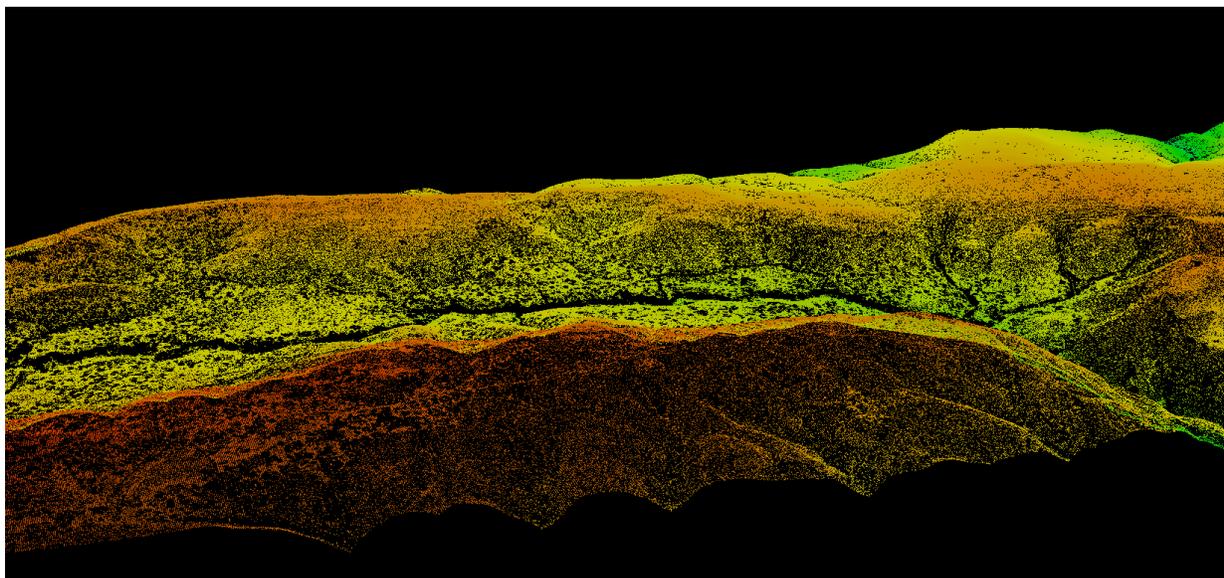
Figure 10.4 Aerial LiDAR Point Cloud of Haitian fault

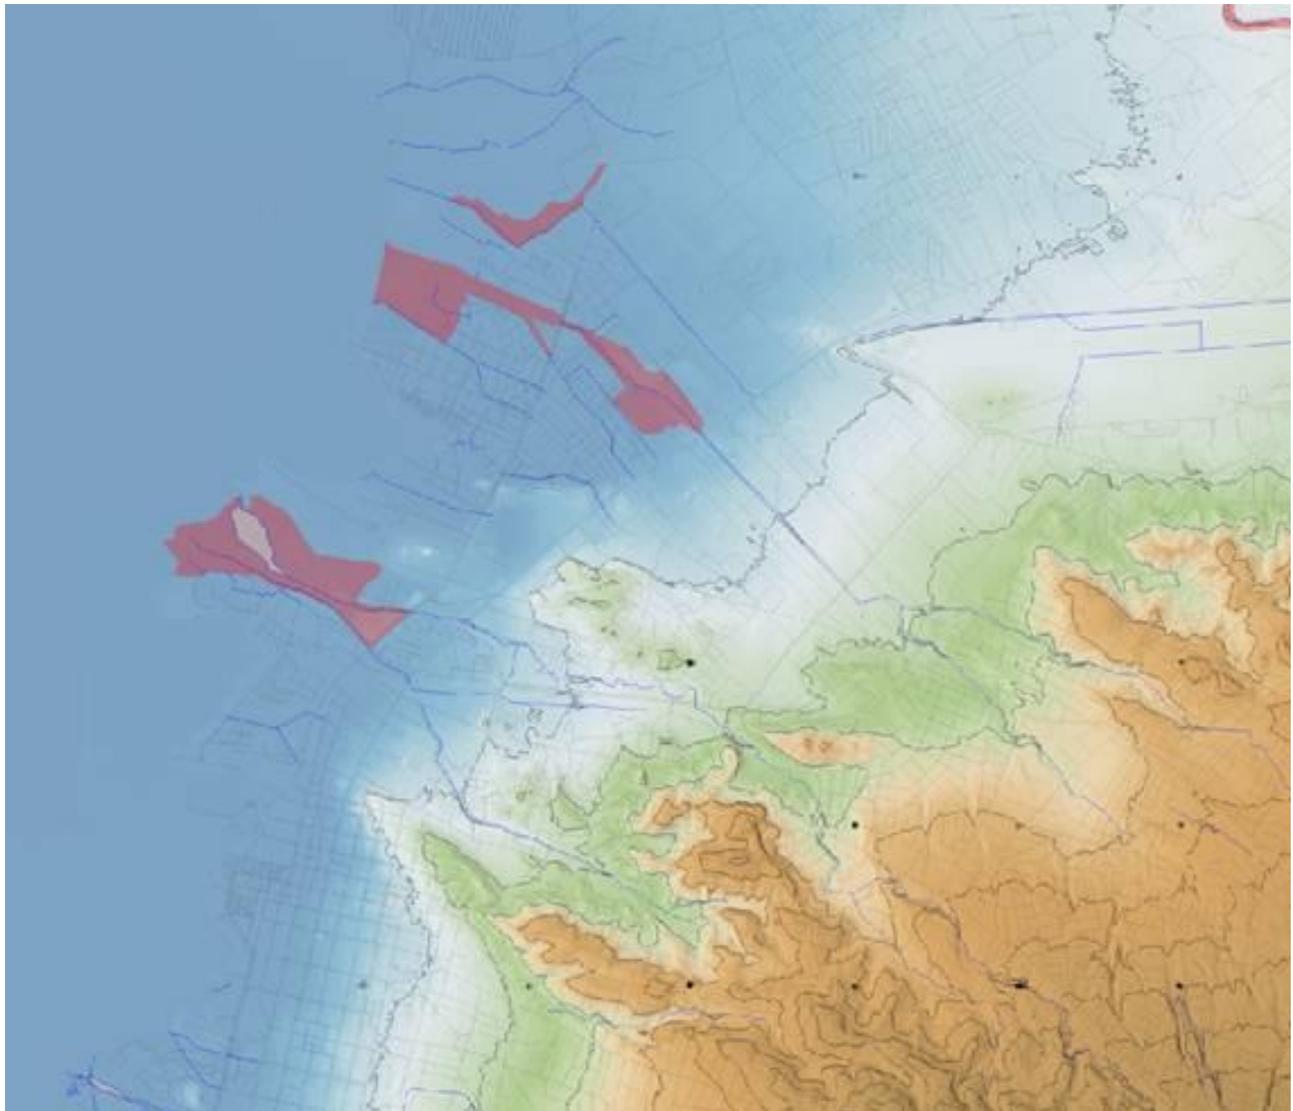
Figure 10.5 Ground Elevation GIS Layer with Flood Areas Mapped in Red (WB-IC-RIT LiDAR Data; Corps of Engineers)

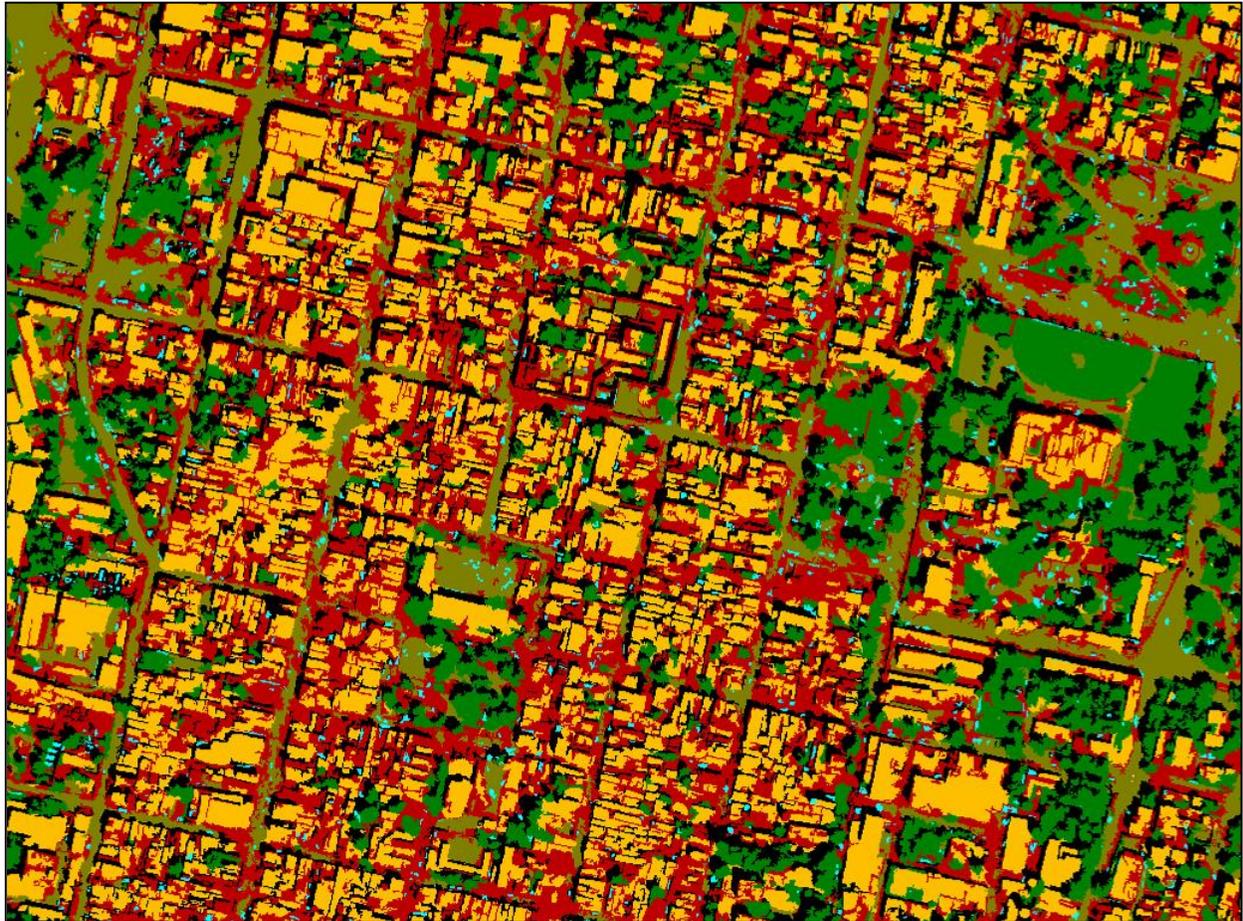
Figure 10.7 Identification of Building Footprints along with Rubble and Debris Areas for Downtown Port-au-Prince

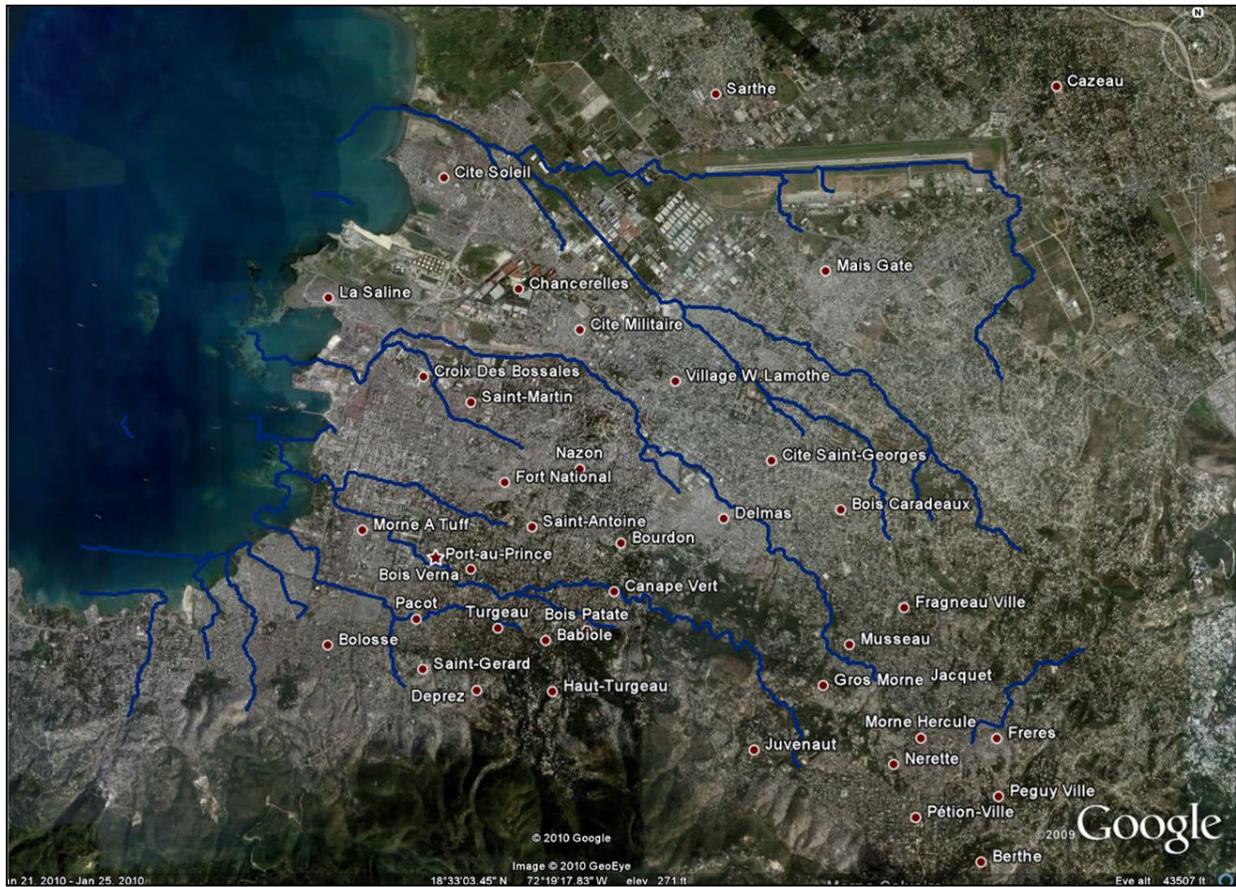
Figure 10.8 Drainage Patterns for Port-au-Prince shown in Blue
